Diploma Thesis (DT) title: <u>Evaluation of the Broumov parish house failure, its causality, and some ideas of remediation</u>	
Diploma Thesis title in English: <u>Evaluation of the Broumov parish house failure, its causality, and some ideas of remediation</u>	
Instructions for writing the thesis: <p>The main goal of the dissertation will be to assess and evaluate the cause of the failure of the parish house, deanery Broumov. The analysis requires not only technical knowledge but also historical, cultural, and investigative knowledge as well.</p> <p>The work will consist of the following parts:</p> <ol style="list-style-type: none"><li>1. It should start with an overview of the historical development of the area.</li><li>2. Followed by inspection of the Broumov deanery real estate. With a focus on failures and their possible causes and determining the material properties of masonry.</li><li>3. The obtained knowledge will lead to the creation of the FEM models, and selection of the loading cases.</li><li>4. By comparing the results of the FEM model and the current state of the structure, the probable causes of the failure are determined.</li><li>5. Recommendation of the next procedu

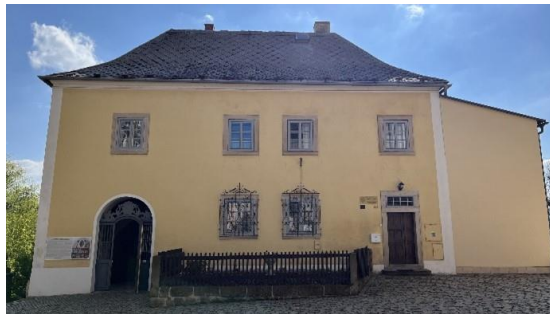
Northeast Façade

Upon the examination that was done, it has been determined that the exterior of the building exhibits no significant damage or deterioration. All the four façades can be seen in Figure 4.1 and their damage mapping is provided in Annex 1. The findings reveal that the majority of the exterior elements remain structurally intact. In contrast, the plaster on the exterior surfaces shows signs of decay. This observation suggests that the deterioration is primarily limited to the superficial layer of plaster rather than affecting the underlying structural elements.

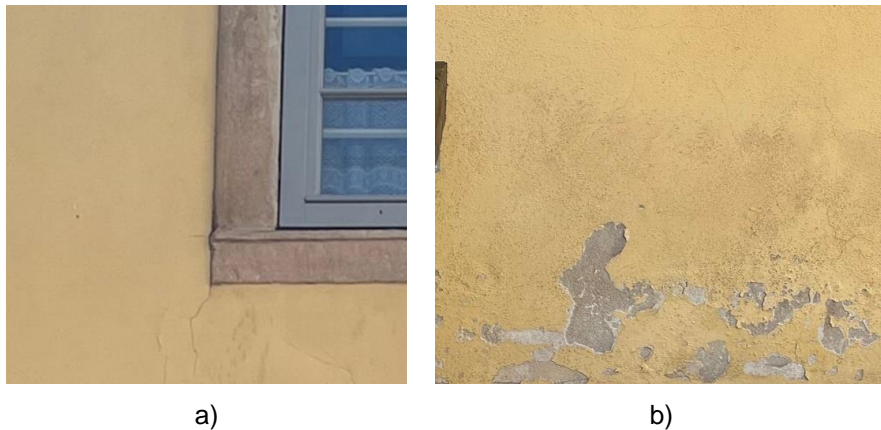
According to ICOMOS, there are many types of cracks such as fracture, star crack, hair crack, craquelè, and splitting. The façades have some minor fractures on the corners of some windows. The main façade appears to have craquelè cracks on the plaster close to the small garden in front of the building.

Figure 4.2 - a) Fracture crack near a window, b) craquelè effect

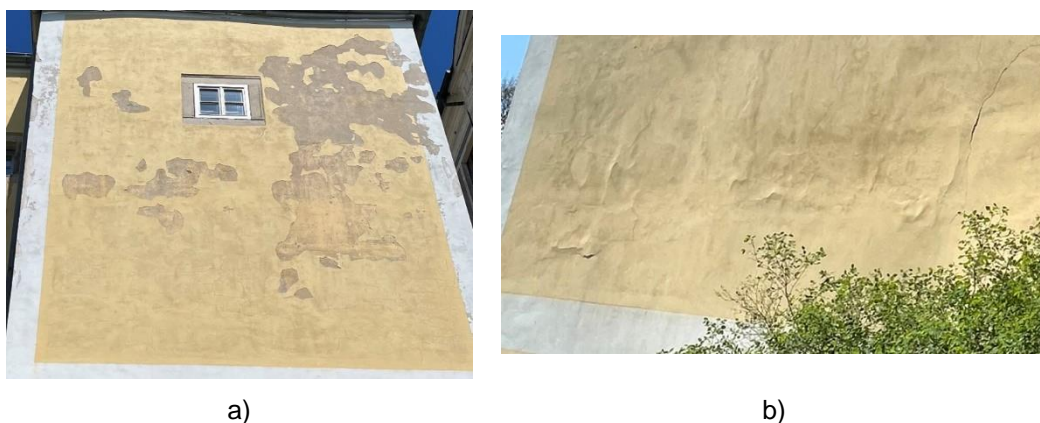
According to ICOMOS guidelines, detachment encompasses various manifestations such as blistering, bursting, delamination, disintegration, fragmentation, peeling, and scaling. In the case of the building's façades, specific issues observed include blistering, delamination, and peeling. Among the façades, the southwest side exhibits the highest level of decay, with large sections of missing plaster. The southeast façade displays widespread blistering issues across its entire surface. On the other hand, the northeast and northwest façades demonstrate no significant detachment problems, apart from minor instances near the area adjacent to the small garden on the main façade.

Figure 4.3 - a) Delamination of Southwest facade, b) Blistering of Southeast facade

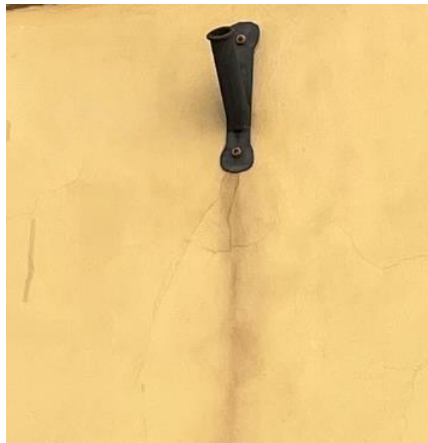
Discoloration and deposits include coloration, bleaching, moist area, staining, deposits, crust, efflorescence, encrustation, film, glossy aspect, graffiti, patina, soiling, and sub-efflorescence. None of the façades have significant problems with this type of decay. Only the main façade has a small, discolored part of the wall because of the metallic flag case, which is because of the water-licked color on the wall.

Figure 4.4 - Discoloration on the main façade

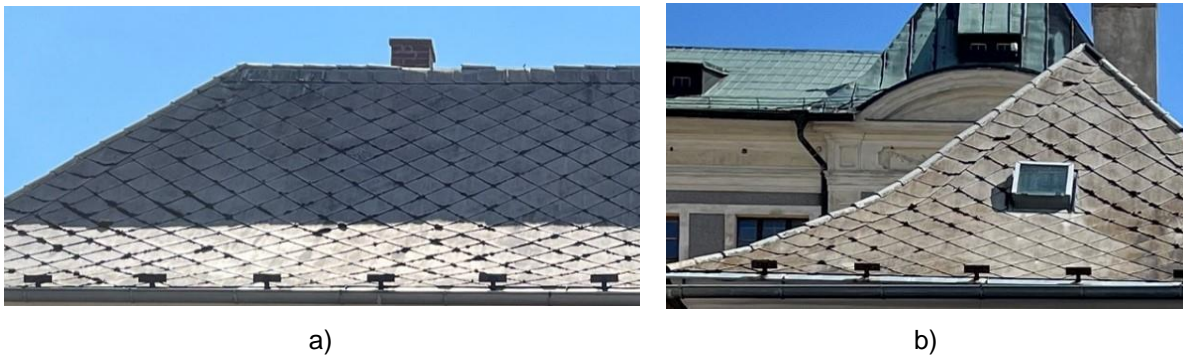
Biological colonization, as defined by ICOMOS, is the colonization by plants and microorganisms such as bacteria, cyanobacteria, algae, fungi, and lichen. It also includes influences from other organisms such as animals nesting on and in parts of the building. The roof of the building is the only part where this phenomenon takes place to a large extent, as the whole roof appears to be affected by moss. Something worth mentioning again is that the northwest part was built in 2019, so the organisms grew during the last 4 years.

Figure 4.5 - Part of the roof a) main facade, b) northwest facade

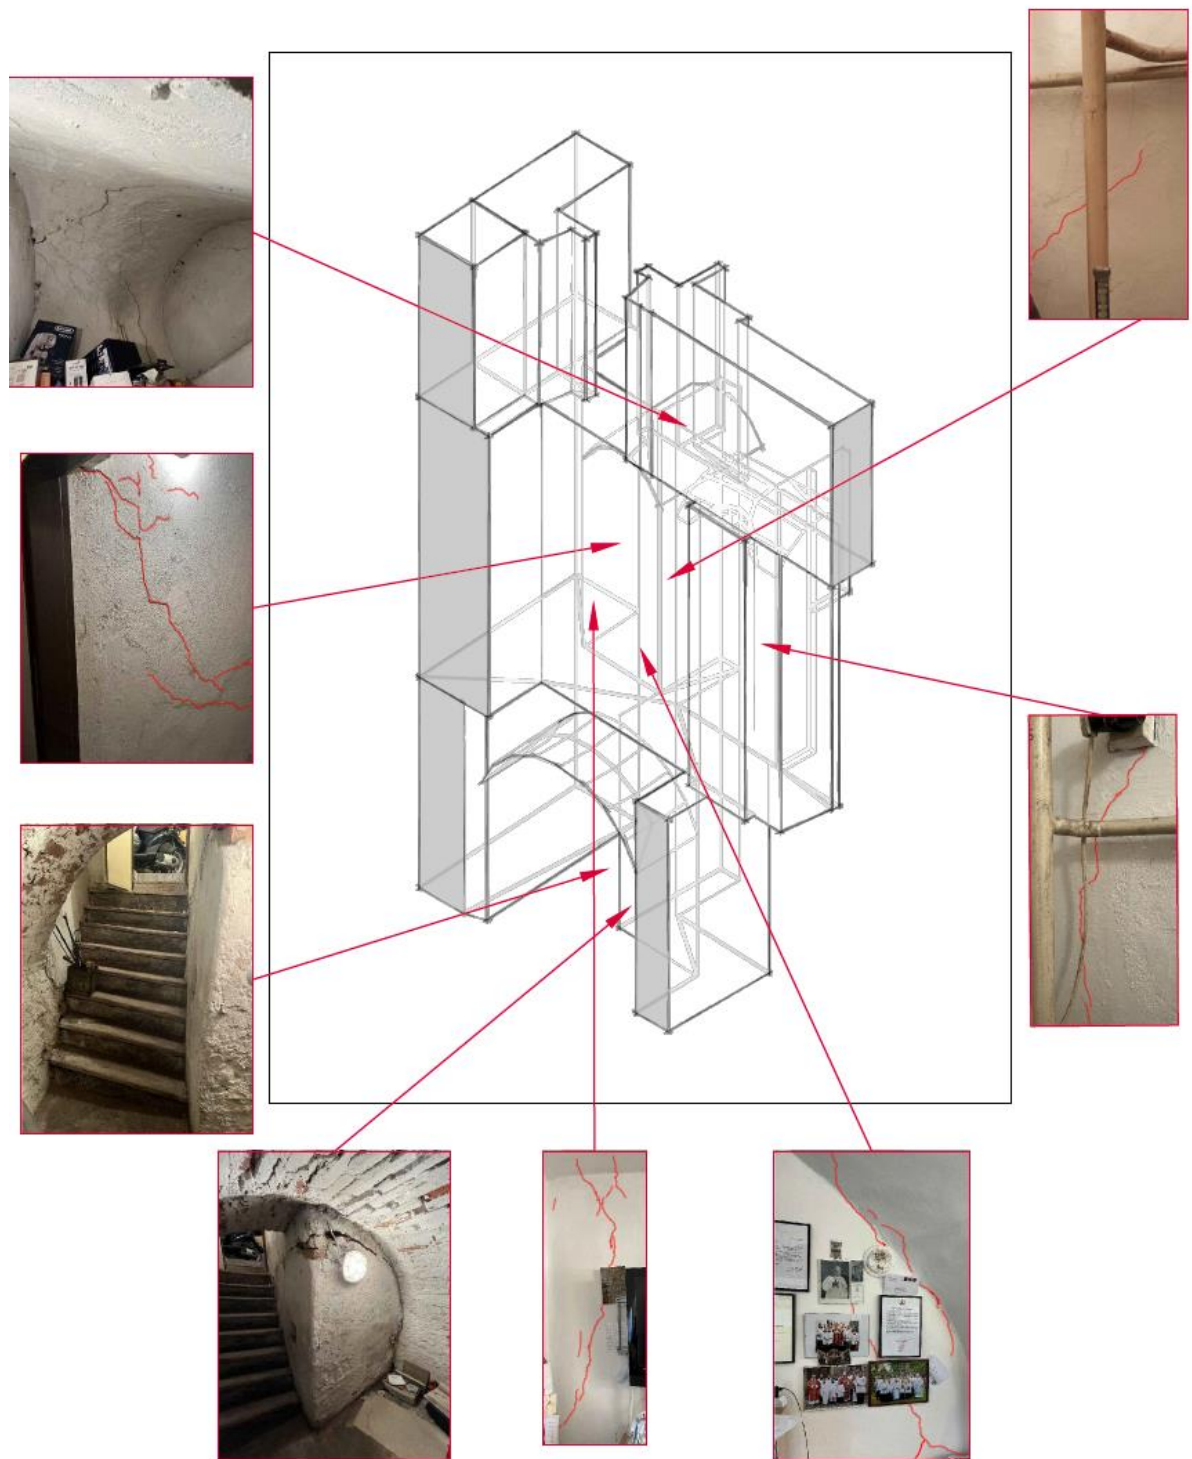
Within the interior of the building, two primary types of decay are observed. The first type is fractures that as it is depicted in Figure 4.7 are concentrated along the middle wall of the main section of the building (Figure 4.6). A particular concern is the basement, where part of a wall has become detached, and the staircase within the basement area has become inclined. The reason is assumed to be potential ground deformations.

Figure 4.7 - Cracks mapping on part of the middle wall

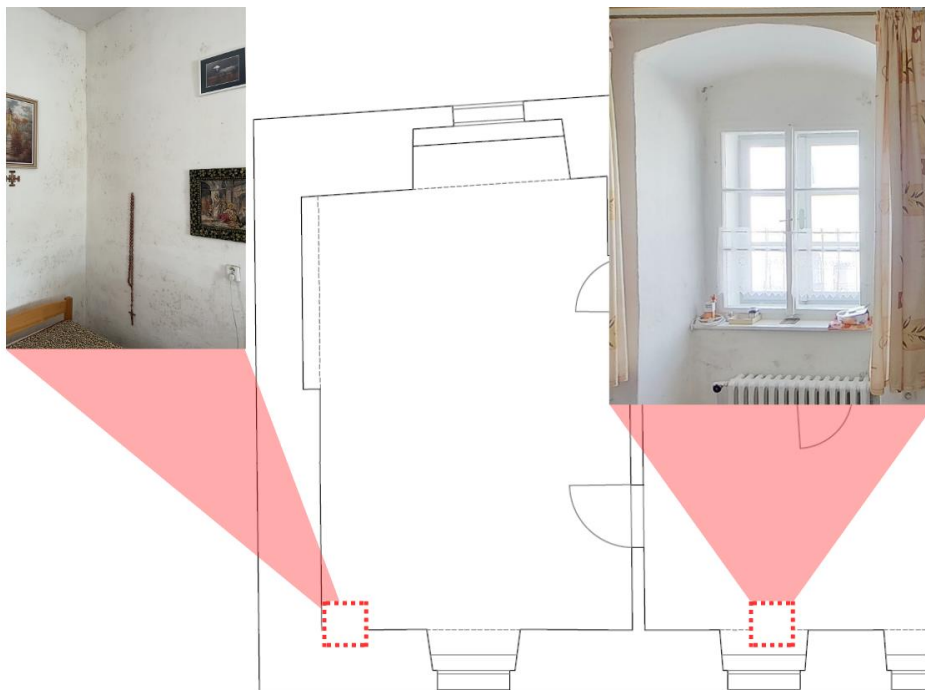
The second prominent form of decay is the extensive moisture observed primarily on the first floor, particularly in the bedroom and the kitchen areas. The presence of significant moisture infiltration poses a significant concern, as it can contribute to the deterioration of building materials, promoting the growth of mold and mildew. The most possible reason for the existence of moisture is problems on the roof of the building, which was inaccessible for further investigation.

Figure 4.9 - Moisture on the walls of the first floor

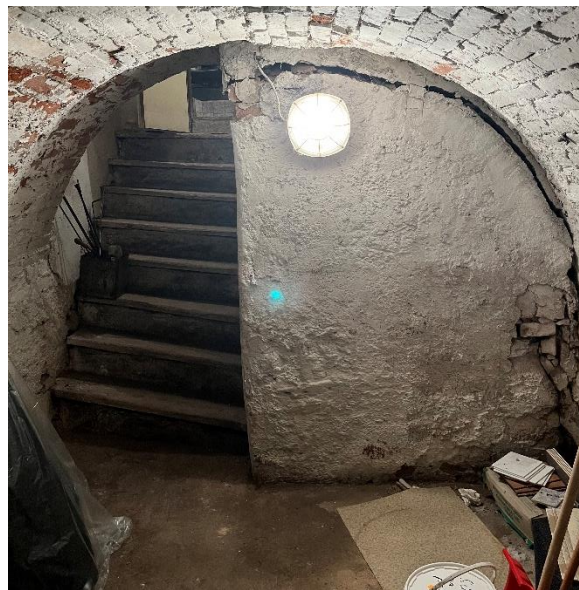
Figure 6.12 - The condition of the basement of the building
