ADVANCED MASTERS IN STRUCTURAL ANALYSIS
OF MONUMENTS AND HISTORICAL CONSTRUCTIONS

Master's Thesis

Winery Wilomenna Chlumčany
u Loun: Revitalization of the
winery grounds

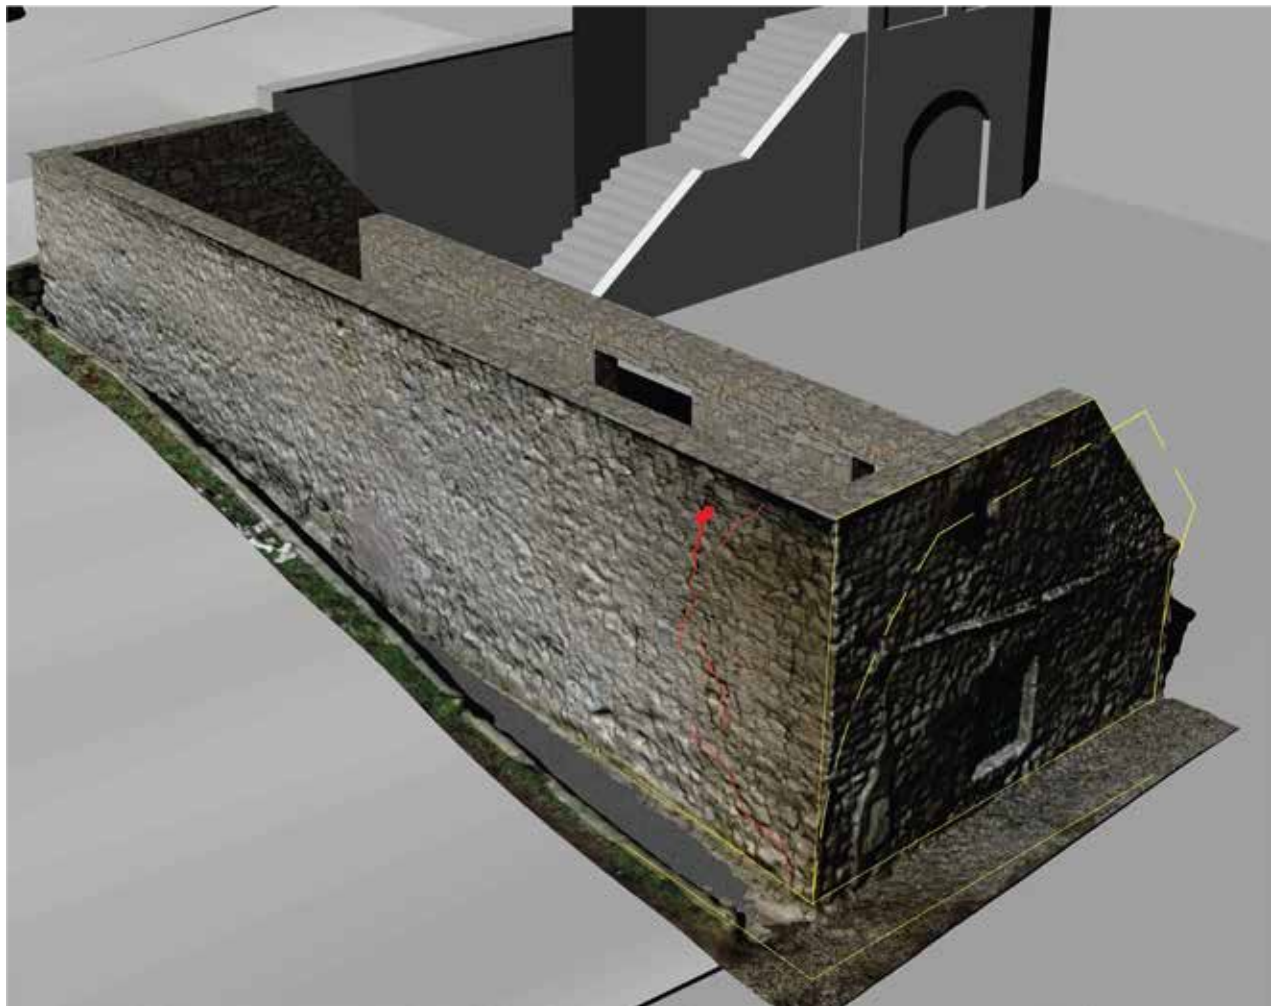
Fig 32: Structural failure diagram made with photogrammetric model of masonry building.

The masonry is not in bad condition and there is no risk of imminent collapse. Nevertheless, there are a number of failures. The most serious are a set of cracks located in the north-west corner of the building. The cause is thought to be rotation or uneven settlement foundation joints of the gable wall. This may have been contributed by inappropriate drainage design (running along the north wall of the building), insufficient depth of the foundation and also the substantial increase in traffic on the adjacent road due to construction work of the new motorway bridge in the vicinity of the area in question (particularly frequent passage of heavy motorized equipment in the immediate vicinity object).

Cracks run through the entire thickness of the masonry and their width varies between 10 and 37 mm on the exterior side and 4 to 28 mm on the interior side. The widest crack is under the crown of the north wall of the building where it is 69 mm wide.

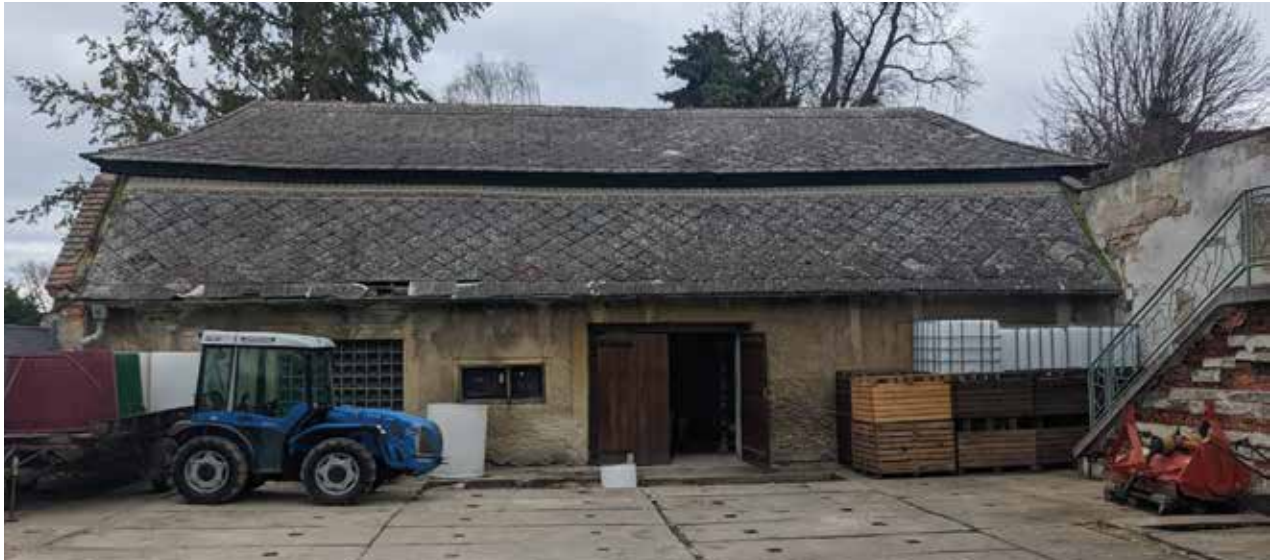
Fig 33: West facade is mainly covered by eternite roof with biological attack of lichee and moss.

The existing eternite roofing cover is composed of a double sloped gable roof , which it's made of asbest and concret sheets, which have been proven dangerous for human health. This cover is now eroded by the environment, leaving it in bad conditions. Therefore it needs to be replaced, this aspect is one of the main concerns about the project, due to the importance of it.

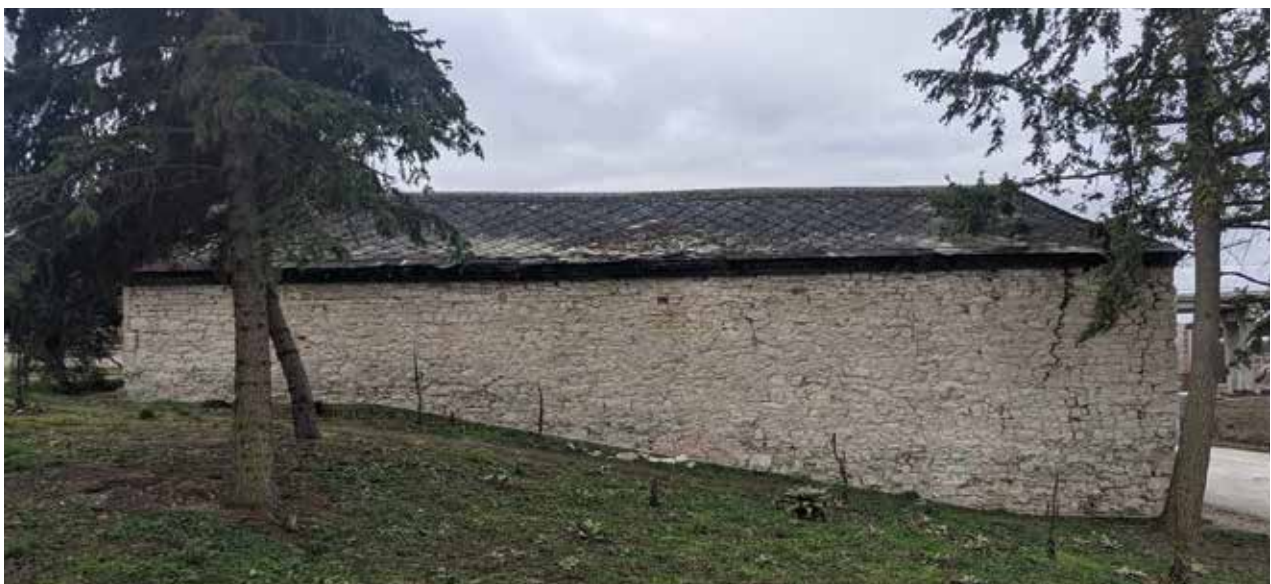
Fig 34: East masonry wall shows cracks in its colindance with the street and slope.

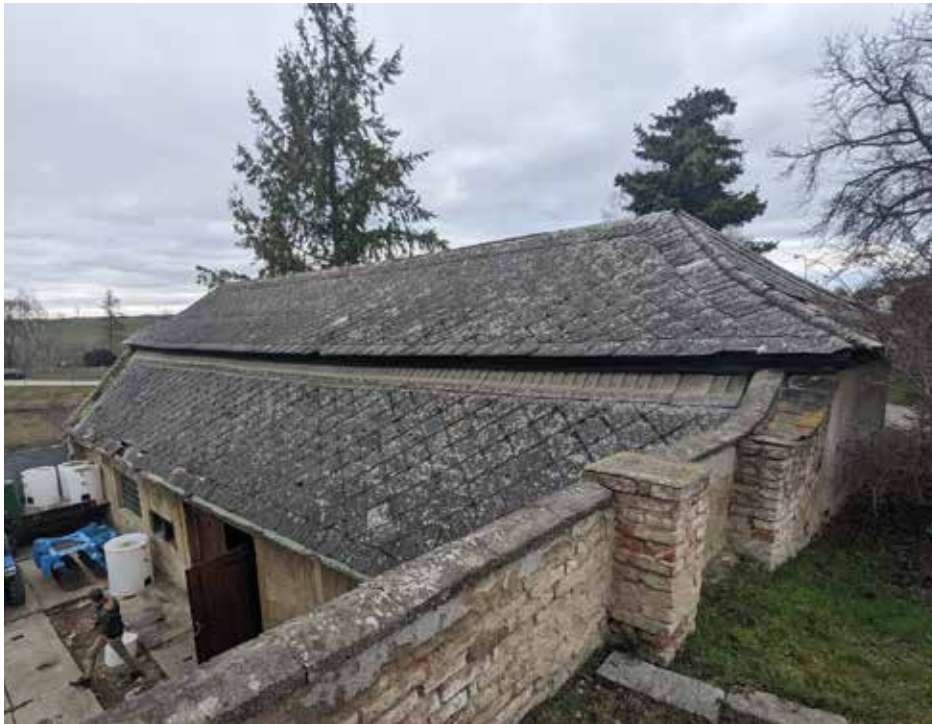
Fig 35 :South Facade

Few remains of original plaster on South Facade. Biological growth of lychee and moss over the Eternite roof

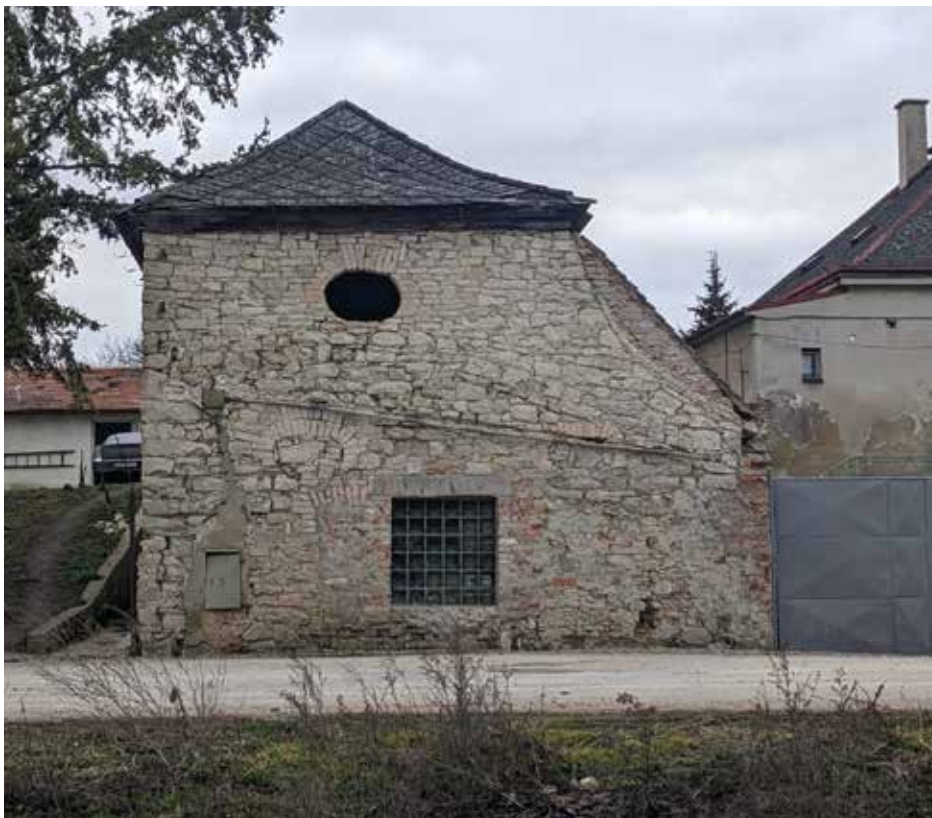
Darkened masonry strip due to moisture saturation of opuka stone is causing cracks and fractures on the Opuka stone

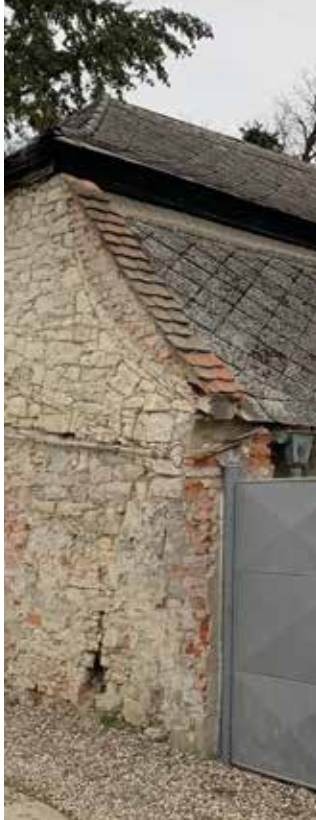
Fig 42; Cracks & fracture

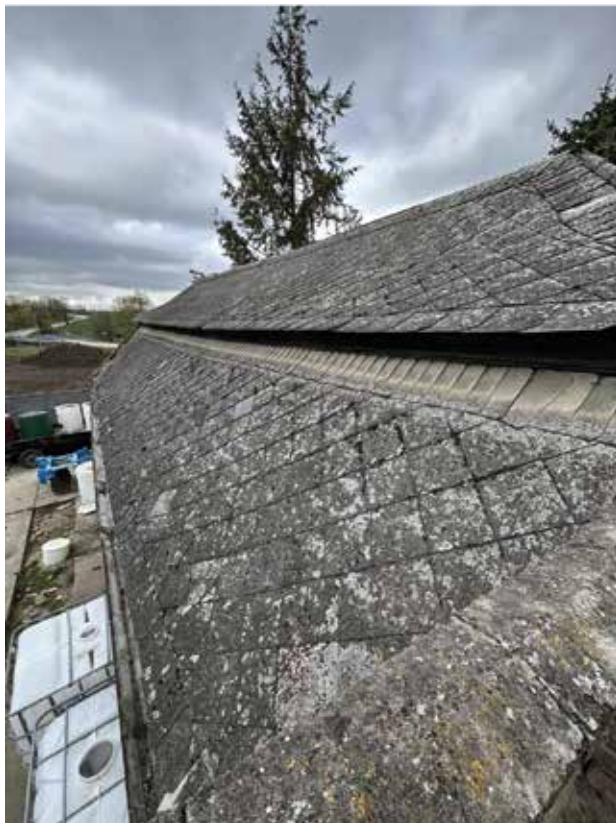
Fig 47: Degraded Eternit roof by biological colonization

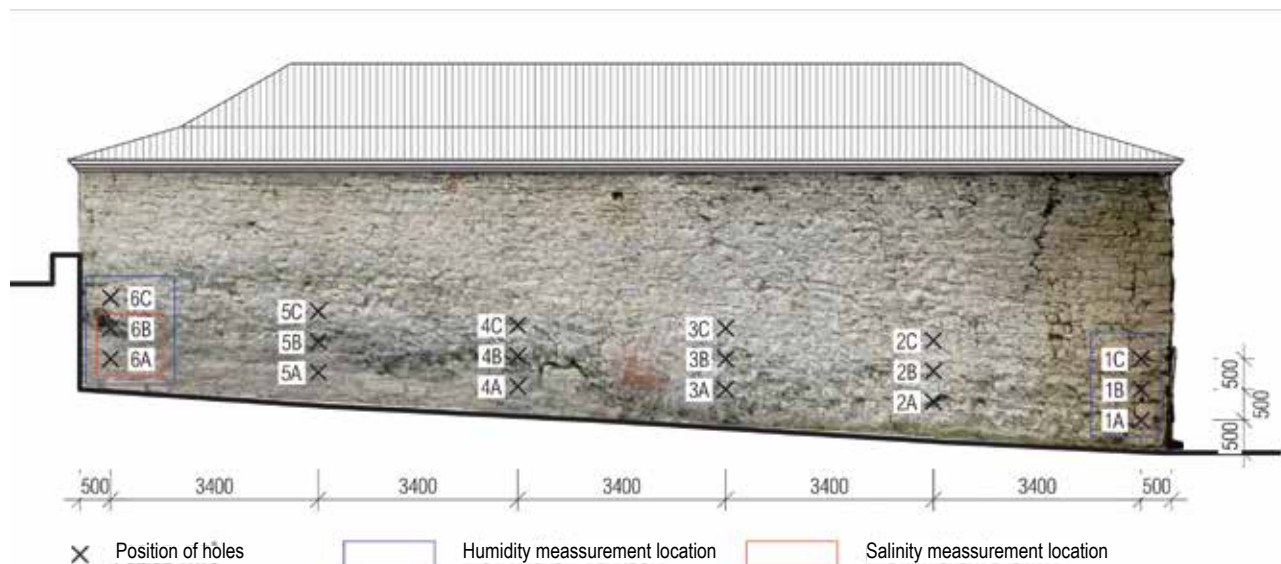
Waterproofing of historic masonry buildings is an important measure to consider in the renovation and maintenance of the structure. With the following mapping of results obtained, it is observed that in most of the top pareas of the masonry the moisture content is low, but in the bottom part of the masonry there is elevated moisture content. Based on the obtained values, it can be concluded that the moisture is caused by contact with the soil. Observing that the values decrease from the bottom to the top, and having the highest moisture content at the point where the wall is in direct contact with the ground.

Fig 49: Mapping of samples taken of stone and mortar from masonry wall in East Facade.

Having analyzed the previous information it's important to adopt diferent measures for the renovation project, for instance ventilation of the floor and masonry foundations with, air canals and mechanical separation of the rear wall from the direct contact with the slope. Also it is important to remove salt cristalization in the masonry. In order to do so, th first step is to restrict water access, which transports soluble salts with it and previously stated which techniques can be used.

The next step is the removal of crystalized salts from the masonry. Since the salinity values are not high in this case and in the case of increased salinity are only the chlorides, which are more soluble. A sufficiently effective method in which the masonry is exposed should be desalination wraps, a well-effective mixture is a combination of pulp, bentonite, pumice and Ajatin (in a 1:1:8 ratio), recommended to be applied at least two cycles (2nd cycle in a 2:1:8 ratio)

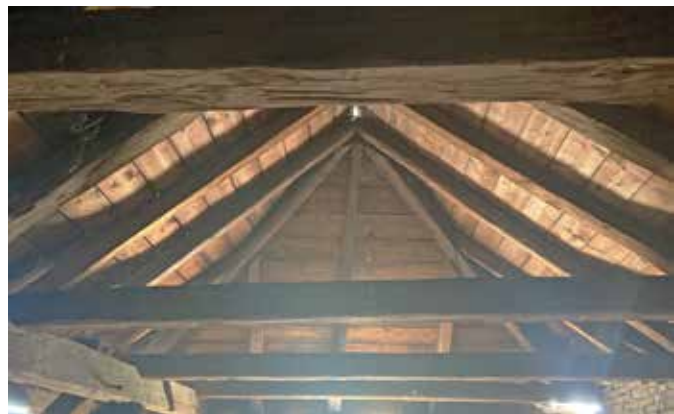
Most of the trusses type are in a considerable salvage state of conservation. It present from moderate to sever damages in their members such as cracks, biological attack ,interventions with new timber members and repairs made with sealings and polyurethane.The trusses were coded by its diferent members in order to have a better understanding of the localized damage.

The wood struts , vertical posts and partition walls were found in a completely degraded state by humidity and insect attacks. The posts are not longer complying with any function and so for this reasons they will be removed completely.

Fig 53:
First section of timber roof, facing north

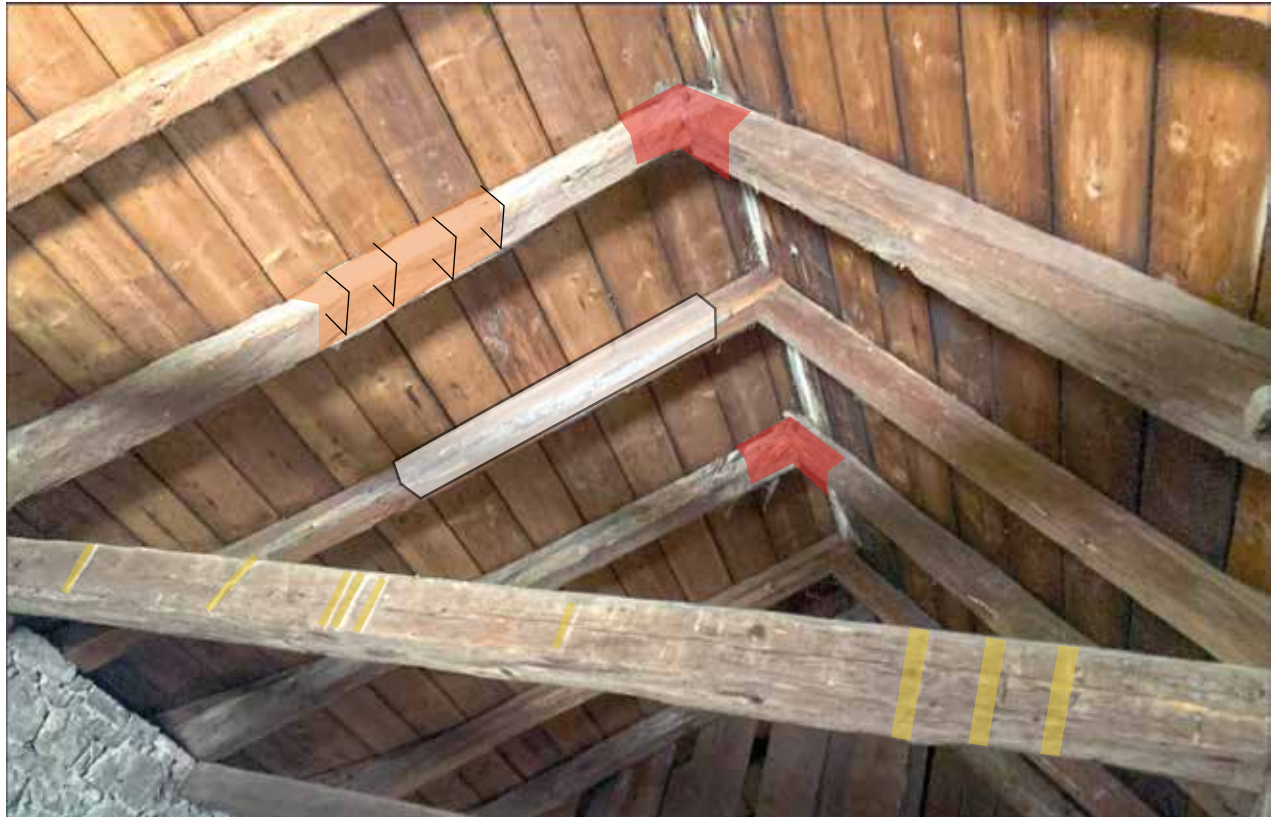
Fig 54: Truss type A North section with damage mapping

Truss A1 shows some minor damage on its front face caused by acidity provoked by organic fecal mater of peagons and xilophagus attack that are penetrating inside the wood. Insecticide should be sprayed and/or injected in this areas depending on the exact insect species that is eliminated.

The restoration methods recommended for the wooden elements and the whole structure are prosthesis, bolting and anchoring to steel brackets.
