Master's Thesis

Static Assessment of Judit
Tower in Prague.

University of Minho

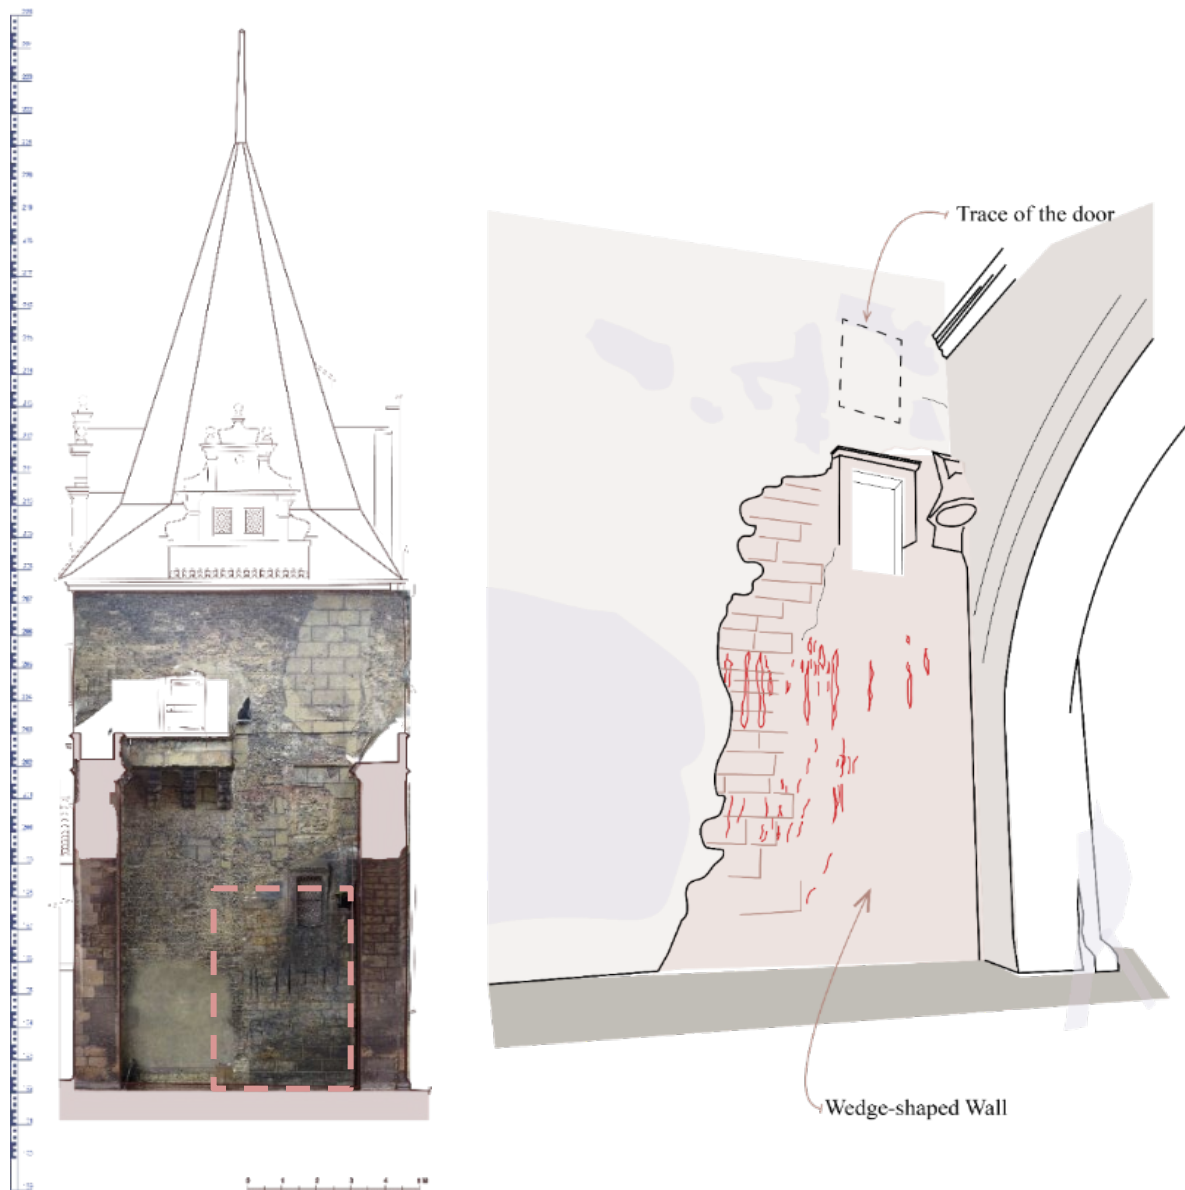
The Northern facade exhibit mechanical damage and Loss of material due to the action of an edge tool. The stone blocks of the wedged addition the appearance of an excavated cavity with an incision and missing edges. The propagation of these deficiencies happened because of weather conditions and the nature decay mechanism of the types of stones with the high porosity punctuated by water.

Figure 4.2 Northren Façade – The conection between the tower and the piers of Mostecká Gate

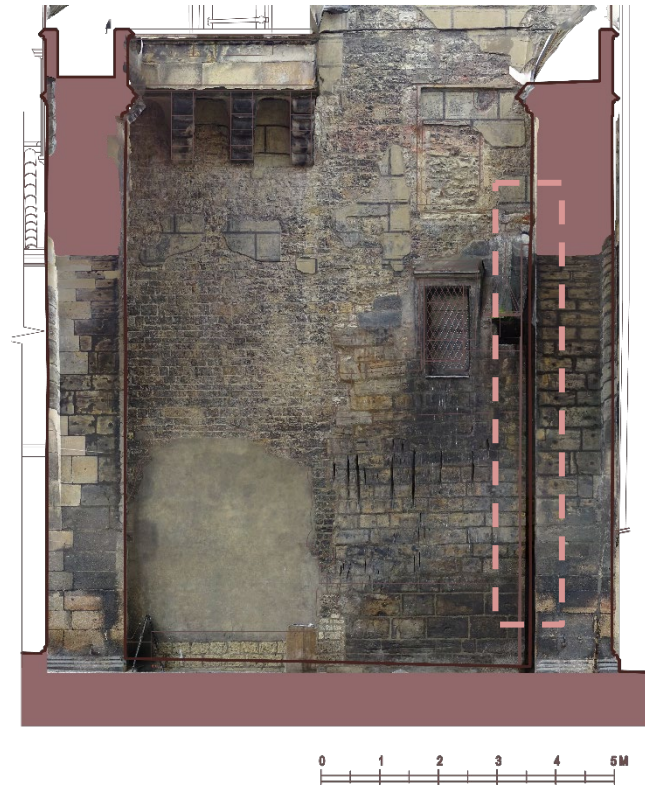
Figure 4.3 The lower part of the Northern façade, the dashed line highlighted the vertical groove.

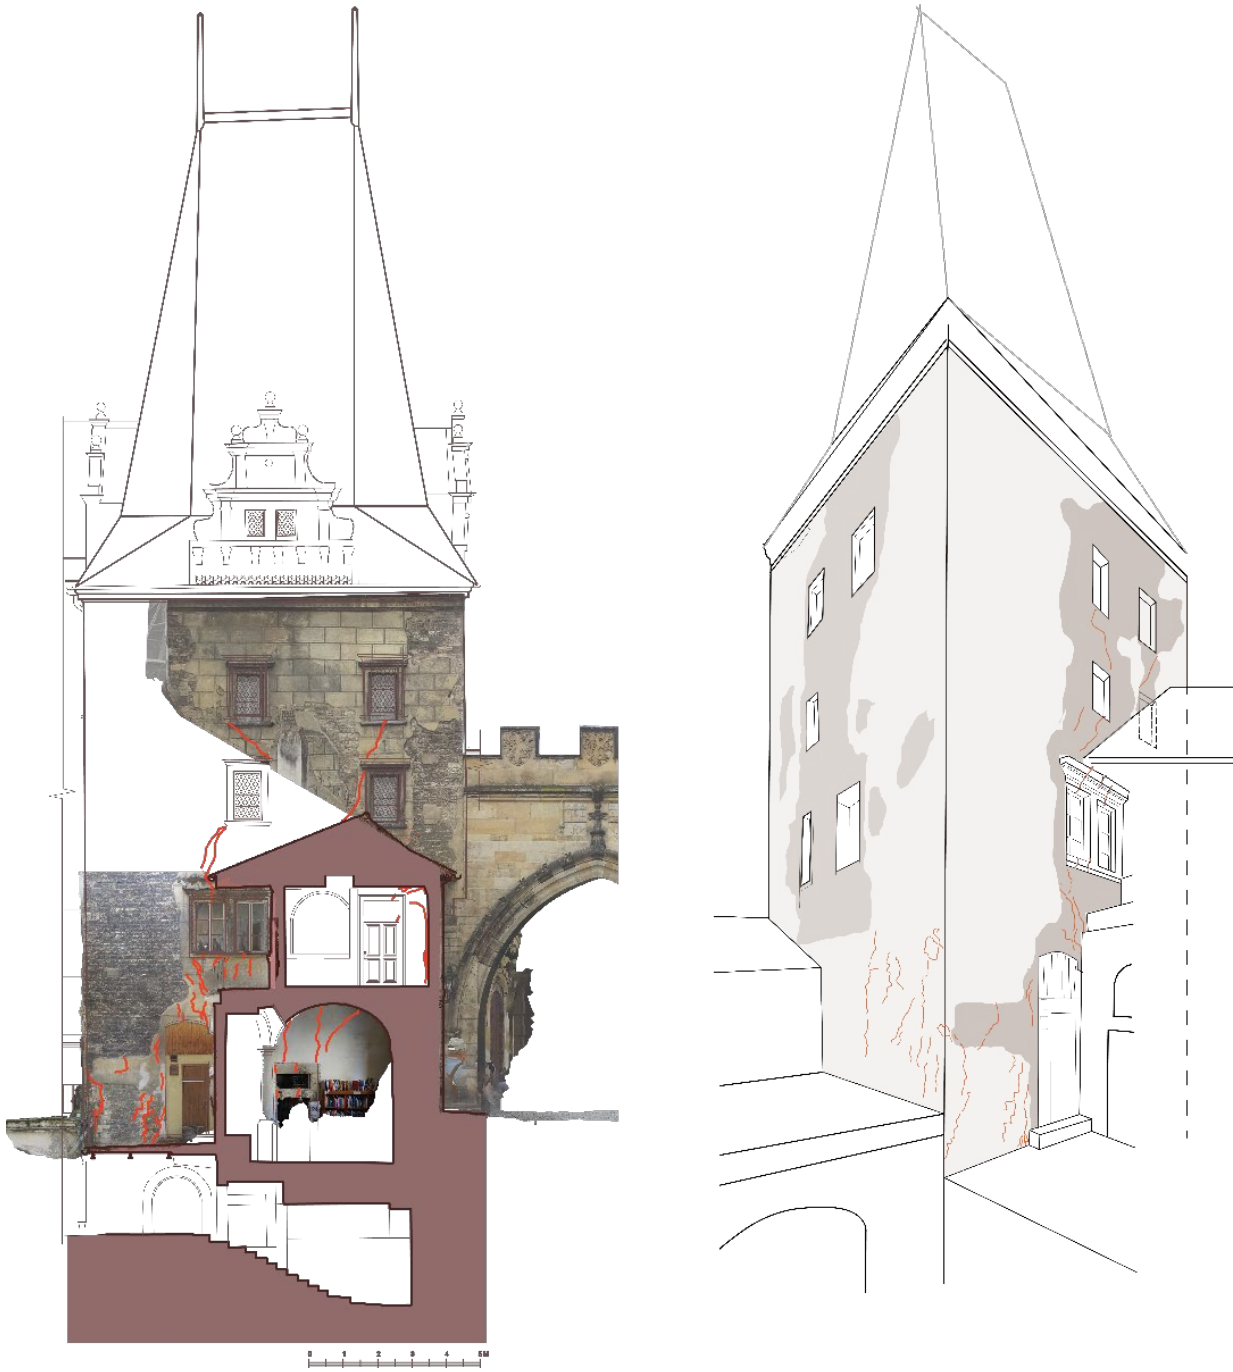
The stress prerogative on these elements had caused fractures at their edges, as strongly observed in the double window on the first floor, which suffers from multiple fractures where the crack that crosses completely its decorative stone. In the middle of the window's lintel, the stone exhibits some splitting and fracturing caused by microcracks or clay/silt layers. The shear crack under the window extends to the top of the door on the ground floor level (Figure 4.6 – a).

Figure 4.5 Eastern façade – (a) orthoimage documentation of the damaged part of the facades, (b) sketch showing the façade deficiencies and damages.

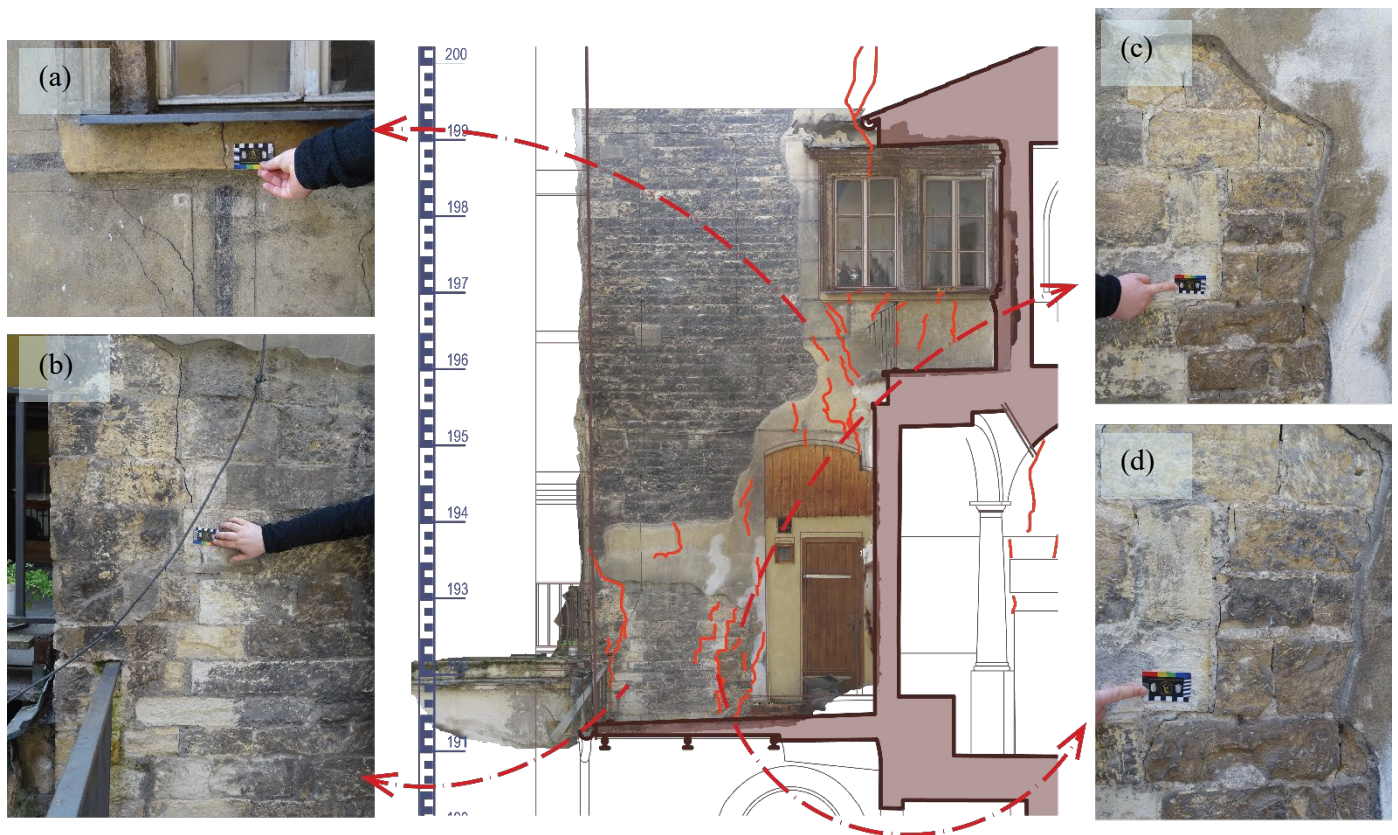
To the left of the door on the ground floor (The toilet), cracks have developed diagonally, causing a fracture and detachment that alternate with lines of sliding between the joint of the masonry wall. The stress release causes cracks with detachment fractures in the stones observed at the end bottom of the wall (Figure 4.6 – a). This type of crack is usually associated with the brittleness of the material (Angelillo, Lourenco, & Milani, 2014)), but the sliding between the stones is associated with the in-plane shear (Figure 4.7 – b and c). The loss of some of the stones on the southeast corner of the tower is caused by the installation of the railing in the courtyard.

Figure 4.6 cracks mapping – Southeast corner of the Tower.

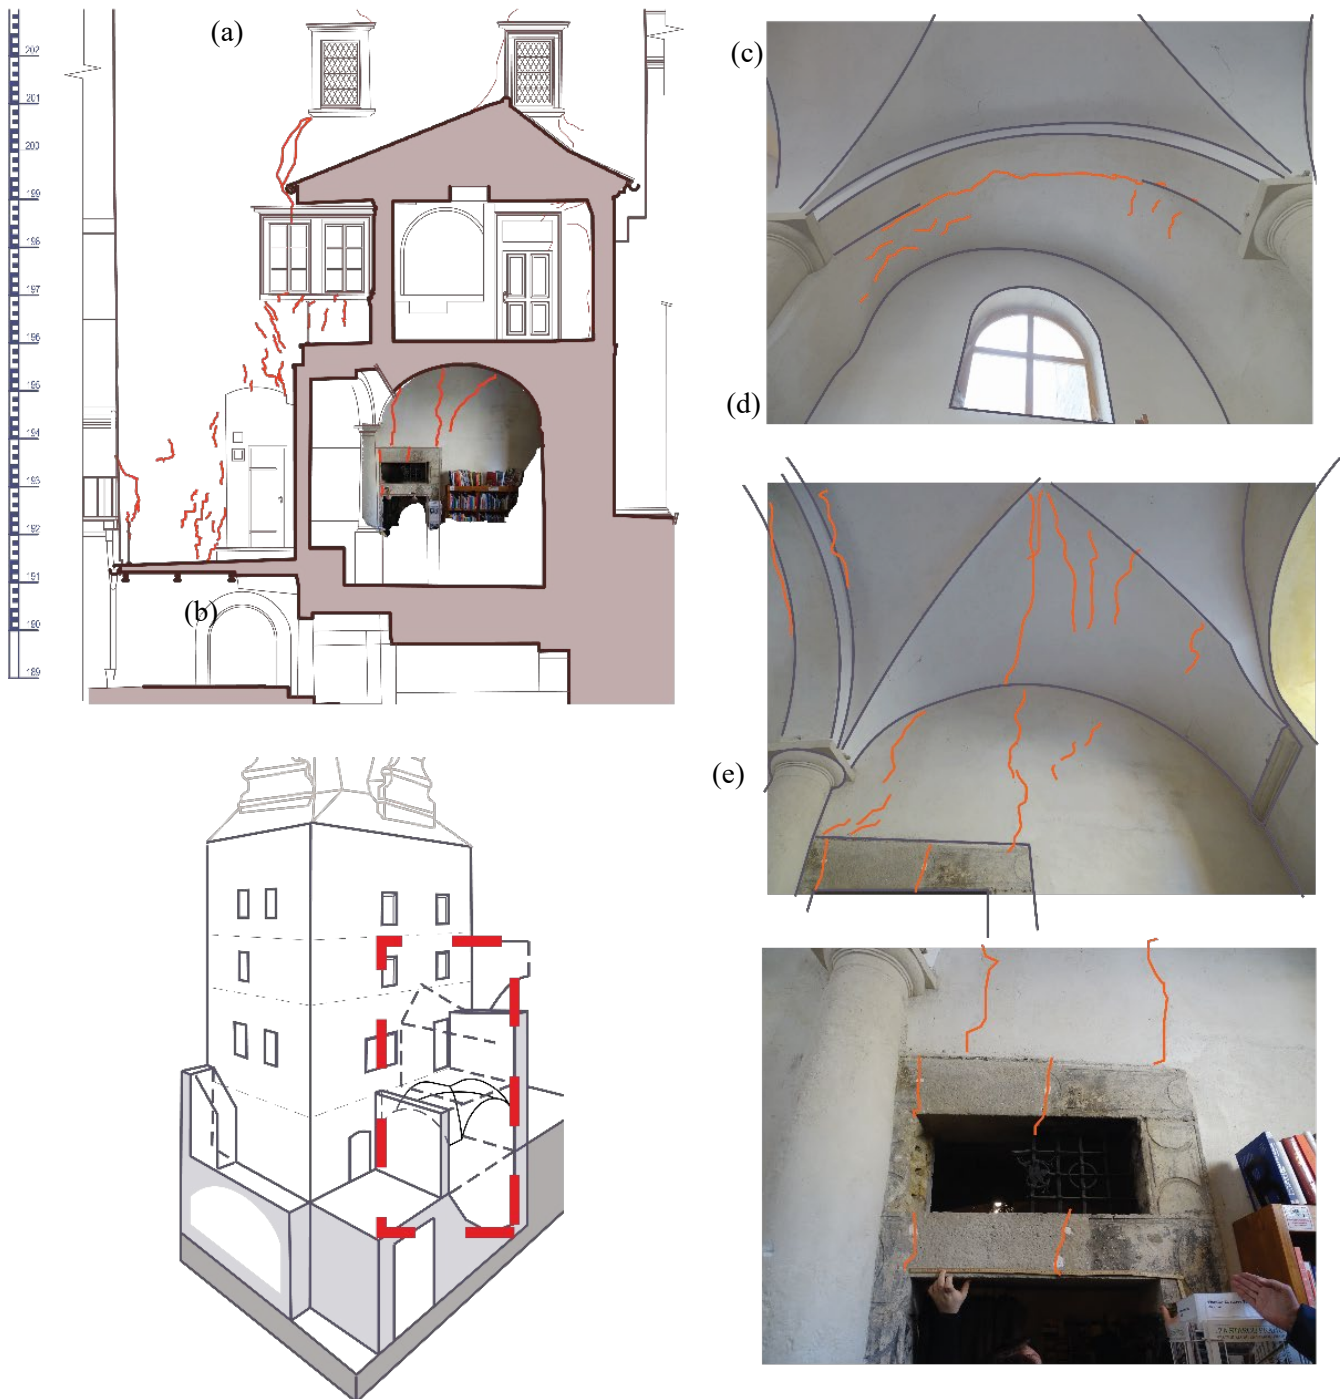
Figure 4.7 Crack mapping – the interior of the intersection between the tower and structure of the house 56.

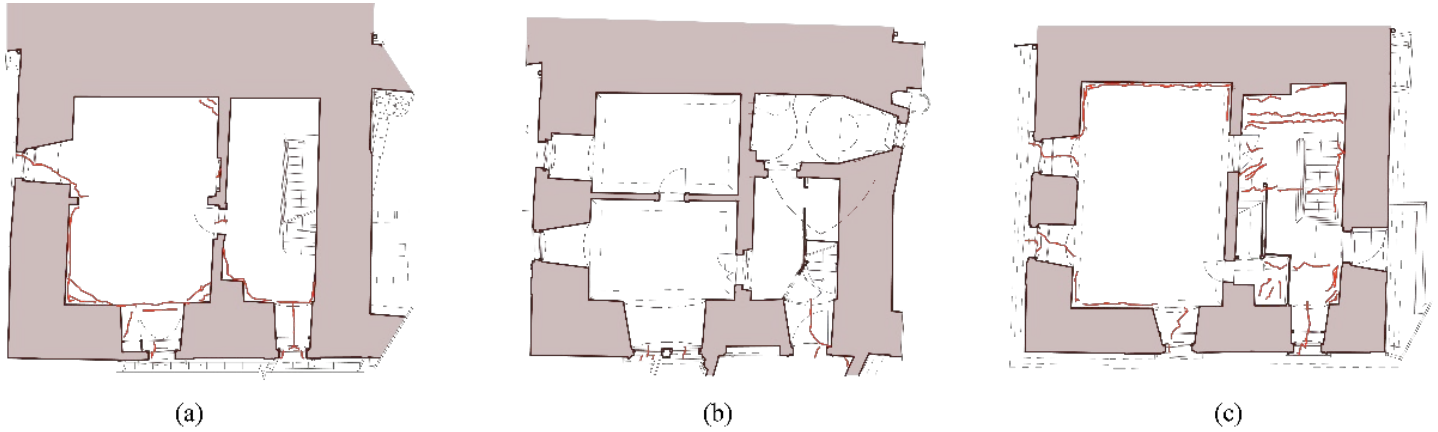
Figure 4.8 Localization of the crack on the plans – (a) First floor, (b) second floor, (c) third floor.

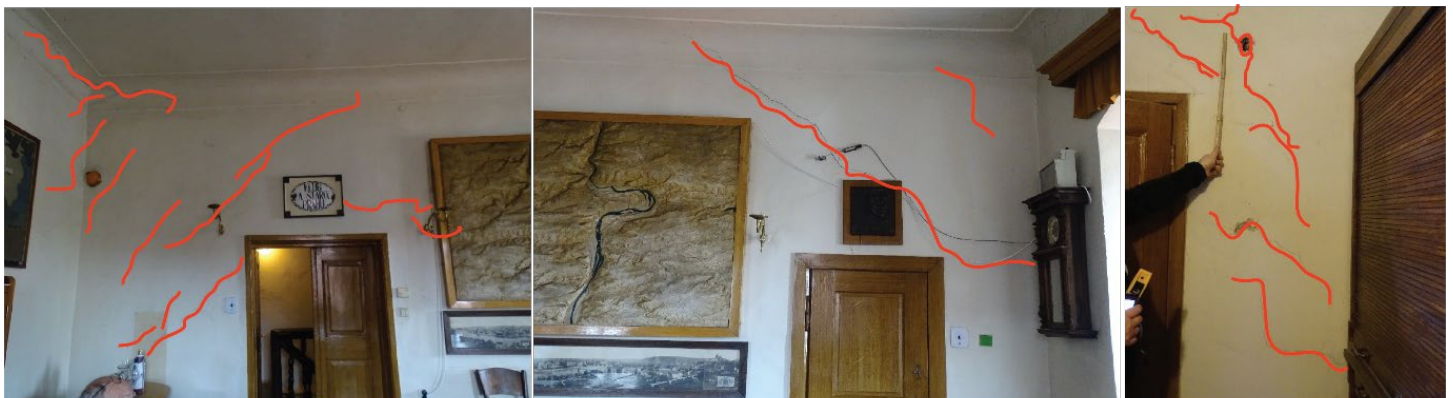
On the third floor, the timbered partition with a thickness of approximately 350 mm directly above the wall of the 2nd floor is showing cracks long and wide, at the base of which is a beam. These inclined symmetrical cracks, interpreted as shear cracks resulting from the settlement of the fill or the threshold beam beneath the load-bearing wall, were caused by the expansion of the thick plaster, which has detached from the timber structure of the partition (Figure 4.9).

Figure 4.9 Third floor – Wall partition

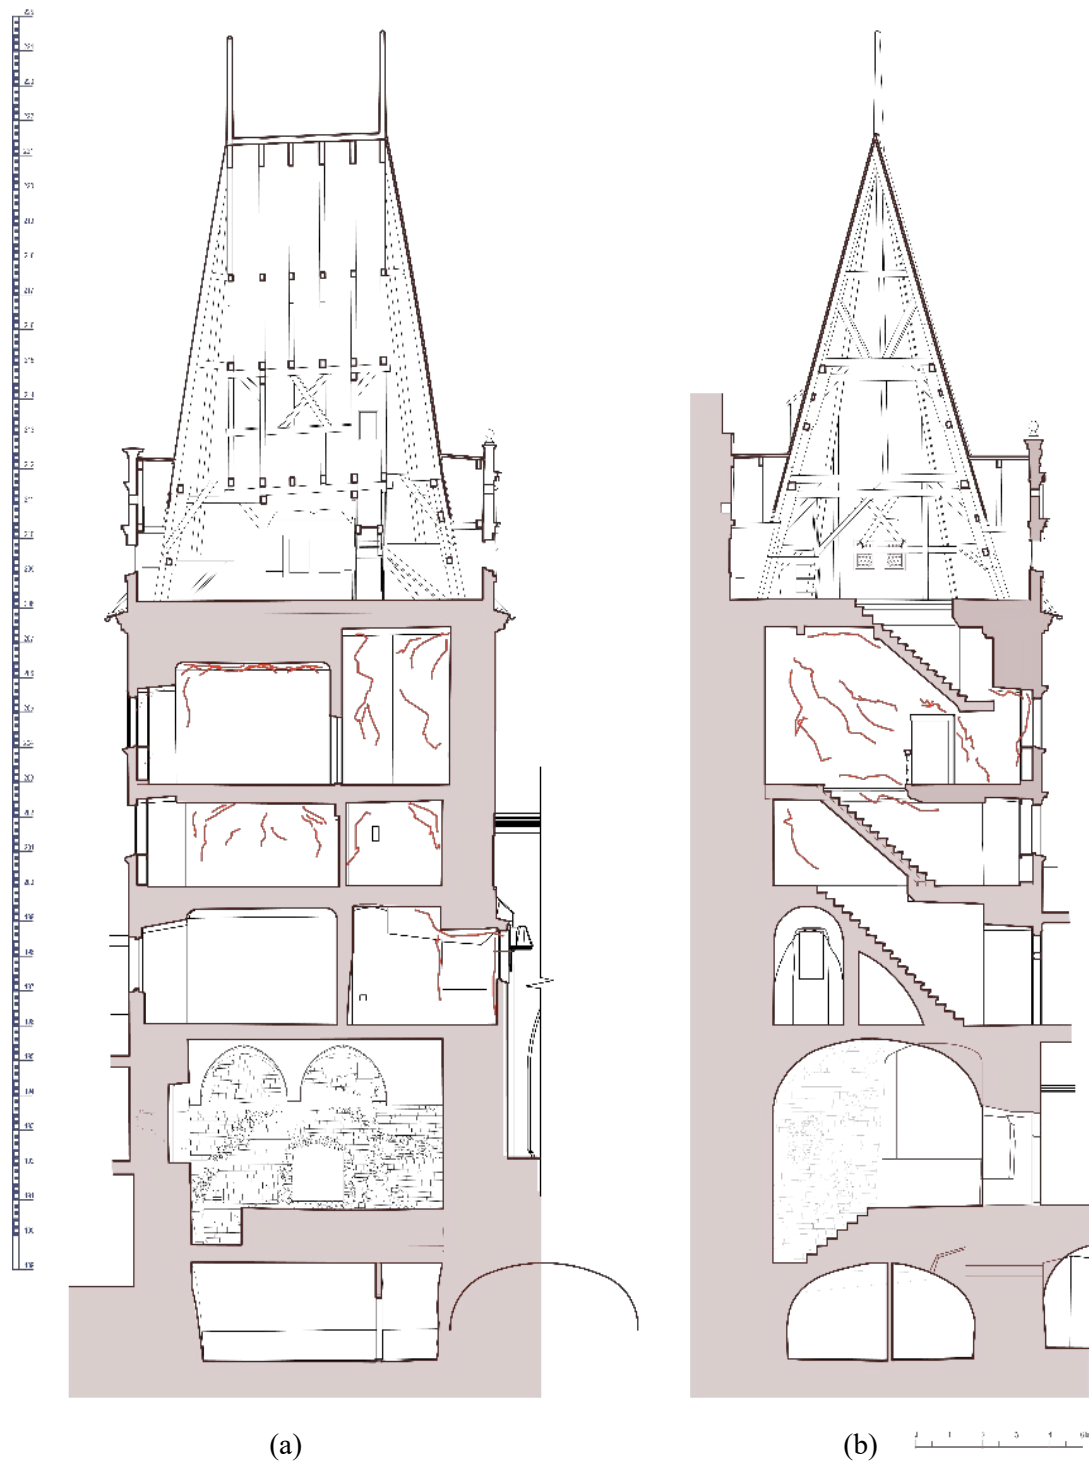
the eastern façade extend to the segmental pediment of the four windows, and the same is true for the two windows to the north on the third floor – See Figures 4.9 and 4.10.

Figure 4.10 Localization of the crack on the sections

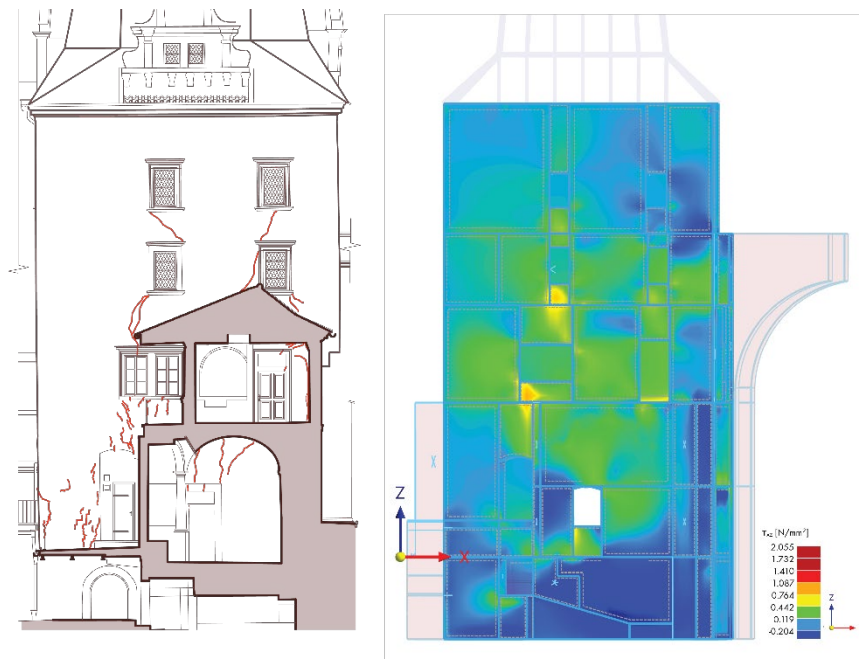
Figure 6.5 Eastern Façade: Comparison between (a) the Visual inspection, and (b) the shear stress distribution in M2

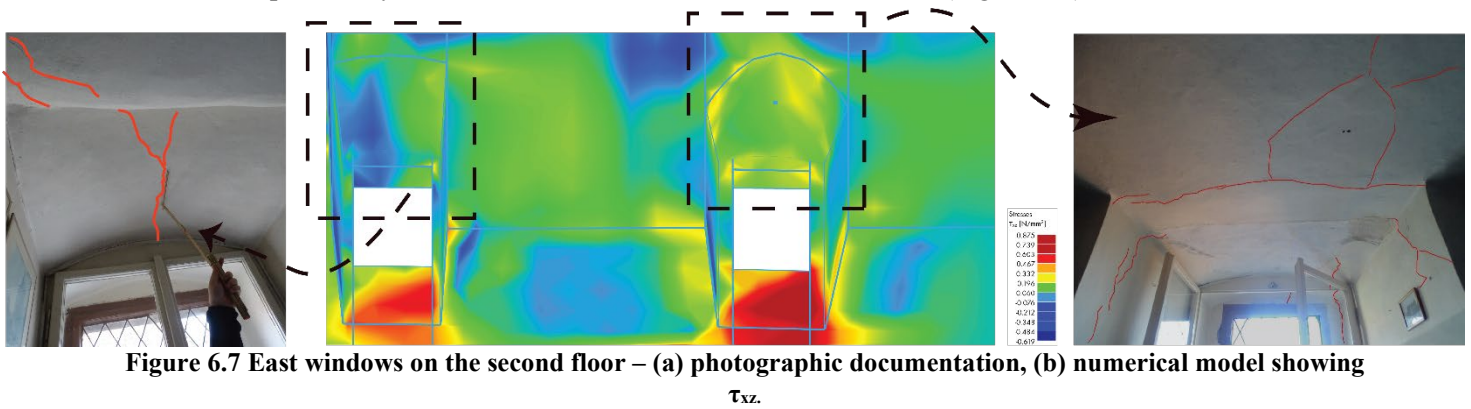
Figure 6.7 East windows on the second floor – (a) photographic documentation, (b) numerical model showing τ_{xz} .

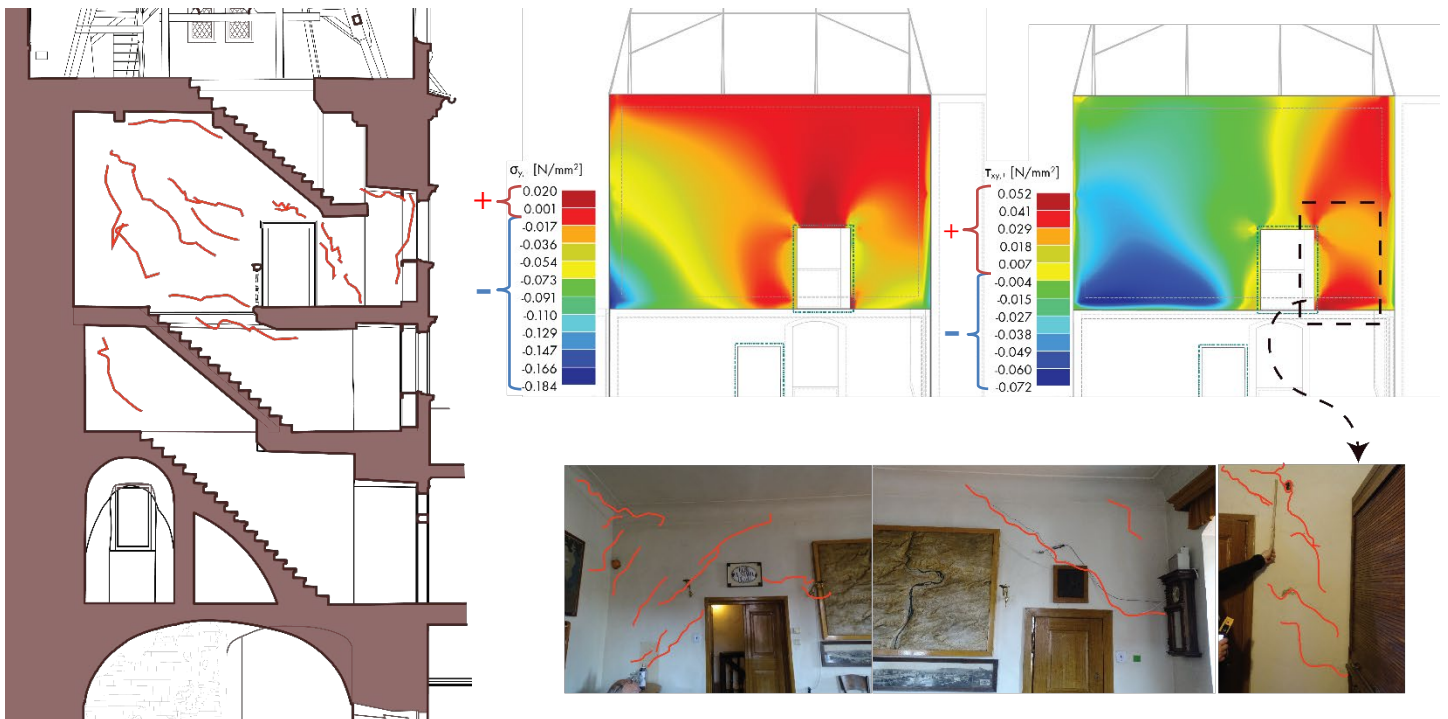
Figure 6.9 Interior wall partition on the third floor; (a) Compressive stress σ_y , (b) Shear stress τ_{xz} , (c) photographic documentation with crack mapping
