ADAPTIVE REUSE OF AN OLD STEEL HALL

Thesis submitted in partial fulfillment of the requirements for the degree of
MASTER OF SCIENCE

The frames damaged by the storm are the frames in axis 4 (significant plastic deformation of the girder) and the frame in axis 5 (the girder is only slightly deformed). The state of the structure following the storm is presented below.

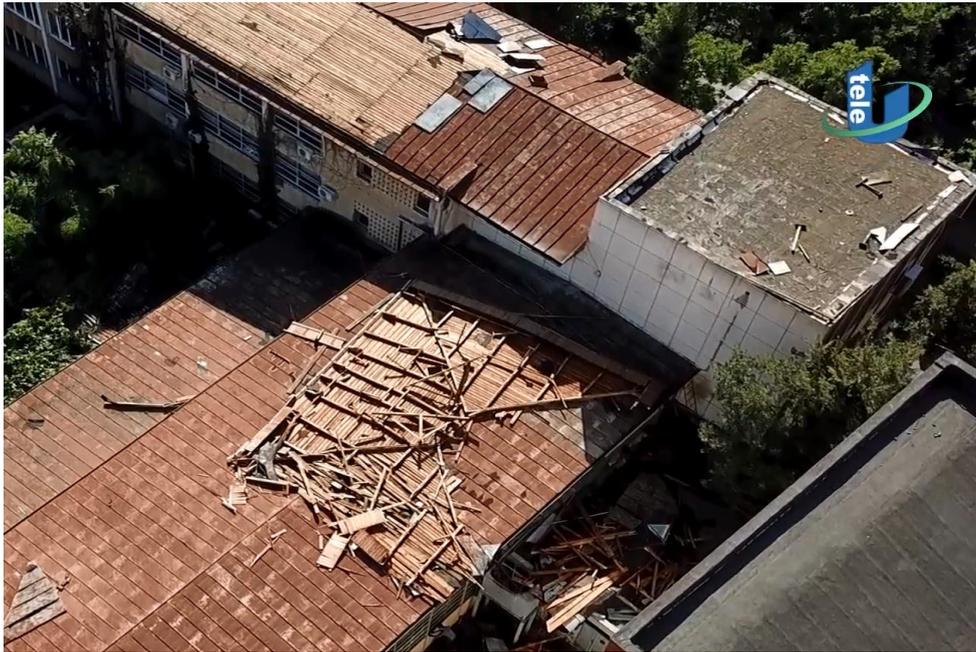
The top view of the hall is presented in Figure 2.6. It can be observed how the roof from the adjacent higher building was carried by the storm on the roof of the hall. This is the cause of the damage of the structure; the roof of the hall was smashed by the roof of the higher building, being subjected to a load greater than the bearing capacity of the structure.

Figure 2.6 Top view of the hall after the storm

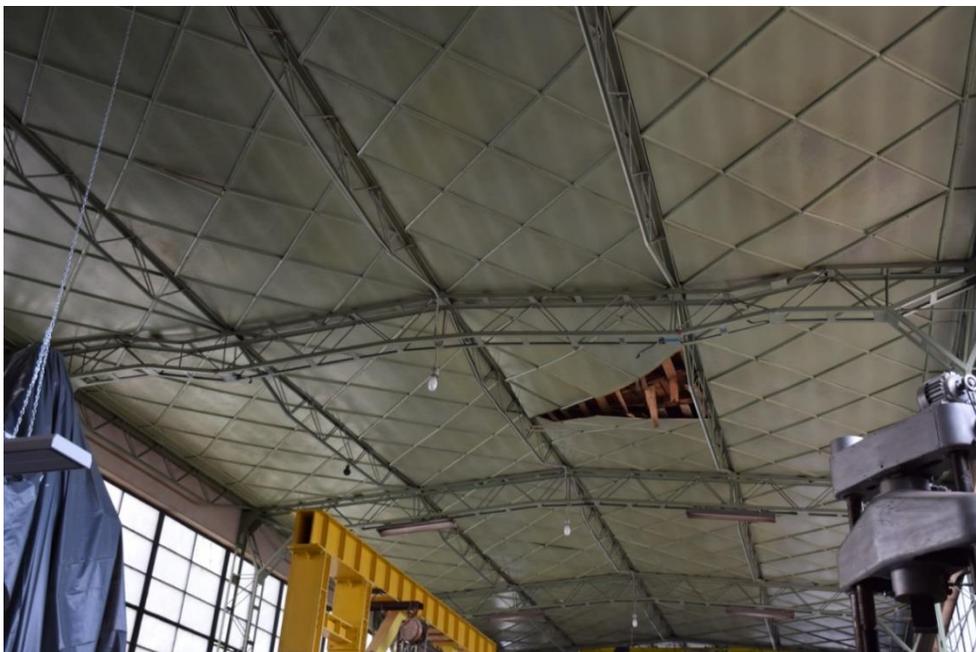
The general view of the frame in axis 4 is presented in Figure 2.7. It can be observed how the girder experienced severe plastic deformations in the regions close to the nodes, as well as the damage suffered by the roof.

Figure 2.7 The girder from the frame in axis 4 after the storm

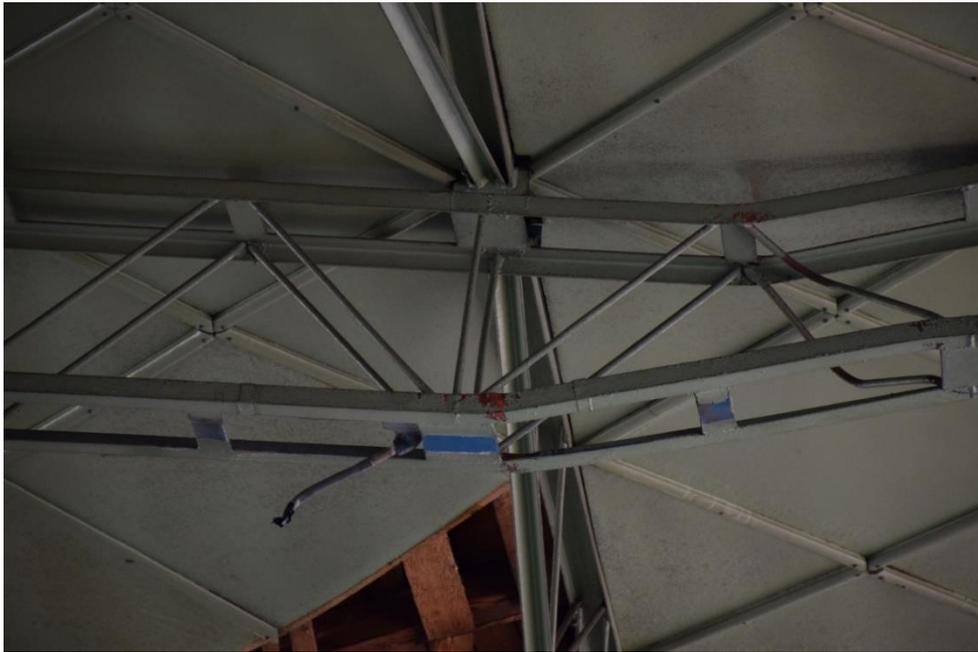
The damage in the right-hand side of the girder from the frame in axis 4 is presented in the following. The excessive deformation of the girder angles and the buckling of the diagonals can be noticed in Figure 2.8. The cracking of the continuity weld of the angles is presented in Figure 2.9. The buckling of the diagonals can also be noticed in Figure 2.10.

Figure 2.8 Deformation of the girder angles and buckling of diagonals

The failure of the node occurs due to the out-of-plane flexural buckling of the column diagonals, which leads to the formation of a mechanism. The same failure mechanism was observed in case of the damaged girders after the September 2017 storm (See Paragraph 2.3).

The partial rehabilitation of the frames from axes 4 and 5 consists of welding steel plates in the regions where deformations occurred (the nodes in which cracks occurred in the welds, as well as the adjacent nodes in which the weld did not fail) in order to ensure the continuity of the angles. Also, the buckled diagonals will be replaced with new ones. The steel plates have a thickness of 10mm and the new diagonals are angles with the cross-section of L45x45x5. Both the steel plates and the angles are made from S235 steel.

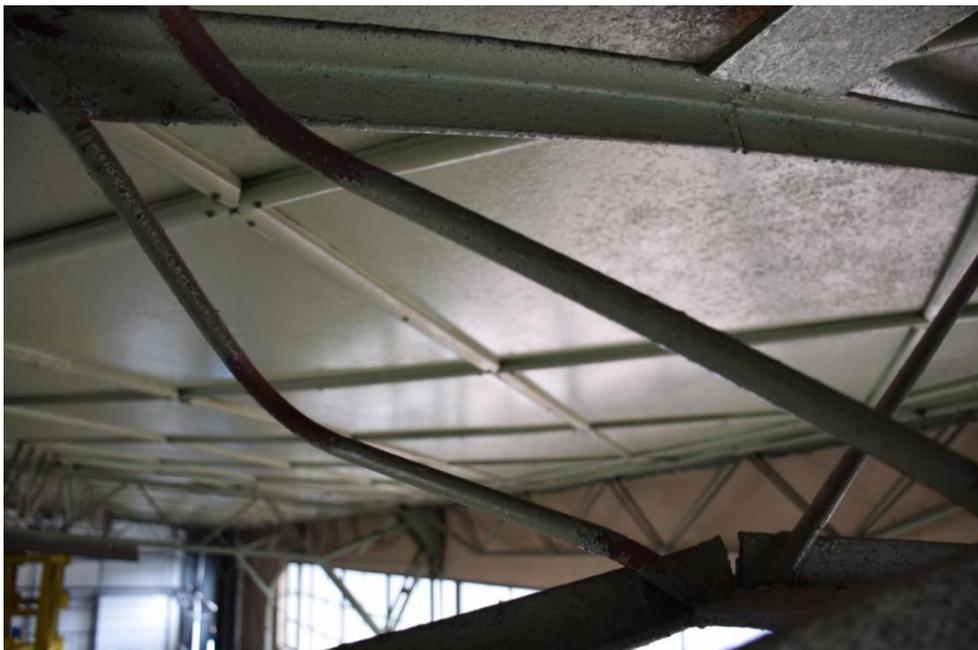
Figure 2.9 Cracking of the continuity weld of the angles

The same damage (cracking of weld and buckling of diagonals) occurred in the left-hand side of the girder from the frame in axis 4, as well as in the girder from the frame in axis 5 (both right and left-hand side).

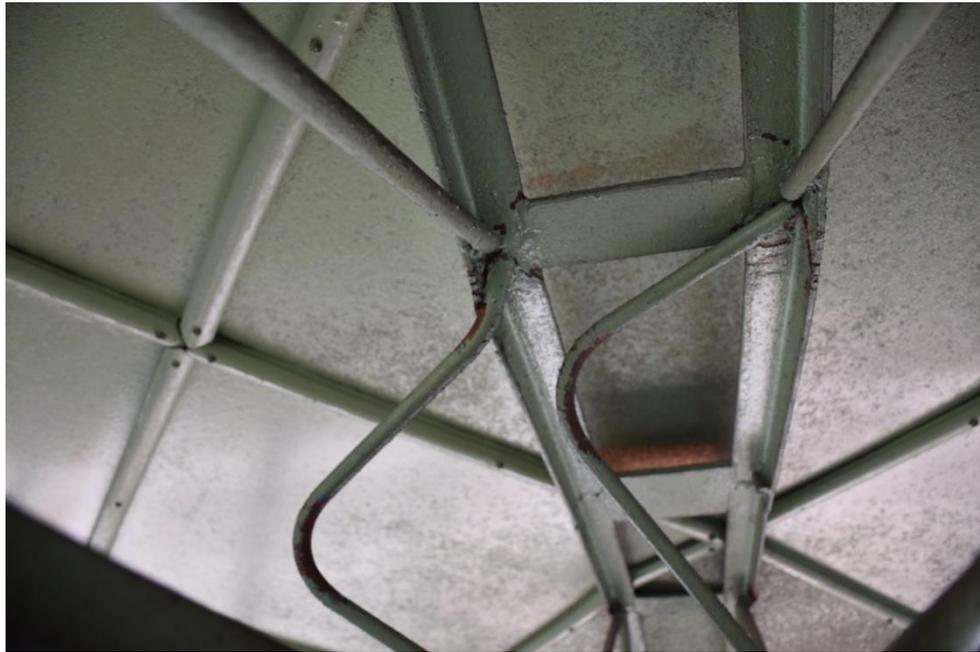
Figure 2.10 Buckling of diagonals

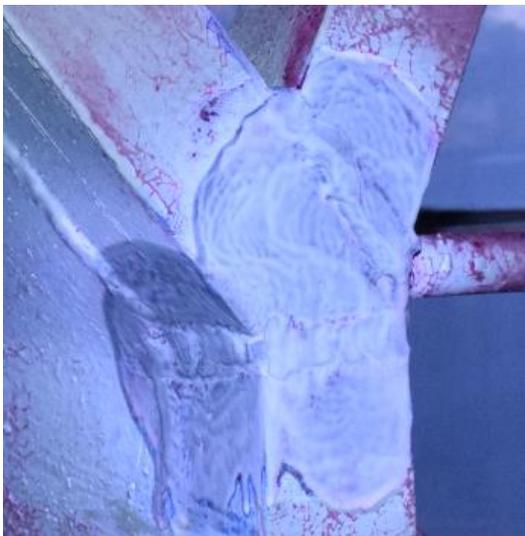
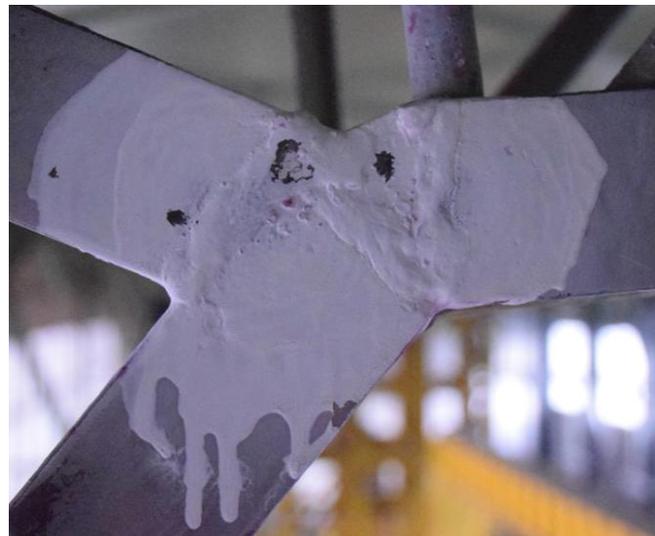
Finally, the surface is inspected. Due to the fact that no trace of the penetrant is visible on the surface, it results that the welds do not present any damage. The same results were obtained in case of all the welds that were tested.
