## MASTER'S THESIS PROPOSAL

Thesis title: Nonlinear numerical evaluation of the wall bearing capacity and the structure stability of the St. Ann Church from the Broumov Group of Churches

This report summarizes the visual investigation, structural investigation using ATENA 2D software, Geo 5 geotechnical FEM software and DIANA FEM software, to assess and verify the safety of the church walls regarding the damages it currently suffers. With regards to the material and sub-soil data available, micro modelling of different wall configuration in longitudinal and transversal direction was done with ATENA 2D software to evaluate the safe bearing capacity of the walls, from the analysis it was found that the current bearing capacity of the walls are higher than the values recommended by the Eurocodes. From this 2D FEM analysis, a set of homogeneous properties were also computed, which were later used in the geotechnical and 3D macro FEM analysis. In Geo5 software, the effect of sub-soil conditions was analyzed, and it was observed that, for the present condition of the soil, the church suffers from the differential settlements between the area where drainage water is accumulated and have

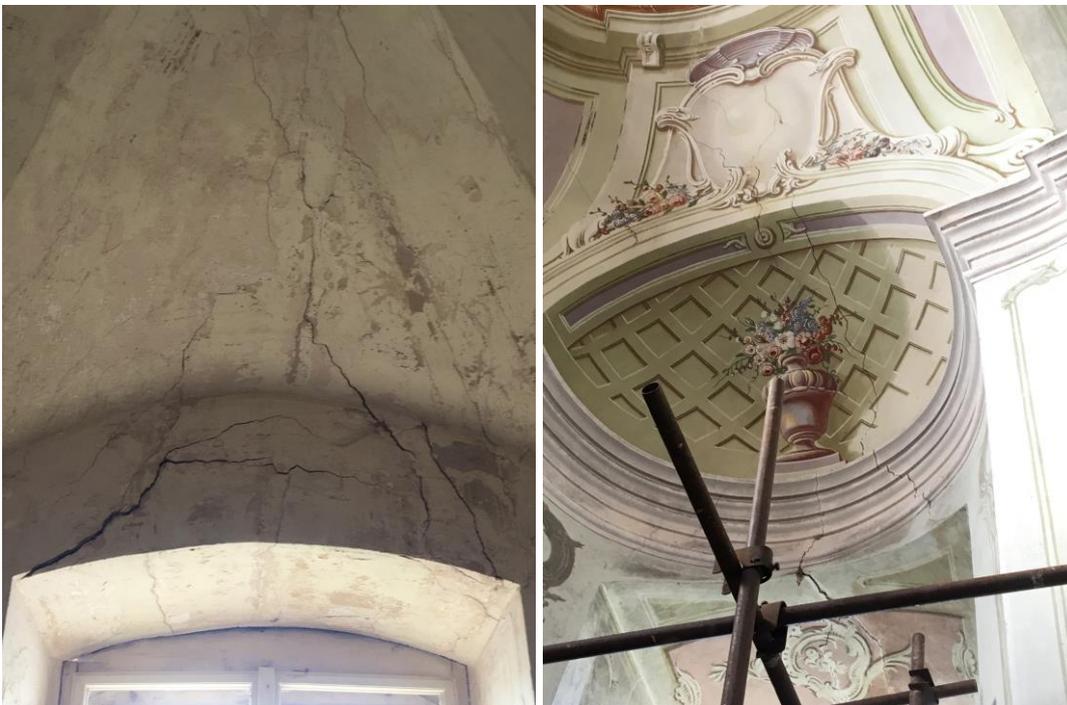
A crack, defined by ICOMOS, is an individual fissure, clearly visible by the naked eye, resulting from the separation of one part from another. There are diverse types of cracks, including fracture, star crack, hair crack, craquele, and splitting. The façades of the church have several cracks which can be classified as fractures. These cracks are in mostly on the interior part of the church (**Figure 3.4**), but some cracks can be observed from the exterior of the church as well (**Figure 3.5**).

Figure 3.4 - Cracks on the Interior of the Church. Sacristy (Left) Main Nave (Right)

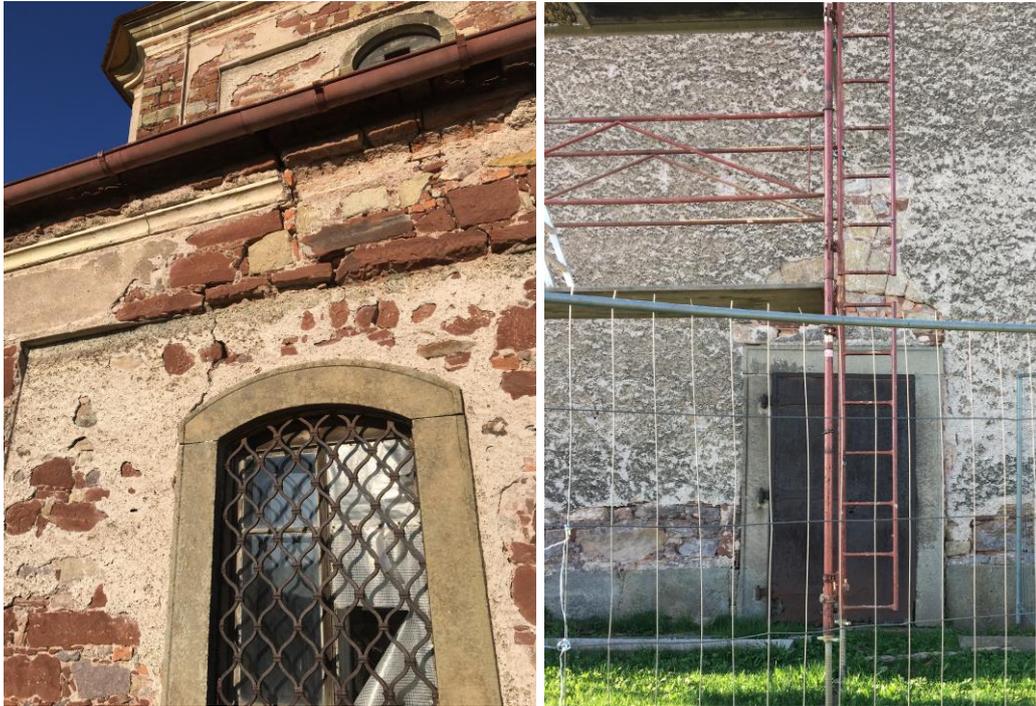
Figure 3.5 - Cracks on the exterior of the church. Sacristy (Left) Main Nave South side (Right)

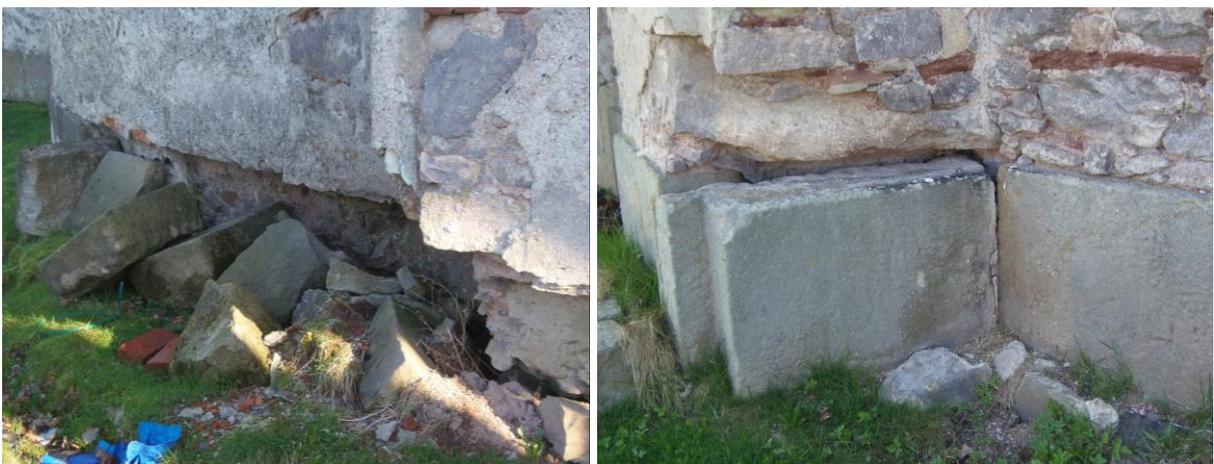
Many observations regarding the deformation of the plinth stones can be observed on the exterior part of the church. In this case, it can also be observed that the major deformations are located on the northern part of the church while some deformations can be observed on the south side as well (**Figure 3.5**).

Figure 3.6 - Deformation of Northside (Left) Southside (Right)

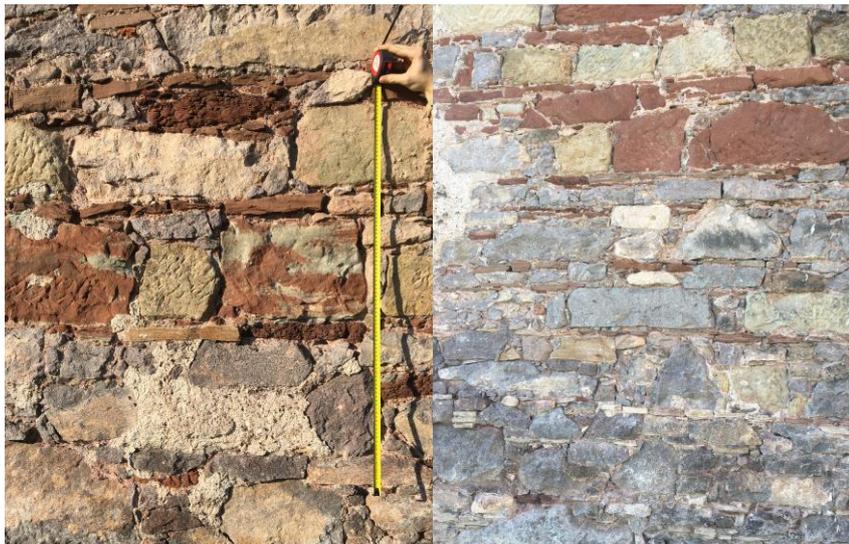
The material loss includes alveolization, erosion, mechanical damage, microskarst, missing part, perforation, and pitting. The exterior of the Church presents erosion including loss of matrix and rounding of the edges close to the joints, these are due to the erosion of the stones at the exterior part mainly due to freeze and thaw cycles **Figure 3.8**. There are also some missing parts, as shown in **Figure 3.9**.

Figure 3.8 - Erosion of stones at the exterior side

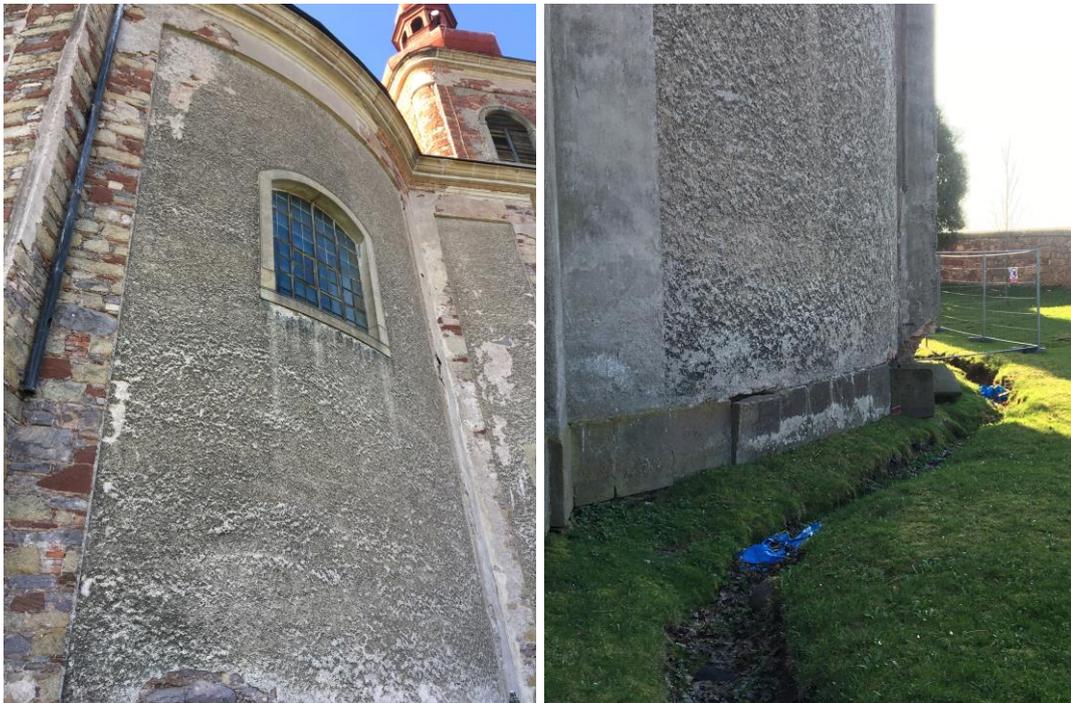
Discoloration and deposits include coloration, bleaching, moist area, staining, deposits, crust, efflorescence, encrustation, film, glossy aspect, graffiti, patina, soiling, sub efflorescence. The exterior of the Church presents black crust on the North façade. Also, the exterior of the Church has patina and staining due to moisture, as shown in **Figure 3.10**.

Figure 3.10 - Patina and Staining on exterior part

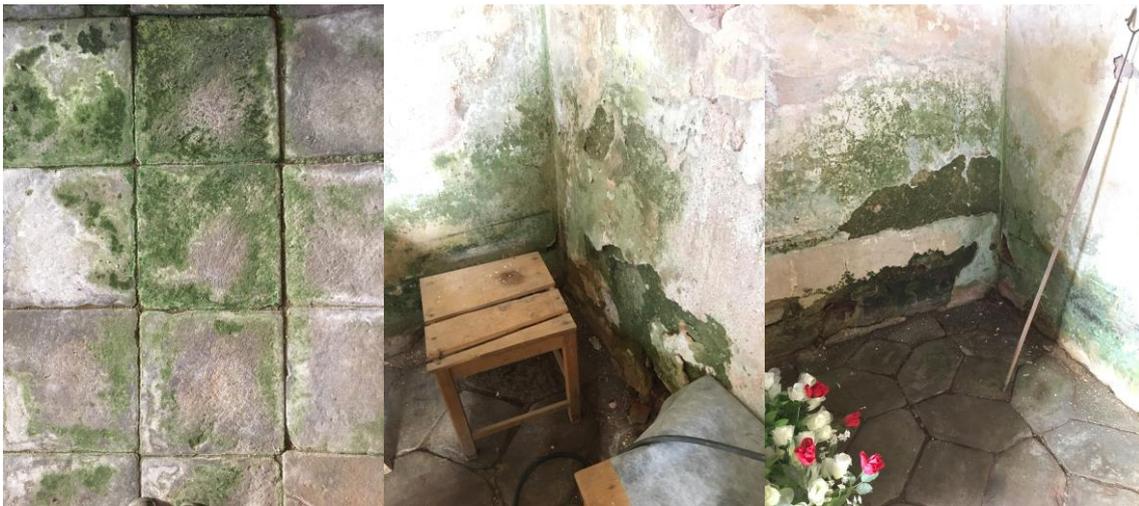
Biological colonization, as defined by ICOMOS, is the colonization of the stone by plants and micro-organisms such as bacteria, cyanobacteria, algae, fungi, and lichen. It also includes influences from other organisms such as animals nesting on and in stone. Around the Church, several types of biological colonization were observed, including algae and lichens; as shown in **Figure 3.11**. Also, the biofilm is observed in the facades of the Church, especially in the North Façade, as shown in **Error! Reference source not found**.

Figure 3.11 - Biological colonization at interior of Church

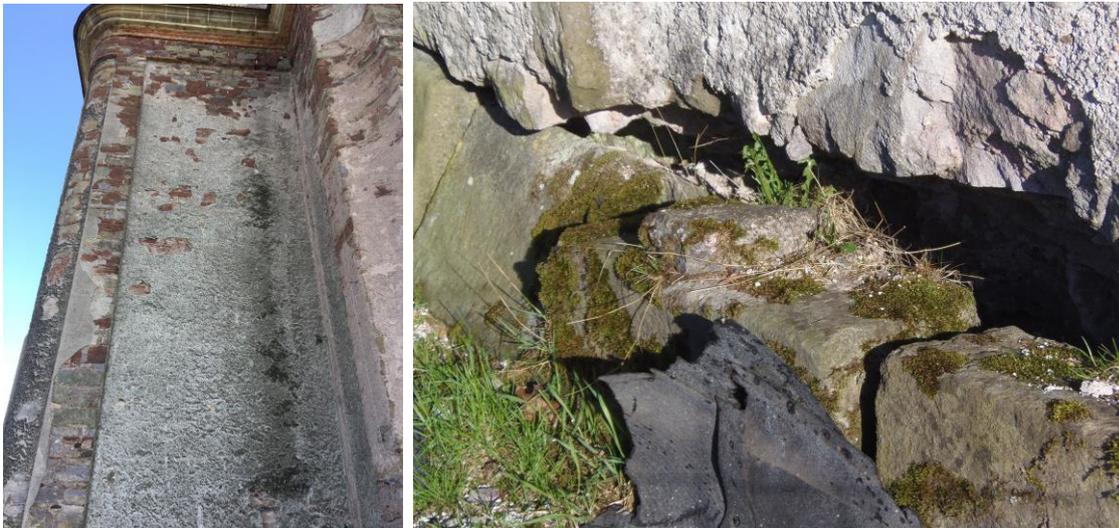
Figure 3.12 - Biological colonization on exterior side

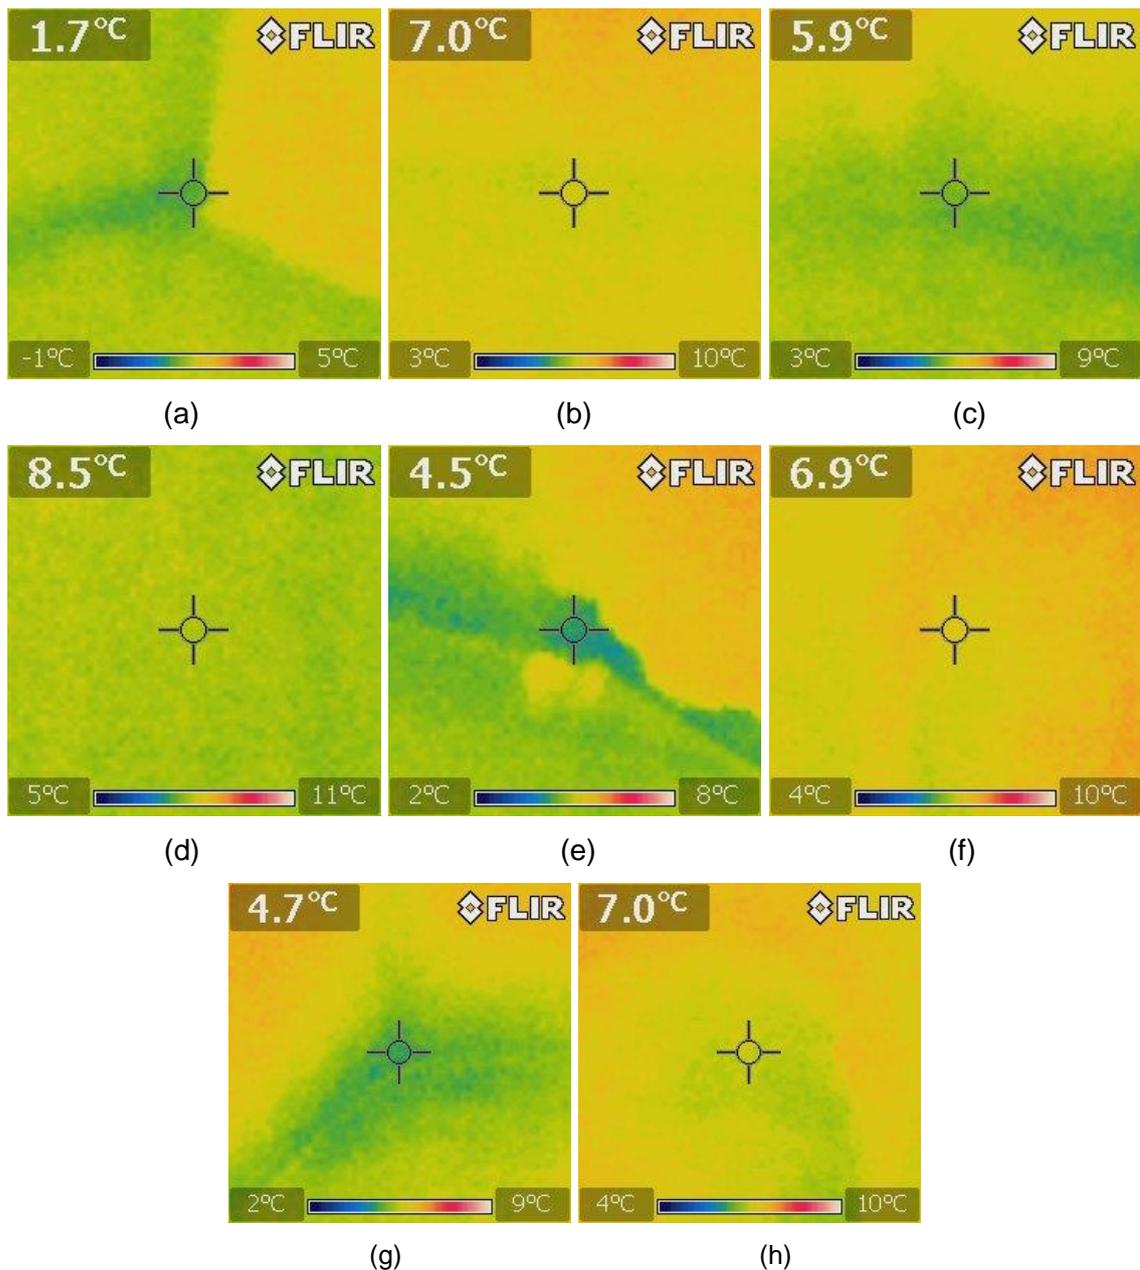
Thermographs are an important tool to measure the difference in the wall temperatures and to identify the superficial damage. Different materials present different temperatures as well as superficial damage. In the following images in **Figure 3.13**, it is possible to observe the difference in wall temperature at different parts of the church, from the images, it can be observed that the bottom one meter of the church suffers from the higher moisture content compared with the upper parts, this can be due to the capillary rise of the water from the ground.

Figure 3.13 – Thermographs at (a) east side bottom (b) east side top (c) south side bottom (d) south side top (e) north side bottom (f) north side top (g) west side bottom (h) west side top

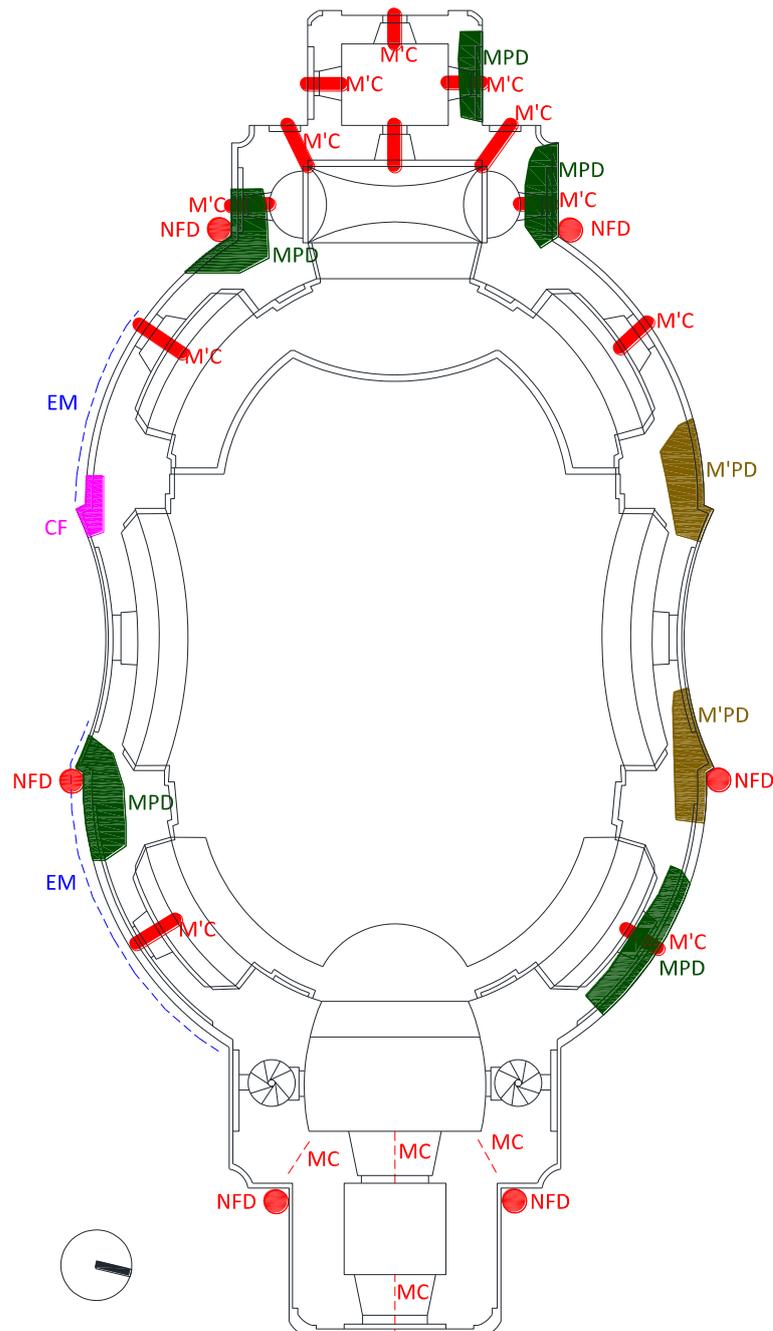
Figure 3.19 - Damage Plan

To assess the actual damage of the St Ann Church, Visual Inspection was carried out. This method is considered as one of the effective methods to qualify the real state of the structure, to the acquisition of data and its analysis. Due to the advantages previously mentioned, visual inspection can also be characterized as one of the most effective non-destructive methods for a preliminary analysis. In **Figure 3.19**, damage plan is presented for this case of study.

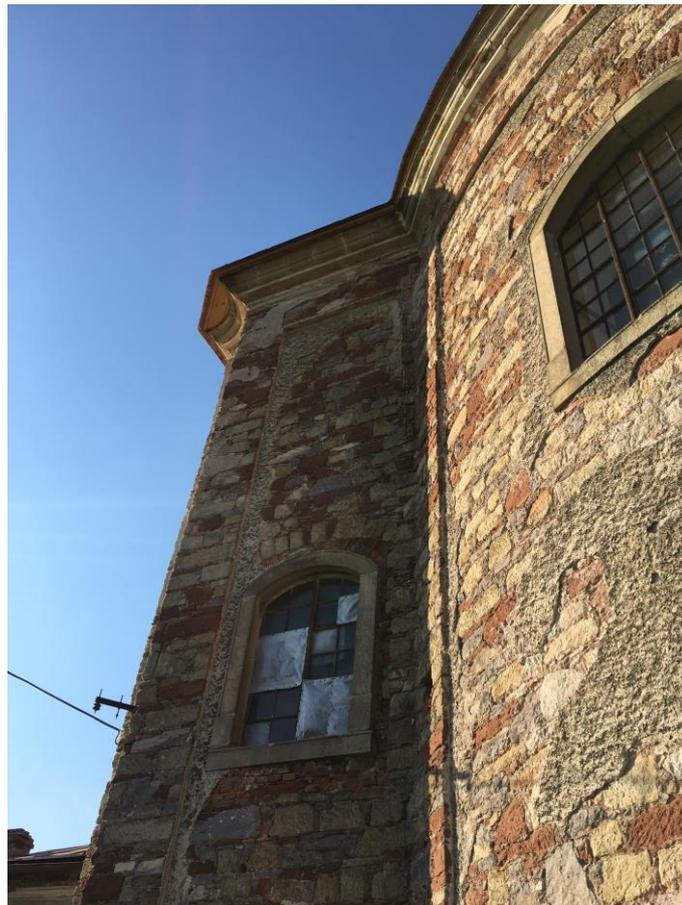
Figure 4.1 - Enclosure wall masonry from the exterior shows non-uniform combination of stones building up the outer layer

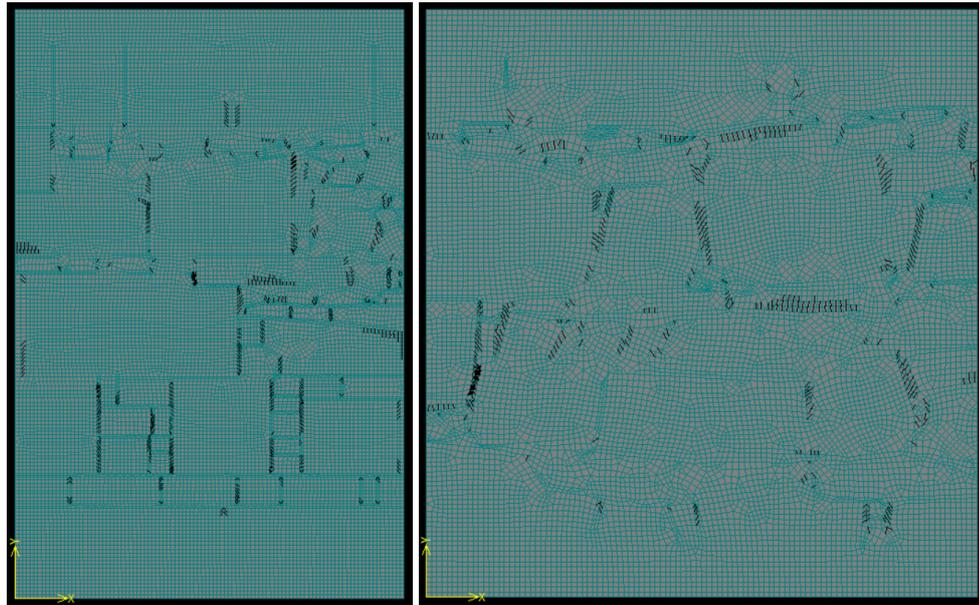
From this analysis it is possible to observe the damages occurred in the walls, which can be defined as the tensile failure of the lime mortar near the joints and at some isolated locations, crushing of stones which are concentrated at the sharp corners.

Figure 4.7 - Crack pattern in longitudinal wall configuration 1 (Left) configuration 2 (Right)

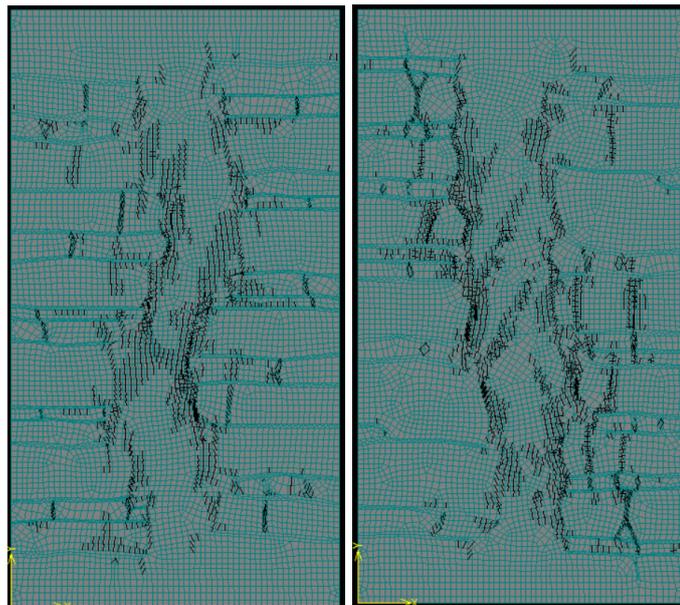
**Figure 4.10 - Crack pattern in a transversal wall configuration 1 (Left) configuration 2 (Right)**

From this analysis, it is possible to observe the damages occurred in the transversal walls. Here with an increase in the compressive stress, it can be observed that the wall undergoes the damage, which starts to occur near the infill rubble and outer leaf from both sides, these cracks separate the infill from the external masonry and relatively high transversal deformations can be observed in the wall. With further increase in the load, cracks in the lime mortar and crushing of stones can be observed at some locations. From this analysis, a stress vs strain graph can be plotted which is shown in Graph 2.

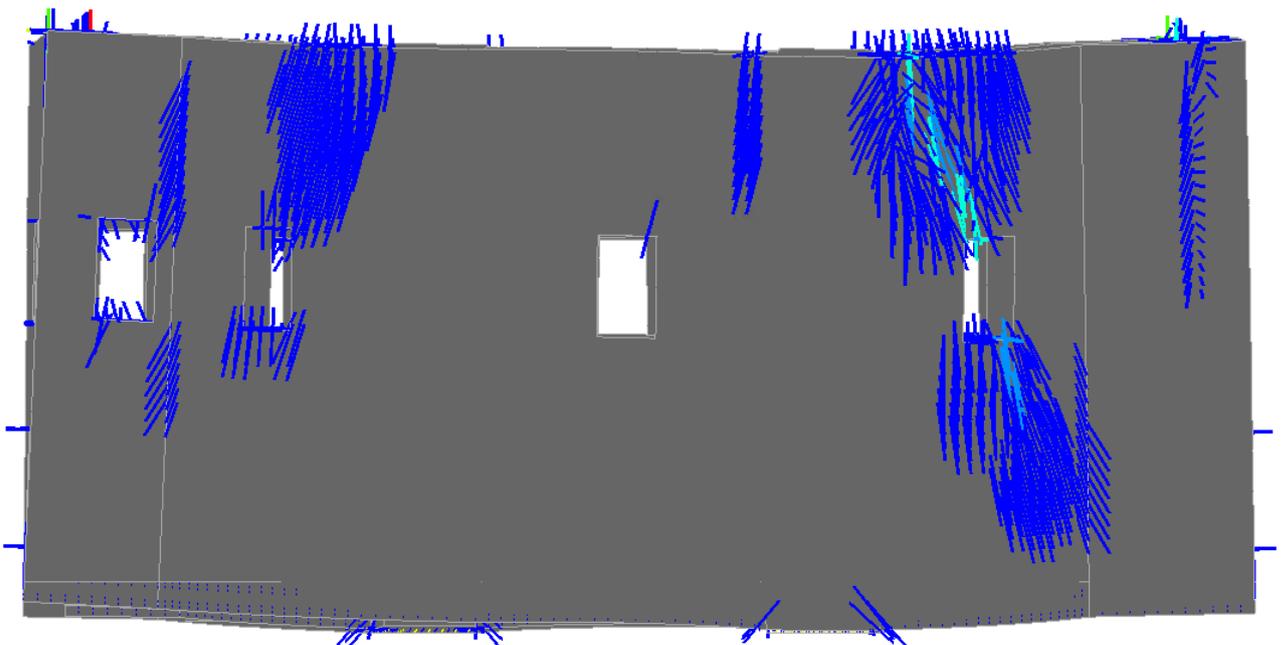
**Figure 5.16 - Crack strains at the north facade**

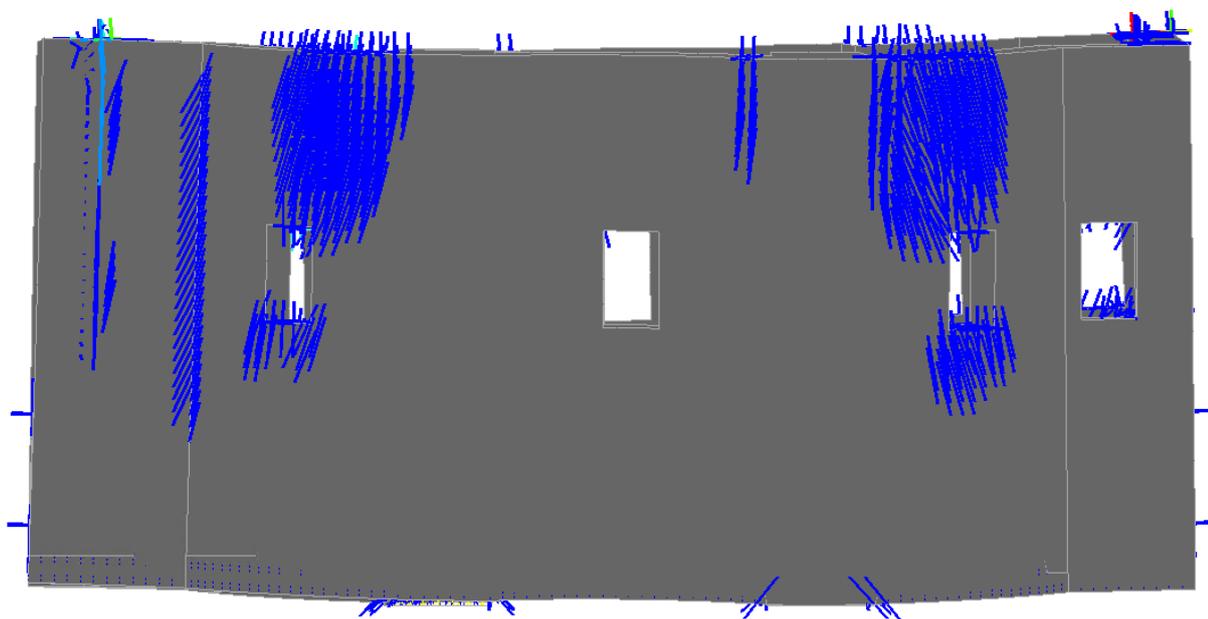
**Figure 5.17 - Crack strains at south facade**

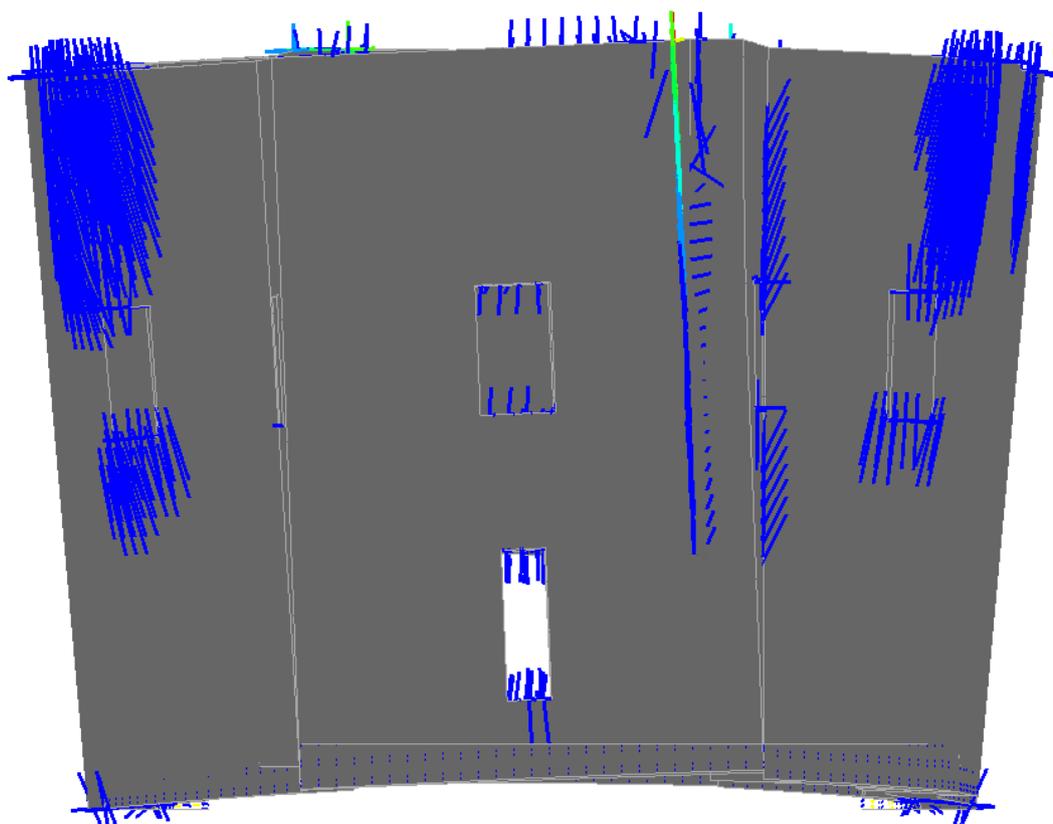
**Figure 5.18 - Crack strains at the West facade**

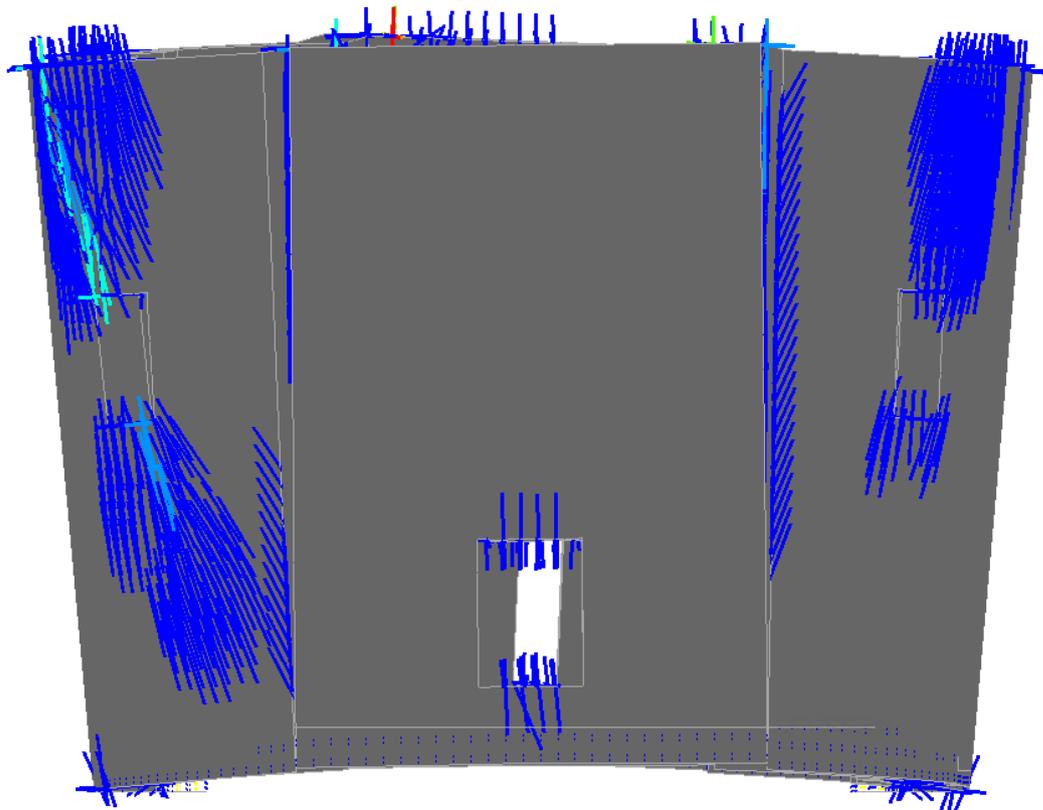
**Figure 5.19 - Crack strains at the east façade**

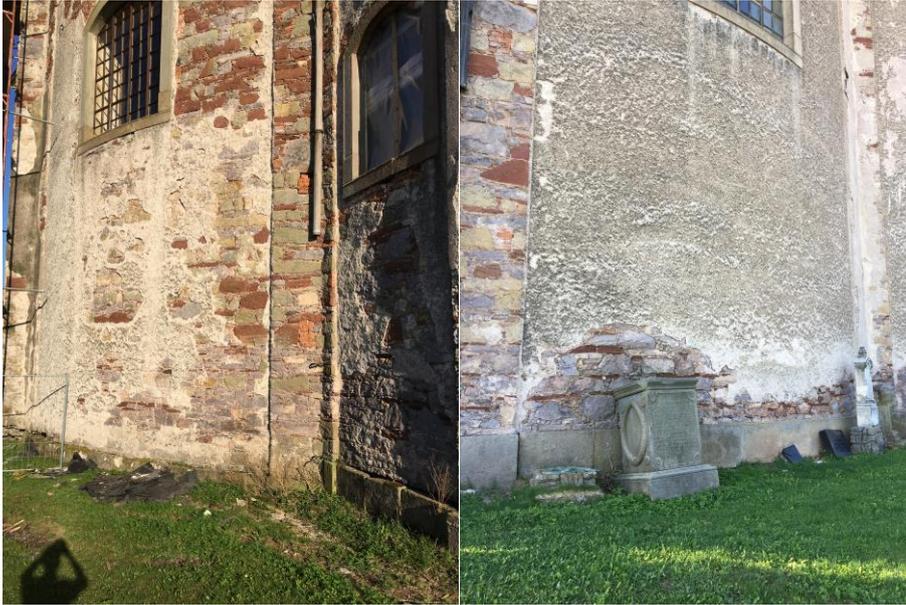
**Figure 7.2 - non-performing rain water downspout (Left) damage in walls due to groundwater in walls (Right)**

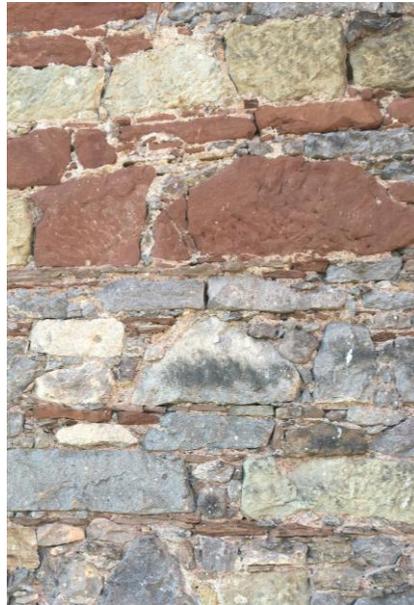
**Figure 7.5 - Outer masonry wall showing missing mortar at some locations**
