## MASTER'S THESIS PROPOSAL

Student's name and surname: Bledian Nela  
Department: Department of Mechanics  
Thesis supervisor: Jiří Bláha  
Thesis title: The analysis of the timber roofs of the Loreta in Prague  
Thesis title in English: see above

Title of the Msc Dissertation: The analysis of the timber roofs of the Loreta in Prague

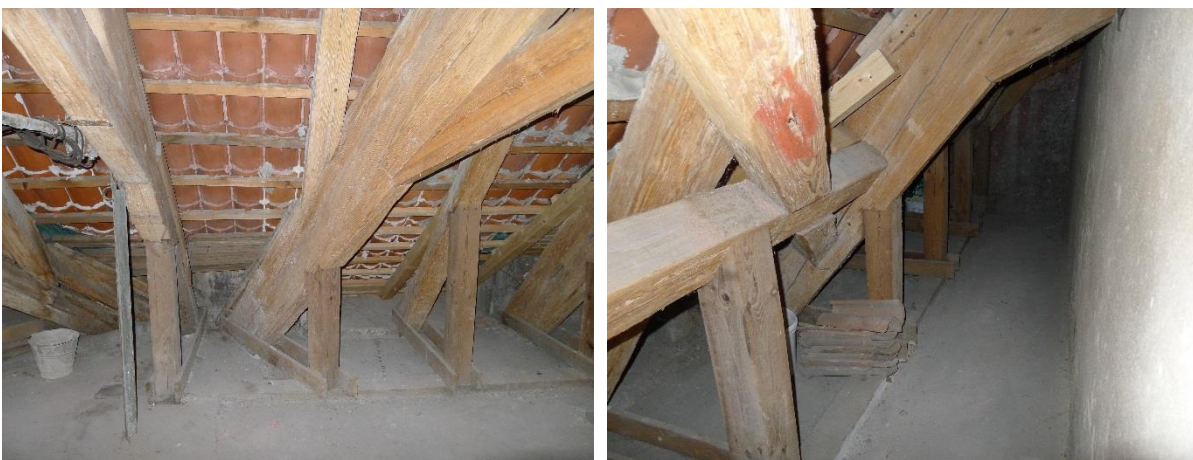
The first intervention measure which can be observed are the strengthening short columns on the timber frames. These columns are on the sides, near the end of the rafters connected directly to them. The columns are supported on a timber beam which is embedded in the concrete floor. Moreover, the end of the rafter is connected with two timber planks to the column as seen in Figure 3.19.

**Figure 3.19 – The short columns connected to the rafters**

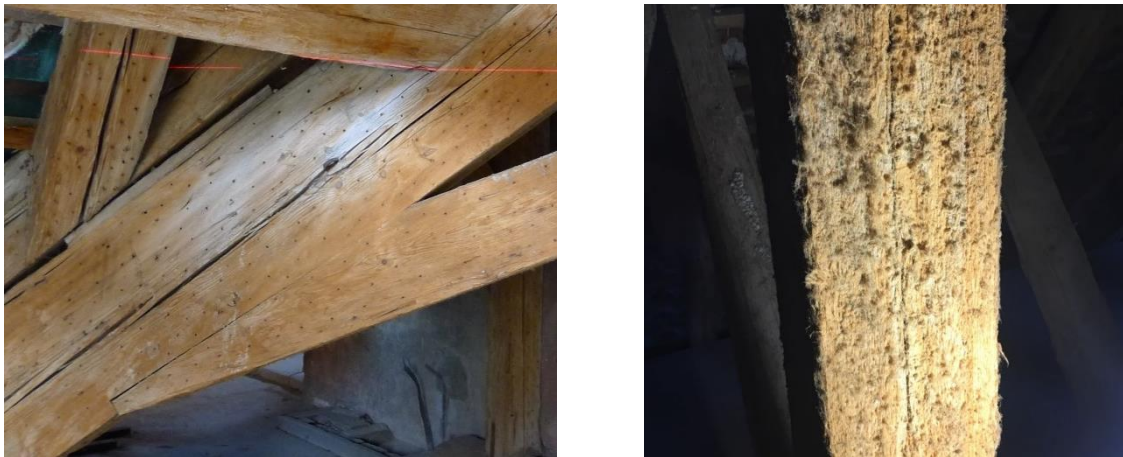
On the timber elements can be observed a considerable number of small diameter holes. The number of these holes per area are too many as can be seen in Figure 3.20 (left). This can be an injection to the timber elements as a measure of protection against the insects. Moreover, layers of fireproofing can be observed in certain elements as can be seen in the Figure 3.20 (right).

**Figure 3.20 – The injection holes (left) and the fireproofing (right)**

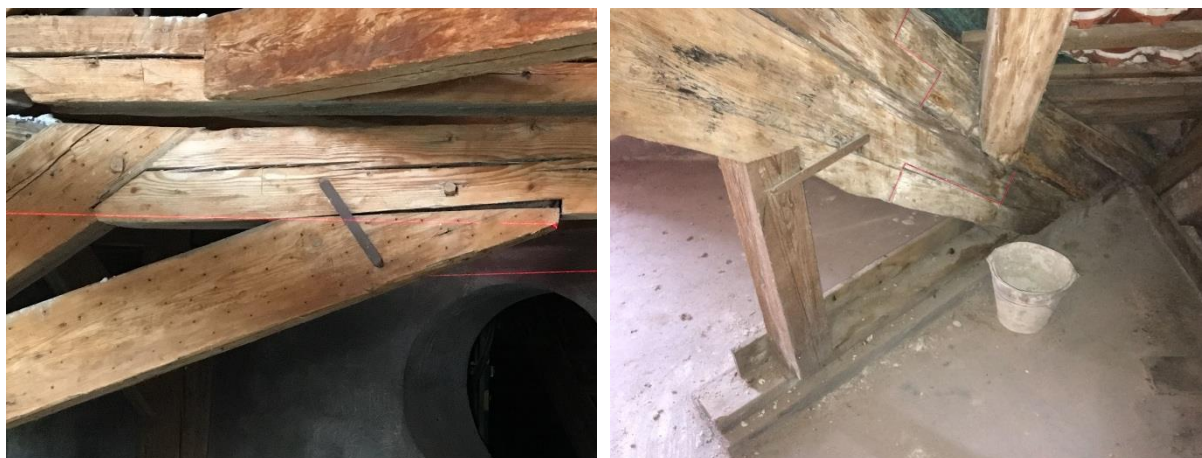
Something else which can be observed on the roof are the metallic elements. These elements are located usually near the connections to strengthen them, as can be seen in the Figure 3.21. Furthermore, a strengthening measure carried out in the roof are the end rafter repairs. The cause may have been the decay of the rafter on the ends due to the contact with moisture. Therefore, prosthesis have been used as a strengthening measure which can be seen in the Figure 3.21 (right).

**Figure 3.21 – The metallic element in the diagonal strut (left) and the prosthesis (right)**

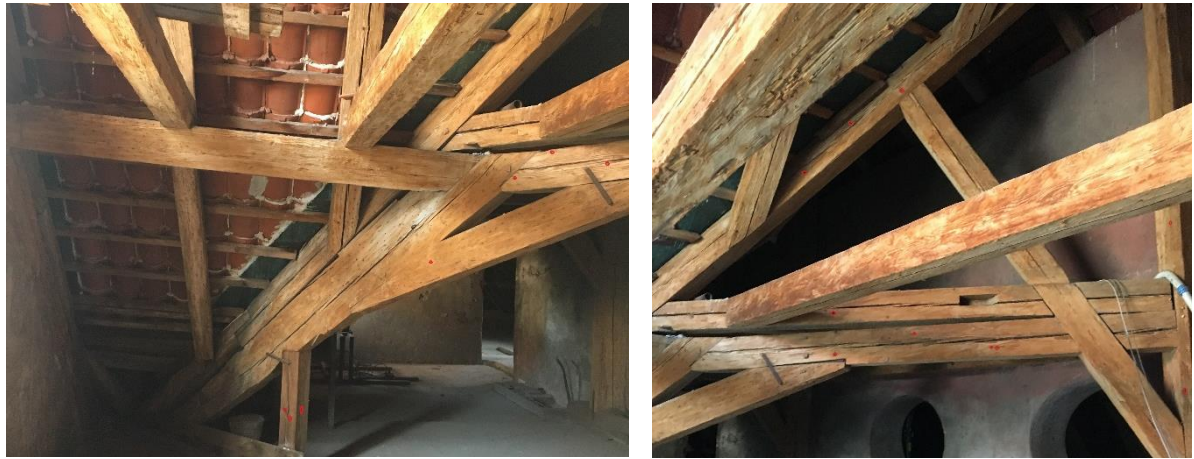
Concerning the knots in the elements, the entire frame has few single knots with small diameter as can be seen in Figure 4.3. In Figure 4.3 (right) can be seen grouped knots as the only example of grouped knots. Therefore, for the parameter of knots the frame can be classified as S1.

**Figure 4.3 – The highlighted knots on Frame 1**

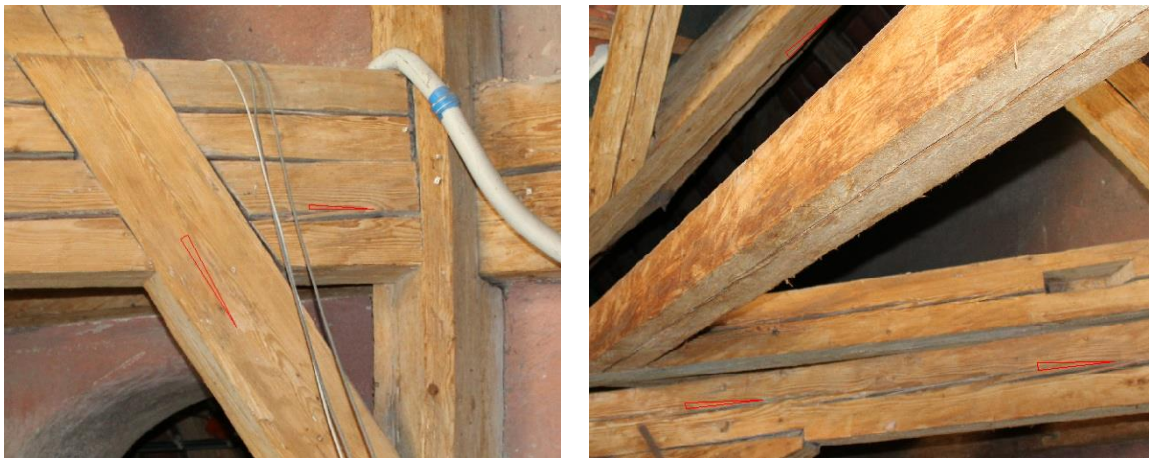
The slope of the grains is measured in different locations, where the deviation of the straight grains can be observed. The places where the slopes are measured can be seen in the Figure 4.4 below. The values obtained vary from 1:16 to 1:8 with a majority of values bigger than 1:14. According to this parameter the frame is classified as S2.

**Figure 4.4 – The direction of the grains on Frame 1**

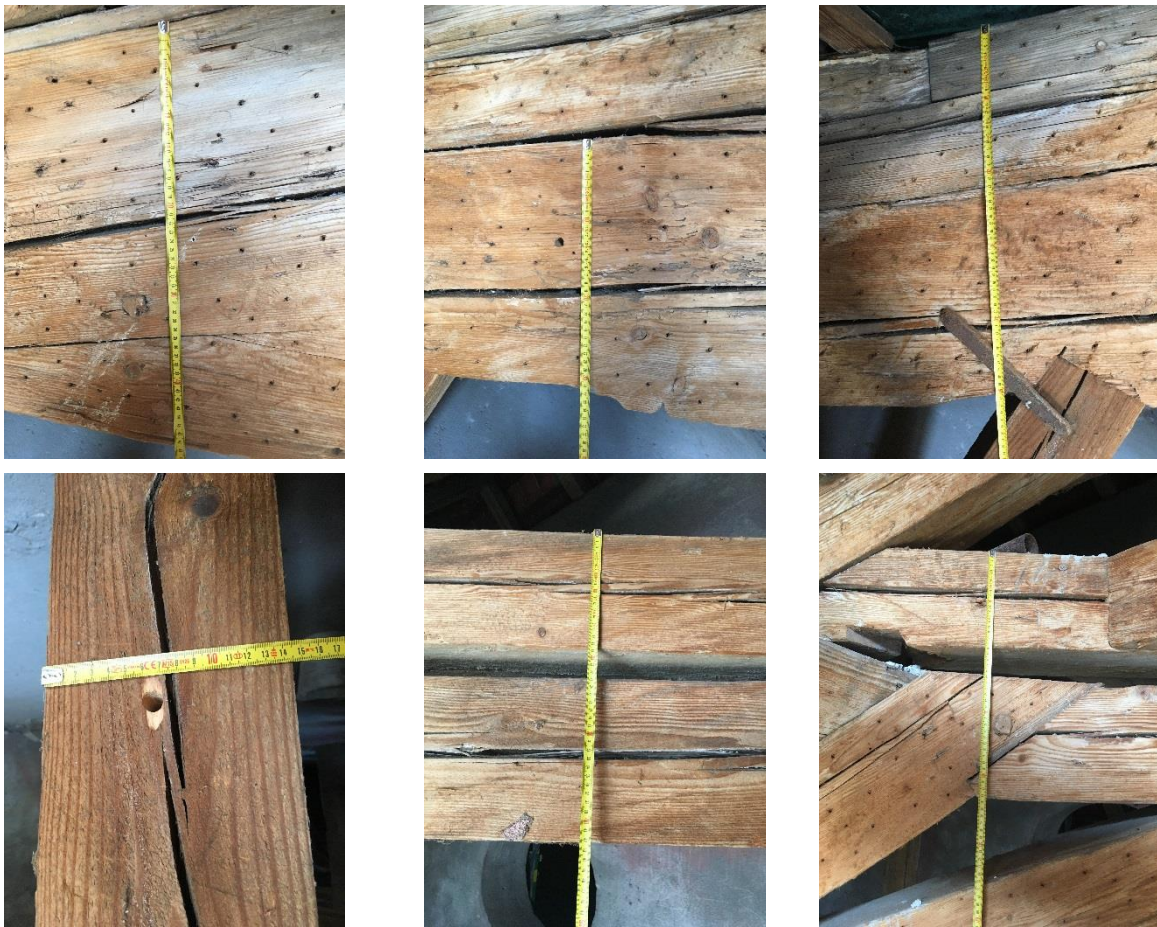
In the frame can be seen a majority of fissures on the outside. They are mainly longitudinal and follow the direction of the fibers as can be seen in Figure 4.4. The widths of fissures vary from 5 mm to 20 mm. As for the internal fissures they are not assessed and no categorization can be done. Moreover, as can be seen in the Figure 4.5 below, there is a big deformation of about 56 mm on one end of the lower beam. This deformation caused the separation of the two beams and its safety will be further evaluated in the other chapter.

**Figure 4.5 – Measurement of cracks and deformations on Frame 1**

It can be concluded from the visual inspection that the timber element is in a good condition with the issue of large deformation at one point. Nonetheless, the mechanical condition observed from the inspection can be stated in a good state. As for the visual grading of the timber according to the UNI 11035:2003, the frame can be classified in the S1 class, leaning towards S2. The mechanical parameters which this code provides are mainly for the Italian wood species. Therefore, only an approximation can be made for the current frame. The species which corresponds to the frame of interest is the fir in the North of Italy. The mechanical parameters of this category for classes S1 and S2 are shown in Table 4.2.

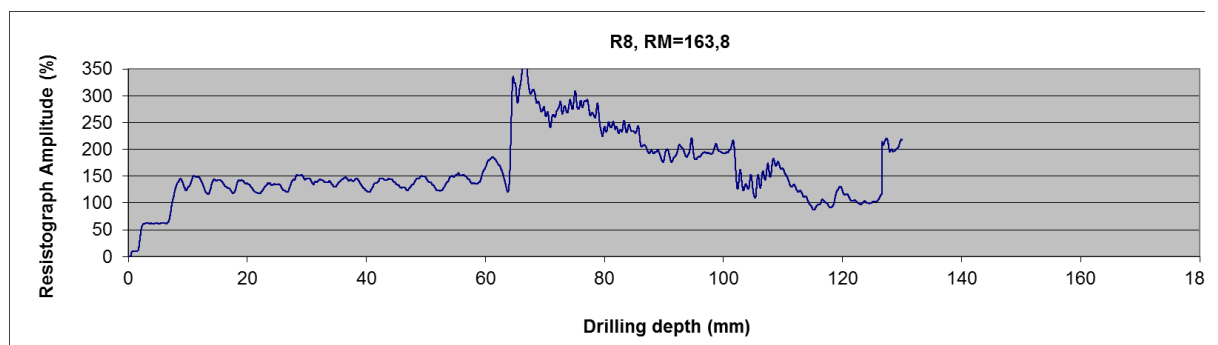
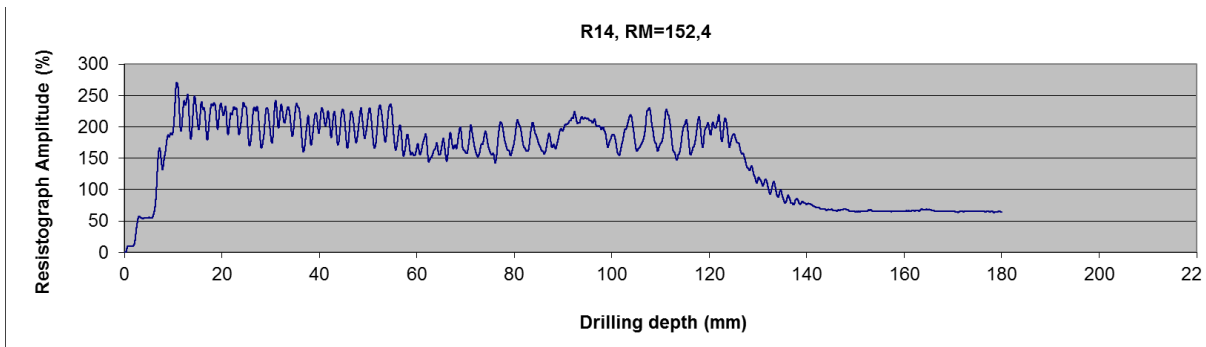
As can be observed in the Figure 4.7, 18 tests are performed on the frame. During the test R8, which was performed near R9, the needle broke because it ended in a metal element and it can be clearly seen in the graph in Figure 4.8 (top). From the graph can be observed how the resistance experiences an immediate jump and then stops. This was peculiar since the connections in the roof are mainly timber connections and from this can be stated that there are some strengthening works which are not visible. Furthermore, during the drilling of R14 the needle ended in a crack and the test was carried on with R15 on the other side of the element. It can be observed from the graph in Figure 4.8 (bottom), that the resistance amplitude decreases drastically until the test was stopped.

**Figure 4.8 – Microdrilling resistance graph for R8 (top) and R14 (bottom)**

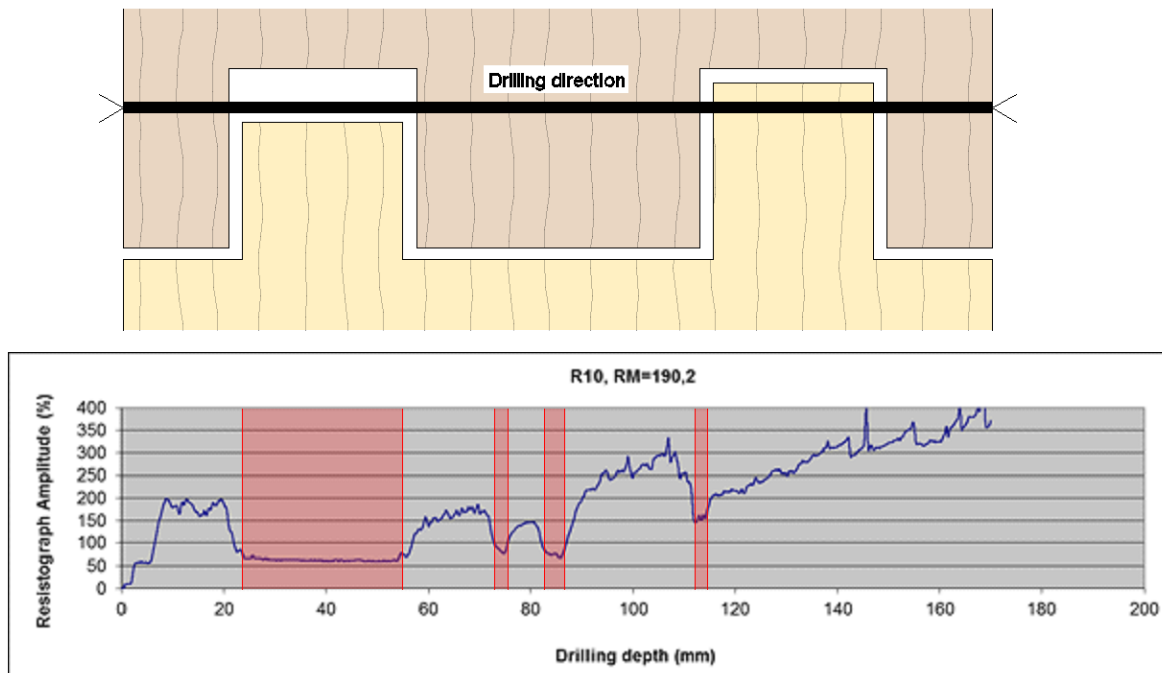
From the test R10 which is plotted and shown in Figure 4.9, can be seen a variation in resistance. The testing point is on the connection joint which is a wooden joint. If the joint is supposed to be a twin mortice and tenon then the sudden reduction in resistance can be due to a gap in the connection between the first tenon. According to the test the width is about If the second tenon is placed symmetrically on the opposite side the last drop in reduction can be expected as a small gap between the two members. The two reductions in the middle of the section can be due to cracks in the section. A schematic illustration is shown below in the Figure 4.9, where on top is shown the possible top view of the joint and below is the graph of R10.

**Figure 4.9 -Hypothetical drawing of the internal structure of the carpentry joint according to microdrilling measurement R10**

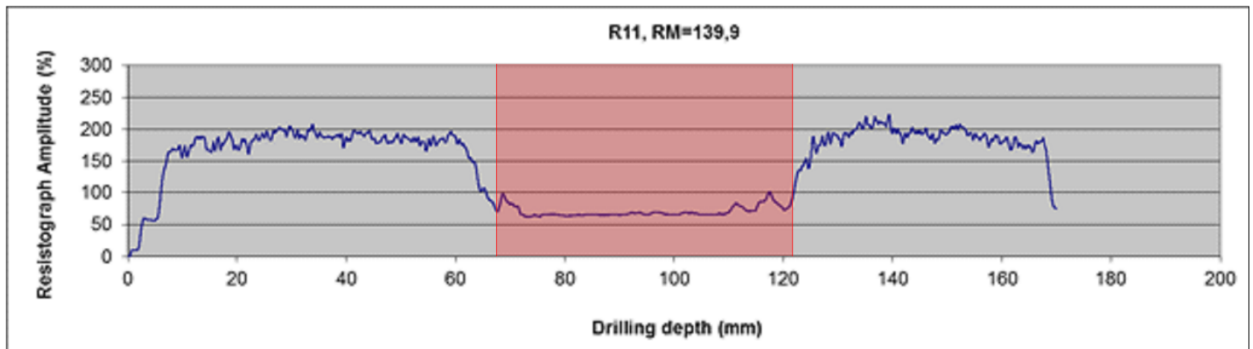
**Figure 4.10 – Reduction of the resistance in the microdrilling measurement R11**

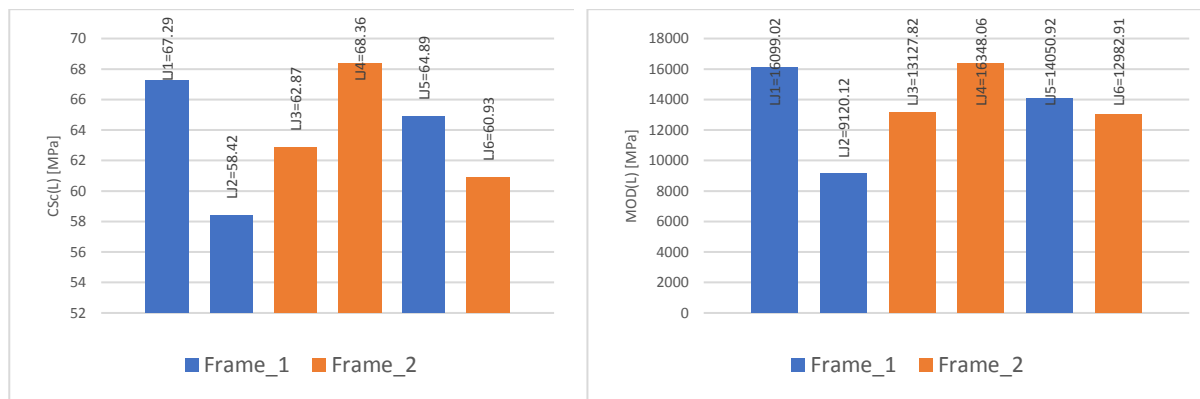
The  $CS_c$  and the MOD of the first test which represent the original rafter of Frame 1 show higher values than the newly added column (LJ5) and the original column (LJ2). The mechanical condition of the rafter is in good compared to the above mentioned. Nevertheless, the mechanical property of the added column and the rafter are similar and therefore the mechanical compatibility is roughly achieved. The modulus of deformability of the column of the frame is considerably low. Regardless, the column works mostly in axial forces and the axial deformations are usually lower. Correspondingly, the deformability is measured in the axial direction and will not highly influence the column. In contrast the values from Frame 2 of  $CS_c$  and MOD are similar with small variation in-between. Compared to Frame 1 the values are similar overall. The average values are shown in the Figure 4.19.

**Figure 4.19 – Comparison of results between Frame 1 and Frame 2 for conventional strength (left) and modulus of deformability (right)**

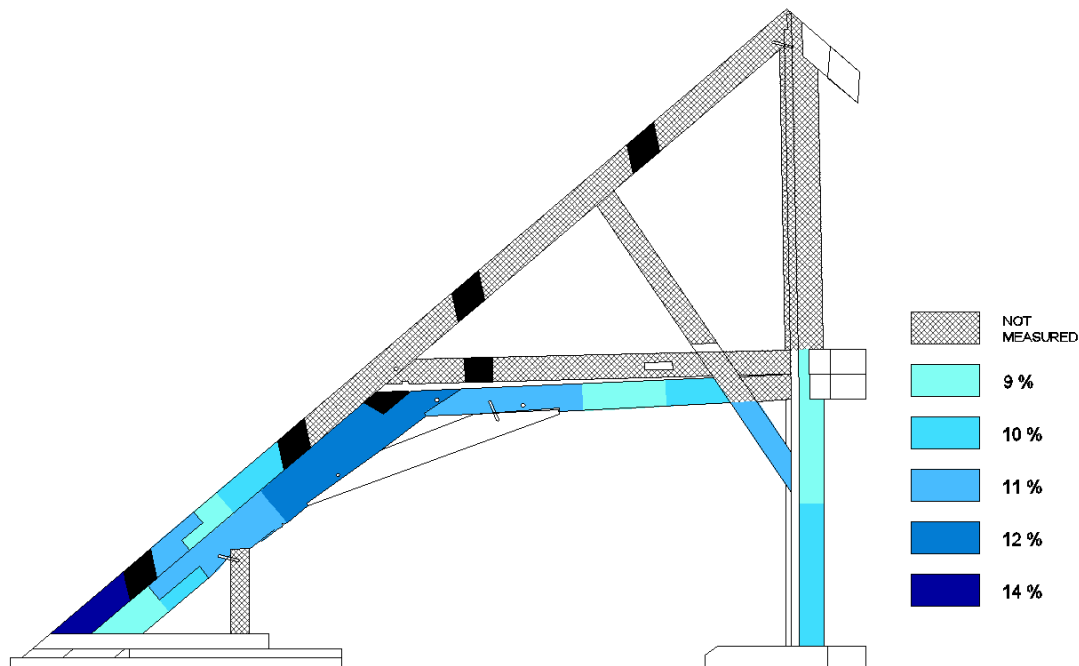
Figure 4.22 – Surface moisture content measurement on Frame 1

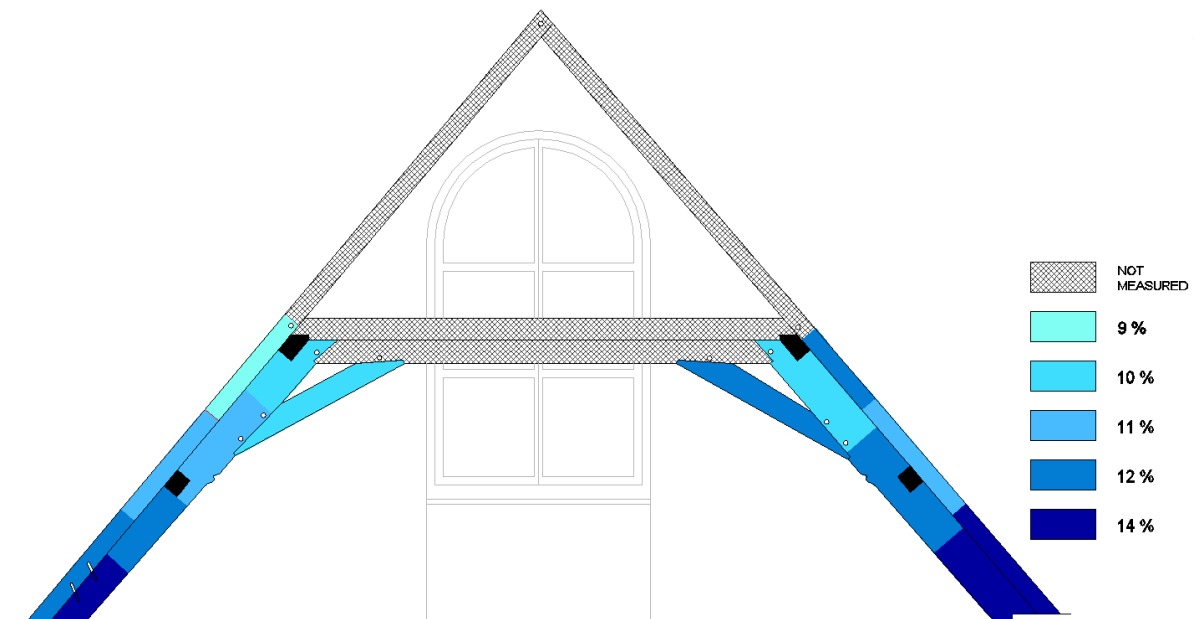
**Figure 4.23 - Surface moisture content measurements on Frame 3**
