ADVANCED MASTERS IN STRUCTURAL ANALYSIS
OF MONUMENTS AND HISTORICAL CONSTRUCTIONS

Master's Thesis

Structural Survey of Historical Building Strahovská FARA in Pohořelec

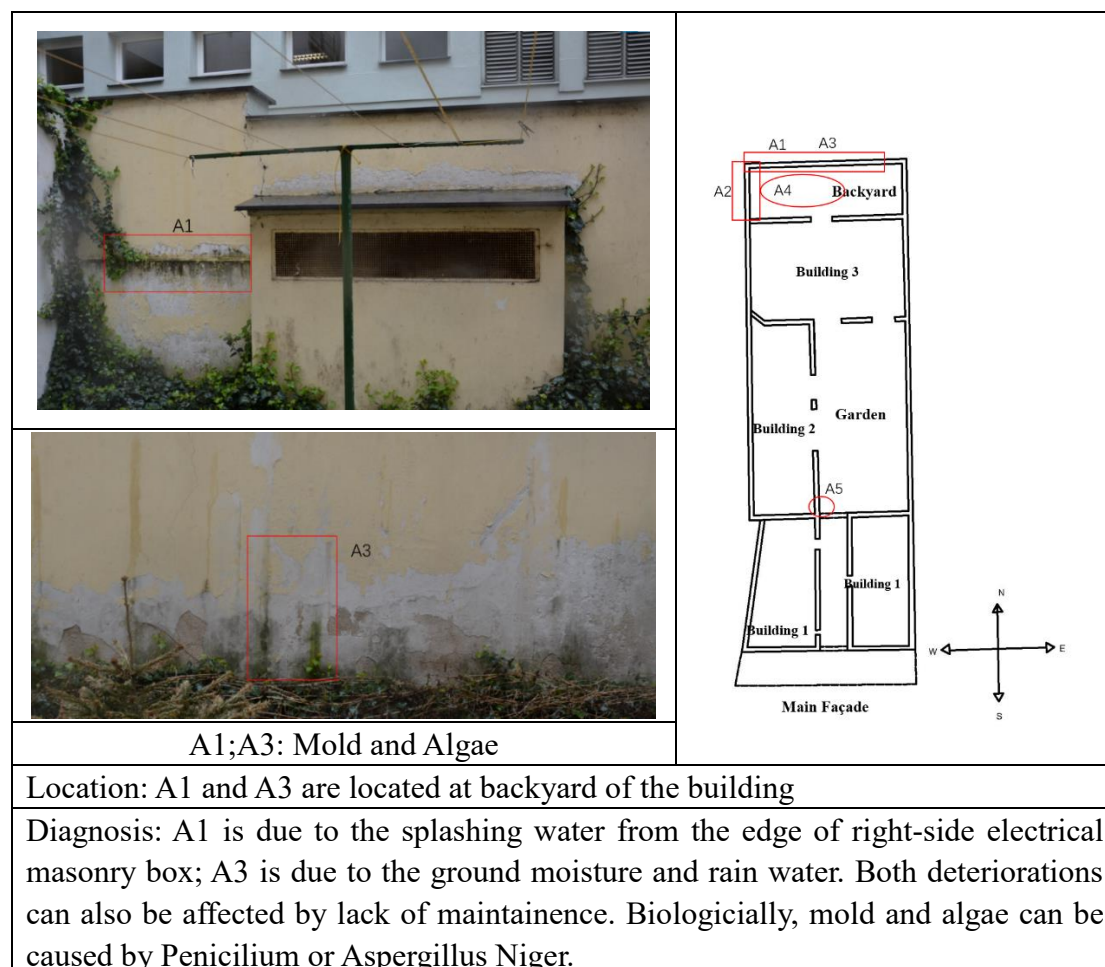
Plants and mold are main agents of bio-deterioration for the historical building Strahovská FARA (See Figure 15 & 16). Although bio-deterioration would not cause structural issue to the building, they would affect its aesthetics. Main reasons of bio-deterioration are lack of maintenance and moisture.

Figure 15: Bio-deterioration by Mold and Algae

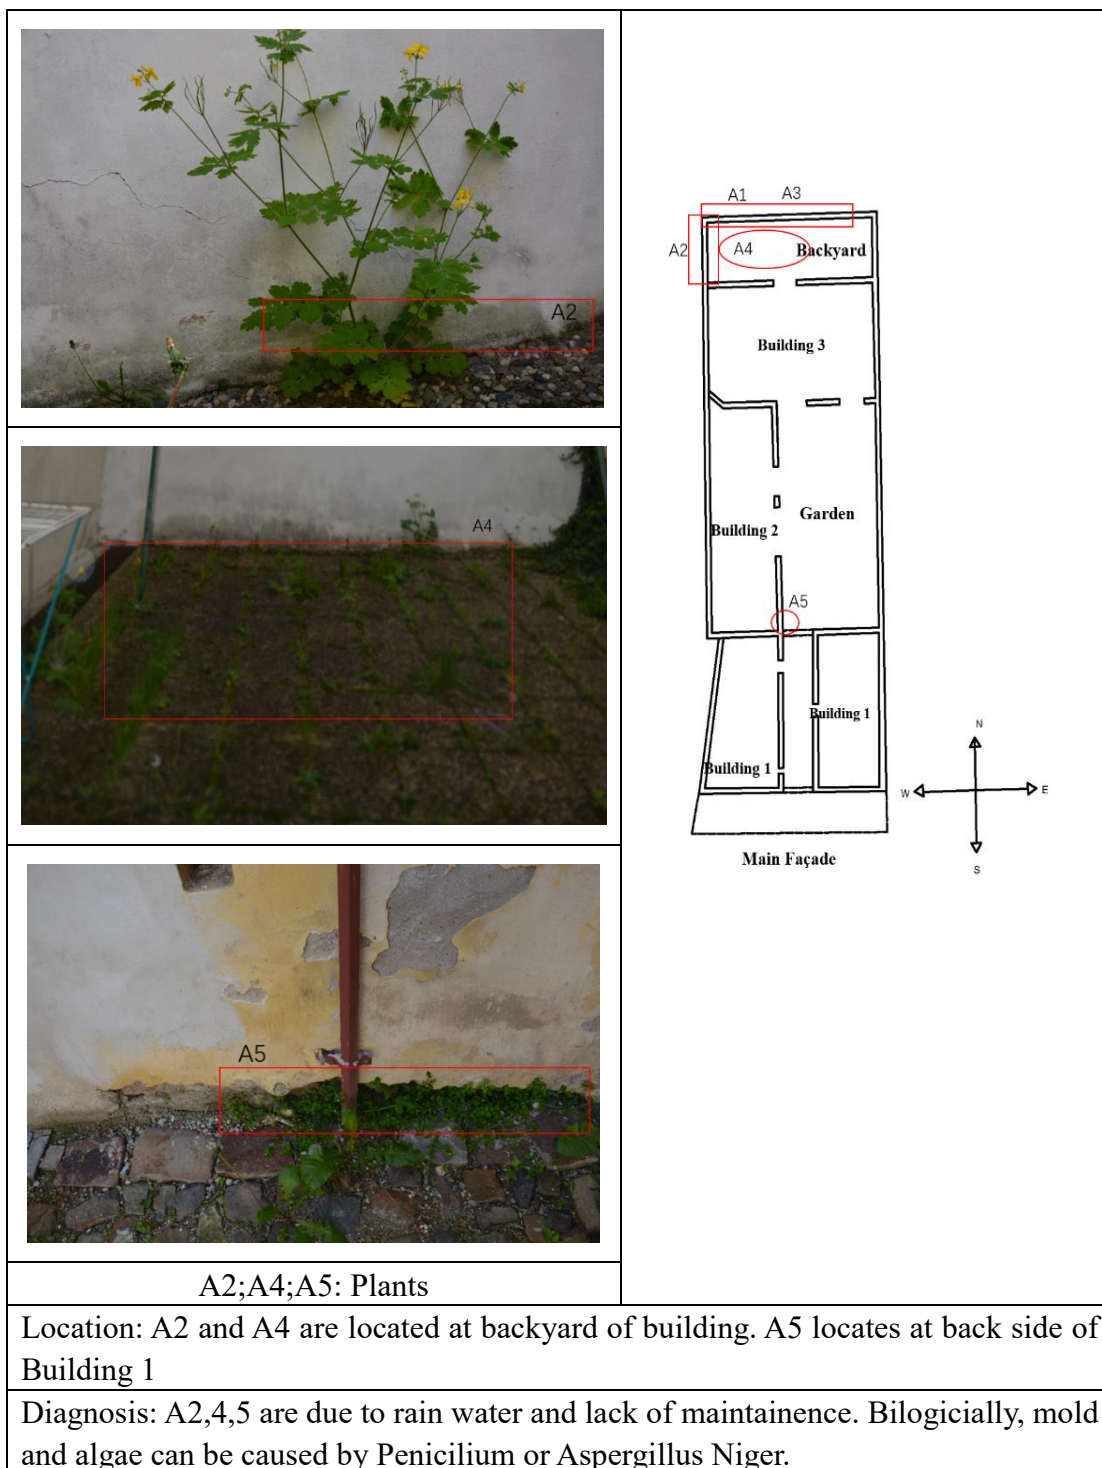
Figure 16: Bio-deterioration by Plants

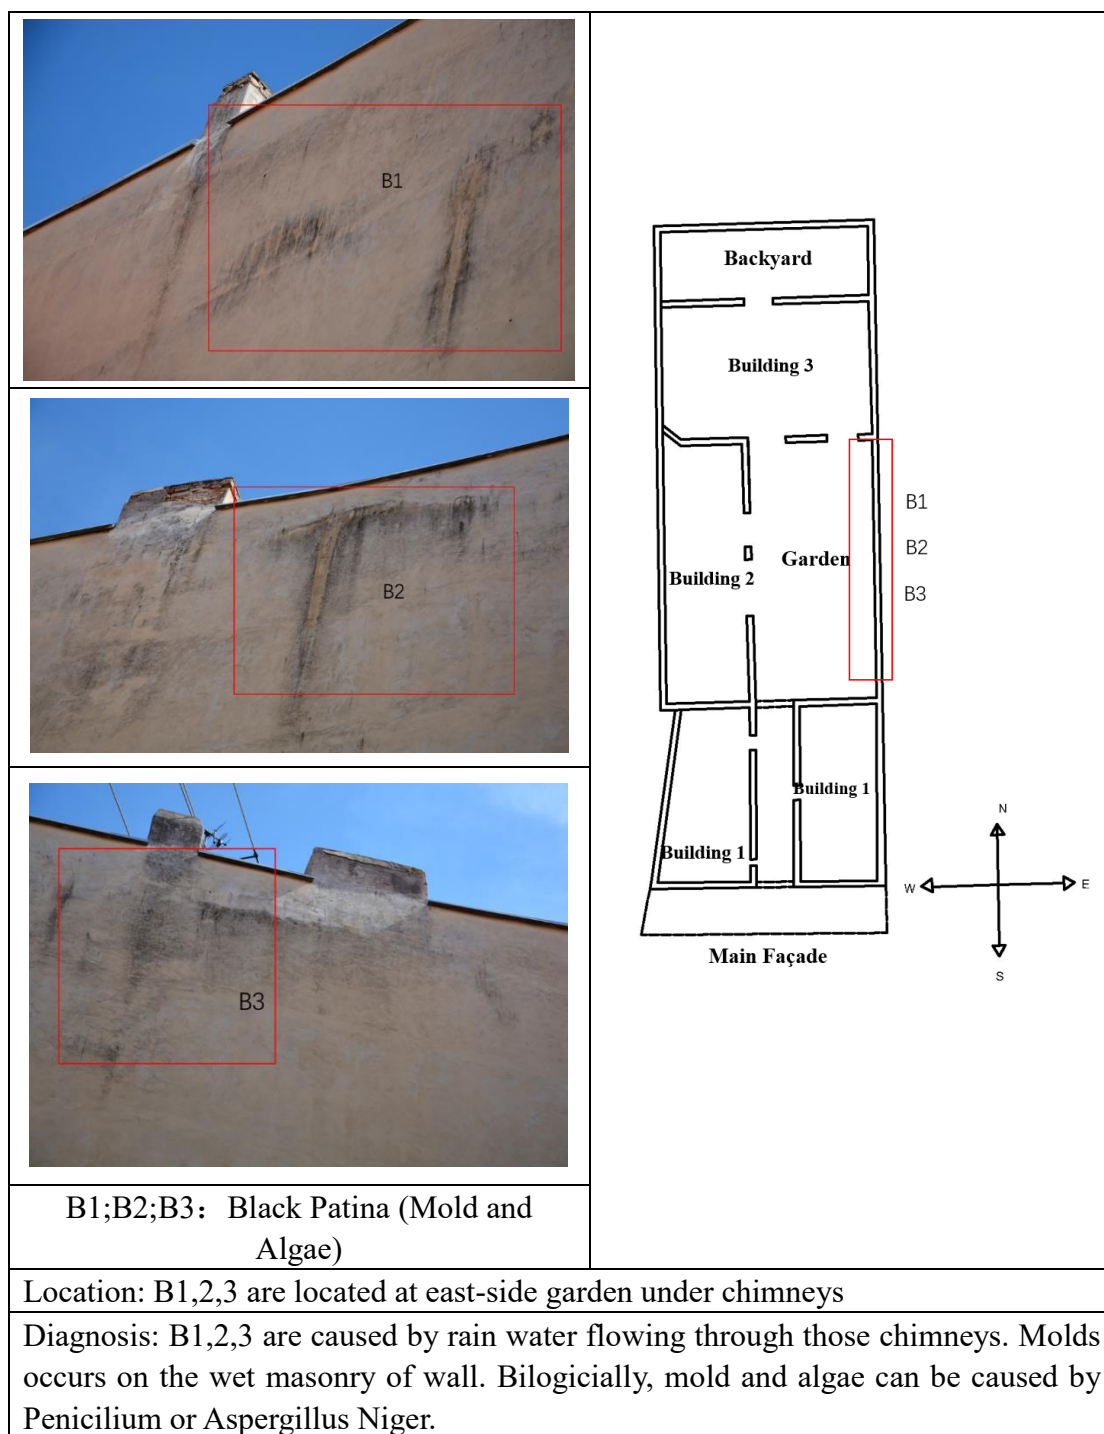
Figure 17: Bio-deterioration by Black Patina

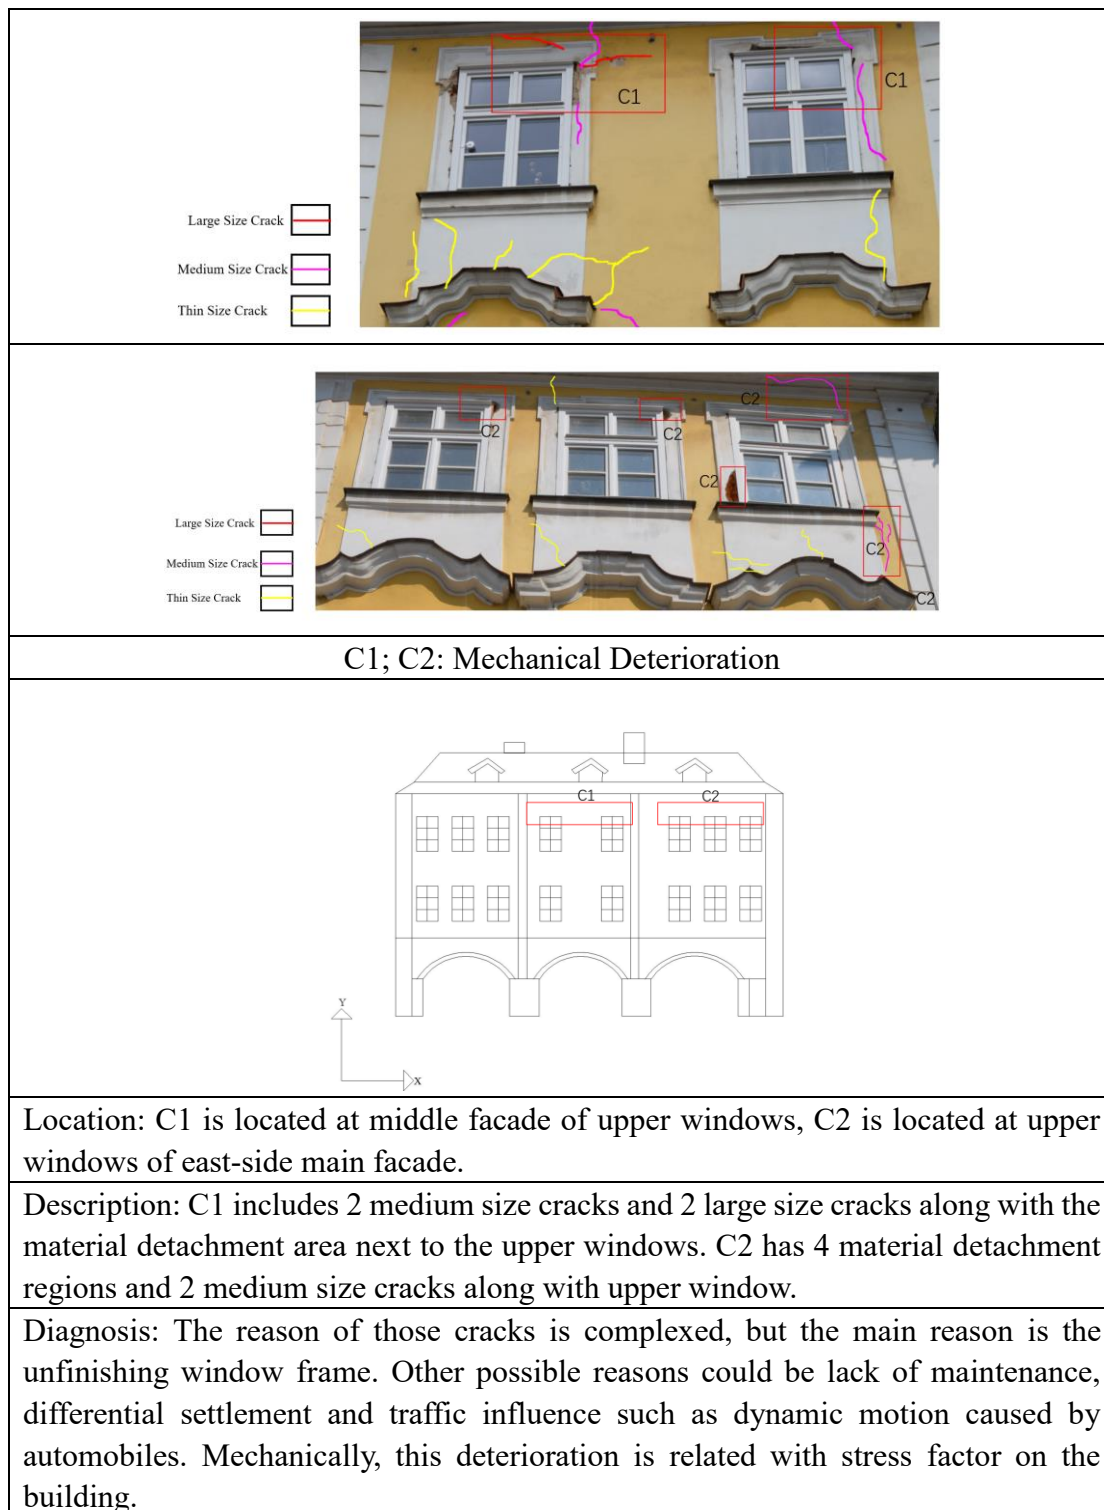
not cause structural issue, it affects its aesthetics. In this case, only medium and large size cracks have been analyzed, and the definition of crack size is shown in section 6.1.4.

Figure 18: Mechanical External Deterioration of Main Facade

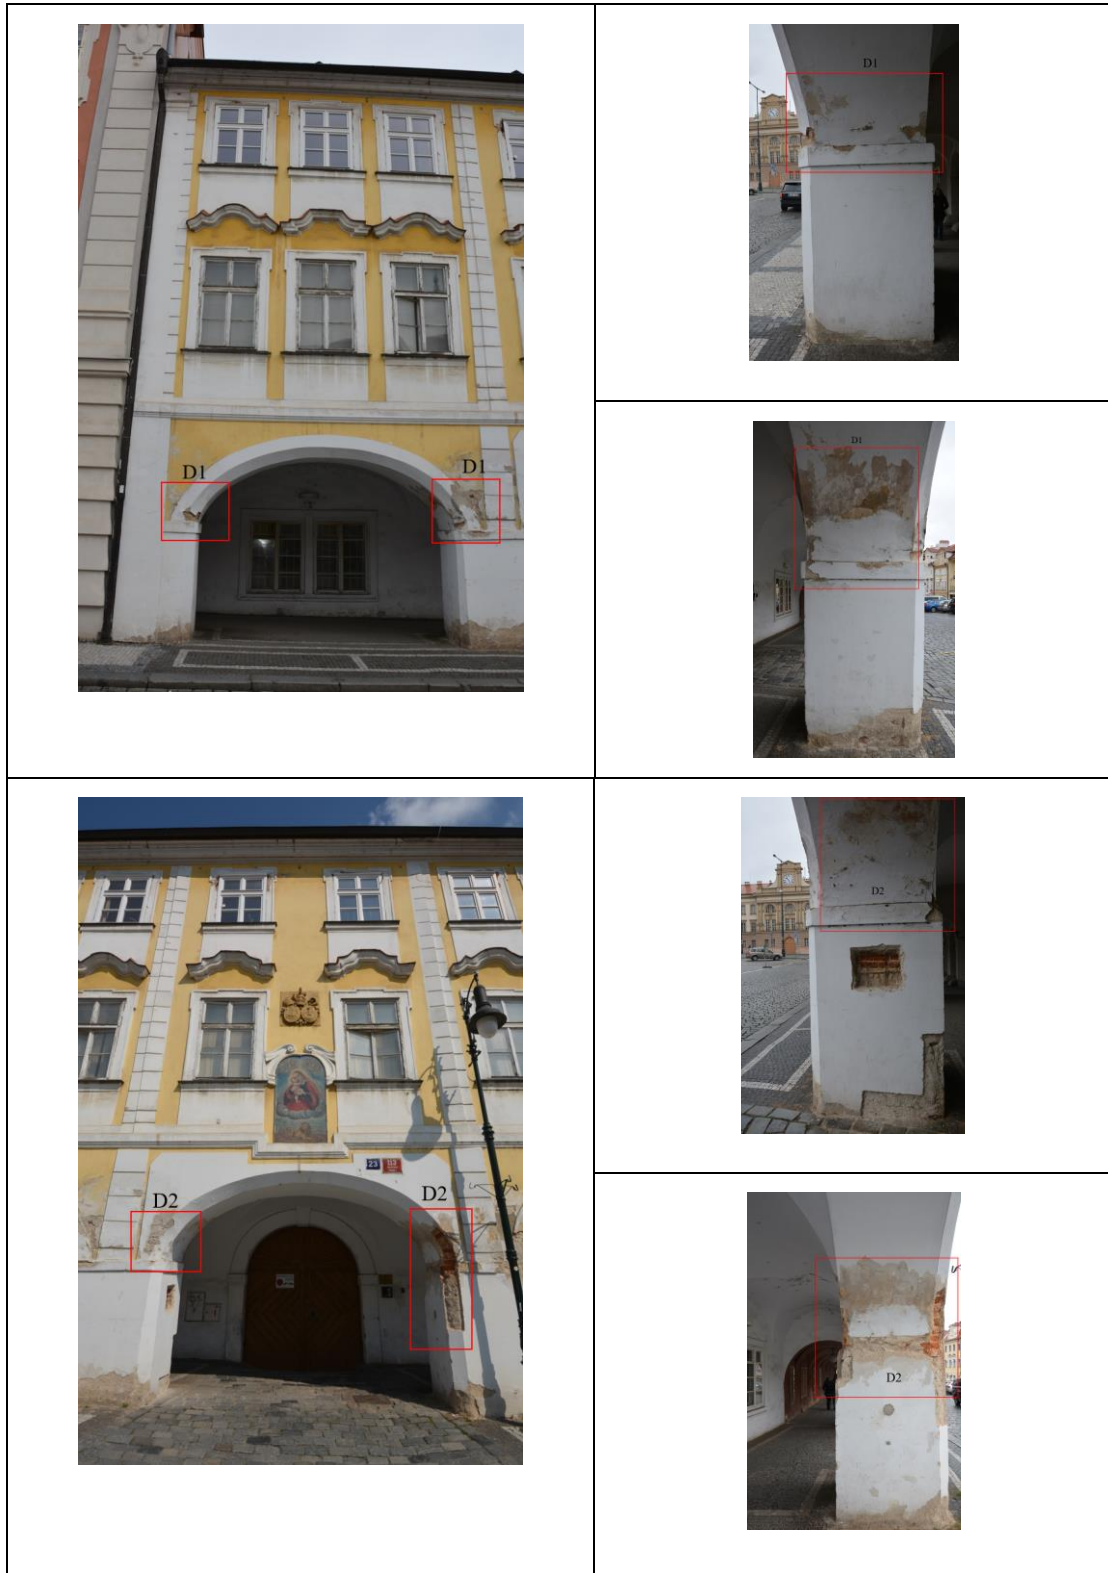
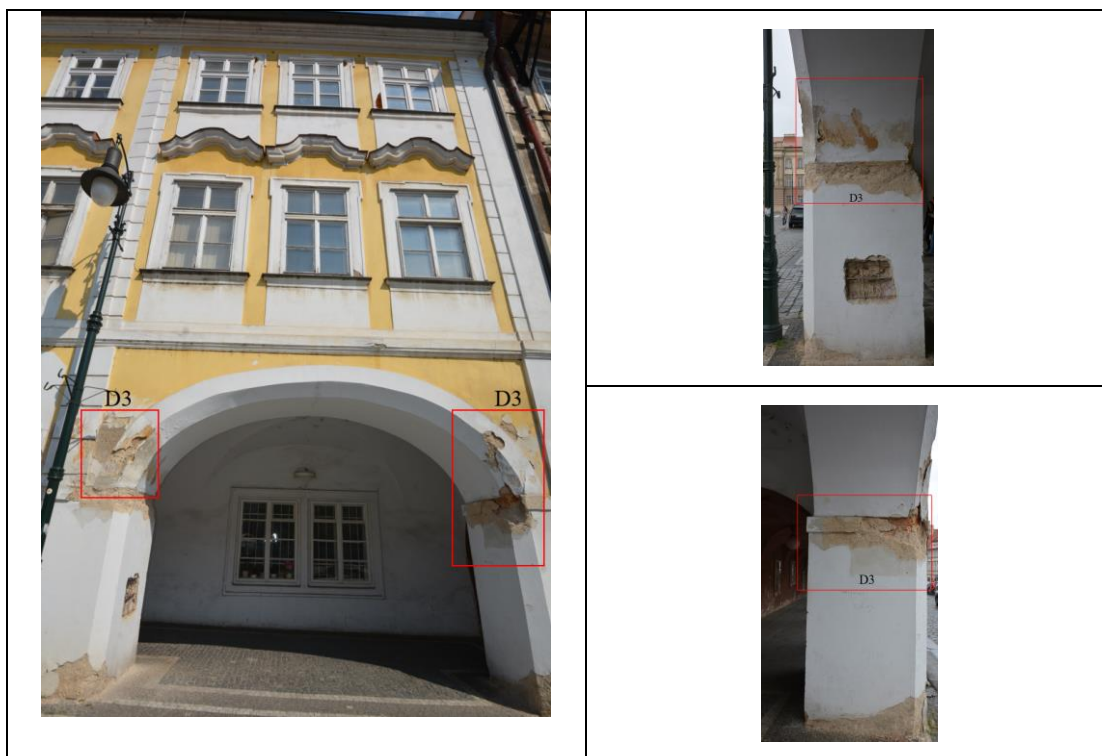
D1;D2;D3: Rising Damp

Figure 20: Rising Damp on Main Facade

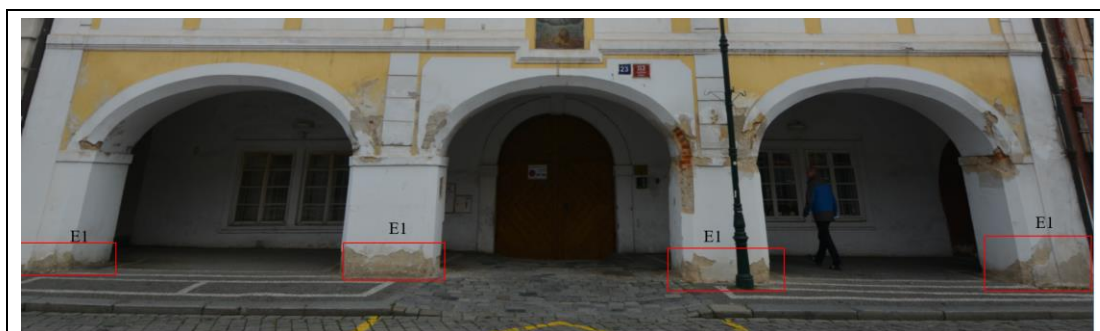
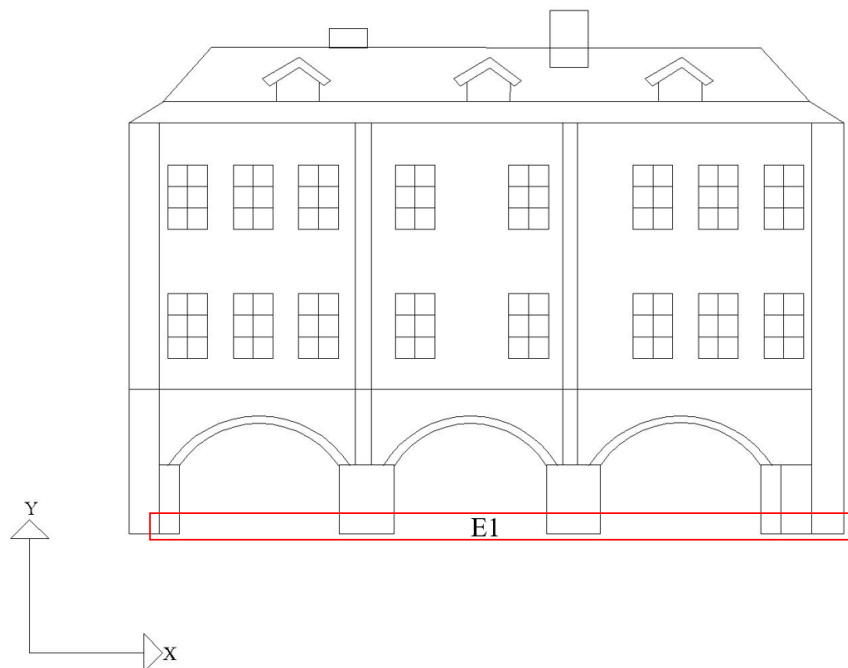
E1: Splashing Water and Rising Damp

Location: E1 locates at the bottom part of main facade

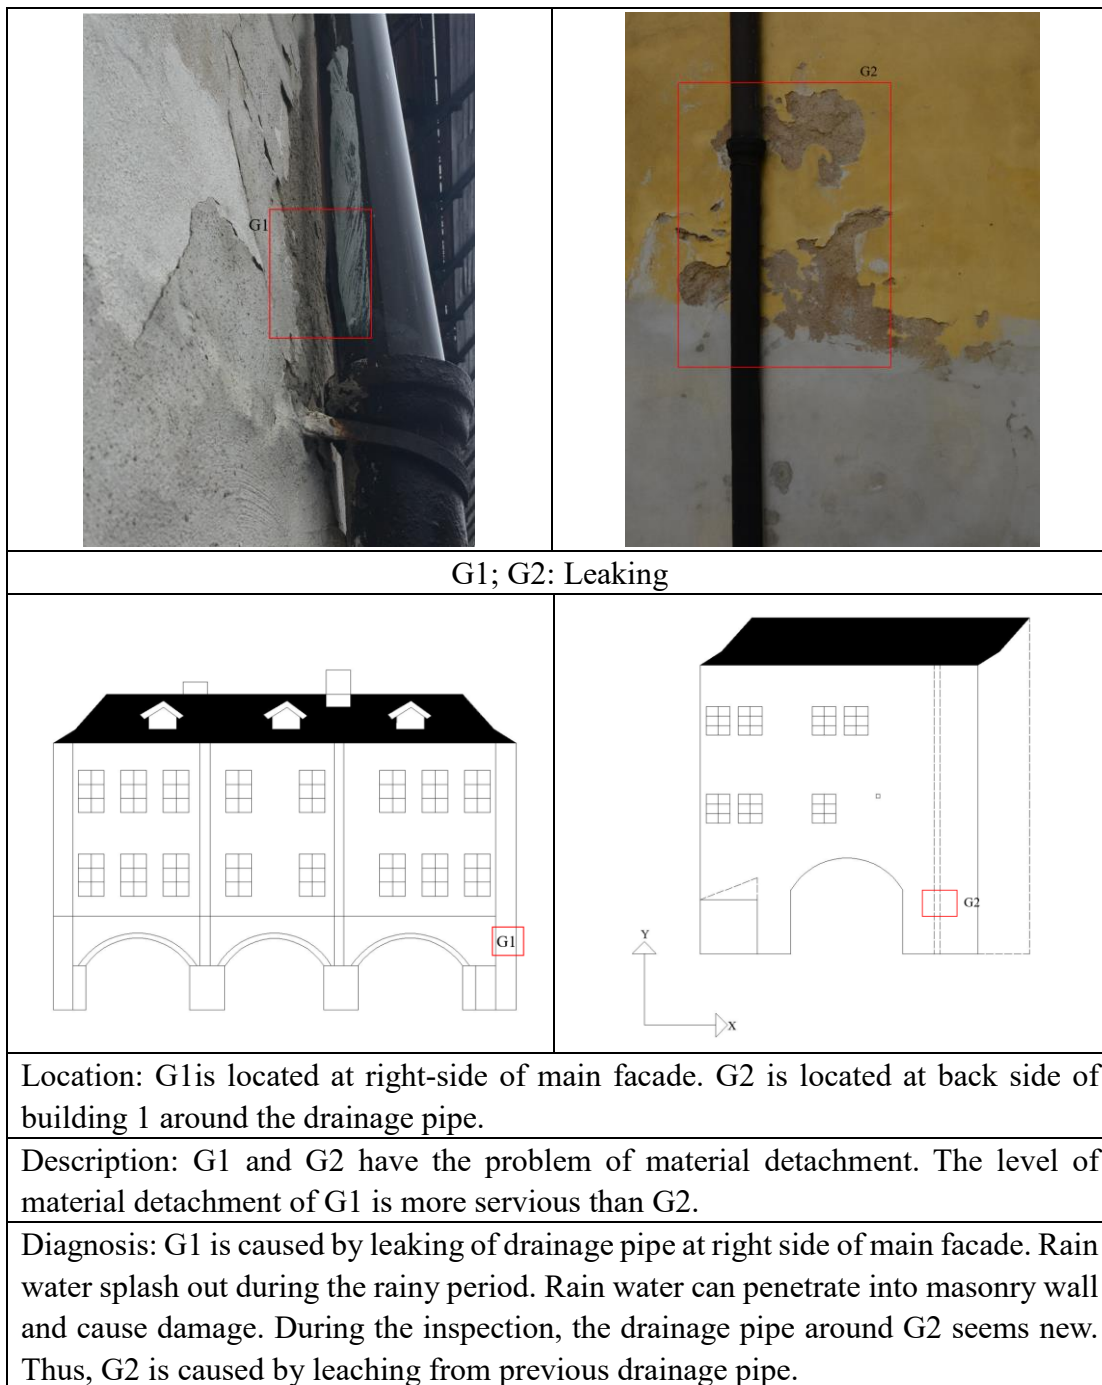
Figure 22: Leaching from Drainage Pipe on Building 1

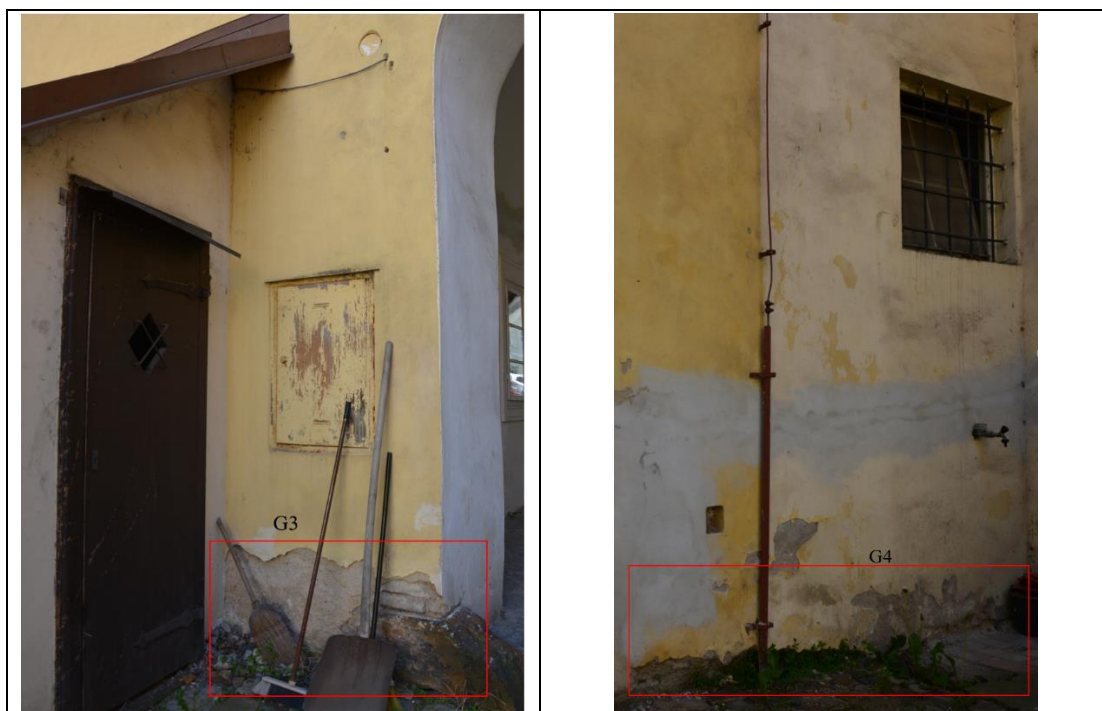
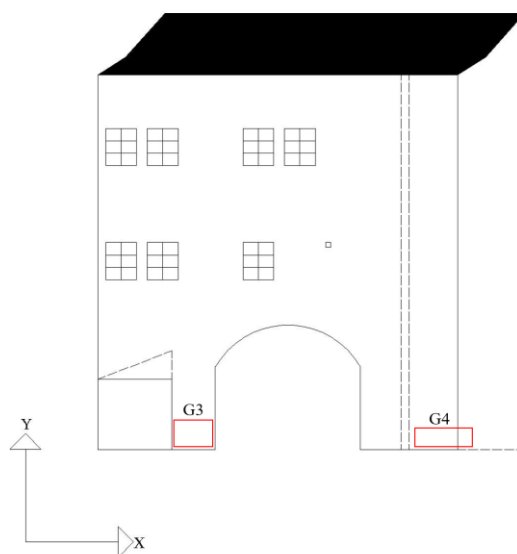
G3; G4 : Splashing Water and Rising Damp

Location: G3 and G4 are located at the back side of building 1.

Figure 23: Splashing Water on Building 1

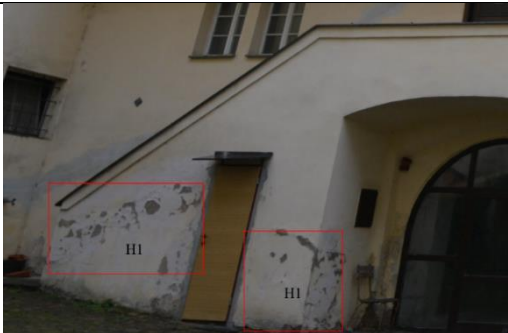
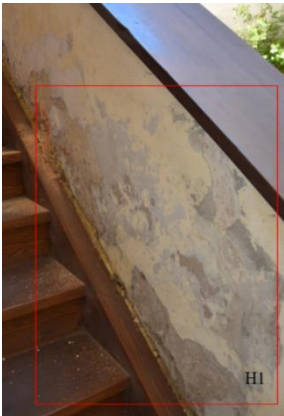
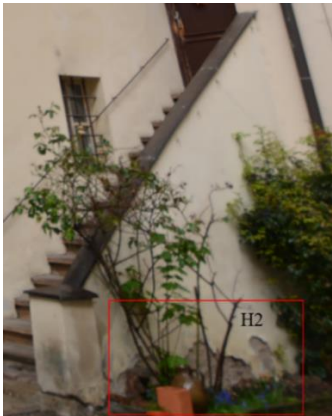
<p>H1; H2: Water Splashing and Rising Damp</p>

Figure 24: Water Splashing and Rising Damp on Building 2

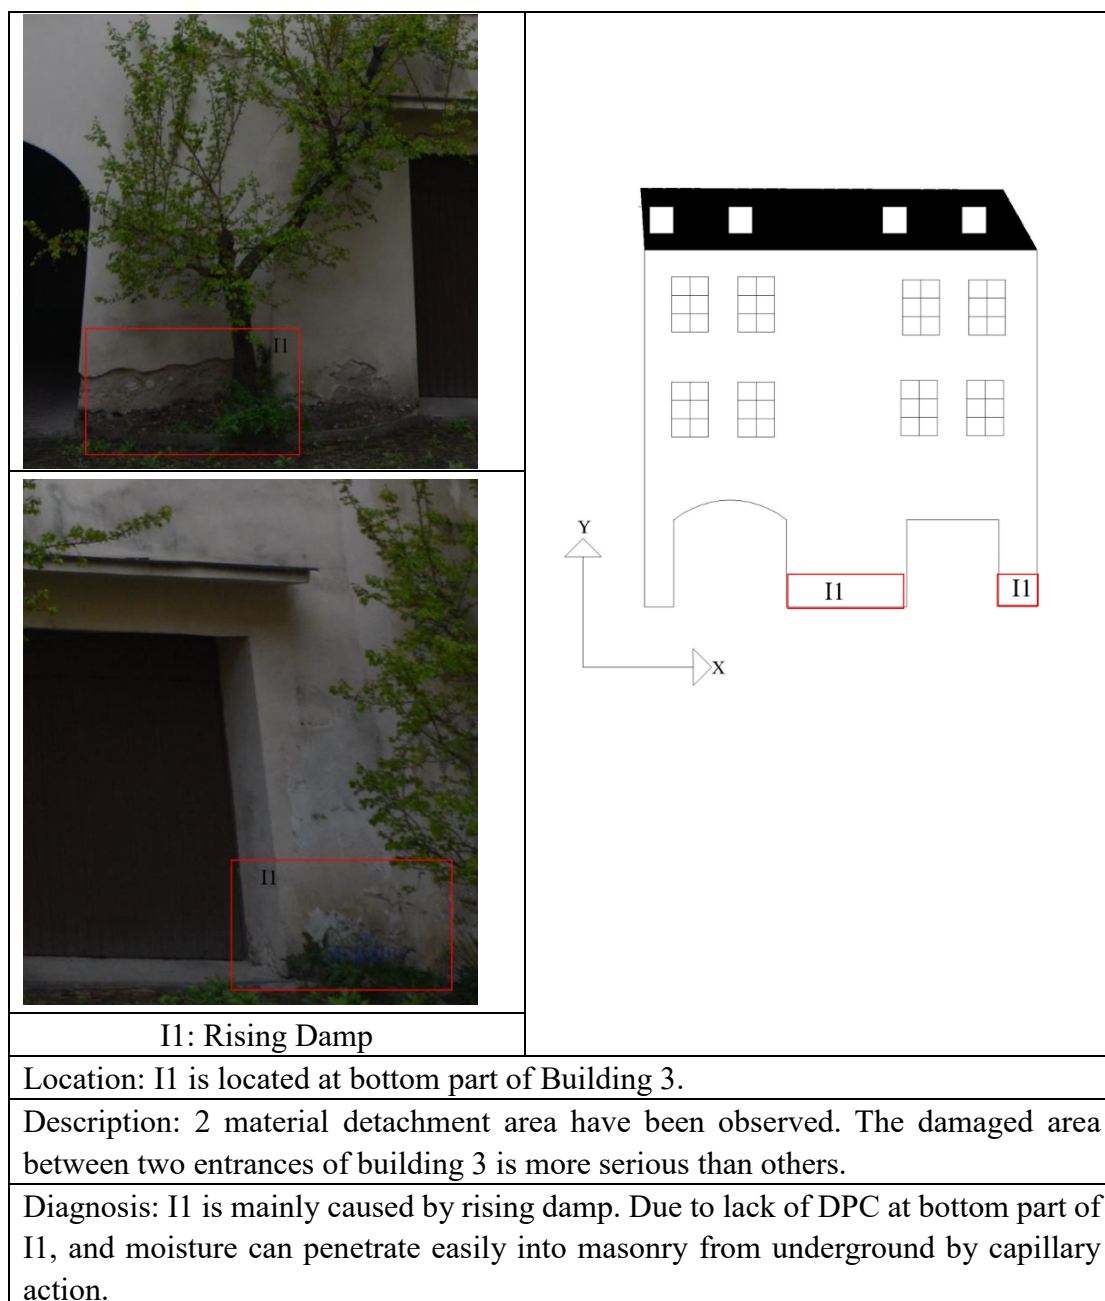
Figure 25: Rising Damp on Building 3

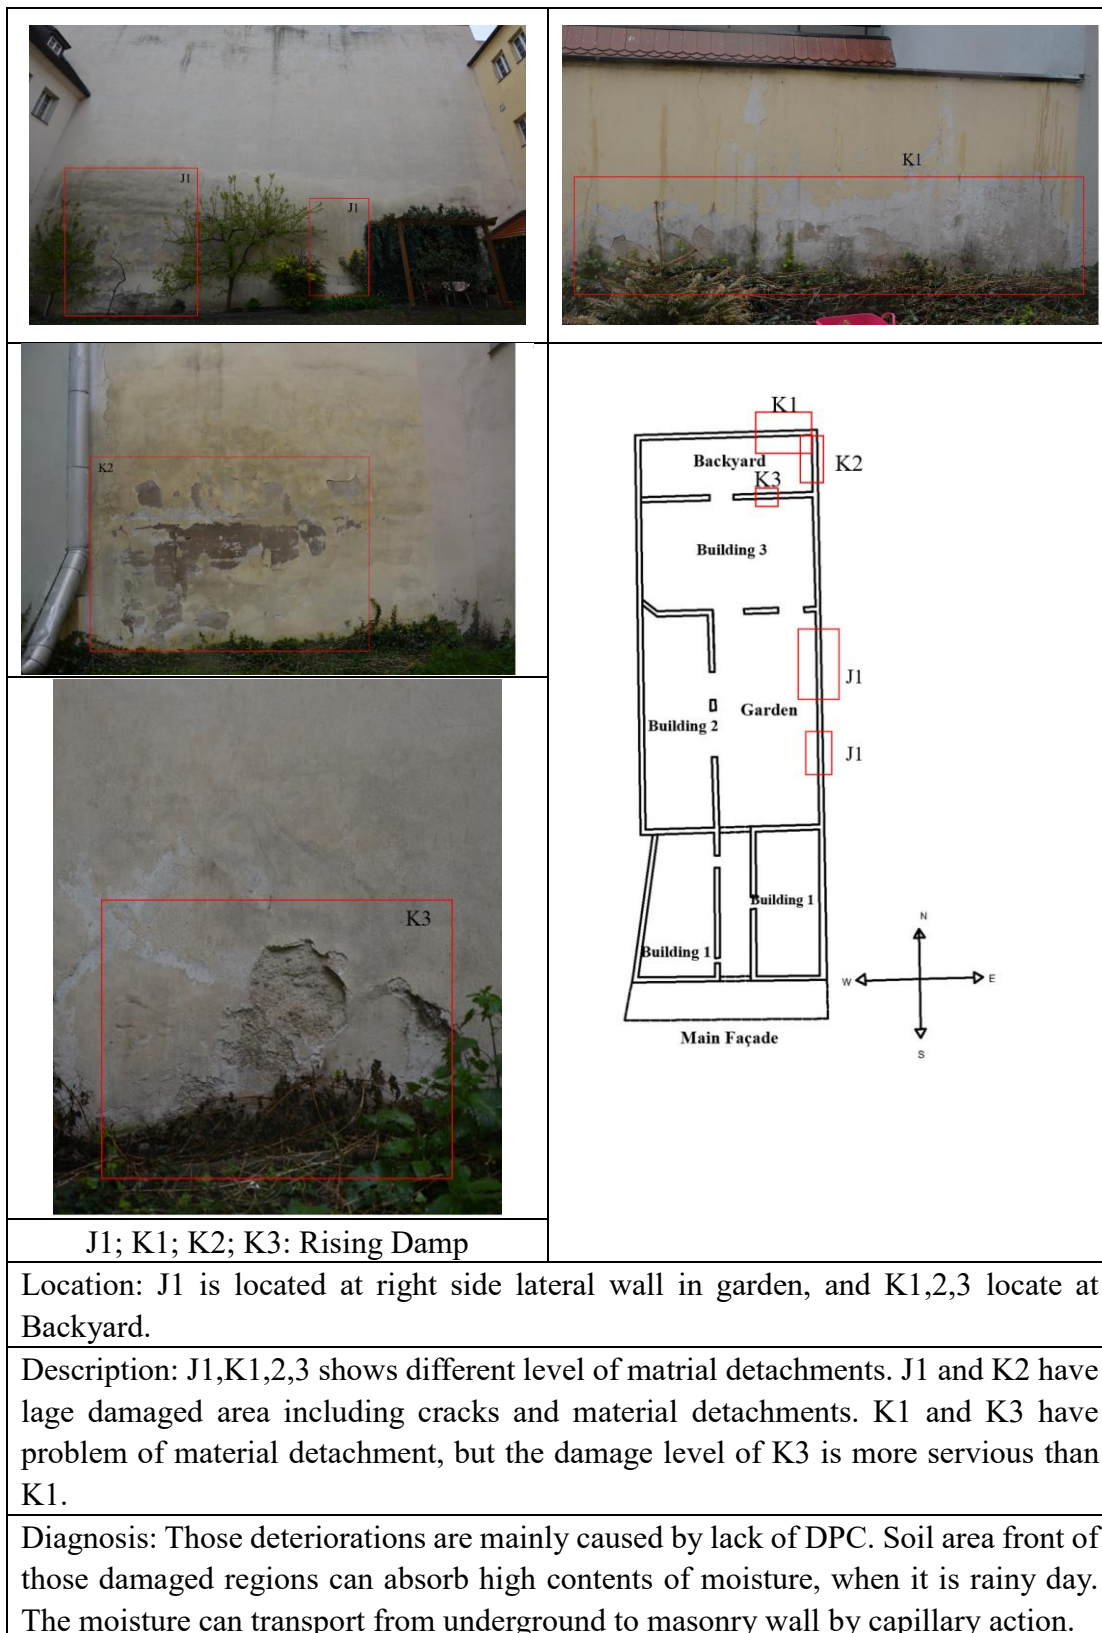
Figure 26: Rising Damp on Walls

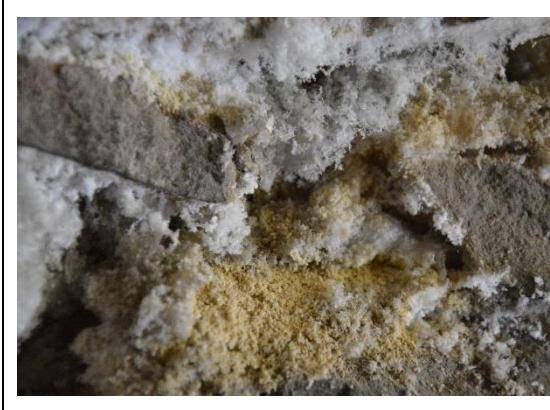
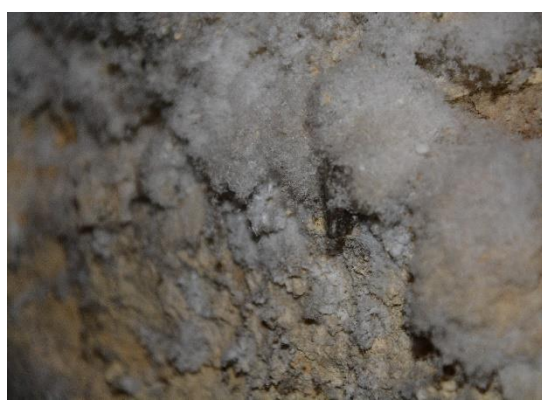
<p>Salt Crystallization</p>	
<p>Location: the problem of salt crystallization have been found at storage room inside of Building 3.</p>	
<p>Description: large amont of salt have been generated on the wall in the Building 3. Some of areas affected by salt are detachable.</p>	
<p>Diagnosis: in this case, the salt crystallization can be caused by the previous use of the building and missing DPC at bottom part of masonry wall. In order to obtain further detailed result of salt in this case, spectrophotometric test has been proposed in laboratory tests (See Section 6.2).</p>

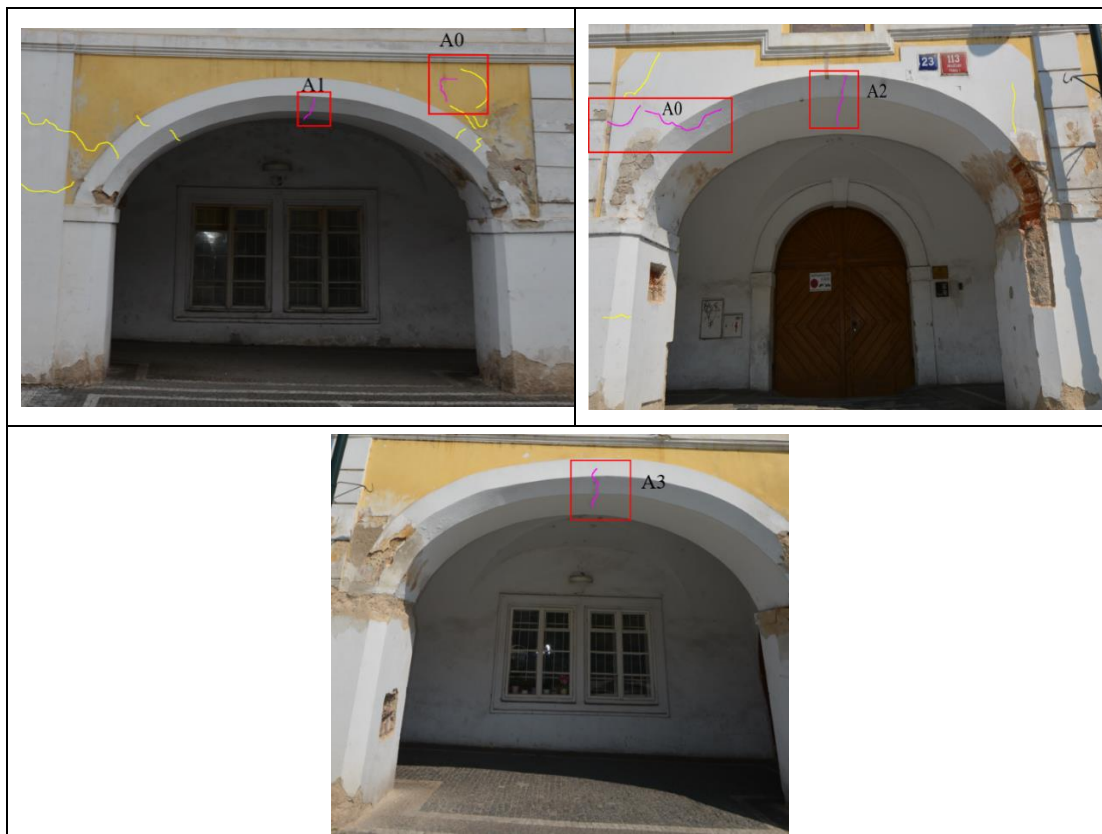
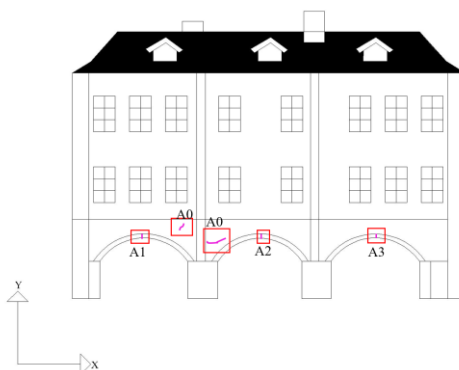
A1,2,3: Cracks on Arches

Location: A1,2,3 are located at middle of arches on the main façade. Around A1,2,3, there are two medium size cracks (See Crack A0).

Figure 29: Cracks on Main facade

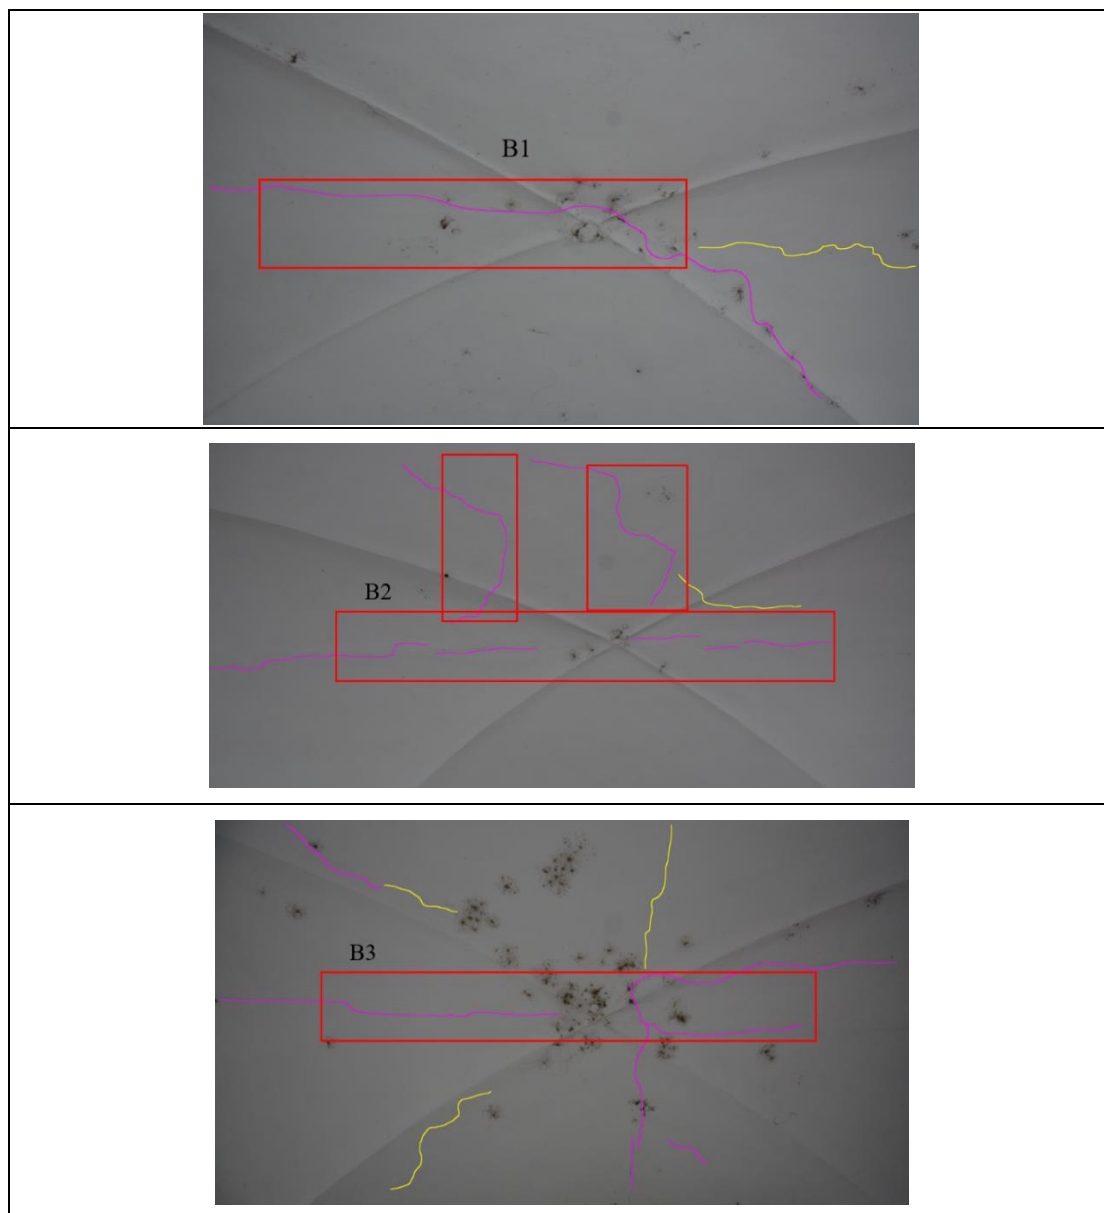
B1,2,3: Longitudinal Crack & Vertical Cracks

Figure 30: Longitudinal and Vertical Cracks on Vaults

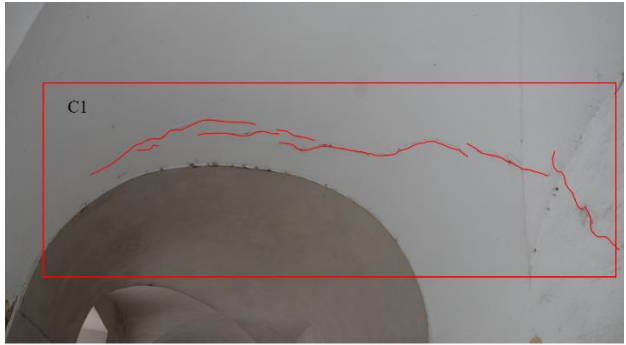
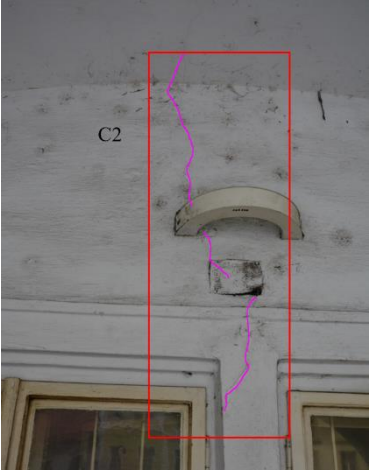
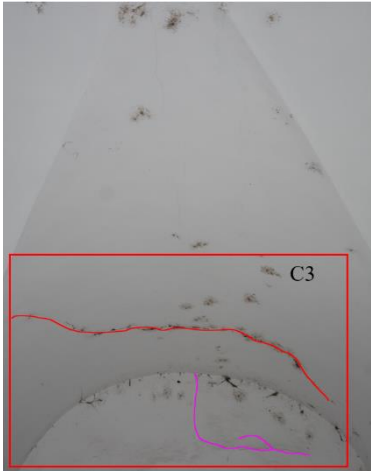
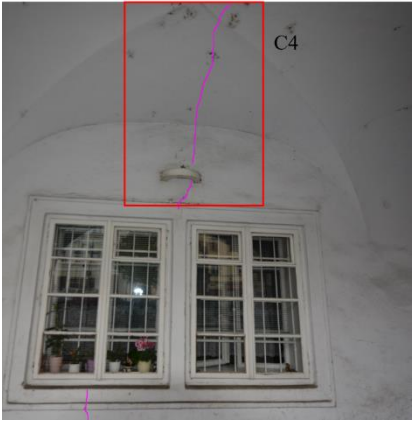
<p>C1,2;C3,4: Horizontal and Vertical Cracks</p>	
<p>Location: C1,2 are located at left side vault above the arcade, and C3,4 are located on the right side vault of main facade.</p>	
<p>Description: C1,3 are horizontal cracks with large-size and long length. C2,4 are vertical cracks with long length and medium size, which are along with interior window openings.</p>	
<p>Diagnosis: C1, 3 are caused by the settlement and the movement of subsoil. C2,4 is caused that vaults are not fixed enough. The appearance of C1,2 is related with the movement of differential settlement between left-side neighbor building and main facade of Strahovská FARA. The appearance of C3,4 is related with the movement of differential settlement between left-side neighbor building and main facade of Strahovská FARA</p>

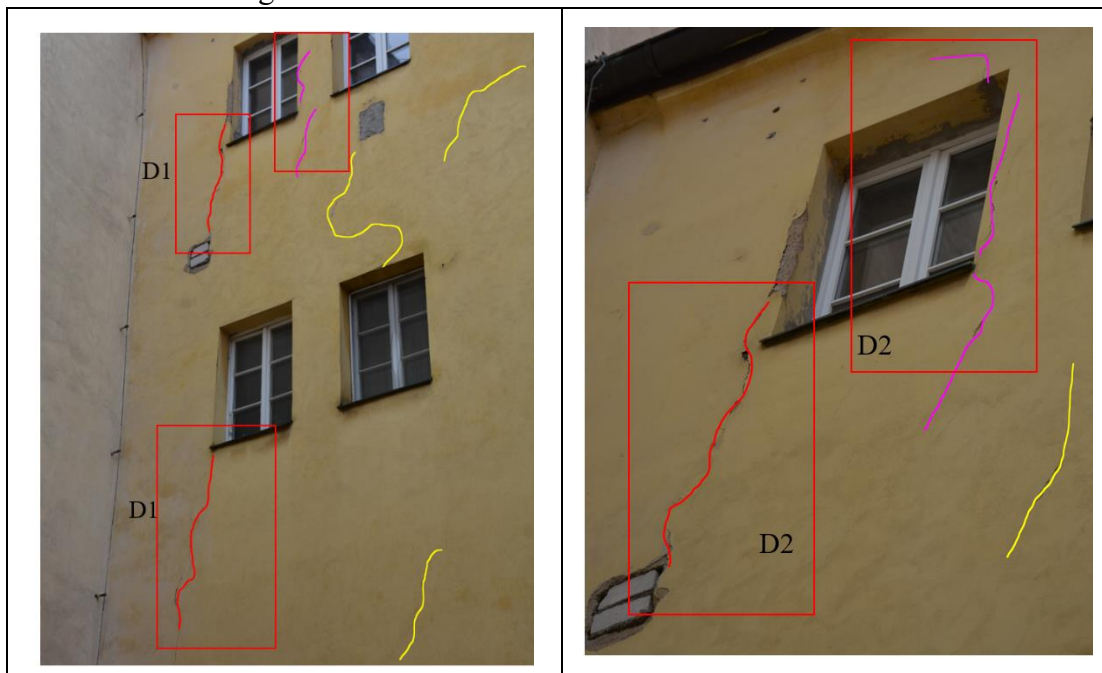
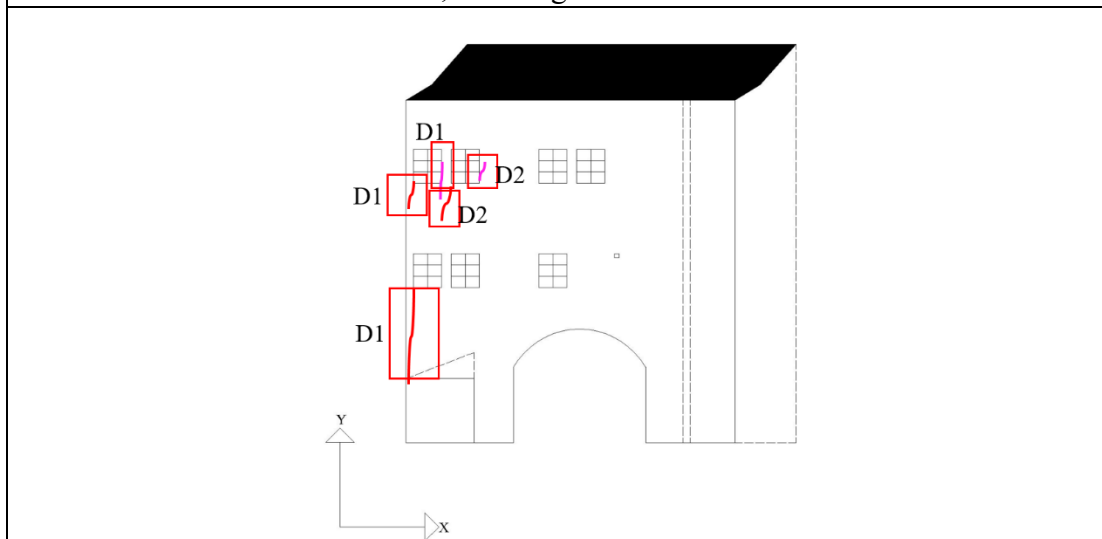
D1;D2: Diagonal Cracks

Location: D1,2 are located at left of back-side of building 1, near the right side neighbor building.

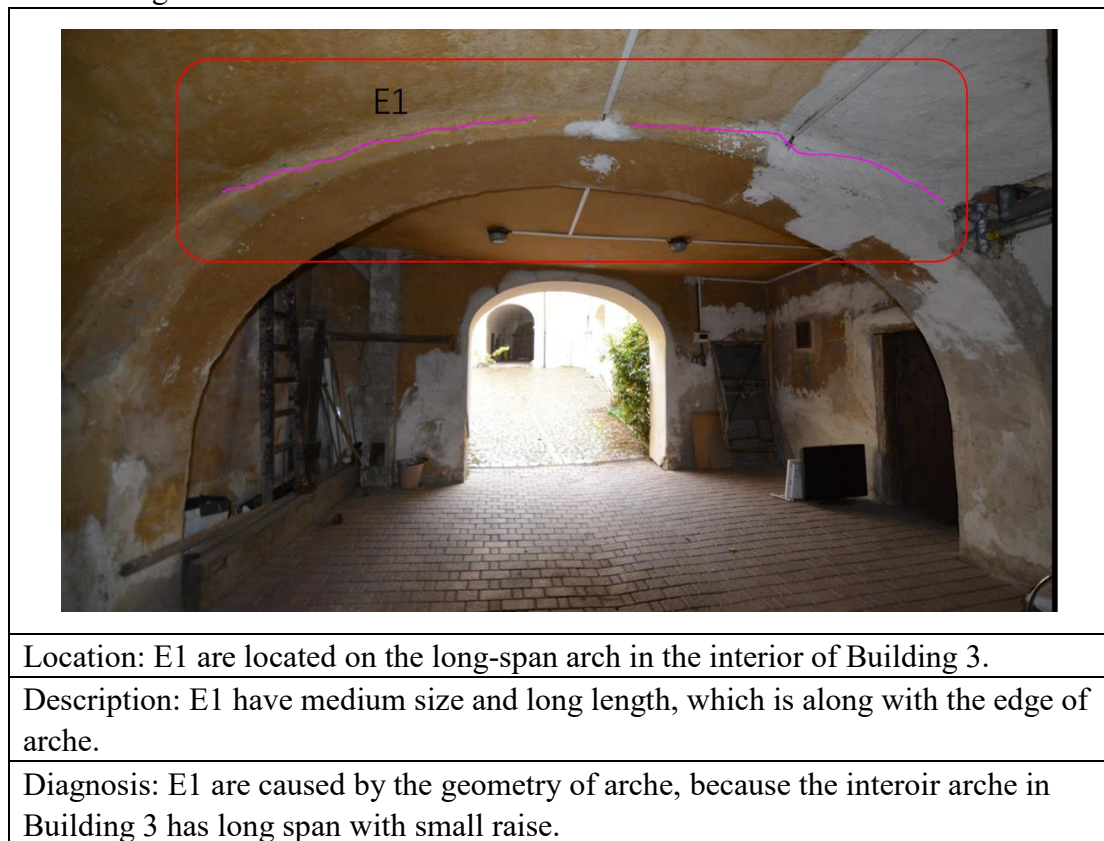
Figure 33: Crack on Interior of Building 3

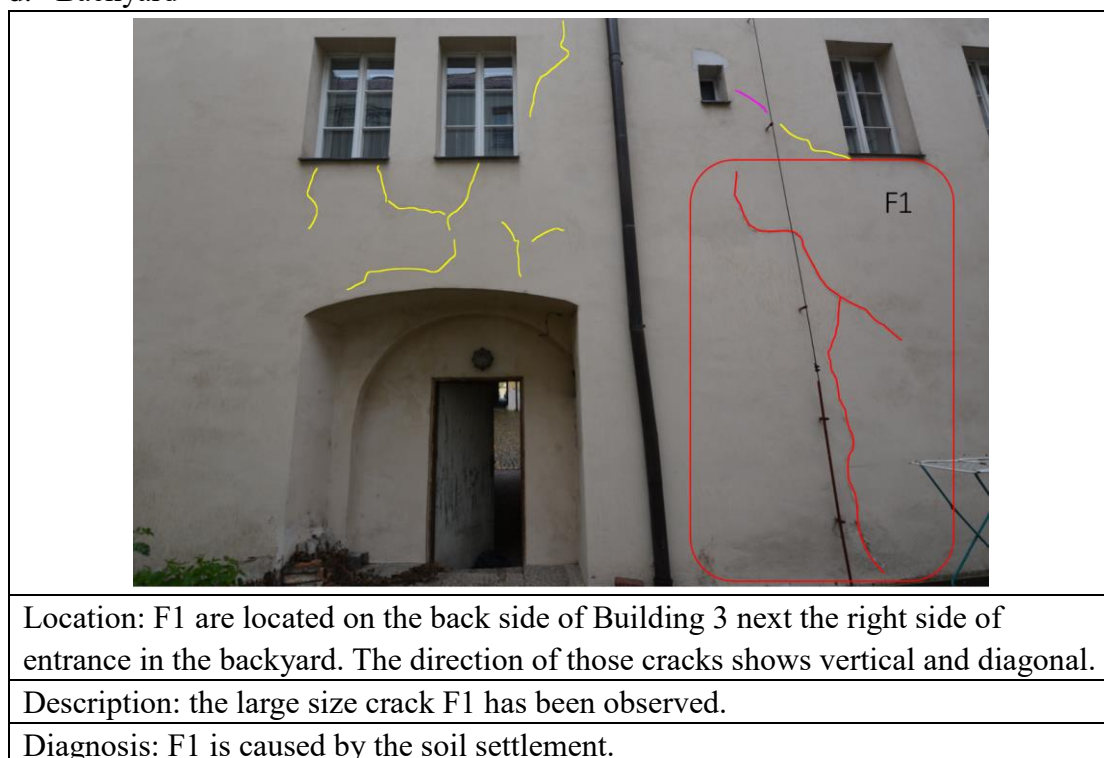
Figure 34: Crack on the Back Side of Building 3
