ADVANCED MASTERS IN STRUCTURAL ANALYSIS
OF MONUMENTS AND HISTORICAL CONSTRUCTIONS

Master's Thesis

Structural Survey of Historical Building Strahovská FARA in Pohořelec

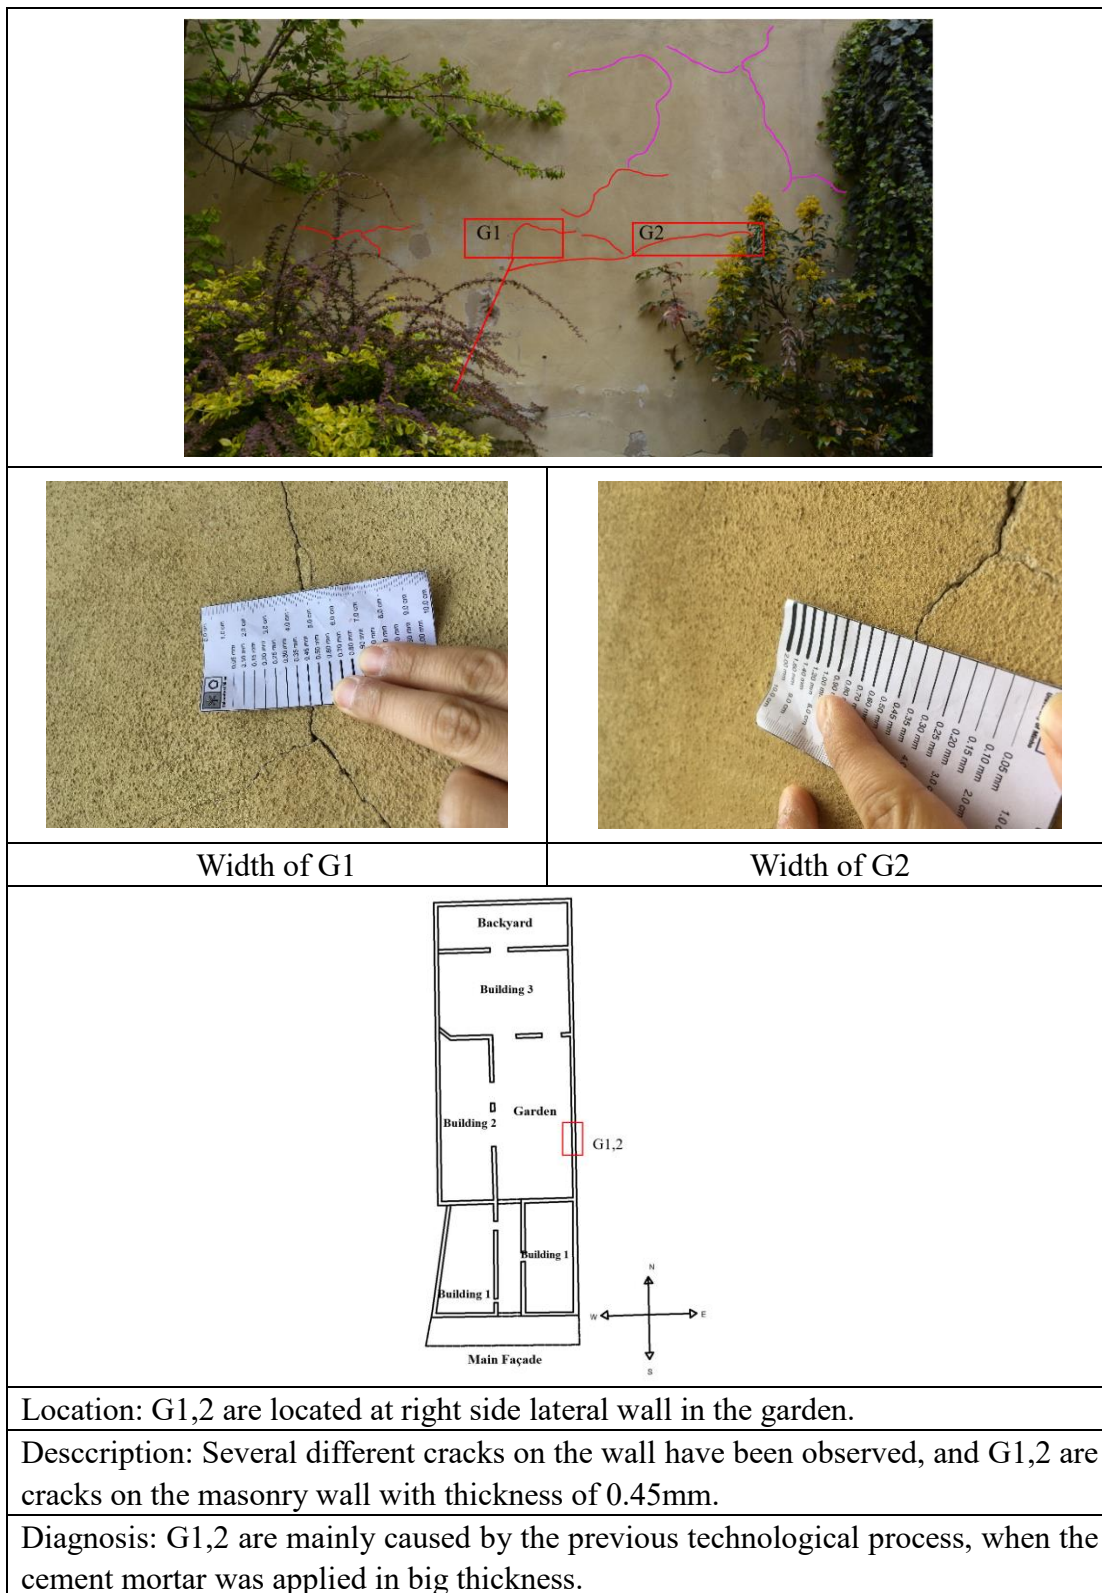
Figure 35: Crack on the Lateral Wall

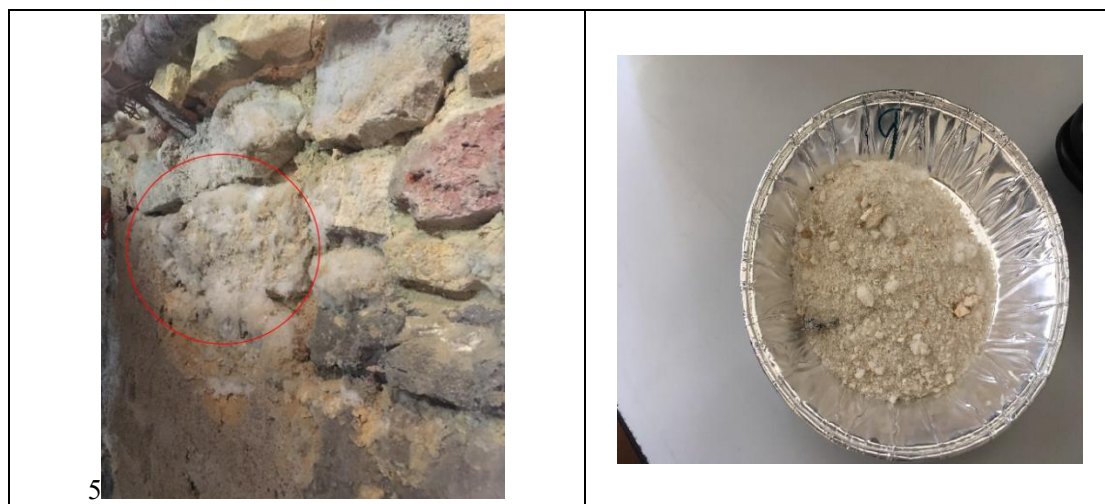
Based on the result of moisture test, building 3 and columns on main façade have serious moisture problem in building Strahovská FARA. According to the survey of failure and deterioration, salt crystallization within the pore of masonry wall have been observed at building 3. Salt is transported by water in the masonry year after year. The chemical analysis has been applied by using the microscope, in order to confirm previous analyses. The sample of salt has been taken from the fractured section of masonry wall, in order to be analyzed qualitative and quantitative salt level in the laboratory (see Figure 38).

Figure 38: Salt Crystallization in-situ
