CZECH TECHNICAL UNIVERSITY IN PRAGUE

MASTER'S THESIS

**THE INFLUENCE OF DAMAGED ZONES IN WOOD COLUMN
ON ITS LOAD BEARING CAPACITY**

JANUARY 2017

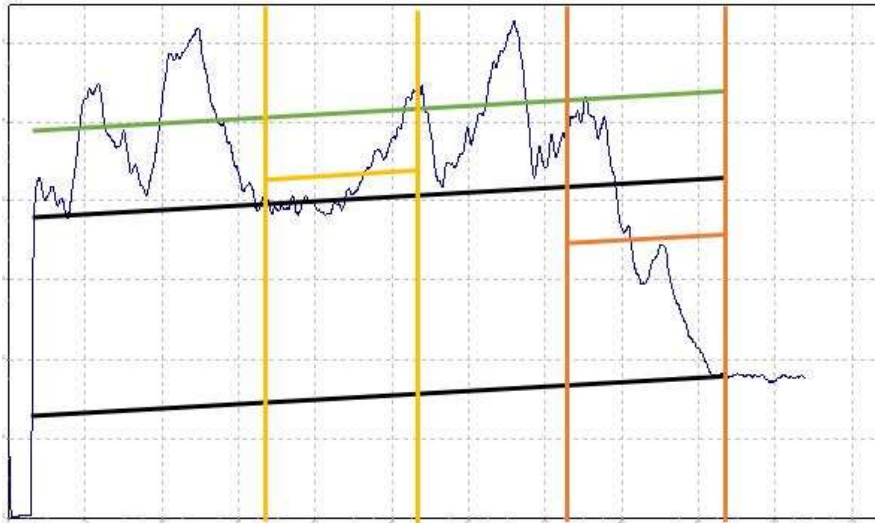
Figure 3-12 Analyse of the diagram G1

- First 3 cm are undamaged
- 4. and 5. cm has degree of damage $d = 0,3$ [-]
- 6. and 7. cm is without any decay
- 8. and 9. cm in damaged up to the $d = 0,5$ [-]

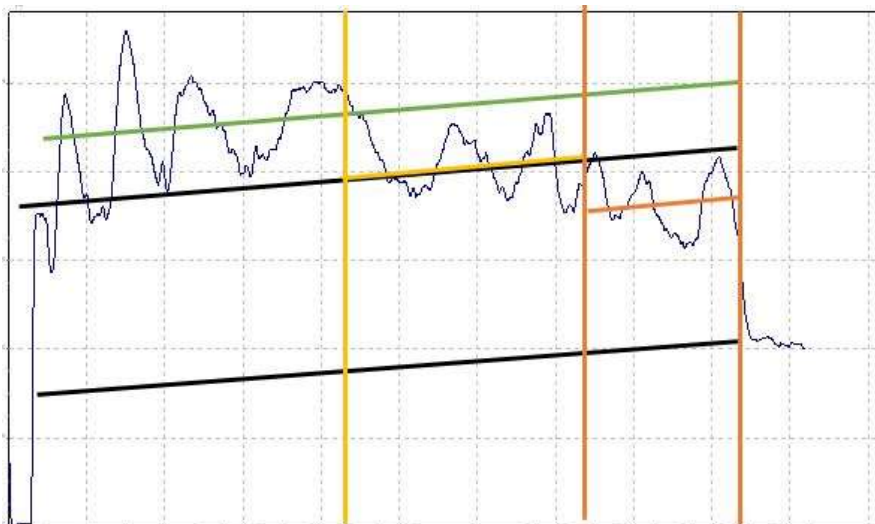
Figure 3-13 Analyse of the diagram G2

- First 4 cm are undamaged
- 5. - 7. cm has degree of damage $d = 0,3$ [-]
- 8. and 9. cm in damaged up to the $d = 0,5$ [-]

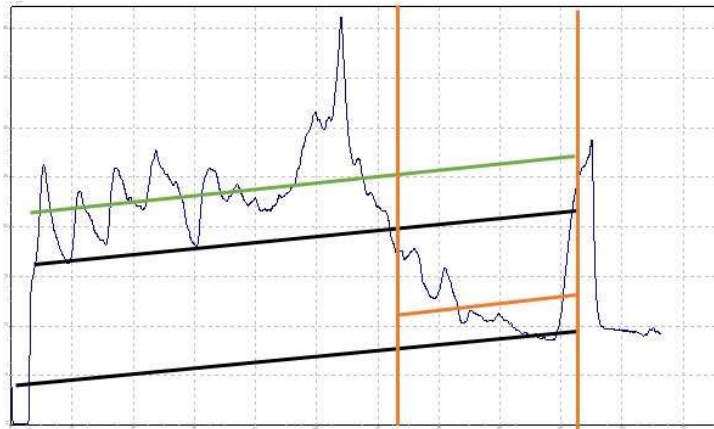
Figure 3-14 Analyse of the diagram G3

- First 6 cm are undamaged
- 7. - 9. cm is almost destroyed with the $d = 0,8 [-]$

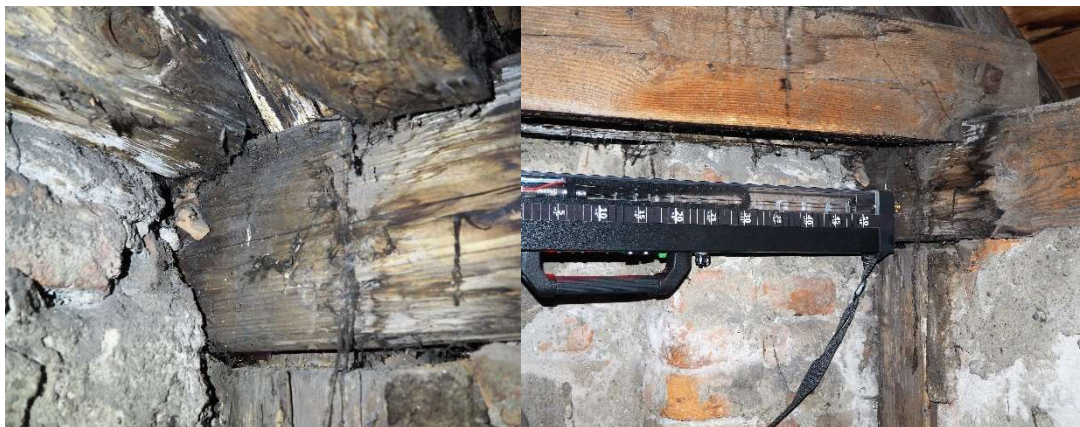
Photo 4–3 Detail D1

At the southwest corner of the roof a wet wall plate was found, which responded by a hollow sound after knocking on its surface. Furthermore, discolorations and fungi were spotted.

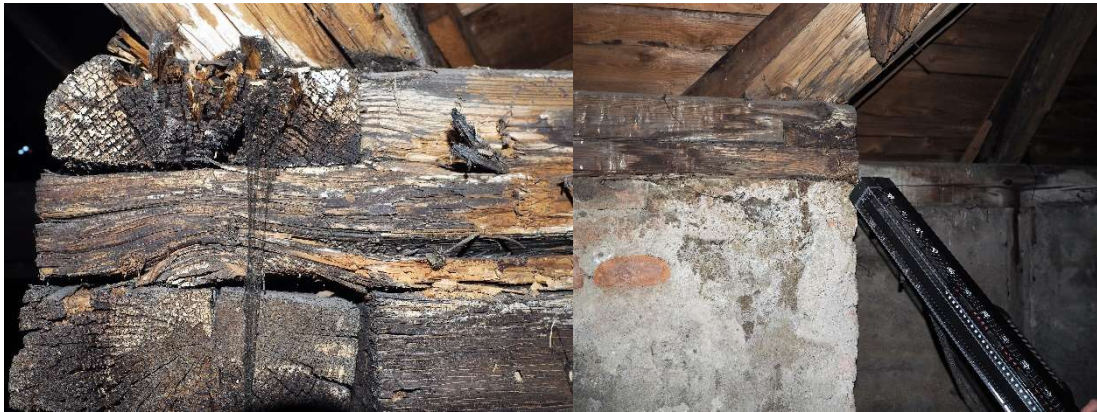
Photo 4–4 Detail D2

As can be seen in the Photo 4–4 Detail D2, a reduction in the wood substance can be determined on the basis of the visual survey in detail D2. The Figure 4-4 shows the locations of the drillings.

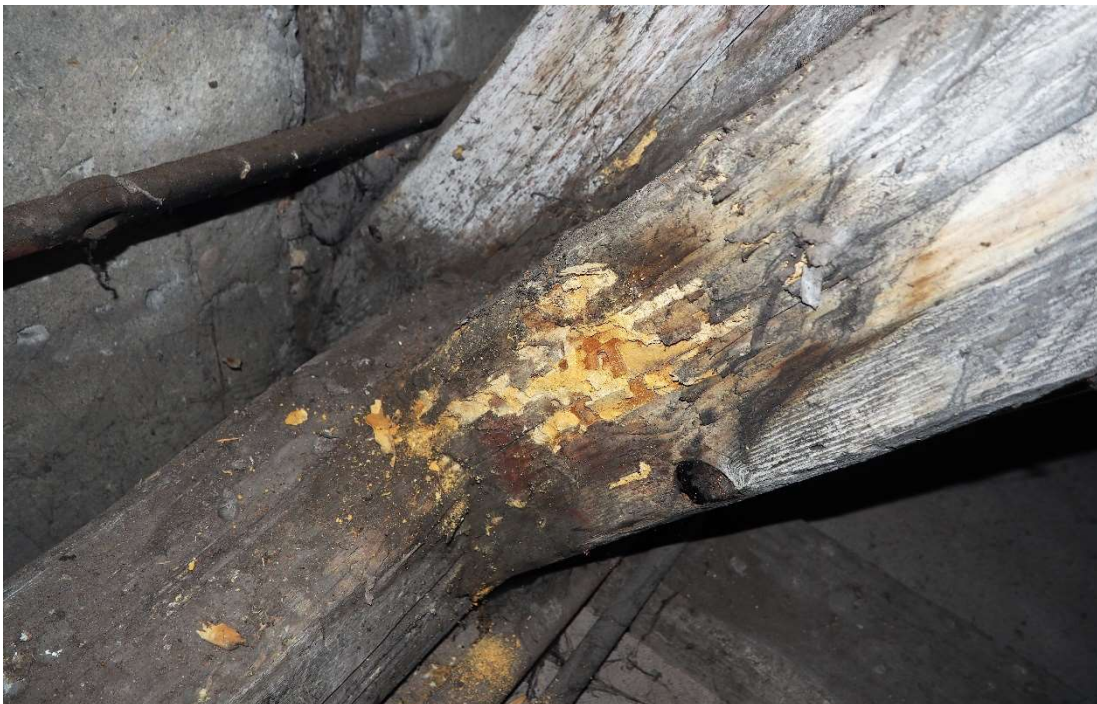
Photo 4-5 Detail D3

Damage caused by insects was found in a strut in the middle part of the roof. This member supports the top purlin in the spot, where it is interrupted. Damaged zone was found close to the floor.

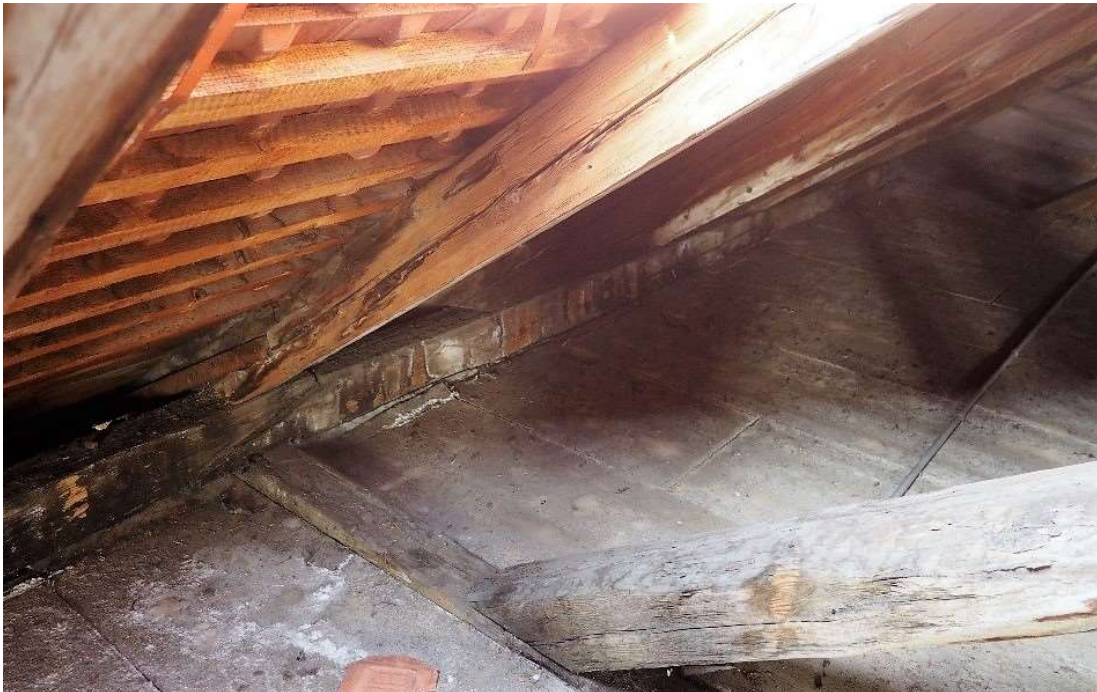
Photo 4–6 Detail D4

Wet and moldy surface was found on the rafter which is a part of the main bond. The rafter is situated next to a roof window. Several drillings were made to determinate the internal condition of the rafter. The wall palate is affected by a mold as well.

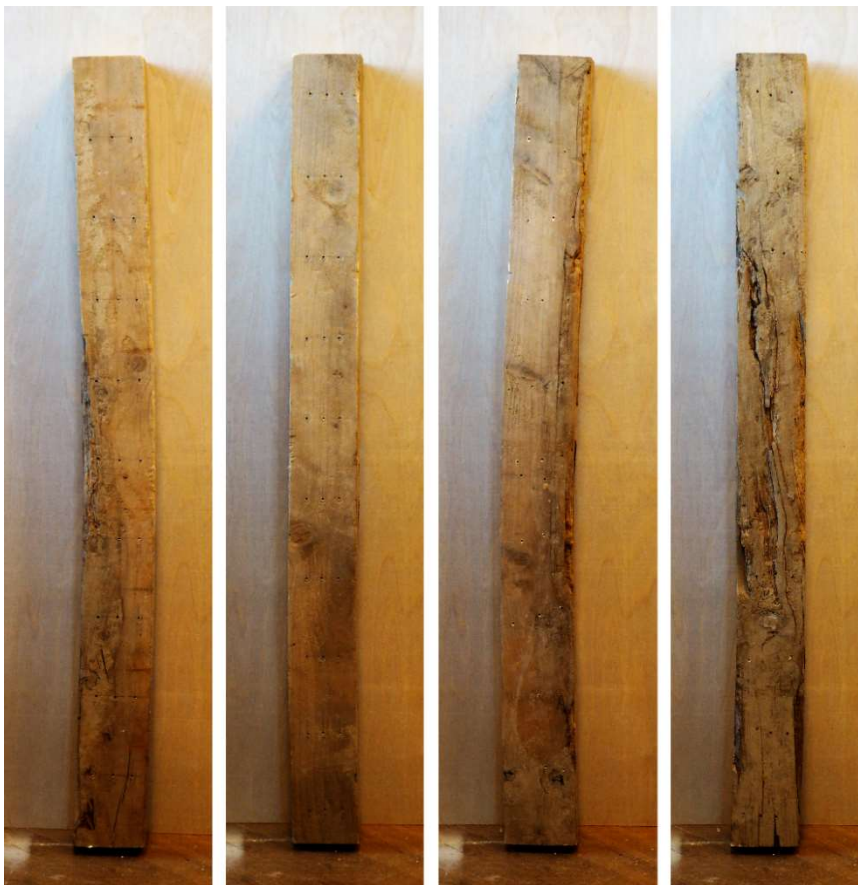
Photo 5-42 Column S after collapse

Column S is an old piece of fir wood which is naturally damaged by rot. One task of this thesis was to investigate its load bearing capacity.
