Evaluation of Blast Resistance of Fiber Reinforced Composite Specimens under Contact Blast Load

Ondřej Janota¹ and Marek Foglar²

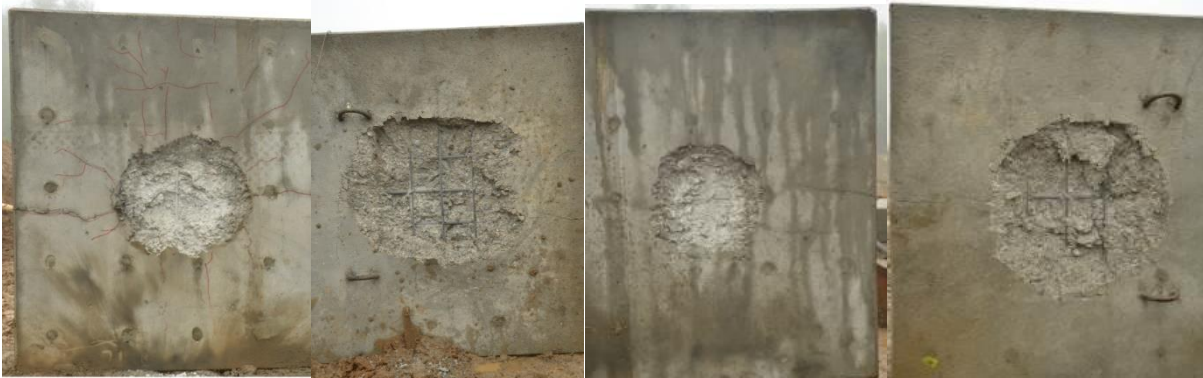
Specimen No. 12 was loaded by explosives of 1.0 kg on the right side and 1.4 kg on the left side. Damage of the specimen on the both sides can be seen in Figure 2. Final damages on the left and right side of the specimen were very similar by its character. Also damaged areas on the contact and soffit of the panel were very similar. The blasts did not achieve puncture of the specimen. On the contact side, the blast damaged area is not deeper than the cover layer. Reinforcement was not damaged by the blast. On the soffit of the specimen, the damage is deeper than the cover layer, but the rebars were not damaged or bent. The damaged area on the soffit was approximately 2.5 times bigger than damage on the contact side. The damaged areas had circular shape on both sides of the panel. Concrete in the perimeter of the damaged area was affected by cracks. Some of the cracks on the left contact side reached edge of the specimen.

Figure 2. Specimen No. 12 after contact blast loading, 1.4 kg charge left left contact side, left right soffit, 1.0kg charge right left contact side, right right soffit

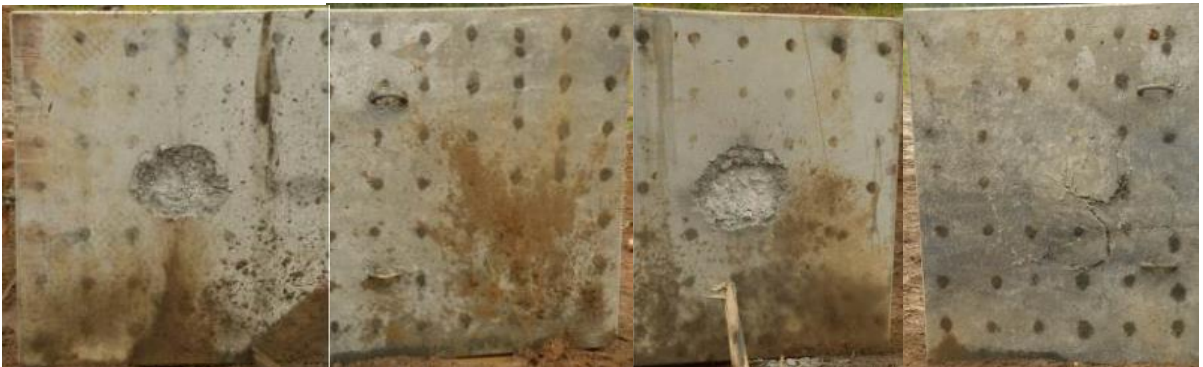
Specimen No. 13 was loaded by explosives with weight 1.0 kg on the right side and 0.5 kg on the left side. Damage of the specimen on the both sides can be seen in the Figure 3. As well as the specimen No.12, specimen was not punctured through. The damage on the contact side did not reach depth of cover layer and reinforcement was not deformed by the blast. Shape of the damaged area was a circle. Soffit showed only few major crack on the right side and the surface was bulged out of the specimen. On the left soffit there were not marks of the damage at all.

Figure 3. Specimen No. 13 after contact blast loading, 0.5 kg charge left left contact side, left right soffit, 1.4 kg charge right left contact side, right right soffit

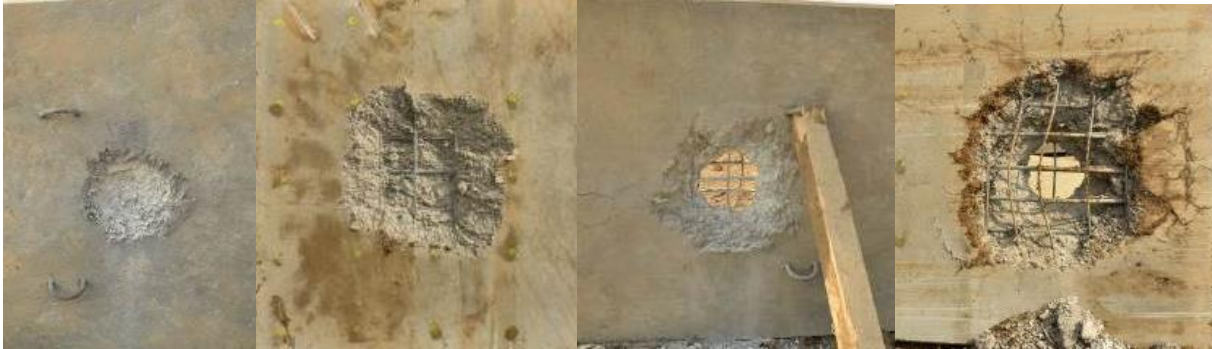
Specimen No. 14 was loaded by explosives with weight 2.8 kg on the right side and 1.4 kg on the left side. Damage of the specimen on the both sides can be seen in the Figure 4. Specimen was punctured through on the right side. Shape of the puncture was circle and was the same as in case of the damaged area of surfaces on both sides of panel. Area of damaged surface on the contact side was approximately 43% of the soffit on the right side and 30% on the left side. There were no cracks on the contact side. The soffit on the right side was strongly disturbed by cracks, left side was not disturbed by cracks. Some of the wide cracks reach edges of the specimen. Cracks were mostly perpendicular to the perimeter of the damaged area.

Figure 4. Specimen No. 14 after contact blast loading, 1.4 kg charge left left contact side, left right soffit, 2.8 kg charge right left contact side, right right soffit

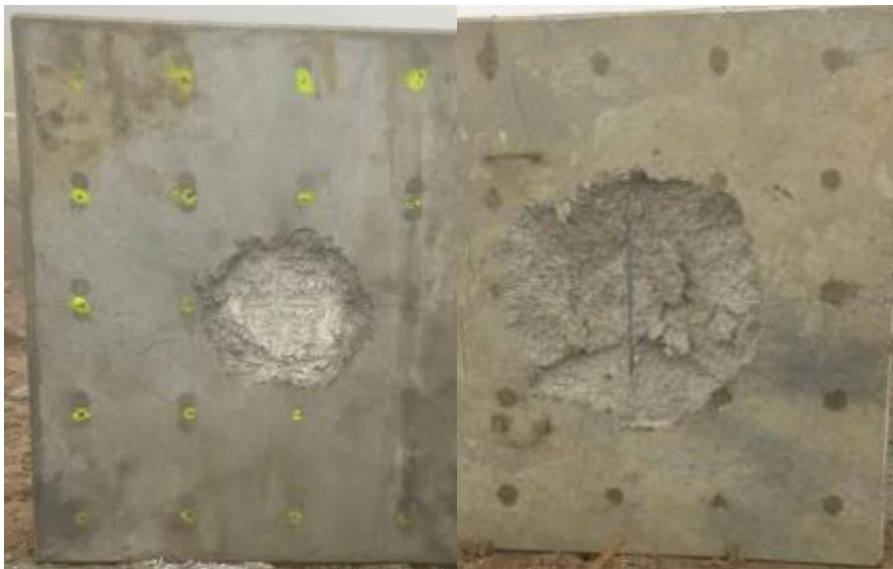
Specimen No. 15 was loaded by explosives with weight 1.4 kg only on the left side. Damage of the specimen can be seen in the Figure 5. The specimen was not punctured. Damaged area depth was mostly lower than the concrete layer. Damage on the contact side was approximately 25 % of the damage on the soffit. Reinforcement was not damaged on both sides of the panel. Type of damage was more close to pulling out failure than punching shear failure. On the contact side, there were cracks that reached edges of the specimen. Cracks on the soffit were perpendicular to the perimeter of the damaged.

Figure 5. Specimen No. 15 after contact blast loading, 1.4 kg charge left left contact side, left right soffit

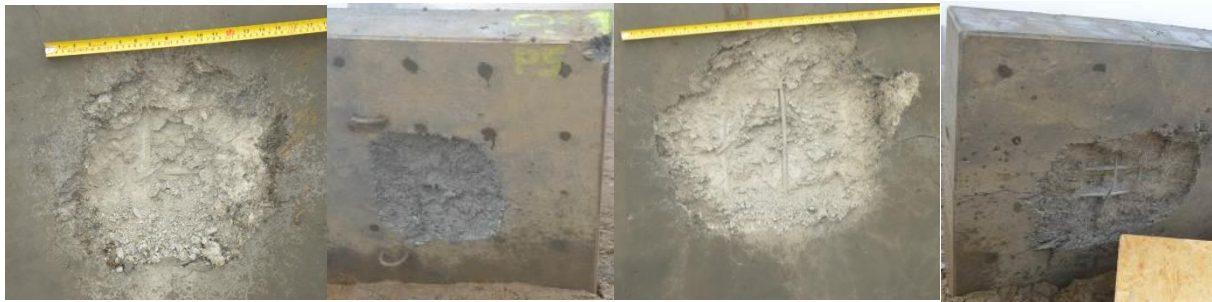
Specimen No. 16 was loaded by explosives with weight 2.8 kg on the right side and 1.4 kg on the left side. Damage of the specimen on the both sides can be seen in Figure 6. Specimen on the both sides was not punctured through. Shape of the damaged area on the contact side was circular, on the soffit it was more similar to the rectangle. Reinforcement on the contact blast was not deformed but the depth of damaged area reach the reinforcement. Steel bars were deformed and bent out of the panel on the right side of soffit, on the left side reinforcement was not damaged. Type of damage was similar to specimen No.15. There was a very dense mesh of microcracks on the contact blast. Cracks on the right side of soffit were wider and some of them reached edges of the specimen.

Figure 6. Specimen No. 16 after contact blast loading, 2.8 kg charge left left contact side, left right soffit, 2.0 kg charge right left contact side, right right soffit

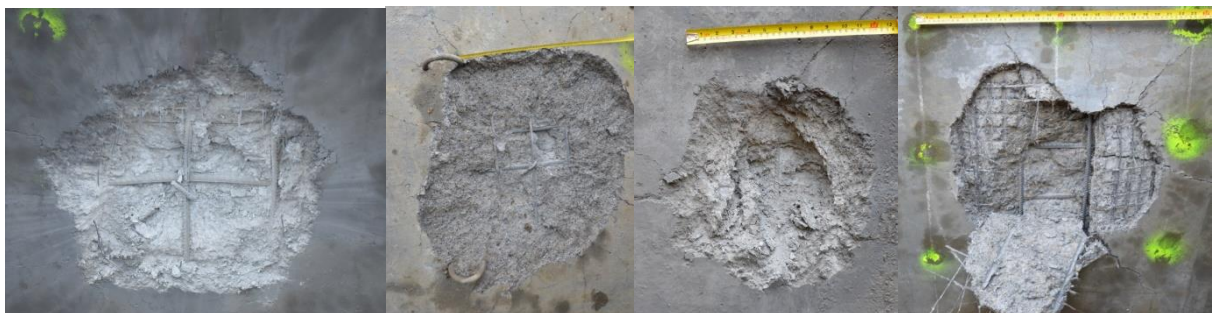
Specimen No. 17 was loaded by explosives with weight 2.0 kg on the right side and 2.8 kg on the left side. One ballast mesh was added into the cover layer. Charge on the left side was placed on the side with basalt mesh in cover layer. Charge on the right side was placed on the opposite side of the specimen. Damage of the specimen on both sides can be seen in Figure 7. Specimen was not punctured on both sides. Damage on the right contact side was similar to the failure due to punching shear but the depth was equal to cover layer. The reinforcement was not damaged. Shape of the damaged area was circular. Area of the damage on the contact side was approximately 65% of the damaged area on the soffit. The soffit was damaged more and the shape of the damaged area was irregular. The type of the failure corresponded with the delamination of the concrete layers. Most of the damaged area was a delaminated layer to the depth of the basalt mesh. Second delaminated layer consists of concrete the depth basalt mesh to the depth of reinforcement bars. Reinforcement on the soffit was practically undamaged. Damage on the left contact side of the specimen was deeper than the cover layer. The reinforcement was unbroken but little bent. Type of the damage was similar to the punching shear failure. Damage area on the soffit was rectangle shape with the depth slightly more than the cover. Reinforcement was only little bent. Soffit side on the left side was not broken into the layers as the right soffit side was.

Figure 7. Specimen No.17 after contact blast loading, 2.8 kg charge left left contact side, left right soffit, 4.2 kg charge right left contact side, right right soffit

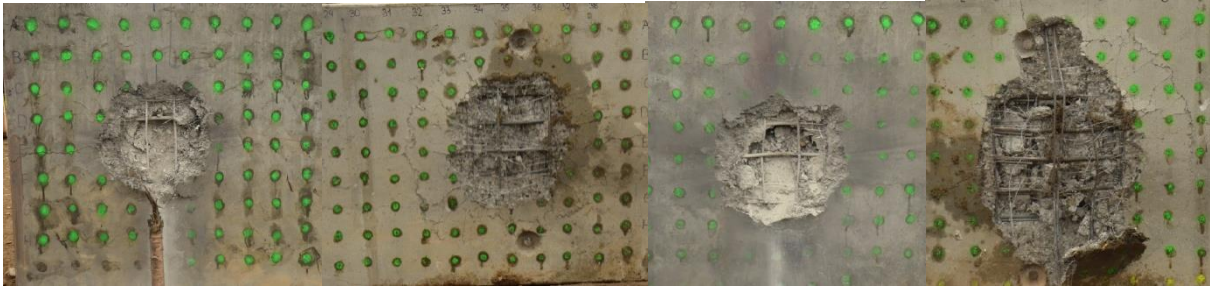
Specimen No. 18 was loaded by explosives with weight 4.2 kg on the right side and 2.8 kg on the left side. Damage of the specimen on both sides can be seen in the Figure 8. Ballast meshes were added into the cover layer in the both sides and between reinforcement. Specimen was not punctured. The damage on the left and right side was similar in its shape and type. The shape of the damaged area on contact blast was circular and was more similar to punching shear failure. The damage reached deeper than the cover layer. Reinforcement was little bent but not broken. Damaged area on the soffit was more complex than damaged area on the contact side. Shape of the damaged area was ellipse and similar to pulling out failure. Reinforcement was heavily bent but not broken. Under the reinforcement mesh there were pieces of the panel that were bigger than the spacing of the reinforcement or ballast mesh. Perimeter of the damaged area was broken by many cracks in the radial direction. Crack which

crossed radial cracks and copying perimeter of the damaged area was detected approximately in the distance 220 mm from the damaged area.

Figure 8. Specimen No. 18 after contact blast loading, 2.8 kg charge left left contact side, left right soffit, 4.2 kg charge right left contact side, right right soffit

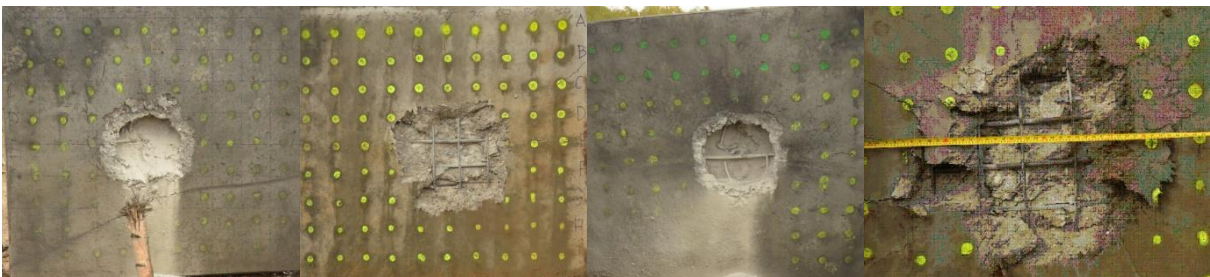
Specimen No. 19 was loaded by explosives with weight 4.2 kg on the right side and 2.8 kg on the left side. Damage of the specimen on the both sides can be seen in the Figure 9. The recycled textile sheets were added to the specimen between reinforcement layers. The specimen was not punctured. Type of the failure on the both sides was similar to the specimen No. 18. On the contact side, it was caused by the punching shear failure, on the soffit by the tension failure. On both sides the depth of the damage was bigger than the cover layer. On the contact side the reinforcement was broken. On the soffit the reinforcement was bent but not broken. Cracks could be seen on the soffit. Cracks are radial to the damaged area. Some of them were reaching edge of the specimen. As well as in the case of No. 17 there was a crack perpendicular to the radial cracks but not continuous.

Figure 9. Specimen No. 19 after contact blast loading, 2.8 kg charge left left contact side, left right soffit, 4.2 kg charge right left contact side, right right soffit

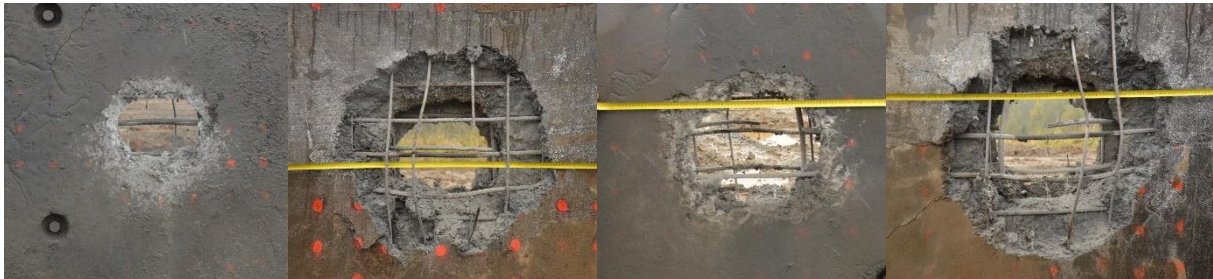
Specimen No. 21 was loaded by explosives with weight 4.2 kg on the right side and 2.8 kg on the left side. Damage of the specimen on the both sides can be seen in the Figure 10. The specimen was punctured on both sides. Type of the failure on the both sides was similar in its type. Shape of the damage area on both sides and surfaces was circular. On the contact side and soffit, it was caused by punching shear failure. On the both sides the reinforcement was broken and on the soffit reinforcement was broken and bent out of the specimen. Cracks could be seen on the on the soffit. Cracks are radial to the damaged area. Damaged area on the right contact side is approximately 2,5 times smaller than on the soffit. On the right side damage on the contact side is approximately 3 times smaller than on the soffit.

Figure 10 Specimen No. 21 after contact blast loading, 2.8 kg charge left left contact side, left right soffit, 4.2 kg charge right left contact side, right right soffit

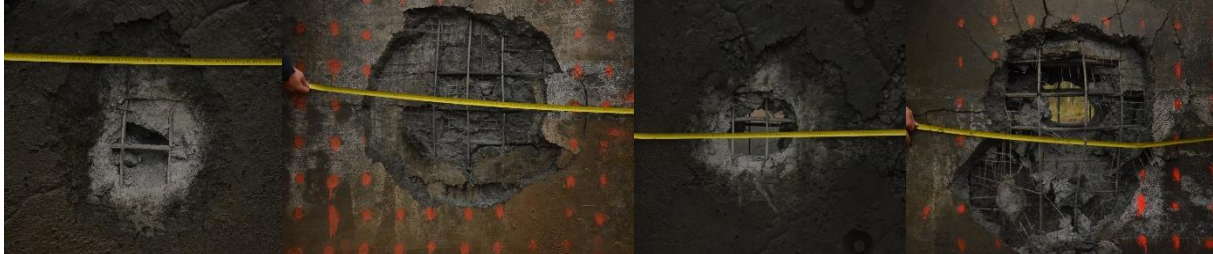
Specimen No. 22 was loaded by explosives with weight 4.2 kg on the right side and 2.8 kg on the left side. Damage of the specimen on both sides can be seen in the Figure 11. Ballast meshes were added into the cover layer in the both sides and between reinforcement. Specimen was punctured through on the right side. Damage on the left and right side was similar in its type. Damage on the contact side and soffit was caused by punching shear failure. Damaged area on the contact side was approximately 55% of the damaged area on the right soffit and 70% on the left side. Reinforcement on the contact side was not deformed. Reinforcement on the soffit is broken and bent out of the panel. On the soffit there was evident delamination caused by adding basalt mesh. As well as in the case of specimen No. 17 the first delaminated layer contains concrete from the surface to the depth of the first basalt mesh. Second delaminated layer was from basalt mesh to the reinforcement. Perimeter of the damaged area was broken by cracks on the soffit.

Figure 11. Specimen No. 22 after contact blast loading, 2.8 kg charge left left contact side, left right soffit, 4.2 kg charge right left contact side, right right soffit

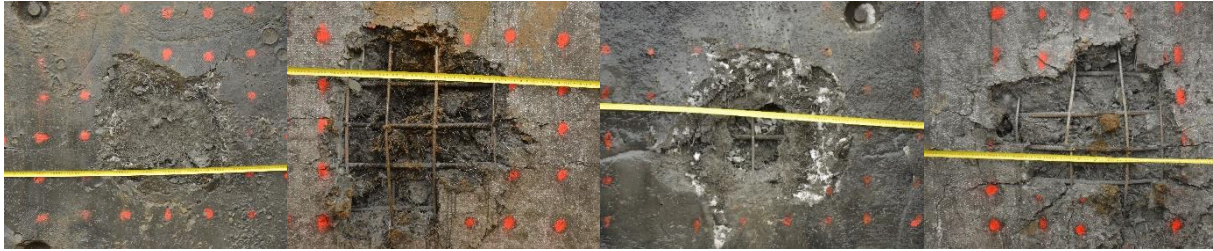
Specimen No. 23 was loaded by explosives with weight 4.2 kg on the right side and 2.8 kg on the left side. Damage of the specimen on the both sides can be seen in the Figure 12. Textile sheets were added to the specimen between reinforcement layers. The specimen was not punctured. On the contact side, it was caused by punching shear failure, on the soffit by the tension failure. On the left contact side damage did not reach the reinforcement. On the rightside damage was deeper than the cover layer. Reinforcement was not damaged. Reinforcement on the soffit was broken on the right and left side. Damaged area on the contact side was approximately 86% of the damaged area on the right soffit and 68% on the left side. Cracks could be seen on the soffit. Cracks are radial to the damaged area. Some of them were reaching edge of the specimen.

Figure 12. Specimen No. 23 after contact blast loading, 2.8 kg charge left left contact side, left right soffit, 4.2 kg charge right left contact side, right right soffit
