Title of the MSc Dissertation: Chateau Lobkovice Revitalization of the Castle Grounds
Supervisor(s): Arh. ing Klara Kroftova, Ph.D
Year: 2022

ABSTRACT

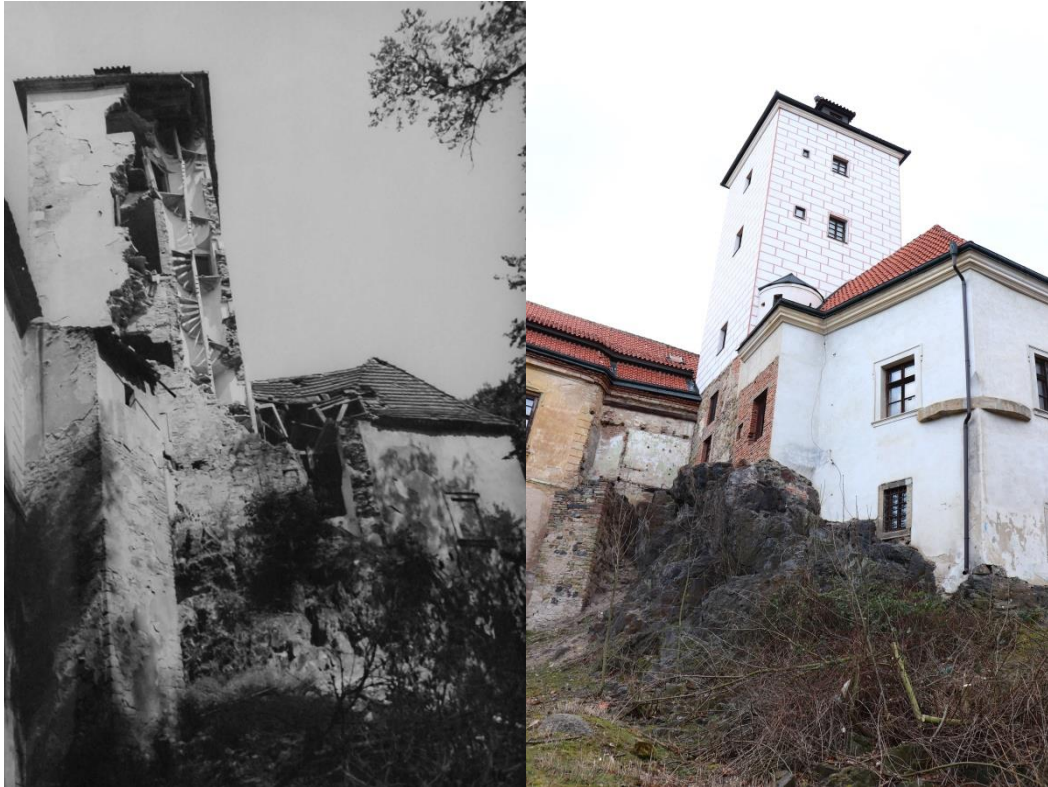
Figure 12 – Demolished tower (left) and the tower today (right). Source [3]

In 1977 the part of the tower damaged during the storm finally collapsed. The left part of the tower was gone, leaving the staircase exposed. The external corridor suffered damage as well.

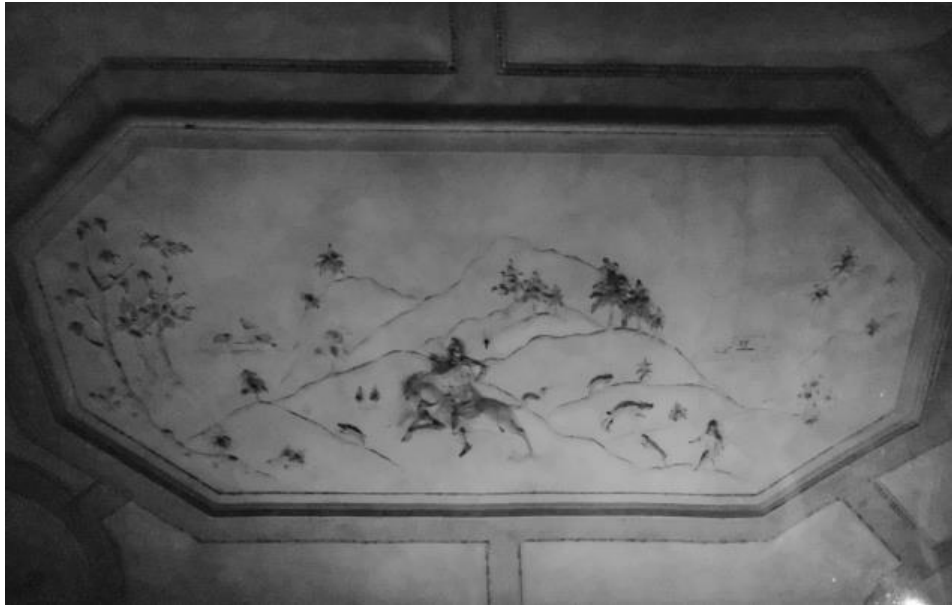
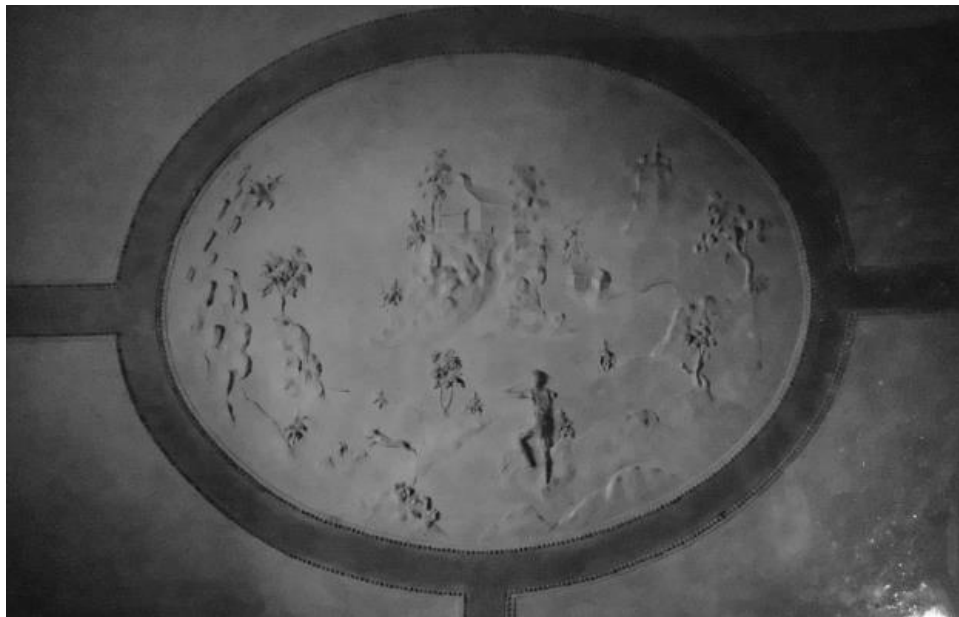
The last construction work was carried out by the Faculty of Arts of Charles University in Prague at the end of the 1980s. The work included new roof installation, and adaptation of the right-hand side of the library depository and study center [9]. During these interventions, the ceilings of the ground floor were replaced, along with the stucco decorations from the renaissance period (Figure 17 and Figure 18).

**Figure 17 – Stucco decoration on the ceilings in the renaissance part of Chateau from 1978.
Source [3]**

**Figure 18 – Stucco decoration on the ceilings in the renaissance part of Chateau from 1978.
Source [3]**

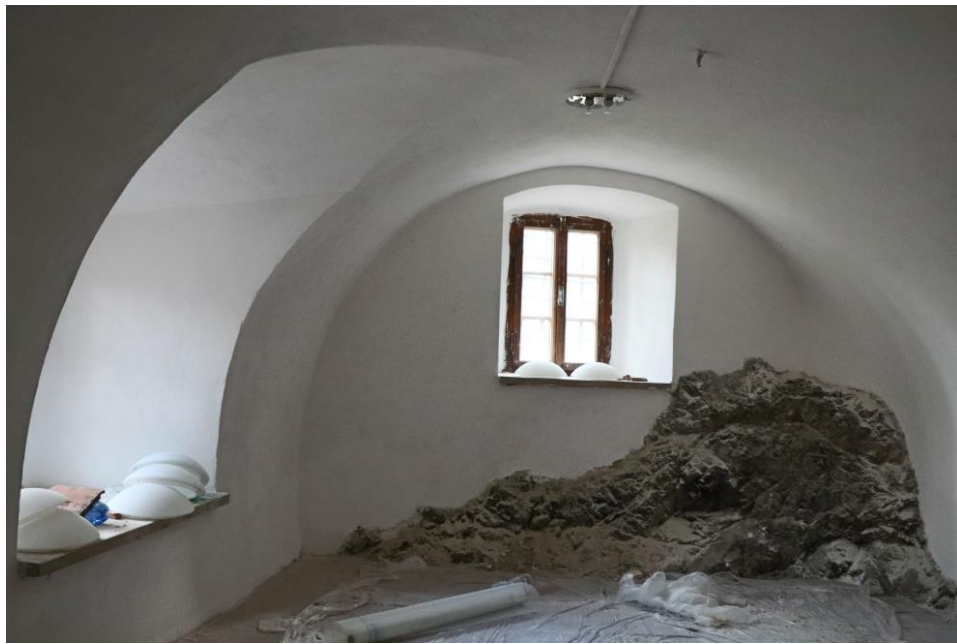
As previously stated, the basement of the right-hand side was built in Gothic style. The basement consists of the entrance area, hallway, three larger rooms, and one smaller room. This part of the structure lies on the rock, as can be seen in Figure 23. The stairs lead to the inner courtyard on the ground floor. The whole structure has a vaulted ceiling. The windows are placed in the niches with the arches above them.

Figure 23 – The oldest part of the Chateau lays on the rock

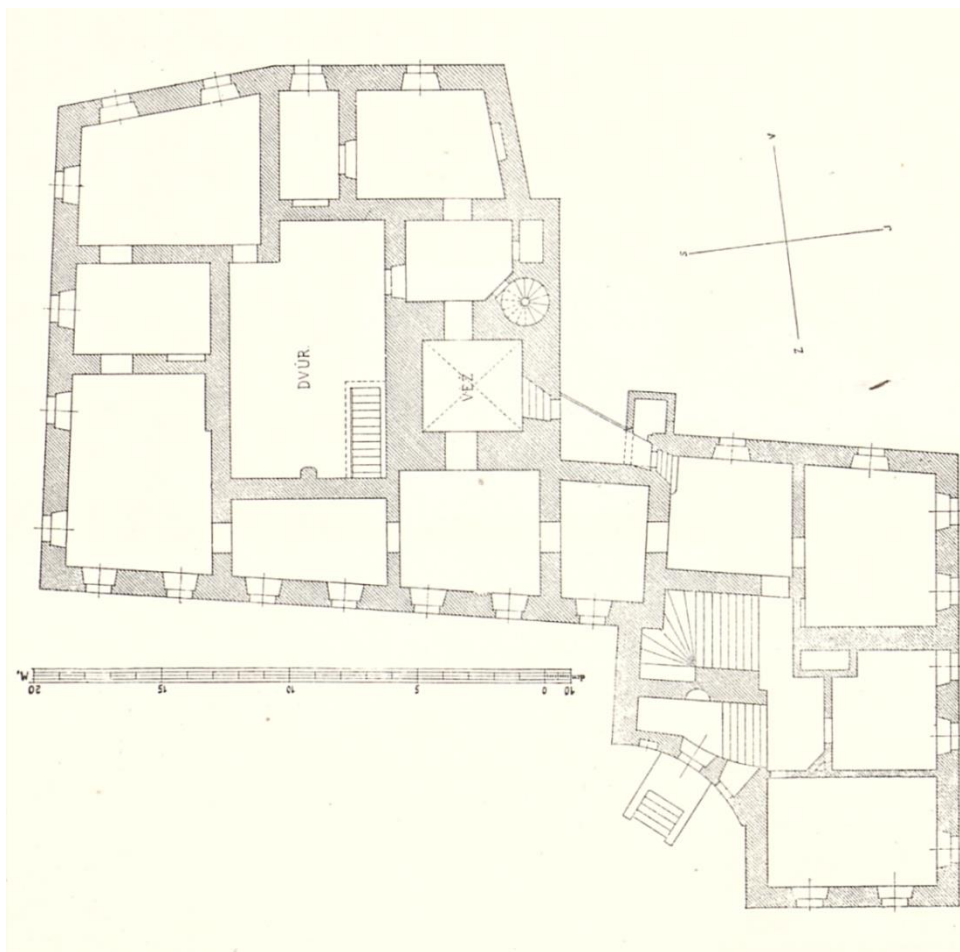
Figure 24 – Ground floor plan of the Chateau Lobkovice from 1901. [3]

Comparing the two Ground floor plans, one from 1901 (Figure 24) and one from the 1980s (Figure 25), several changes in the structure are noticeable. Since the external corridor was demolished due to a weather disaster, the entrance was walled up. Besides, there have been multiple modifications related to the positions of the openings - the existing ones were closed and the new ones opened. However, the most visible difference is in the main entrance area access on the right-hand side of the Chateau. The patio has a new appearance (Figure 27) that doesn't resemble the previous one (Figure 26).

Figure 25 – Ground Floor plan. Source [10]

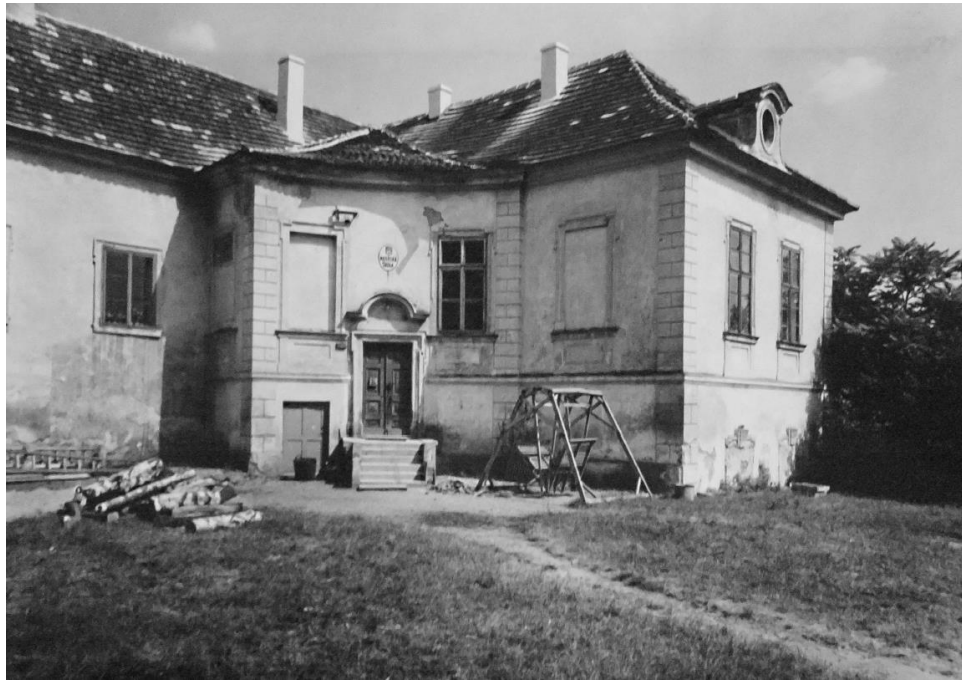
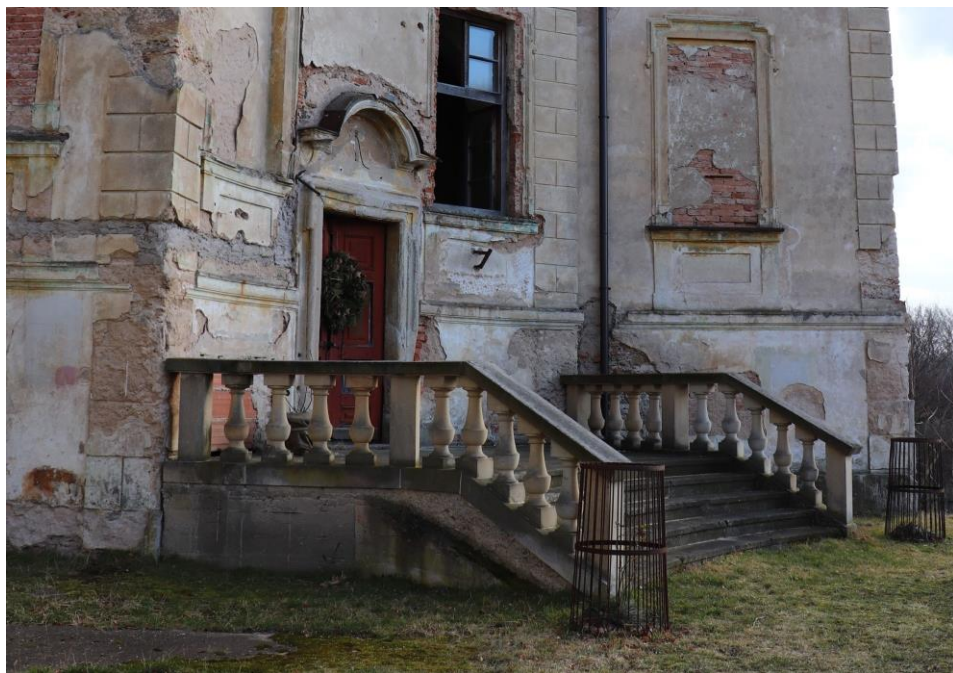
Figure 26 – The entrance of the right-hand side of the Chateau in 1978. Source [3]

Figure 27 – The entrance of the right-hand side of the Chateau today

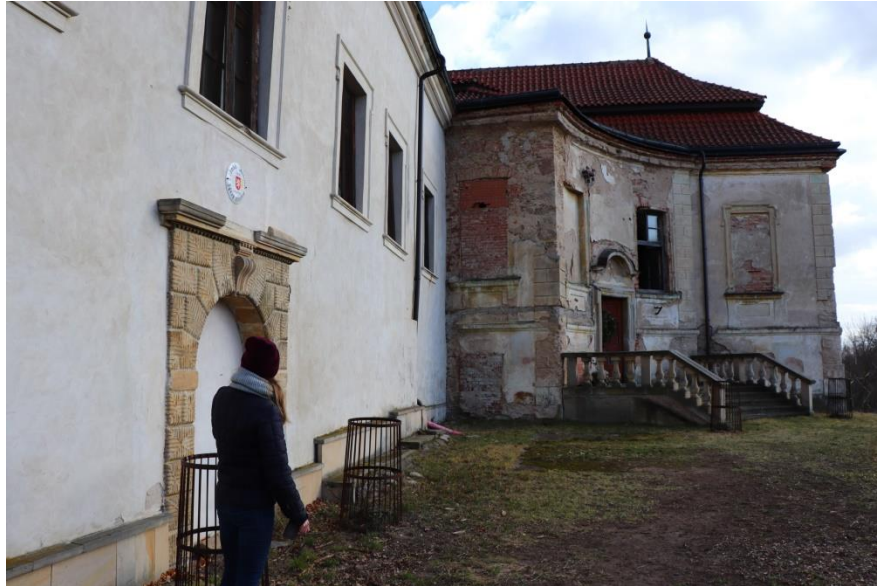
Figure 29 – West elevation

The plaster in the part of the left-hand side of the Chateau has been renewed during the last intervention in 1989. Mostly, it stands in a good condition. However, the façade of the right-hand side of the castle hasn't been repaired. The plaster has fallen off in many places, so the stone masonry stands exposed.

The Renaissance portal on the left-hand side of the castle has been walled up. The new one next to it on the left has been opened and it serves to access the rooms in the basement. The main entrance of the right-hand side was made of a wooden door that is still used. Windows in the castle are also wooden, with glass infill. Some of the windows are in poor condition, with the infill missing. The decorative elements around the windows on the left-hand side were repaired or replaced with the new ones. On the contrary, the sandstone decoration around the windows and the main entrance of the right-hand side suffers a type of stone deterioration. Additionally, a lot of the sandstone elements have missing pieces.

The roof of the whole castle including the tower has been replaced. The new roof is covered with red ceramic tiles. There is only a part of it in the west elevation that is cut-out. During interventions, the chimneys were left out.

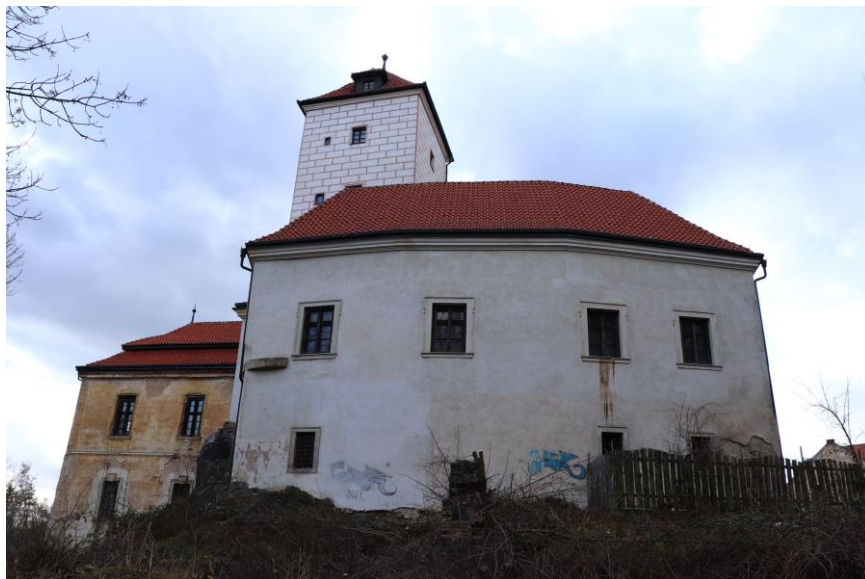
Figure 30 – East elevation

The tower, same as the older part of chateau is repaired with the new plaster. It was during the 1977, that the part of the tower collapsed, so the intervention was needed. The plaster is painted so it represents the masonry elements. Still, the bottom part of the tower hasn't got plaster rendering at all. The roof of the tower has been fixed. The balconies of the back façade of the castle, described in the textual documentation and drawings from the 1978, do no longer exist. What is left is a wall that served as the base.

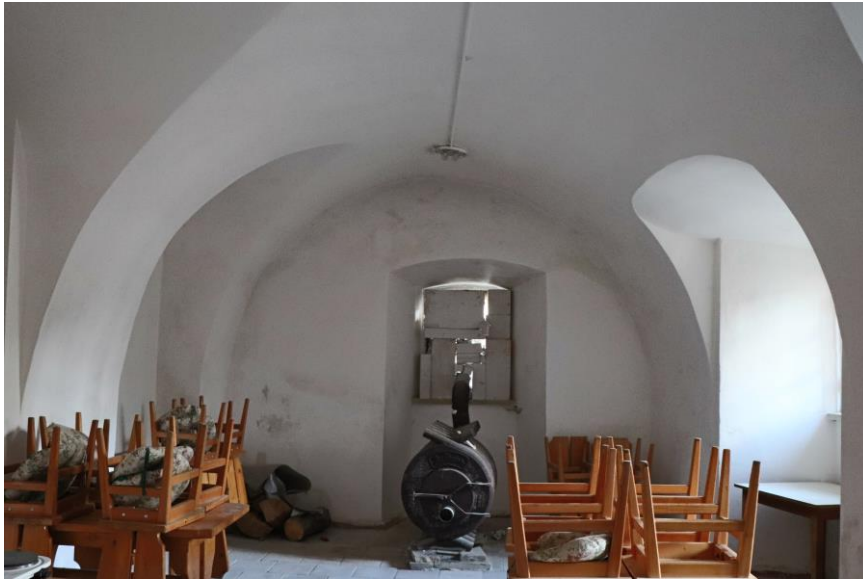
Figure 31 – Basement

The basement of the left-hand side is occasionally used by the local community for the events. The entrance is from the west elevation through the new door installed on the left side. This part of the castle is regularly maintained. The space is equipped with furniture and gets heated during the winter period. The walls are painted and the floors are covered in stone tiles. However, due to improper choice of the flooring material, damp areas can be found on the walls. Therefore, in some parts, there is a loss of rendering mortar. Also, the efflorescence occurred on one of the walls (Figure 32).

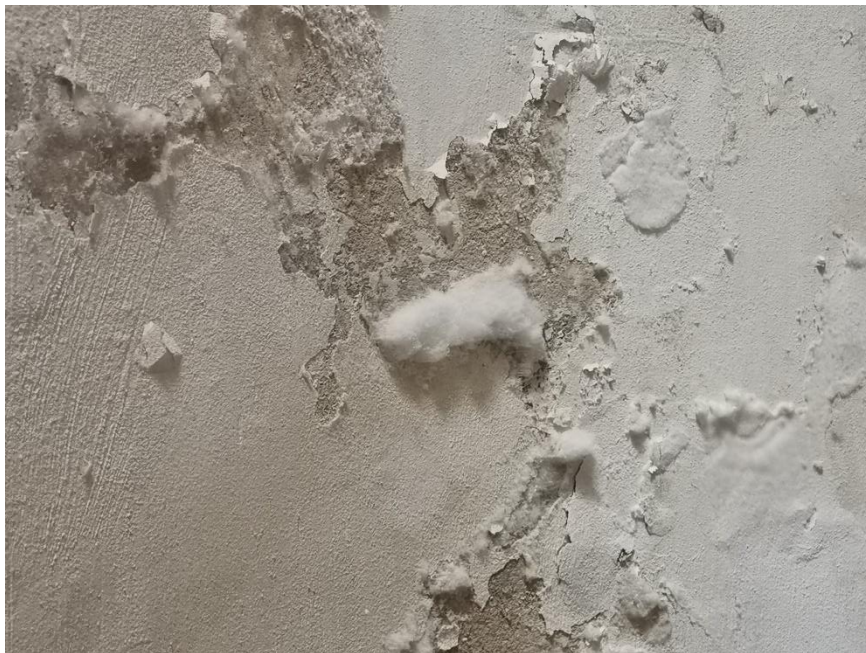
Figure 32 – Salt efflorescence

The biggest issue in the Chateau is the rising damp in the basement level, particularly in the oldest, Gothic side of the Chateau. These issues are the result of the poor ventilation system, as well as the inappropriate choice of material for floor construction. The concrete floor prevents moisture evaporation into the air, which causes the rising dampness in the walls. The rising dampness in the walls is the main cause of the detachment of the plaster as well as the appearance of the salts on their surface (efflorescence). To solve the humidity, an appropriate ventilation system should be introduced. For instance, "IGLU" is the ventilated under-floor cavities for civil and industrial buildings that are being built new or reconstructed. This system allows for controlling humidity and temperature. The "IGLU" system is modular, placed side by side in sequence to a predefined direction. On the top of the created self-supporting created platform, the concrete layer is cast. The simple piping system is placed in the cavity area below, allowing connection with the outside. This way, the natural airflow that crosses the cavity and eliminates moisture is created [16].

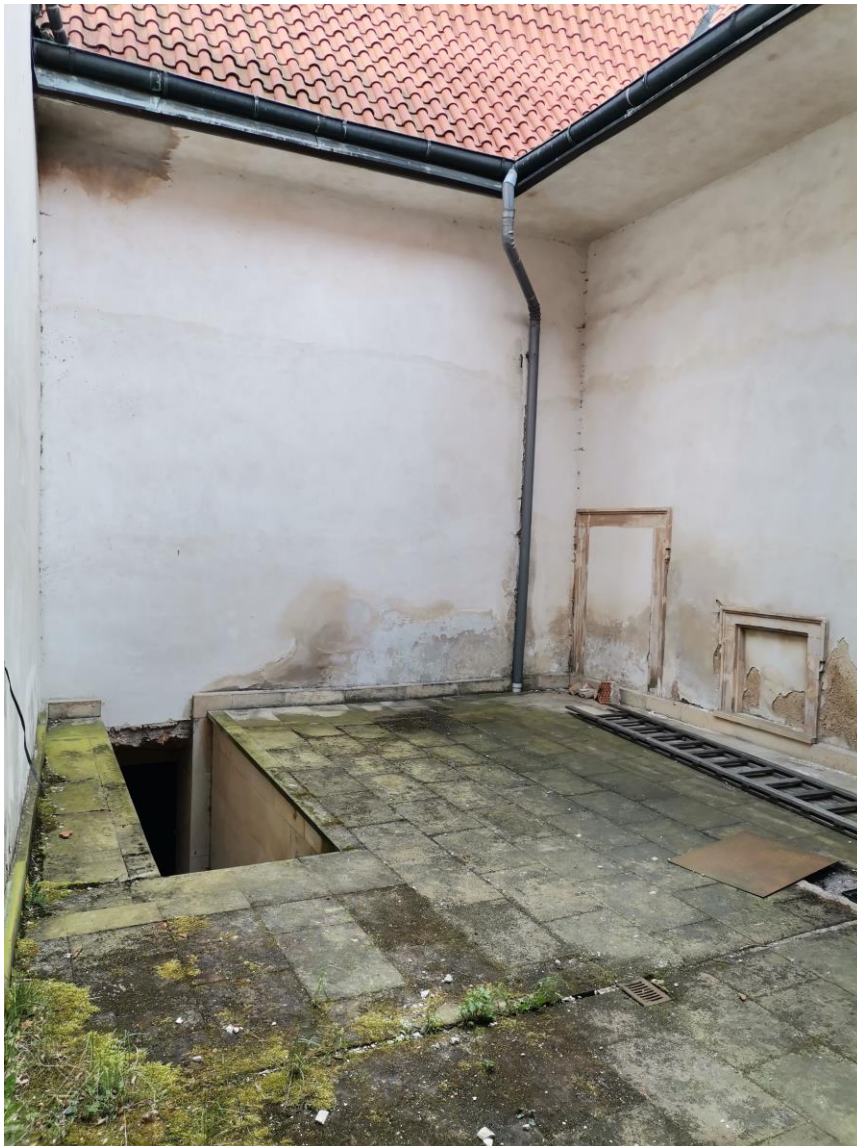
The inner courtyard can be accessed in two ways. Directly from one of the rooms from the ground floor (Renaissance part), or climbing the stairs from the basement (Gothic part). The whole inner courtyard suffers from the raising damp in the walls, causing rendering mortar to detach in the lower parts of the walls. Also, due to inadequate draining system, the floor and the stairs are suffering biological colonization and vegetation to grow. In the corners of the eaves there are moist. The north wall of the inner courtyard had two window openings, now walled up. The sandstone frames of the windows are in the good condition.

Figure 34 – Inner Courtyard of the Chateau

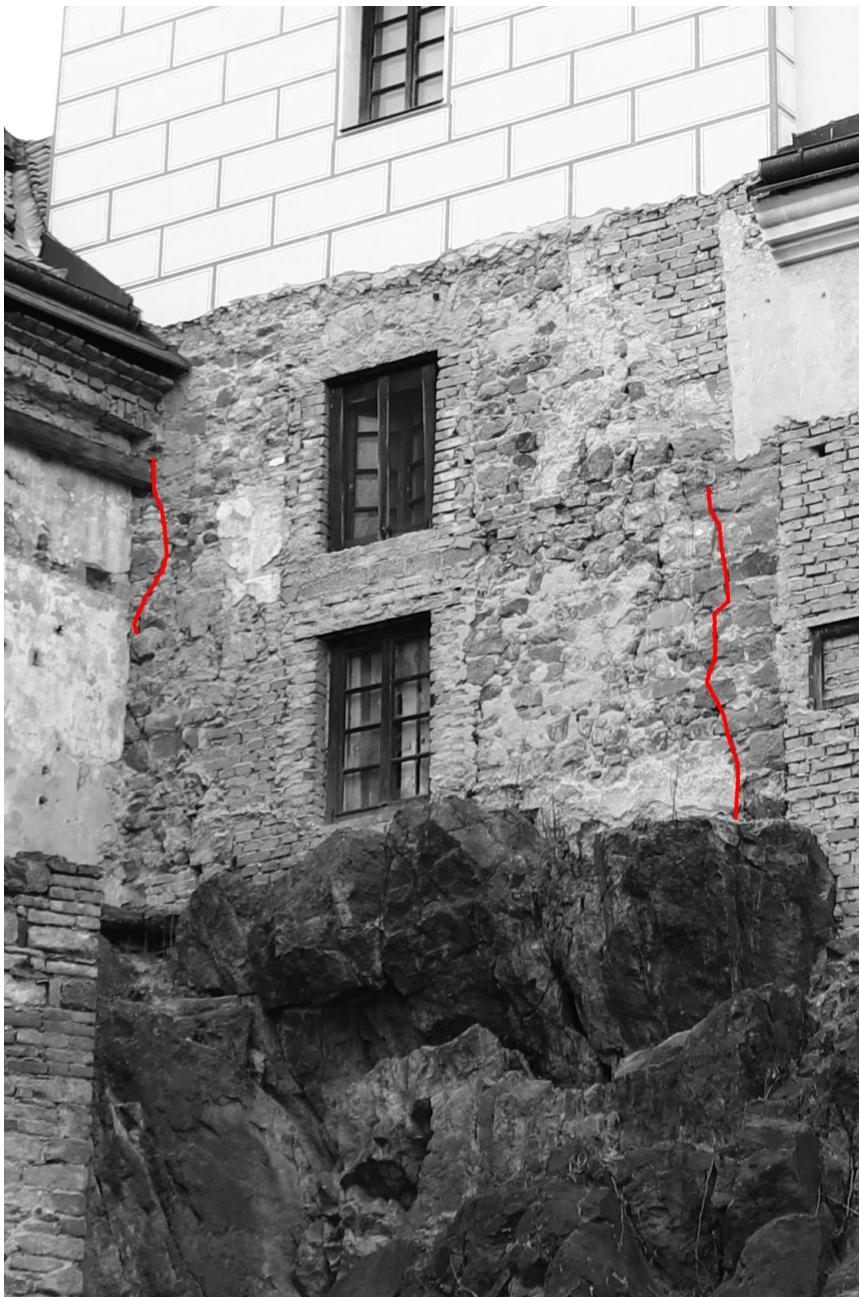
The tower can be entered from the ground floor of the Renaissance part of the Castel. The steel staircase exists, though it was impossible to climb due to safety reasons. From the exterior, the tower doesn't show any damage in the upper part. The rendering mortar has been renewed during the last intervention in 1980s. However, the bottom part of the tower stands without any rendering, leaving the structure exposed to external conditions. Also, there are cracks noticed in the bottom part of the tower. The cracks appear to be structural.

Figure 35 – Cracks in the bottom of the tower

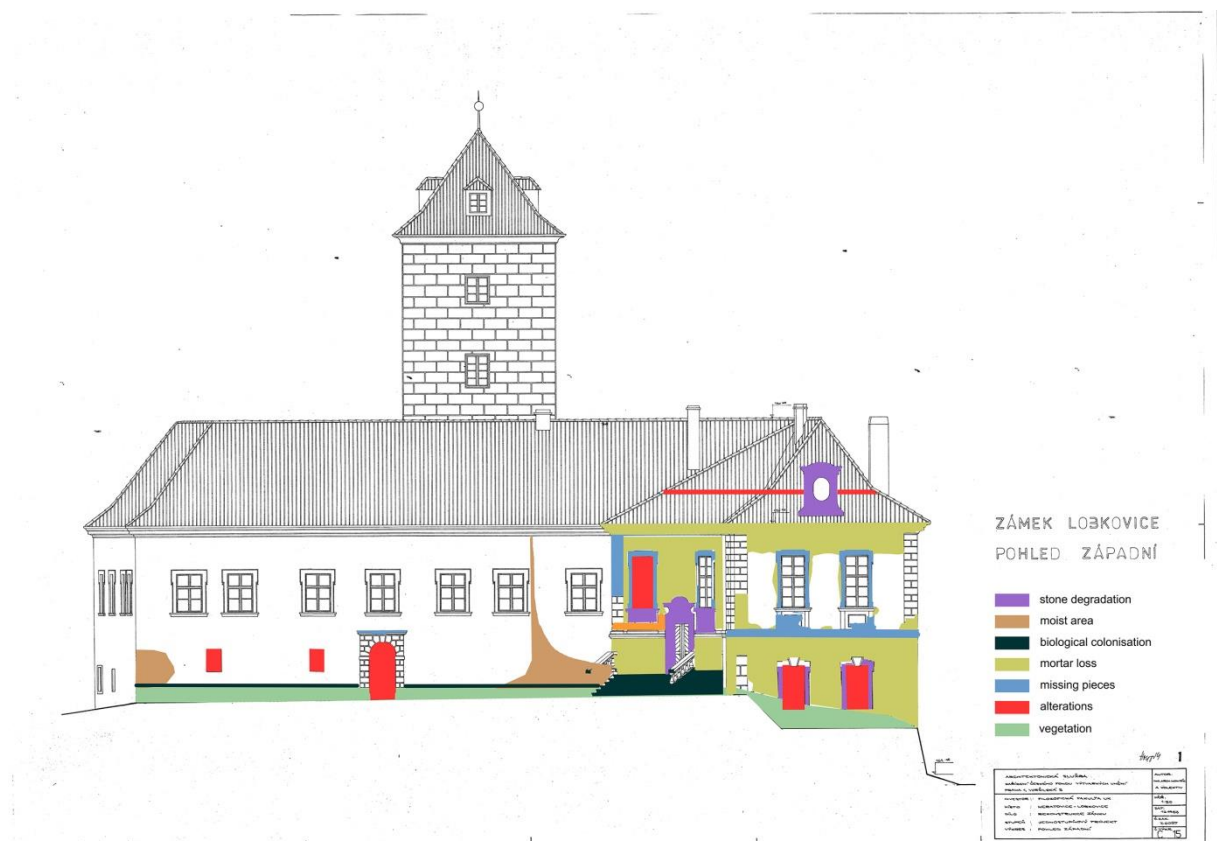
Considering the above mentioned interventions on the castle, it is noticeable that the left hand side – the coexisting renaissance and gothic part, suffers less damage than the right hand (baroque) side. Several types of damage can be described. On the baroque part, there could be clearly noticed the degradation of the rendering mortar. This type of damage is due to the lack of the maintenance for a long period. It can cause further penetration of the moist into the masonry, threatening to cause a structural damage. The bottom part of the castle suffers some biological colonization. There can be noticed different types: lichen, algae. This type of damage is caused by humidity in the areas for a long time (r).

The layer of vegetation covers the bottom part of the castle (~30cm). The vegetation keeps this area moist. Further, the humidity in the bottom of castle walls makes a good substrate for different types of biological colonization, like lichen and algae.

Figure 36 – Damage mapping: West Elevation

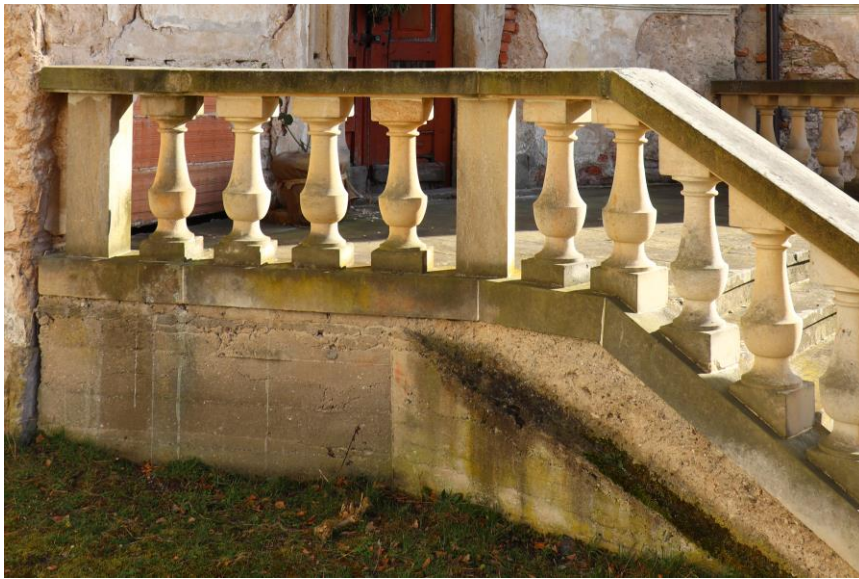
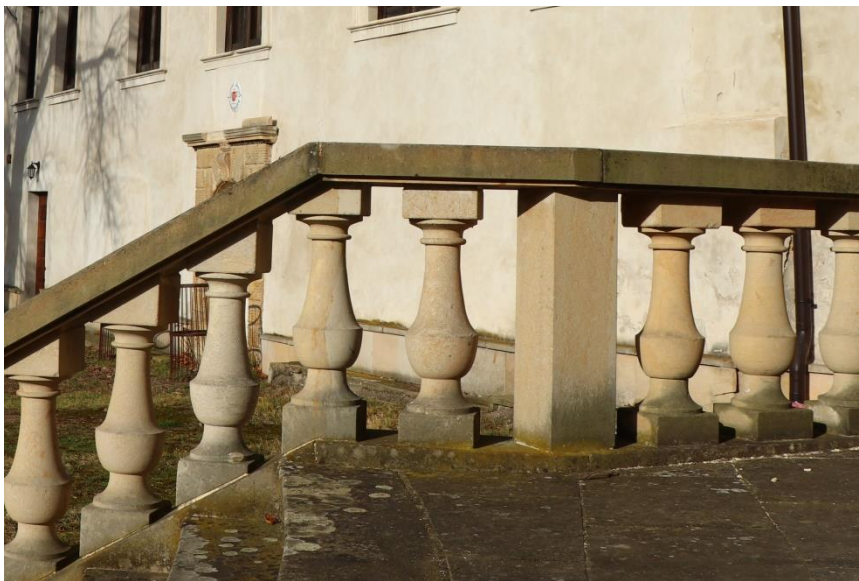
Figure 37 – Biological colonization on the entrance staircase

Figure 38 – Biological colonization on the entrance staircase

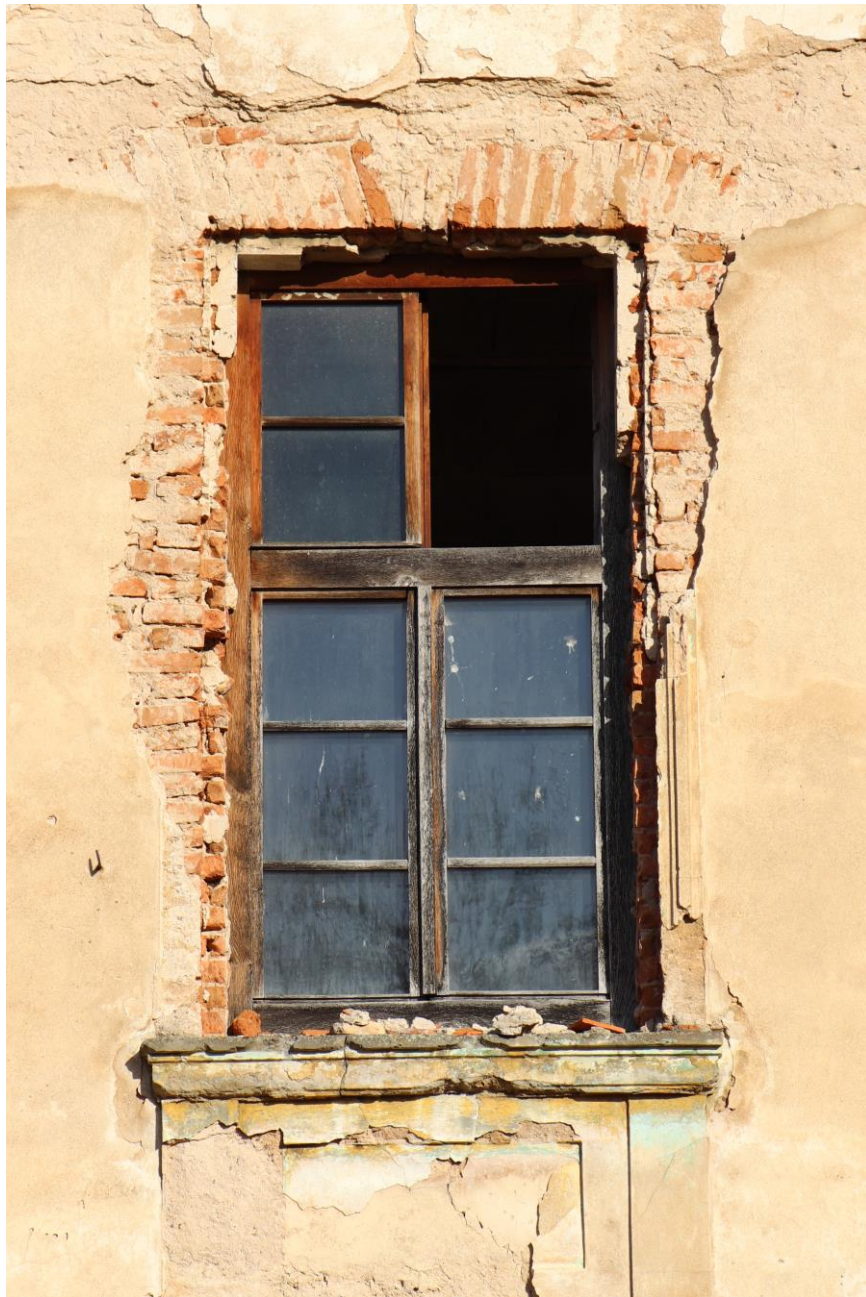
Figure 39 – Missing pieces and degraded sandstone decoration

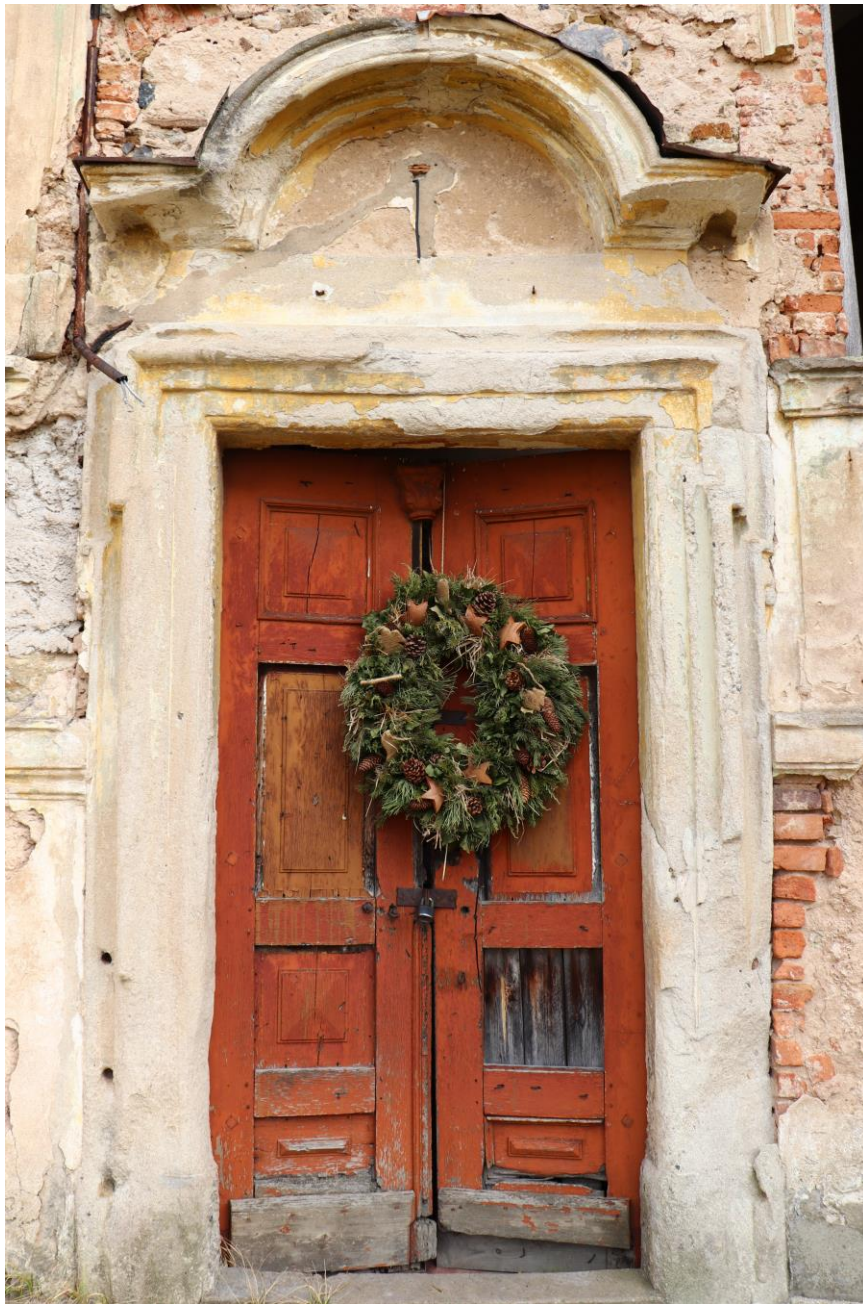
Figure 40 – Deterioration of the sandstone [11]

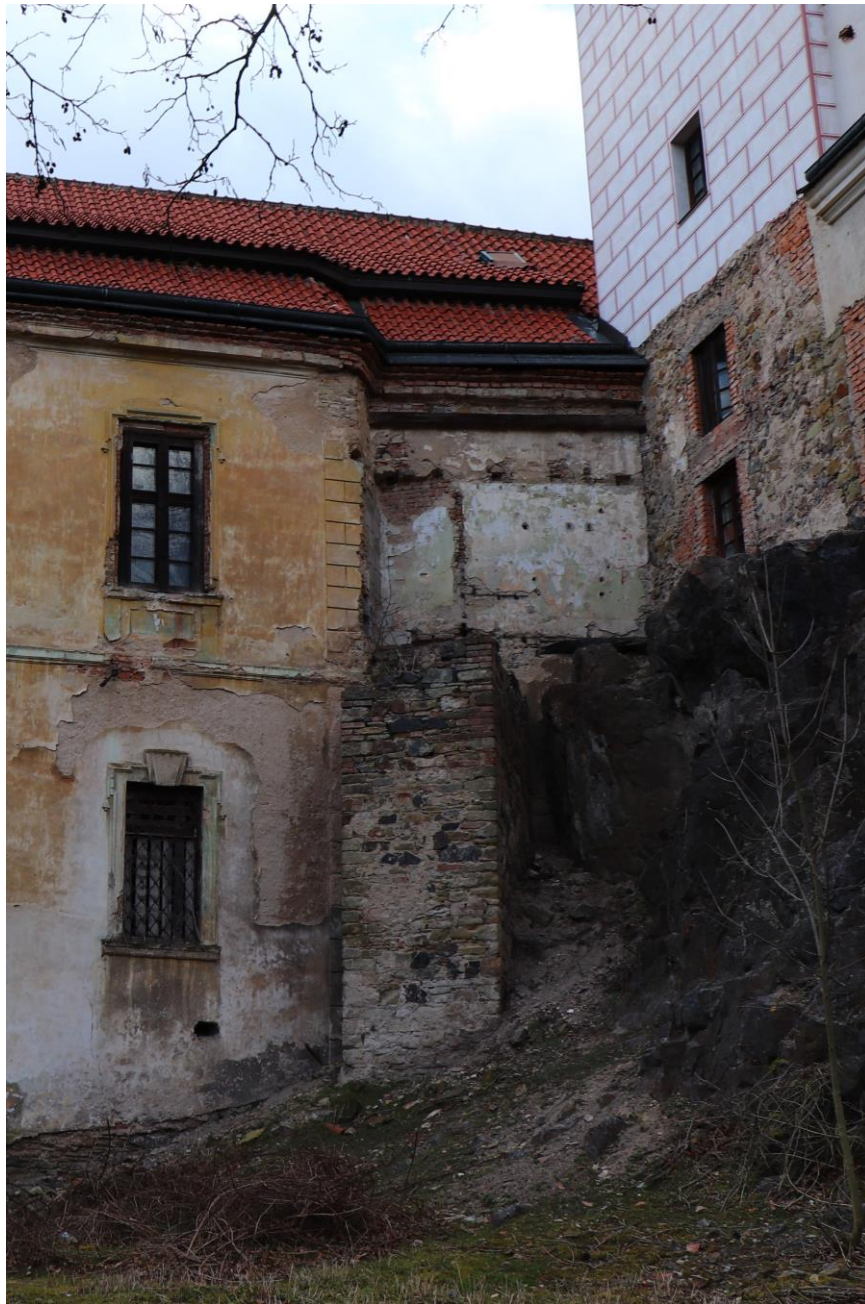
Figure 43 – The base of the demolished external corridor

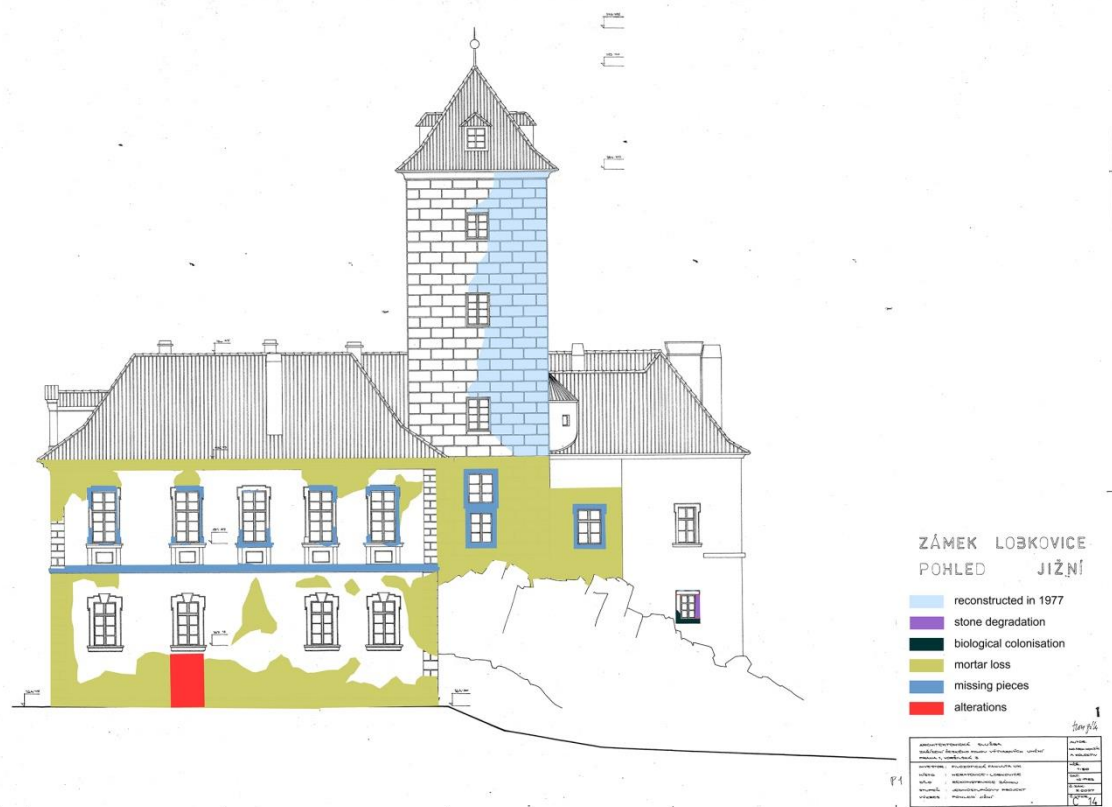
Figure 44 – Damage Mapping: South Elevation

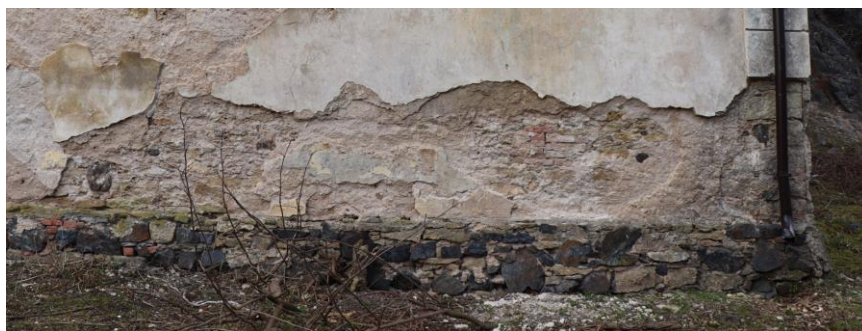
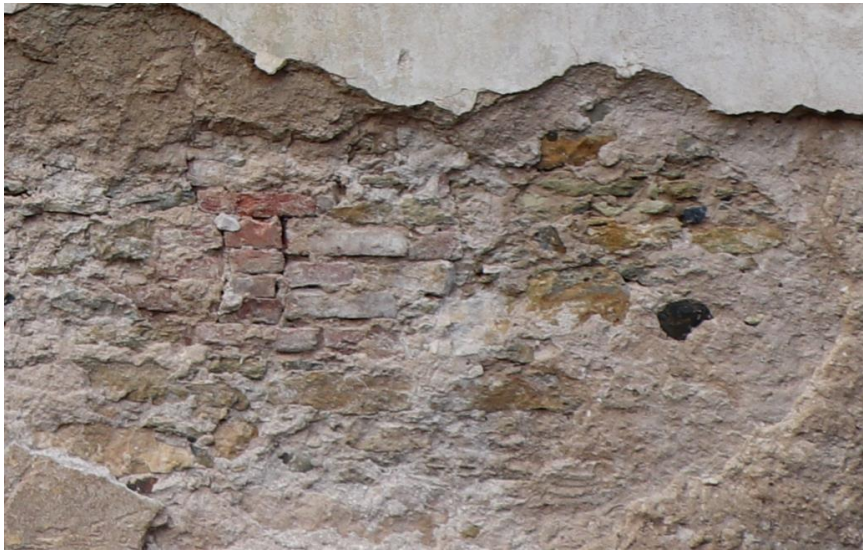
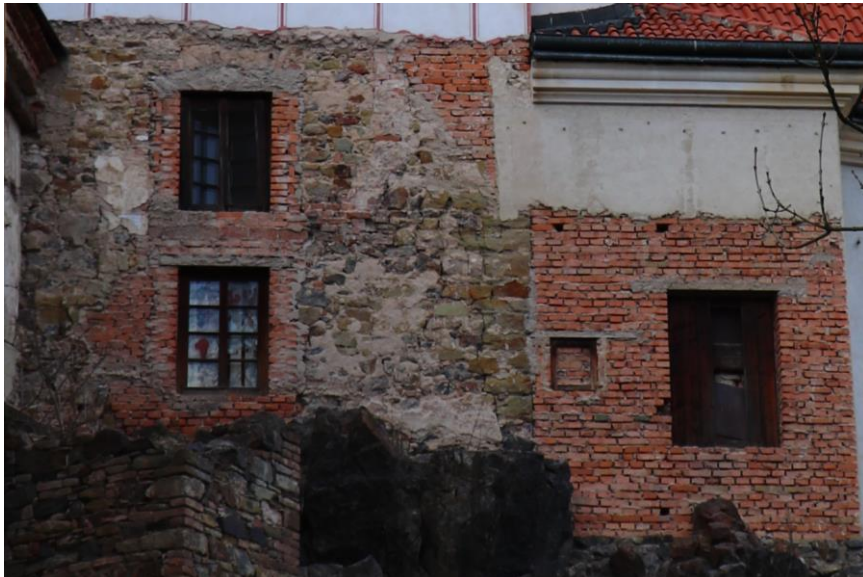
In Figure 45 – Figure 48, we can detect the structure's non-homogeneities. Diverse types of stone are present, in irregular shapes and different sizes. The brick pieces served as the infill where the stone parts were missing. Above, the stone and brick masonry are entwined.

Figure 45 – Right-bottom part of the right-hand side of the castle

Figure 46 – Stone and brick masonry

Figure 47 – Stone and brick masonry

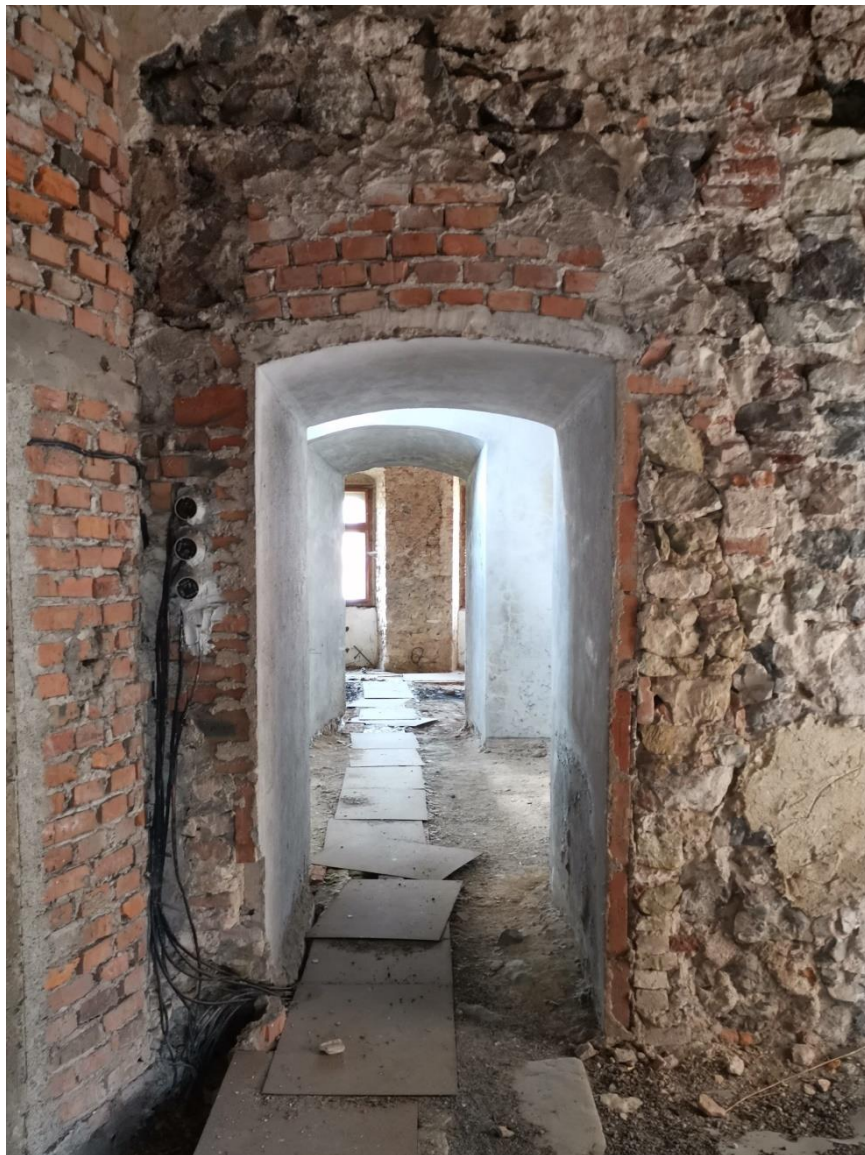
Since the windows and doors were replaced, implying that the current ones are not traditional, the structure that fixes them in place had to be replaced as well. The average thickness of the structural walls in the basement is about 1m. In the niches where the windows are positioned, the walls have a thickness about 0.4m. The partition walls are with the average thickness of 0.7m. The ones made in the same period as the castle built from the stone masonry. The ones added during the adaptation from the side of Charles University of Arts are made from the brick masonry with the thickness of 12cm.

Figure 48 – Brick masonry visible from the interior

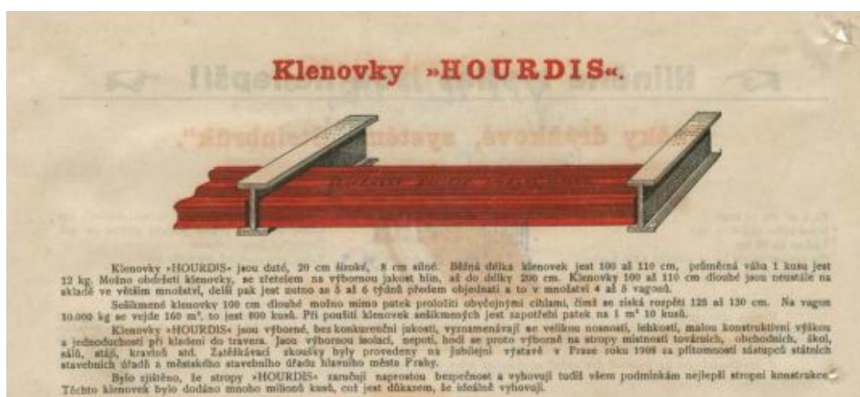
According to the textual documentation, the historic floor of the attic had to be replaced due to severe damaged caused by the absence of the roof structure. The new floor of the attic was made of the “HURDIS” floor system (Figure 49). On the other hand, the structure of the ground floor is the historic one, vaulted ceiling. However, when renovated, the layers of the floor above the structural elements were removed.

Figure 49 – “HURDIS” ceiling system. Source [12]

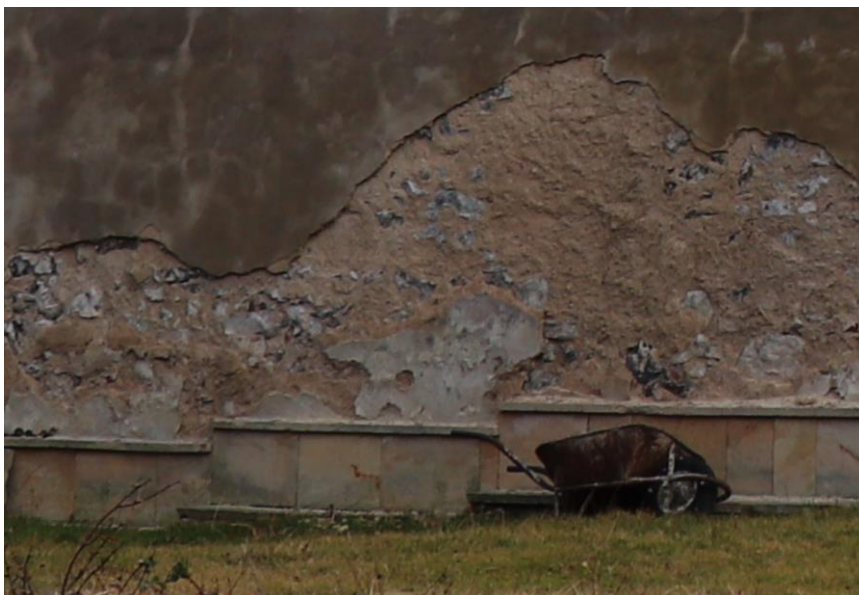
The basement, on the left-hand side of the castle is the oldest part of it, made in the Gothic style. The rooms have the vaulted ceilings, with the arched niches above the windows. Both from the interior and the exterior the rendering mortar has been renewed, so the morphology of the walls can't be determined.

Figure 50 – Deterioration of the mortar

When the problem of humidity is solved and the dry environment secured, the deteriorated wall and ceiling rendering mortar should be replaced. First, all the damaged areas should be mechanically removed and properly cleaned. Then, the joints should be refilled with lime-based mortar. All walls without the previous rendering should be rendered in a lime-based mortar and painted in white color.

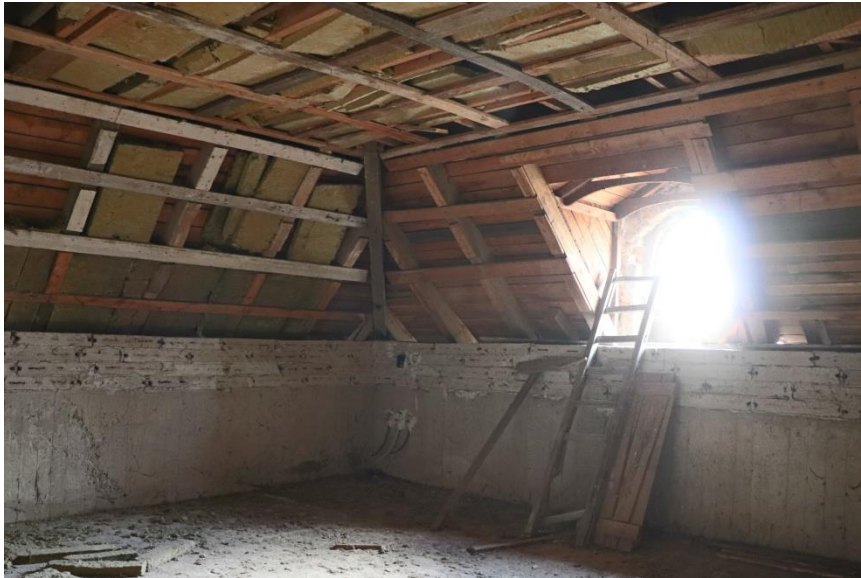
The roof is a timber structure, covered with the ceramic tiles. It consists of the rafters (10/14cm), top plate timber beam (14/14cm) and ties (8/16). However, the parapet wall is made of concrete, as it can be seen in the Figure 51.

Figure 51 – The roof structure
