Title of the MSc Dissertation: Chateau Lobkovice Revitalization of the Castle Grounds
Supervisor(s): Arh. ing Klara Kroftova, Ph.D
Year: 2022

ABSTRACT

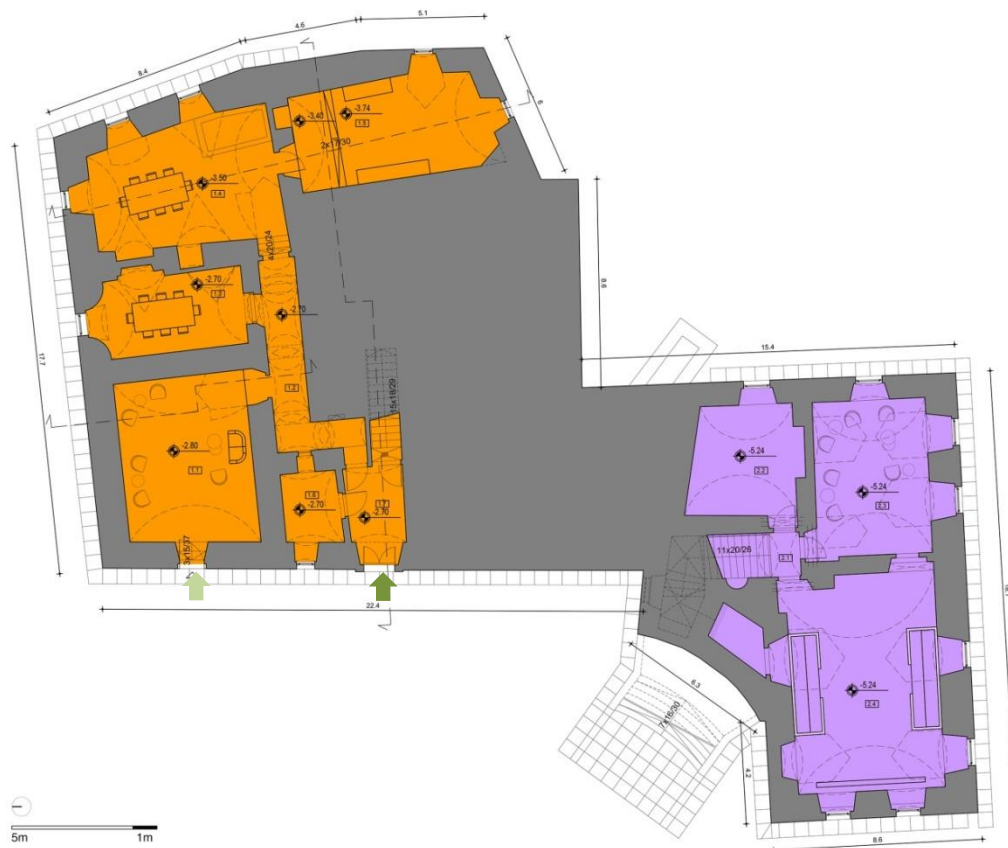
The left-hand side of the basement is currently used by the community of the Lobkovice village. The space is equipped with the furniture – tables and chairs, as well as the furnace. To preserve the relation of the community with the Chateau, this space will remain in the function of the event space for the community needs. It will be adapted to host various events such as weddings or cultural manifestations or, commemorating tradition. This space includes a lobby area, two multipurpose rooms and a wine storage.

Figure 55 – Basement: future use recommendation ¹

The new main entrance to the Chateau is indicated by the dark green arrow in the Figure 44. It leads to the stairs providing the access to the inner courtyard. The alternative entrance is indicated with the light green arrow. Currently, this entrance is walled up, so the “reopening” of this entrance is required. This way allows the access directly to the lobby. From the lobby, through the hallway, two dining rooms, a larger one and a smaller one, are accessible. The wine storage can be accessed only through the larger dining room.

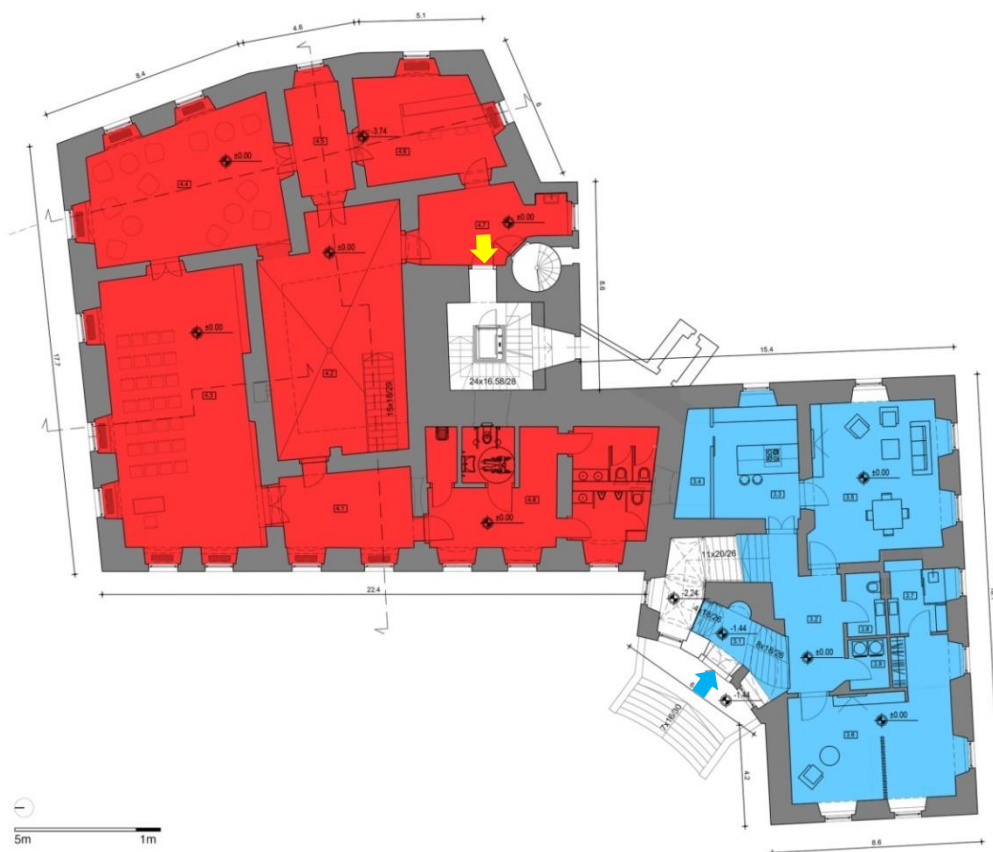
The ground floor is divided into two main parts - the private on the right-hand side and the part open for public on the left-hand side of the Chateau (Figure 45). The right-hand side of the part is adapted to match the requirements of the apartment for a member of the family. The access is through the patio of the main entrance. It consists of the master bedroom, living room with the dining area, kitchen, bathroom, guest bathroom and the service room. The left-hand side of the Chateau will serve as a congress center. Since the main entrance of the Chateau belongs to the private area of it, the only access to this area is through the entrance on the Basement level. Further, the stairs lead to the inner courtyard. From the inner courtyard multiple rooms can be accessed, allowing circular communication. Besides the lobby and the congress hall, the space is equipped with sanitary facilities and the kitchenette. For the purpose of the sanitary facilities, larger intervention is required. The access to the Attic is from through the tower (indicated with the yellow arrow). However, since there is no existing vertical communication, there is a demand for a staircase structure to be designed. The communication would include an elevator as well.

Figure 56 – Ground floor: future use recommendation²

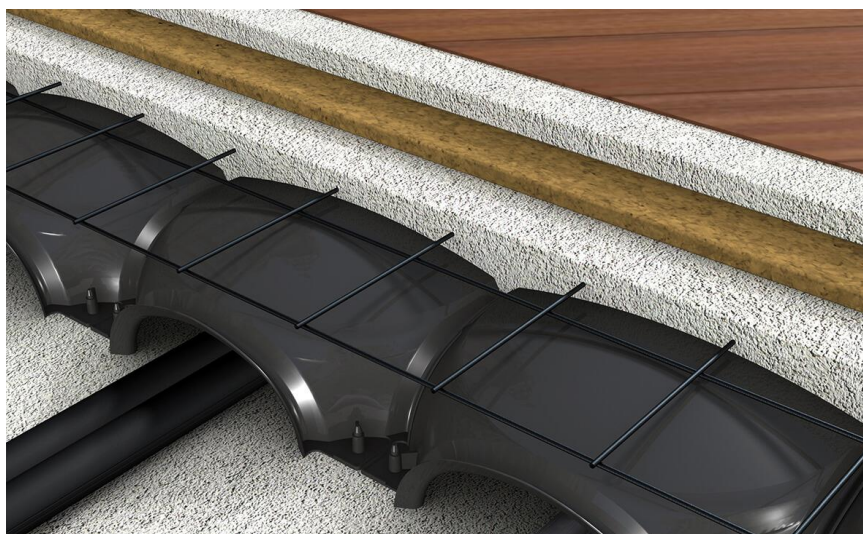
The reinforced concrete slab is cast on top of the infill layer on top of the vault. The infill layer provides a flat separated for the slab and the finishing. The infill is made from the foam glass that provides thermal insulation as well. The hydro-isolation membrane is placed between the concrete slabs from the infill. The finishing layer of the floor is parquet, placed on the layer of glue.

Figure 59 – IGLU' System. Source [16]

The biggest issue in the Chateau is the rising damp in the basement level, particularly in the oldest, Gothic side of the Chateau. These issues are the result of the poor ventilation system, as well as the inappropriate choice of material for floor construction. The concrete floor prevents moisture evaporation into the air, which causes the rising dampness in the walls. The rising dampness in the walls is the main cause of the detachment of the plaster as well as the appearance of the salts on their surface (efflorescence). To solve the humidity, an appropriate ventilation system should be introduced. For instance, "IGLU" is the ventilated under-floor cavities for civil and industrial buildings that are being built new or reconstructed. This system allows for controlling humidity and temperature. The "IGLU" system is modular, placed side by side in sequence to a predefined direction. On the top of the created self-supporting created platform, the concrete layer is cast. The simple piping system is placed in the cavity area below, allowing connection with the outside. This way, the natural airflow that crosses the cavity and eliminates moisture is created [16].

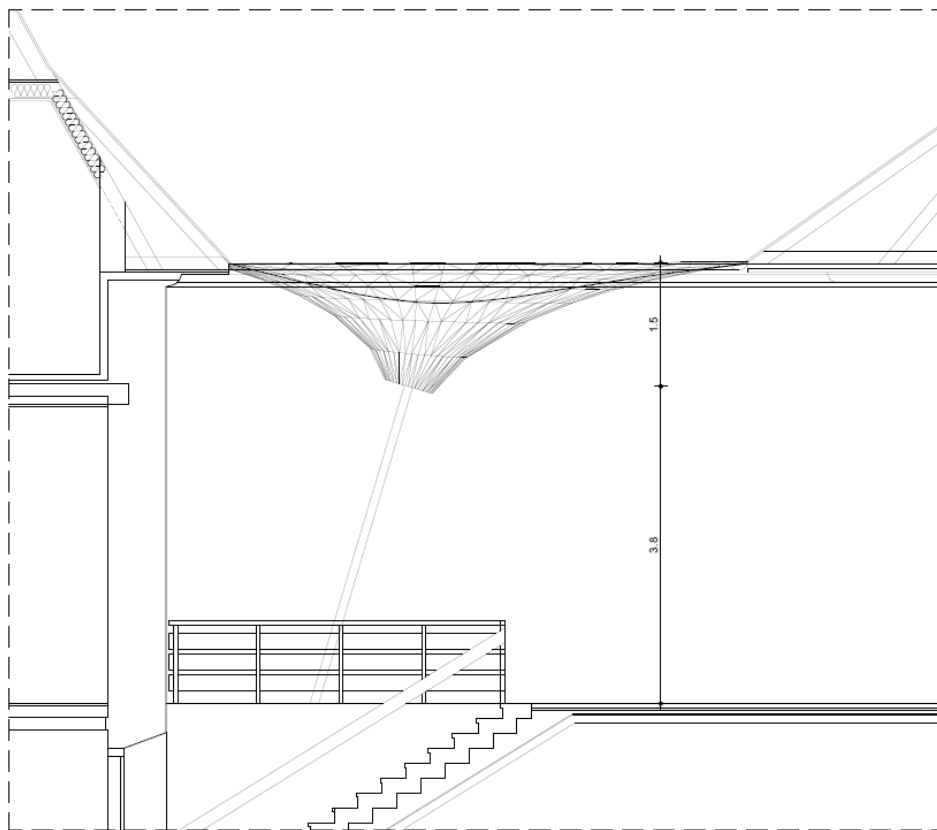
Since the inner courtyard will serve as the entrance zone, a covering that will protect it from the precipitation will be needed. For this purpose, the membrane structure has been designed. The membrane is attached to the roof structure, since its eaves crates a rectangular shape. The structure is inclined. The drainage system is integrated in the mast of the membrane, where it further goes into the drainage system of the inner courtyard. The membrane was designed using the “FORMFINDER” software [18]. In its plane the dimensions of the membrane are roughly 5x6m, while the height is 1.5m or 5.1 with the mast (Figure 63).

Figure 61 – Membrane structure: section
