Diploma Thesis (DT) title: Numerická a experimentální analýza kostelní věže sv. Jakuba v Kutné Hoře  
Diploma Thesis title in English: Numerical and experimental analysis of the Bell Tower of St. Jacob's Church in Kutna Hora Town

Title of the Msc Dissertation: Numerical and Experimental Analysis of the Bell Tower of St. Jacob's Church in Kutna Hora Town

University: Czech Technical University in Prague

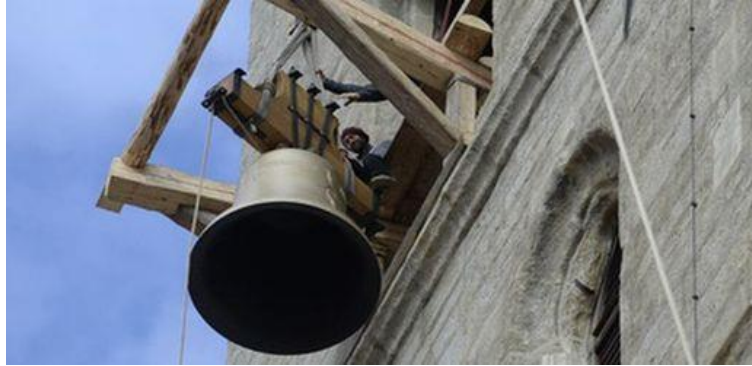
Figure 4: The raising of the bell in 2017 was completed using traditional lifting methods and was carefully supervised by the bell maker and project engineer. [4]

there was concern for public safety, and so in 2016, reconstruction efforts were started to stabilize and strengthen the tower. These works were completed in 2017 and commemorated with the placement of a new bell and bell frame within the tower, the raising of which can be seen in Figure 4. [3]

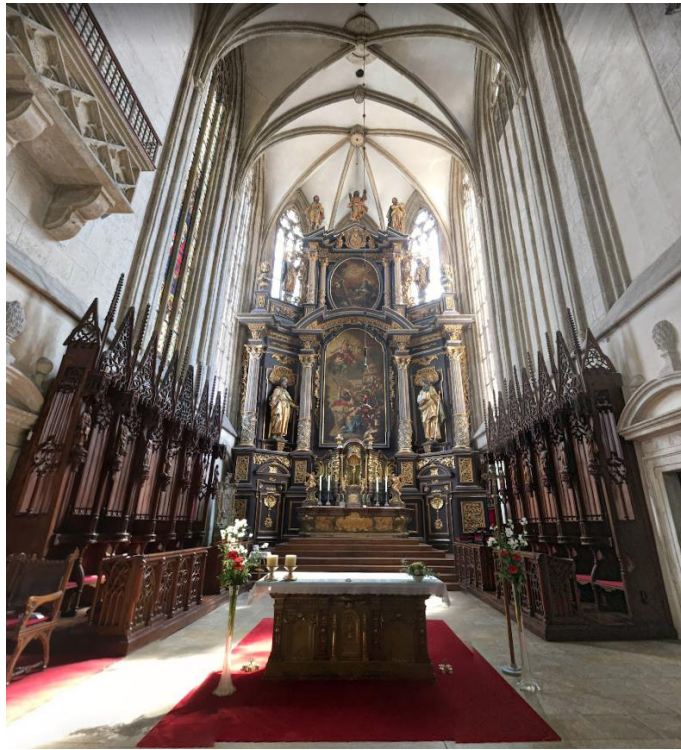
Figure 6: Facing east to the altar. The ornamentation in the altar and surroundings can be seen, as well as the tall gothic vaulting. (Image captured from Google Street View)

St. James Church is a traditional three nave church with large columns between the naves. The altar is found at the east end of the church, while the two towers and the choir are opposite, at the west end. Figure 5 illustrates the floor plan in a simplified schematic. The interior of the church is highly ornamented with statutes and other elements dating back to construction. The structure itself is Gothic, with large, tall columns and quadripartite vaulting. There are also elements of Renaissance and Baroque architecture within. These decorative and structural elements can be seen in Figure 6 and Figure 7.

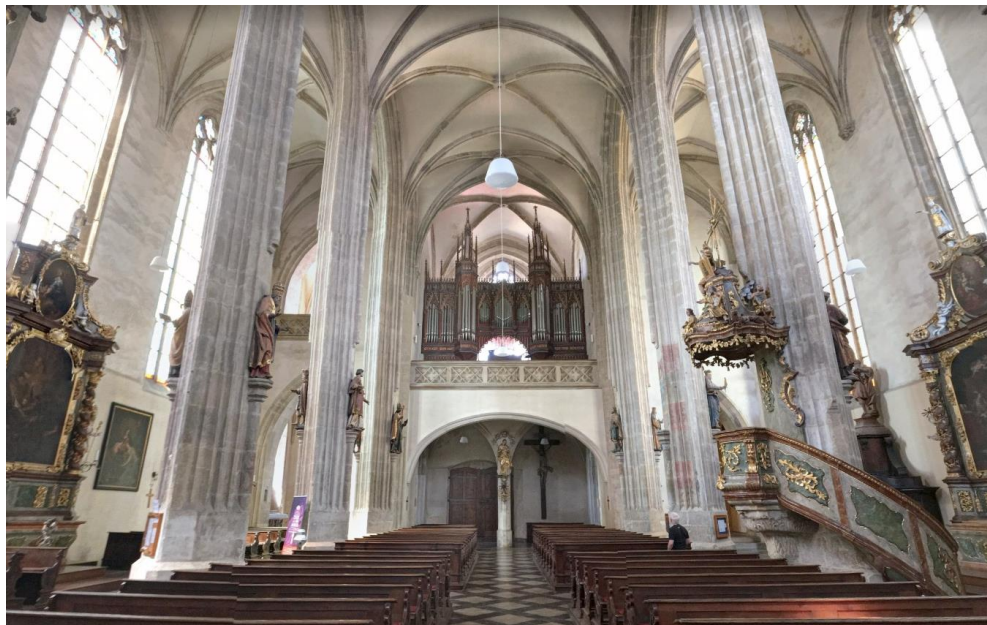
Figure 7: Facing west towards the towers. While the towers cannot be seen, the large columns, as well as the choir and supporting arch are visible. Additionally, there are more Baroque and Renaissance decorative elements to be seen. (Image captured from Google Street View)

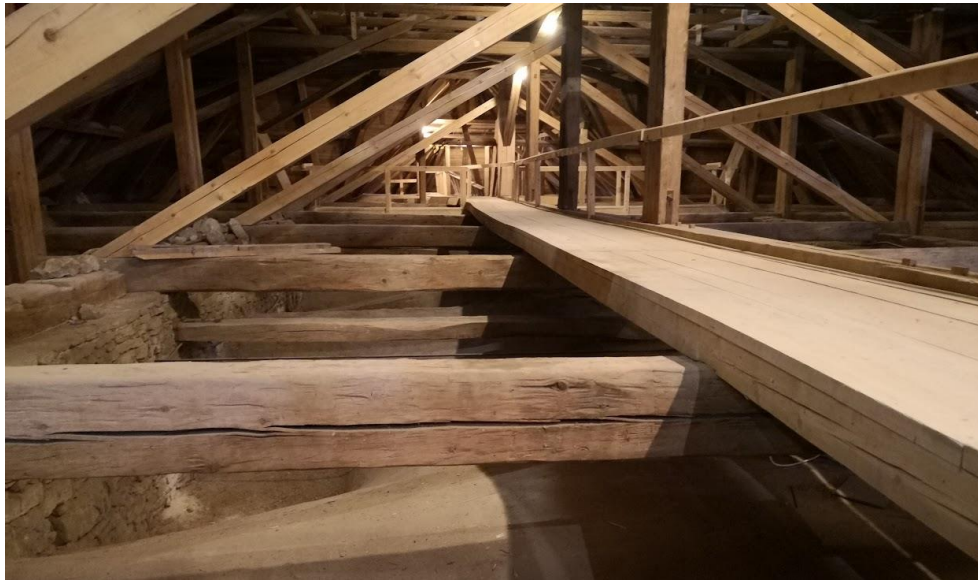
Figure 8: Upper roof structure of the church. The small masonry wall is found on the left side of the image. The large truss is part of the roof system and contains old and new elements. It also supports the walkway, as seen on the right side of the image. (Photo by author)

In the roofing above the vaults, there are two small masonry walls above the column lines. Above them, a large roofing truss system was built to make the peaked roof. An extensive walkway system was also built for ease of access to the different parts of the upper structure. All of these elements are visible in Figure 8.

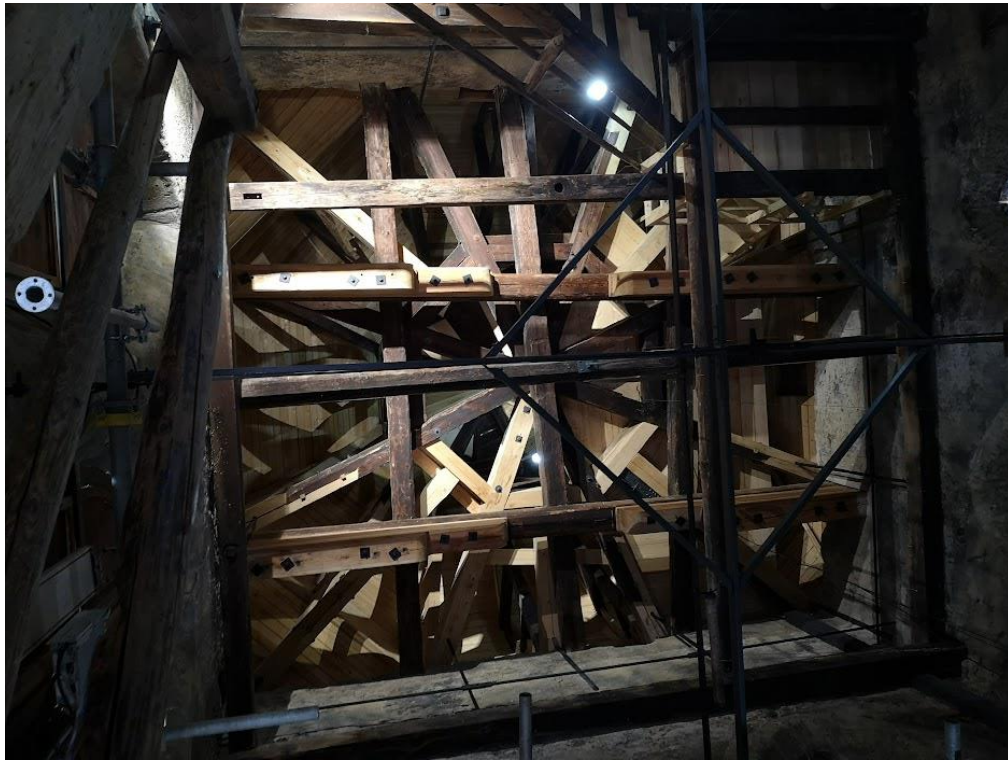
Figure 9: Looking up at the Baroque timber roof truss. The complexity of the truss, with all its diagonal members is a sight to behold. Many of the members have been replaced or reinforced with new timber. (Photo by author)

For the purposes of this study, a further in-depth inspection was conducted for the towers. Structural elements, openings, materials, and conditions were all reviewed for their potential impact on the structural model. Inside the northern tall tower, the first set of stairs are stone, up to the level of the church roof, with one exit on route, into an intermediate floor, currently used as a storage space. After that, a timber stair system has been designed to allow passage to the top of the tower. In fact, most of the interior structure on the tower is timber, leading to flexible floors and minimal rigidity impact on the structure by the flooring. The newer Baroque style roof on the tower is also made of a complex timber frame system, which is pictured in Figure 9. Ties of varying age are located within the tower connecting the external walls together to create a system that moves together, instead of as separate walls. The older ties are historically significant as they are Renaissance era wrought iron ties, which have now been reinforced with modern steel rods [5].

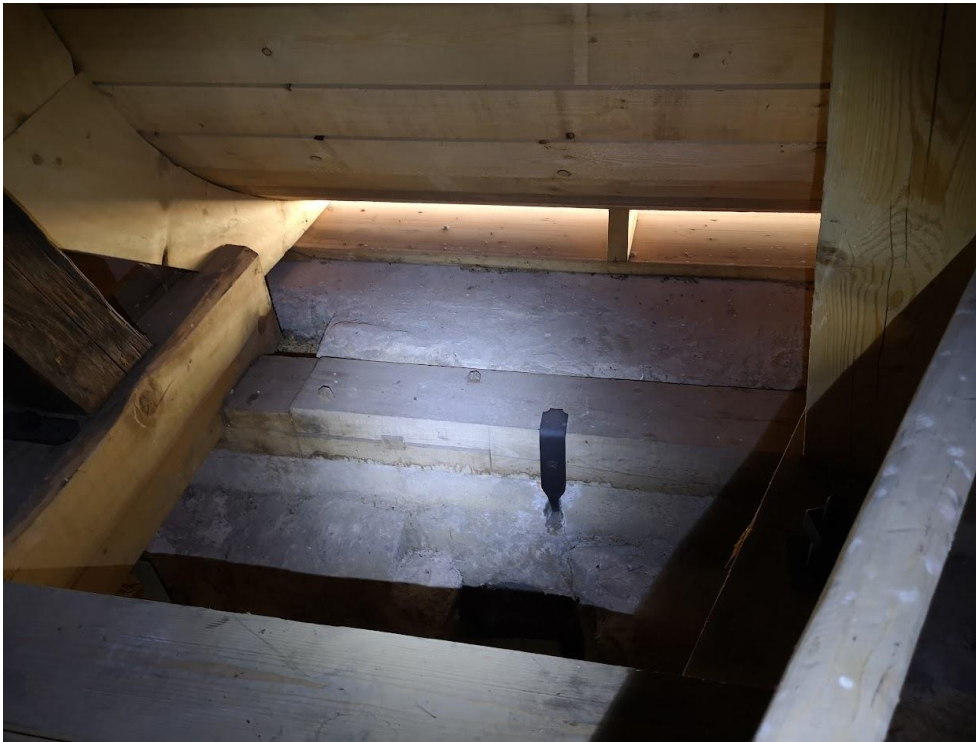
Figure 10: Concrete overlay 'capping' on top of the masonry walls to connect the wall leaves together. Metal and timber components are also connected through the capping process. (Photo by author)

The walls themselves are a mixed-stone three-leaf masonry system, about a metre thick. In some areas the walls appear to have cut blocks on both sides, whereas in others, the interior stone layout is more sporadic. What should be noted is that the entire tower seems to have well-maintained mortar. There are no gaps or areas of missing mortar on the tower that would indicate weakness, damage, or deterioration. In the most recent renovations, it was understood that a re-pointing and capping technique was used, which would explain the excellent state of the mortar. This means that compatible mortar was applied to the exterior jointing and the top of the walls, covering any defects or loss of material that may have happened with time. The capping is illustrated in Figure 10. In addition, some stitching work was completed in the upper levels, which means that extra material was added into the mortar joints to connect the masonry pieces and create a more stable and cohesive system [5]. However, neither of these techniques ensure a lack of voids in the interior leaf of the wall, such that the overall wall strength may be less than a solid, consolidated wall. Also, there is a higher quality of masonry found towards the top of the tower as opposed to the bottom of the tower. This can be clearly seen by looking at the stones themselves and their mortar joints. Higher quality masonry has larger, more regular stones with even, thin joints. While there are elements of the higher quality masonry in the lower part of the tower, it is not consistent enough to be considered the same as the top of the tower.

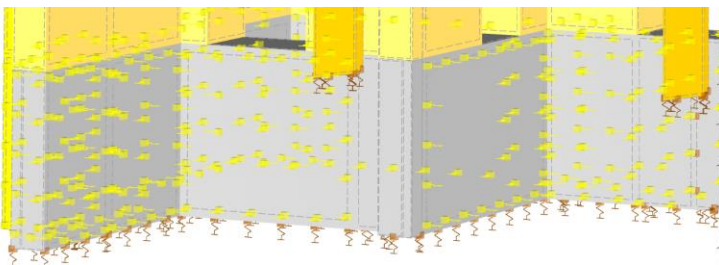
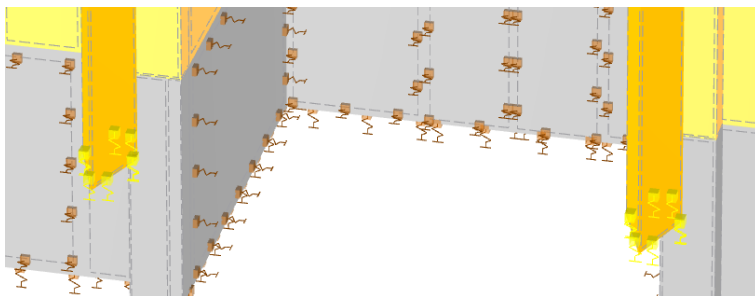
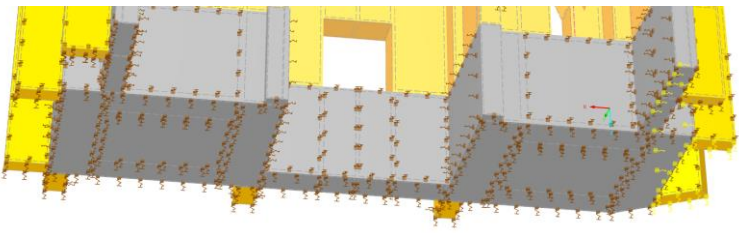
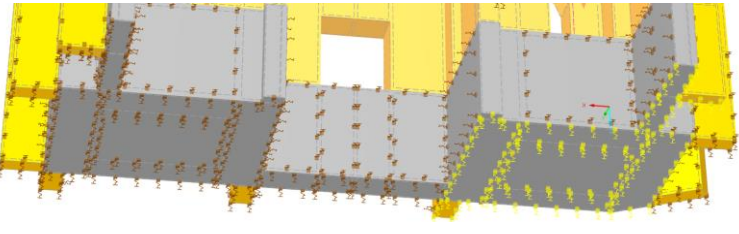
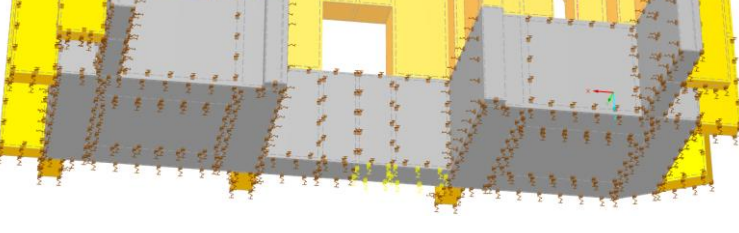
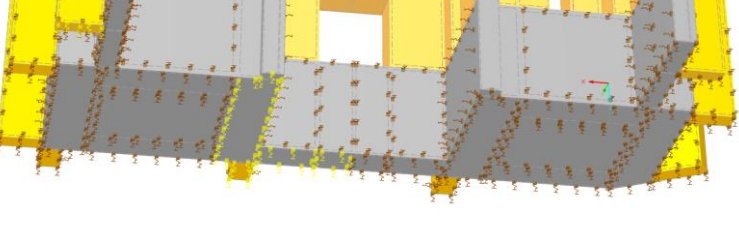
Table 2: Final spring constants for boundary conditions affecting the church. Indicated supports are in yellow.

Support	Spring Constant	Location
Confining Pressure Supports	10 MN/m <sup>3</sup>

Column Supports	1000 MN/m <sup>3</sup>

Northern Buttress Supports	150 MN/m <sup>3</sup>

North Tower Supports	150 MN/m <sup>3</sup>

Northern Entryway Supports	130 MN/m <sup>3</sup>

Southern Entryway Supports	110 MN/m <sup>3</sup>

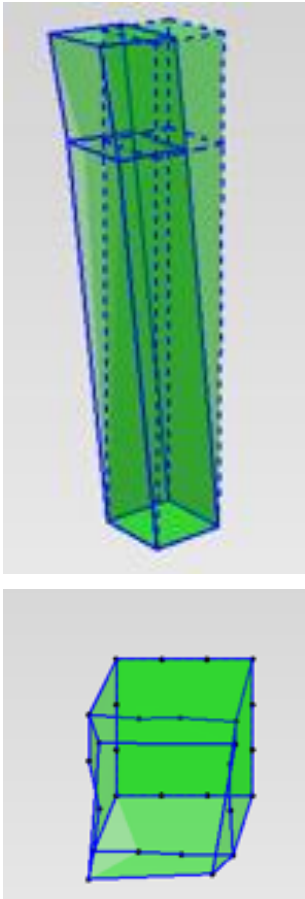
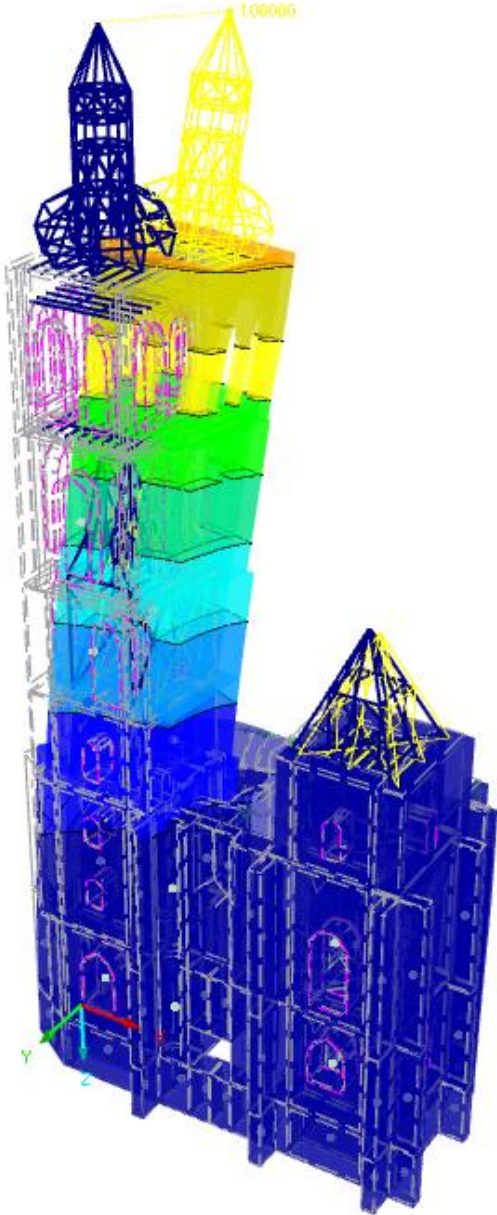
0.977 Hz	0.989 Hz

Furthermore, a final comparison between the testing and model frequencies and mode shapes can be seen in Table 3, Table 4, and Table 5. These confirm that both the frequencies are similar and have matching mode shapes. This is important because computer models can sometimes have local modes that do not reflect the behaviour of the tower, so it is critical to ensure that the shapes and the frequencies match, which they do for this tower.

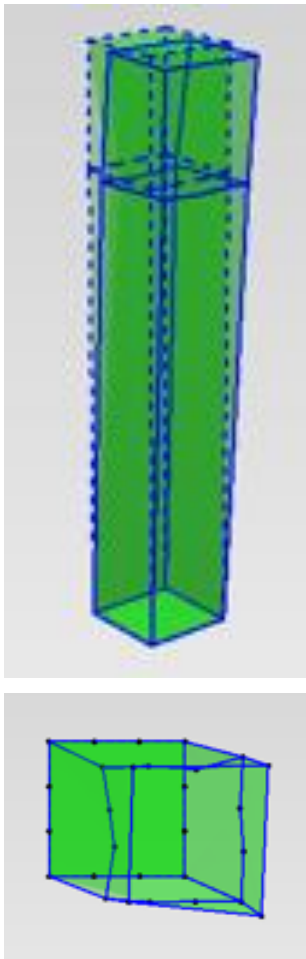
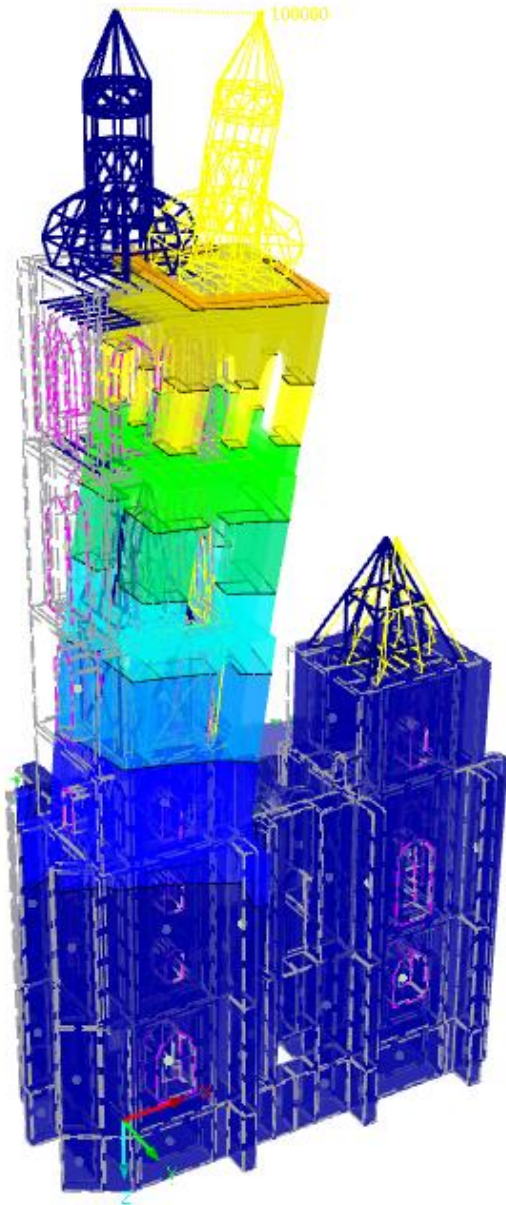
1.129 Hz	1.075 Hz

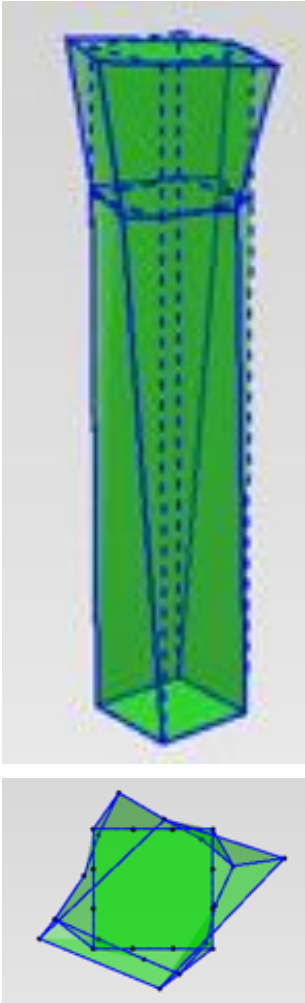
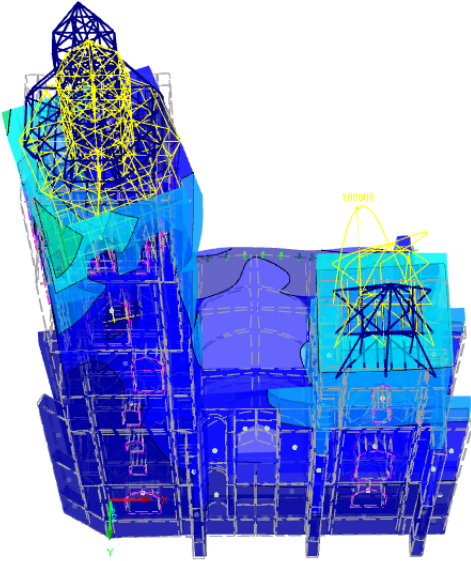
2.88 Hz	2.831 Hz
