ADVANCED MASTERS IN STRUCTURAL ANALYSIS OF MONUMENTS AND HISTORICAL CONSTRUCTIONS

# Master's Thesis

**A new laboratory test to assess the resistance of porous materials to salt crystallization: Assessment of natural stone painted with limewashes**

University of Minho

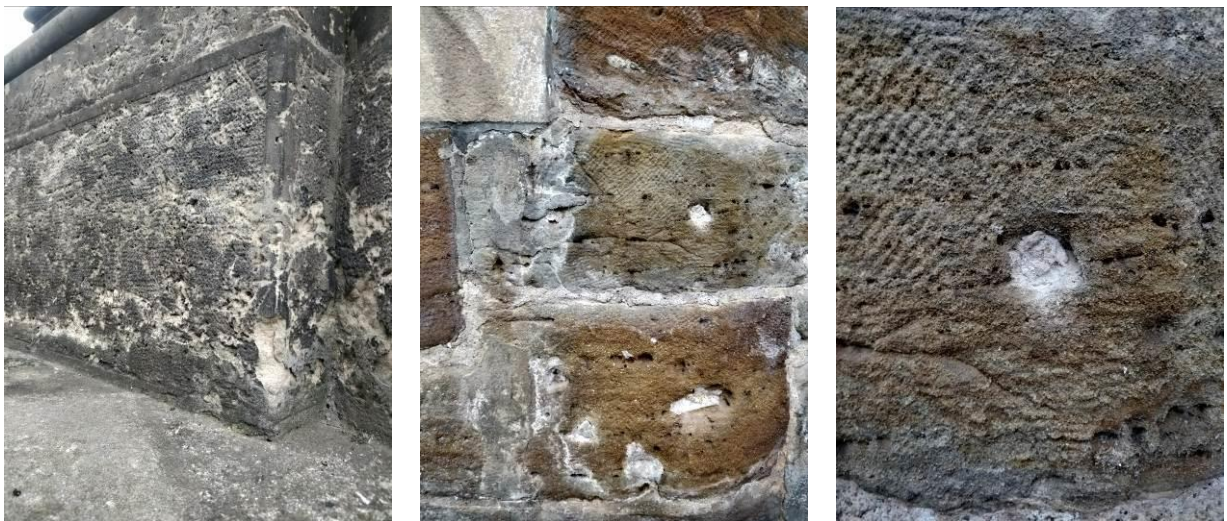
**Figure 1: Example of stone weathering and salt damage near Charles Bridge, Prague Czech Republic**

The deterioration of natural stone may be caused in many different ways due to fluctuation in moisture contents. But in porous stone the most significant deterioration agents are the atmospheric pollution, salt crystallization and freezing [5]. The assessment of material's durability in historic buildings could be understood by performing accelerated weathering tests in laboratory that can provide reliable results and suggest methods to repair and reduce their decay without changing its mechanism within a reasonable period of time. Figure 1 shows an example of stone weathering and salt deposit on the sculptures and masonry work near Charles Bridge in city of Prague, Czech Republic.

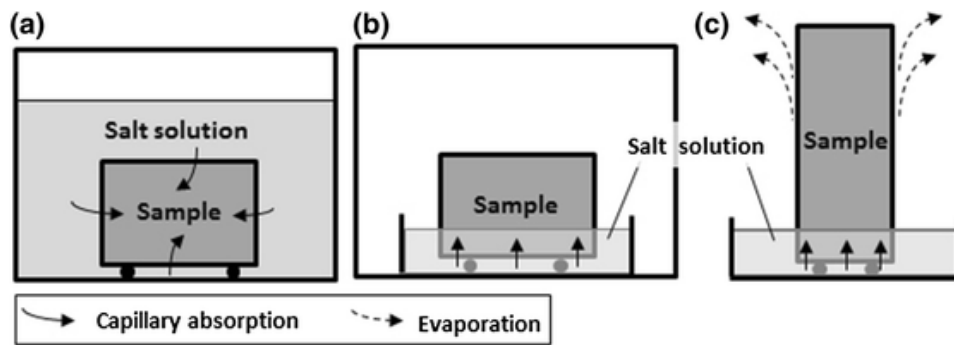
**Figure 2: Overview of the most common salt contamination procedures (a) repeated total immersion of the specimen (b) repeated partial immersion (c) continuous partial immersion[8]**

The most widely used standard test, EN 12370, relies on cycles of impregnation by full immersion (Figure 2) of specimens in a sodium sulfate solution, followed by drying at 105 °C. This leads to damage during the re-wetting phase of a cycle and, because of the contamination procedure and the extreme salt load and drying temperature, is not expected to be representative for most situations found in practice, as for example capillary rise. Therefore, the issue of knowing how to obtain reliable results from accelerated testing remains open [2].

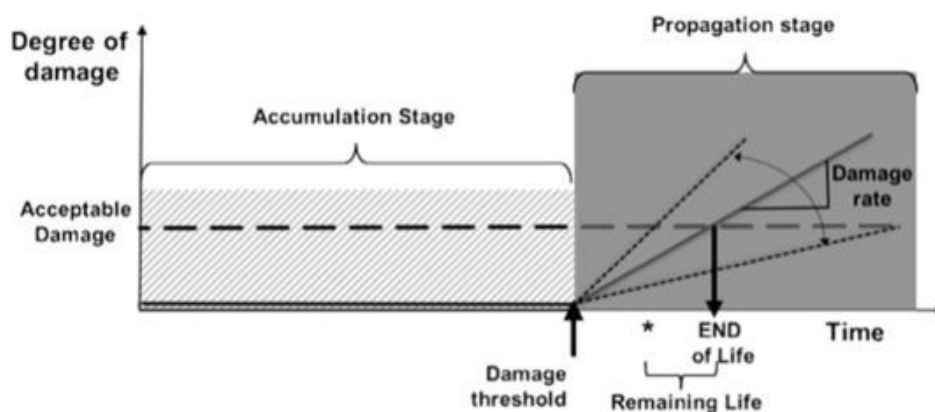
**Figure 3: Schematic representation of durability of a stone, subject to salt damage[8]**

Compared to EN 12370 standard, the salt crystallization test developed by the RILEM TC 271-ASC proposes a new approach different from existing salt crystallization tests and derived from a common approach to the durability of natural stones. It starts from the consideration that it is necessary to accumulate a certain amount of salt, i.e., reach a certain degree of pore filling before damage initiates. Salt damage can thus be seen as a process developing in two stages: accumulation and propagation Figure 3.

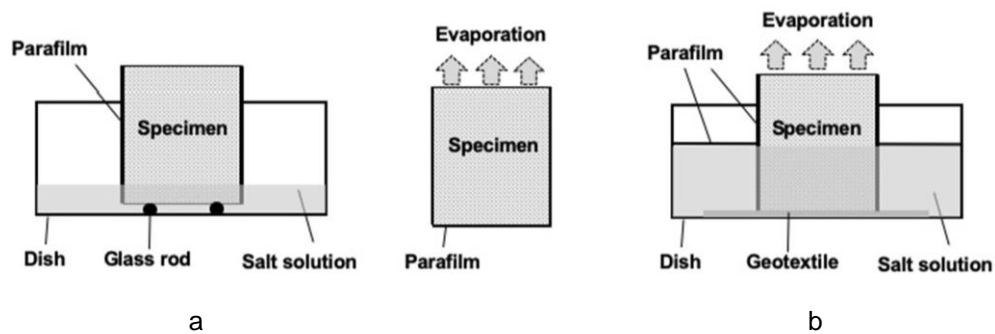
**Figure 4: Experimental setup used in the contamination experiments: (a) capillary absorption followed by drying (b) continuous capillary absorption**

The RILEM MS-A.1 also proposes the use of more realistic test conditions, i.e. contamination by capillary absorption (Figure 4) of 10 wt% sodium sulphate or sodium chloride solution followed by drying at 20 °C and 50% relative humidity (RH), but still has the important limitation of being very time consuming[22].

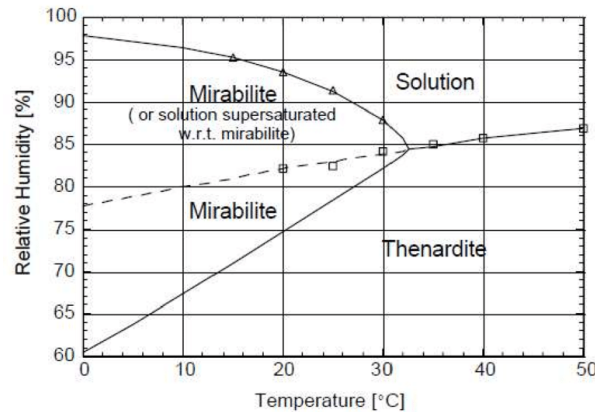
**Figure 5: Phase diagram for sodium sulfate.**

Rodriguez Navarro et al. [7,31] showed that under normal conditions, i.e., non-equilibrium, 40% RH and 20°C and relative fast evaporation, the anhydrous thenardite will crystallize directly from solution (although it is below the 32.4°C thenardite-mirabilite transition point) inducing significant deterioration to the substrate and thereby also reflecting the importance of crystallization kinetics (Figure 5). Furthermore, no direct hydration of thenardite occurred, with mirabilite being produced only from the dissolution of thenardite and its reprecipitation [7]. For materials with a relatively homogeneous pore system, those with finer pores tend to suffer more deterioration from salt crystallization than those with larger pores. Further studies by Cultrone and Sebastián [7,32] confirmed the increase of smaller pores after salt crystallization tests is possibly caused by microfissures formation. Benavente et al. [7,33] characterized material parameters of several different rocks and applied a non-standard  $\text{Na}_2\text{SO}_4$  crystallization test to determine their resistance to it. Using a principal component analysis they correlated the resulting salt weathering to the pore structure of the stone, its water transport properties, as well as its mechanical strength finding that the latter was the most important parameter in resisting this particular salt weathering in agreement with previous tests carried out on bricks [7,34]. It would appear that this nonstandard crystallization test proved to be more useful than the accepted standard test.

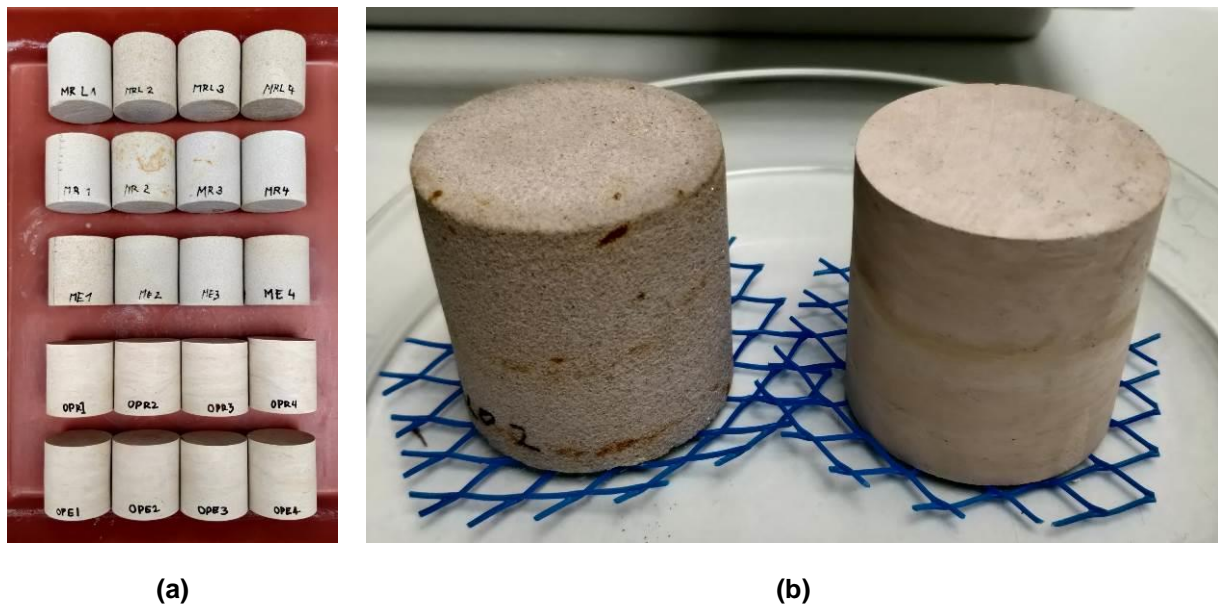
Figure 6: (a) Example of specimens used during the EN and RILEM test, (b) Mšené and Opuka stones during reference capillary test

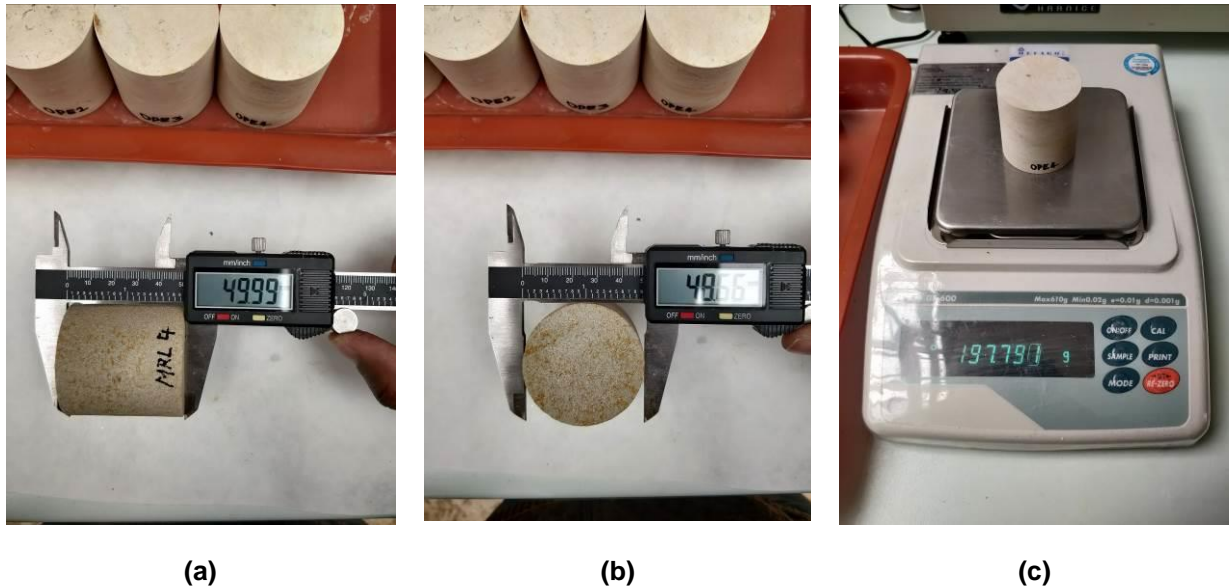
**Figure 7: Example of measurements of geometrical characteristics of specimens (a) Height (b) Diameter, (c)Weight**

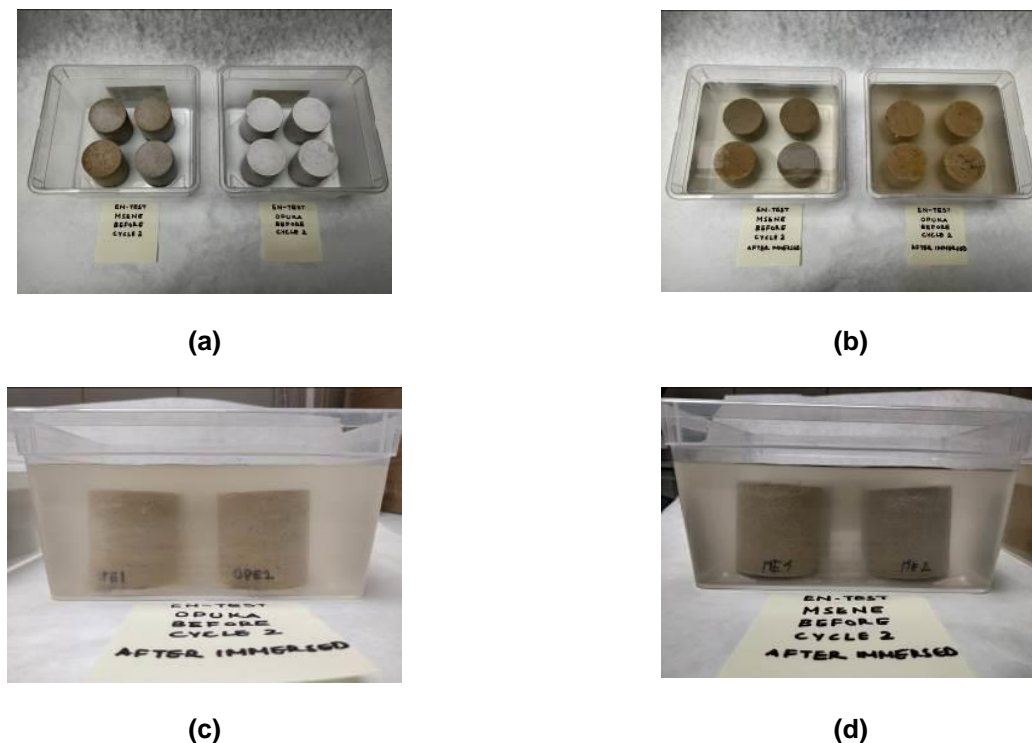
**Figure 8: Top: Example of complete immersion of EN specimens (a) Before test (b) After immersion**

**Bottom: Contamination for 2h (c) Opuka (d) Mšené**

**Test Procedure P1 – EN12370:** Following the EN 12370 Test procedure, a 14% salt solution of sodium sulphate decahydrate ( $\text{Na}_2\text{SO}_4 \cdot 10\text{H}_2\text{O}$ ) was prepared for 1-15 test cycles and the specimens were completely immersed in the salt solution for 2hrs in a rectangular plastic container measuring 19.5 x 16.5 x 9.5 cm. A group of four specimens of each stone type were kept together in one single plastic container with a salt solution ca.10mm above the top of the specimens and the containers were covered with the plastic lid to prevent evaporation. The specimens were left to soak in the salt solution for 2h at  $20 \pm 0.5$  °C.

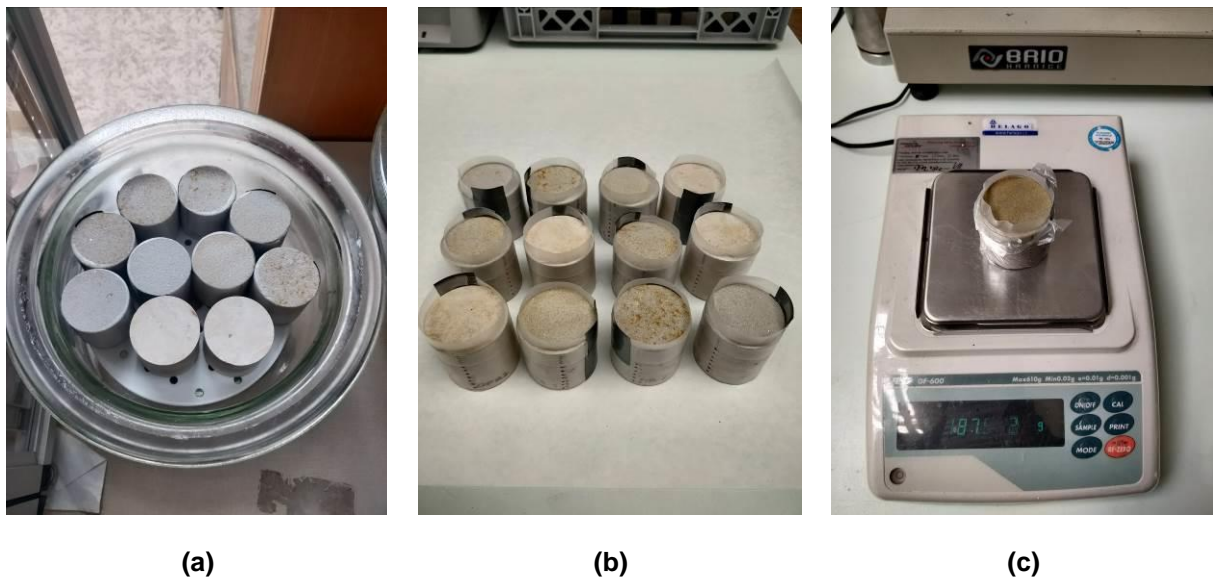
Figure 10: Examples of RILEM Samples (a) With Parafilm (b) With 5mm parafilm on top (c) Bottom sealed after salt contamination/rewetting

Before initiating the RILEM test and contaminating the specimens with salt solution, a single layer of parafilm was wrapped around circumference of core cut cylindrical stone specimens which was secured using a textile tape to ensure adequate sealing of the specimens during the wetting and drying phase. Additional layer of parafilm was also wrapped around the top of the specimens extending 5mm above the top surface to collect efflorescence or material debris during the RILEM test. After wrapping specimens with parafilm, the ultrasonic pulse velocity (UPV) test was performed on each RILEM test specimens in their initial dry (sound) state without any damage.

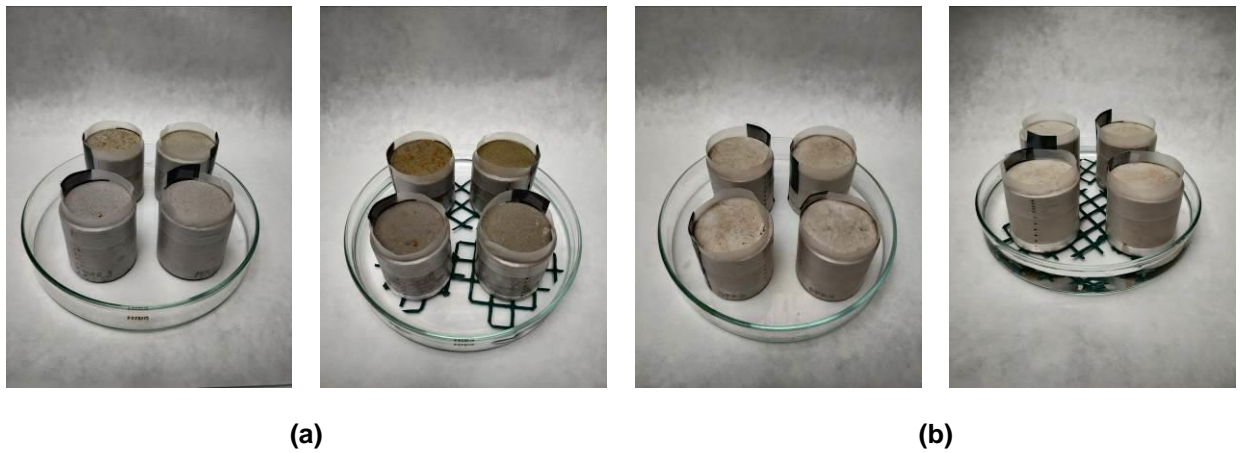
**Figure 11: Example of RILEM samples partial immersion before and after salt contamination (a) Mšené (b) Opuka**

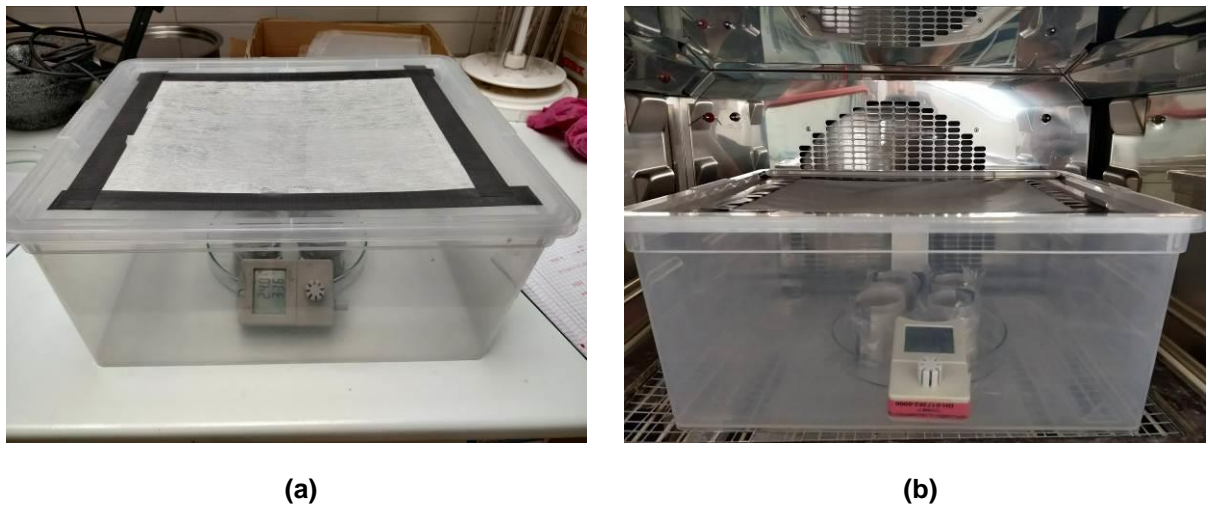
**Figure 12: Example of RILEM samples during oven drying (a) Drying room conditions (b) Oven drying**

on top to maintain reduce air flow which resembles the in-situ conditions. Samples during the accumulation phase were dried at 40°C / 15±5% RH in oven by maintaining low air low.

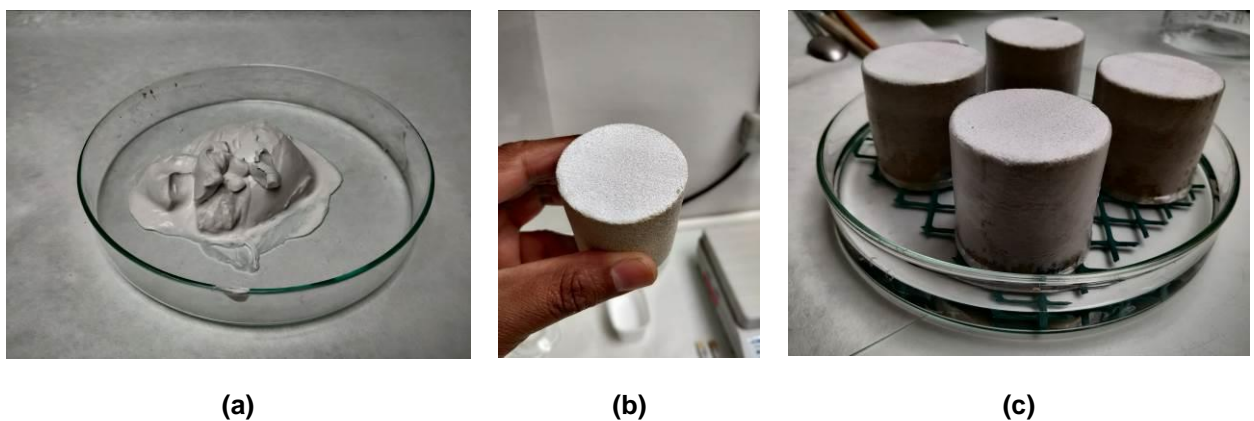
**Figure 13: Example of lime coated Mšené samples used during RILEM test procedure P2 (a) Lime Putty (b) Lime painted specimen (c) Salt contamination of limewash coated samples**

**RILEM with 1 salt contamination and limewash:** Before beginning the RILEM test, group of selected 4 Mšené stone specimens (MRL1-MRL4) were coated with limewash application over its evaporative surface to assess the antiseptic properties of limewash against the salt crystallization. A pure lime putty with mass of ca.  $50\pm 3$  wt.% of class CL90 was used on the specimen's evaporative surface which was prepared by storing air lime hydrate powder under water for 1 year following standards of EN459-1 [42]. Before applying the first coat of limewash, the specimen's top surface was wetted with distilled water using soft brush to ensure adequate penetration and adherence of the limewash inside the porous structure of the specimens and avoiding crazing of the limewash paint. A total number of 6 limewash coats were applied on each specimen's top surface at a regular interval of 24h in a crisscrossed manner and the weight of each specimen was recorded before and after application of limewash coats. The rest of the test procedure of sample preparation, accumulation phase and propagation phase was same as for uncoated Test Procedure P2.

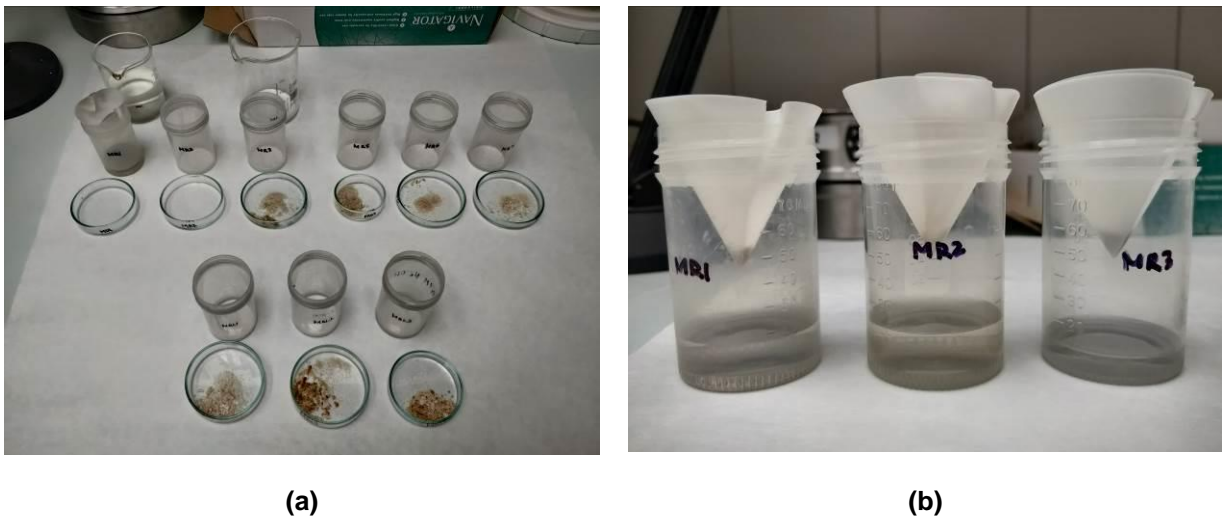
**Figure 14: (a) Example of debris collected during RILEM test (b) Example of materials loss calculated using filtration method**

During the RILEM test cycles, the weight of each specimen was recorded both before and after salt contamination and the amount of salt absorbed by the specimens was calculated during the accumulation phase which helped quantifying the salt efflorescence developed during each propagation cycle. As RILEM test was carried out in two phases: accumulation and propagation, during the drying stage of two phases the weight of each specimen was regularly monitored at an interval of ca.24h until 80% of the moisture had evaporated. At end of drying cycles during the propagation phase, the debris (salt efflorescence and material loss) were collected from specimen's evaporative surface using a soft brush and they were weighed on a digital balance with resolution of  $10^{-4}$ g and accuracy of  $10^{-3}$ g. At the completion of RILEM test, the debris collected were diluted in distilled water and were filtered with the help of filter paper to quantify the material loss and calculate the salt efflorescence developed in each propagation cycle (Figure 14). The filtration of the debris was only carried out for the RILEM specimens [8].

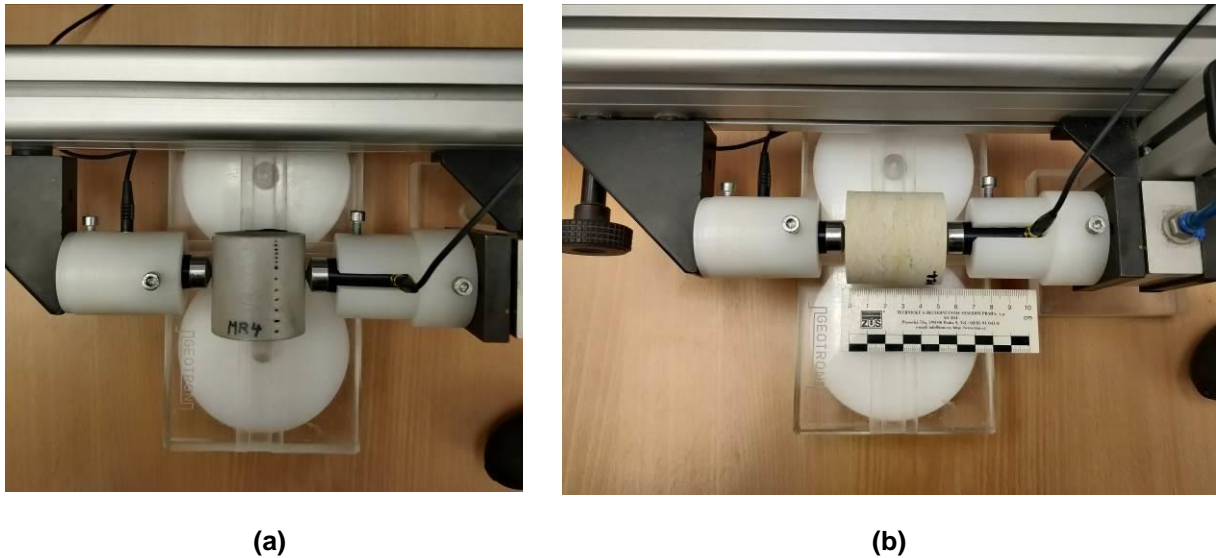
Figure 15: **Example of ultrasonic tests performed on specimens (a) through diameter (b) through height)**

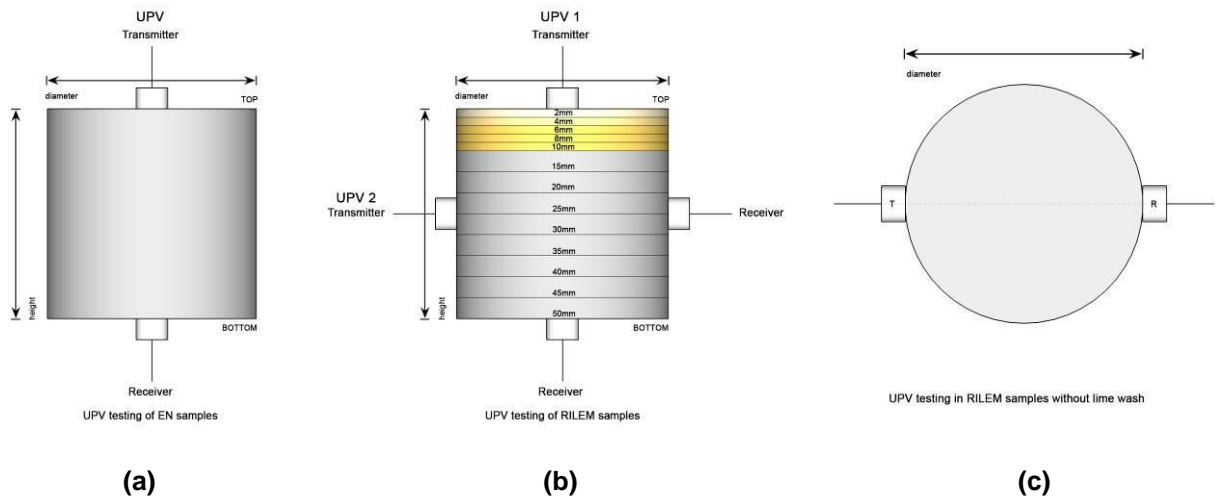
**Figure 16: Determination of ultrasonic velocity by the direct transmission method (a) UPV in EN samples (b) UPV in RILEM samples along height (c) UPV in RILEM samples along diameter**

UPV measurements were performed to assess the salt distribution non-destructively, using a portable instrument (USG 40 Krompholz Geotron Elektronik (DE) with pointy-ended transducers with a contact section of  $\varnothing$  2 mm. Only one measurement on EN specimens was taken through the height as compared to RILEM specimens. UPV test in RILEM specimens was performed through the height at the center of specimen and through the diameter along the height of the specimens. Along the height, first 10mm was marked at interval of 2mm where the salt concentration was expected to be higher and then followed by marking specimens at interval of 5mm each till the bottom of the RILEM test specimens show in Figure 16. Initial UPV test was also performed on EN and RILEM test specimens in their sound state. During the test UPV was performed after cooling the specimens at the end of each test cycle.

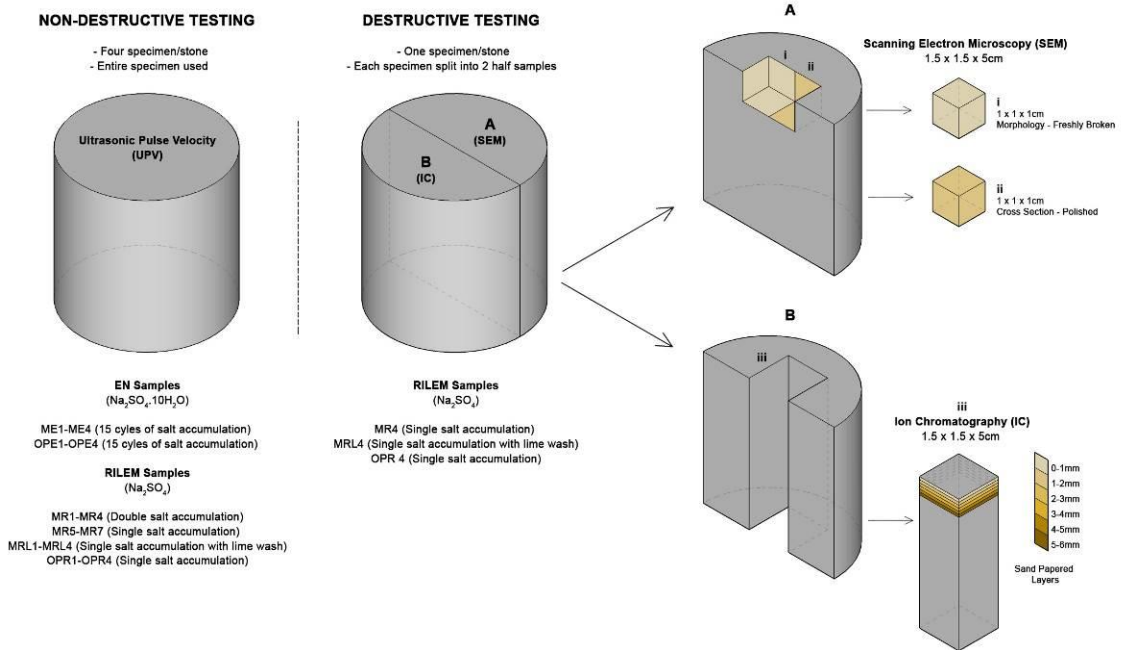
Figure 17: Schematic representation of specimens used for destructive and non-destructive testing

The sodium sulphate (5wt.%  $\text{Na}_2\text{SO}_4$ ) salt concentration and distribution was only analyzed for the selected stone specimens tested with RILEM procedure using two destructive testing methods: ion chromatography (IC) and scanning electron microscopy (SEM). The Mšené (uncoated and limewash coated) and Opuka (uncoated) specimens analysed with IC and SEM were only contaminated once with salt solution during the accumulation phase. At the end of single salt accumulation phase, the stone specimens MR4, OPR4 and MRL4 were split into two equal halves (along the height) using a hammer and a chisel after they were completely dried (Figure 18). Before splitting the selected stone specimens, the non-destructive UPV test was also conducted as per methodology discussed in previous section to compare the results from the destructive and non-destructive test and check the reliability of the two testing methods for salt distribution and damage propagation assessment. Figure 17 below summarizes the type of specimens selected for IC and SEM analysis for assessment of salt distribution

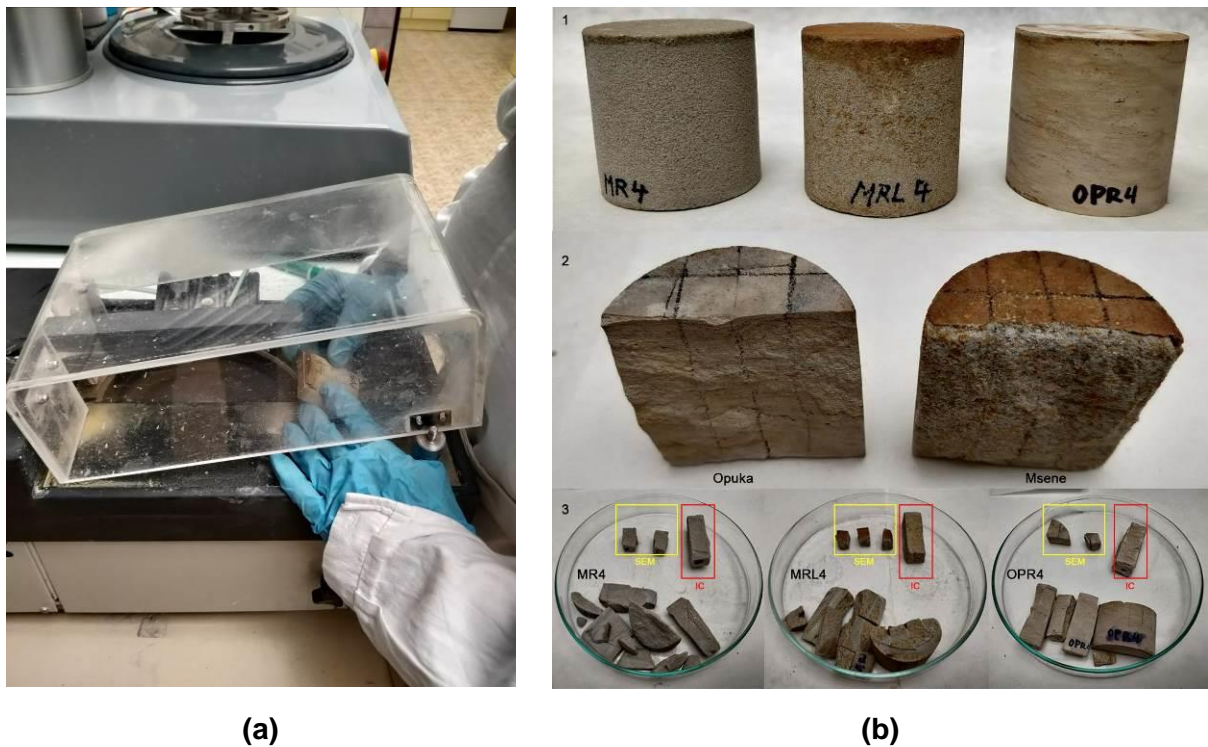
Figure 18: (a) Example of sample preparation (b) Example of prepared samples

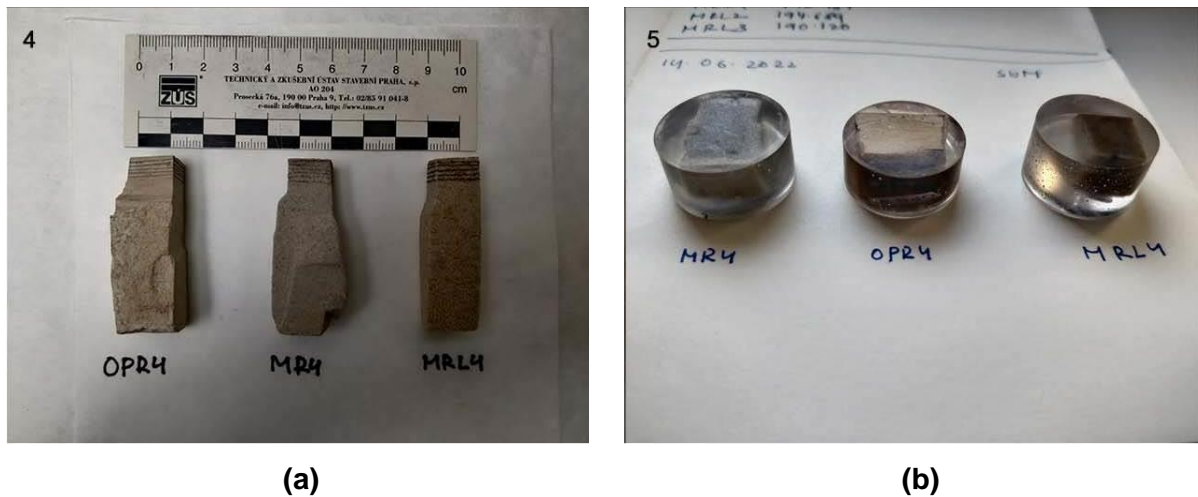
**Figure 19: (a) Example of samples marked equally at 1mm interval for salt with ion chromatography analysis at each layer from evaporative surface (b) SEM samples embedded in epoxy resin and prepared for microscopic analysis**

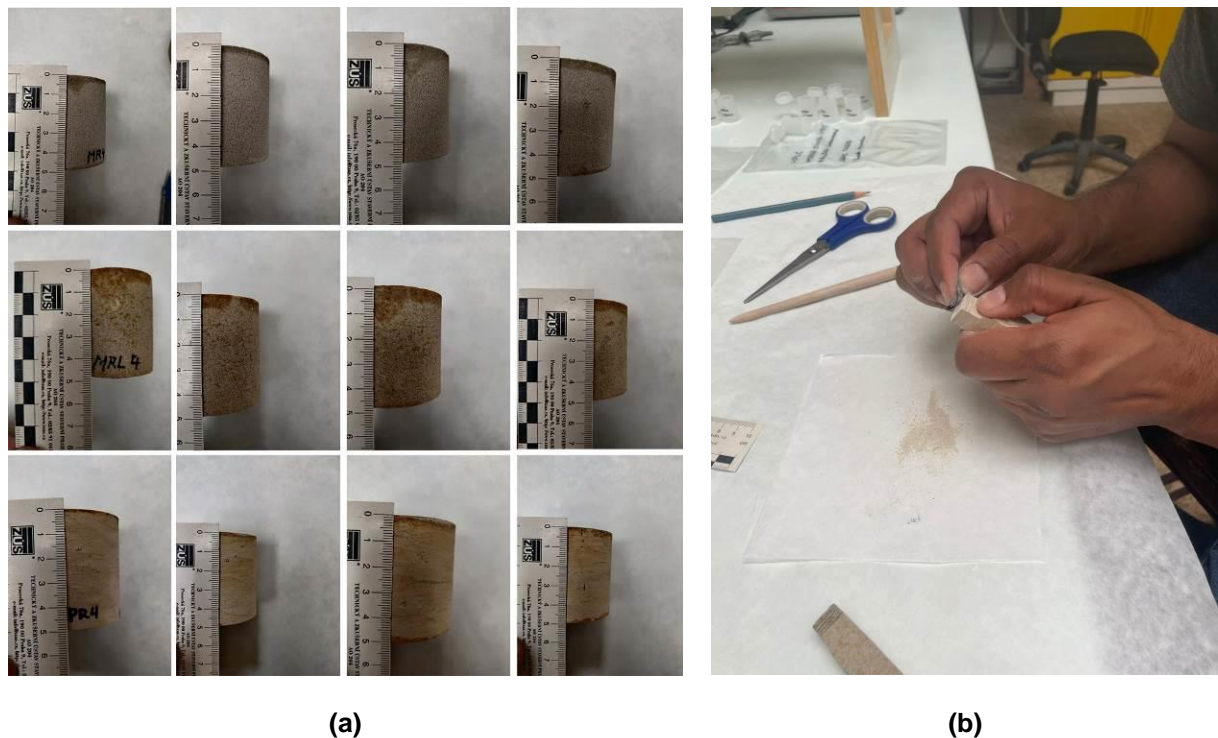
**Figure 20: (a) Visible salt layer formed after drying specimens during RILEM test accumulation phase (b) Grinding of specimen manually into fine power for each 1mm layer for ion chromatography (IC) test**

The salt concentration near the evaporative surface was only analysed for the RILEM lime coated (MRL4) and uncoated Mšené (MR4) and Opuka (OPR4) stone specimens through means of ion chromatography using Dionex ISC-5000. A rectangular cross-section sample measuring 1.5 x 1.5 x 5 cm was cut through the first half part of the RILEM stone specimens using a mechanical saw cutter using isopropanol to avoiding any salt dissolution [Figure 18(a)]. Using a pencil, reference lines were marked on the cross-section obtained at an interval of 0-1, 1-2, 2-3, 3-4, 4-5 and 5-6mm starting from the top of evaporative surface up to the depth of 6mm Figure 19(a). Each 1mm layer of the cross-section was manually hand grinded [Figure 20(b)] into a fine powder using a fine grade sand paper to get the precise information about the salt distribution in the first salt-rich outer layers [Figure 20(a)]. The weight of the grinded salt and stone powder was kept within the same range to acquire more precise results. Anions ( $\text{SO}_4^{2-}$ ) and cations ( $\text{Na}^+$ ) were analysed by ion chromatography (IC) for each layer and the results in parts per million (ppm-mg/L) were converted to wt.% (relative to the dry sample weight) and the sum of the equimolar contents of  $\text{Na}^+$  and  $\text{SO}_4^{2-}$  was estimated. The salt amount present in each layer was calculated as the percentage of the total salt content present in the sample during accumulation phase. The average amount of each ion (in wt.%) in each group of three specimens contaminated with each procedure was calculated in relation to the respective total weight of each group of samples.

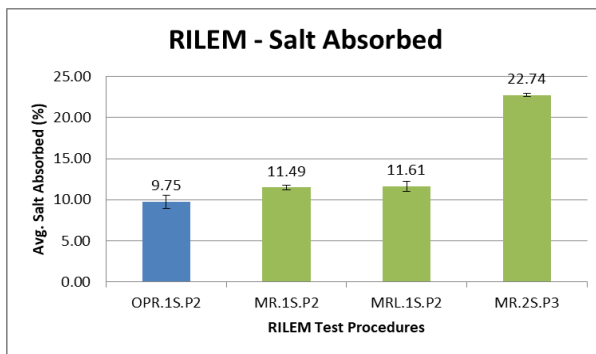
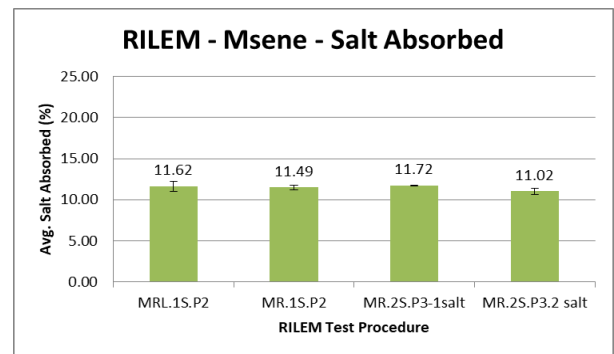
**Graph 1: Average salt absorbed amount (wt. %) during salt accumulation phase with RILEM procedure P2 and P3 (a) Comparison of Mšené and Opuka stones (b) Comparison of only Mšené stones**

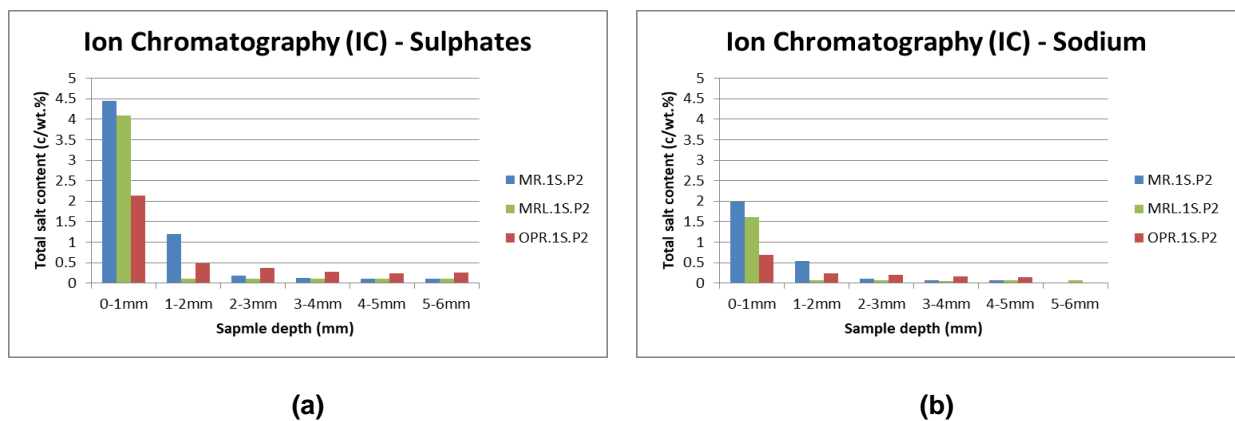
**Graph 3 Salt distribution upto 6mm depth from evaporative surface with procedure P2**

Assessment of salt distribution and its concentration inside the aged specimens was only studied on specimen tested with RILEM standards using destructive testing through ion chromatography. One sample of uncoated Mšené (MR4), limewash coated Mšené (MRL4) and uncoated Opuka (OPR4) was selected from group of four samples aged with test procedure P2 (1-Salt accumulation). The salt distribution depth analyzed with IC provided useful information about the salt crystallization damage near the evaporative surface of specimens. The higher salt concentration near the evaporative surface in RILEM specimens implies risk of potential damage due to increased crystallization pressure.

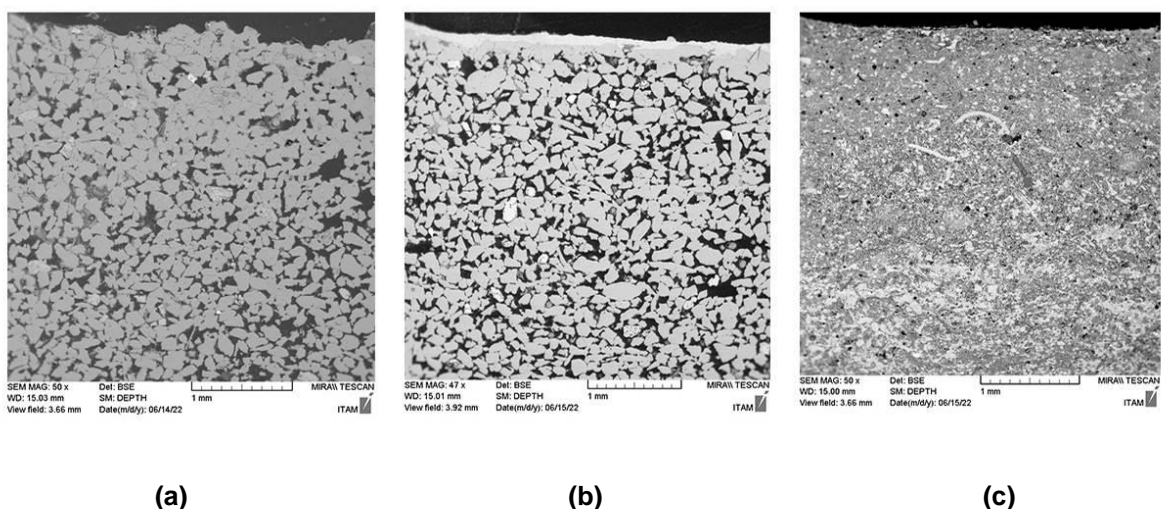
**Figure 21: SEM investigation of salt laden samples (cross sections) showing granular structure (a) Mšené uncoated (b) Mšené lime coated (c) Opuka uncoated with 1-salt accumulation**

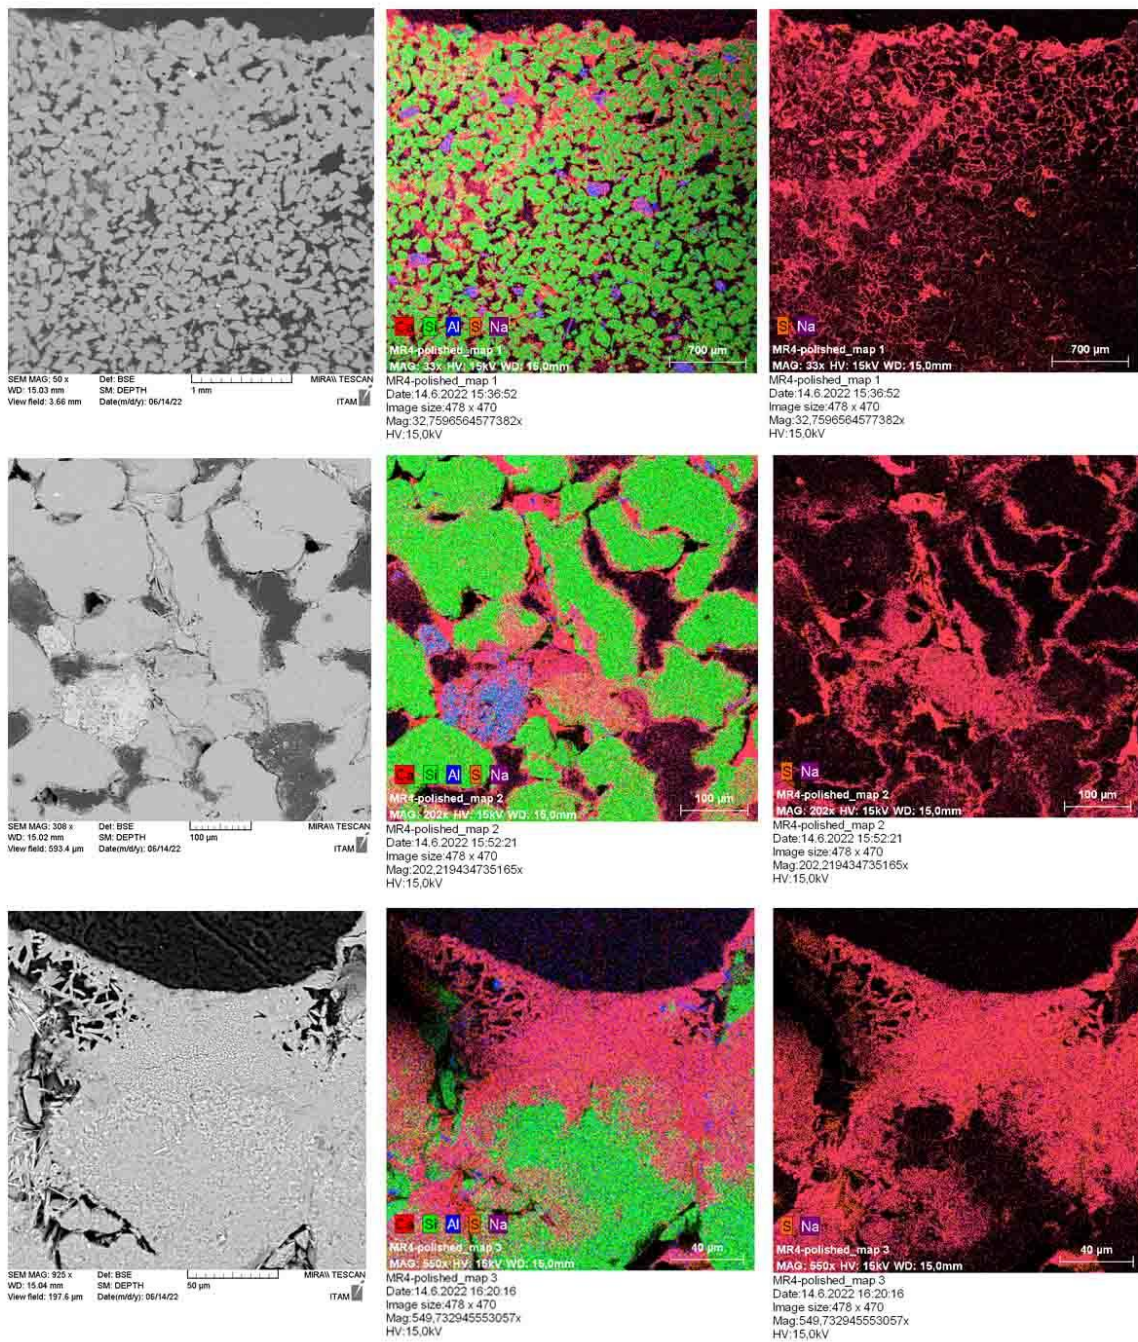
Figure 22: SEM microphotographs of uncoated Mšené stone (MR4) with RILEM procedure P2

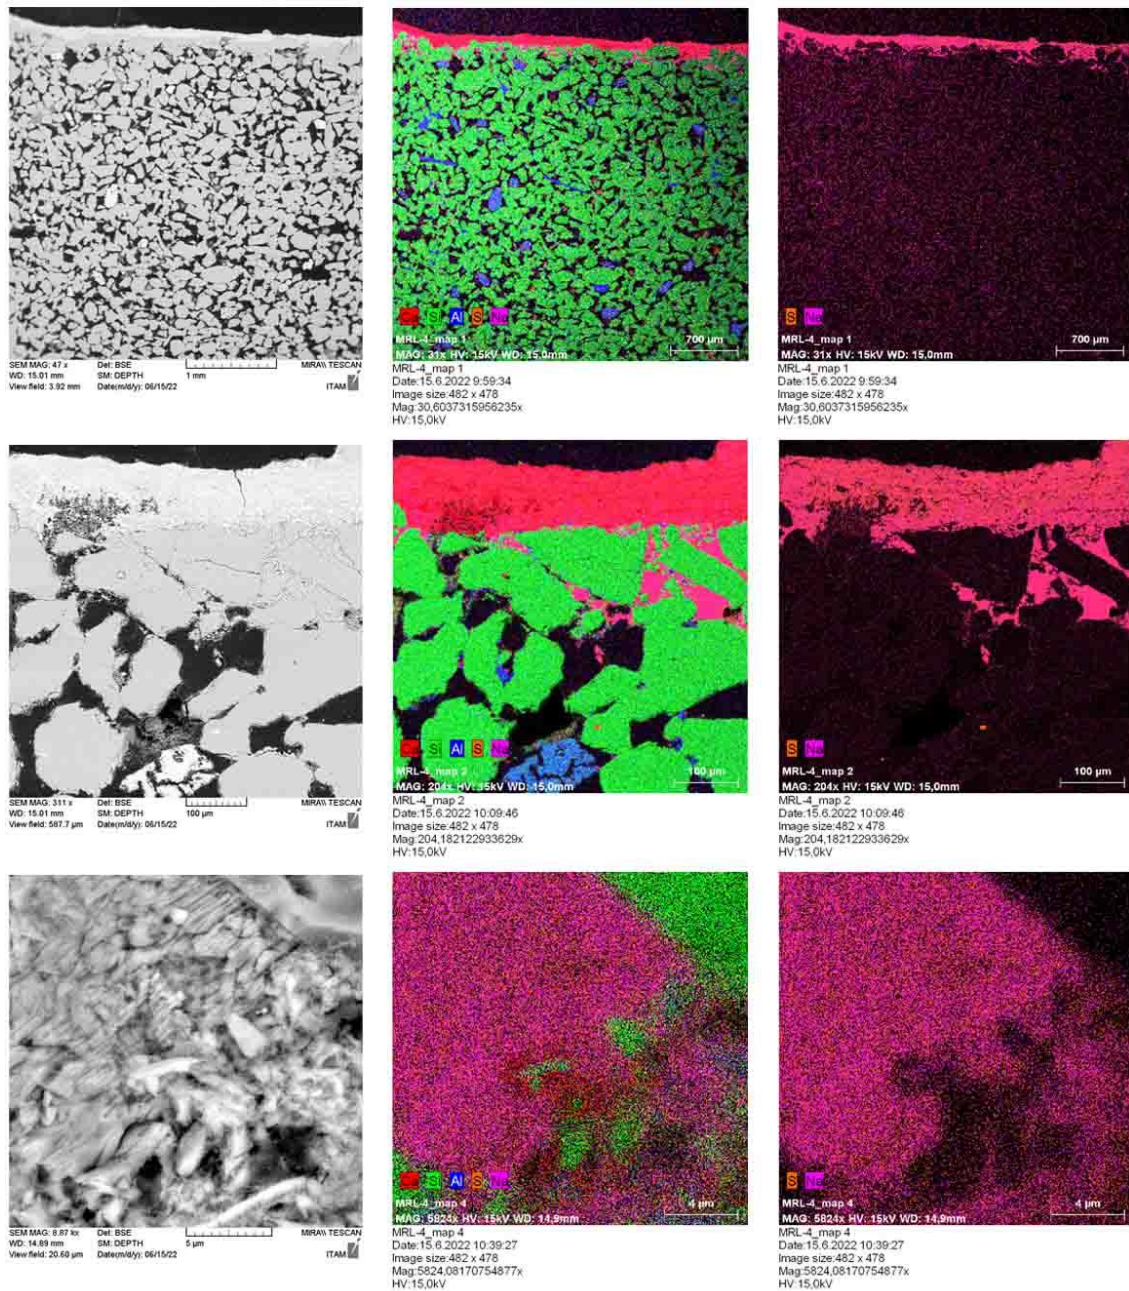
Figure 23: SEM microphotographs of limewash coated Mšené stone (MRL4) with RILEM procedure P2

The salt crystals in the Mšené limewash coated specimens were hard to distinguish because of the layer of the lime penetrated beneath the evaporative surface, but with few point imaging the salt crystals were located but it is inconclusive to say the found crystals were salts as elemental mapping was ineffective for such greater magnification due to sensitivity of electron beam.

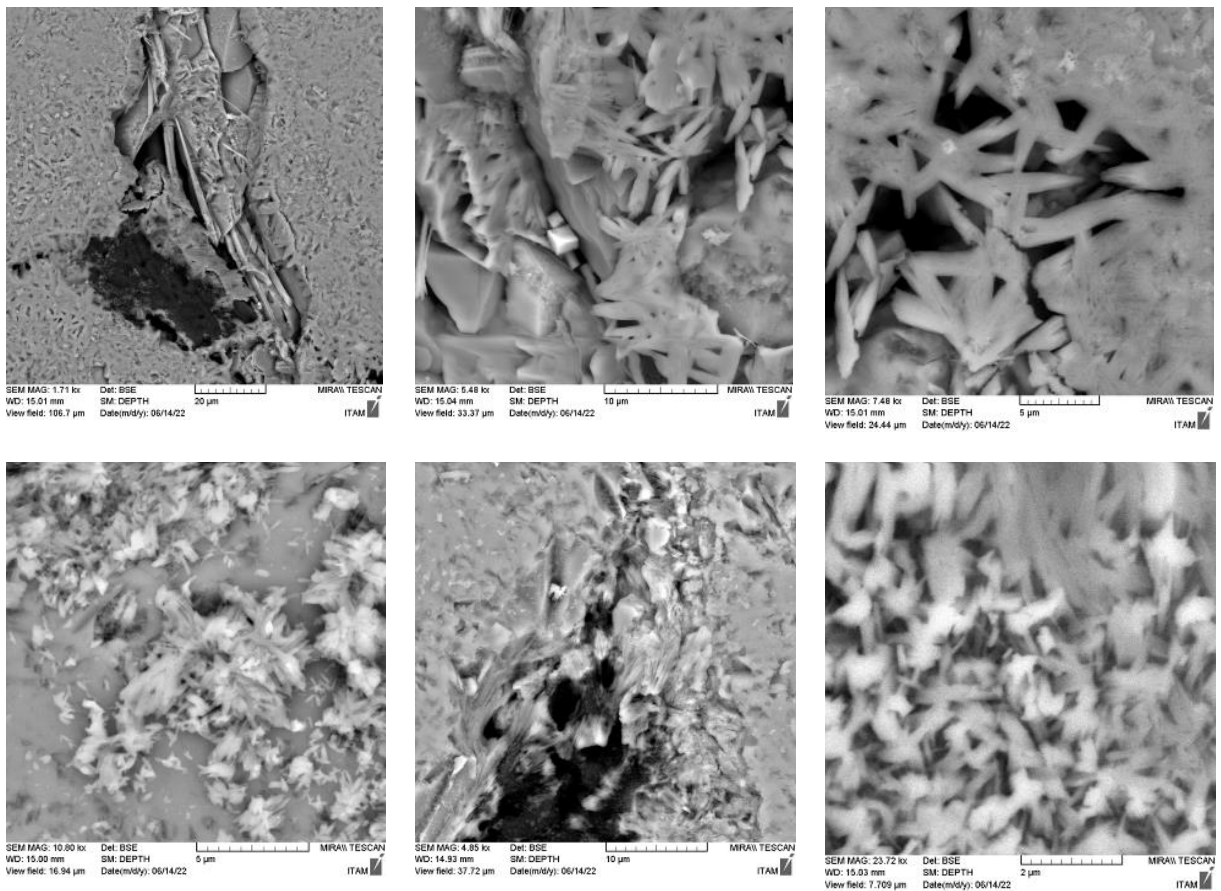
**Figure 24: SEM microphotographs of salt crystals created in pores of Mšené stone (MR4, uncoated)**

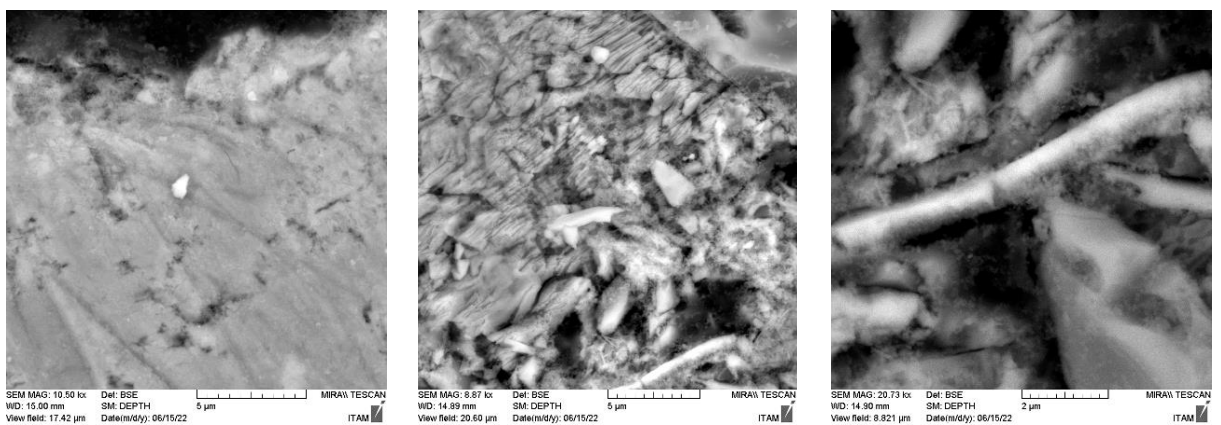
**Figure 25: SEM microphotographs of salt crystals created in pores of Mšené stone (MRL4, limewash coated)**
