ADVANCED MASTERS IN STRUCTURAL ANALYSIS OF MONUMENTS AND HISTORICAL CONSTRUCTIONS

# Master's Thesis

**A new laboratory test to assess the resistance of porous materials to salt crystallization: Assessment of natural stone painted with limewashes**

University of Minho

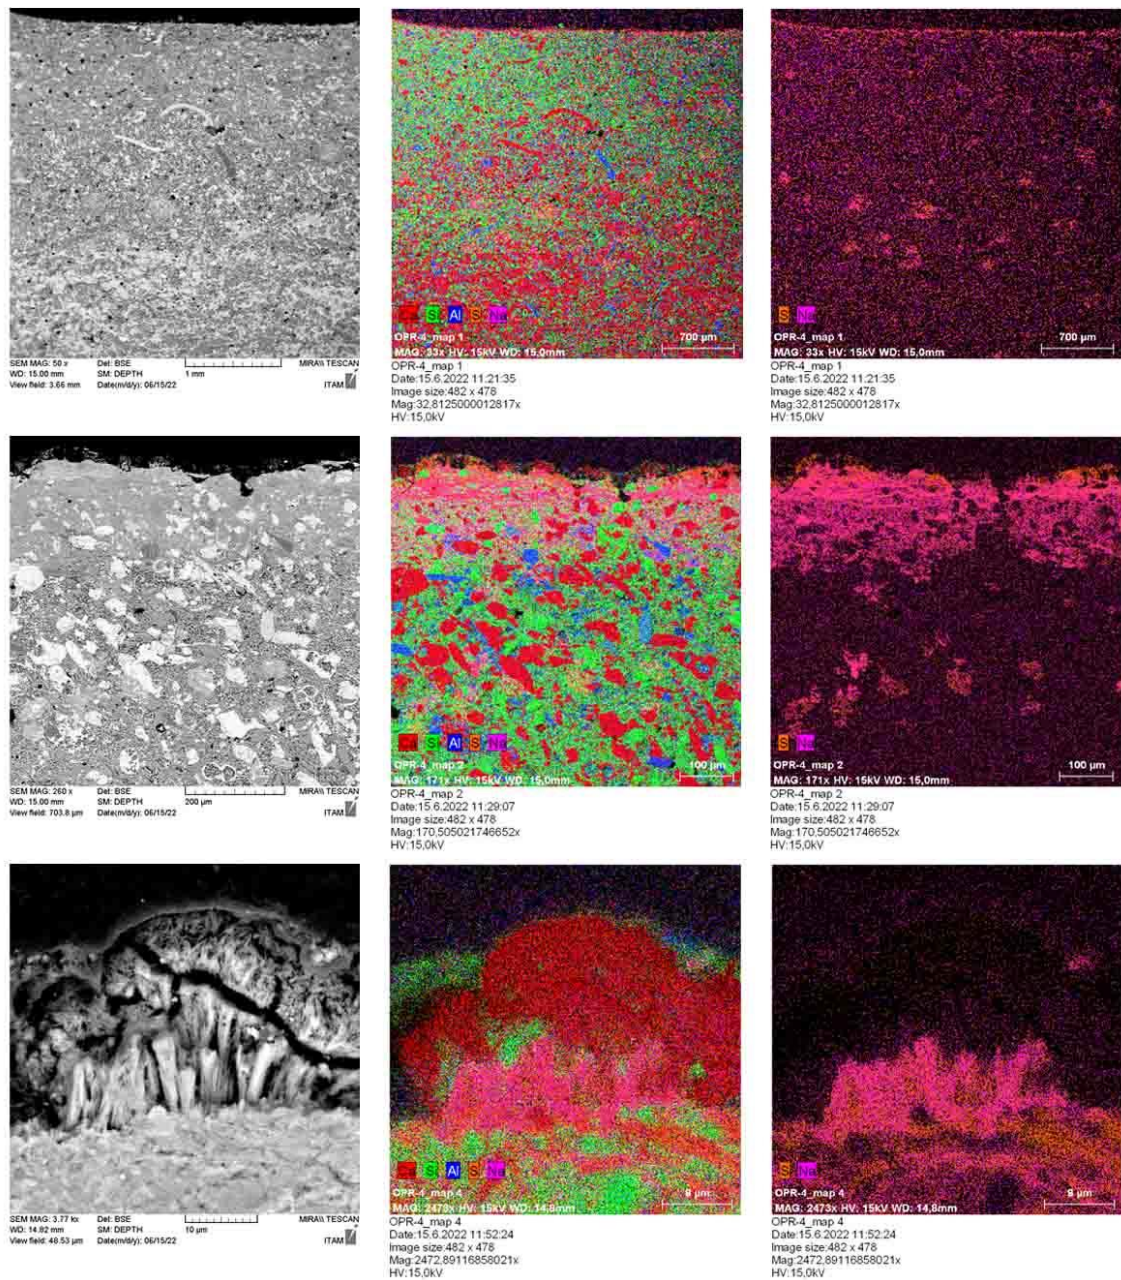
**Figure 26: SEM microphotographs of uncoated Opuka specimen (OPR4) with RILEM procedure P2**

evaporative surface as it was in the case of Mšené. As the SEM analysis was only done for the first 2mm beneath the evaporative depth it did not give the fair conclusion about the concentration of sodium sulphate near the evaporative surface. Due to the small pore size of Opuka compared to Mšené it could be estimated even the salt migrated towards the evaporative surface but they were confined in the fine pores which was hard to detect even through elemental mapping. There were very rare locations where few salt crystals were detected near the evaporative surface which are presented in Figure 26 (mid and bottom row). The salt crystals formed were hard to see through the element mapping again due to limitation of the magnification but few salt crystals formed near the evaporative surface as shown in Figure 27. More SEM analysis along the depth could give much better understanding of the salt distribution inside the pores of Opuka stone.

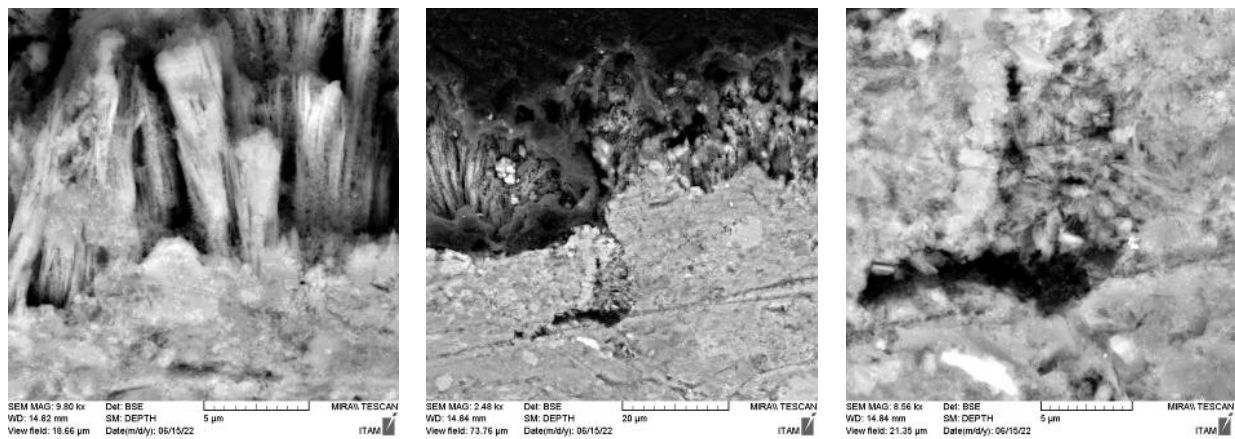
**Figure 27: SEM microphotographs of salt crystals created in pores of Opuka stone (OPR4, uncoated)**

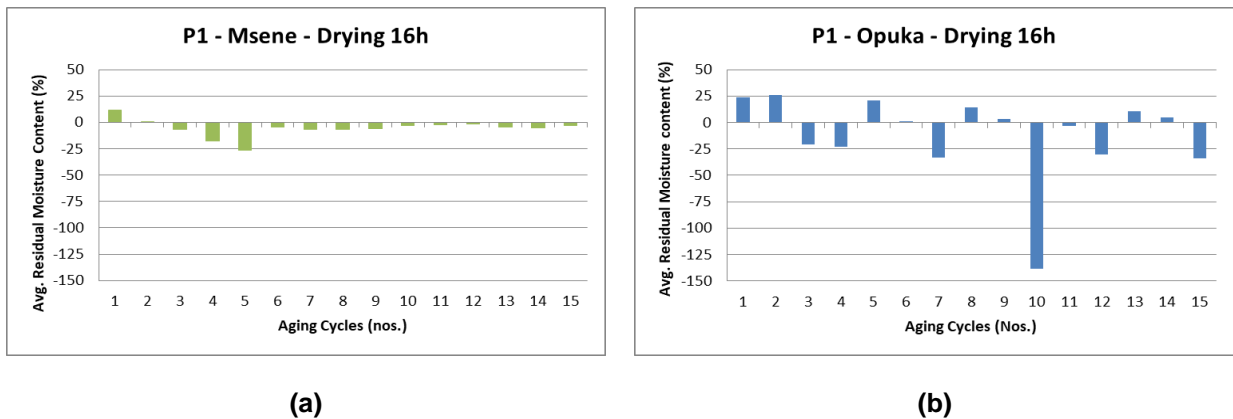
**Graph 4: Average residual moisture content after 16h of drying (a) Mšené (ME1-ME4) (b) Opuka (OPE1-OPE4) stones with EN procedure P1**

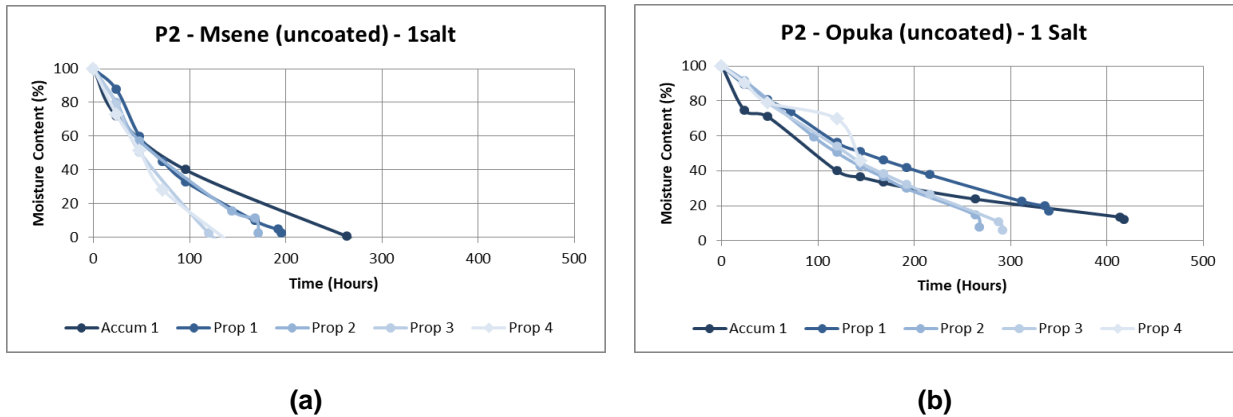
**Graph 5 : Comparison between drying time (a) Mšené stone (uncoated MR5-MR7) (b) Opuka stone (uncoated OPR1-OPR4) with procedure P2 following RILEM standards**

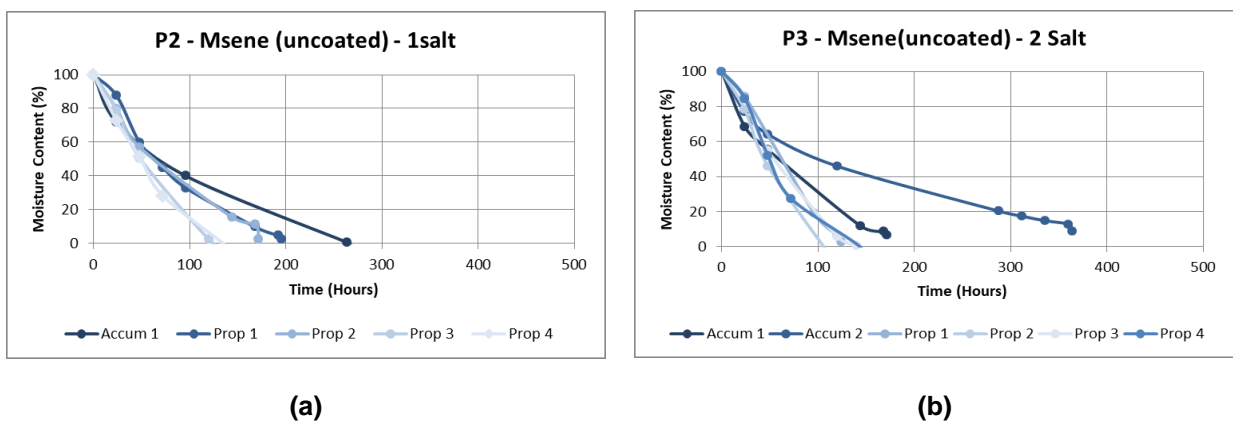
**Graph 6 : Comparison between drying time (a) Mšené stone (uncoated MR5-MR7) with procedure P2 (b) Mšené stone (uncoated MR1-MR3) with procedure P3 following RILEM standards**

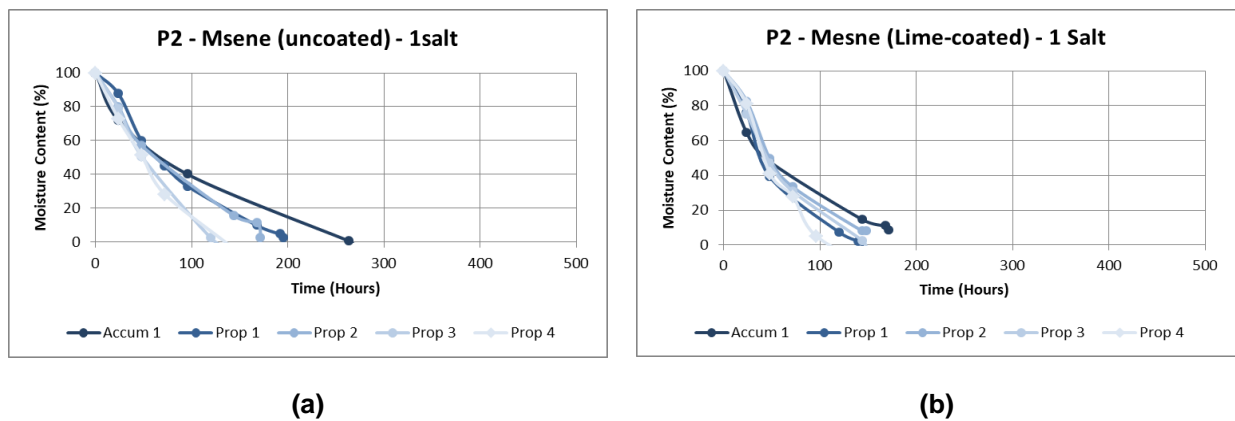
**Graph 7 : Comparison between drying time (a) Mšené stone (uncoated MR5-MR7) (b) Mšené stone (limewash coated MRL1-MRL4) with procedure P2 following RILEM standards**

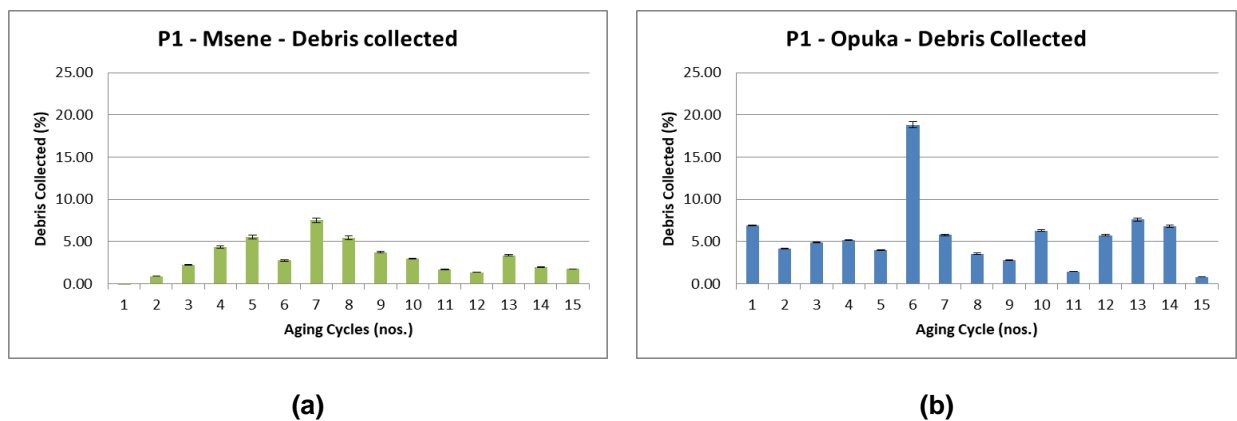
**Graph 8: Average Debris brushed off from (a) Mšené stone (b) Opuka stone aged with procedure P1**

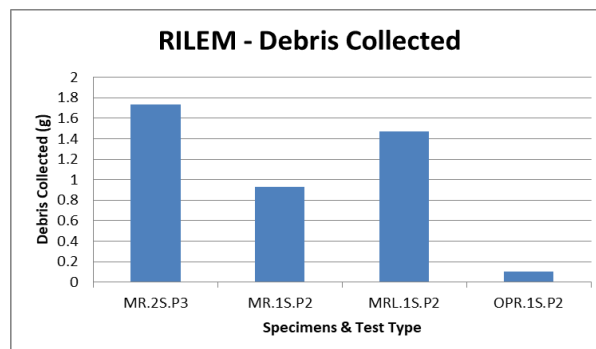
**Graph 9: Debris collected from RILEM test specimens tested with procedure P2 and P3**

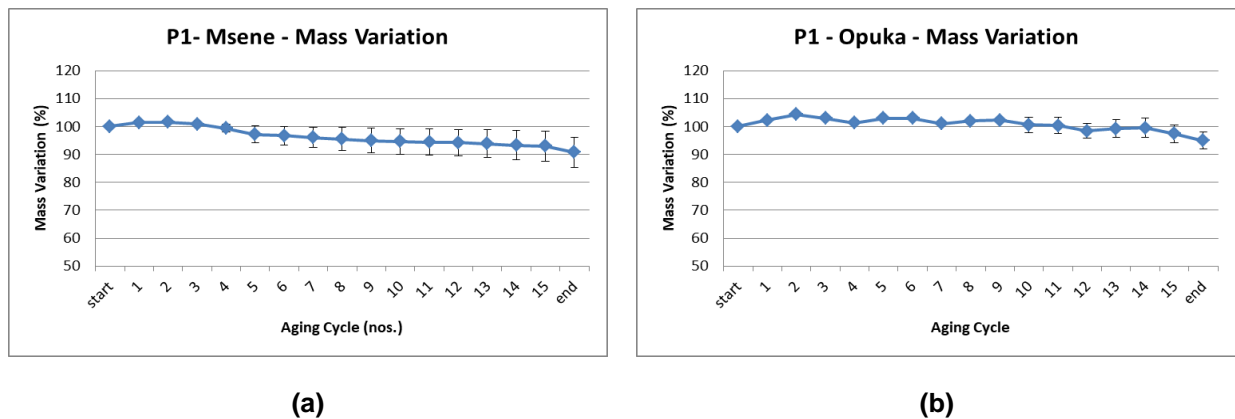
**Graph 10: Mass variation of (a) Mšené and (b) Opuka specimens with EN procedure P1**

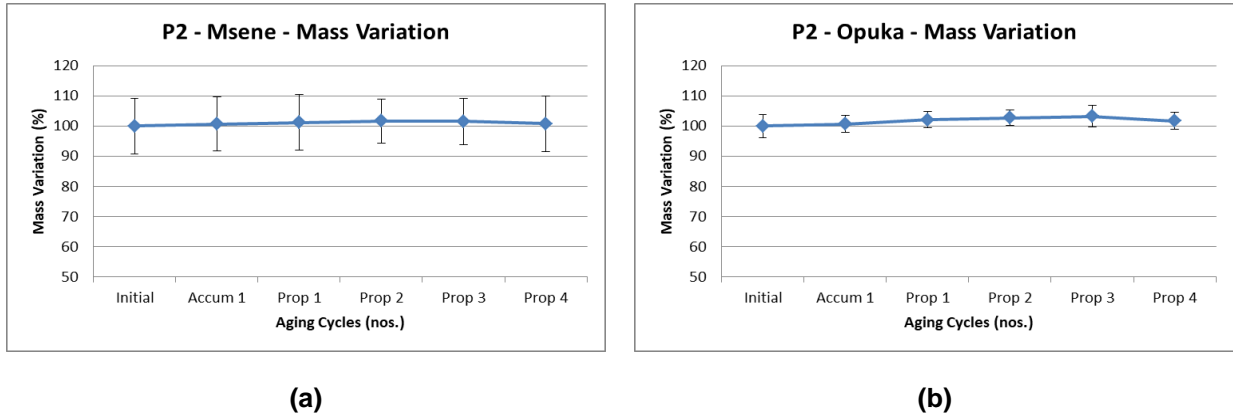
**Graph 11: Mass variation comparison of (a) uncoated Mšené and (b) uncoated Opuka specimens with procedure P2**

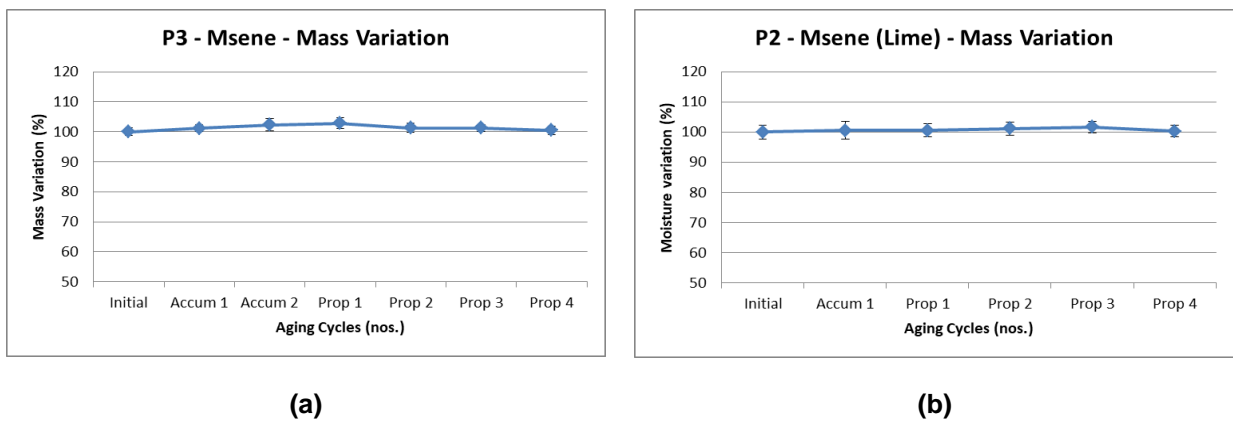
**Graph 12: Mass variation in (a) uncoated Mšené (2-Salt) with procedure P3 and (b) limewash coated Mšené specimens with procedure P2**

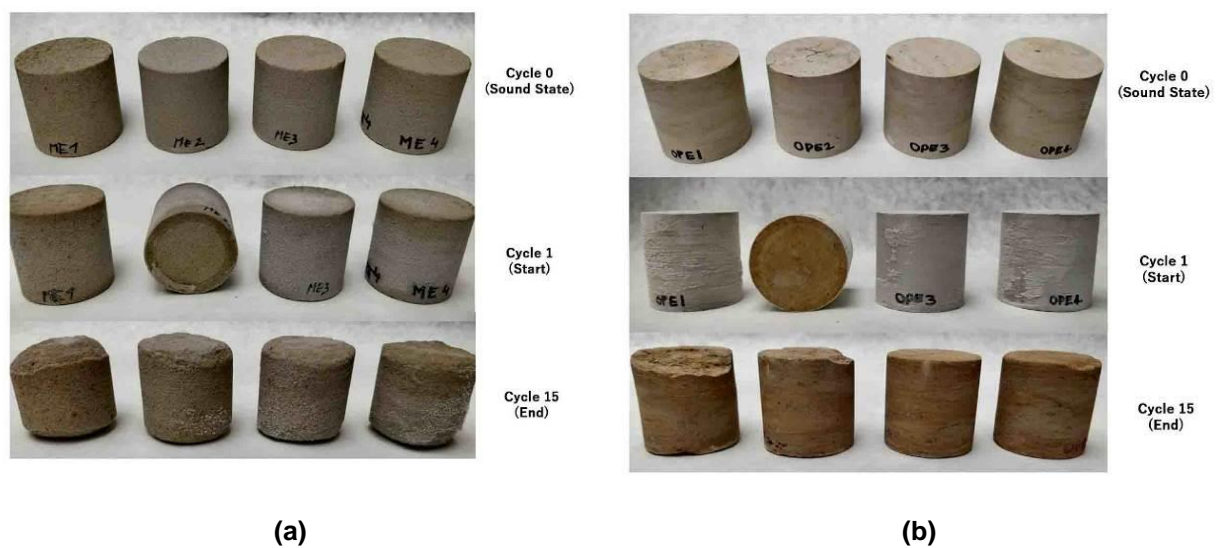
Figure 28: Example of Mšené (a) and Opuka (b) specimen deterioration

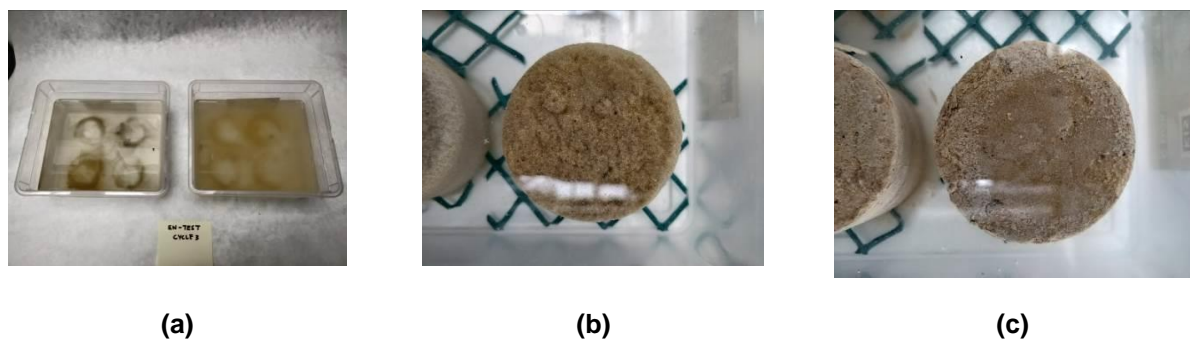
Figure 29: Example of material loss during EN12370 tests (a) Material Loss during wetting stage (b) Sand disintegration in Mšené specimens (ME1-ME4) (c) Scalping of sedimentation layers from sides of Opuka specimens (OPE1-OPE4)

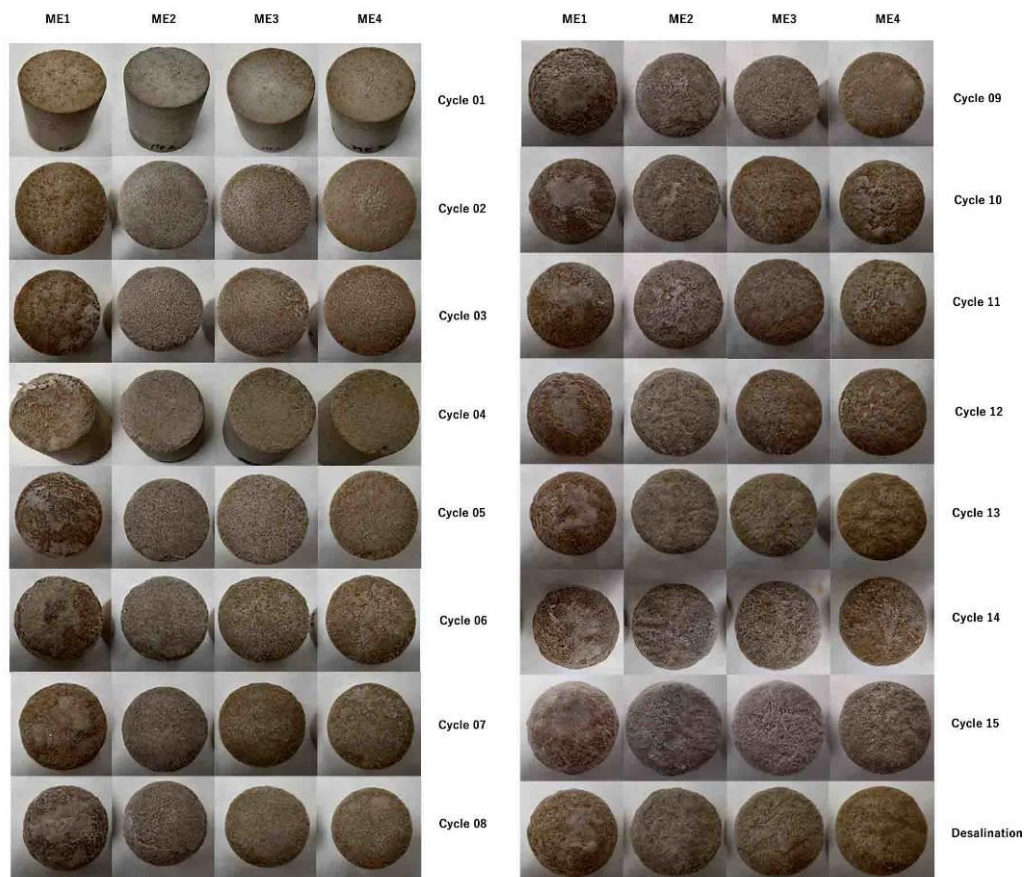
**Figure 30: Example of chromatic alteration and material deterioration of EN Mšené specimens (ME1-ME4) tested with procedure P1 during 15 cycles**

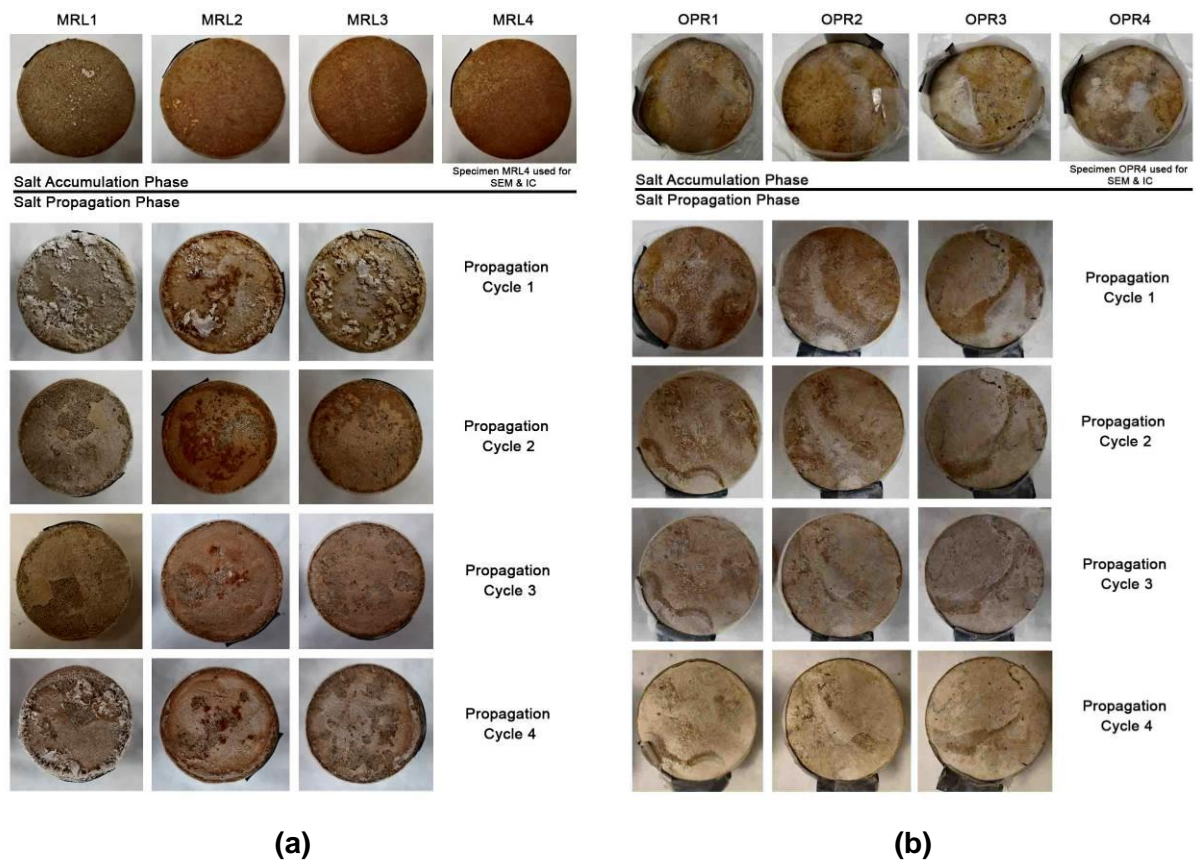
Figure 33: Summary of macroscopic visual observations during RILEM tests (a) 1-Salt contamination cycle, limewash coated Mšené specimens (MRL1-MRL4) tested with procedure P2 (b) 1-Salt contamination cycle, uncoated Opuka specimens (OPR1-OPR4) tested with procedure P2

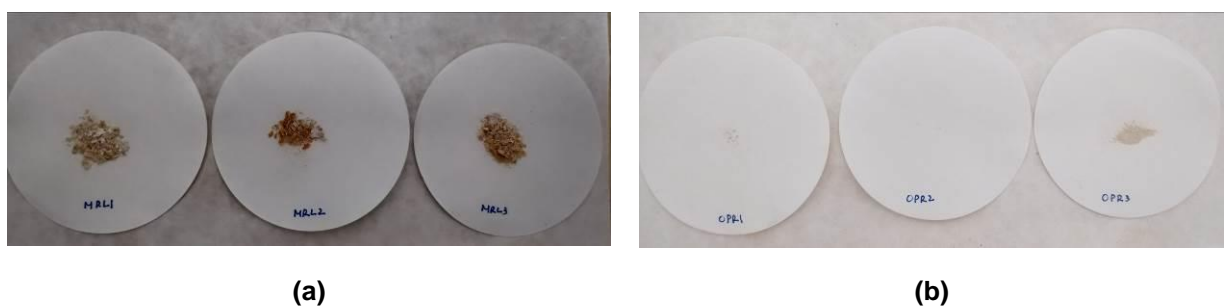
Figure 34: Example of debris (salt efflorescence and material loss) collected during RILEM tests (a) 1-Salt contamination cycle, lime-coated Mšené specimens (MRL1-MRL4) tested with procedure P2 (b) 1-Salt contamination cycle, uncoated Opuka specimens (OPR1-OPR4) tested with procedure P2

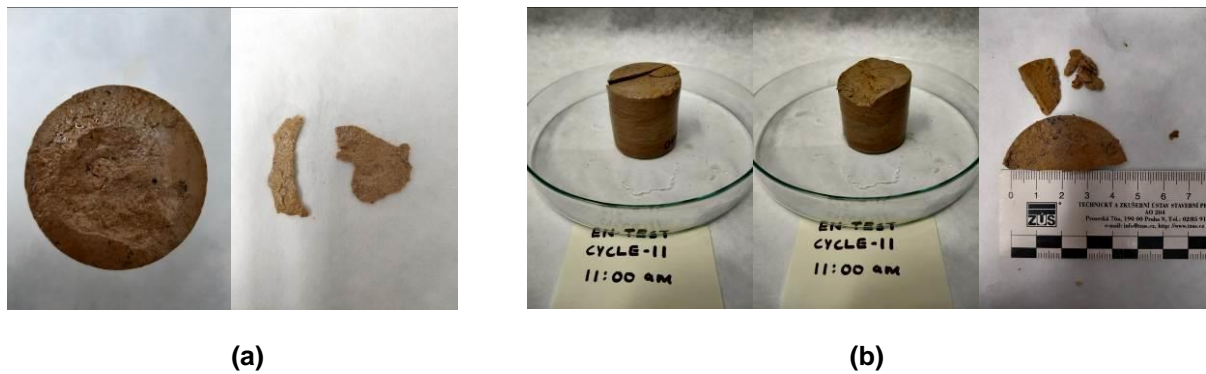
**Figure 35: Example of material loss from (a) bottom surface and (b) top surface (Right) of EN Opuka specimen during wetting stage tested procedure P1**

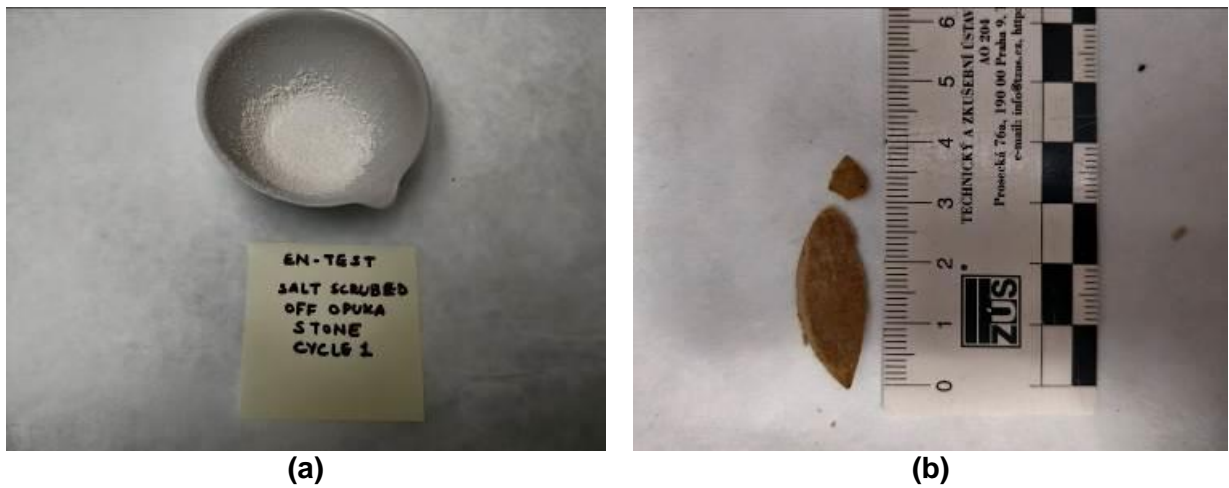
Figure 36: (a) Example of salt brushed off from Opuka specimens after drying stage (b) Example of stone material loss from top part of the specimen

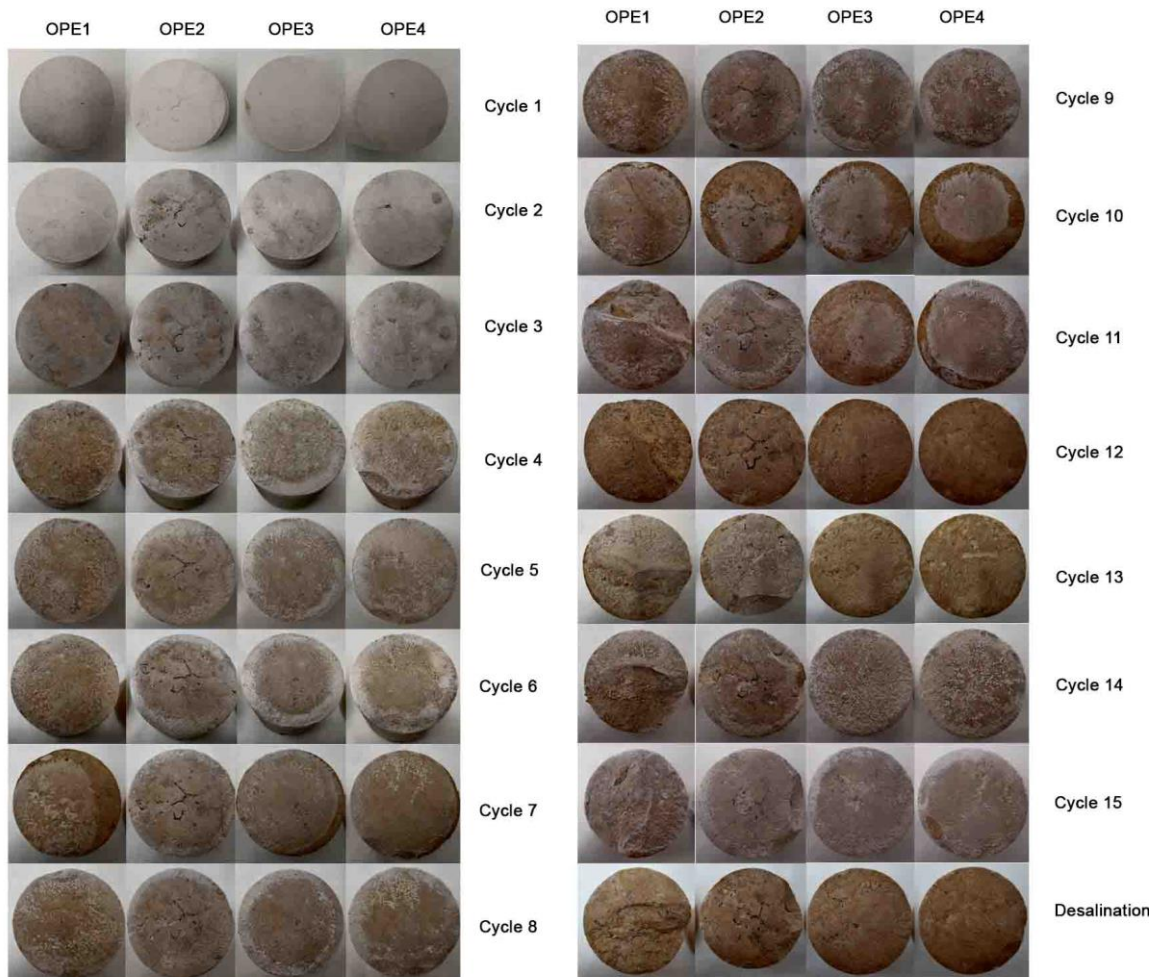
Figure 37: Example of chromatic alteration and material deterioration of EN Opuka specimens (OPE1-OPE4) tested with procedure P1 during 15 cycles

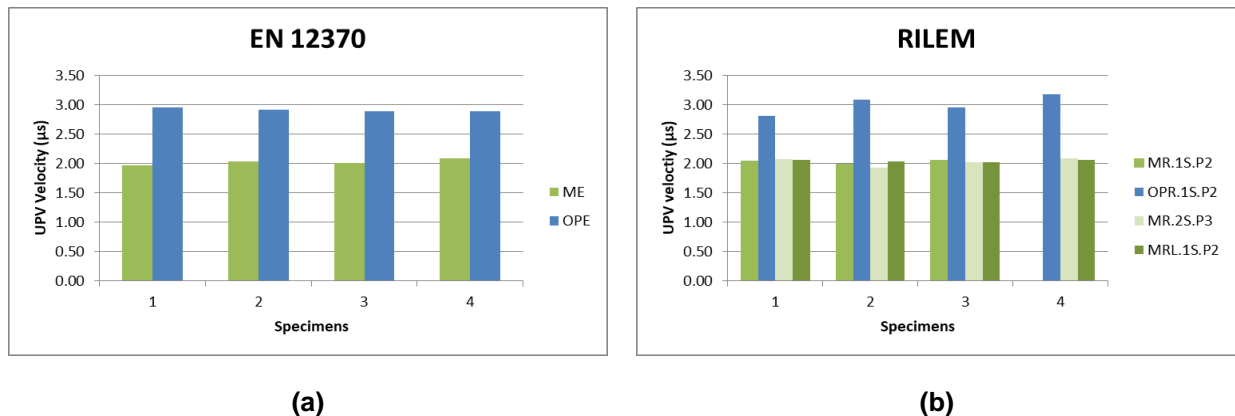
**Graph 15: UPV of specimens in sound state before starting (a) EN and (b) RILEM tests**

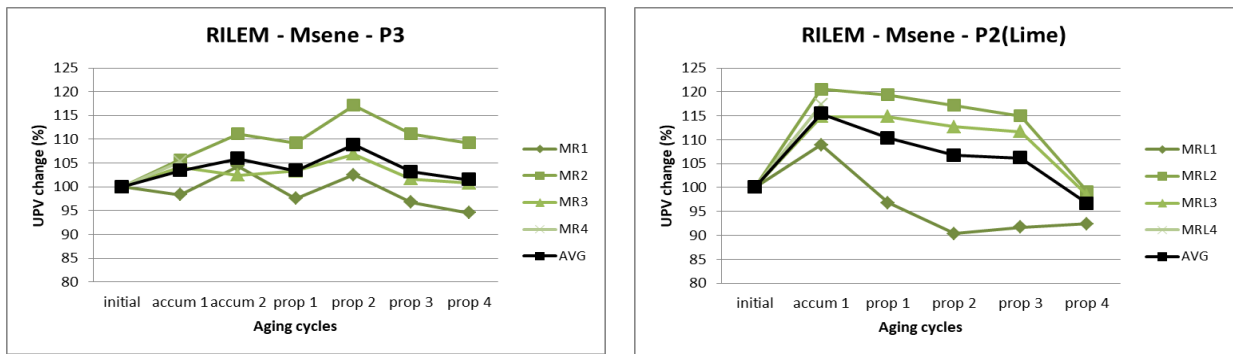
**Graph 17: Comparison of first 4 cycles ultrasound velocity (through height) for Opuka and Mšené samples with test procedure P1-P2-P3**
