PERFORMANCE ASSESSMENT OF STEEL TRUSS RAILWAY BRIDGE WITH CURVED TRACK

ABSTRACT. Non-destructive Structural Health Monitoring techniques can be incorporated into bridge integrity management by assessing structural conditions. This paper describes a performance assessment of a steel truss railway bridge in Bratislava using vibration-based techniques as a further part of maintenance in addition to standard visual inspections. To obtain the necessary data, a multipurpose measuring system was used. Various types of data were measured, e.g. accelerations, strains, and displacements. The advantage of the multipurpose measuring system was that the traffic over the bridge was not restricted, even though the bridge carries only a single curved track. Two test campaigns were conducted to assess the performance of the bridge. One campaign was devoted to measuring ambient vibrations in order to perform the operational modal analysis, and the second was carried out to measure strains and displacements during a train passage. The results show a successful system identification of the structure using ambient vibrations; and a finite element model was verified and validated by a comparison of str

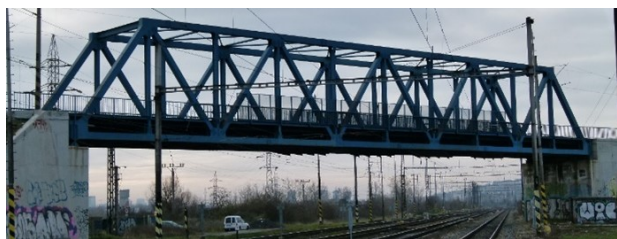
FIGURE 1. Steel truss railway bridge in Bratislava.

Therefore, in this paper, the initial system identification of the observed steel truss railway bridge (Figure 1) is described and the first results are stated to represent a background for future measurements and decision-making by the administrators. The paper also details the preparation and the performance

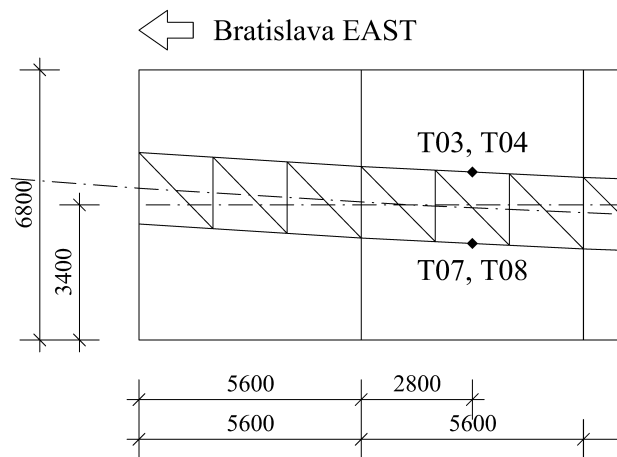
FIGURE 6. Locations of strain gauges on the bridge.

The acceleration was measured in the vertical directions (in the direction of Z axis) by ten sensors to identify the vertical bending and torsional mode-shapes. In addition, ten other sensors were positioned in the horizontal direction. These were used to analyse horizontal (in the direction of the Y axis) and torsional mode-shapes. The last two sensors were used to determine whether the sliding supports work properly. In order to eliminate future environmental effects on modal parameters, temperature sensors were placed in proximity of the chosen accelerometers. Six contact thermocouples were positioned evenly along the bridge. The other two sensors measured air temperature. Furthermore, several strain gauges (Figure 6)

were attached to the second stringers from the side of the fixed supports (the station Bratislava – East).

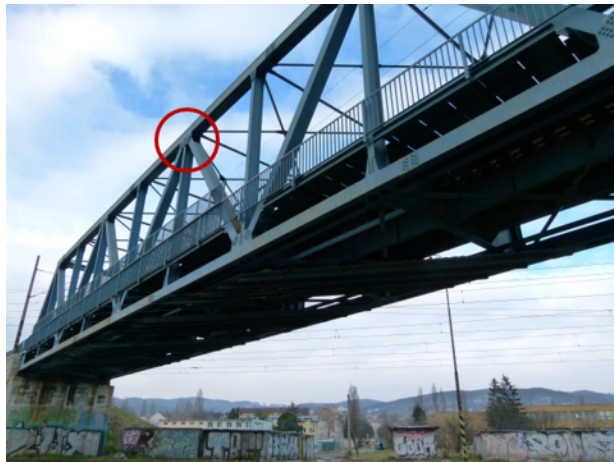
FIGURE 7. Exact point of the bridge structure monitored by IBIS-S radar.

Although it is possible to measure at several locations at the same time, in this case, for the sake of simplicity, attention was paid to measuring displacements in one location only. The interferometric radar was oriented toward the upper joint of the main truss girder. The exact measured point (Figure 7) is located

on the main girder of the bridge, in the middle of the span.

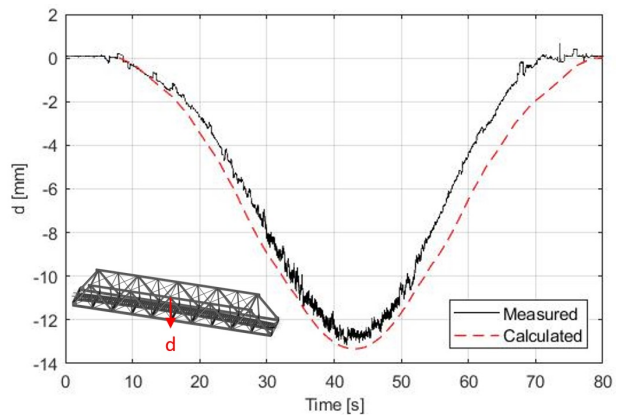
FIGURE 15. Comparison of measured and calculated displacement.

Figure 15 shows a comparison of the measured and calculated displacements of the monitored point of the structure (Figure 7). In this case, the resulting values arise due to the passage of a train consisting of only two connected locomotives (both no. 240, Figure 10). During the second measuring campaign, the locomotives moved at a speed of approximately 4.6 km/h. Due to the fact that the bridge was not closed, the trains' speeds were random. However, the slow passage was very useful, allowing a comparison of the measured data with the quasi-static analysis. The difference between the test and analysis values is only 4 %, which is a very satisfactory result. Because the speed and geometry of the track is known, it is possible to estimate the displacement on the opposite side of the bridge cross-section. This consideration concerns only the estimation of the maximum displacement on the bridge. In this case, the value at this point should be 11 % higher than at the measured point (Figure 16).
