STUDY OF THERMAL CREEP OF COATED CLADDING MATERIALS

MARTIN ŠEVEČEK^{a,b,*}, KOROSH SHIRVAN^b, RONALD G. BALLINGER^b

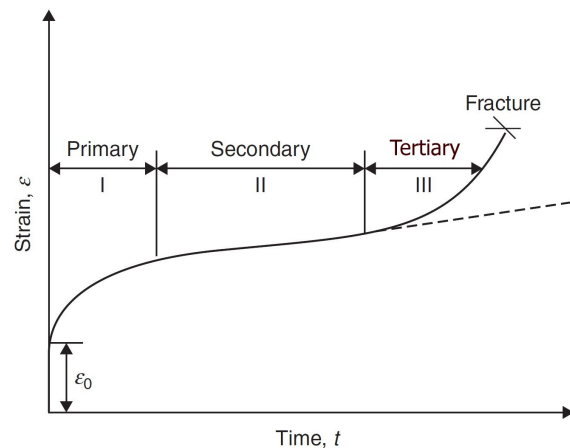
FIGURE 1. Typical creep curve for materials under load at elevated temperature [2].

Creep is slow time- and temperature-dependent strain that occurs in a material under load at higher temperatures. In a creep test, a constant load is applied to a specimen maintained at a constant temperature. The strain is then measured over a period of time. Primary creep is a period of primarily transient creep with decreasing creep rate due to work hardening of the material. Then secondary creep is a period with roughly constant creep or strain rate due to which is also referred as steady-state creep due to balance between work hardening and annealing. If the cross-sectional area reduces enough, tertiary creep occurs. The creep rate increases due to necking and increased local stress and eventually results in fracture as shown in Fig. 1. Irradiation creep is the additional strain that occurs as a result of irradiation and stress in material that needs to be considered in nuclear applications [1]. The presented experiment was performed out-of-pile therefore only thermal creep was studied.

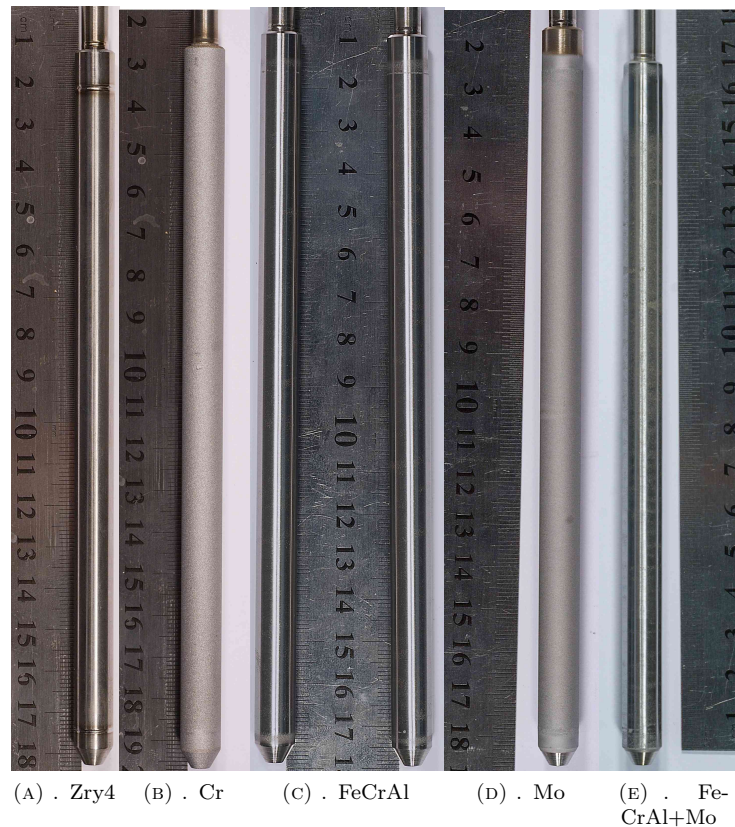
FIGURE 2. Pressure tubes for creep experiments in as-coated state. Cr-coated tube is fully coated including the welds and the end cap, the other coatings cover linear part of tubes only.

coating materials were deposited by the cold spray technique – pure Cr (deposited by Army Labs), Fe-CrAl – low alloy (LA); pure Mo; and FeCrAl+Mo multilayer (deposited by University of Wisconsin-Madison). The as-coated tubes are shown in Fig. 2. Uncoated Zircaloy-4 was also studied as the reference case. The reference uncoated Zry-4 pressure tube and the as-coated samples are shown in Fig. 2.

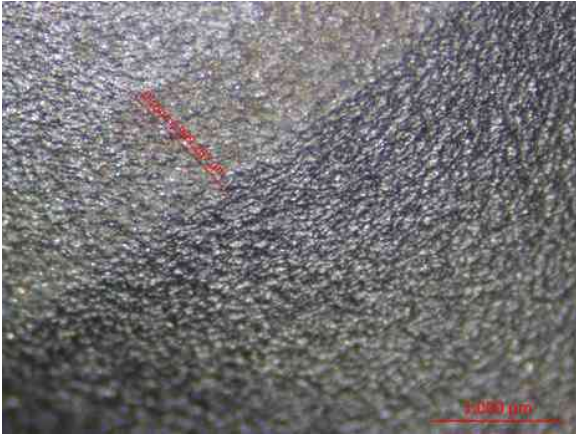
FIGURE 3. Cr CS coated pressure tube - detail of the bottom weld.

The standard Zry-4 tubes were welded with an end cap on one end and with a thinner Zry-4 tube at the other end. The as-prepared samples were then pressurized by air at room temperature up to 30 MPa to check the quality of welds. The Zry-4 samples were then coated using the cold spray technique with pure Chromium, Molybdenum, FeCrAl low alloy and multilayer of FeCrAl+Mo. The leakage test was then repeated using air. Samples were pressurized by air at room temperature up to 11 MPa for 5 minutes with no pressure decrease. Then He leakage test was performed with the base pressure of 0.013332 Pa with the leak rate $1.3E-8$ Pa*liter/second and no indications. There was a concern that the welding can be partially disrupted by cold spraying but it was not confirmed. A detail of the over-coated weld with Cr is shown in Fig. 3.

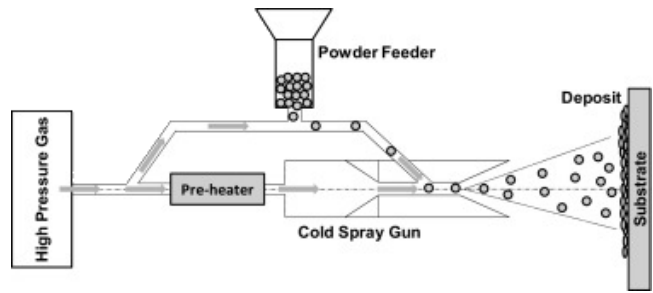
FIGURE 4. Schematic representation of cold spray process [14].

interaction with the substrate, the particle undergoes tremendous plastic deformation. Upon impact, the plastic deformation disrupts and breaks down surface oxide layers on both the powder and substrate leading to a metallurgical bond, as well as mechanical interlocking. Since the feedstock powder is deposited in the solid state, the microstructure is retained after deposition with the exception of dynamic recrystallization due to high strain levels. A schematic representation of the CS is shown in Fig. 4.

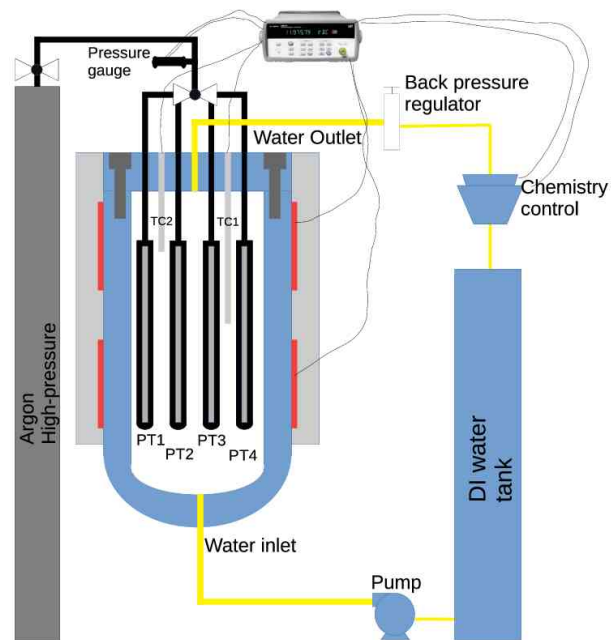
FIGURE 5. Schematics of the experimental setup.

The simplified schematics of the experimental setup is shown in Fig. 5. Two independent heaters are placed onto the autoclave designed for pressure up to 24.13 MPa (3500 psi) and thermally insulated from outside. They are controlled by the in-house designed controller that uses two thermocouples and two pressure gauges. Four proportional-integral-derivative (PID) controllers are interconnected to ensure that the parameters are within allowable limits and define the temperature of the preheater and autoclave by providing power to heaters. The water pressure is controlled by high-pressure pump which will run throughout each experiment on one side and by the back pressure regulator on the other side. The autoclave pressure for the experiments was between 13.4 - 14 MPa depending on the particular test. Instrument leads as well as the pressure tubes exit the autoclave through an appropriately configured Conax fittings. A data acquisition system records temperature from four thermocouples. Two are inserted into the autoclave at different axial positions, one measures and controls the preheater and the last checks the temperature at the exit of the high-pressure part of the loop for safety reasons. The system collects also pressure from three pressure transducers. One is installed at the high-pressure pump outlet and controls the high pressure inside the autoclave, one is connected to the tubing on the low-pressure section of the water loop and the third is connected to the inert gas inlet and controls the Ar pressure inside cladding tubes. Omega pressure gauge and Omega DP41-E unit were used to measure argon pressure inside the gas line.

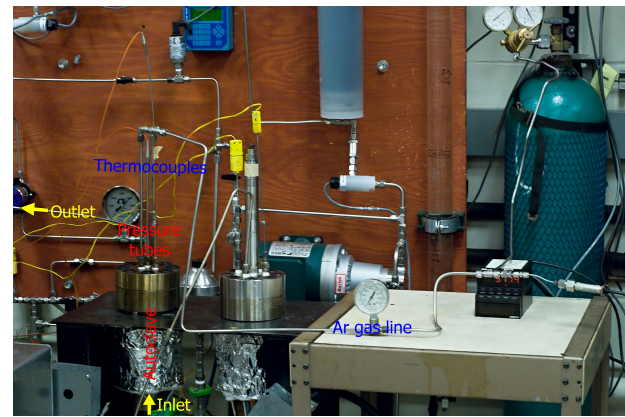
FIGURE 6. Photo of the autoclaves, gas system and water loop.

The picture of the experimental setup is shown in Fig. 6. The second autoclave can be interconnected and allows to test more samples at the same time. The autoclaves are dynamic and allow online control of the chemistry as well as purification of the DI water. Small leakages were found in the gas line that pressurizes pressure samples during the test e.g. in Fig. 12 (green line). For that reason, the load was slowly decreasing. Later the tubing was replaced and lower loads were applied with no leakages.

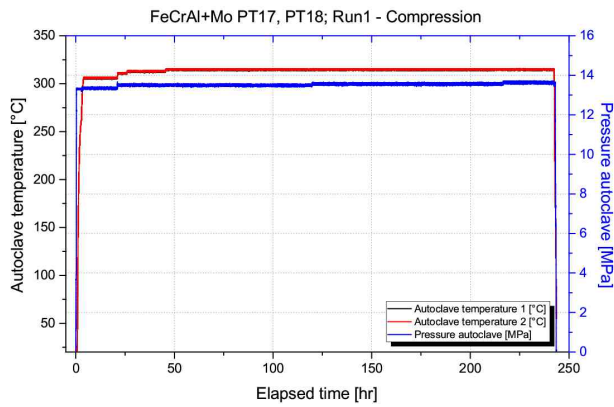
FIGURE 7. FeCrAl+Mo Run 1 - autoclave temperature and pressure.

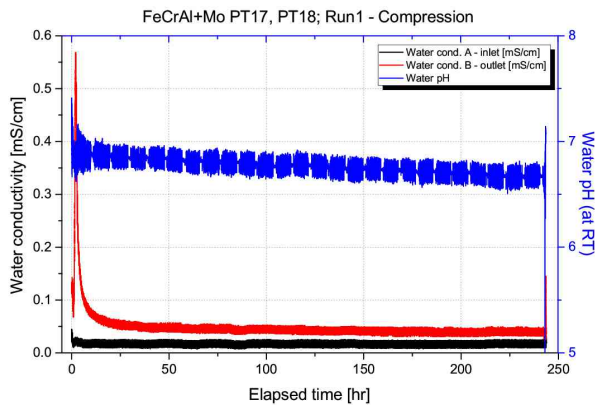
FIGURE 8. FeCrAl+Mo Run 1 - Water inlet and outlet conductivity and pH.

Due to the limited length of this paper, only results for FeCrAl+Mo samples (PT-17, PT-18) are shown. Three consequent test runs were performed. During the first run, the pressure tubes were under atmospheric pressure and the autoclave pressure was around 13.5 MPa resulting in fast down creep. Because the outer surface of the pressure tubes is exposed to the standard HWC environment [15] the pressure tube corrodes. For that reason, the chemistry of the environment was monitored. The temperature of the system was between 305-315 °C and hydrogen was bubbled into the DI water tank to reduce oxygen concentration and the electrochemical potential. The oxygen concentration during Run 1 is shown in Fig. 9. The fluctuations are caused by periodic operation of the hydrogen bubbler but the concentrations are generally very low. Water pH slowly decreases during all runs between 7.2 down to 6.7 at the end of the test. The water conductivity was measured at the inlet and outlet of the system. A filter is placed between them to clean the water and keep its properties during the test. The rapid increase of the outlet conductivity at the beginning of the test is probably caused by rapid corrosion of Mo. Mo quickly corrodes and creates volatile oxide in HWC environment. Mo should be fully overcoated by FeCrAl but it seems that some parts have defected or some residual Mo was left on the outer surface. The corrosion reduced after about 20 hours as shown in Fig. 8.

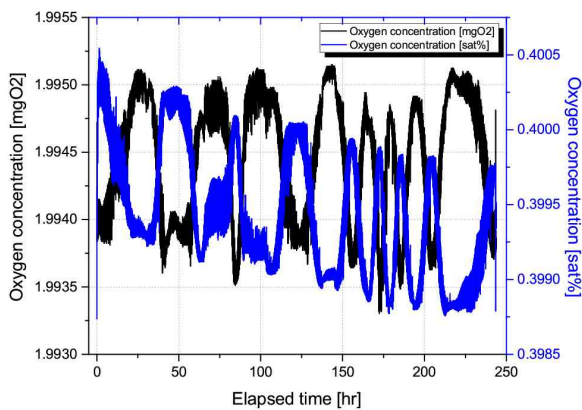
FIGURE 9. FeCrAl+Mo Run 1 - oxygen concentration.

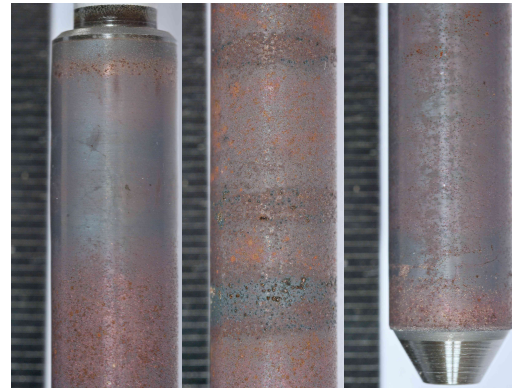
(A) . Top (B) . Overcoat (C) . Bottom

FIGURE 10. Visual inspection of FeCrAl+Mo pressure tubes after Run 1 - compression.

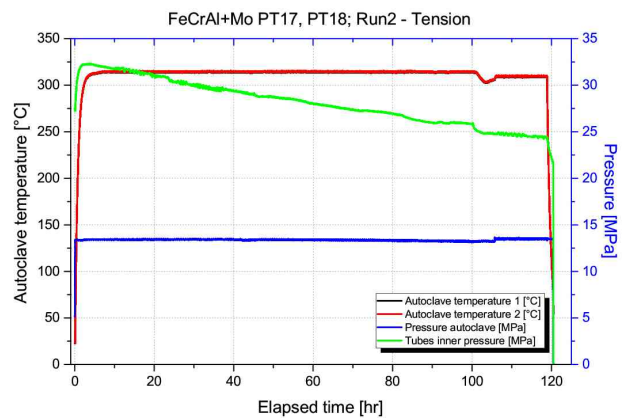
FIGURE 11. FeCrAl+Mo Run 2 - autoclave temperature and pressure, inner tube pressure.

The Run 1 when pressure tubes were under compression lasted 245 hours. The system was then cooled and depressurized and samples visually examined. The samples were then placed back into the autoclave and Run 2 was initiated. The tubes were first pressurized by Ar from the gas line and the system was filled with water and pressurized. After cleaning of the loop the heatup of the autoclave started. The leakage of Ar in the gas line was discovered but the test continued for 120 hours. As can be seen from Fig. 12 the water conductivity increased rapidly at the beginning after loading the samples with the inner load. The decrease of conductivity is much slower in comparison with Run 1 which suggests that the FeCrAl coating cracked due to excessive loads and exposed Mo coating. Run 2 was interrupted due to leakages in the gas line. Samples were visually inspected and then placed back for Run 3 for another 190 hours.

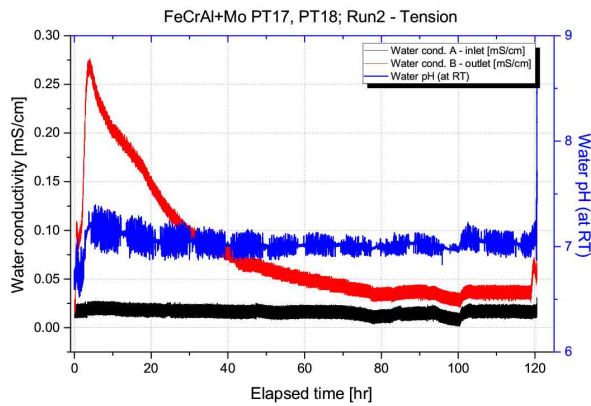
FIGURE 12. FeCrAl+Mo Run 2 - Water inlet and outlet conductivity and pH.

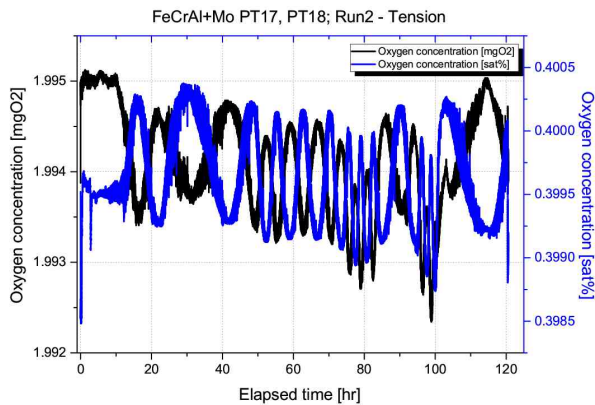
FIGURE 13. FeCrAl+Mo Run 2 - oxygen concentration.

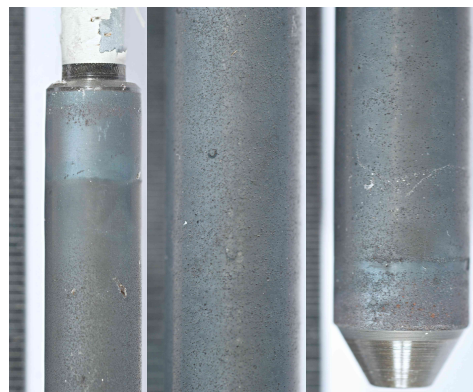
(A) . Top (B) . Overcoat (C) . Bottom

FIGURE 14. Visual inspection of FeCrAl+Mo pressure tubes after Run 1 and Run 2 - tension.

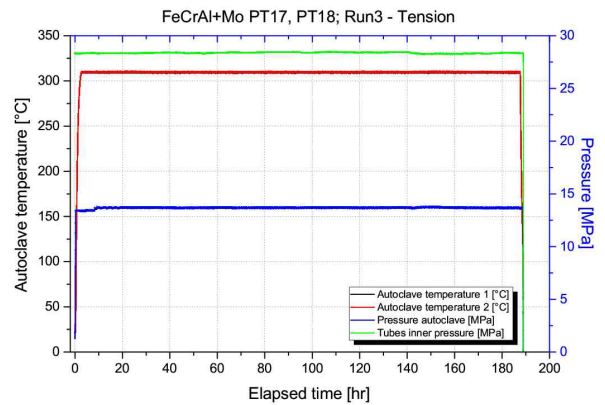
FIGURE 15. FeCrAl+Mo Run 3 - autoclave temperature and pressure, inner tube pressure.

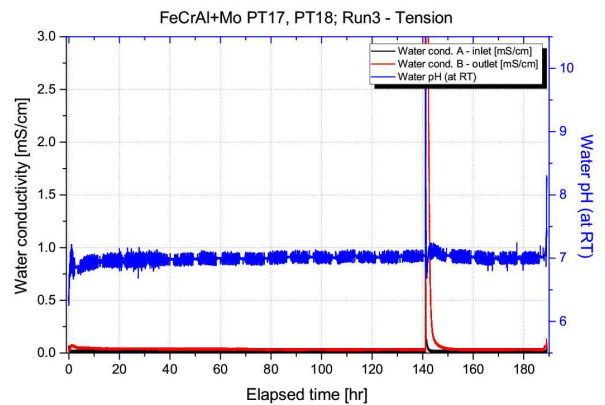
FIGURE 16. FeCrAl+Mo Run 3 - Water inlet and outlet conductivity and pH.

The leakage of Ar was repaired so that the load can be constant during the run. The inner pressure reached 28 MPa. The autoclave temperature and pressure were similar to previous runs. As shown in Fig. 16, there was a sudden increase of water conductivity after 140 hours. It was explained by a crack in the

coating on PT-18 that was later identified. This crack was much bigger in comparison with the micro-cracks observable under a microscope. Visual inspection of the samples showed different axial corrosion behavior. Most of the sections of the samples formed dark red iron oxide similar to FeCrAl PT-12 and PT-13 where no interlayer was applied. However, some parts of the sample were dark grey and black. It seems that the FeCrAl did not fully protect Mo inter-layer in these regions. Mo interacted with FeCrAl and slightly corroded due to the cracks formed in the outer coating. This can be observed in Fig. 18. The darker regions are visible where the FeCrAl was thinner (top of the tube) and where the inner load was the highest (lower third of the pressure tube).

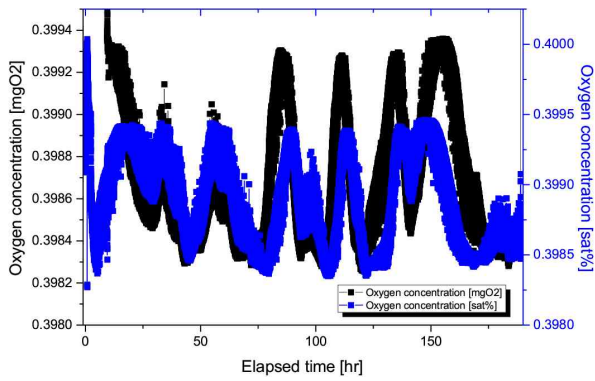
FIGURE 17. FeCrAl+Mo Run 3 - oxygen concentration.

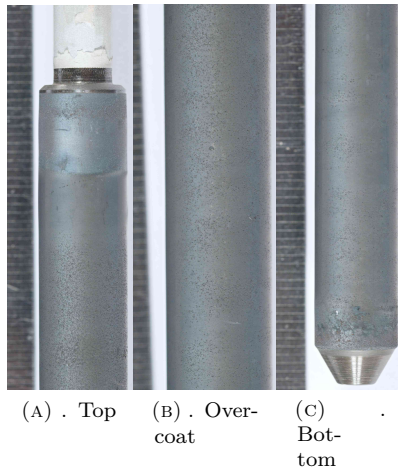
FIGURE 18. Visual inspection of FeCrAl+Mo pressure tubes after Run 1, Run 2 and Run 3 - tension.

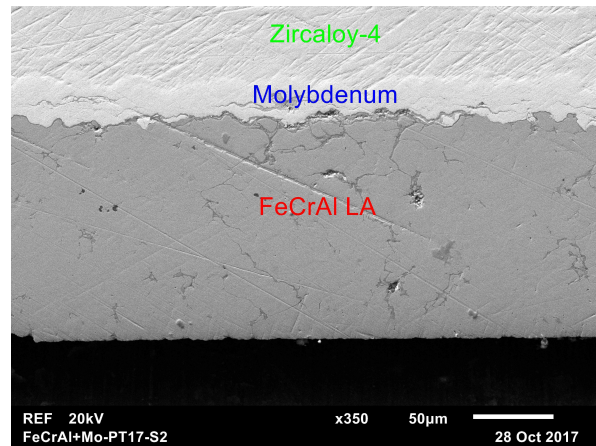
FIGURE 19. SEM micrograph of the PT17 sample after the test (all three runs). The cracks in both FeCrAl and Mo coating are visible. There is no spallation visible but the bonding between FeCrAl and Mo was reduced.

The SEM micrographs show that cracks first initiated at the Mo/FeCrAl interface. Molybdenum is harder and more brittle than both Zry-4 and FeCrAl. It cannot accommodate as much strain as the other two materials, therefore, the crack initiation starts here.

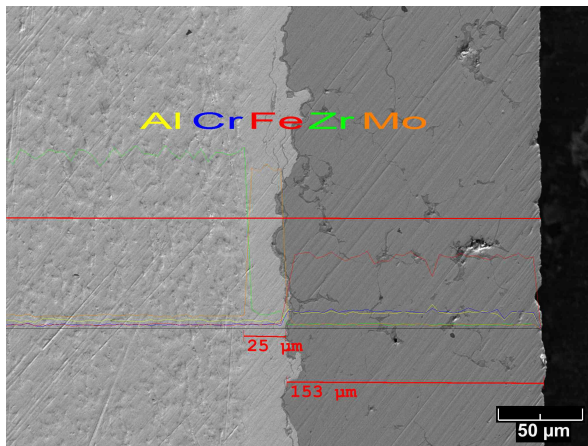
FIGURE 20. EDS linescan with SEM micrograph of the PT17 sample. The thickness of the Mo interlayer is around $25\ \mu\text{m}$ and FeCrAl LA coating is about $150\ \mu\text{m}$ thick. High number of cracks is visible in both Mo and FeCrAl.

Energy-dispersive X-ray spectroscopy was performed to study the elemental composition at the cross-section of the samples. The EDS line scan did not confirm the diffusion and mixing of the materials. There are bonding layers at the interfaces between each layer that were challenged by the test where neighboring materials are partially mixed. EDS is however not very sensitive to low concentrations and more detailed study using WDS is needed. The ESD also confirms the composition of each layer and their thickness as shown in Fig. 20.
