ADVANCED MASTERS IN STRUCTURAL ANALYSIS
OF MONUMENTS AND HISTORICAL CONSTRUCTIONS

Master's Thesis

Experimental investigation of
climate effects on historical
building materials: the Gothic
towers of Prague.

University of Minho

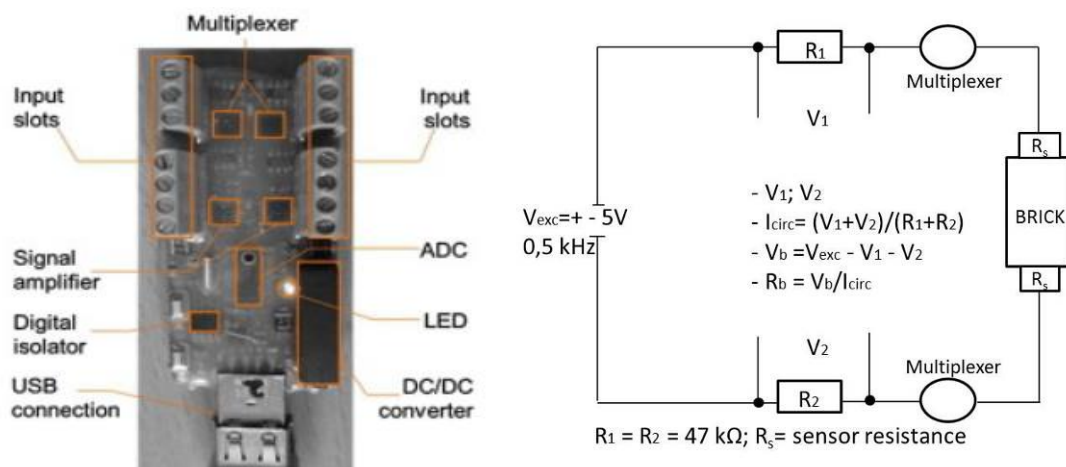
Figure 2: left electronic board, Righ Moisture control system sensor

The moisture monitoring system relies on an ammeter voltmeter method. The circuit enables the assessment of the voltage drop due to the changing electrical resistance of the material specimen. An alternating voltage $V_{exc} = \pm 5\text{ V}$ is applied with a frequency of 0.5 kHz . Voltages V_1 and V_2 are measured employing voltmeters across two resistors R_1 and R_2 of known resistance $47\text{ k}\Omega$. Depending on the direction of the current one of these measurements indicate the voltage drop because of crossing the material. To allow

simultaneous measurements at multiple points on the brick, a multiplexer is used so that several signals share the same device. The multiplexer prevents the crisscrossing of current flow among different pairs of electrodes installed..

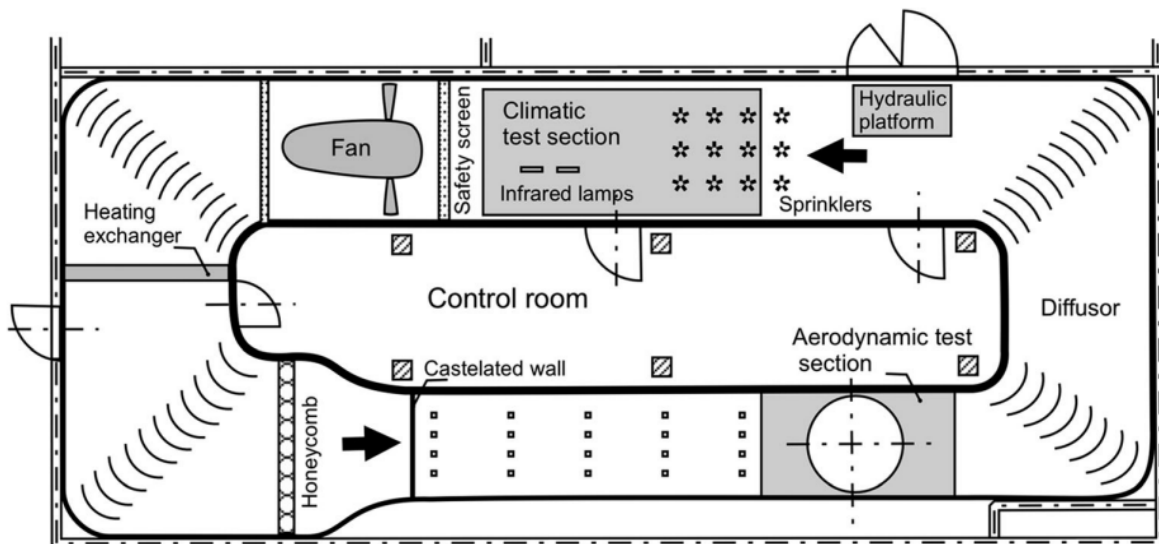
Figure 4: Right-Plan view of the Vincenc Strouhal wind tunnel, designed in a near-oval closed shape adapted for aerodynamic and climatic testing. Arrows point in the wind flow direction. Left-inside the climatic section. Source: [R. Cacciotti & S. Pospíšil & S. Kuznetsov1 & A. Trush](#)

Testing of sandstone specimens for monitoring their response when subjected to different climate scenarios, is carried out in the laboratory-size tunnel. The 173 cm x 200 cm x 43.5 cm (height, width, and depth respectively) small-scale wind tunnel of the Institute of Theoretical and Applied Mechanics of the Czech Academy of Sciences is ideal for performance studies of historical building materials, presenting among its major advantages a didactic and low-budget analysis that allows simulating natural ventilation and other representative environmental conditions to which samples of building materials can be exposed for a prolonged period of time.(22). To determine the proper operation of the device, the adequacy of the environmental control system was investigated to evaluate the mutual effects between temperature (T) variations with two boundary temperatures, relative humidity (RH) and airflow velocity within the test section, it has the following characteristics: operating airflow velocity between 0.2 and 0.7m/s, operating temperature between 10°C and 35°C and allowable operating relative humidity between 30% and 99%. Its performance was validated by numerical simulation and experimental research, confirming the existence of stable wind and boundary layer conditions, and validating the correct operation of the tunnel for natural ventilation simulation for studies of the response of historical building materials under different environmental scenarios. Considering that the environmental control functionalities are subject to the operational limitations of the electronic or structural components of the circuit. (23). The description of the device components can be seen in [Figure 4](#).

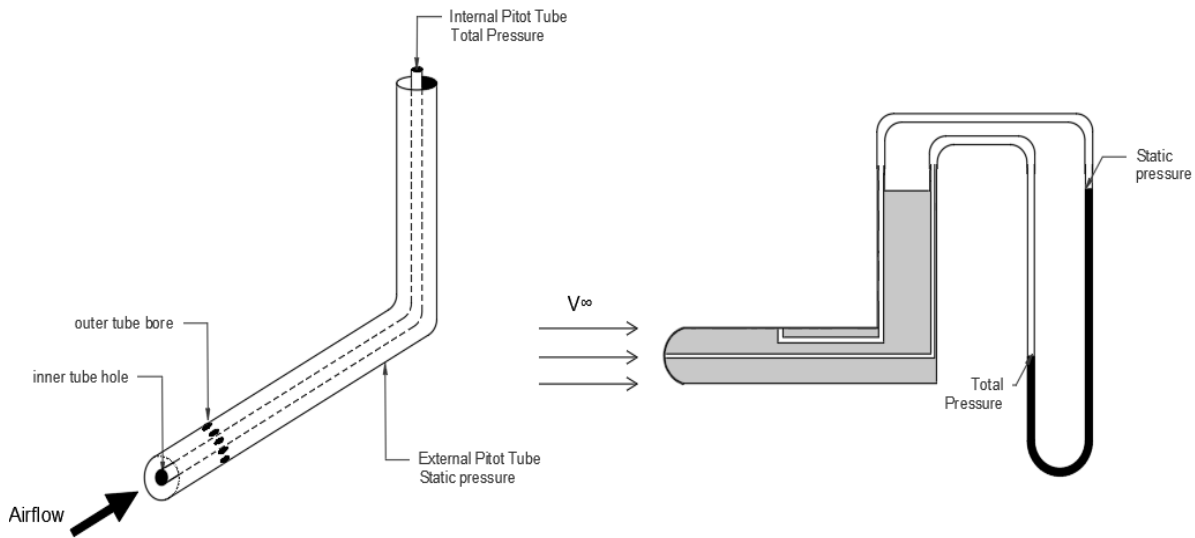
Figure 5: Pitot-Static Tube (Prandtl tube)

As measurement equipment, the Pitot (Prandtl) tube is used, which is an instrument that allows measuring the speed of a fluid by converting the kinetic energy of the flow into potential energy. The tube allows to measure the static pressure p_s . According to Bernoulli's equation, the difference between the total and static pressure is the dynamic pressure P_d . Pressures in the model were acquired using two Scanivalve MPS 4264 pressure transducers, this is a self-contained, temperature-compensated electronic pressure scanner that can work with a maximum of 64 pneumatic inputs. The inlets are connected to the pressure taps with silicone tubes.

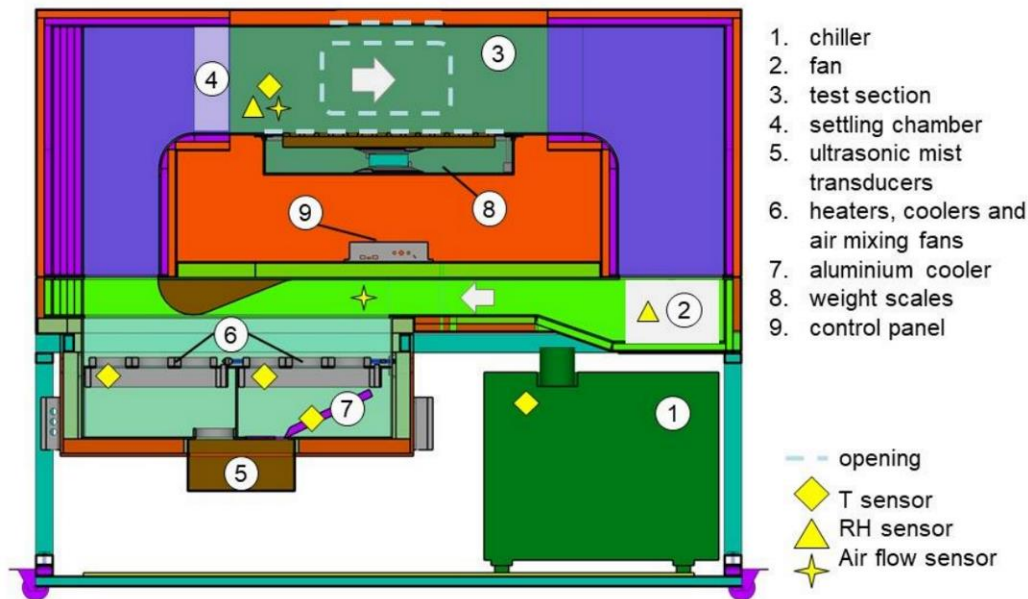
Figure 6: Above: isualization of main components of the SSWT. Source: [R. Cacciotti a, B. Wolf a , M. Macháček.](#)

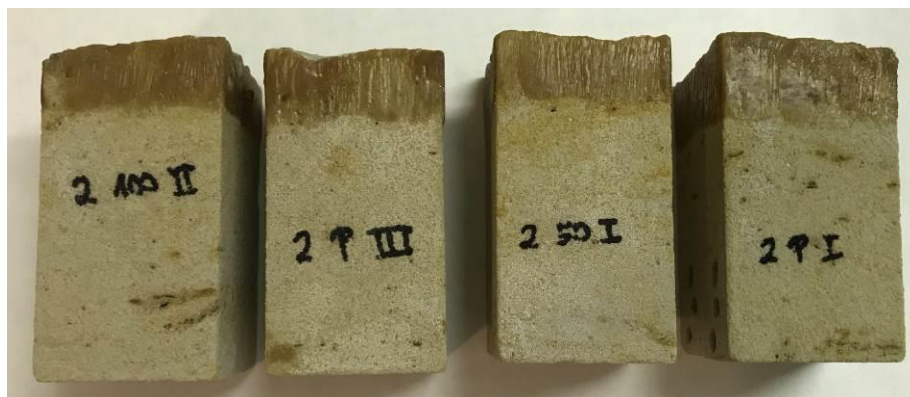
Figure 8: Classification of sandstone samples.

The sandstones extracted from the cathedral (used for this study) were obtained from the internal report of the research group of Dr. Jan Valek at ITAM, showed alteration on their surface at an estimated depth of at least several mm, these showed a low degree of salinity according to the ČSN P 73 0610 standard, the highest degree of sulfate content was due to surface contamination, the representation of chloride and nitrate was low.

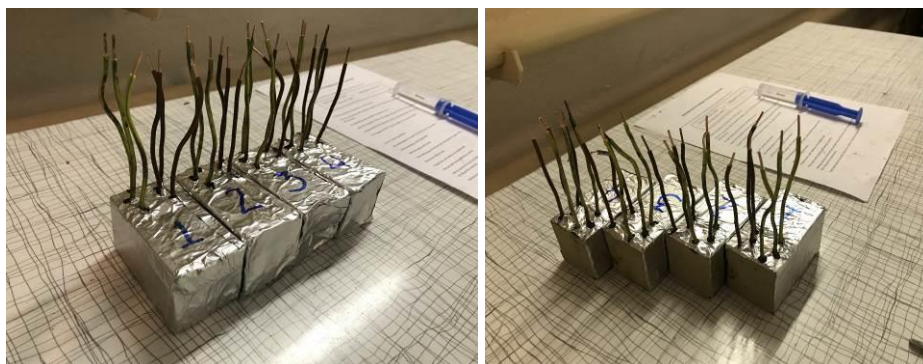
Figure 9: sandstone specimens.

The identical specimen are marked No. 1, 2, 3, and 4 (figure 9) they are insulated on all faces except the front one and their initial conditions are the laboratory ones (i.e. $T = 23\text{ }^{\circ}\text{C}$ and $\text{RH} = 50\%$). Three experiments are conducted with three different airflow speeds: exp1 involves specimens 1 and 2 with airflow speed around 1 m/s (max fan power of 700 rpm); in exp2 specimens 3 and 4 are used with airflow speed around 0.4 m/s (350 rpm fan speed), and finally, specimens 1 and 2 were tested again after drying and exposed to an airflow speed close to 0 m/s (60 rpm fan). The environmental conditions inside the tunnel throughout the tests are $T = 23\text{ }^{\circ}\text{C}$ and $\text{RH} = 75\%$. These parameters correspond to the average relative humidity and temperature during summer months in Prague, taken as a reference location for this study. The two specimens are placed one beside the other, parallel to the direction of flow in a way that the exposed face is perpendicular to the flow.

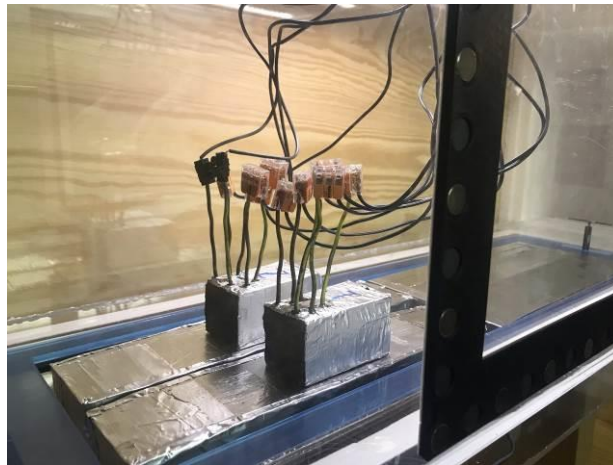
Figure 10: specimens inside the wind tunnel

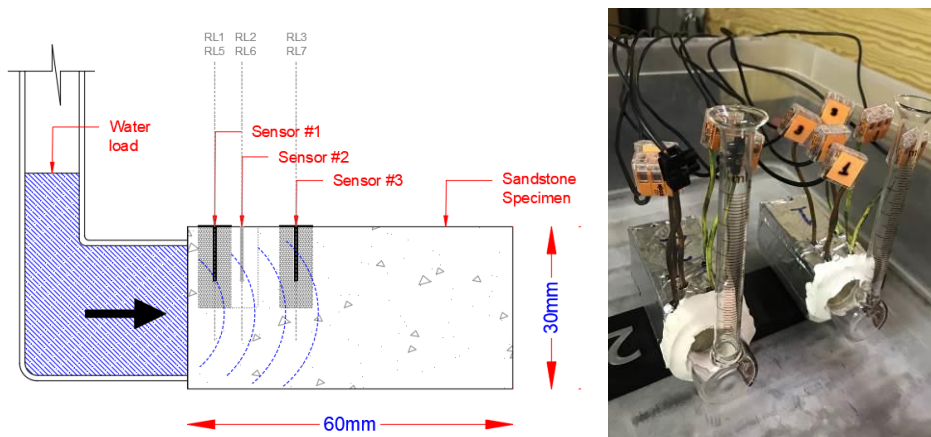
Figure 11: Schematic of rainfall simulation in sandstone specimens.

For the proper analysis of the wind-driven rain simulation on the above-mentioned specimens, electrode sensors of standard dimensions (30 mm depth, 6 mm diameter) were used with epoxy resin basic mixture of 5 ml of Araldite 2020 (5.484 g) compound A, 1.5 ml of Araldite 2020 (1.468 g) compound B, plus 2.959 g of graphite powder, which allows conductivity, resistance and electrical contact quality between the specimen and the electrode. These were topped with a sealing layer of epoxy glue to prevent resistance measurements from being affected by higher conductivities on the face of the specimen at the time of the rain load simulation. (33). (Figura 11).

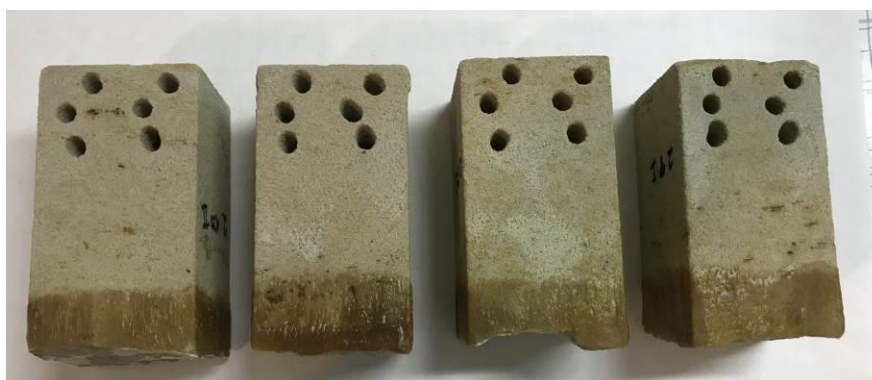
Figure 12: Drilling in the sample for electrode installation

First, identical sandstone samples are taken and 6 mm holes are drilled into the specimen with an electric drill to the midpoint of its thickness, for installation of the electrode pairs on only one side of the sample, the hole layout configuration is shown in Figure 12. In addition, impurities inside the holes should be cleaned with compressed air, adhesive tape should be placed around the holes to protect their edges from resin injection

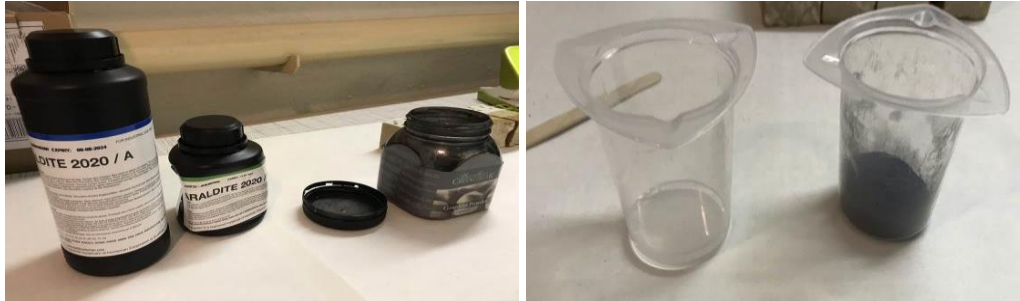
Figure 13: Preparation of syringes for on-site injection.

inside a 10 ml syringe. Pour component B into a small container with the previous mixture obtained. Mix the components thoroughly with a suitable paddle stirrer/mixer until a homogeneous mixture is obtained. Figure 13.

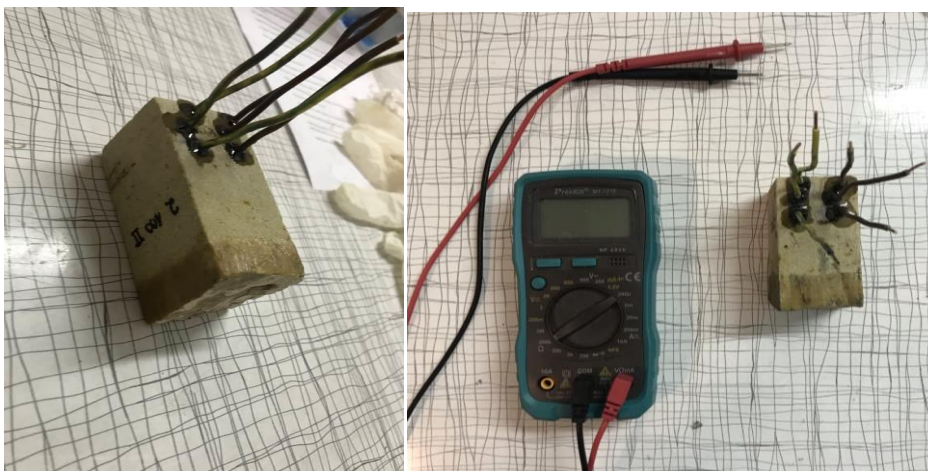
Figure 14: Left-Clean specimen. Right-Check to prevent the measurement from being influenced by surface resistance values.

The injection must be done in a vertical position to the perforation, the application must be done slowly starting from the base of the perforation in order to generate different layers until the complete sealing of the perforation is obtained, avoiding air bubbles. Then the insertion of the solid copper wires is performed, these must be previously cut to the desired measures, additionally, the coating must be removed at one end to better grip the resin mixture, these are left to cure for about 24 hours, then the removal of the tape must be performed, The excess resin around the sensors should be removed with a file, cleaning completely any presence of the material on the face of the specimen in order to avoid that the measurement is influenced by the surface resistance values, after this the upper part should be sealed with pure epoxy glue. Figure 14.

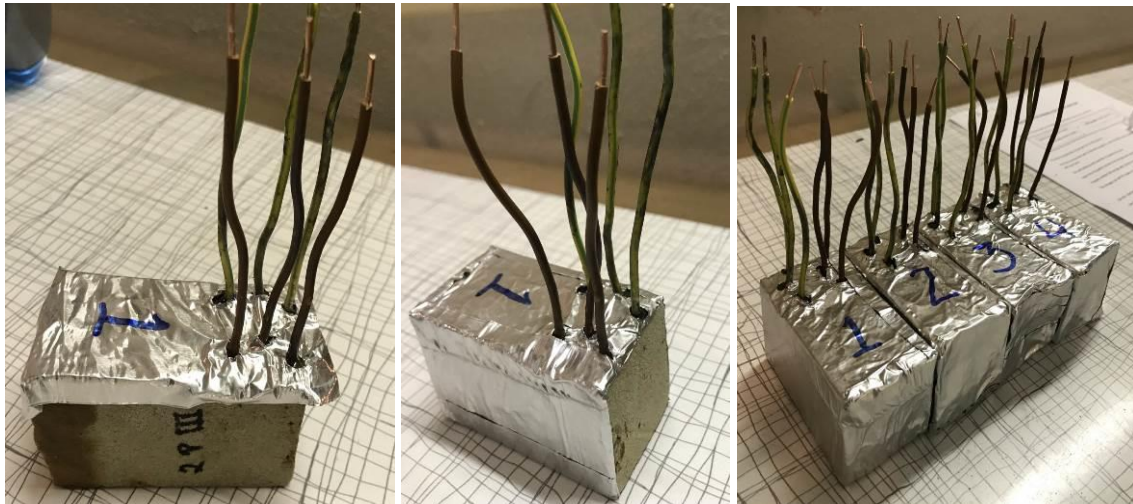
Figure 15: Specimens covered with aluminum

After testing, the specimens are coated in aluminum so that only the top side of the sample is exposed, this is done to ensure saturation of the sample during the experimental test. Figure 15.

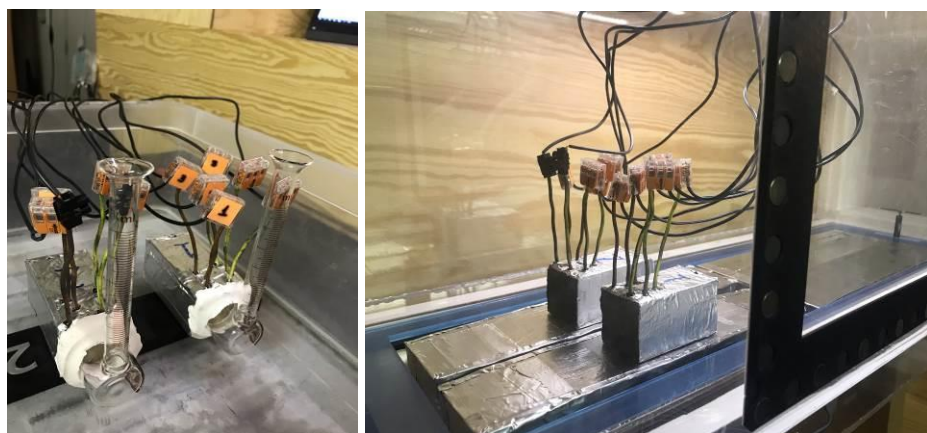
Figure 16: left - Rain simulation. Right - placement of specimens in the wind tunnel.

Once the specimens are sealed and coated, rain simulation is performed on two of the specimens employing a Karsten tube. The circular base of the Karsten tube is fixed to the surface of the aluminum-free face of the specimen utilizing plastic putty. Once the resistance gauges are installed on each of the wires, water is poured until the desired level is reached, in this case, 12 ml of distilled water was measured in a syringe, the application should be done quickly, 5 minutes of the simulation of the rain load is timed. The specimens should then be taken to the wind tunnel for wind-driven rain simulation.

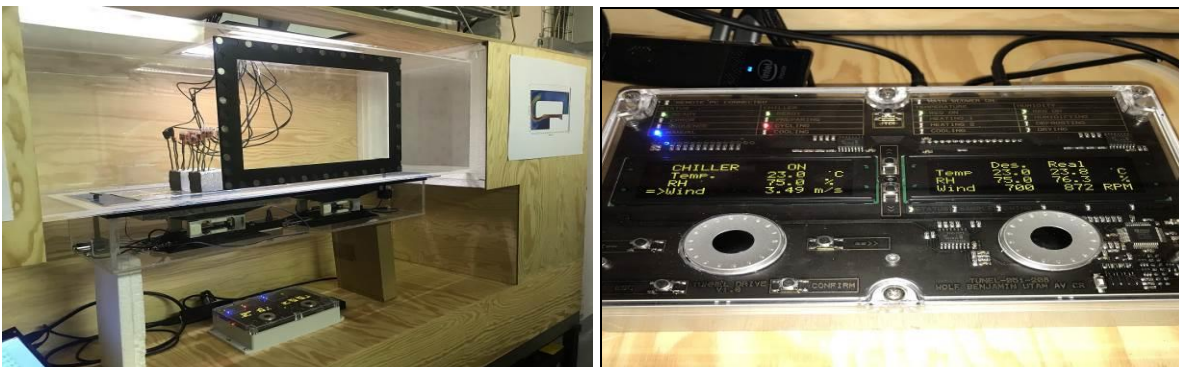
Figure 17: Samples in the wind tunnel and assignment of wind speed, temperature and relative humidity parameters.

For the study material, three different flow velocities are used, the first at 700 rpm i.e. at 1 m/s for samples 1 and 2, the second at 350 rpm (0.4 m/s) for samples 3 and 4, and the third at 60 rpm again for samples 1 and 2. The temperature is constant and close to that of the laboratory, i.e. $T=23^{\circ}\text{C}$, and a relative humidity of 75%.

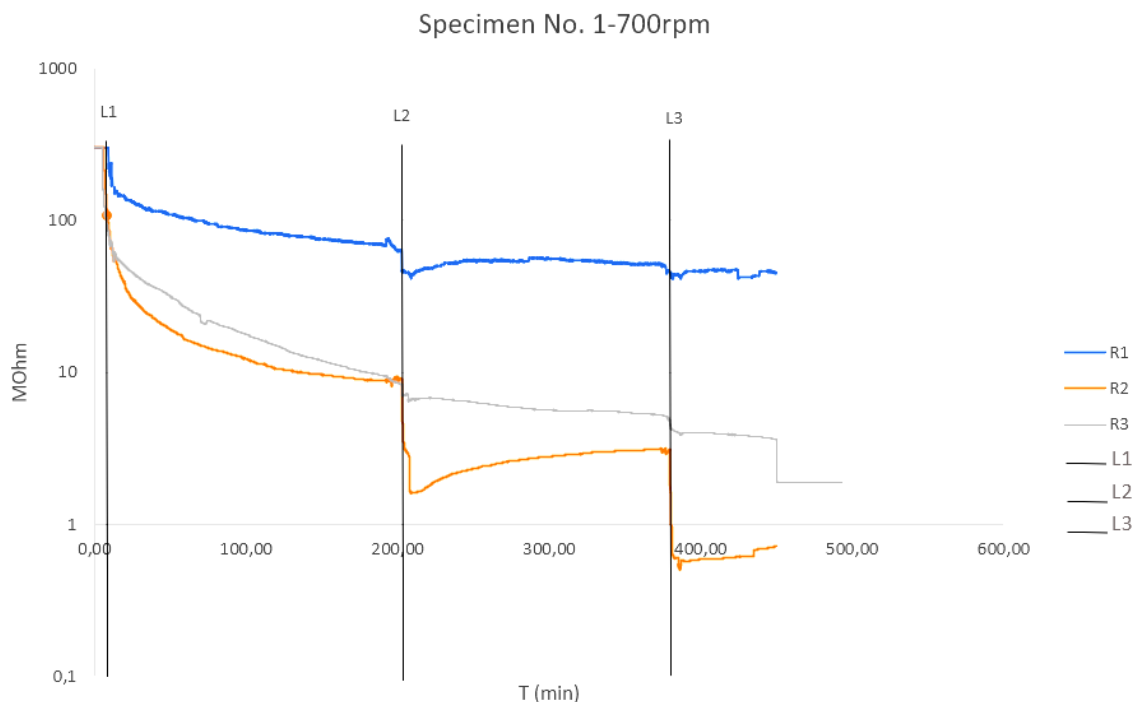
There is a noticeable change between L2 and L3 with a small increase in electrical resistance values, this may be due to a difference in the heights of the liquid that has a direct dependence on the radius of the pores and can cause no contact with the sensors $R_2=2.19$ rpm presents a behavior of increased resistance once it approaches the time $T = 400$, which may indicate that before the third rain simulation the sample at the sensor point R2 had decreased moisture content, this can be corroborated by the behavior pattern R1, between L1 and L2. The trend of $R_3=4$ rpm is of decreasing resistance during the three rainfall simulations, without abrupt changes in its values.

Graph No. 1: Electrical resistance measurement - Especimen No.1 700 Rpm

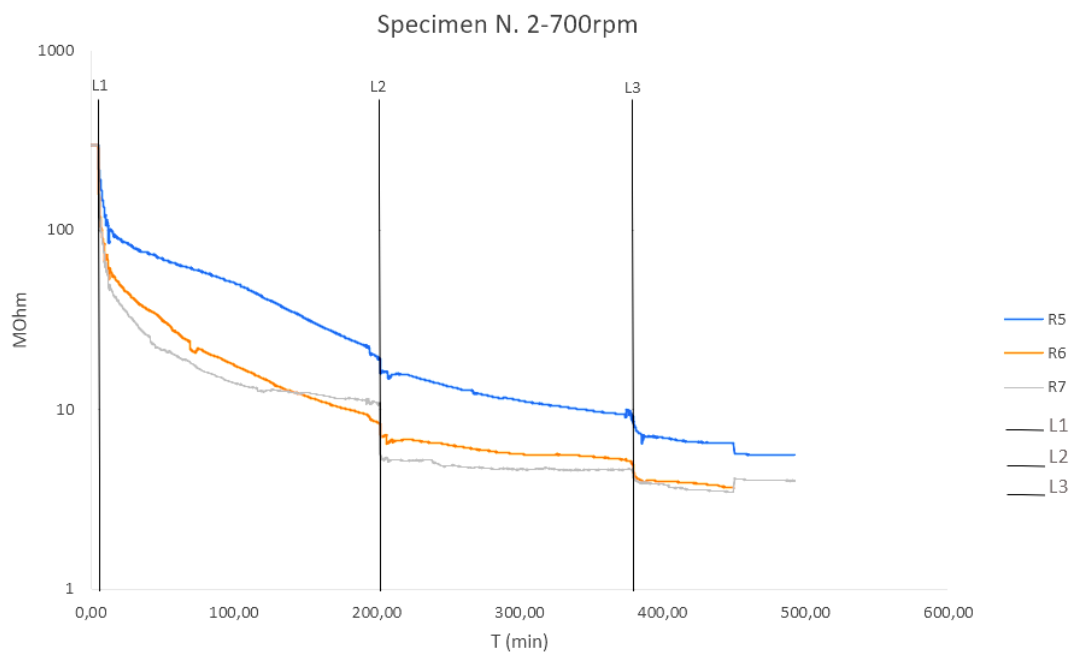
There is no evidence of an increase in resistance in any of the three rain simulations carried out, and on the contrary, this value tends to decrease, so it can be considered that the material presents a high degree of saturation.

Graph No. 2: Electrical resistance measurement - Especimen No.2 700 Rpm.

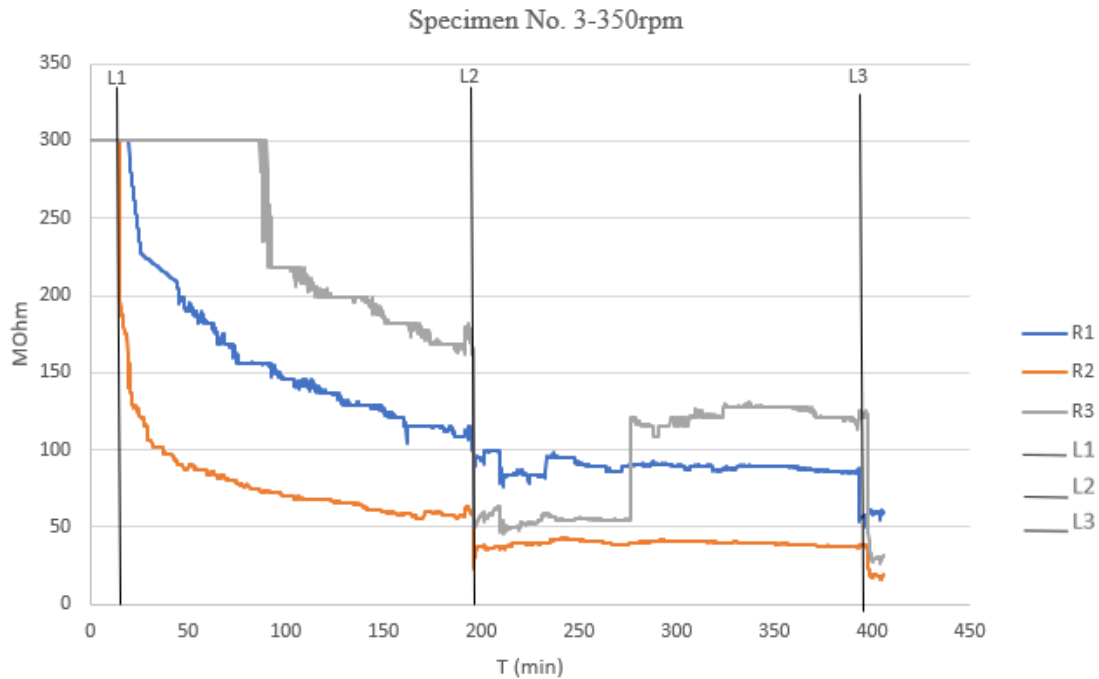
Therefore, the considerable decrease in resistance shortly after the first L1 rain simulation (approximately 15 minutes) may be due to the size of the pore and its interconnections within the material, this may be the cause of R3=235 rpm having activated up to 90 minutes and that presents a different behavior to R1 and R2 between L2 and L3.

Graph No. 3: Electrical resistance measurement - Especimen No.3-350 Rpm

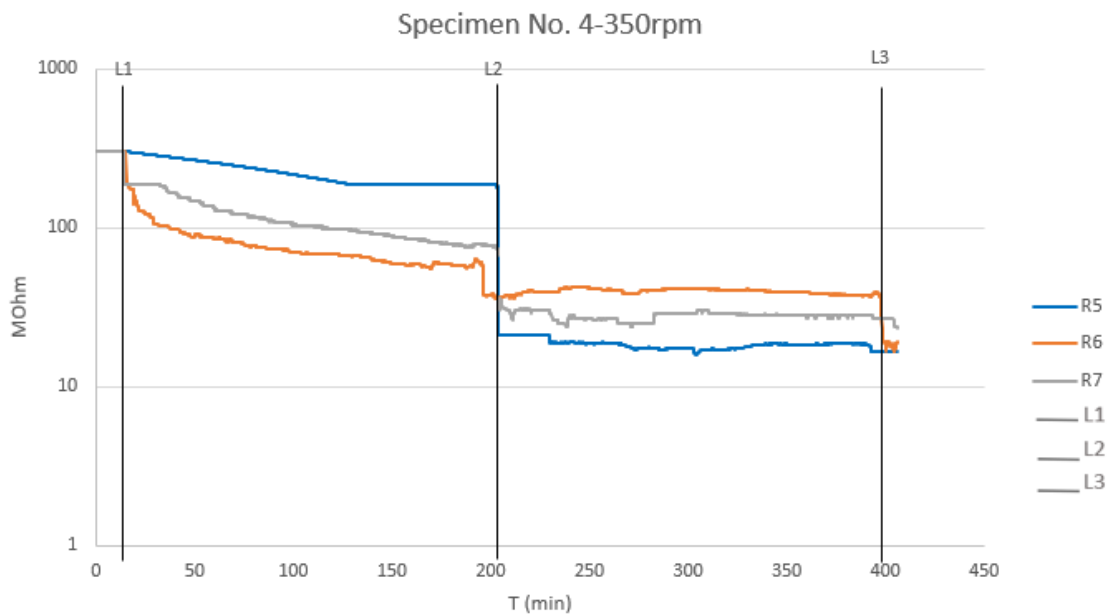
Graph No. 4: Electrical resistance measurement - Especimen No.4-350 Rpm

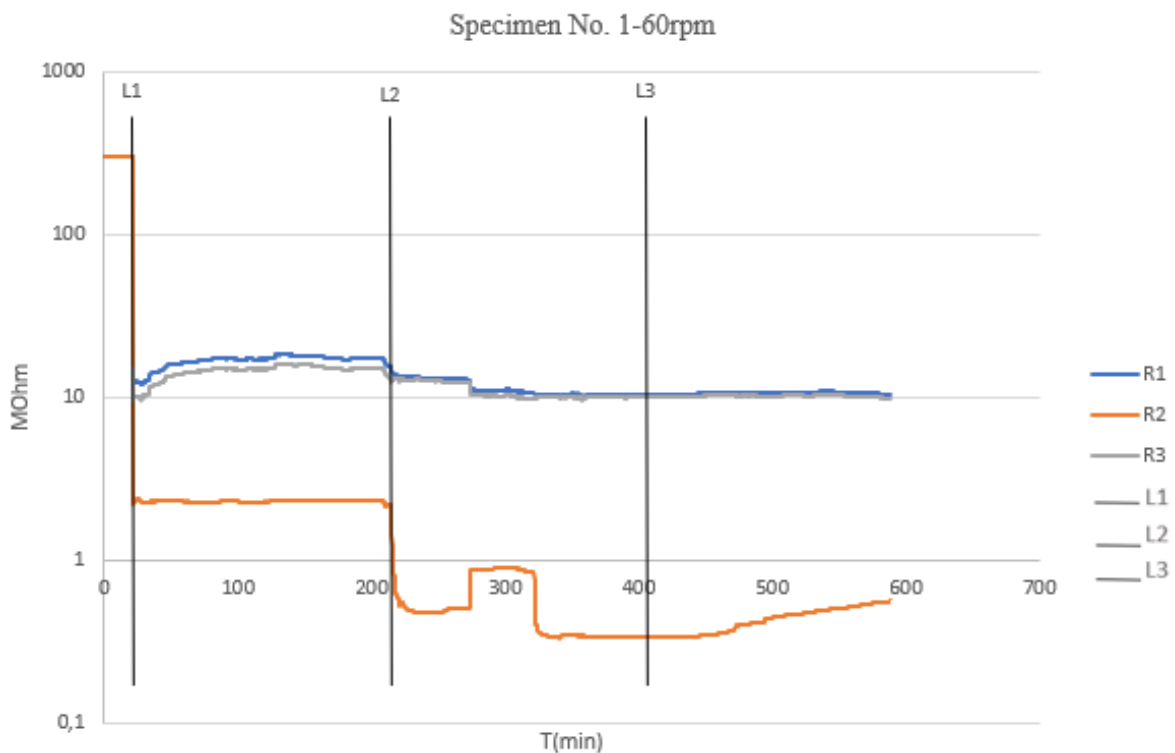
Graph No. 5: Electrical resistance measurement - Especimen No.1-60 Rpm

Experiment3 is carried out with conditions of a temperature of 23 °C, relative humidity of RH 75%, and wind conditions of 60 rpm, the results of graphs No. 5 and No.6 are obtained for specimens 1 and 2 (the same specimens of the 700 rpm test). In these graphs it is observed that R2 always presents a lower resistance than R1, R3, R5, and R7 of graphs 5 and 6 respectively, it can also be observed that the readings do not present an initial electrical resistance of 300 MΩ, this may be due to the fact that the specimens already contained residual moisture from the tests performed during the first 700 rpm test. Likewise, it is observed that the readings R1 and R5, in approximately a time of 200 minutes (between L1 and L2) show a tendency of increasing electrical resistance which may indicate a failure in the reading of the sensors.

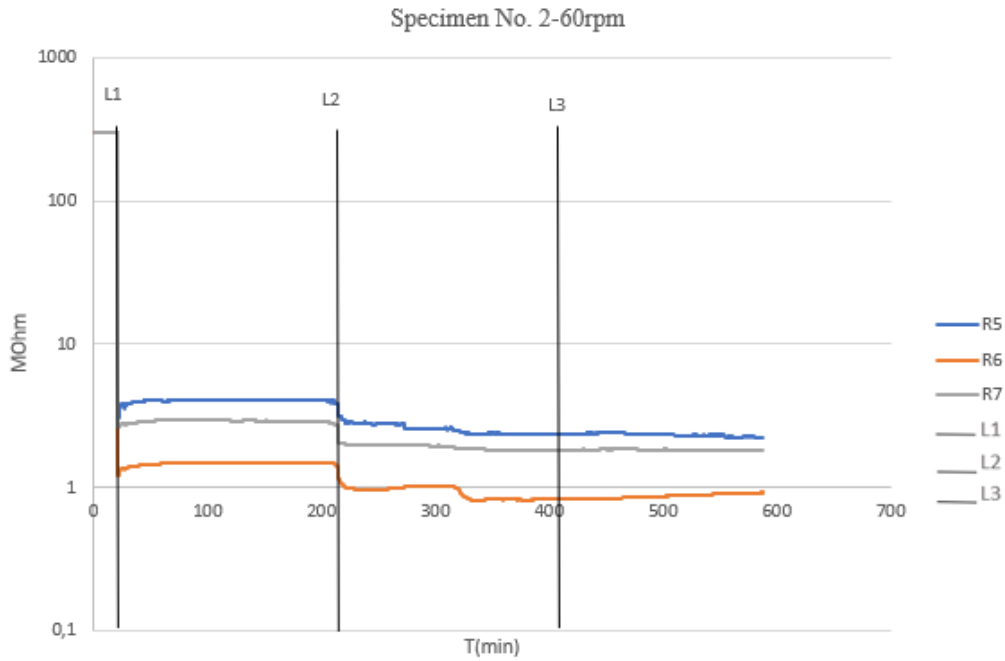
Graph No. 6: Electrical resistance measurement - Especimen No.2-60 Rpm

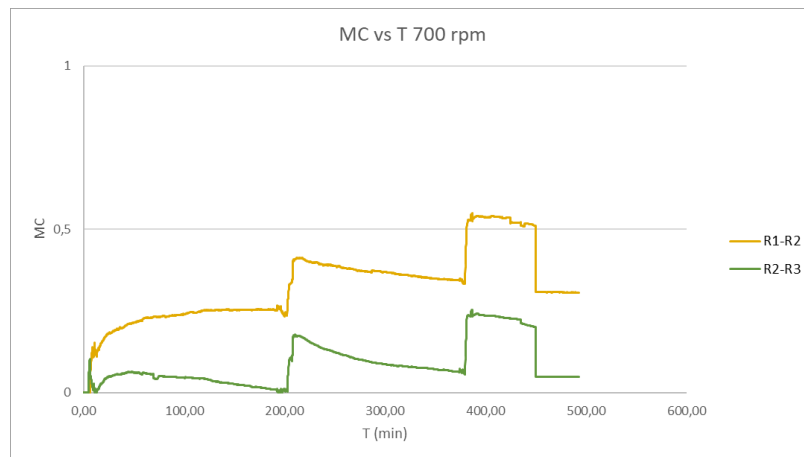
Graph No. 7 shows higher moisture content at R1-R2 for 700 rpm, with a high peak after the third rainfall simulation.

Graph No. 7: MC vs T 700 rpm. Specimen 1 and 2.

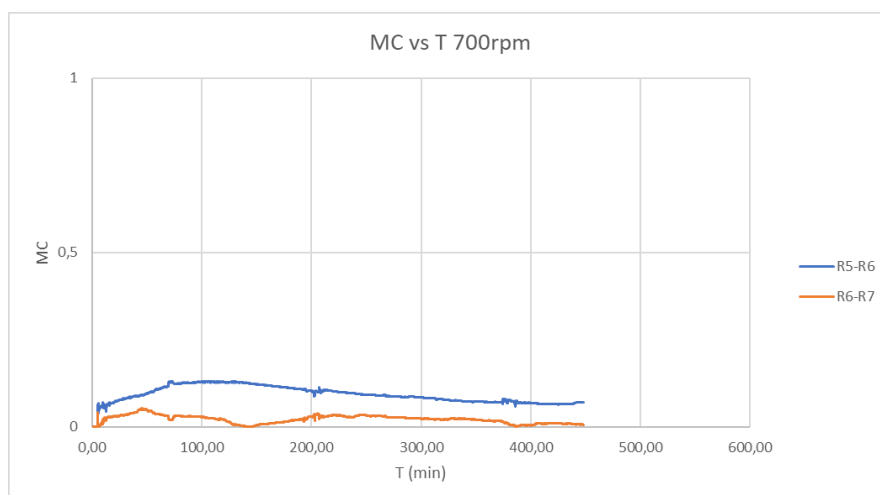
Samples R5-R6 show higher moisture content in the first rain simulation, and a continuous decrease in moisture content during subsequent rain loads.

Graph No. 8: MC vs T 700 rpm. Specimen 3 and 4

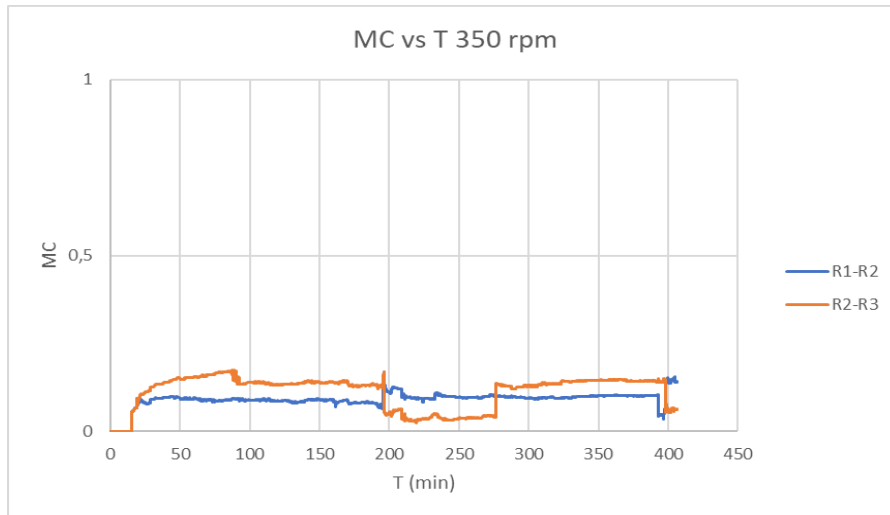
Samples R2-R3 at 350 rpm show a higher moisture content between the first and second rain simulation, decreasing between the second and third rain load, and increasing again in moisture content after the third simulation. Sample R1-R2 shows a steady increase in moisture content after the second rain simulation (Grafico No. 9)

Graph No. 9: MC vs T 350 rpm. Specimen 1 and 2

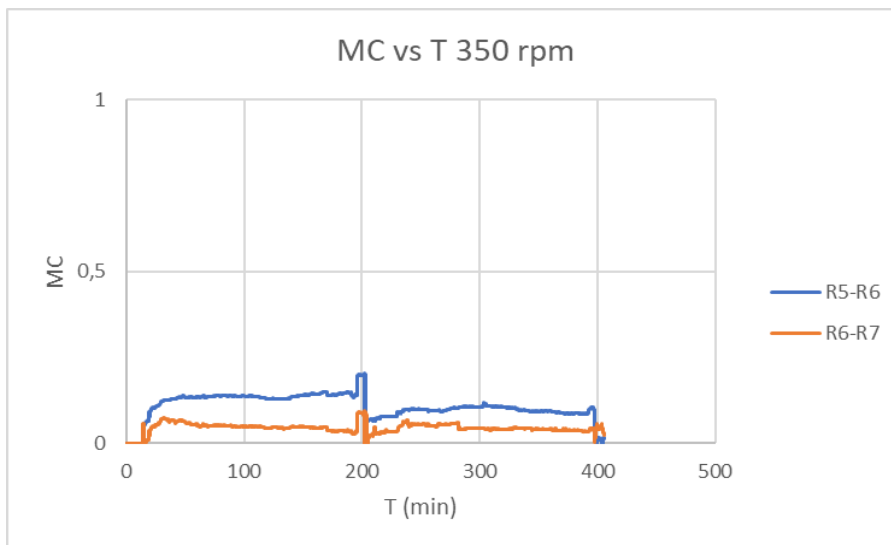
Graph 10 shows a higher moisture content near the second rainfall simulation, being higher in R5-R6.

Graph No. 10: MC vs T 350 rpm. Specimen 3 and 4

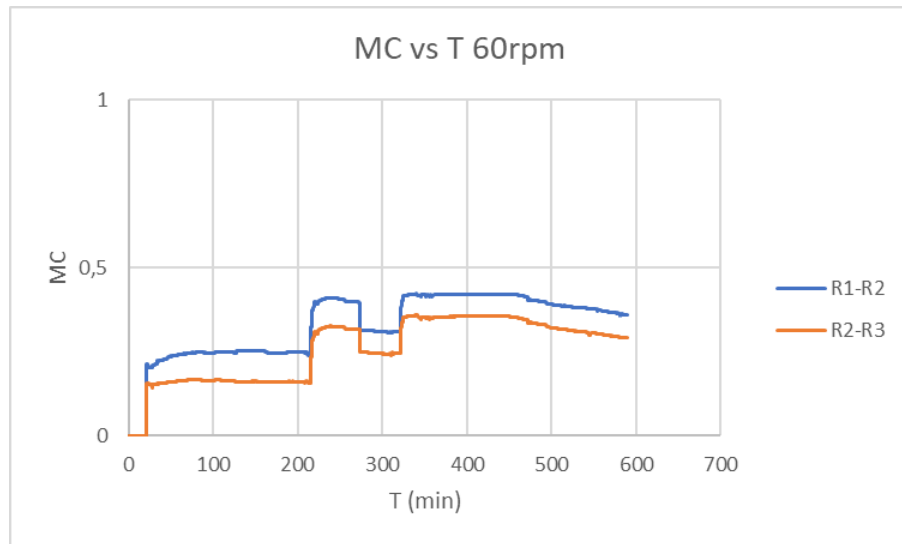
Graph 11 shows a higher content in R1 and R2 for a wind speed of 60 rpm, an increasing behavior of the moisture content is observed with each of the rain loads.

Graph No. 11: MC vs T 60 rpm. Specimen 1 and 2.

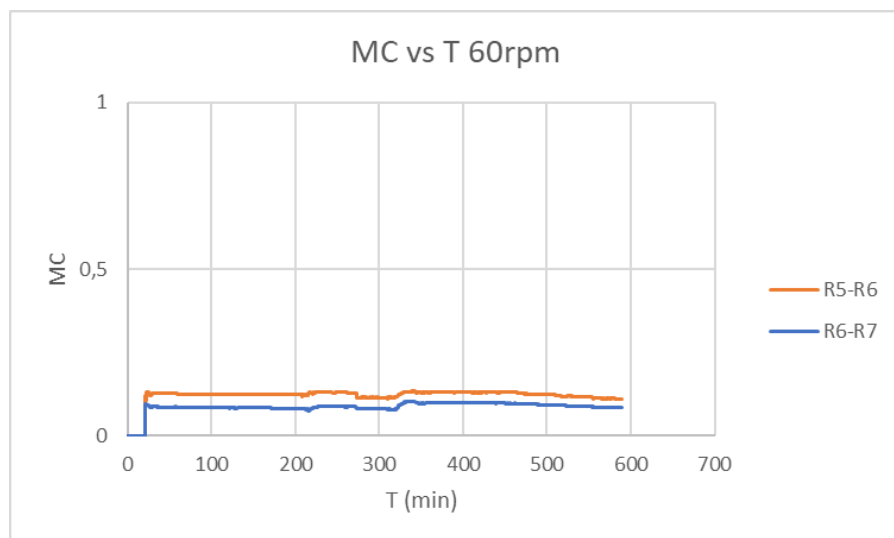
For samples 3 and 4 at 60 rpm the moisture content presents a constant behavior lower than 0.5 of the moisture content, having a higher saturation R5-R6. Graph 12.

Graph No. 12: MC vs T 60 rpm. Specimen 3 and 4.

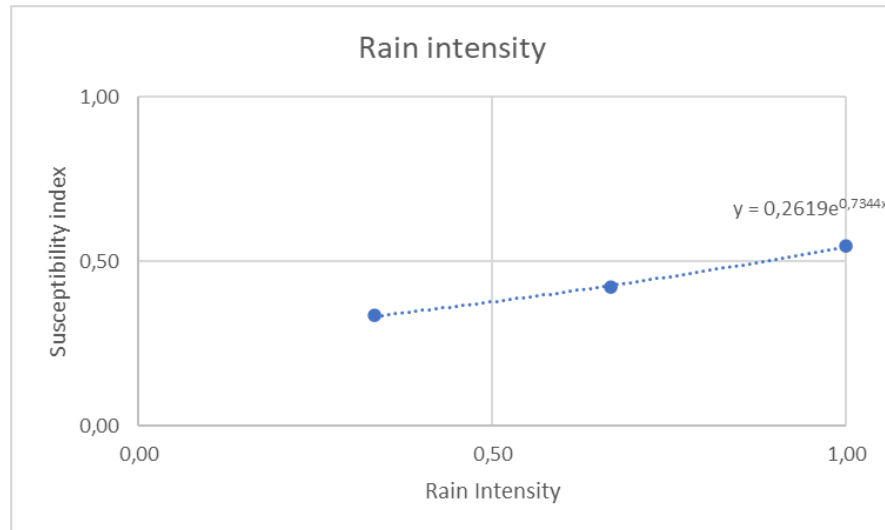
Graph N° 13 shows a predisposition to developing lesions coming from the effects of rain on the material, i.e., for example, the high presence of moisture inside the material can cause pressure problems in the internal walls of the material, generating cracks and fissures, in addition to crystallization processes that modify the structure of the rock, as well as other related pathologies. It is understood that water reacts with the stone substrate dissolving its components and acting as a transport vehicle. Therefore, the material can be classified with a moderate degree of susceptibility, higher than 0.50.

Graph No. 13: Rain Intensity

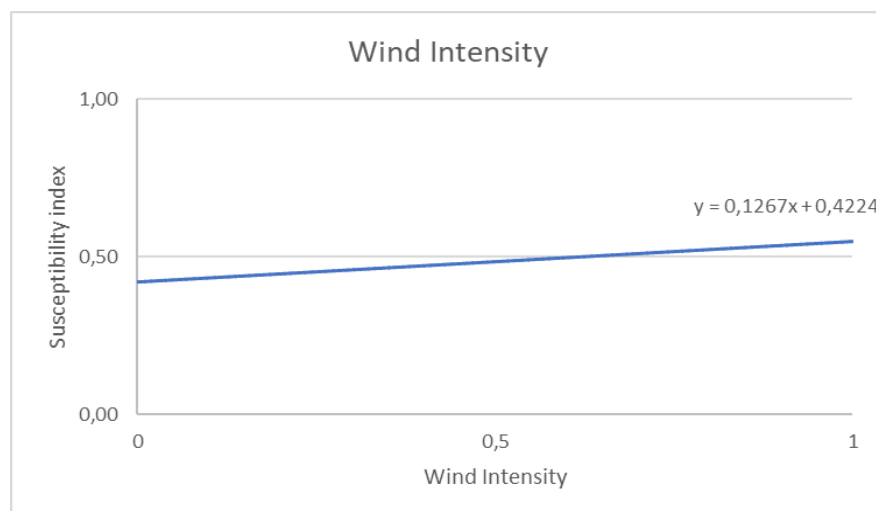
Graph No. 14 shows an increasing behavior of the susceptibility index at higher wind intensities. 14 presents an increasing behavior of the susceptibility index at higher wind intensities, this factor allows the transport of suspended particles that hit the stone, generating erosions in the material, which further increases the degree of damage in the presence of salts, humidity, and environments prone to contaminating agents such as sulfur compounds SO_2 , H_2S , H_2SO_4 , carbon compounds CO , CO_2 , CH_4 , HCT , nitrogen compounds NO , NO_2 , NH_3 , among others. The material is classified with a moderate susceptibility index.

Graph No. 14: Wind Intensity

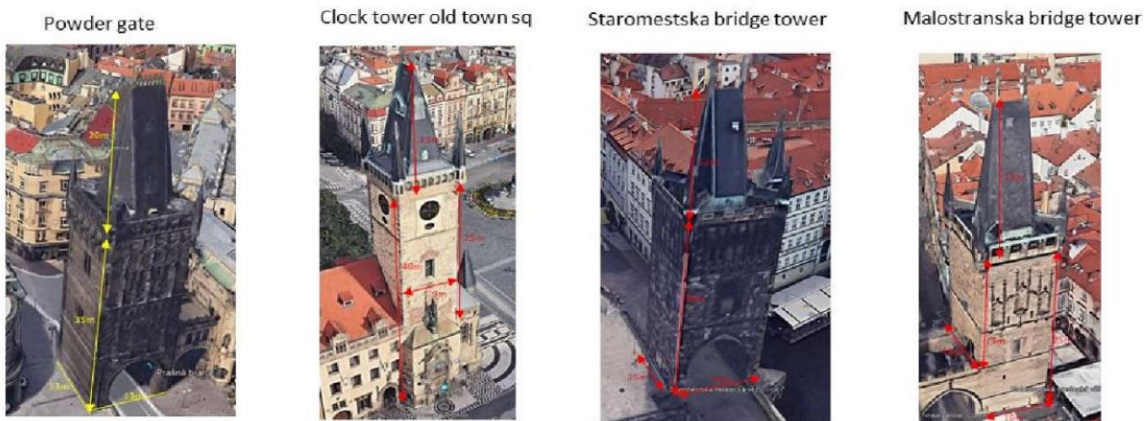
Figure 19: Dimensional relationships from Google measurements

For the physical model with the idealized geometry, it was necessary to compare the dimensional relationships from the Google measurements (for example, height/width), then the averages that could be used for the idealized model were calculated taking into account that it had a fixed width of the body of 30 cm.

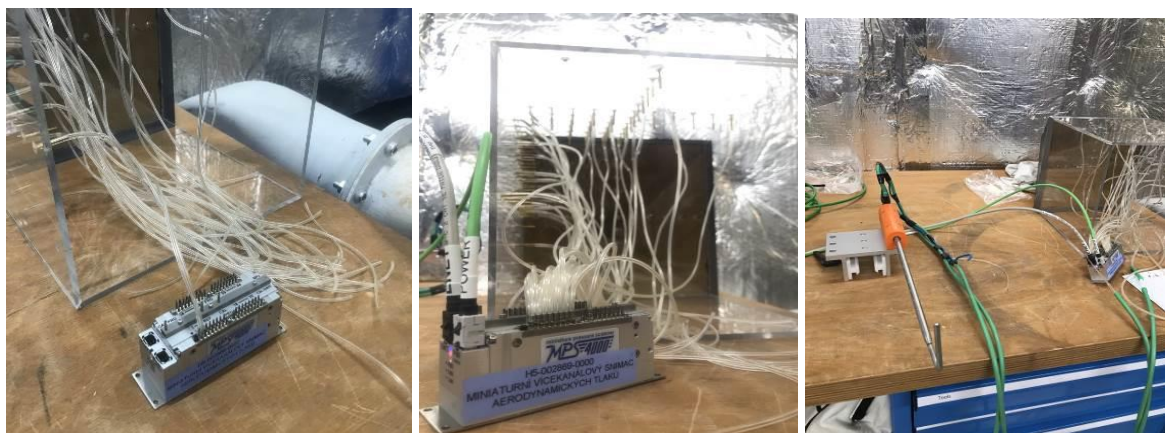
Figure 20: Left- Scanivalve MPS 4264 pressure transducers. Right- Pitot tube connection.

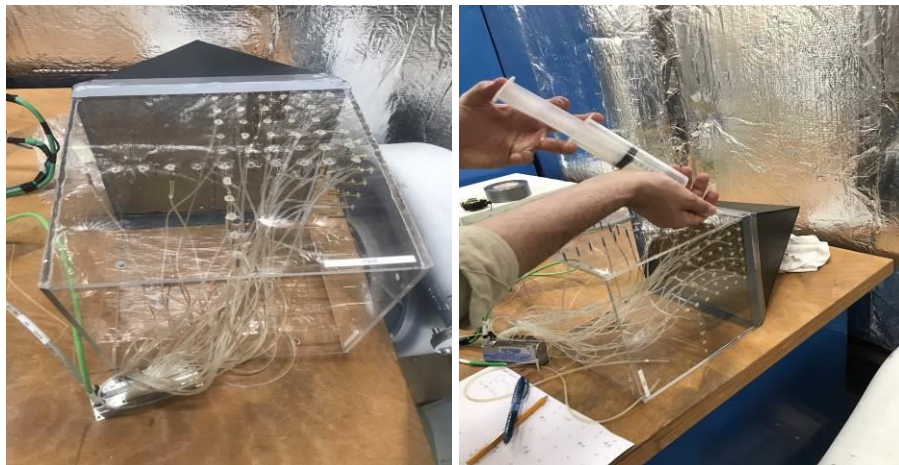
Figure 21: Sensor installation and testing

In order to avoid a distortion of the structural behavior of the frame, the pressure transducers cannot be mounted directly on the frame; therefore, they are connected to the intakes by means of optimized tube systems, with a length of 1000 mm. These tube systems provide a flat response of pressure signals up to 200 Hz. The tubes are attached to the taps with short brass tubes, which are glued to the inside surface of the housing.

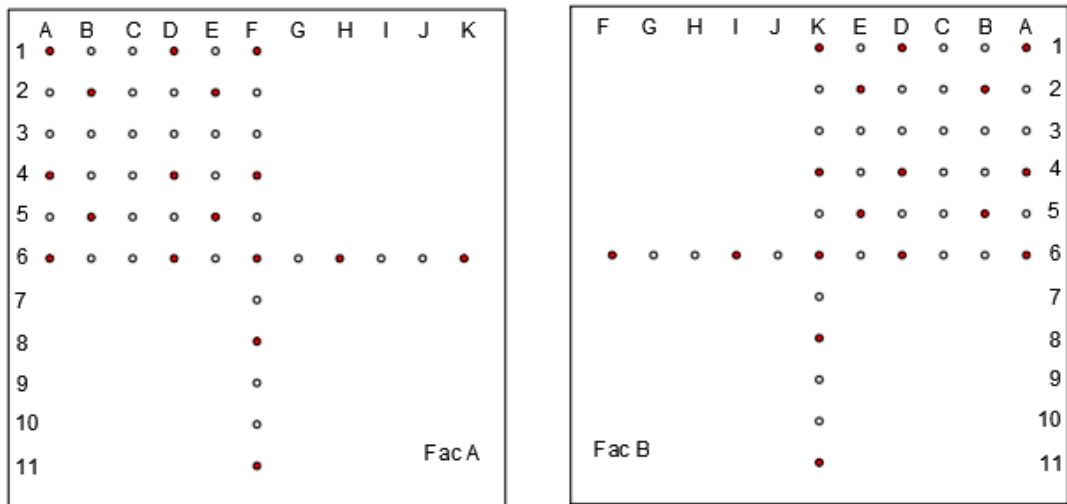
. A total of 92 pressure taps were placed on the model, 46 pressure taps were placed on facade A and 46 on facade B (Figure 22).

Figure 22: Distribution of sensors on facade A and B of the scale model.

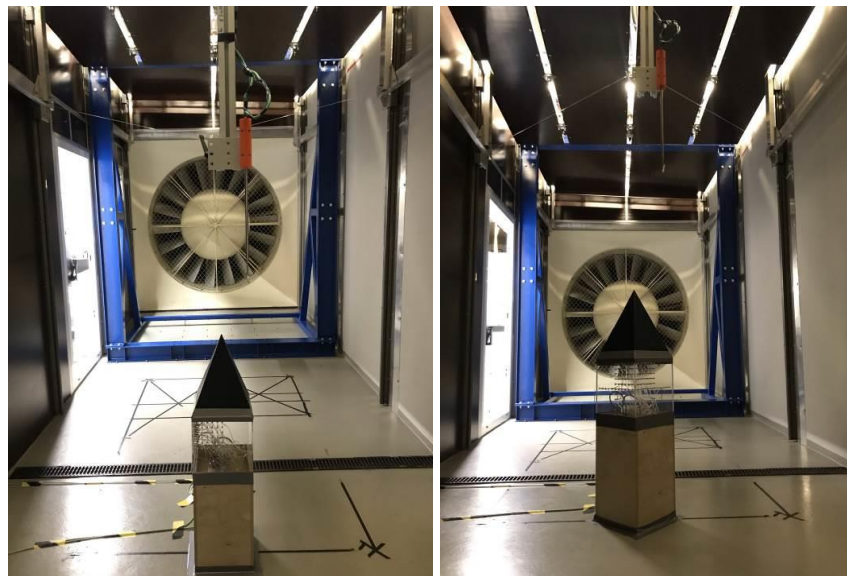
Figure 23: Left-Position of the scale model inside the tunnel at 0 degrees. Right-Position of the scale model inside the tunnel rotated at 45 degrees.

The Prandtl tube was placed 1 meter in front of the model and at a height of 27 cm from the wind tunnel floor, and was used as a reference velocity.

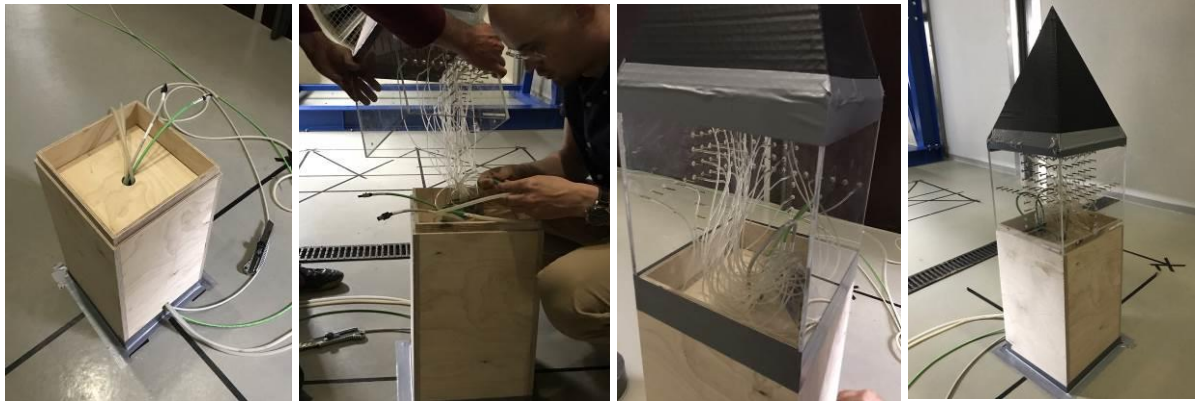
Figure 24: Montaje del modelo a escala dentro del tunel de viento.
