ADVANCED MASTERS IN STRUCTURAL ANALYSIS
OF MONUMENTS AND HISTORICAL CONSTRUCTIONS

Master's Thesis

Experimental investigation of
climate effects on historical
building materials: the Gothic
towers of Prague.

University of Minho

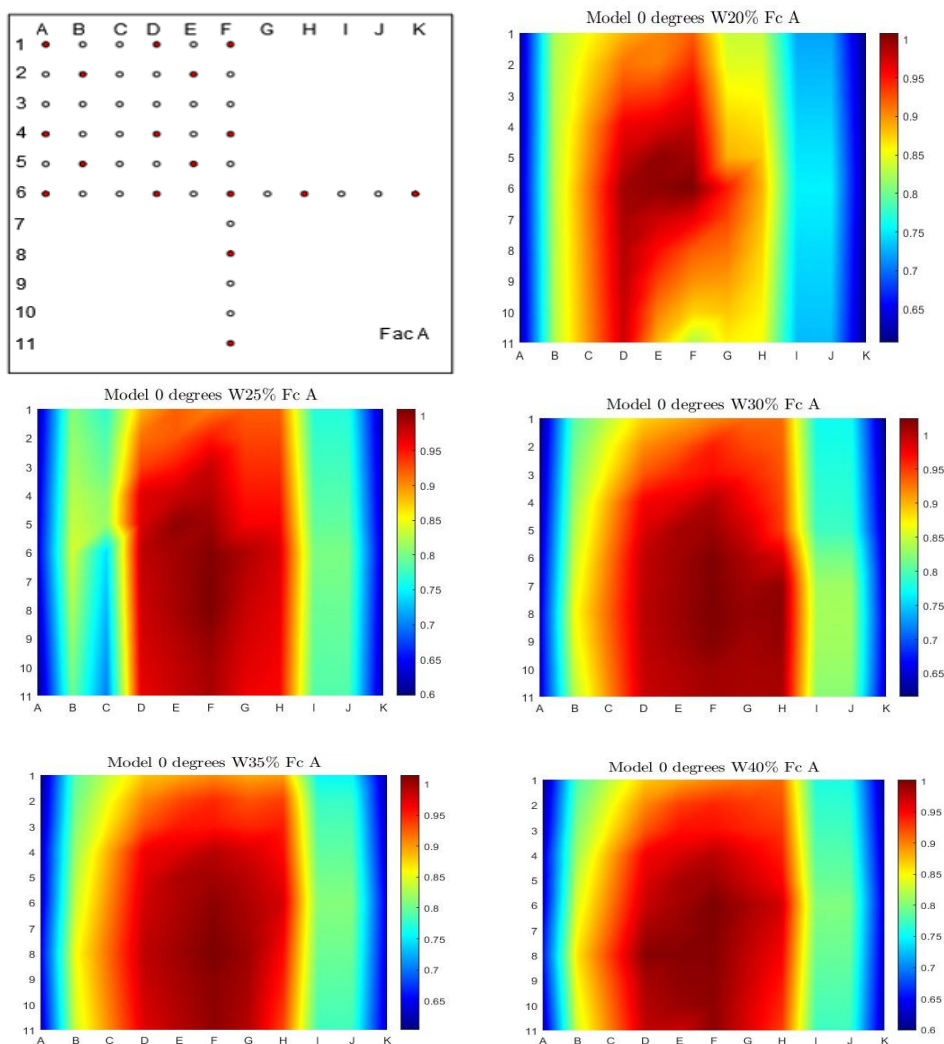
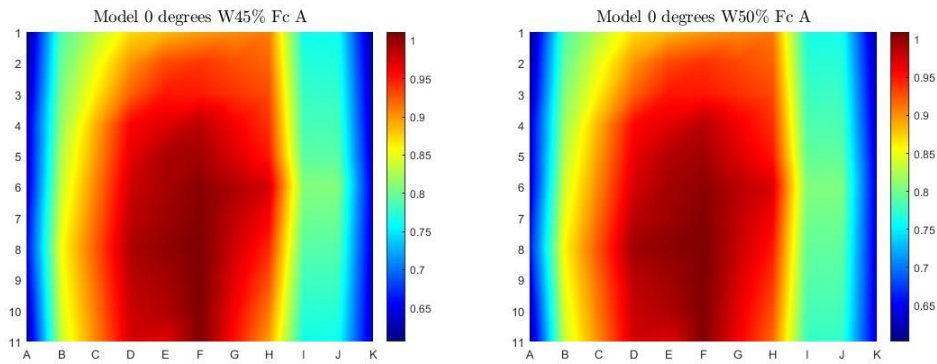
Figure 25: Pressure map at 0° degrees at different speeds. Façade A.

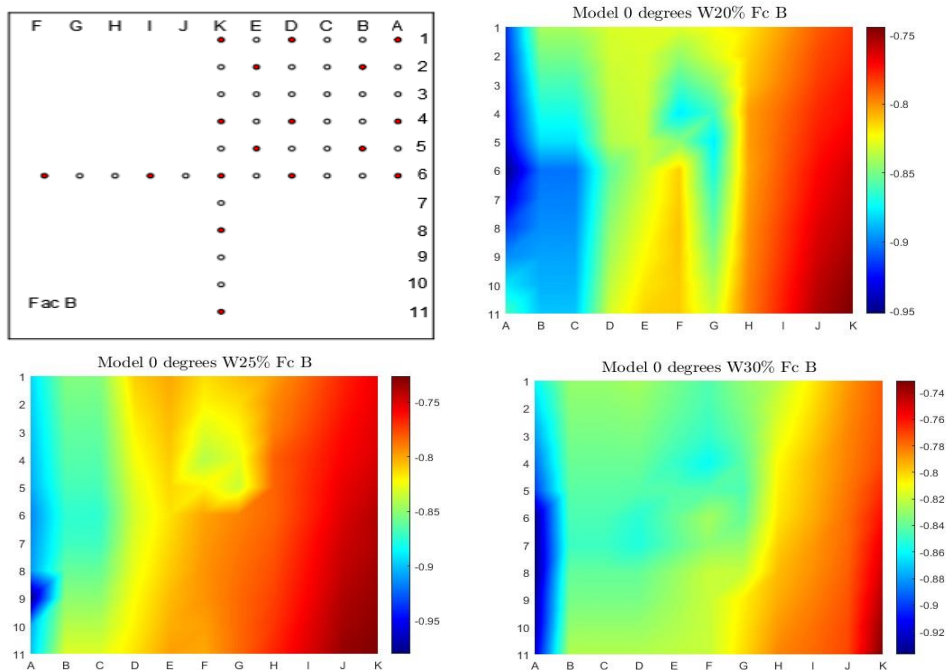
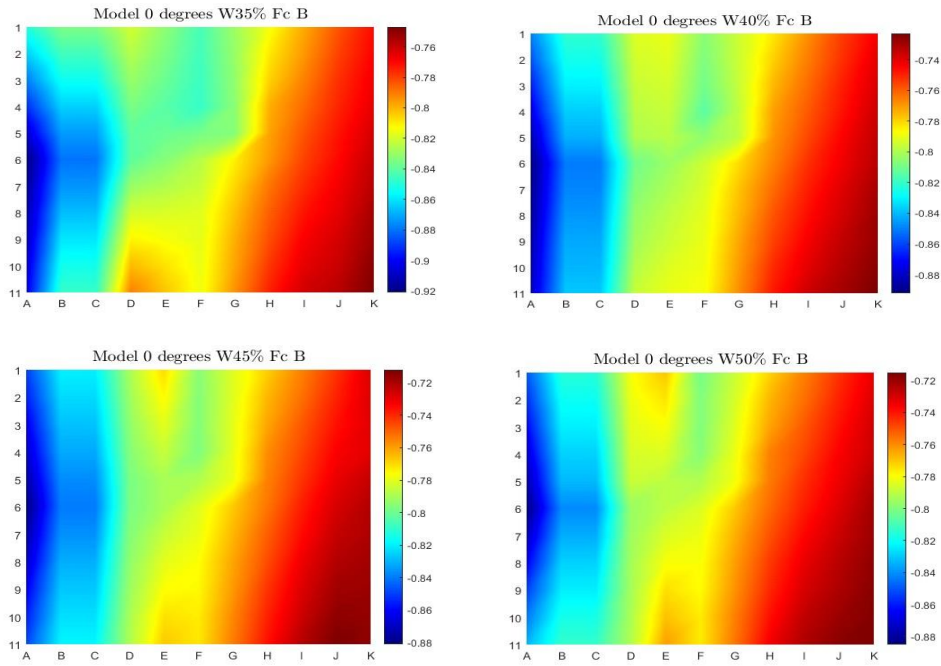
Figure 26: Pressure map at 0° degrees at different speeds. Façade B.

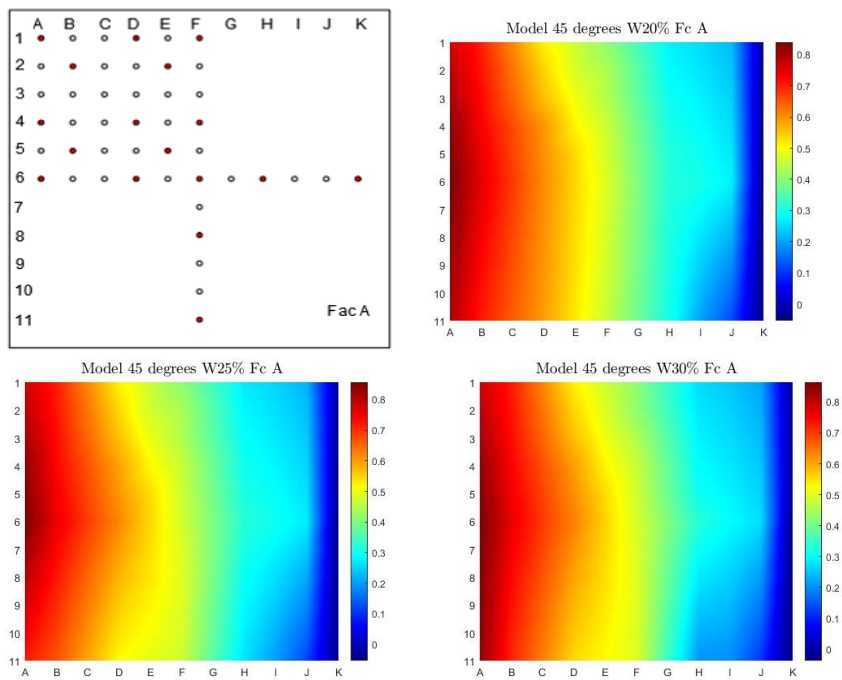
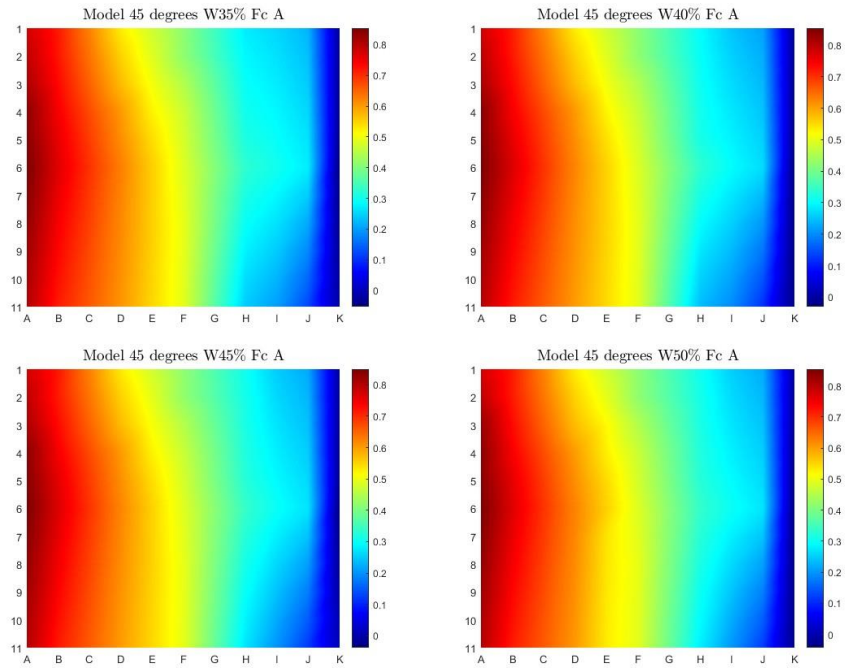
Figure 27: Pressure map at 45° degrees at different speeds. Façade A

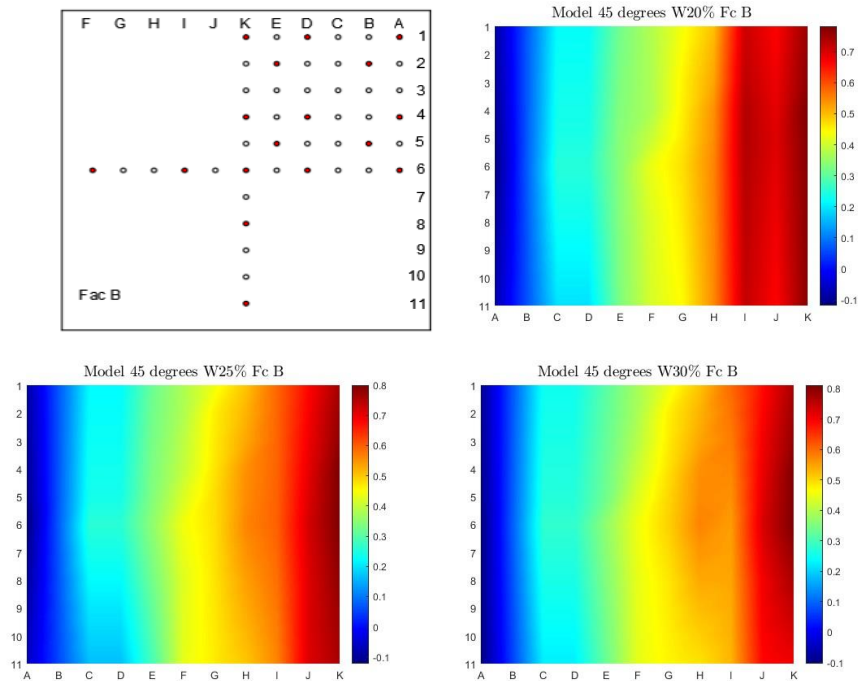
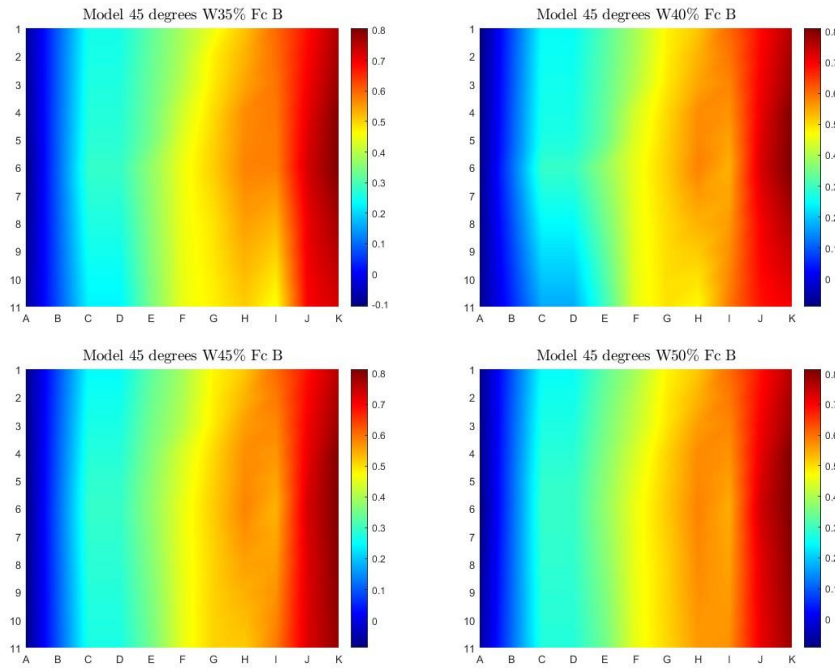
Figure 28: Pressure map at 45° degrees at different speeds. Façade B.

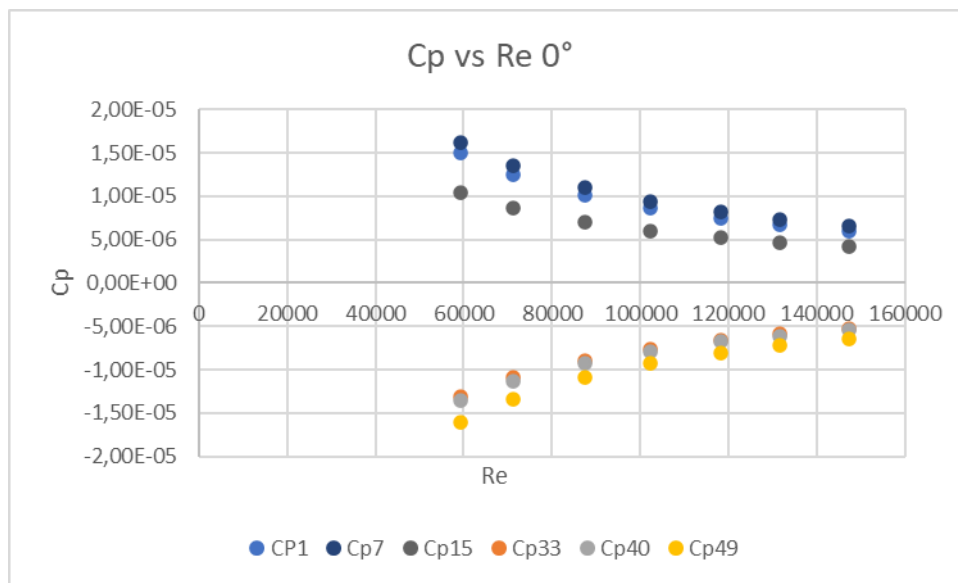
Graph No. 15: C_p vs Re 0°

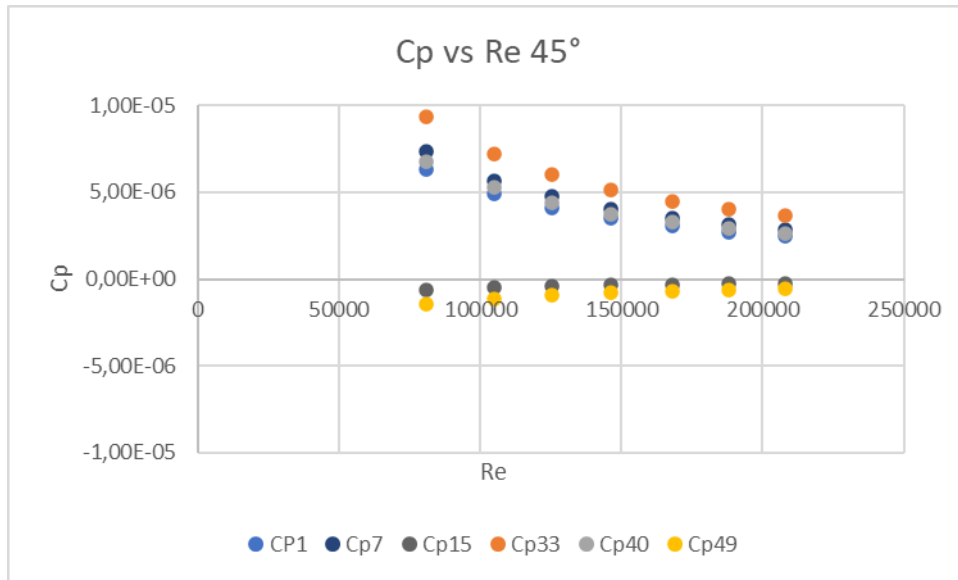
Graph No. 16: Cp vs Re 45°

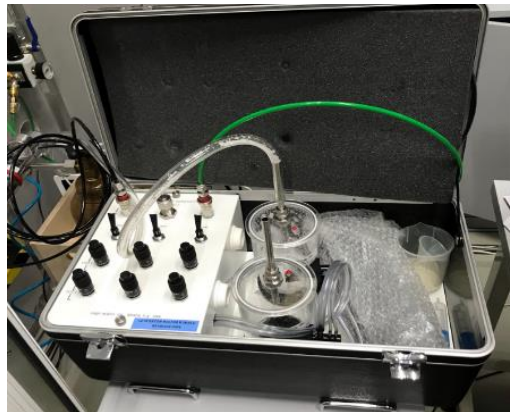
Figure 29: Helium bubble generator model 5

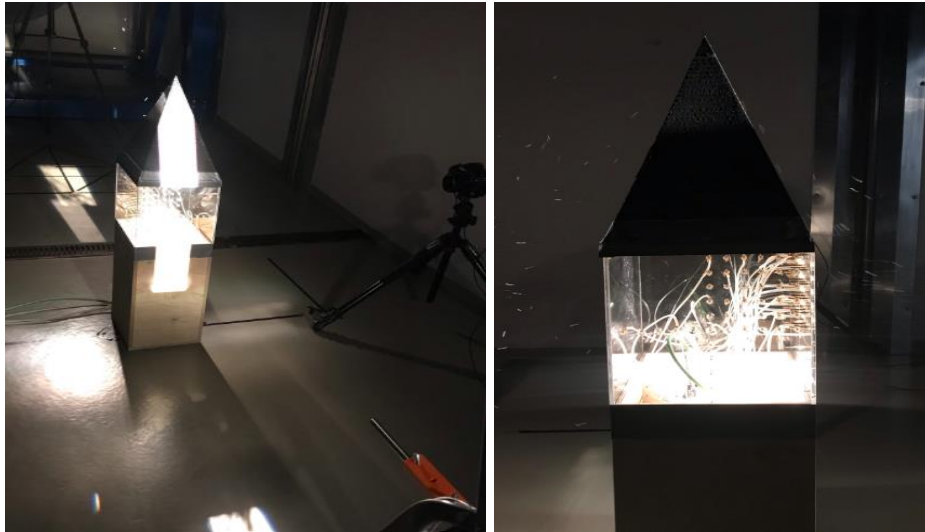
Figure 30: General configuration of the test with tower at 0 degrees.

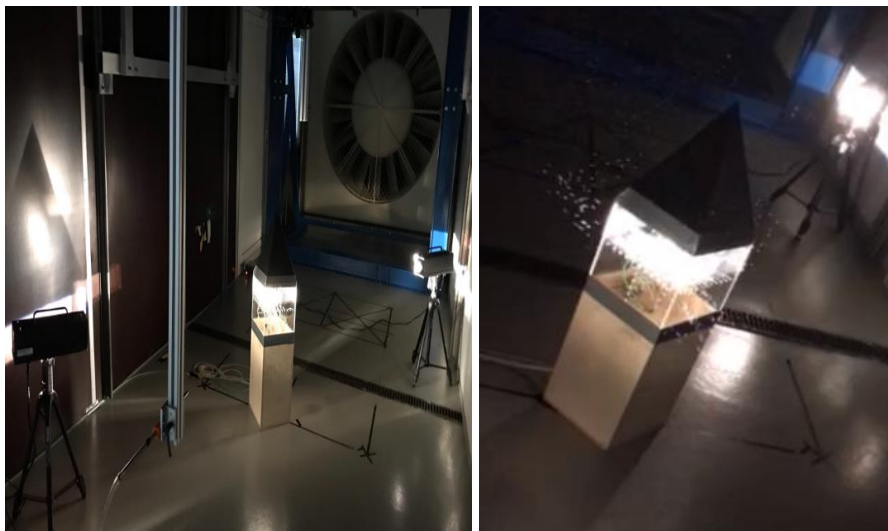
Figure 31: General test setup with tower at 45 degrees.

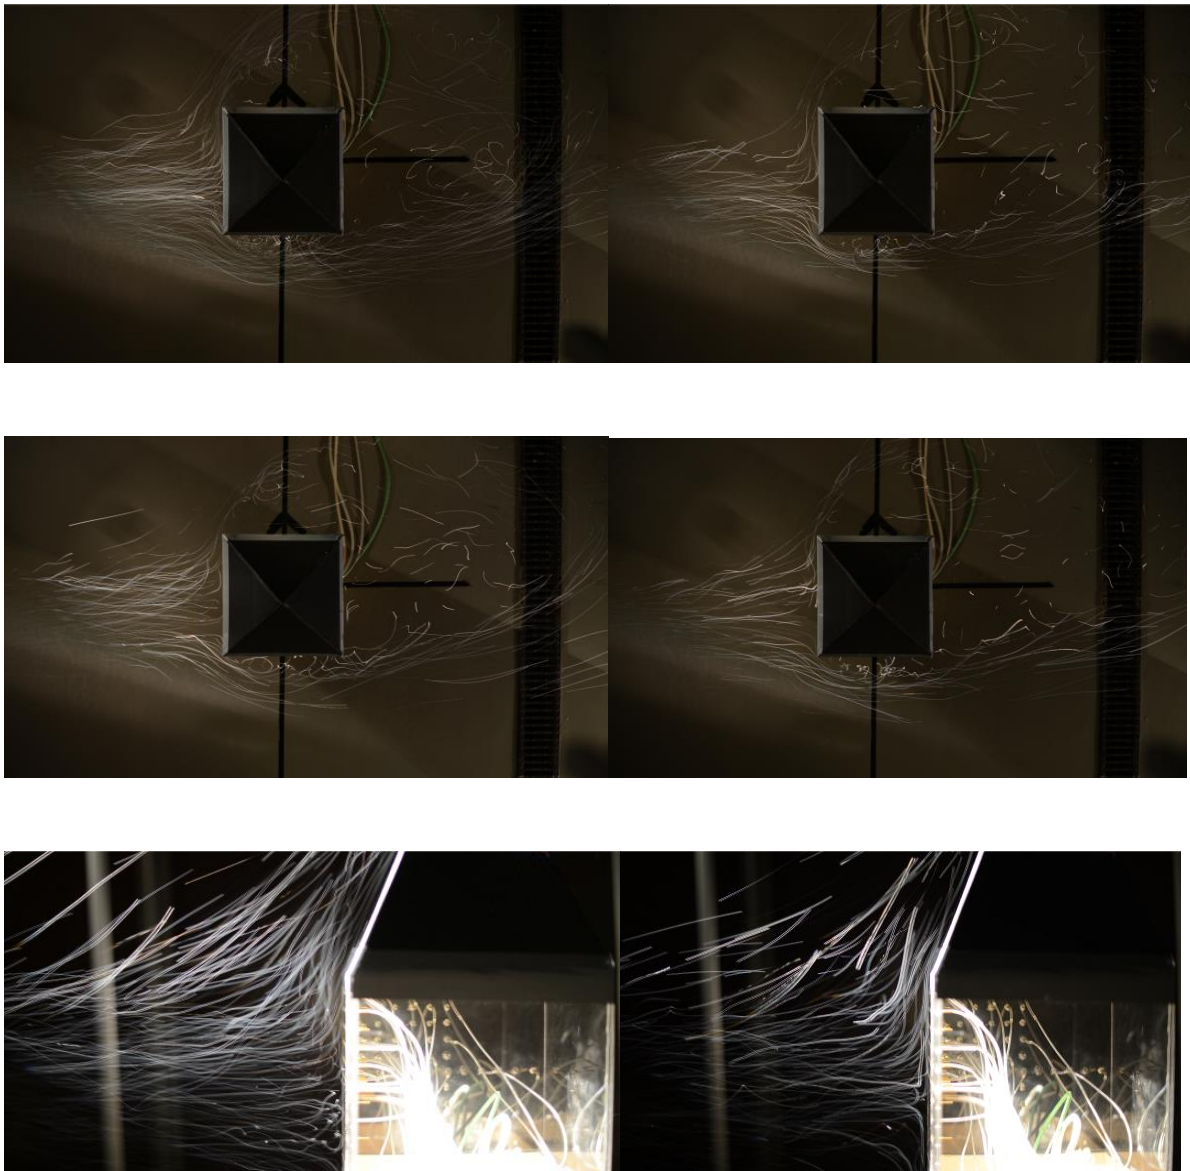
Figure 32: 2% flow visualization test.

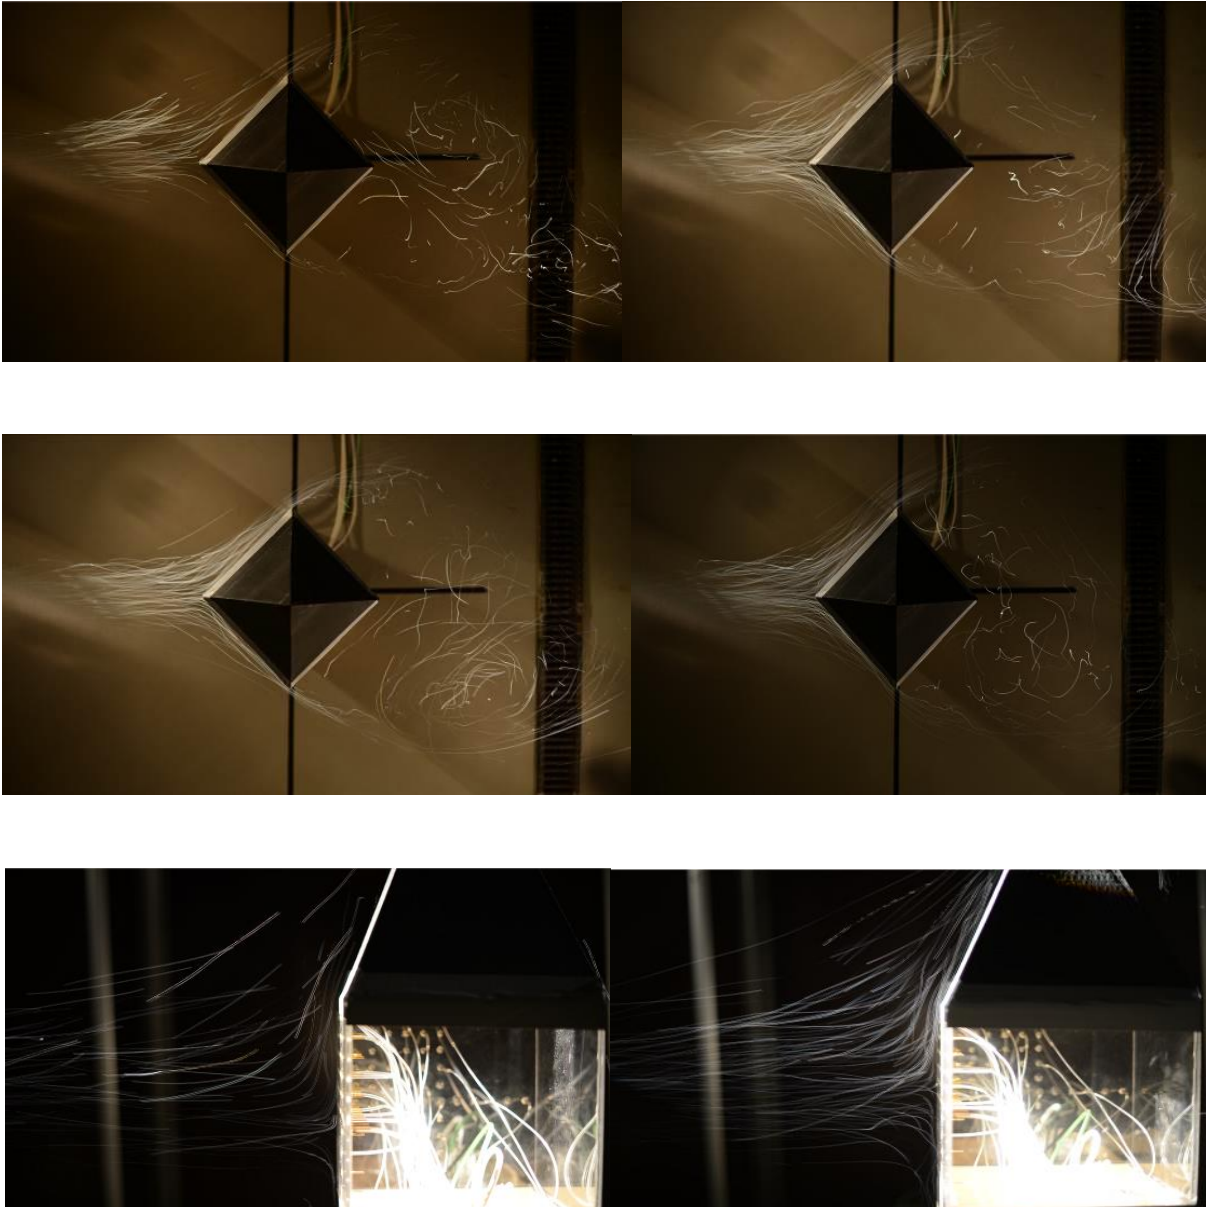
Figure 33: 5% flow visualization test.

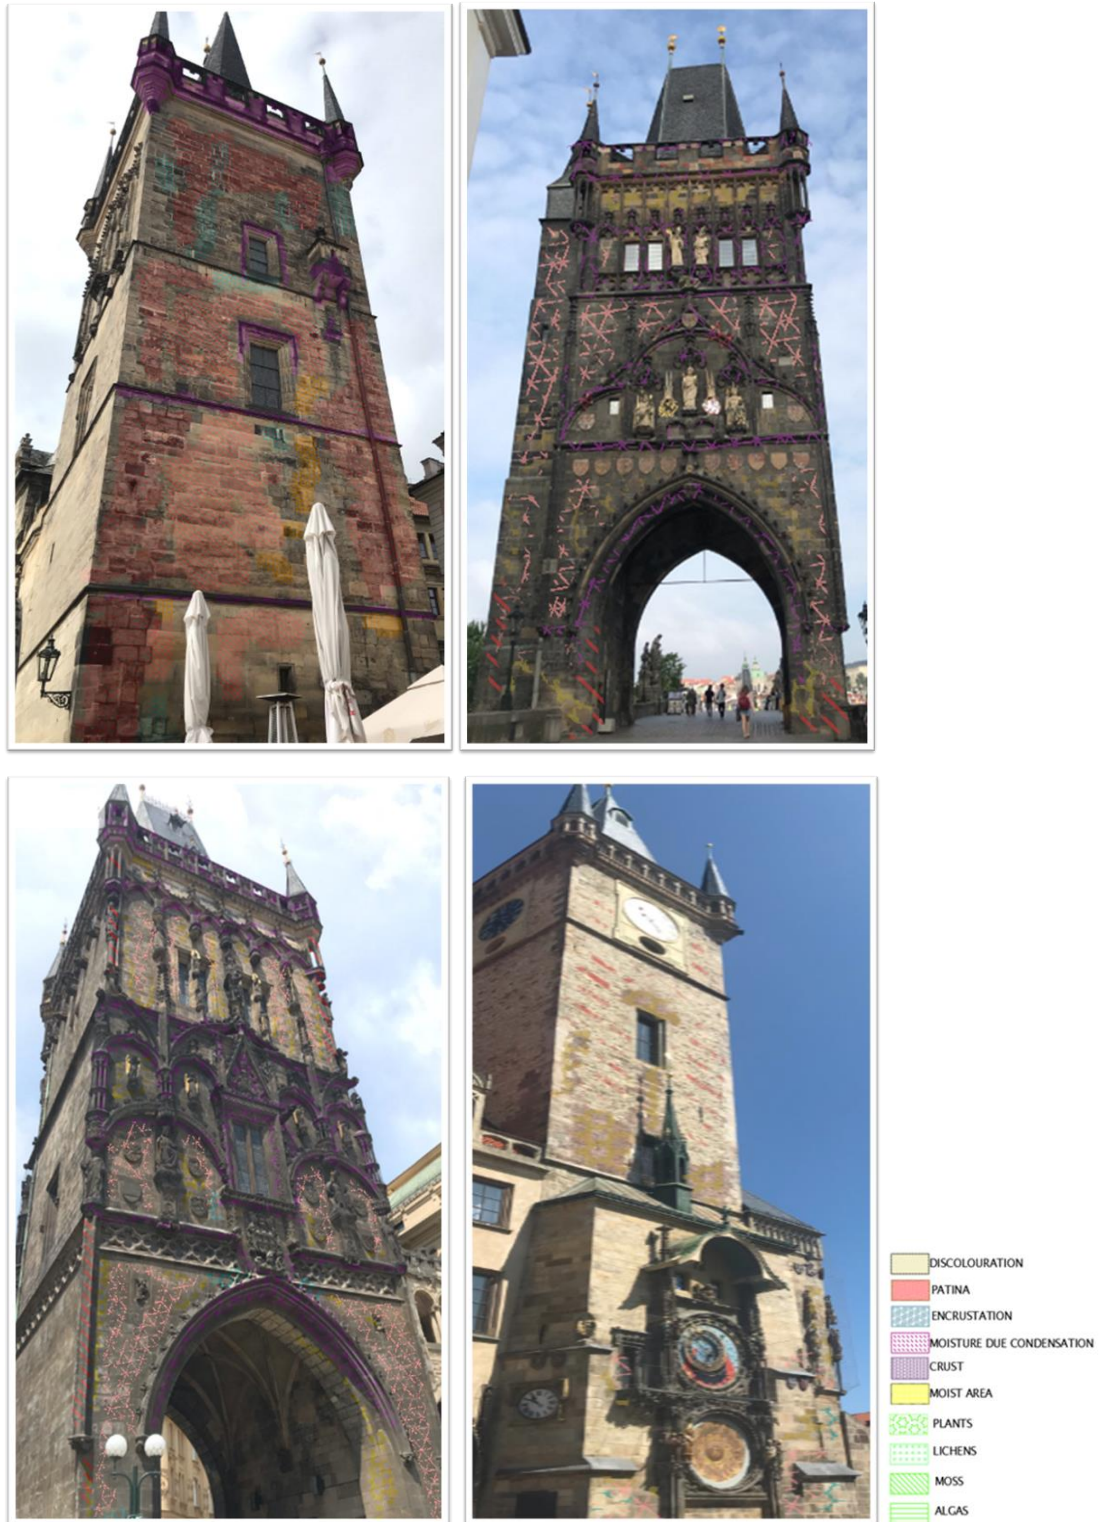
Figure 35: Survey of damages in the study towers.

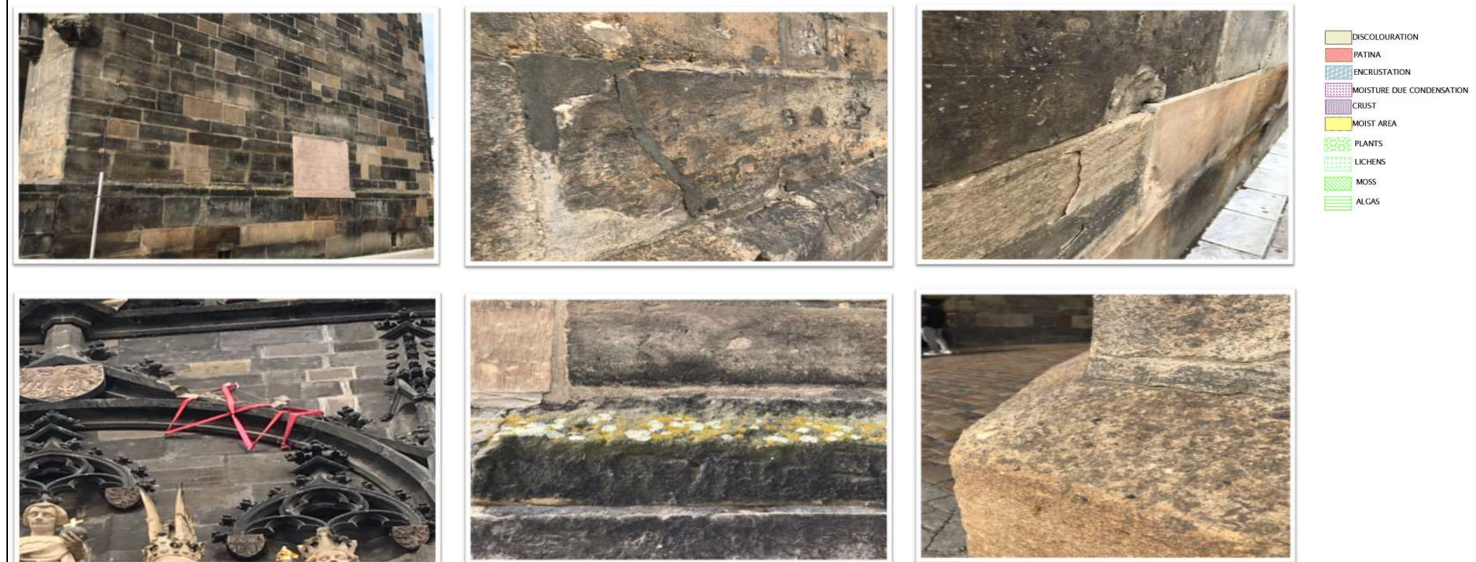
PHOTO	Cod.	DAMAGE	DEFINITION	INTERVENTION PROPOSAL
1	CD-01-05	Efflorescence	Generally whitish, powdery or whisker-like crystals on the surface. Efflorescences are generally poorly cohesive and commonly made of soluble salt crystals	The deterioration processes must be interrupted, in general the process is based on the manual cleaning of the material in order not to generate strong abrasions in the rock, it is advisable to make samplings of the dirt to determine its nature and to eradicate them in an effective way. Within this work is included the pre-consolidation, this should be done when there are pieces of great historical value where the cleaning itself can generate destruction of the element, desalination in which salts are extracted with the application on the surface of the stone of an additional absorbent material, a consolidation will be executed with the objective of increasing the cohesion of the components of the superficial zone of the stone.

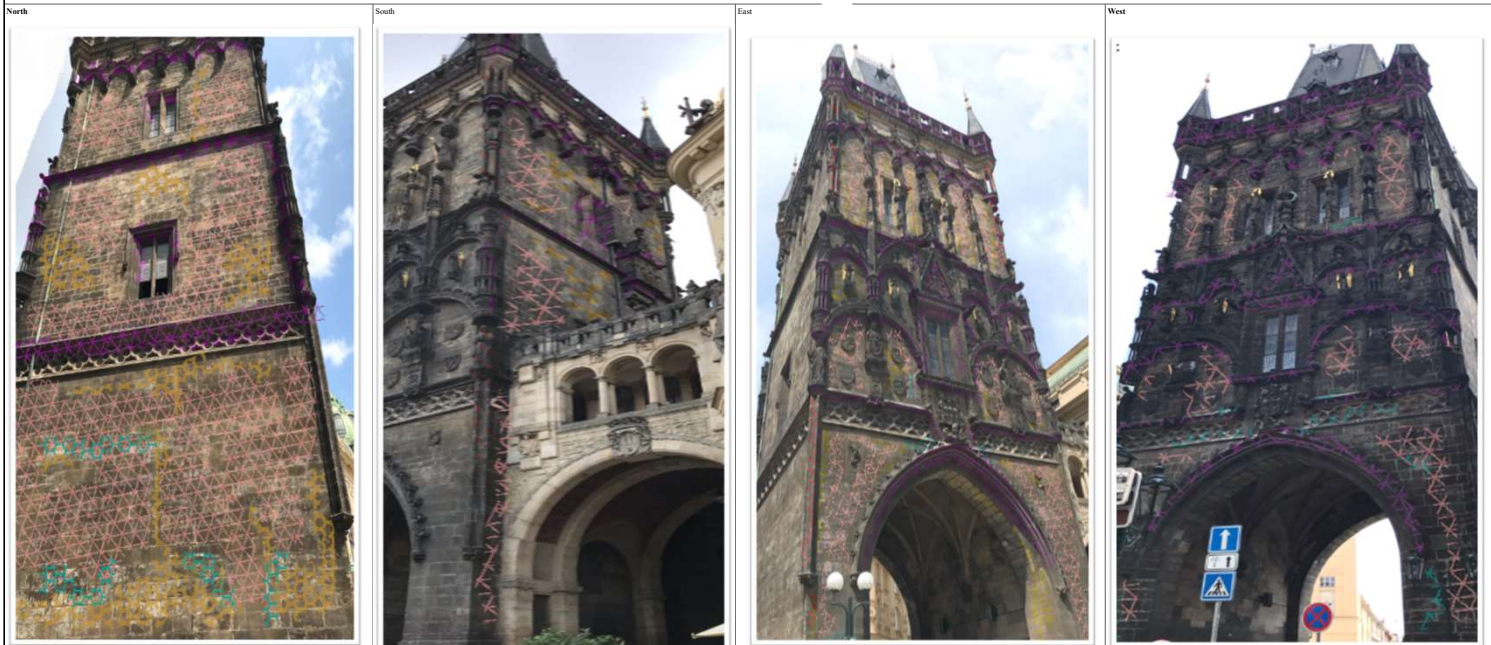
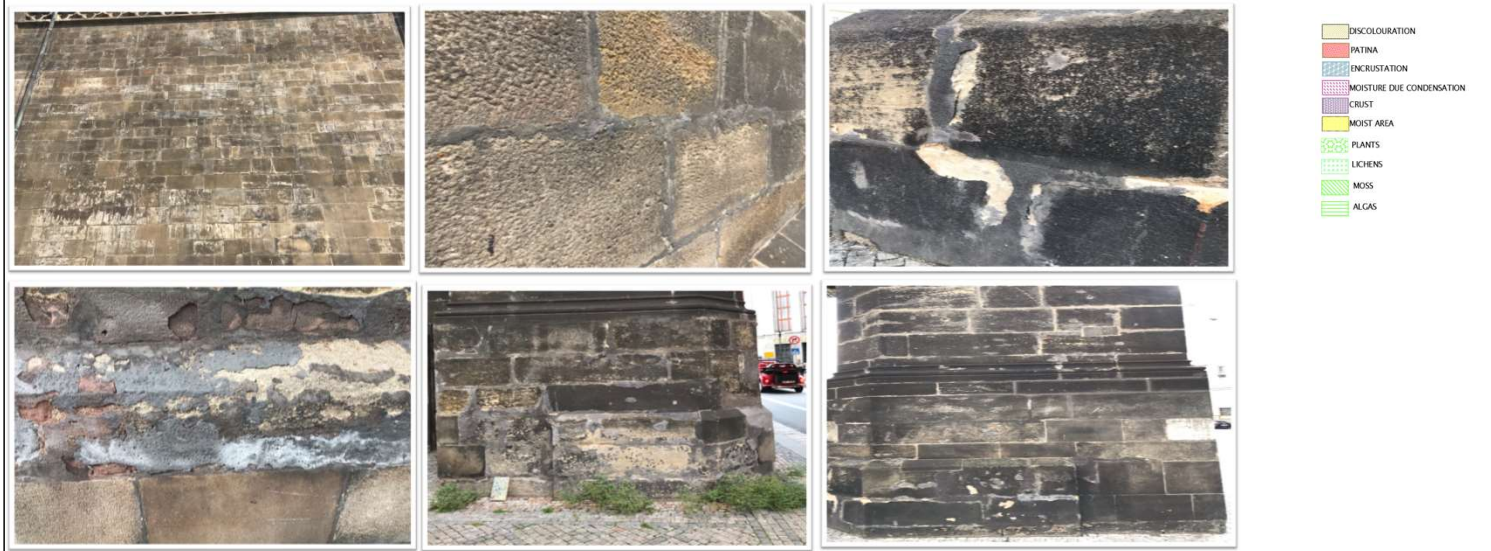
PHOTO	Cod.	DAMAGE	DEFINITION	INTERVENTION PROPOSAL
1	CD-01-05	Efflorescence	Generally whitish, powdery or whisker-like crystals on the surface. Efflorescences are generally poorly cohesive and commonly made of soluble salt crystals	The deterioration processes must be interrupted, in general the process is based on the manual cleaning of the material in order not to generate strong abrasions in the rock, it is advisable to make samplings of the dirt to determine its nature and to eradicate them in an effective way. Within this work is included the pre-consolidation, this should be done when there are pieces of great historical value where the cleaning itself can generate destruction of the element, desalination in which salts are extracted with the application on the surface of the stone of an additional absorbent material, a consolidation will be executed with the objective of increasing the cohesion of the components of the superficial zone of the stone.

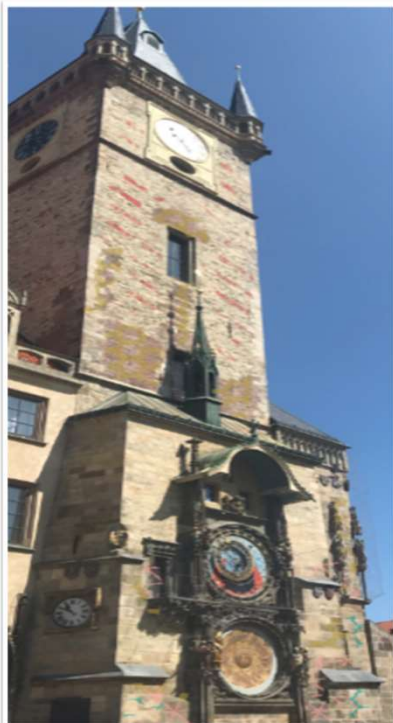
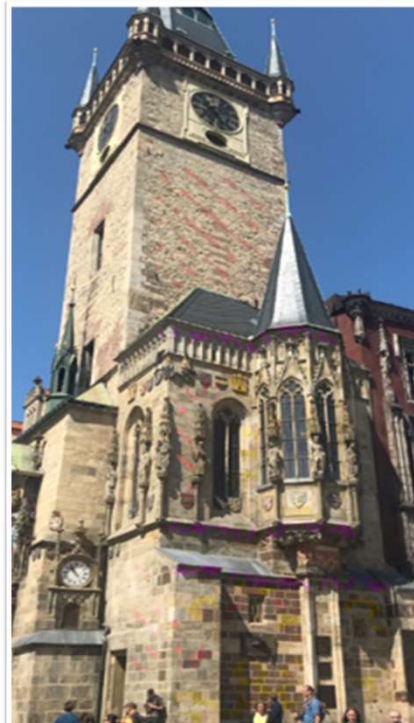
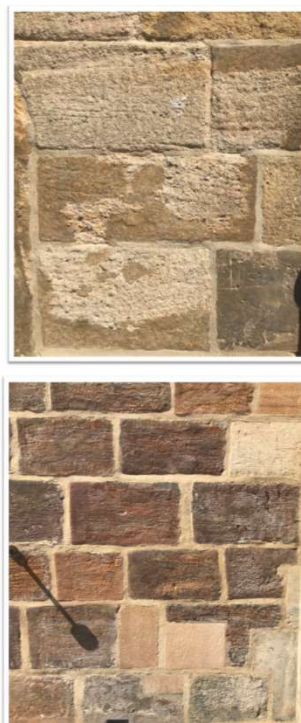
RELEVANT DAMAGES

PHOTO	Cod.	DAMAGE	DEFINITION	INTERVENTION PROPOSAL
1	CD-01-05	Efflorescence	Generally whitish, powdery or whisker-like crystals on the surface. Efflorescences are generally poorly cohesive and commonly made of soluble salt crystals	The deterioration processes must be interrupted, in general the process is based on the manual cleaning of the material in order not to generate strong abrasions in the rock, it is advisable to make samplings of the dirt to determine its nature and to eradicate them in an effective way. Within this work is included the pre-consolidation, this should be done when there are pieces of great historical value where the cleaning itself can generate destruction of the element, desalination in which salts are extracted with the application on the surface of the stone of an additional absorbent material, a consolidation will be executed with the objective of increasing the cohesion of the components of the superficial zone of the stone.
