DYNAMIC TESTS OF THE PROTECTIVE AND SECURITY BARRIER SYSTEM PROBAR

ABSTRACT. The purpose of this paper is to present a series of dynamic tests for testing the protective and security barrier of the PROBAR system, developed by STRIX Chomutov, a.s., according to the PAS 68:2013 standard. The goal of the tests was to assess how the obstacle resist impacts and whether it can absorb the energy exerted on it. Verification of the mechanical properties of the device was performed in two types of impact configurations. Emphasis was placed on the behaviour of both the obstacle and the vehicle during the impact and in the short time interval after the collision. In terms of criteria for evaluating the impact tests, it can be stated that Test 2 exceeded the Theoretical Head Impact Velocity (THIV) criterion by 20 km h^{-1} , while Test 1 did not exceed the limit value. However, all values for other criteria (ASI, PHD, HIC, 3ms) were within the specified limits, and the safety barrier met the required criteria which allows to be certificated.

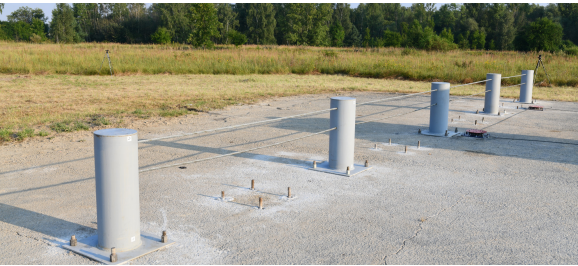
The construction of the barrier consists of a set of identical steel columns interconnected by two steel cables (Figure 1). The columns are made up of 324 mm/12.5 mm (outside diameter/width of material) seamless thick-walled steel tubes, with a column height of 918 mm and a weight of approximately 120 kg. Each column is fixed to the subgrade using 4 anchors (IBO32, 2 m long, fixed with grout). The method of anchoring may vary according to the specific geological investigation of the subsoil, always in relation to the required strength of the anchoring connection. The axial distance between two columns is 3.5 m. The technical parameters of the wire ropes used to connect the columns to each other are 20 mm 6x36WS-IWRC with a weight of 1.64 kg m⁻¹. The bottom rope is located at a height of 550 mm, the top rope at a height of 800 mm.

FIGURE 1. PROBAR system – test layout
