# REDUCTION OF TORQUE PULSATION IN ULTRALIGHT HELICOPTER TRANSMISSION

**ABSTRACT.** Usually, 1–2 seats helicopters use piston engines. One of their disadvantages is a significant torque pulsation on the engine shaft. The main reason for such fluctuations is the change in parameters during the engine’s operating cycle. The purpose of the investigation was to define the pulsation on the helicopter rotor shaft. An additional elastic clutch was used on a single-seat ultralight helicopter Rotorschmiede VA-115 of German firm RS Helikopter GmbH for pulsation dampening. Several flights were performed to assess the pulsation on the shafts. The results of the tests showed that the torque pulsation on the shaft in all modes does not exceed 30%. This is 10 times less than the pulsation value of 300% specified by the airworthiness standards for this helicopter class.

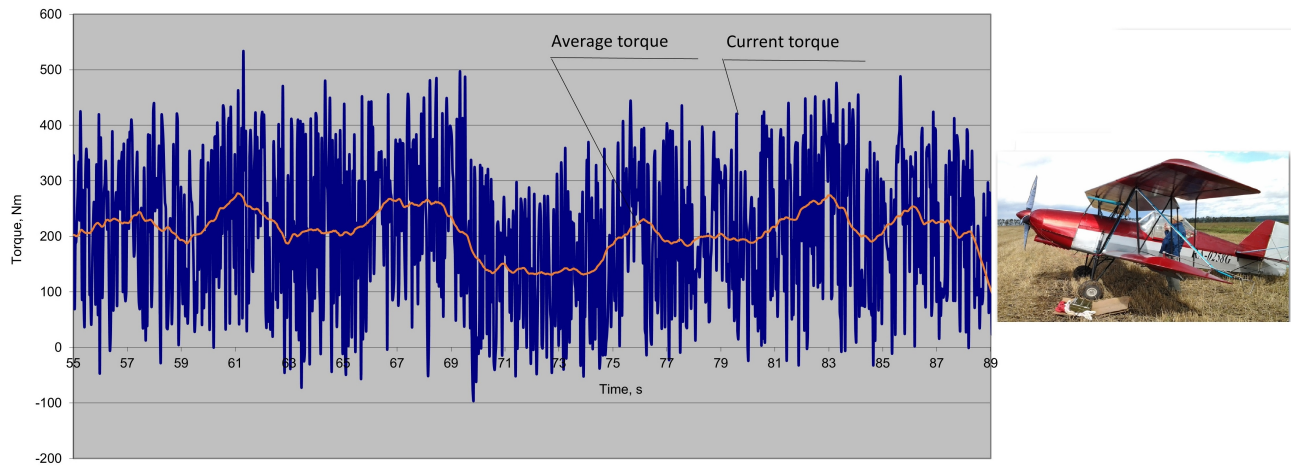
FIGURE 1. Recording of the torque pulsation on the rotor shaft of a biplane aircraft.

Measurements made on the “Bumblebee” biplane aircraft showed that for a four-stroke, four-cylinder engine (Figure 1), even behind the gearbox, pulsations can reach high values, with a coefficient of unevenness ( $\mu \geq 1$ ).

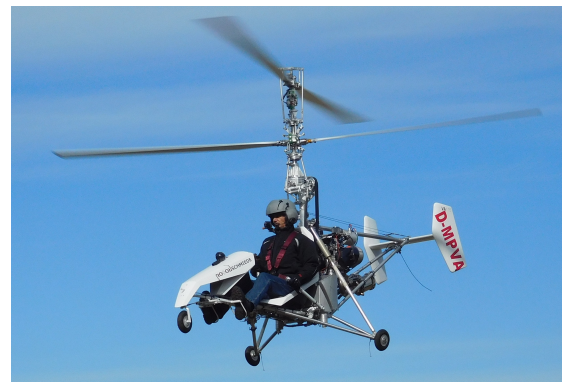
FIGURE 2. Ultralight helicopter VA-115.

An additional elastic clutch was used in a single-seat ultralight helicopter Rotorschmiede VA-115 Rotorschmiede VA-115 of German firm RS Helikopter GmbH (Figure 2). It was installed between the engine and belt drive. This aircraft has a two-stroke two-cylinder engine with a maximal power of 50 hp.

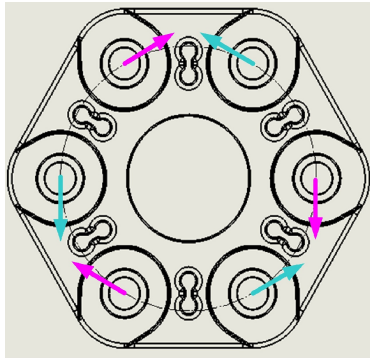
FIGURE 4. The direction of the forces on the rubber elastic clutch.

Rubber was chosen as the main material of the elastic coupling because it is a simple material, and has good damping properties and resistance to physical impacts. Of course, rubber materials have non-linearity in operation, but it is not critical for the operation of helicopter clutches. As can be seen in Figure 4, there are compressed and stretched zones. However, tension zones practically do not work, since the bearing capacity of rubber is five times higher in compression [7]. Several conditions must be met during the choice of a clutch from a rubber material. It should not have an

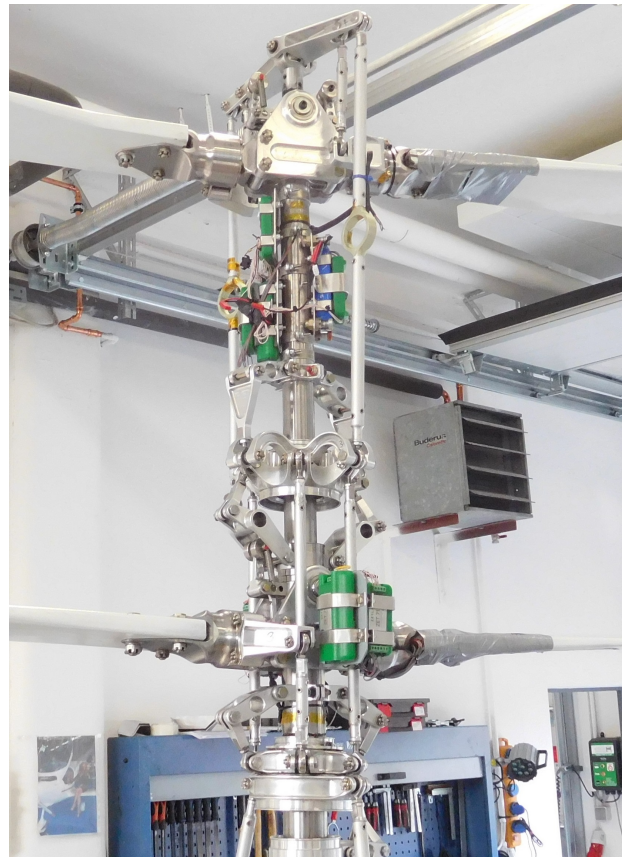
FIGURE 5. Coaxial rotor system of an ultralight helicopter with installed measuring modules.

A measuring system was used to perform measurements on board during flights (Figure 5). In flight tests, a challenge arises in transferring the measured data from the rotating rotor blade to the fixed airframe or saving them in the rotating part [9]. Despite the small size of the ultralight single-seat helicopter, the measuring system consisting of 3 parts was installed on the vehicle. The data were collected on hard drives mounted on the shafts. One performed measurements on the upper main rotor and rotated with it in one direction, the second on the lower rotor and rotated in the other direction, and the third was installed

motionless on the fuselage. The loads were measured on various elements of the rotor system, including the shafts of the rotors. The moments on the shafts and their pulsation were measured by strain gauges assembled according to a bridge scheme. Strain gauges were fixed to the shafts at an angle of  $45^\circ$  to the shaft axis. The quality of the installation of sensors and measuring parameters was controlled by direct and reverse calibrations. The accuracy of the measuring system consisted of the accuracy of calibration, the accuracy of the measuring path, and the discreteness of the system set by software. The accuracy of the measuring path was determined according to the manual data of the measuring equipment. The calibration accuracy was assessed by the difference in measurements for reverse and direct calibrations. According to it, the total error in measuring the bending moment in the plane of rotation was 1.7 Nm for the upper rotor shaft and almost the same for the lower rotor shaft.

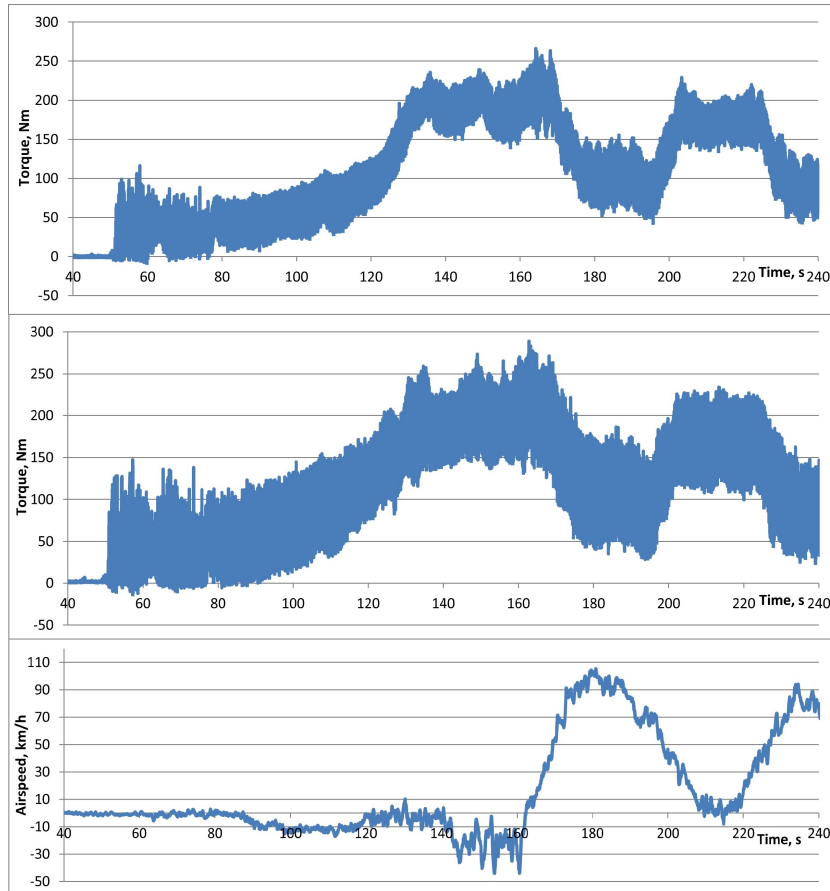
**A.1. RECORDED TORQUE ON THE SHAFT OF THE UPPER ROTOR (TOP), LOWER ROTOR (MIDDLE), AND AIRSPEED (BOTTOM) DURING THE HOVERING MODE AND HORIZONTAL FLIGHT.**

ations in the air with a sharp change in pitch angle were also performed. An example of changing the torque parameters depending on the speed is shown in Appendix A.1. The data is presented from the engine start moment. Negative velocity values correspond to a hovering turn to the wind. From the presented dependencies, it can be seen that the absolute values of the pulsation on the shafts depend little on the magnitude of the transmitted torque. Since the required power drops sharply in a mode close to cruising, therefore, the relative magnitude of the oscillation becomes larger.

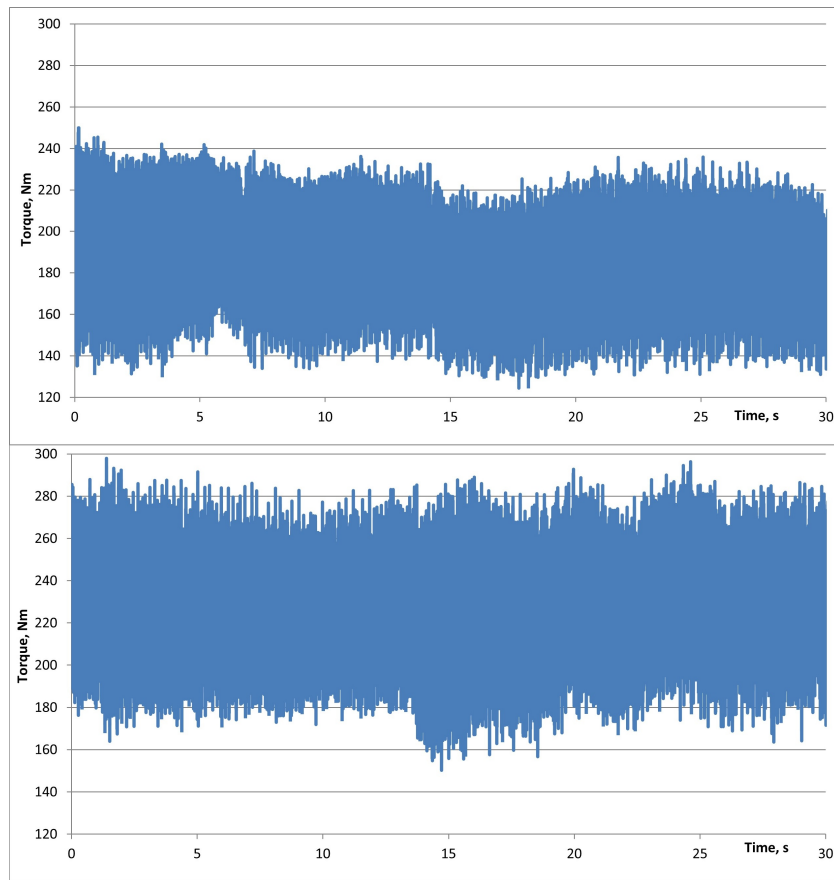
**A.3. RECORDED TORQUE ON THE SHAFT OF THE UPPER ROTOR DURING THE HOVERING MODE,  
TOW - 225 KG (TOP) TOW - 270 KG (BOTTOM).**

As tests have shown, a change in the take-off weight of the aircraft also does not seriously affect the magnitude of the pulsation. Appendix A.3 shows the values of torque pulsation on the shaft of the upper main rotor of a helicopter with different takeoff weights.
