CZECH TECHNICAL UNIVERSITY IN PRAGUE

Faculty of Civil Engineering

Characterisation of Czech Modern Mosaic Mortars

DOCTORAL THESIS

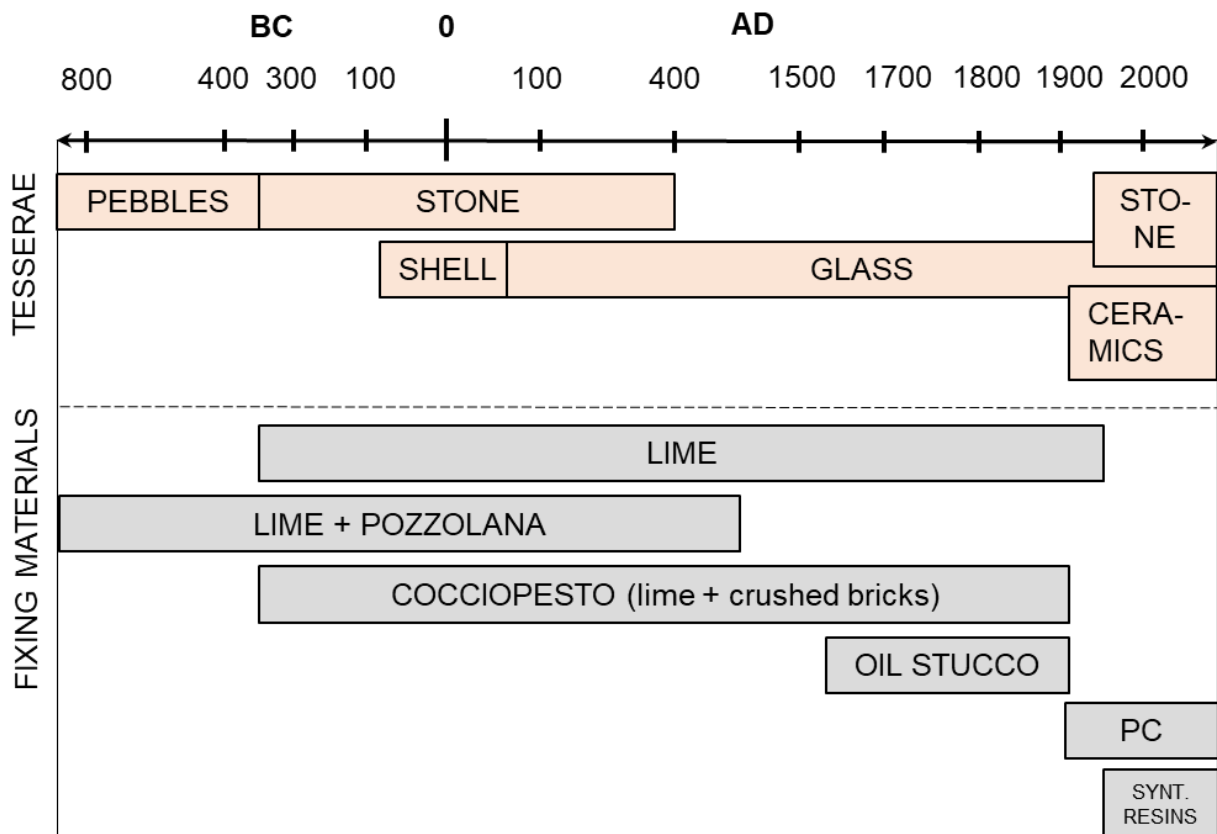
Figure 1. Materials commonly used for mosaic tesserae and mosaic mortars since the Antiquity to this day. PC – Portland cement.

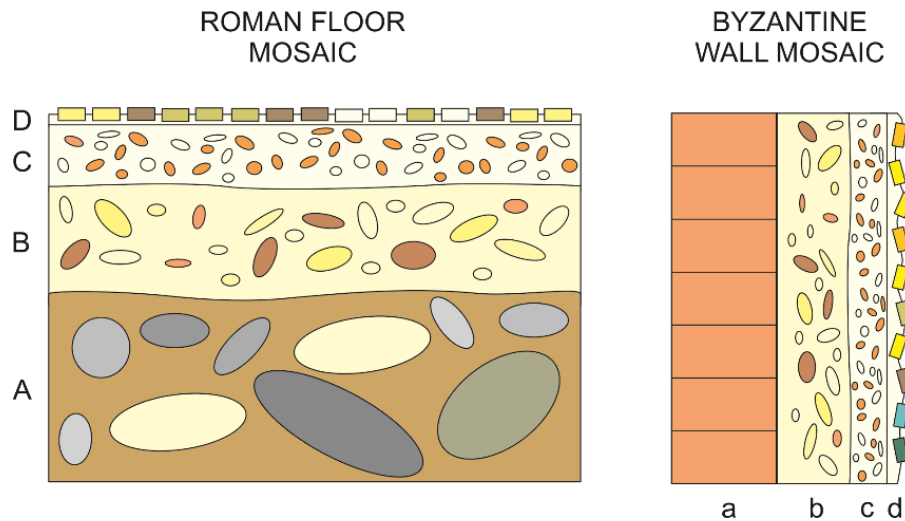
Figure 5. Comparison of multilayer mortar systems in Roman mosaic floors and Byzantine wall mosaics. Roman floor – A – statumen, B – rudus, C – nucleus, D – supranucleus. Byzantine wall mosaic – a – masonry, b – ground mortar, c – finer plaster equivalent to *arriccio* layer in fresco painting, d – fine bedding mortar equivalent to *intonaco* in fresco painting.

The early Christian and subsequent Byzantine period is associated with the transfer of mosaics from floors to walls. The multilayer fixing system continued to have been applied with certain modifications related to the transition to walls (Fig. 5).

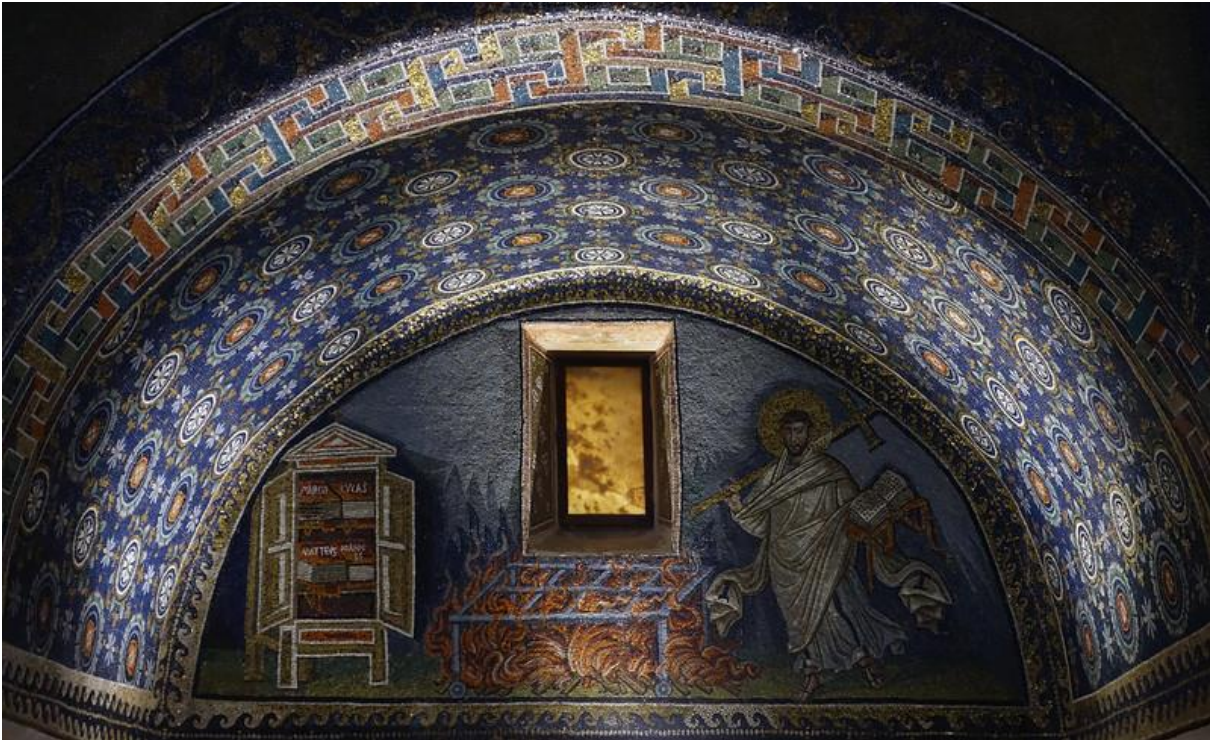
Figure 6. Masterpieces of Byzantine mosaic art: wall and vault mosaics at Mausoleum of Galla Placidia, Ravenna, Italy. The glittering effect of the mosaics occurs due to a special technique of glass tesserae setting. Photo by S. Zucker, licence CC BY-NC-SA 2.0, downloaded from <https://www.flickr.com/photos/profzucker/8619566122/in/photostream/>

Byzantine artists invented a special method of laying the upper-most mortar layer so as to produce an undulating surface. The surface irregularities enabled mosaicists to achieve glittering visual effect of glass (especially gold) tesserae [44] (Fig. 6).

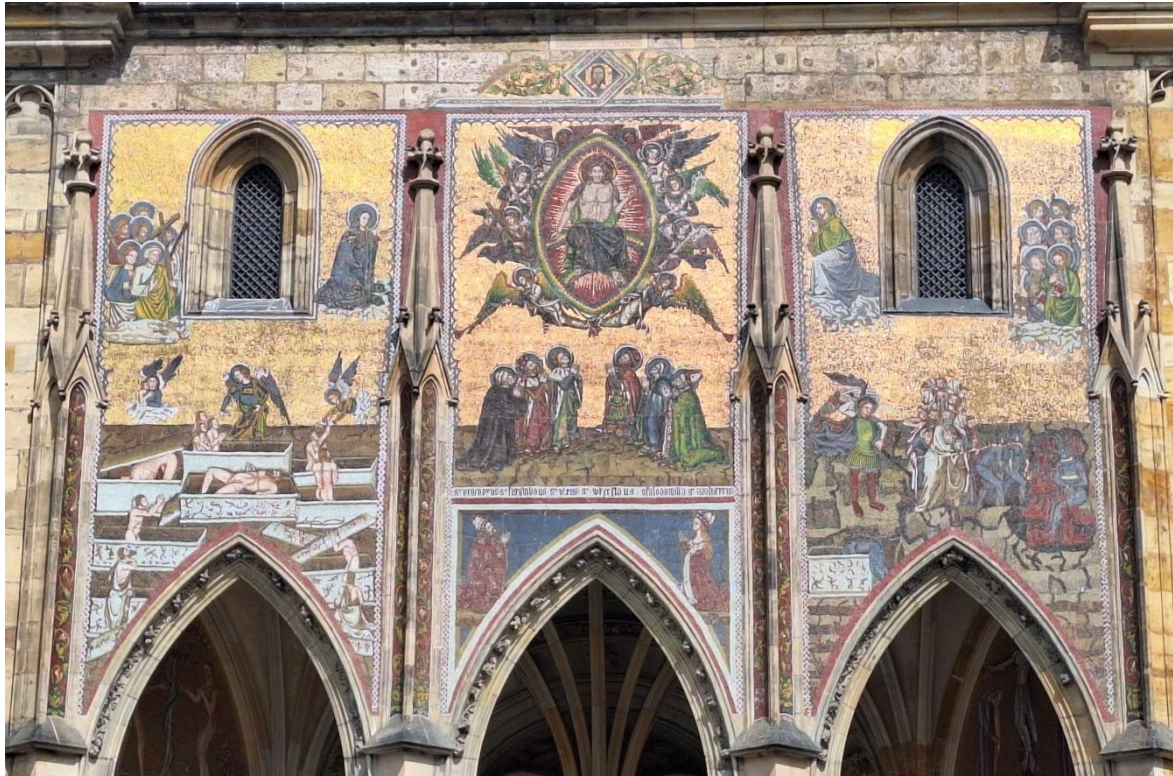
Figure 7. The Last Judgment Mosaic at the Prague Castle, Prague.

The Last Judgment mosaic decorating the southern façade of St. Vitus Cathedral at the Prague castle (Fig. 7) originated in 1370s. According to the results of its detailed investigation and careful conservation [48], [92], two layers of preparatory plasters were applied prior to laying the tesserae. At first, the surface of the cathedral's stone wall was roughed and an iron wire mesh was stretched between double hooked nails placed in regular 37.5 cm intervals along the whole area of the future mosaic. The first mortar layer (several centimetres thick) was applied over the mesh afterwards. Subsequently, a bedding mortar consisting of lime, sand and brick powder was laid in sections corresponding to daily work progress. Mosaic tesserae were installed into this mortar bed immediately. Analytical study of the original mortar bed brought evidence on the presence of organic compounds – egg proteins and linseed oil coming from later 19th century conservation treatment [48].

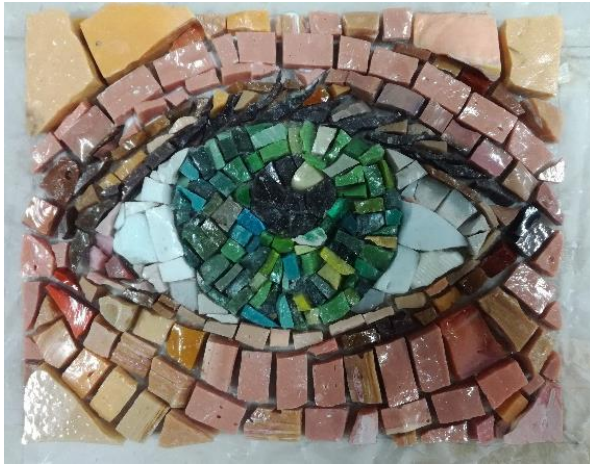
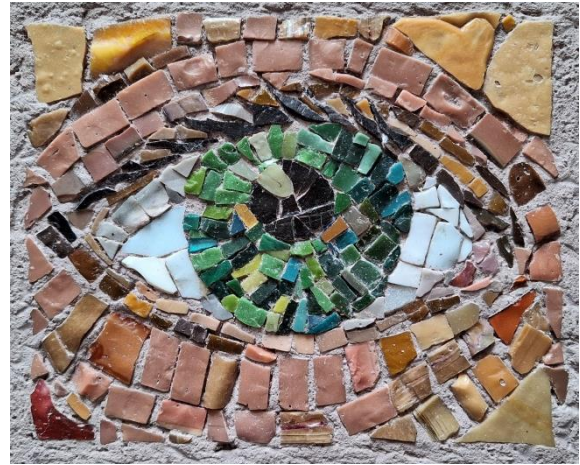
Figure 8. Indirect method of setting. Mosaic glued reverse on top on a temporary paper support (a), final mosaic image fixed to a cement mortar (b). The images are inverted.

The increasing demand for mosaics’ renovation and increasing new production needed an effective solution to accelerate the whole mosaic-laying process. The invention of the so-called *indirect method of setting* (Fig.8), a mid-19th century breakthrough in making mosaics, paved the way to a semi-industrialized mosaic production. Thanks to indirect setting, mosaics started to be manufactured in the studio and transported to sites in sections. Smaller-scale mosaics could be fixed in portable metal frames. This considerably reduced the production costs and opened the door to a widespread marketing area.

The method has been widely used to this day. Mosaic tesserae are first adjusted on a temporary support – a canvas or a paper. The support usually serves as a 1:1 scale cartoon with a reversed mosaic motif. The tesserae are laid reversely, i.e. face side down. Starch paste or gum Arabic with honey can be used to fix the tesserae [39]. Once the mosaic laying has been completed, it is transferred to its final site. The mosaic (at this point visible from the reverse. i.e. with reversely laid tesserae on the top), is squeezed into a permanent bed made of fresh mortar so that the temporary support remains on top. When the bedding mortar sets, the temporary support is washed away with water. What remains is the original, unreversed mosaic motif. Unfortunately, greater efficiency results in the loss of quality and expression in design [44]. Exposed surfaces of indirectly set mosaics remain uniformly flat. Thus, the play of light scattering on undulating tesserae notably reduced.

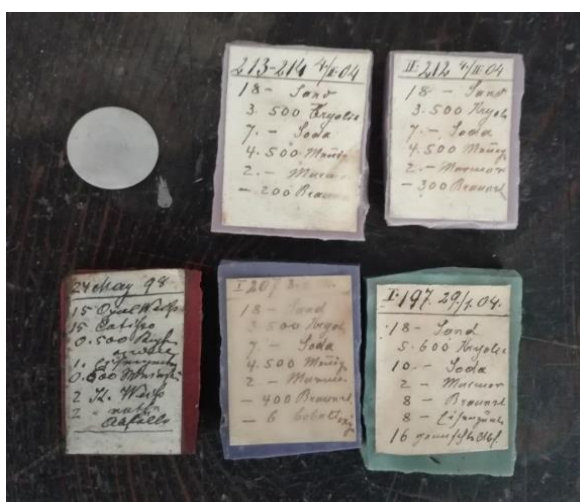
Figure 31. Experimental mosaic glasses from the Tiroler Glasmalerei archive with a label containing the recipe for their preparation.

Due to their inhomogeneity (varying chemical composition, varying texture and degree of sintering) we assume, the frit and glass aggregates as well as the chamotte shards probably represent waste materials from Neuhauser workshop’s own glass production. Neuhauser Company produced its own mosaic tesserae. A glassworks was a part of the company from the beginning. Apart from glass supply it carried out numerous chemical experiments [187]. Some of the experimental samples have been preserved in Tiroler Glasmalerei’s materials archive (Fig. 31)

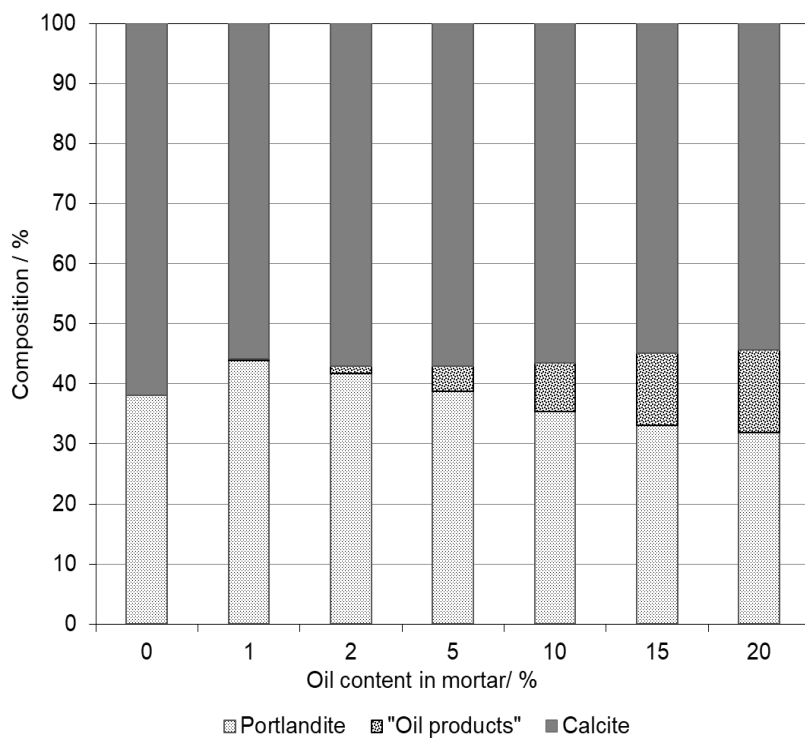
Figure 59. The composition of model mortars as determined by thermogravimetry (% by mass).

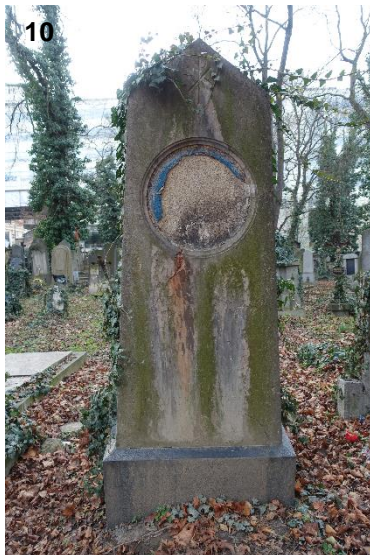
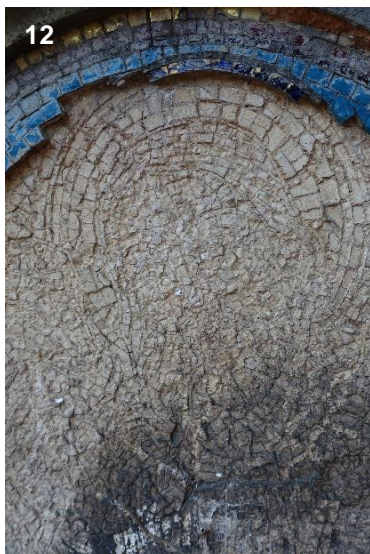
Mašek's tomb, 2018.

Detail of the andamento.

The circular medallion with the half-length figure of Christ as the Good Shepherd was made according to the design of Professor František Sequens. The mosaic has almost completely disappeared, the glass tesserae have gradually fallen out, and only the mortar bed of the tesserae provides a clear record of the mosaic's *andamentum* - the composition of the tesserae [2].

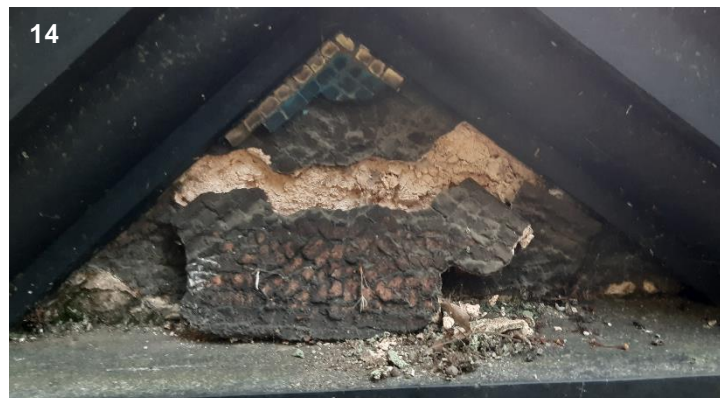
Detail of the mosaic torso studied. Photo: M. Müller.

The tombstone was supplied by the Prague stone company of the Italian stonemason Giovanni Ciani (1847-?), a C.C. court master stonemason who settled in Prague's Vinohrady district and began to supply mainly Neo-Renaissance works at the end of the 19th century. In the lunette of the tomb there is a mosaic with a small motif of the head of Christ measuring 30 cm H, 50 cm W. The mosaic was attributed to the Neuhauser Company [2], [3]. Above the lunette there is a torso of a mosaic decoration in the triangular gable of the tombstone. It has a golden bordure and a blue background of the few surviving tesserae. We assume that the torso is of the same provenance as the underlying undestroyed mosaic.

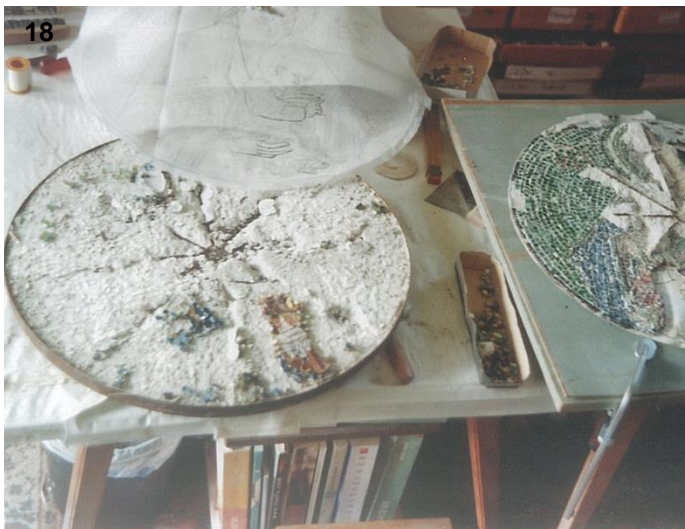
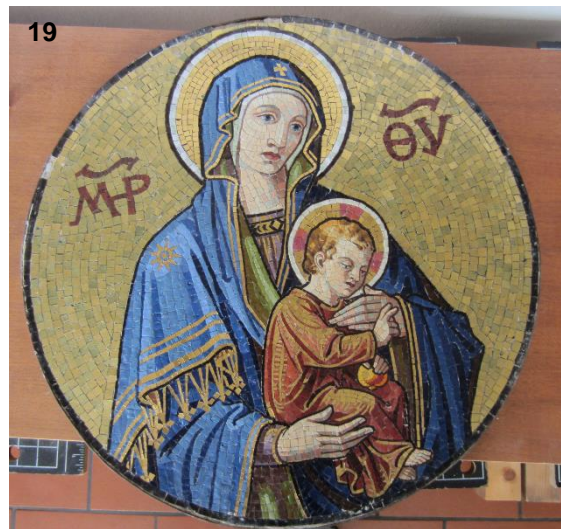
The mosaic during restoration works. Photos 18 and 19: Courtesy of Storch Family.

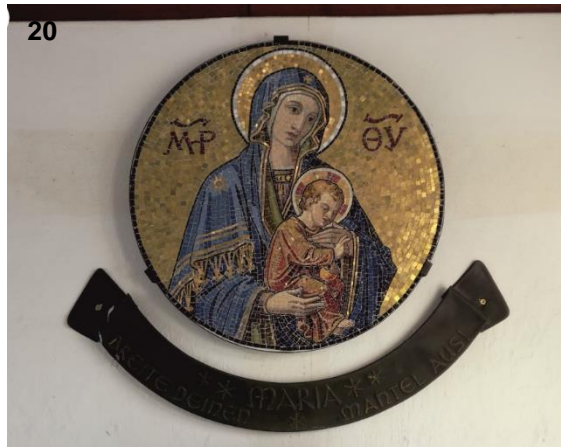
Mosaic after restoration.

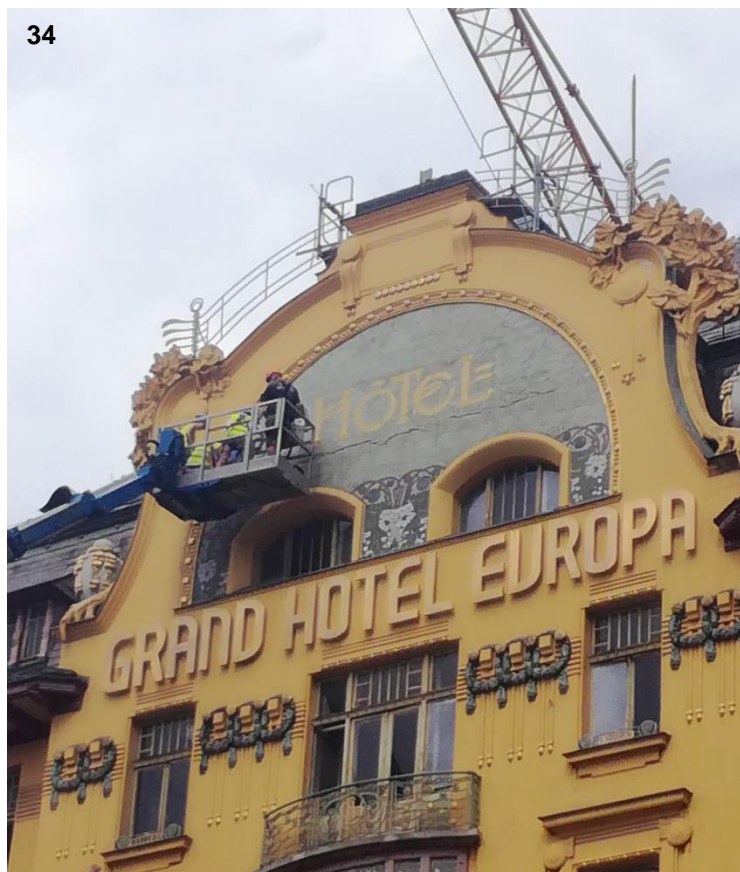
PB1904 – Barrandov

Semi-circular monumental Art Nouveau mosaic with a golden inscription "hotel" and ornamental floral motifs. The mosaic was restored two years ago. The photo shows the mosaic's condition before renovation.

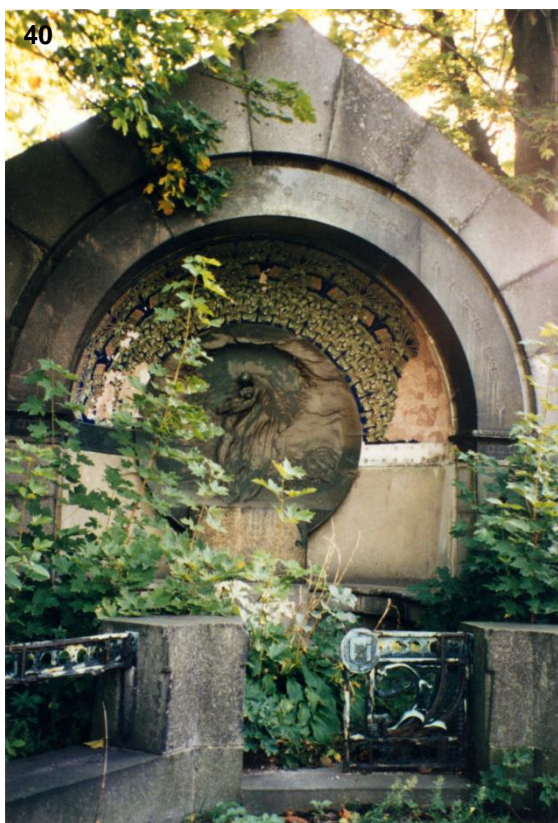
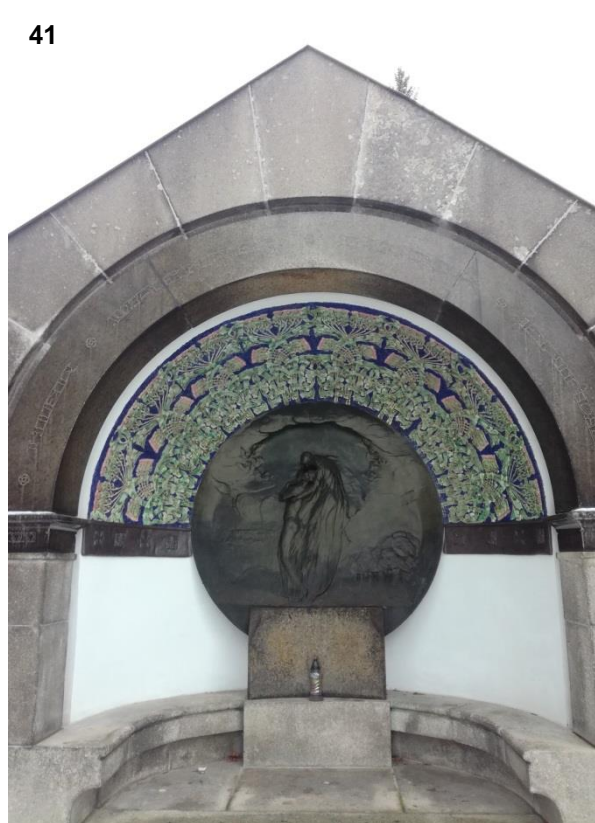
The photos show the mosaic before and after restoration.
