ADVANCED MASTERS IN STRUCTURAL ANALYSIS OF MONUMENTS AND HISTORICAL CONSTRUCTIONS

Master's Thesis

Numerical Evaluation of bearing capacity of the All Saint's Church walls in Broumov, CR

Numerical Evaluation of the bearing capacity of the All Saints' Church walls in Broumov, CR

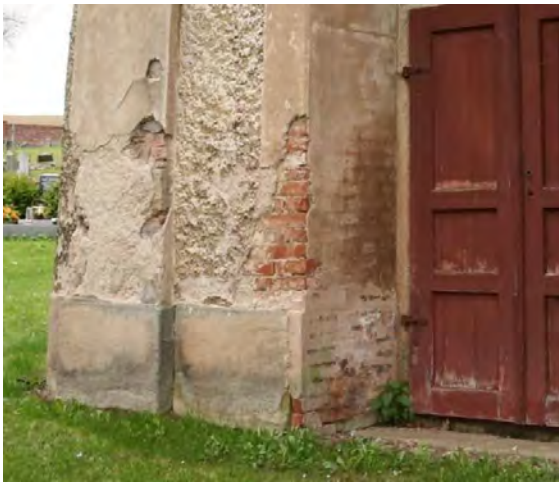
Figure 3.2. Moisture signs at the church exterior

Moisture signs could be observed infiltrating the false stone that covers the bottom half meter of the external church enclosure wall [Figure 3.2]. Similar signs of moisture could be observed from the interior of the church [Figure 3.3].

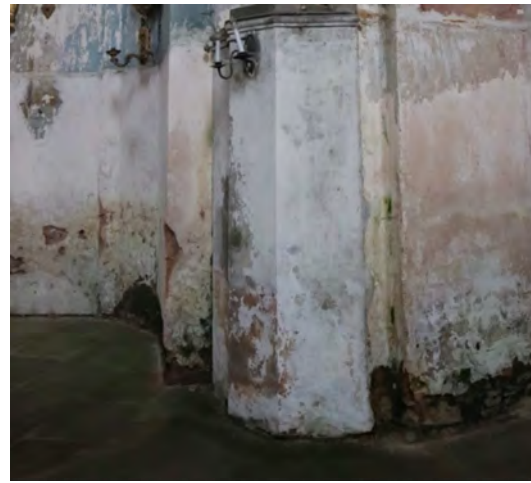
Figure 3.3. Moisture signs in church interior

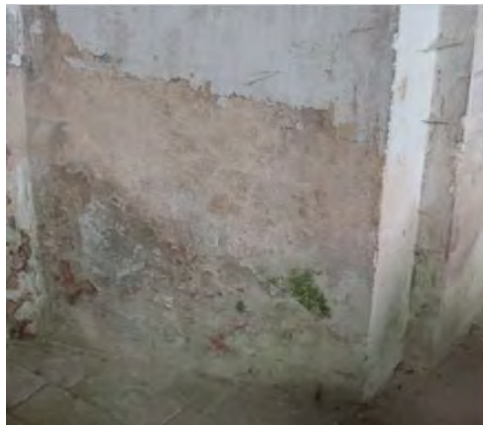
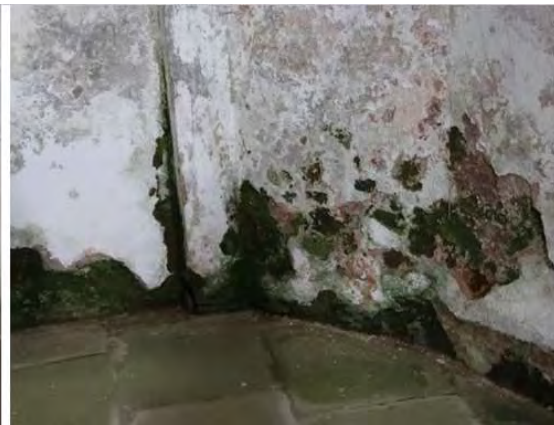
Figure 3.4. Biological growth on the southern wall (left) and on the northern wall (right) in the interior of the church

Biological growth in the form of fungi, algae and moss could be observed at the bottom of the enclosure wall almost throughout the church. In the interior of the church, biological growth on the southern wall is limited to small patches of algae, but larger patches of fungi, algae and moss growth dominate the bottom of the northern wall [Figure 3.4]. At the exterior of the church, the same pattern is observed that the decay of the bottom of the wall is more extensive at the northern wall than it is on the southern wall. While there is microorganism growth on both façades, on the northern wall, it is more spread out and there is moss growth as well.

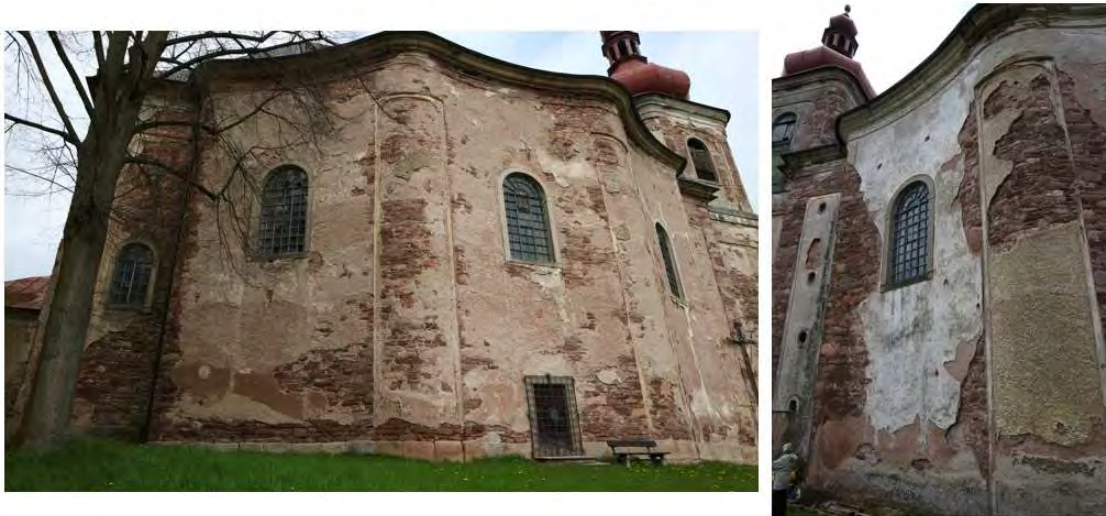
Figure 3.7. Render and plaster deterioration on the external southern wall (left) and northern wall (right)

Throughout the church, the building plaster and rendering are observed to have deteriorated and at some parts the inner masonry are completely exposed due to decay of the rendering. In the interior of the church, this effect is limited to the bottom of the walls and the kink area where a new rainwater downpipe is observed at the exterior [Figure 3.7]. However, on the exterior, this effect is observed to be more extensive. Renders at the top of the wall as well as most of the renders at the convex part of the wall are observed to have been completely deteriorated exposing the inner masonry [Figure 3.7]. Furthermore, the condition on the northern wall is again observed to be worse than it is on the southern wall.

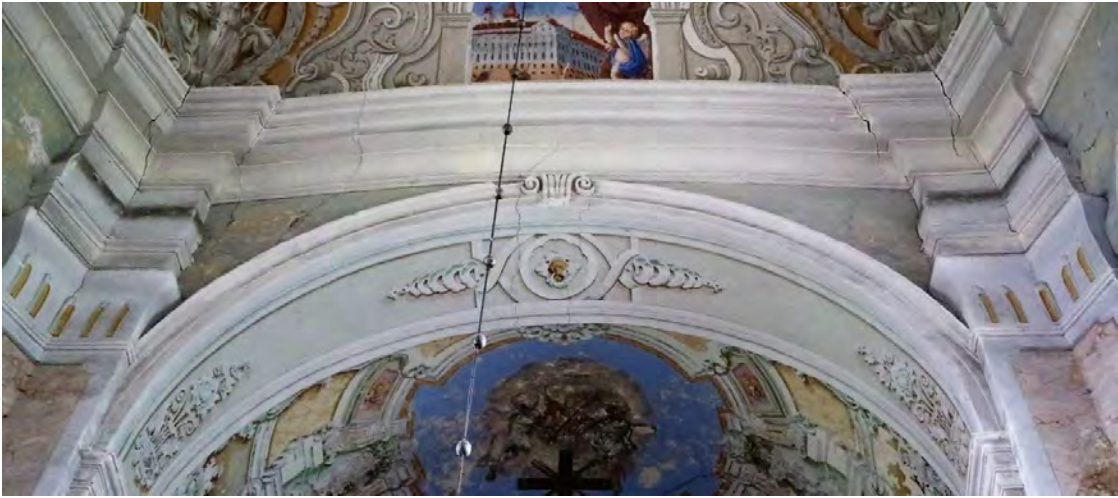
Figure 3.8. Cracks on transverse arches bridging the northern and southern facade

Extensive series of cracks transverse arches bridging the northern and the southern façade were observed [Figure 3.8]. This series of cracks are found consistently throughout the church from the arch connecting the entrance hall and the main central area to the sacristy northern wall. The cracks could be categorized as small cracks at the bottom of the mid-arch, large cracks at the top left and right end of the arches.

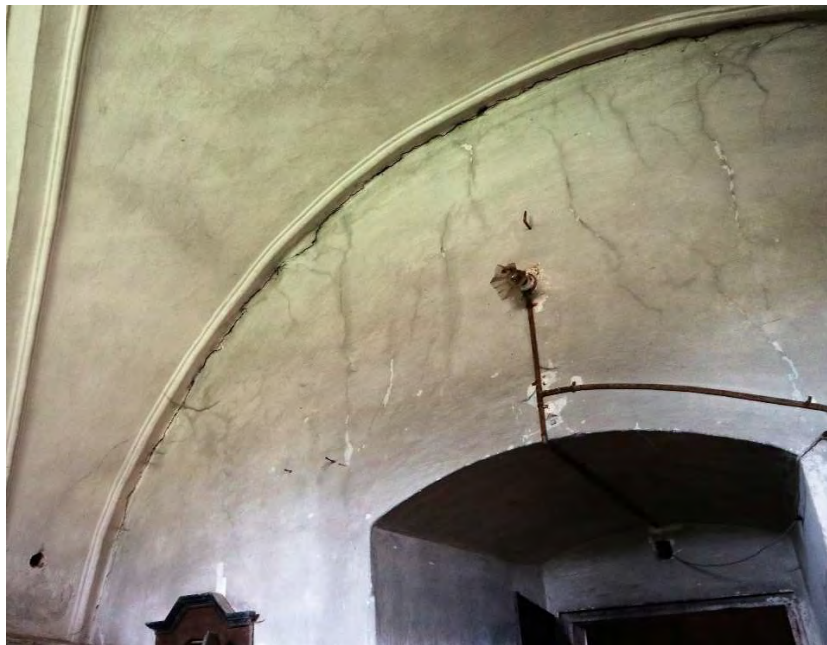
Figure 3.9. Continuous crack separating the sacristy vault to the main church wall

Cracks are also observed at the connection vault connecting the sacristy and the rest of the church. The cracks form a continuous line separating the sacristy and the rest of the church [Figure 3.9].

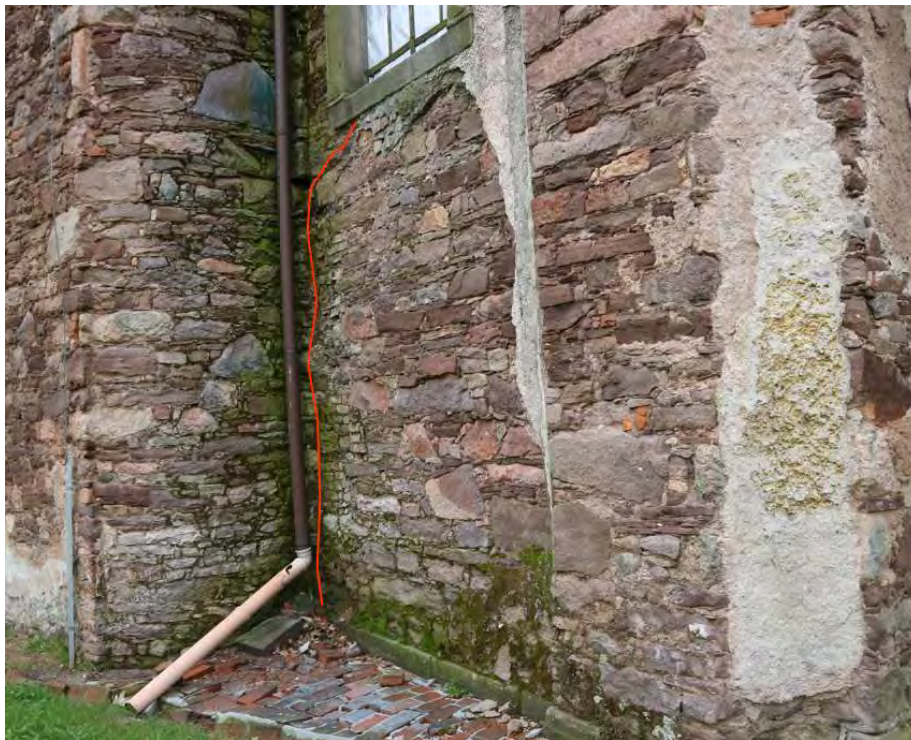
Figure 3.10. Crack on the longitudinal façade near the kink of the church

Furthermore, there is a crack originating from the foundation to the window opening near the kink where faulty drainage system is observed []. This indicates potential movement of the church due to poorer soil condition in this area as compared to the other areas.

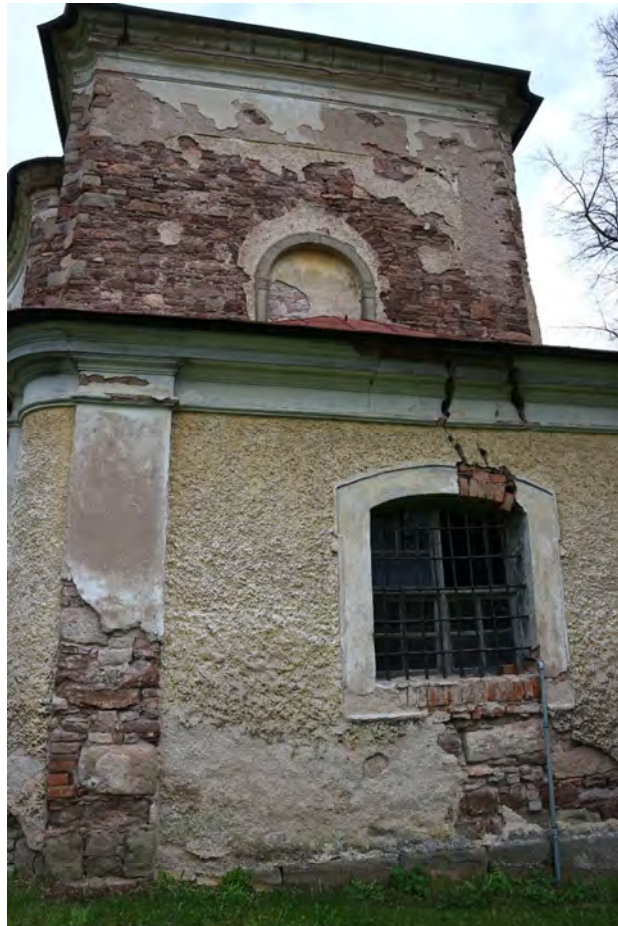
Figure 3.11. Large crack on the western facade behind the sacristy

As can be seen from Figure 3.11, there is a large crack running from the ground to the top of the western façade behind the sacristy. This crack is consistent with the other cracks in the transverse arches in the church.

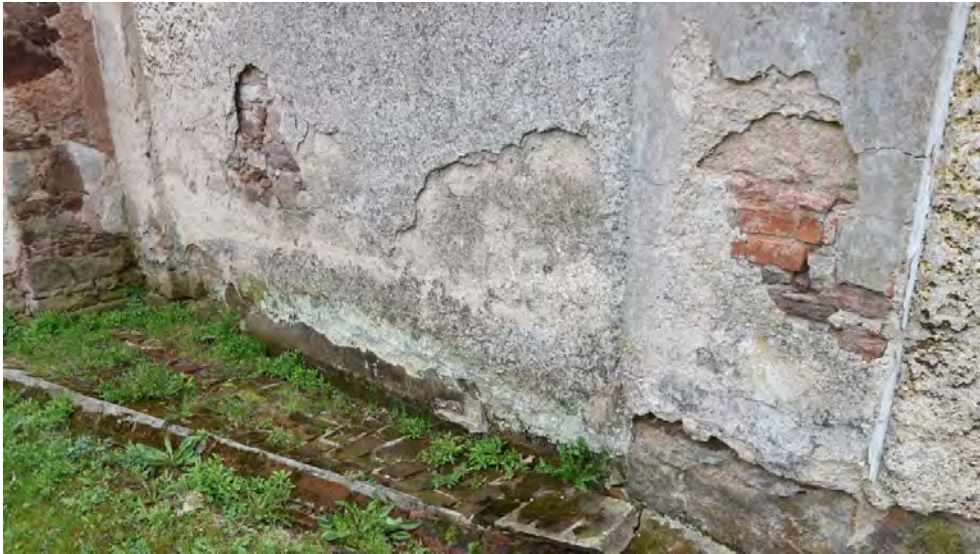
Figure 3.12. Ill-located brick blocks showing signs of reckless repair

Some signs of reconstruction could be observed on the walls from the presence of ill-located brick blocks that are covered with render recklessly at random location [Figure 3.12]. Furthermore, the frames around the doors and windows are observed to be constructed with majorly regular brick masonry [Figure 3.13]. The same kind of stones that are randomly placed in other parts of the walls are arranged in an organized manner at the sacristy walls. It could be inferred that these frames were reconstructed or added at a later time after the completion of the church.

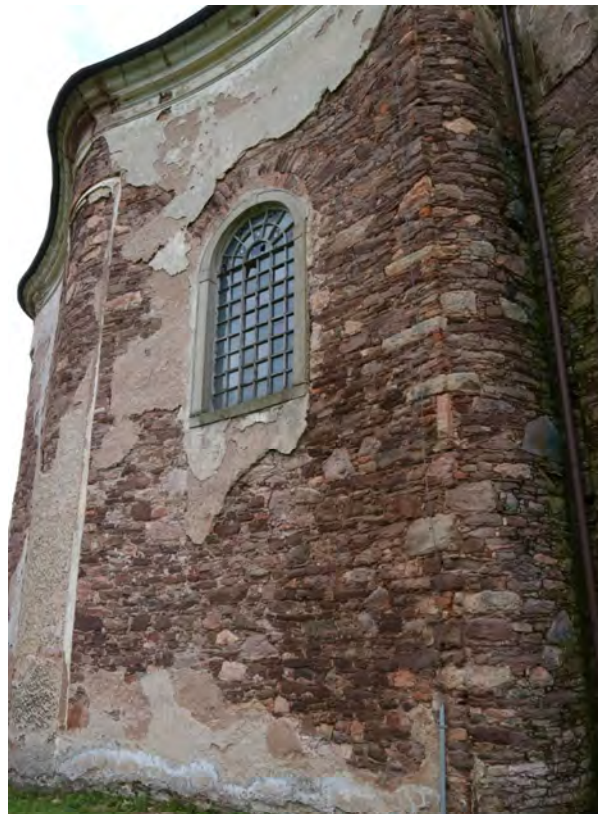
Figure 4.1. Enclosure wall masonry from the exterior shows non-uniform mixture of stones making up the outer leaf masonry layer

As can be seen from Figure 4.1, the church enclosure wall is made up of stone rubble masonry. The stones are of uneven sizes even if they are mostly of rectangular shape. There are at least three different types of stones that could be observed, along with some patches of bricks that were added in unsuitable manner. Furthermore, considering the thickness of the wall – up to 1.2 meters, it is very likely that the enclosure wall is made of at least three-leaf walls with inner infill material. This heterogenous nature of this enclosure wall makes estimation of wall bearing capacity using certain standards very much inappropriate and inaccurate. Hence, modelling representative parts of the wall to obtain its mechanical parameters would be necessary.

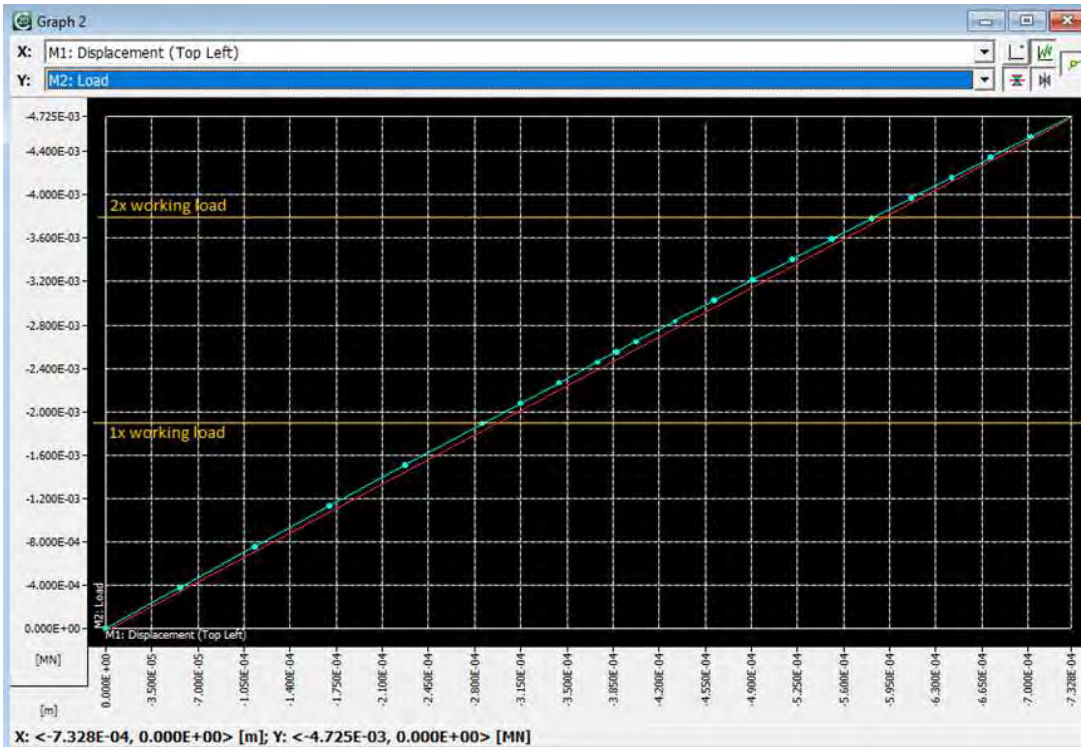
Figure 4.7. Load-displacement curve for sectional wall of configuration 1 with connecting stones between the walls leaves (blue line showing the wall behaviour while red line showing linear line drawn by connecting the peak and initial points)

masonry infill as the stiffer tie stones attract more load. This in turn increases the compressive load that the masonry is able to withstand.

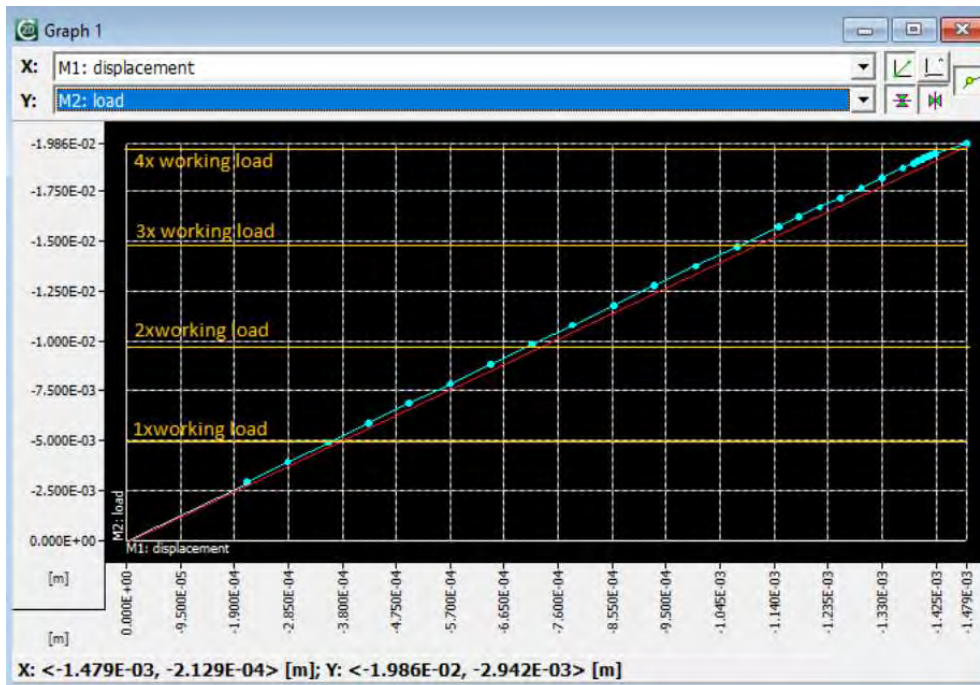
Figure 4.8. Load-displacement curve for longitudinal wall of configuration 1 (blue line showing the wall behaviour while red line showing linear line drawn by connecting the peak and initial points)

Different from the sectional model, in this sectional model, the failure is observed to appear on the mortar joint. However, the same load pattern is observed in load-displacement curve obtained from the longitudinal wall model. A linear curve that is followed by non-linear section to the point the curve stops as it reaches the peak stress. Load displacement curve for longitudinal wall models are shown in Figure 4.8 and Figure 4.9 below.

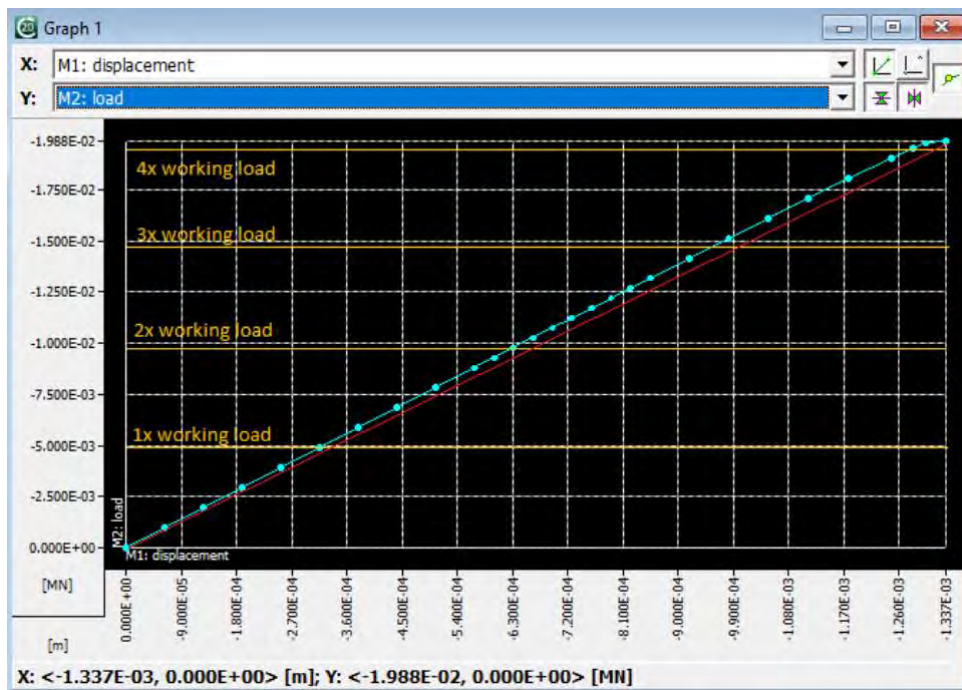
Figure 4.9. Load-displacement curve for longitudinal wall of configuration 2 (blue line showing the wall behaviour while red line showing linear line drawn by connecting the peak and initial points)

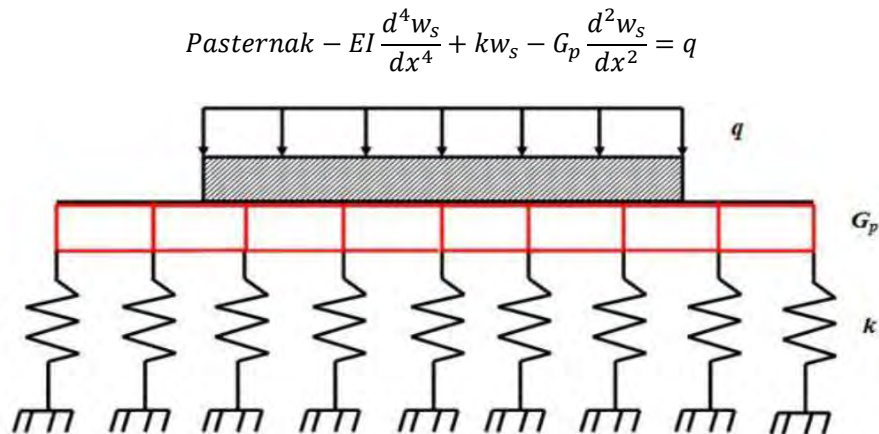
Figure 5.2. Winkler-Pasternak foundation model

In this study, this approach will be used to estimate a spring constant for 3D modelling of the church to simulate the different soil condition at different parts of the church.

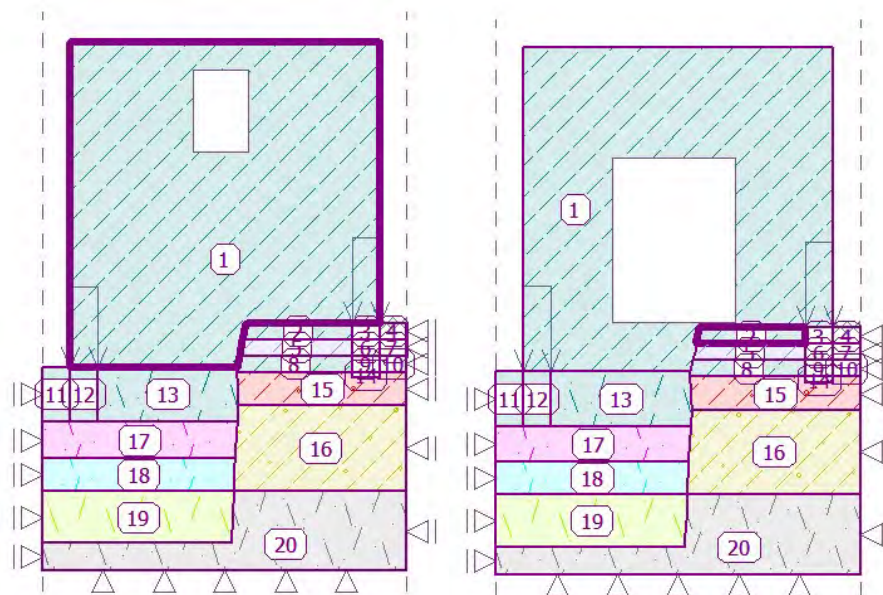
Figure 5.6. Modelling eastern (left) and western (right) transverse facade to analyse the stresses due to differential settlement

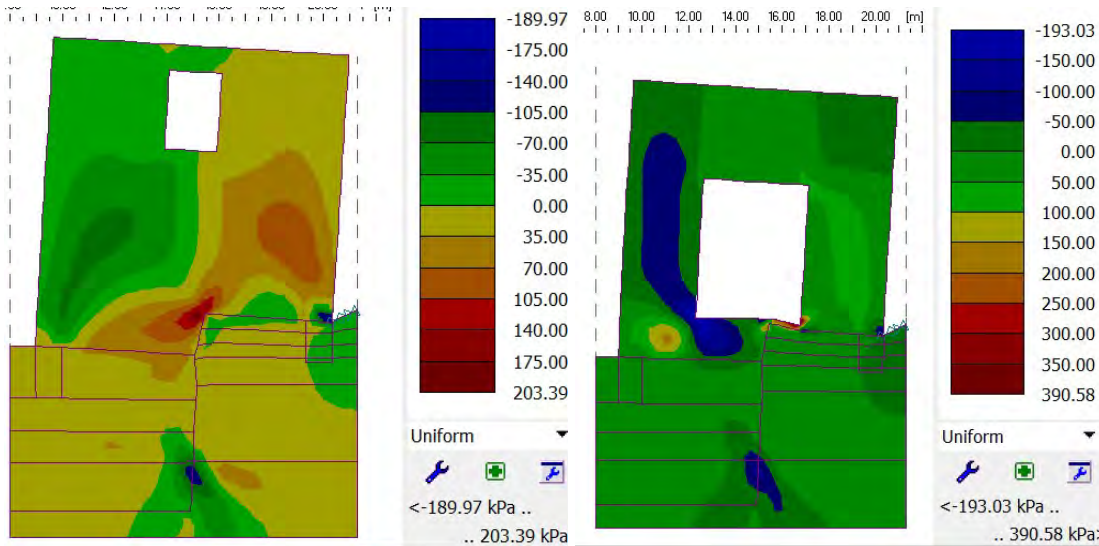
Figure 5.12. Shear stresses in the eastern (left) and western (right) transverse walls of the church due to imposed soil settlement

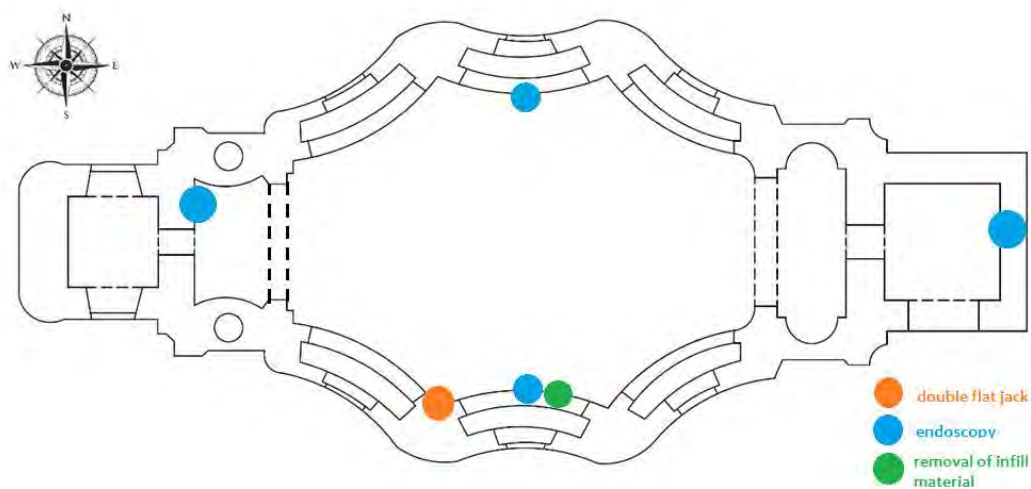
Figure 7.1. Proposed location of additional tests

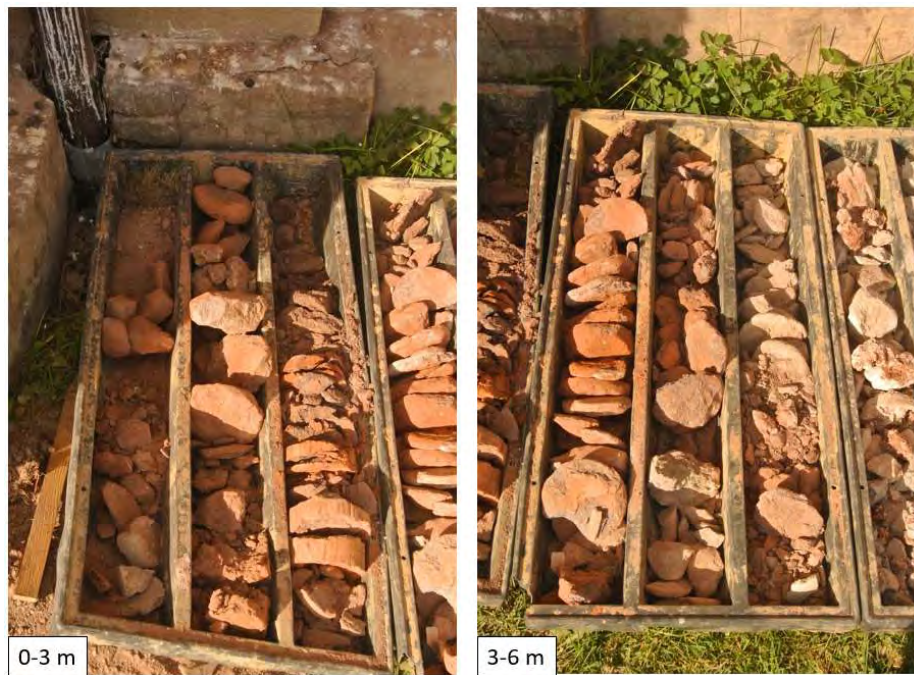
Figure A.3. Extracted soil tube from borehole beside the southern wall at depth 0-3m (left) and 3-6m (right)

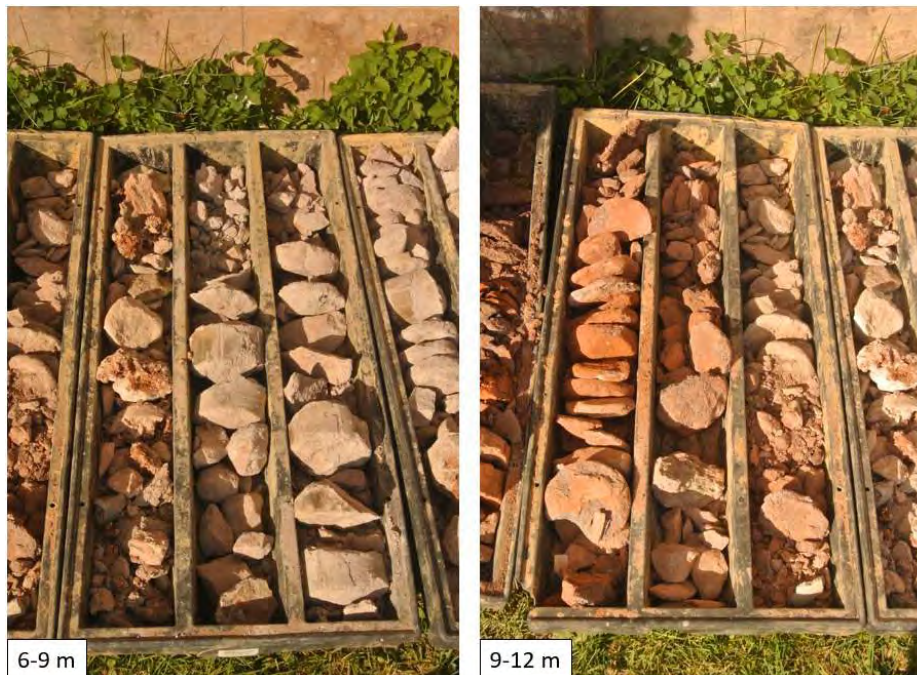
Figure A.4. Extracted soil tube from borehole beside the southern wall at depth 6-9m (left) and 9-12m (right)

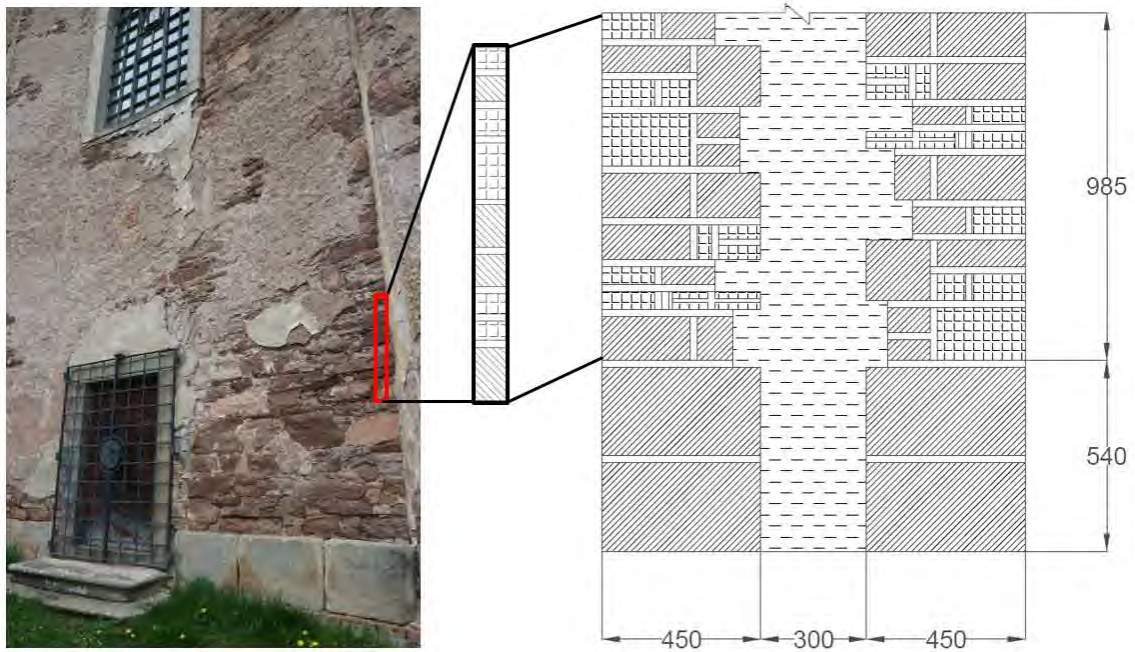
Figure B.3. Derivation of sectional wall configuration 2

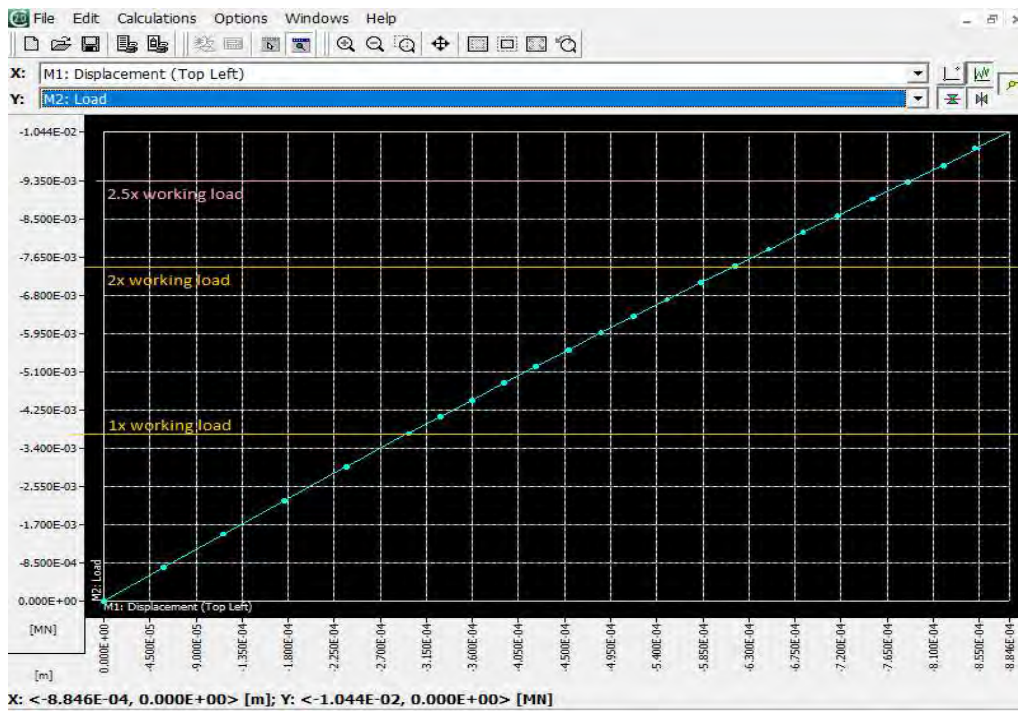
Figure D.3. Load-displacement curve of sectional wall of wall configuration 2 with connecting tie stones

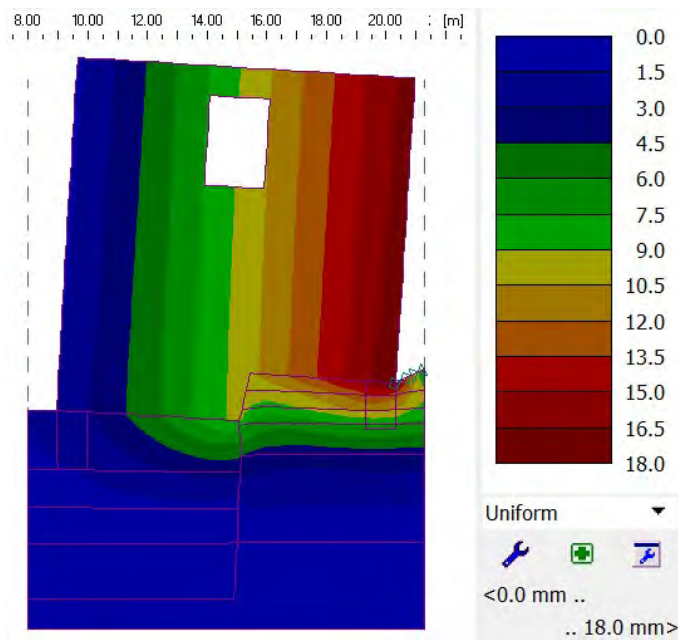
Figure F.3. imposed deformation of eastern facade with the altered load on the model to analyse the wall stresses

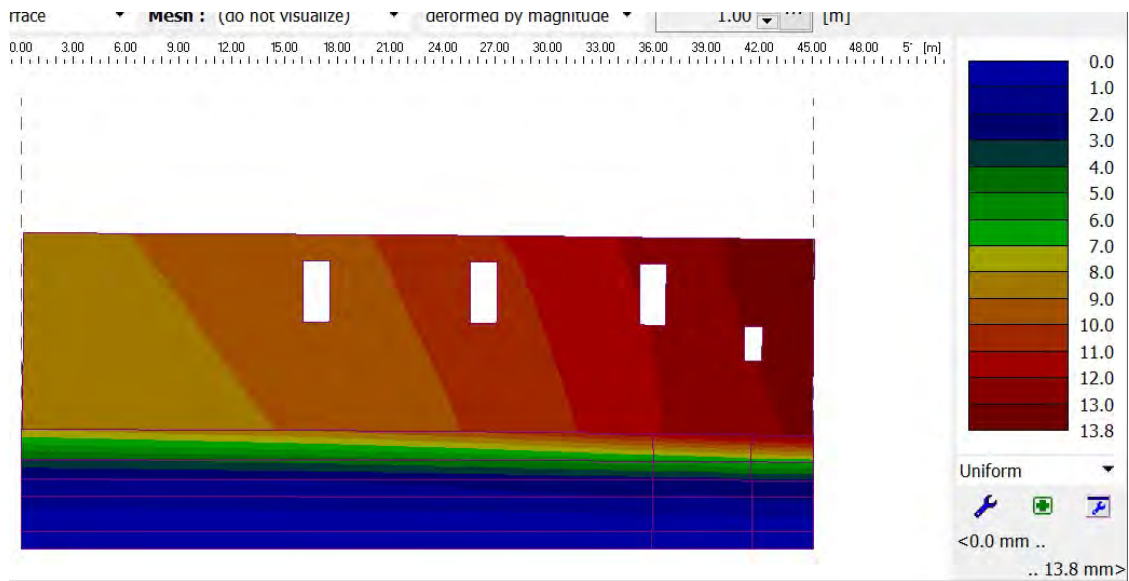
Figure F.5. Deformation of the southern longitudinal wall and the subsoil due to the church load on the current soil condition
