## MASTER'S THESIS PROPOSAL

Student's name and surname: Jacopo Scacco  
Department: Department of Mechanics  
Thesis supervisor: Prof. Ing. Pavel Kuklik  
Thesis title: Nonlinear numerical evaluation of the bearing capacity and the structure stability of the St. Jacob Church from the Broumov Group of Churches  
Thesis title in English: see above

The main objective of the thesis is the FEM modelling and the subsequent evaluation of bearing capacity of St. Jacob Church in the Broumov Region, with a particular attention on the influence of the shallow footing and their degradation.

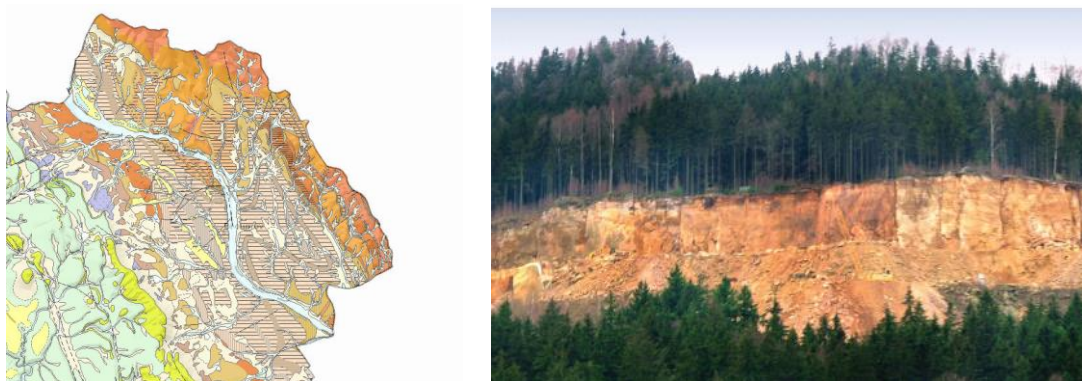
**Fig. 3.8 - Geological Map of Broumov Region; Picture of the quarry in Bozanov (Lom Bozanov, 2010)**

The first one provided an huge amount of material for constructions overall the Czech Republic, having very good physical-mechanical properties, especially strength, frost resistance, absorbency and abrasion resistance. Macroscopic aspect varied from light grey to beige, showing sometimes a darker, rusty brown colour (Vavra & Stelcl, 2010).

The sandstones coming from Vernerovice are distinguished for a peculiar reddish-brown colour. Moreover, it is noticeable the presence of quarries very close to the location of the church, in Ruprechtice, Jetrichov and Mezimesti. In this last case, the macroscopic appearance is as well reddish-brown or rusty brown, but the structure is strongly porous. In Jetrichov the appearance is more variable involving grey, violet-grey, pinkish or brownish arctic sandstone, but incoherent, and easily disintegrating to sand (Vavra & Stelcl, 2010).

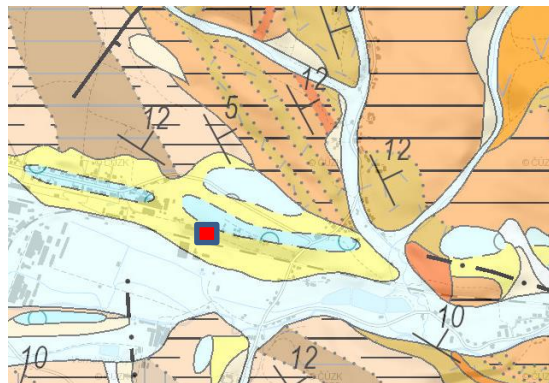
**Fig. 3.9 - Detail of geological map in Ruprechtice (Ceska Geologicka Sluzba)**

As defined in the geological map (Fig. 3.9), even if the Broumov region is mainly characterized by sedimentary sandstones and rhyolite (Palaeozoic era), the church is founded on a relatively recent soil region (Mesozoic era), made of soft clay and loamy clay, with fluvial origin (Ceska Geologicka Sluzba).

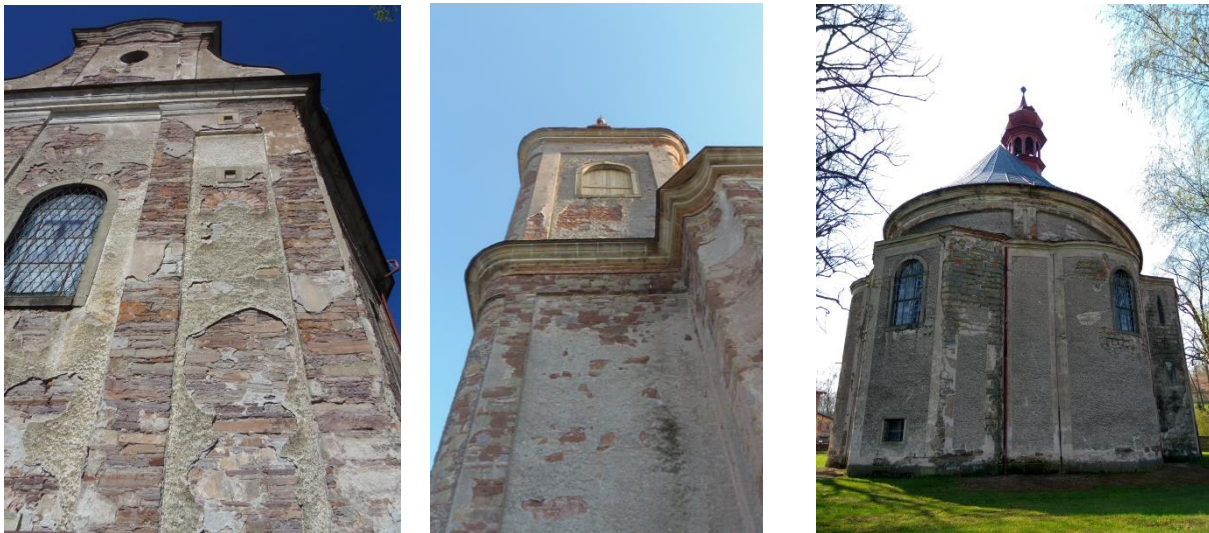
**Fig. 3.10 – Deterioration of the render in St. Jacob Church (Left); St. Anna (Central); St. Barbara (Right)**

Communist regime. In fact, several damages experienced by the churches are strictly related to problems of water penetration, to the high moisture content in the walls and to the phenomena of rising capillarity. The most severe consequences of this situation is the formation of biological colonization on the interior enclosure walls and the loss of plaster's integrity and of the stones as well. Externally, the thinner render results to be loss in almost the totality of the surface, leaving the stones subjected to the external actions. The thicker render, as well, is missing in different location, being characterized by phenomena of detachment and bulging. This kind of damages are peculiar of the churches investigated, the one discussed in this work of thesis, St. Jacob, but also St. Anna and St. Barbara (Fig. 3.10).

The reason of this common situation has, as mentioned, to be related to the presence of water, coming from the soil and from the roof for the poor condition of the gutters (Fig. 3.11). As it is noticeable from the picture, the soil, in correspondence of not working gutters, appears deteriorated and could have a role in settlement phenomena.

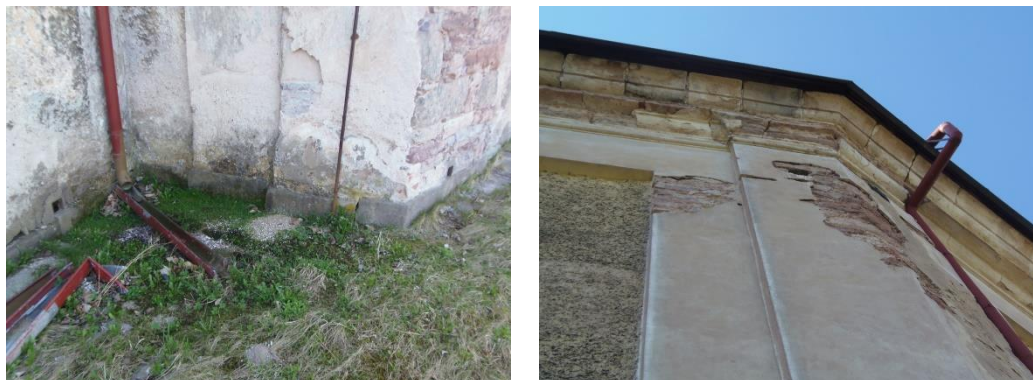
**Fig. 3.11 – Deteriorated soil; Detail of the gutters**

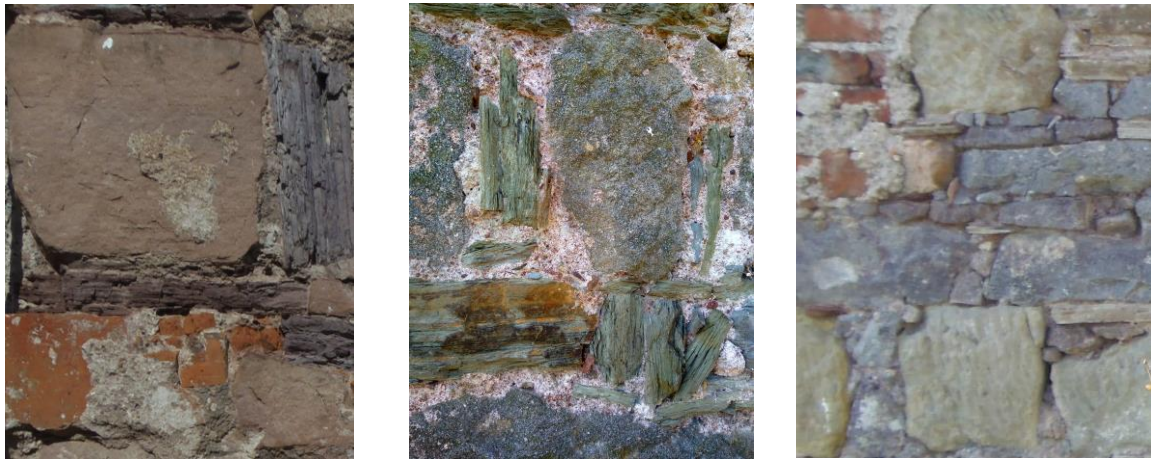
**Fig. 3.12 - Differential deterioration in St. Jacob (Left); St. Barbara (Central); St. Anna (Right)**

This scenario involved phenomena of efflorescence, leading to plaster detachment, and phenomena of freeze-thaw cycles of the stones. As already discussed above, the differential degradation of stones

spread all over the walls' surface as the use of stones of different features (Fig. 3.12). As this approach was used also for the other churches, it is possible to find the same kind of damage in St. Barbara and St. Anna (Fig. 3.12).

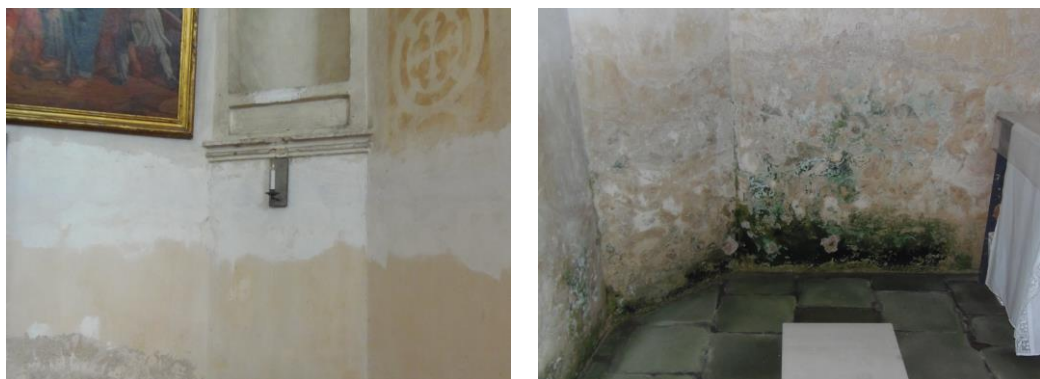
**Fig. 3.13 - Rising dampness and Biological colonization on the internal walls**

The high level of moisture, along with lack of ventilation, had negative impact also in the interior of the Church, involving peeling, discoloration and biological colonization on the surface of the walls. The walls most affected are the ones oriented to NW, being under the shadow of the trees and subjected directly to the sunlight from the opposite windows, ensuring the ideal situation for the biological growth (Fig. 3.13).

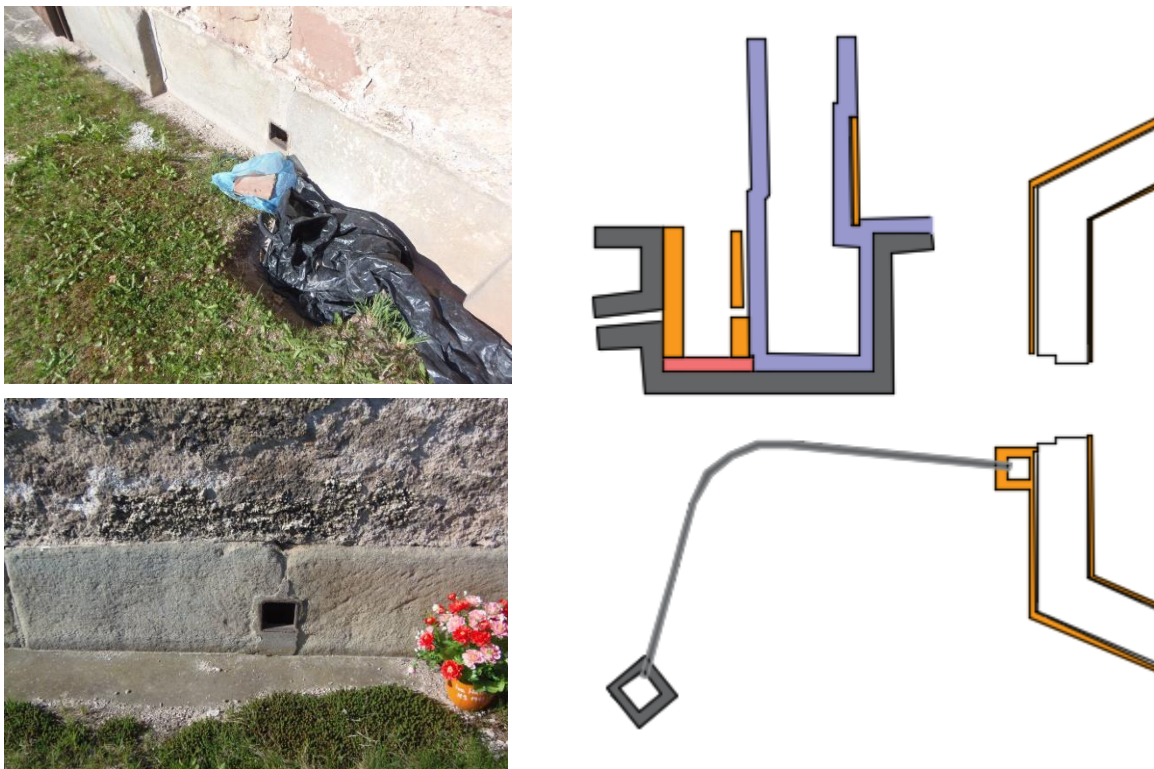
**Fig. 3.14 - Drawing and detail of the drainage system built in 1937**

Moreover, in the '40 some works were carried out to improve the overall situation, even if its efficacy could be put in discussion. A drainage system was installed around all the perimeter in order to collect the water and decrease the problem of rising dampness (Fig. 3.13). This past intervention will be considered again under another point of view in the chapter dedicated to settlement analysis.

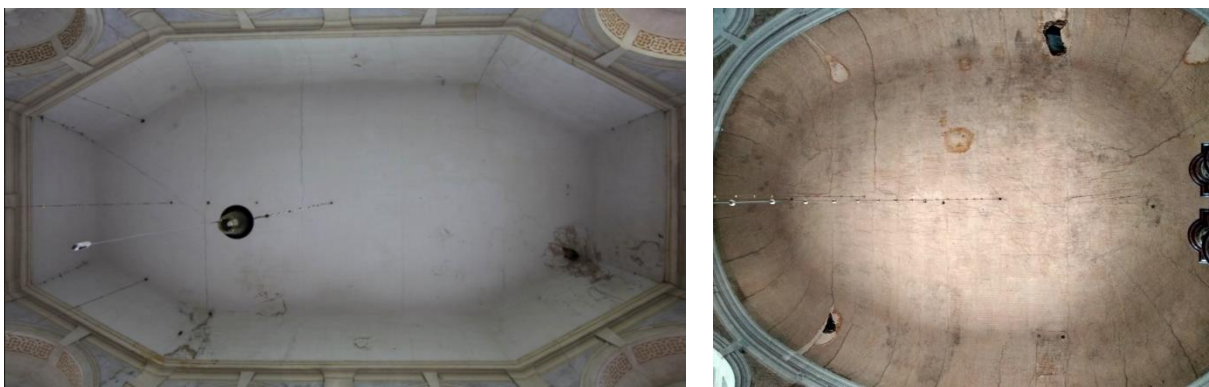
**Fig. 3.15 - Cracking pattern in the ceiling of St. Jacob (Dienzenhofer Adventures); Cracks in the ceiling of St. Barbara**

The cracks of the ceiling have to be related to the false vault system used in the Broumov group of churches. The cracks occurred, in fact, along the above main trusses, caused by the long term action and deformation of timber elements (Fig. 3.15). The same configuration of damage has been detected also in St. Barbara. (Fig. 3.15)

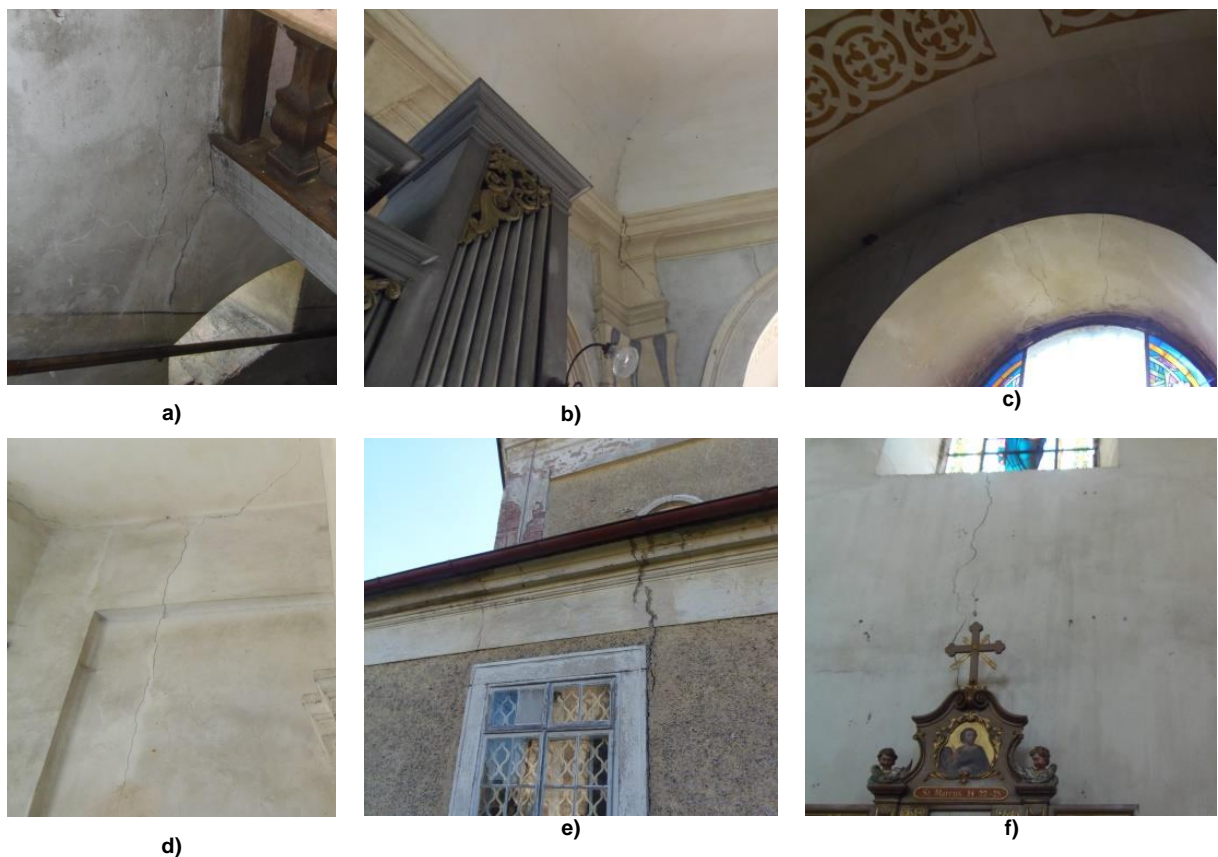
**Fig. 3.16 - Details of cracking pattern in the walls of St. Jacob**

Source of wondering could be the cracks located in the niche at north (Fig. 3.16.f) and in the vault of the sacristy (Fig. 3.16.e). These cracks can be related to a not dangerous formation of relieving arches due to the presence of openings. However, they could be connected to soil settlements phenomena, hypothesis that will be verified in chapter 6.

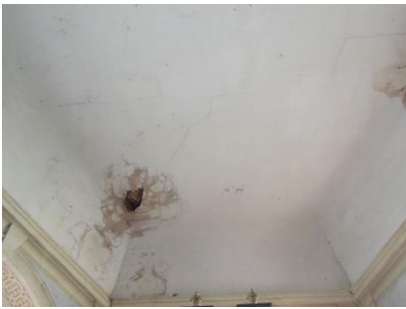
DAMAGE	DESCRIPTION	PHOTO	FURTHER INFO
<b>Hole in the wood ceiling</b>	Due to water infiltrations from the roof, a small portion of the ceiling is completely lost.

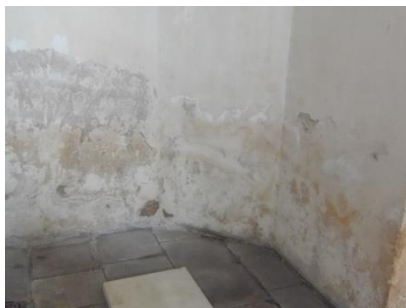
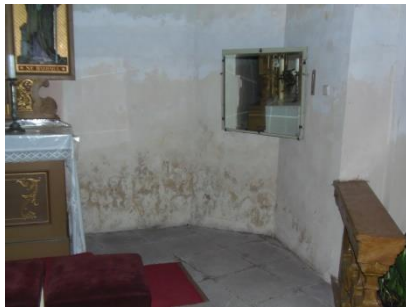
DAMAGE	DESCRIPTION	PHOTO	FURTHER INFO
<b>Rising dampness</b>	The walls at east and north-east experienced rising dampness, until a height of 2 m. This involve deterioration and loosing of the render.

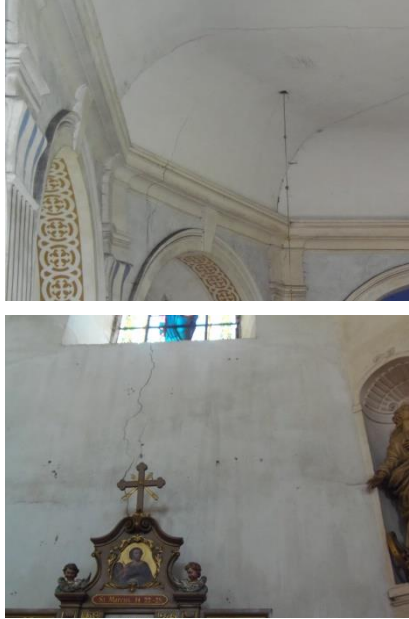
DAMAGE	DESCRIPTION	PHOTO
<p><b>Cracks upon and above the arch in the cell</b></p>	<p>An horizontal crack characterizes the niche located at the north of the church.</p> <p>The reasons for causing this damage could be different, and probably related to soil settlements.</p>

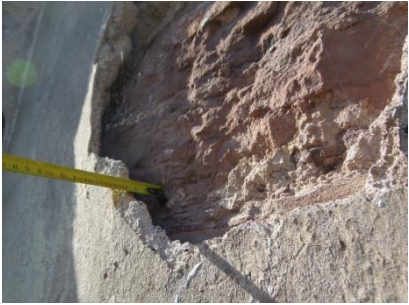
DAMAGE	DESCRIPTION	PHOTO
<p><b>Bulging of Render</b></p>	<p>For reasons related to moisture and salt crystallization on stone surface, the render experienced phenomena of bulging, reaching in some locations values of several cm.</p>

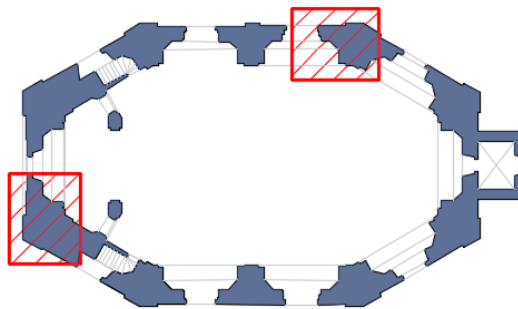
Fig. 4.1 - Locations of the Schimdt Hammer tests

In order to carry out this task, it is fundamental a detailed information of the geometry and material properties. Taking advantage of the current situation of render's deterioration, it was possible to collect two different portions of the walls, identifying the textures. The locations, in the main façade and in the NW longitudinal wall, were selected as the most representative of the church in terms of arrangement and stone used (Fig. 4.1).

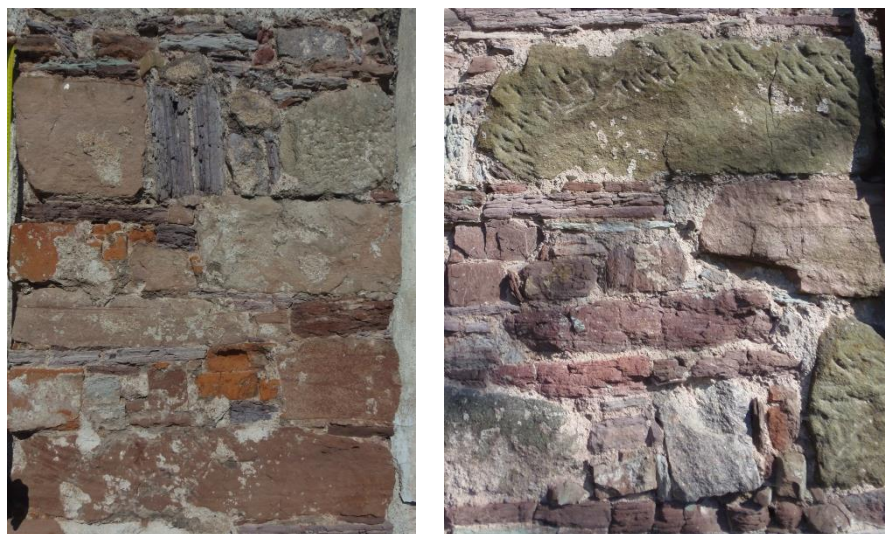
Fig. 4.2 – Walls investigated

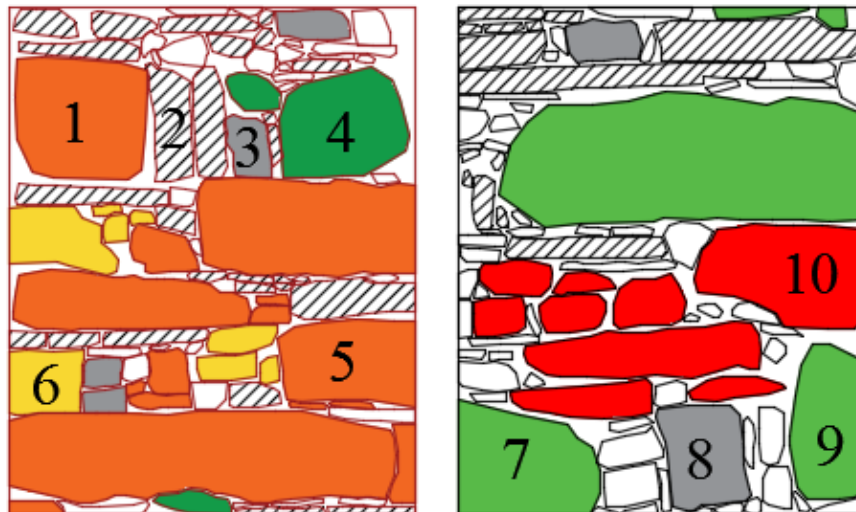
Fig. 4.3 – AutoCAD drawings of the walls

As mentioned in the material overview, a campaign by means of Schmidt Hammer was carried out in order to get the compressive strength of the different stones. For a better understanding of the arrangement, a detailed drawing of the walls is proposed below, with the investigated stones marked with a number (Fig. 4.3).

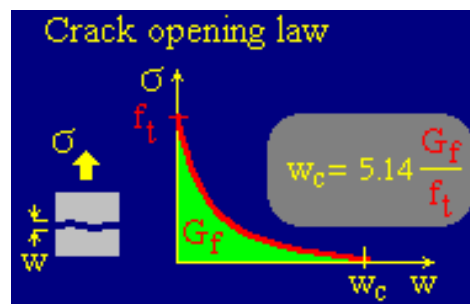
Fig. 4.4 – Exponential opening law (ATENA Manual)

The modelling of the walls was carried out through the software ATENA 2D, analysing separately the models of the longitudinal wall and the sectional walls. ATENA is a software dedicated to reinforced concrete structure, and the application to masonry has to be treat carefully. The constitutive model selected has been the “Non linear cementitious 2” (Cervenka & Jendele, 2018). In this model, it is settled for tensile behaviour an exponential opening law (Fig. 4.4), where is necessary to set directly the fracture energy in tension.

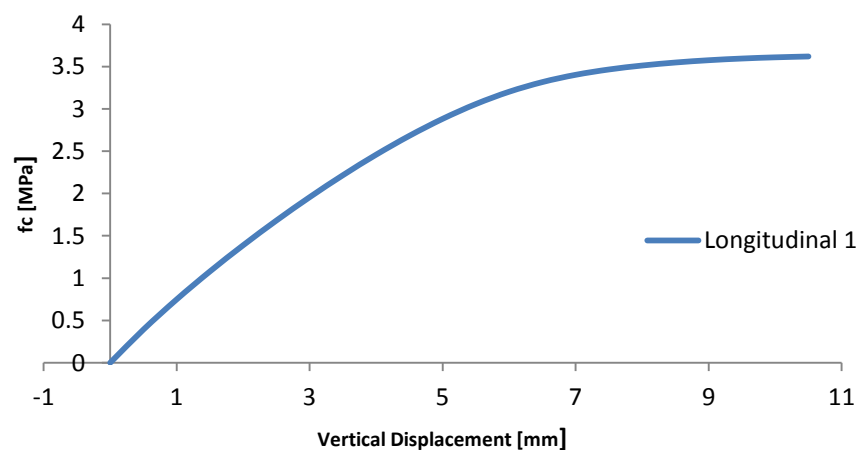
Fig. 4.8 – Curve Displacement – Vertical stress for Longitudinal Wall 1

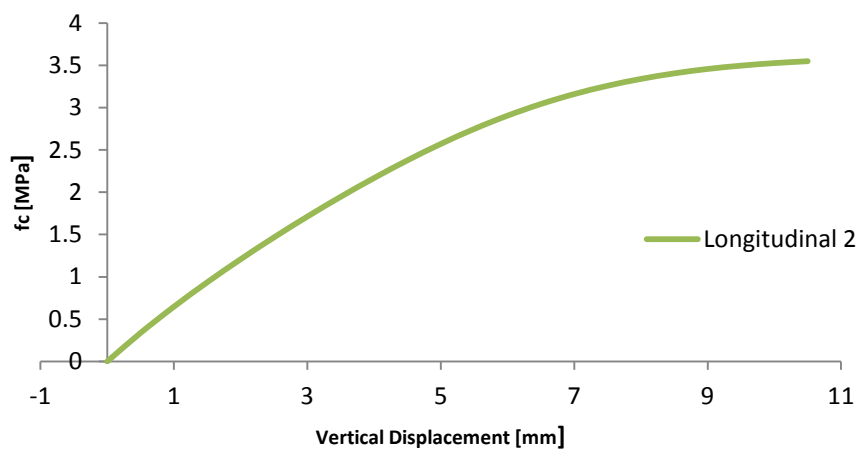
Fig. 4.11 - Curve Displacement – Vertical stress for Longitudinal Wall 2

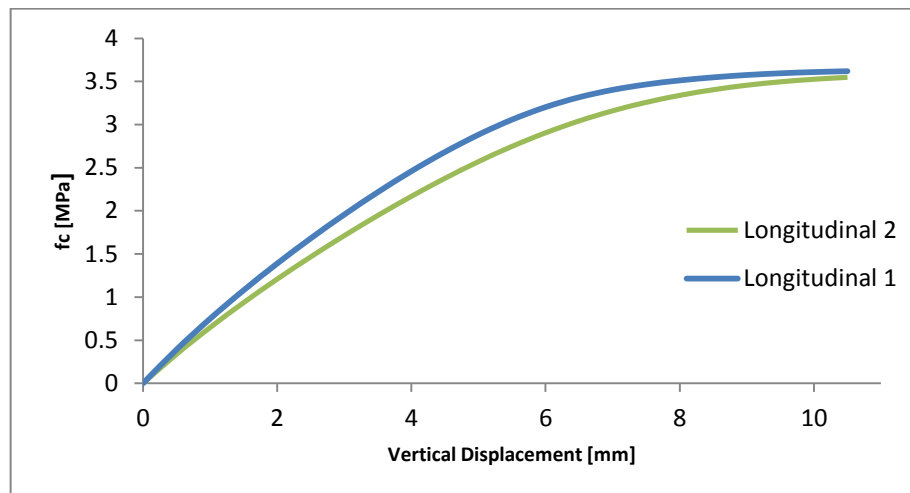
As it could be appreciated in the previous pictures the behaviour under compression is pretty much similar, with the cracks occurring along the line of mortar, and a distribution of vertical stress that is comparable. Both the models show a peak of compressive stress in correspondence of the plateau equals more and less to 3,5 MPa, with a tangential elastic modulus around 0,8-1,0 GPa (Fig. 4.12).

Fig. 4.12 – Comparison of the results

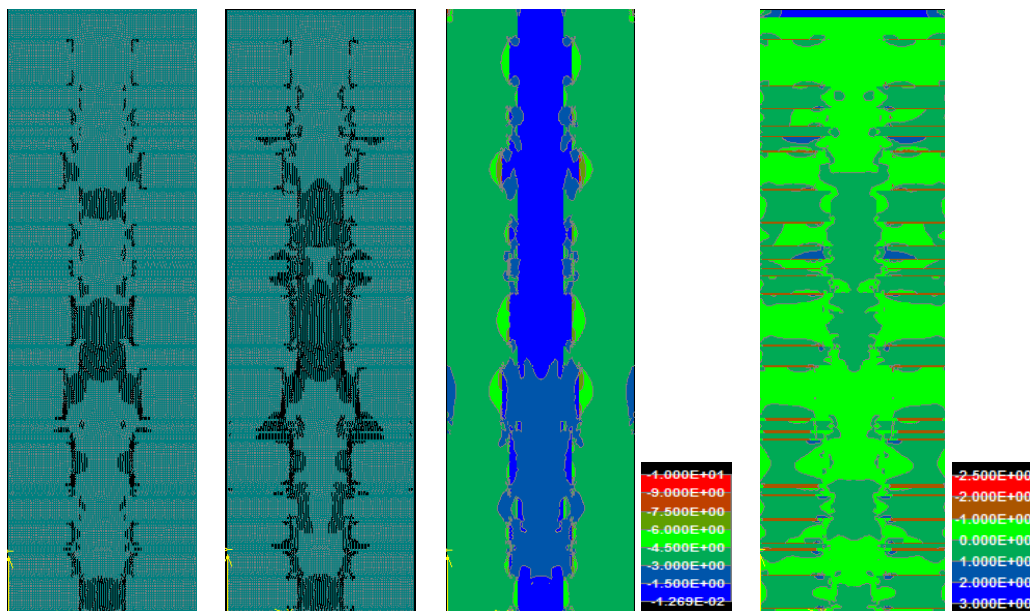
Fig. 4.14 – Cracking pattern of Interlocking Model 1 (5<sup>th</sup> and last step) , Vertical  $\sigma_z$  and Horizontal  $\sigma_x$  stress distribution

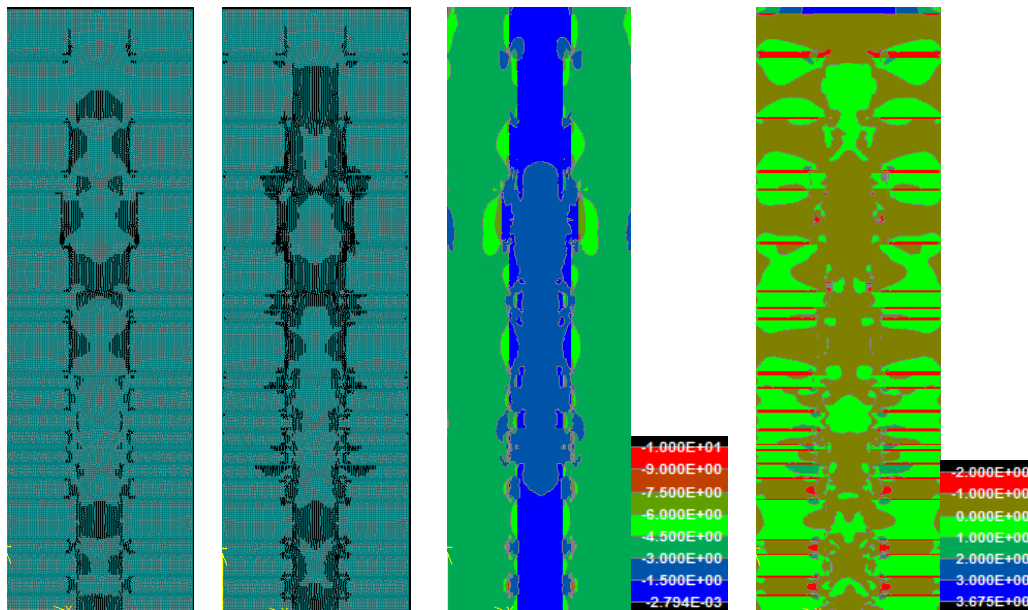
Fig. 4.17 - Cracking pattern of Interlocking Model 2 (5<sup>th</sup> and last steps) , Vertical  $\sigma_z$  and Horizontal  $\sigma_x$  stress distribution

As the previous results, also in this case it is noticeable a progressive evolution of cracks within the rubble and a distribution of vertical stress similar to the first sectional wall. In this case the peak compressive stress increased by 10% more the previous results, with a slight decrement of elastic modulus.

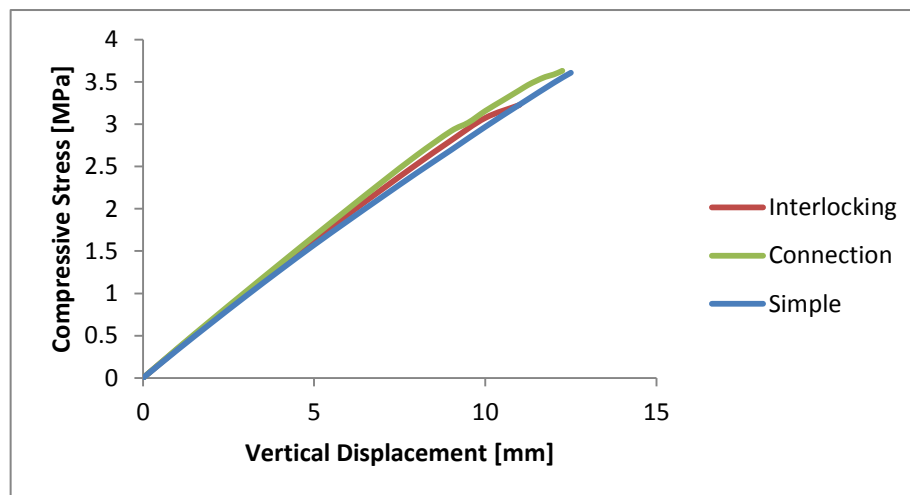
Fig. 4.18 - Comparison curves Displacement – Vertical Stress of the Sectional Walls 2

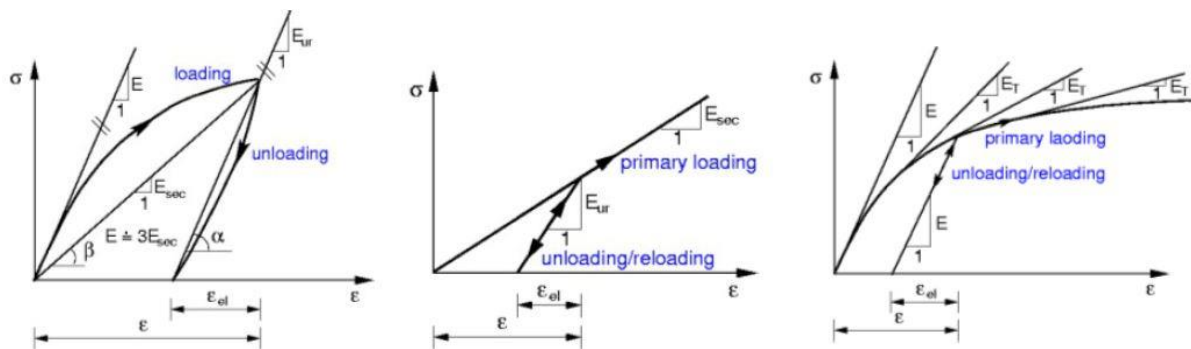
The nonlinear category is able to get better the real behaviour of the soils. By means of Mohr Coulomb Criteria, in GEO5 is possible to capture the change of stiffness of soil at each stress state. These criteria need the definition of more mechanical parameters, including the angle of internal friction ( $\phi$ ), cohesion( $c$ ) and dilatation angle ( $\psi$ ) (Sejnoha, 2009).

**Fig. 5.4 - Realistic behaviour of the soil (Left); Elastic model (Central); Mohr-Coulomb model (Right) (GEO5 Manual)**

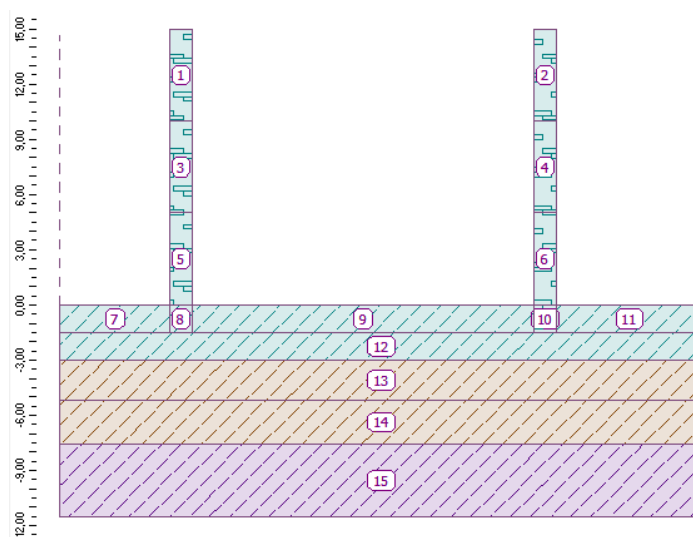
The analysis carried out in GEO5 took into account only the transversal section of the walls along with the subsoil, as was necessary to respect the hypothesis of plan strain, on which GEO5 is based. The subsoil was modelled according to the results from the boreholes related to the front. The walls modelled are the ones in correspondence of the niches, with a thickness of 1,2 m. As in GEO5 is possible to reproduce the stages of construction and condition of soils, the load coming from the wall was divided in three different stages trying to simulate the real process of construction. In order to take into account also the weight coming from the roof, the density of the walls was increased accordingly from 20 kN/m<sup>3</sup> to 22 kN/m<sup>3</sup>.

**Fig. 5.5 – Modelling of the different layer of subsoil and transversal section of walls**

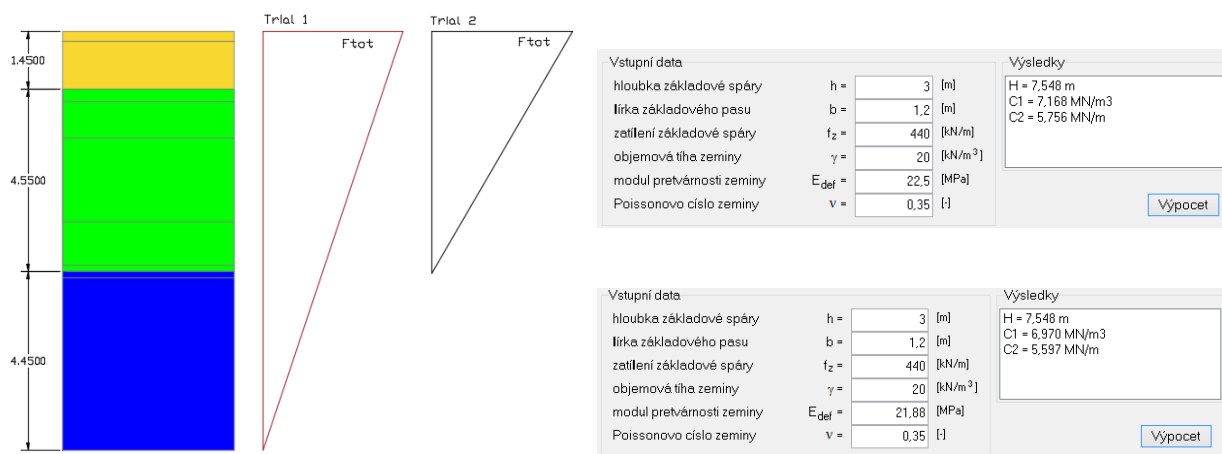
Moreover, being the depth foundation unknown, it was necessary an iterative process. The first computation was done in relation of all depth explored by the boreholes. Afterward, once found the depth foundation and the involved layers of subsoil, a new equivalent Elastic modulus was computed.

Fig. 5.7 – Procedure to find depth influence and Pasternak parameters for the soil in front of the Church

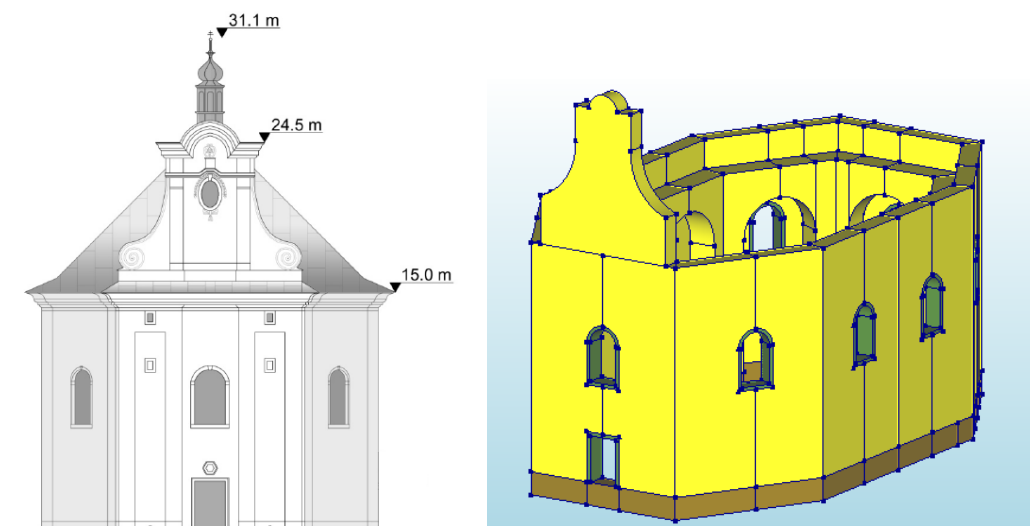
As the purpose was the investigation of the global behaviour of the church and the evolution of possible settlements, it was neglected, in the model, the small sacristy beyond the church. Also, the huge difference in weight and in stiffness between the two structures could have involved numerical problems during the analysis

**Fig. 6.1 – Façade drawing of St. Jacob (Facelli, 2014); 3D Model in DIANA**

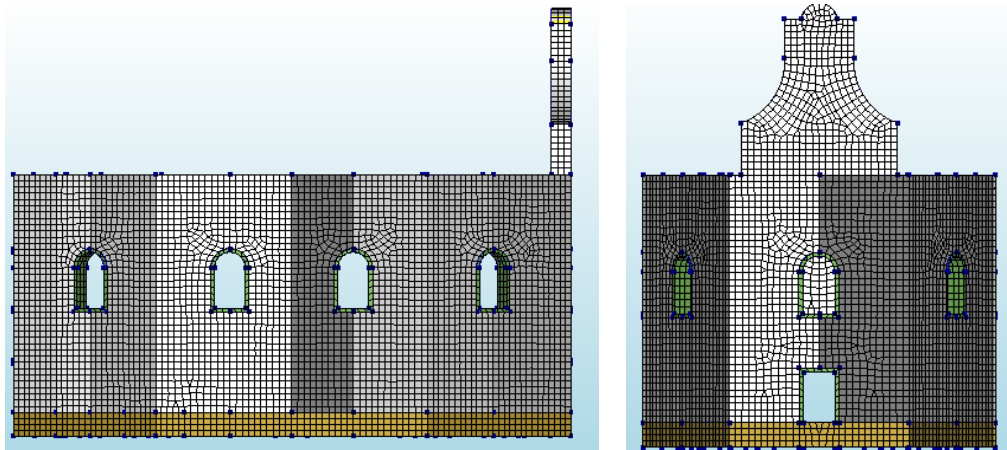
elements (20 nodes) might allow more information and details in the results, the overall number of nodes would have exceeded 250000, making the analysis much more slower. As the final goal is the detection of the position of cracks and their evolution, the linear elements are more than enough for this purpose.

Fig. 6.2 – Mesh of the model in DIANA

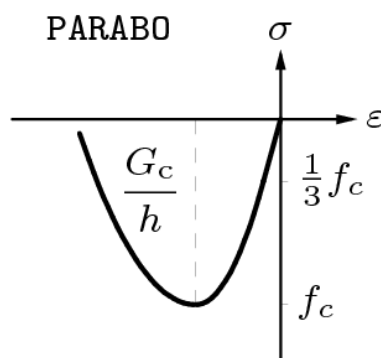
DIANA offers different constitutive models for a wide number of analysis. For a cracking analysis, as in masonry, the “Total strain based cracked model” was selected (DIANA, 2017). For the compressive behaviour a parabolic function was selected:

Fig. 6.3 – Parabolic constitutive model for compression

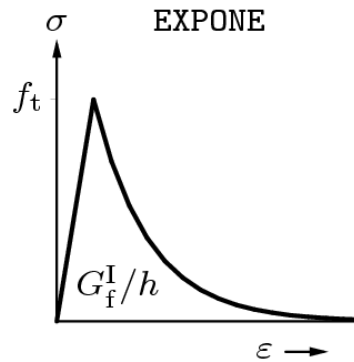
For the tensile behavior, a softening tensile exponential curve was chosen:

Fig. 6.4 – Tension exponential softening model

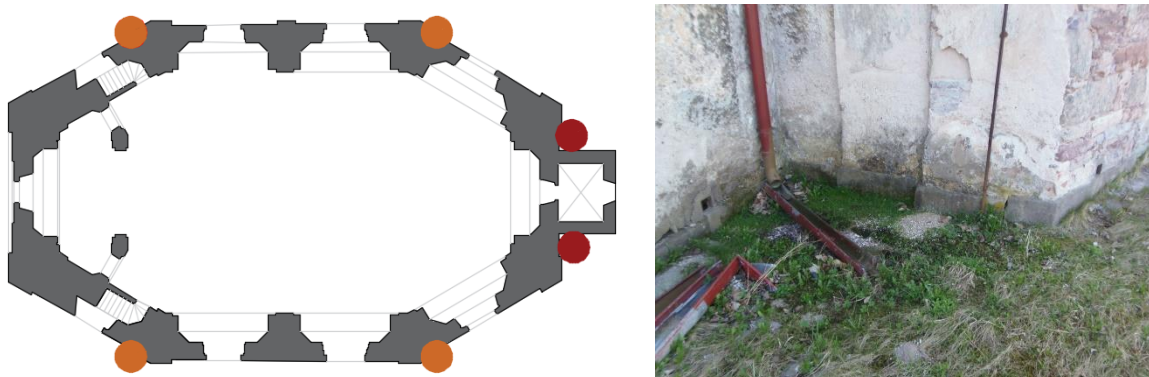
As mentioned in the damage overview, by a visual inspection some portion of the soil were detected as deteriorated. Basically, the locations correspond to the points where the not working gutters do not allow the raining water to run away, making worst the properties of the soil (Fig. 6.6). The most critical situation was detected in correspondence of the gutters coming from the roof of the sacristy (Fig. 6.6), creating concerns for the possibility of settlements in the back side of the church.

Fig. 6.6 – Localization of deteriorated soil (in red the worst condition); Detail of the worst situation

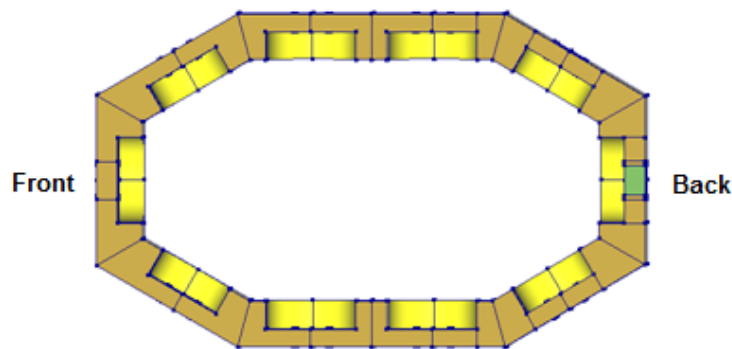
In DIANA model, the foundation was divided in different zone, in order to make easier the application of displacements only in certain locations (Fig. 6.7).

**Fig. 6.7 – Bottom point of view of the model**

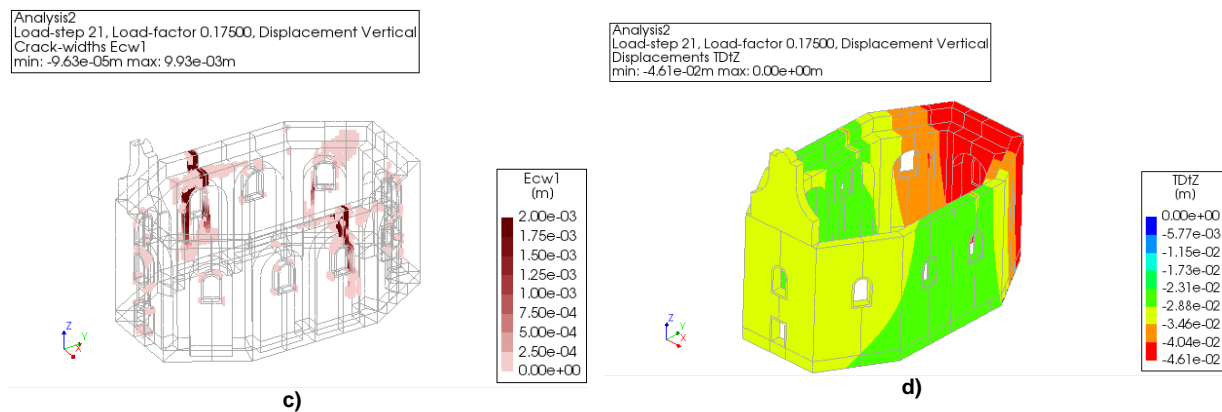
Fig. 6.12 - Cracking pattern in different steps and vertical displacement at the last step (2° Scenario)

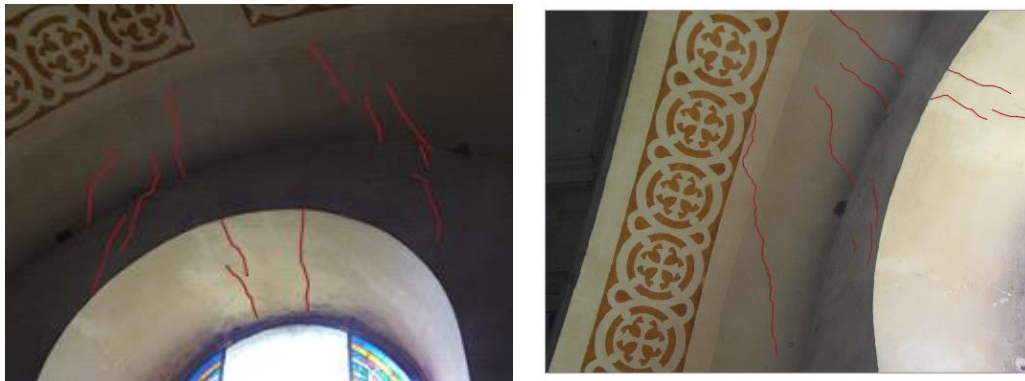
**Fig. 6.17 – Cracking pattern above the opening in one of the niche**

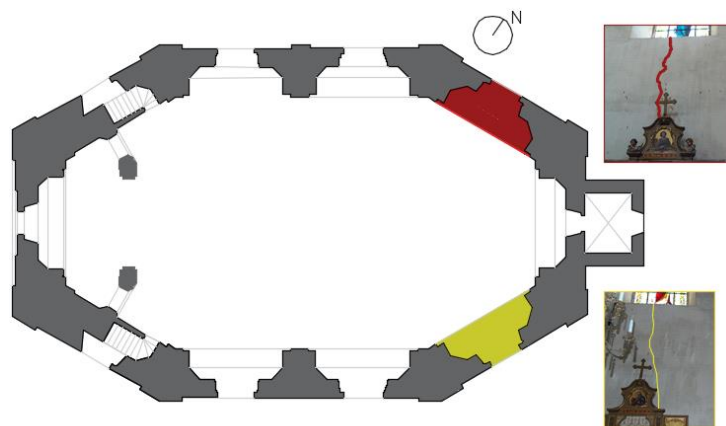
**Fig. 6.18 – Shape and locations of vertical cracks**

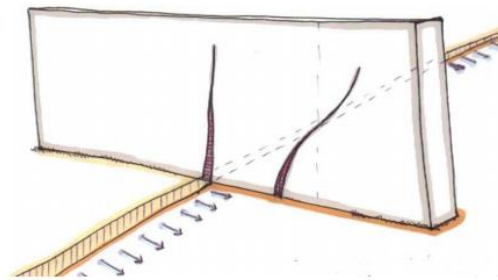
**Fig. 6.19 – Typical crack coming from horizontal movement (Bianconi,2009)**

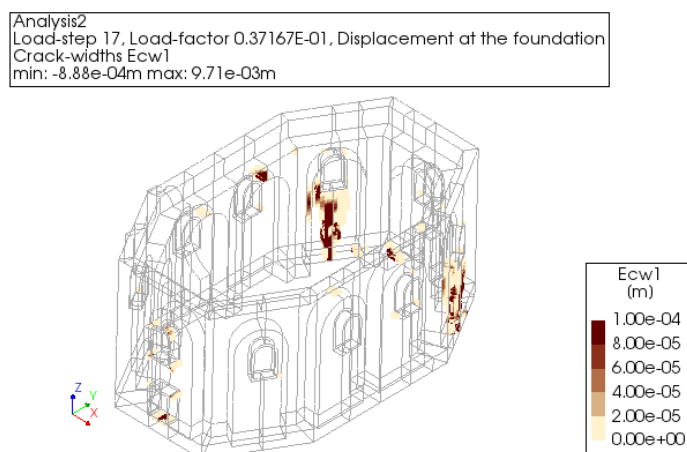
**Fig. 6.20 – Cracks Distribution linked to horizontal displacement at the base**

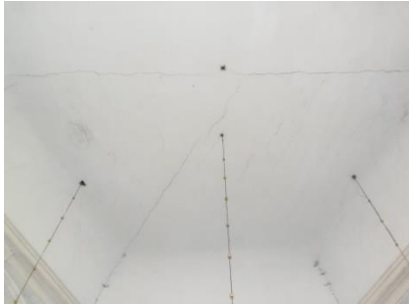
Tab. A.0.1

DAMAGE	DESCRIPTION	PHOTO	FURTHER INFO
<b>Cracks in the wood ceiling</b>	The ceiling presents several cracks due to the presence of the timber roof above, as the thermal picture shows.

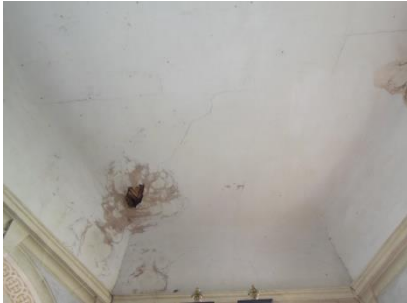
Tab. A.0.2

DAMAGE	DESCRIPTION	PHOTO	FURTHER INFO
<b>Hole in the wood ceiling</b>	Due to water infiltrations from the roof, a small portion of the ceiling is completely lost.

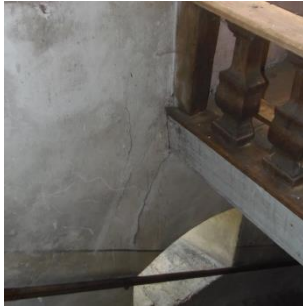
Tab. A.0.3

DAMAGE	DESCRIPTION	PHOTO	FURTHER INFO
<b>Cracks upon an opening</b>	A crack of almost 1 cm of thickness occurred in correspondence of corner the upper level, due to the presence of the opening.

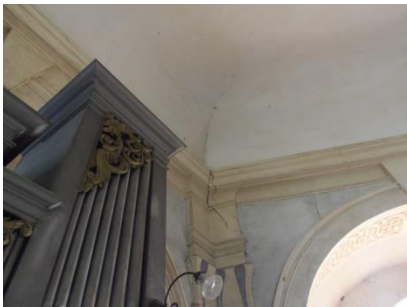
Tab. A.0.4

DAMAGE	DESCRIPTION	PHOTO
<b>Cracks at the corners</b>	At the corner of walls, cracks occurred due to the discontinuity of the shape.

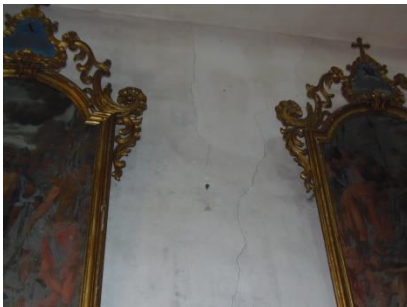
Tab. A.0.5

DAMAGE	DESCRIPTION	PHOTO
<b>Cracks in the plaster</b>	Above all in the walls located at east, some minimal cracks occurred. This could be related to concentration of salts under the surface.

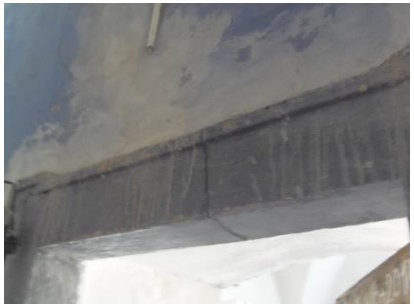
Tab. A.0.6

DAMAGE	DESCRIPTION	PHOTO
<b>Cracks in the lintels</b>	The lintels experienced an high level of tensile stress, this led to vertical crack in the middle section.

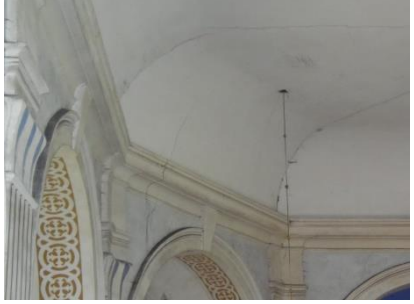
Tab. A.0.7

DAMAGE	DESCRIPTION	PHOTO
<b>Cracks upon and above the arch in the cell</b>	An horizontal crack characterizes the niche located at the north of the church.  The reasons for causing this damage could be various, and probably related to soil settlements.

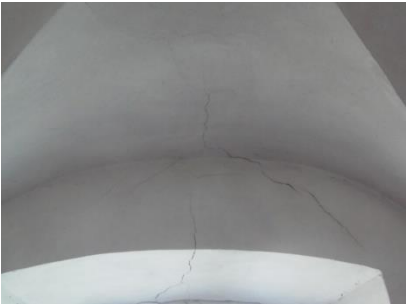
Tab. A.0.8

DAMAGE	DESCRIPTION	PHOTO
<b>Cracks in cross vault (Sacresty)</b>	<p>The cracks occurred upon the opening in correspondence of the cross vault may be marked as “compatibility cracking” due to the development of relieving arches or related to soil settlements.</p>

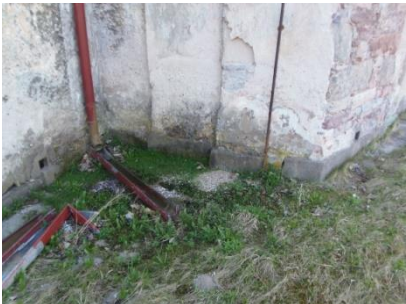
Tab. A.0.9

DAMAGE	DESCRIPTION	PHOTO
<b>Deterioration of soil in correspondence of gutters</b>	<p>The not working gutters do not allow the water to run away from the perimeter of the church, leading to soil deterioration.</p>

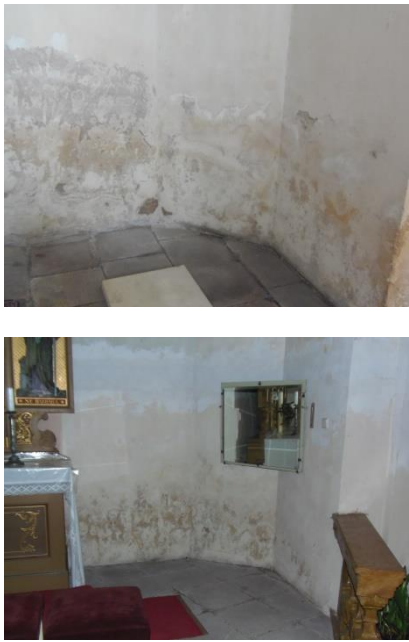
Tab. A.0.10

DAMAGE	DESCRIPTION	PHOTO	FURTHER INFO
<b>Rising dampness</b>	The walls at east and north-east experienced rising dampness, until a height of 2 m. This involved deterioration and loosing of the render.

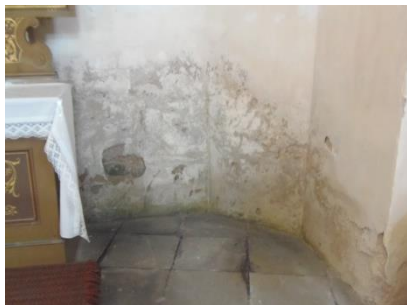
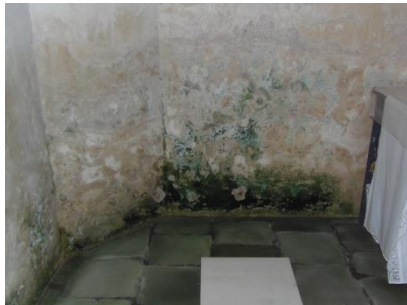
Tab. A.0.11

DAMAGE	DESCRIPTION	PHOTO	FURTHER INFO
<b>Rising dampness</b>  <b>Biological colonization</b>	The walls at north and north-west experienced rising dampness, until a height of 2 m, along with biological colonization.

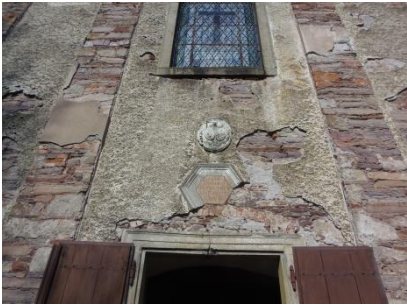
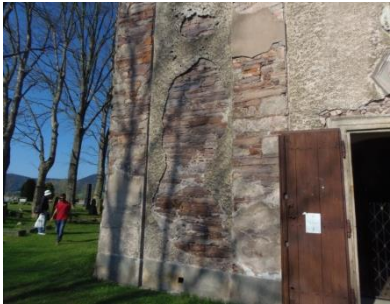
Tab. A.0.12

DAMAGE	PHOTO
<b>Loss Of Render</b>

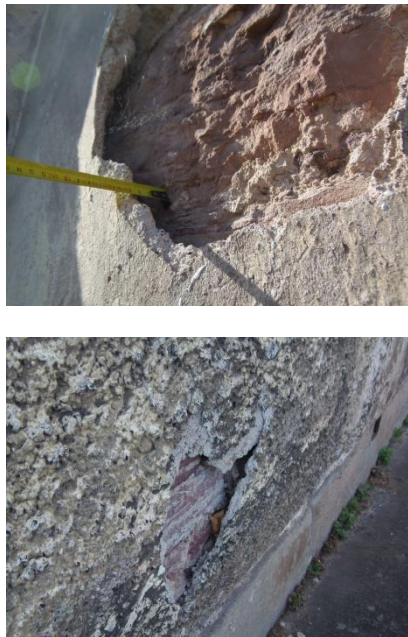
Tab. A.0.13

DAMAGE	PHOTO
<b>Bulging of Render</b>

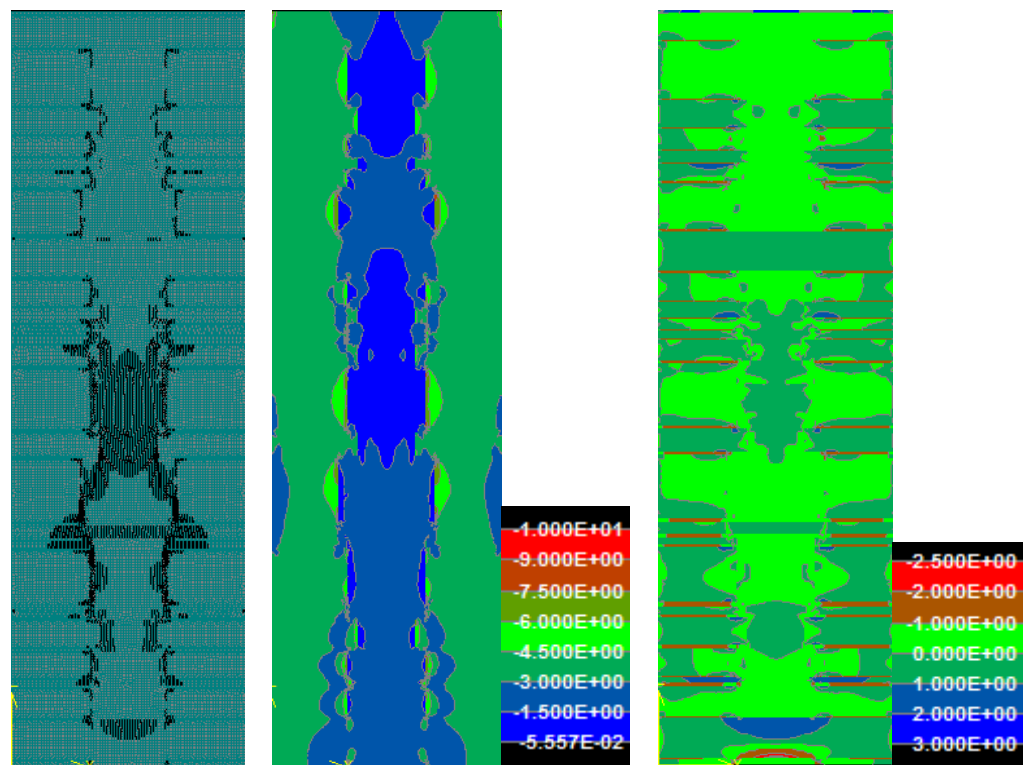
Fig. B.4 - Cracks pattern, vertical and horizontal stress distribution in Sectional Straight Wall 1 (Last Step)
