## MASTER'S THESIS PROPOSAL

Student's name and surname: Jacopo Scacco  
Department: Department of Mechanics  
Thesis supervisor: Prof. Ing. Pavel Kuklik  
Thesis title: Nonlinear numerical evaluation of the bearing capacity and the structure stability of the St. Jacob Church from the Broumov Group of Churches  
Thesis title in English: see above

The main objective of the thesis is the FEM modelling and the subsequent evaluation of bearing capacity of St. Jacob Church in the Broumov Region, with a particular attention on the influence of the shallow footing and their degradation.

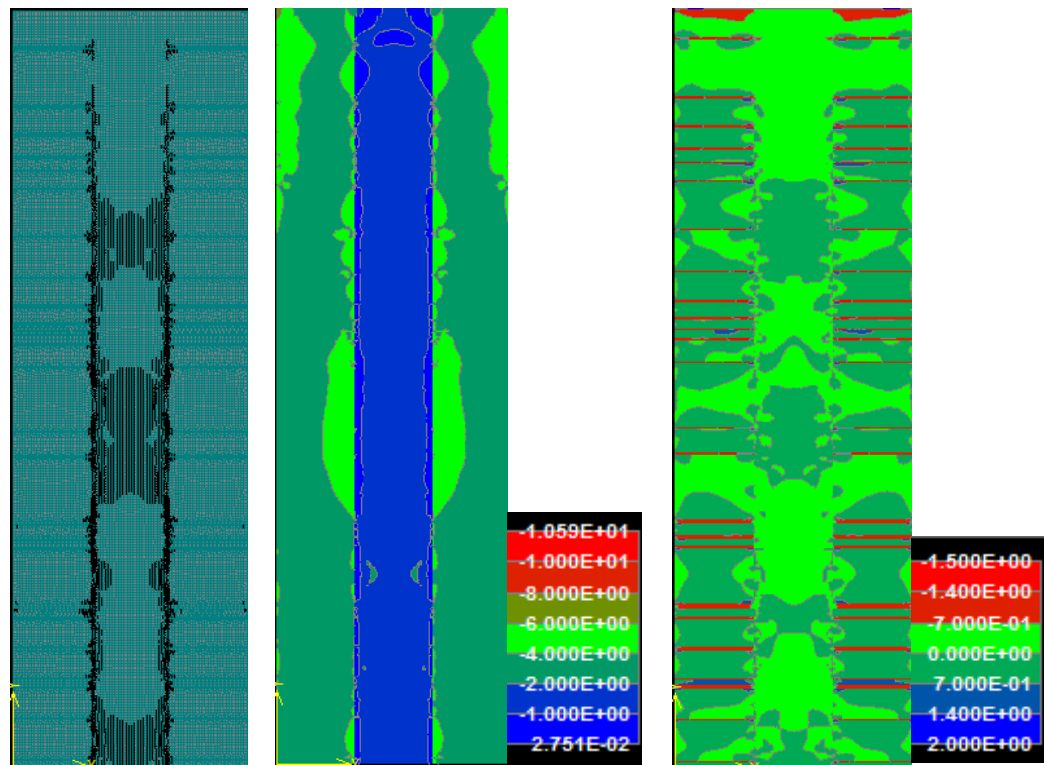
Fig. B.5 - Cracks pattern, vertical and horizontal stress distribution in Sectional Connection Wall 2 (Last Step)

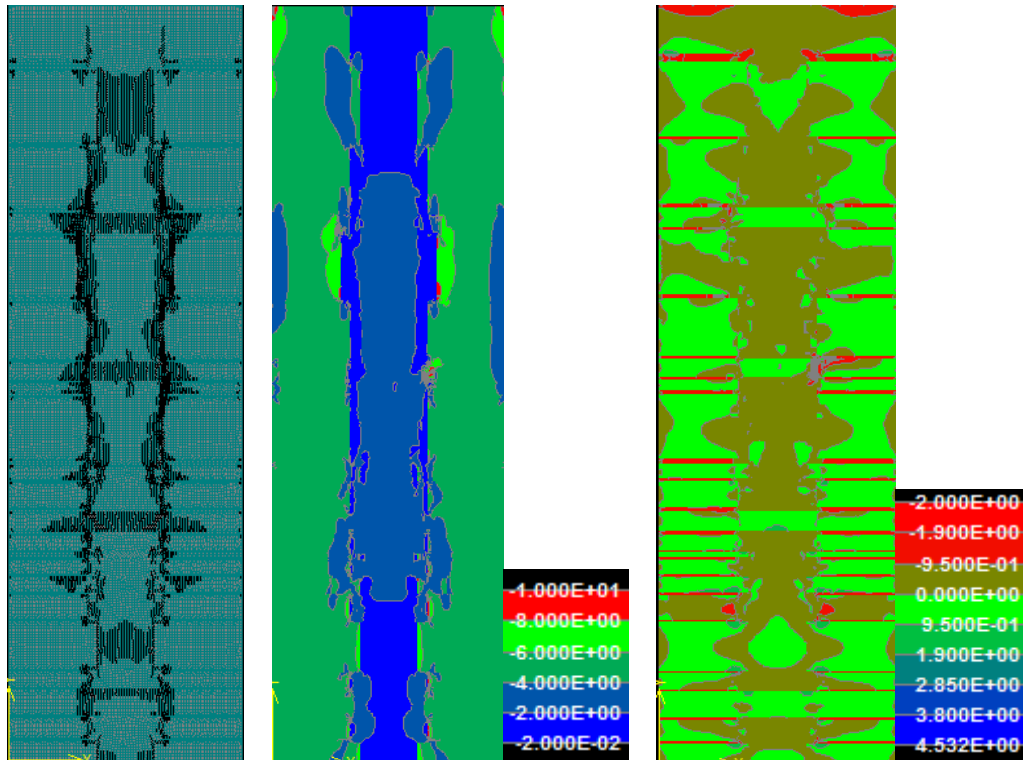
Fig. B.6 - Cracks pattern, vertical and horizontal stress distribution in Sectional Straight Wall 2 (Last Step)
