CZECH TECHNICAL UNIVERSITY IN PRAGUE

Textile Reinforced Concrete (TRC)

Prague 2019

Gleb Zhavoronkov

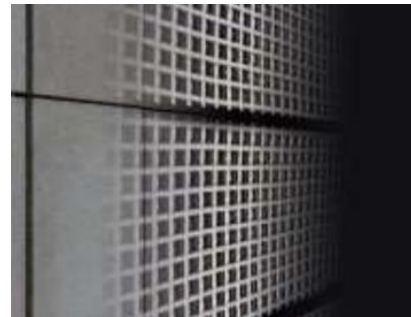
(Fig. 2: TRC tile composition.

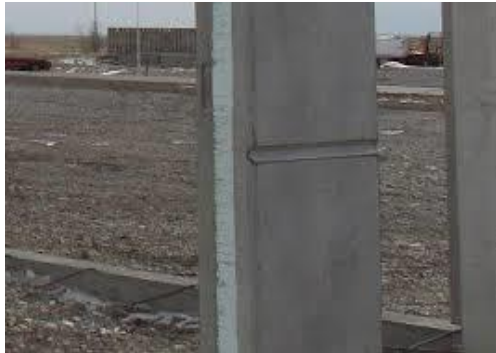
(Fig. 3: Composition of Sandwich panels.
Source: Mountainviewprecast.ca, 2019)

Currently there are two possible materials or approaches can be applied to create TRC facings in sandwich panels (Fig. 3). Materials such as glass fibre reinforced concrete (GFRC) and fibre reinforced polymer (FRP) are used as external layers. These

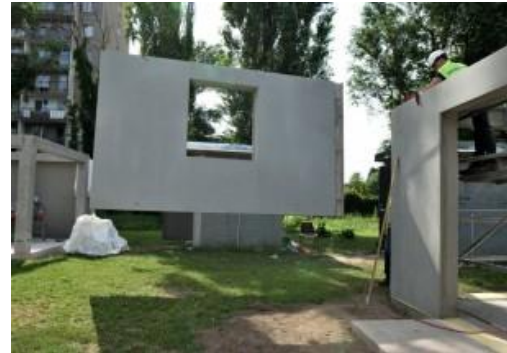
(Fig. 4: Installation of panels.
Source: Mostostal.waw.pl, 2019).

Eco-buildings are usually made from Sandwich panels (Fig. 4) assembled from two facings and a core (rigid or flexible material) which function is to work as thermal insulation and increase the stiffness of the sandwich structure. Furthermore, they also offer extra properties in terms of acoustic insulation, non-flammability, easy assembly, cheap and simple manufacturing, time-saving installation, etc.

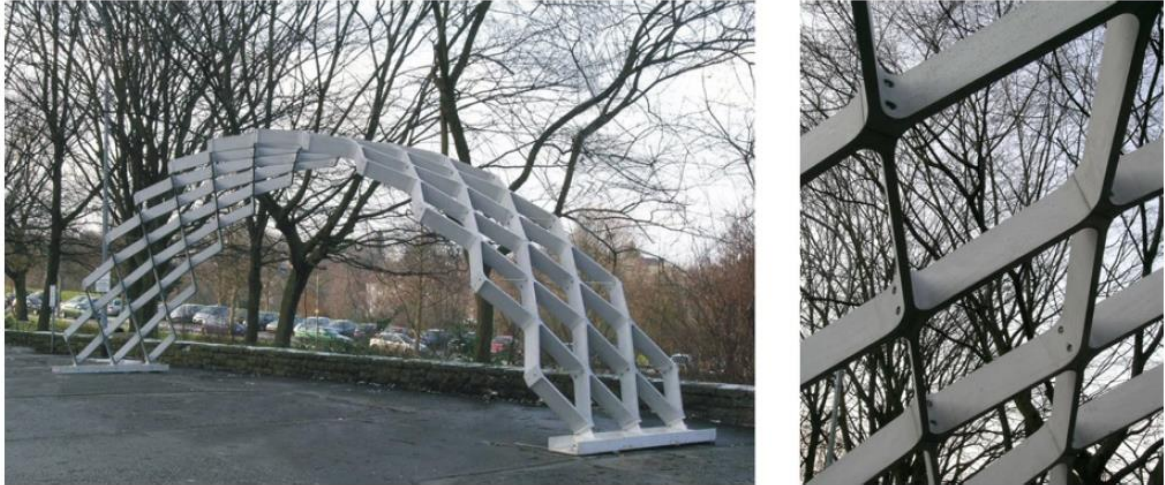
(Fig. 5: Prototype of a diamond-shaped lattice grid. Source: Grca.org.uk, 2019).

While TRC simplifies the problem and provide a flawless opportunity to make prefabricated slender and light-weight structures with complicated and magnificent geometric shapes. The real-existing prototype of Rhombic Lattice-Grid (Fig. 5) is located in RWTH AACHEN UNIVERSITY in Germany and was built in February 2005. The TRC Arch was erected from 36 single rhombic elements with dimensions 1000 x 600 x 160 mm bolted together and connected in 3 parallel rows. This system has the total span of 10m with the height of 3m and the width is 3m. This light weight structure weights only 23kg (Source: Grca.org.uk, 2019)

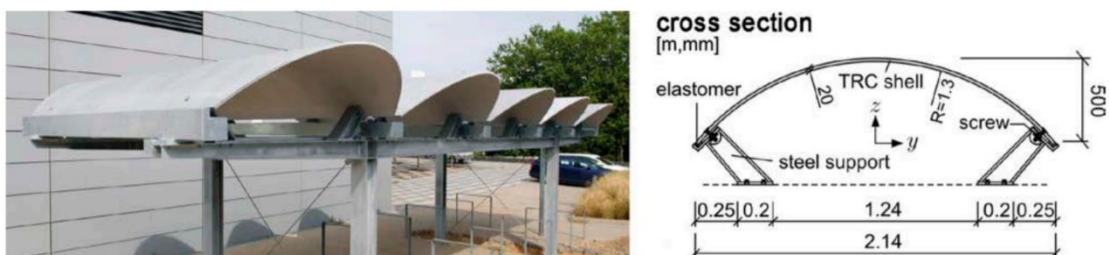
(Fig. 6: Roof of the bicycle stand made of laminated TRC barrel vault shells. Source: Edisciplinas.usp.br, 2019)

Barrel Shell TRC (see Fig.6) has cylindrical shape, domed, paraboloid or ellipsoid shape. The curvature of shell structures have the same distribution of internal forces as arches, which are pure compression forms with no tensile stresses. This property makes the textile-reinforced concrete structure extremely light-weight and the shell is rigid in both the longitudinal and lateral direction than conventional frames. As shown in Figure 6 (left side), the structure consists of four individual barrel shape shells supported on steel elements welded to the steel frame. Each shell has the thickness of 20mm, width of 2,14m and the length is 4,4m. It was produced by RWTH AACHEN UNIVERSITY (Source: Edisciplinas.usp.br, 2019)

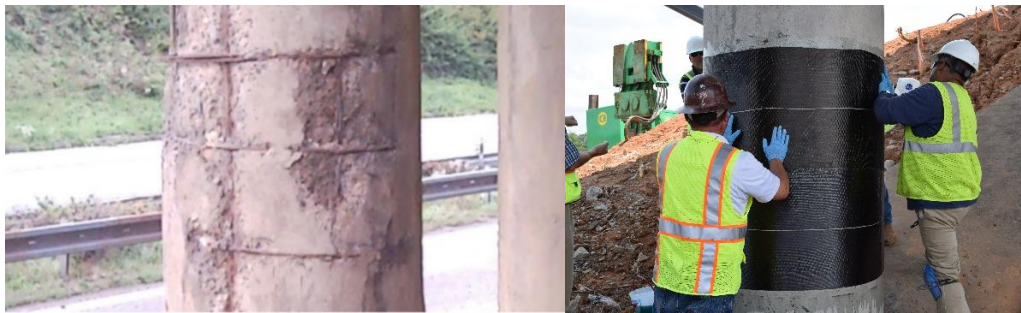
(Fig. 7: Damaged pillar of the bridge. Source: Roads & Bridges, 2019).

Some RC Load-bearing elements, which are subjected to dynamic loading should be strengthened to prevent deterioration of their surfaces. Concrete bridges are loaded by non-static loading that is why the coverage layer of RC supports are destroyed (see Figure 7).

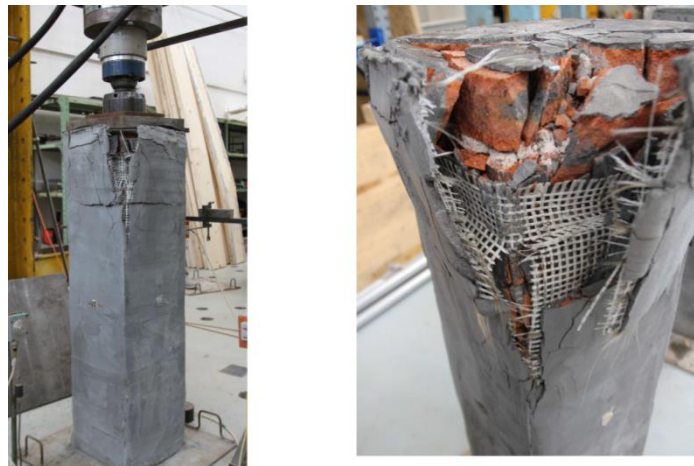
(Fig. 8: Collapsed pillar with TRC protective layer after testing. Source: Holčapek, Vogel and Reiterman, 2019).

Modern approach of application TRC could solve these problems. Wrapping of Alkali-Resistant glass textile around the brick column (see Fig. 8) could benefit with achieving of maximum load up to 150% with respect to in-reinforced element. This

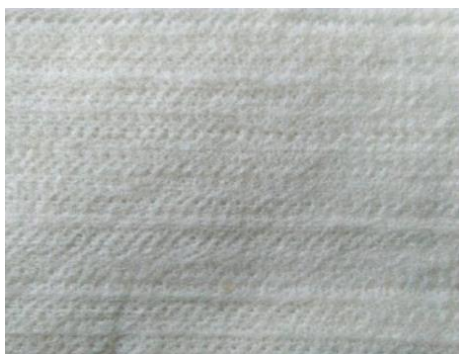
(Fig. 9: Non-woven polypropylene textile. Source: Author)

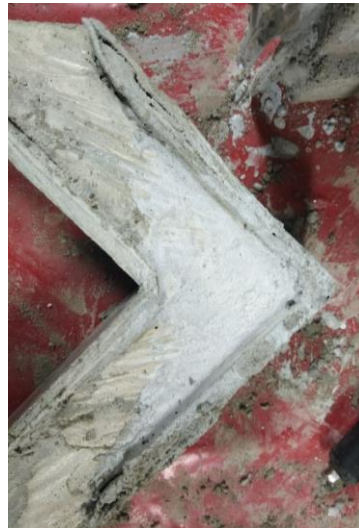
(Fig. 11: Composition of TRC layer. Source: Author)

According to estimated goals; Concrete samples will be created before attaching protective layers from both sides (See Fig. 11) in order to monitor deformations and damage of composition under the loading.

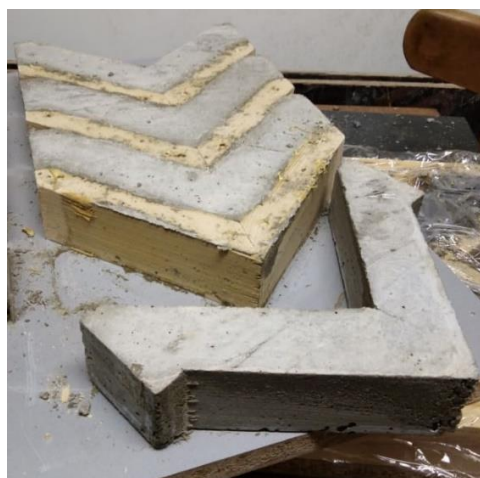
(Fig. 12: Concrete samples. Source: Author)

Twenty-four samples with the shape of a corner frame and the cross-section of 4 x 4 cm and the length of 15 cm from outer surface and 13 cm from the internal side was designed for this work (Fig. 12). Eleven of them are made of fine-grained concrete, meanwhile another part is made of reinforced concrete. The main point of making these samples is to measure all internal forces in samples and PP textile during the compression and tension tests.

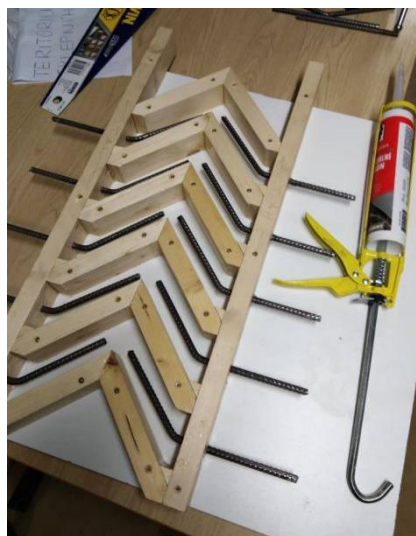
(Fig. 14: Wooden form-work for tension test. Source: Author)

The second step was creating another type of form-work (Fig. 14) for reinforced concrete samples. The modification was made by drilling holes in wooden studs with diameters of 8mm for inserting bent steel re-bars with diameter 8mm.

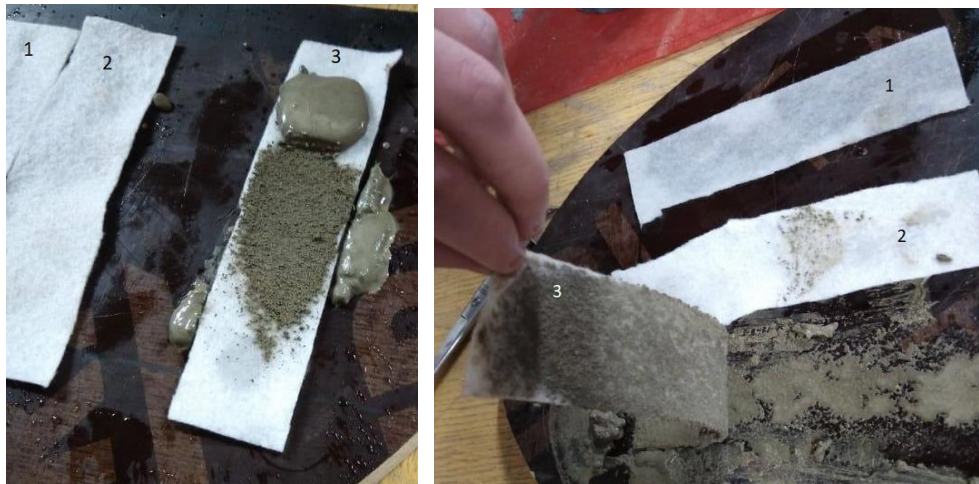
(Fig. 16: PP textile penetration. Source: Author)

Three PP textile were tested (See Fig. 16). Textile number 1 and 2 were concreted with fine-grained concrete, while the canvas number 3 was penetrated with cement paste. Moreover, PP textile 1 was fully submerged to the water, meanwhile other samples were dry before the test.

Due to non-permeability of PP textile the concrete stays on the surface of the material (Fig. 16 left side). In order to penetrate material, it should be gently rubbed with a spatula. In case of intensive rubbing, the concrete becomes crumbly, that is why it has to be applied gently to achieve full penetration of concrete through the canvas.

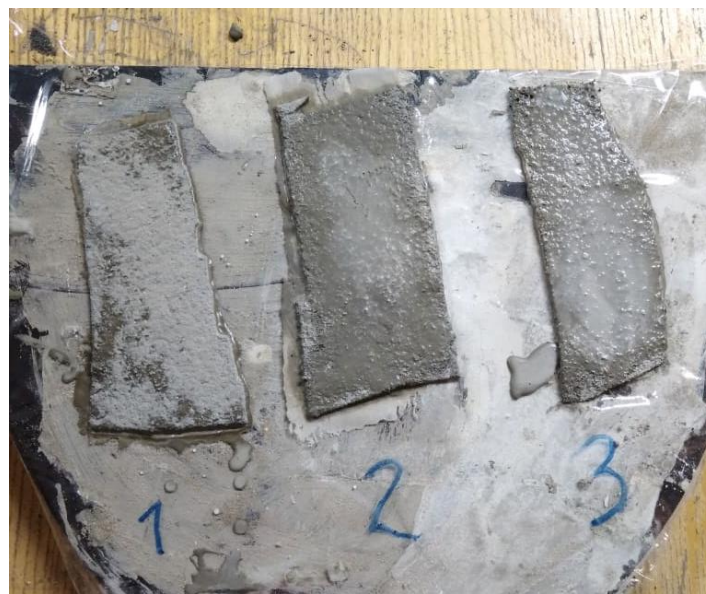
(Fig. 17: Hardened PP textiles. Source: Author)

After hardening of the concrete mixtures, a judgment was settled. Observation of samples (Fig. 17) revealed that textile number 1 had an issue with oversaturation, which influenced the final composition of the hardened concrete. In the result of that, sand disposed on the outer surface of the textile, while only cement penetrated and stayed in the PP canvas. Moreover, during concreting the cement, the paste flowed out from the material, for that reason less concrete would have to be used for that specific textile than in in others. Meanwhile, specimen number 2 with the same concrete mixture was applied on the dry canvas. During the manufacturing difficulties were encountered as the amount of plasticizer was relatively low for penetration of the material, which lead

to an extension of time for the preparation and poor quality of the final composition. The concluding inspection revealed, that concrete did not penetrate PP textile entirely, simultaneously sand remained on the upper surface and partly penetrated the material, but not fully. For the third specimen the cement paste was tested. Big amount of plasticizer was used, that is why hand application was the most successful approach, because the mixture was fluid, whilst the spatula method resulted in a more rigid outcome. Furthermore, the arrangement of the cement paste was homogenous along the whole specimen, for that reason the decision was made to apply this mixture for further work.

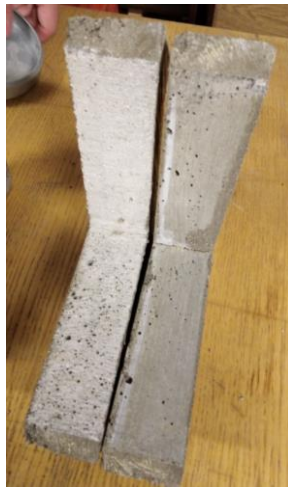
(Fig. 18: Rubbed and smooth surfaces. Source: Author)

The bond between concrete/RC and TRC was decided to be done in two ways. The reason being that it is a reconstruction of damaged surfaces of load-bearing elements, two scenarios were selected (Fig. 18). First one considered to be with smooth external surface of the structure, where TRC will be attached on fresh concrete poured onto a smooth surface. The concrete for attaching the TRC will be identical as concrete used in bonding of PP textile. Another scenario is to apply TRC coverage layer of damaged surface of a structure. The technology of manufacturing will be the same as in the case mentioned above.

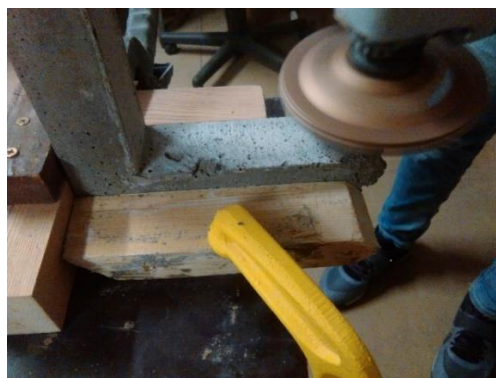
(Fig. 19: Rubbing of samples. Source: Author)

For these conditions 11 hardened RC and 11 concrete samples were prepared. 11 of all samples were rubbed by a grinding tool (7 for compression, 7 with reinforcement for tension) see Fig. 19. All internal and external sides were grinded for application of TRC layers from both sides. Other 11 samples were left as they are (3 compression, 5 tension), because of smooth surfaces of the samples.

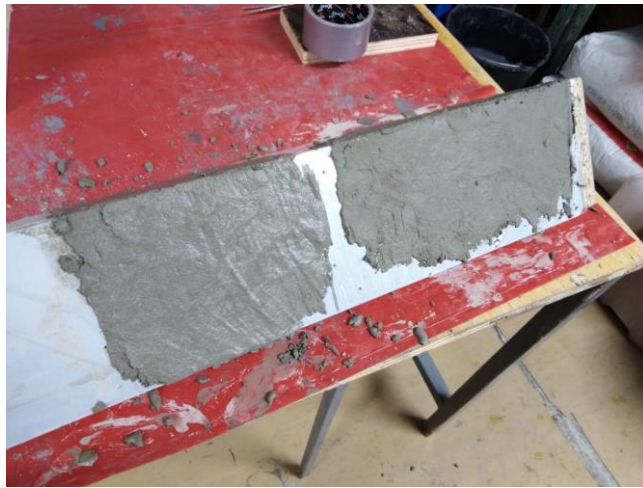
(Fig. 21: Concrete mixture on foil. Source: Author)

prevent the TRC adhering to the wood and making the un-forming process complicated (See Fig.21). Test revealed that during the placement of fresh concrete on foil the substance should be poured on the top edge in a small amount and intensely applied with a spatula. That special treatment makes concrete spread uniformly along the inclined surface in order to reach the thickness of the concrete layer in the range of 1-2 mm. Greater than that the thickness is barely impossible to achieve with the given mixture, because of the self-weight of the substance, which pushes the entire mass down the slope (Fig. 22) and due to the high inclination of the surface (45 degrees) on the slip surface. Probable solution for creating a thicker layer is to use less plasticizer amount in the concrete mixture that will result in less fluidity.

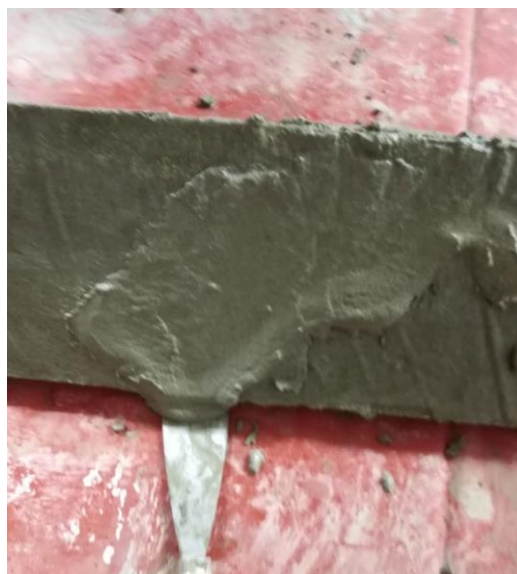
(Fig. 22: Sliding of fresh concrete layer. Source: Author)

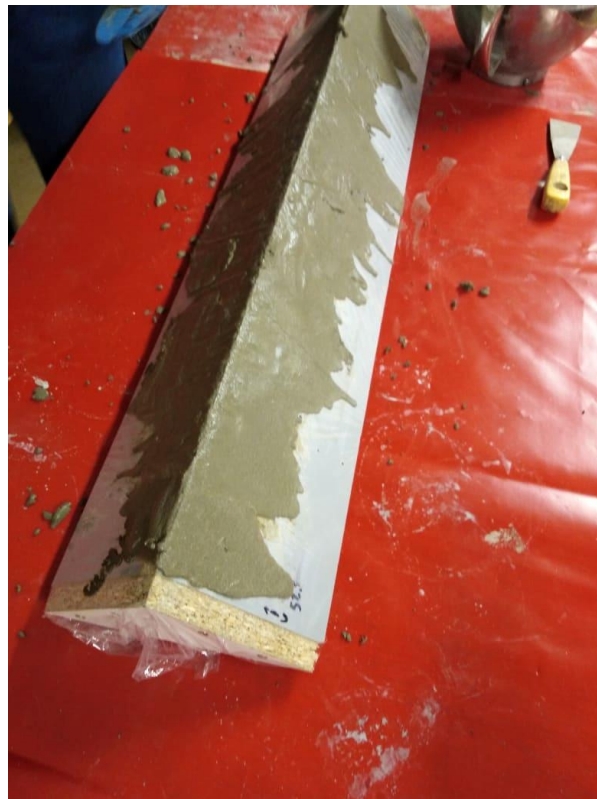
(Fig. 23: Concreting of the outer layer. Source: Author)

Firstly, the foil covered the formwork for an easy detachment of the concrete samples (Fig. 23). Right after that, the concrete mixture was created to make the first and outer layer of TRC composition. The concrete was poured in small portions on top of the edge and gently applied with a spatula for making the concrete flow from top to bottom of the inclined wooden desk with homogeneous layer along the whole slope.

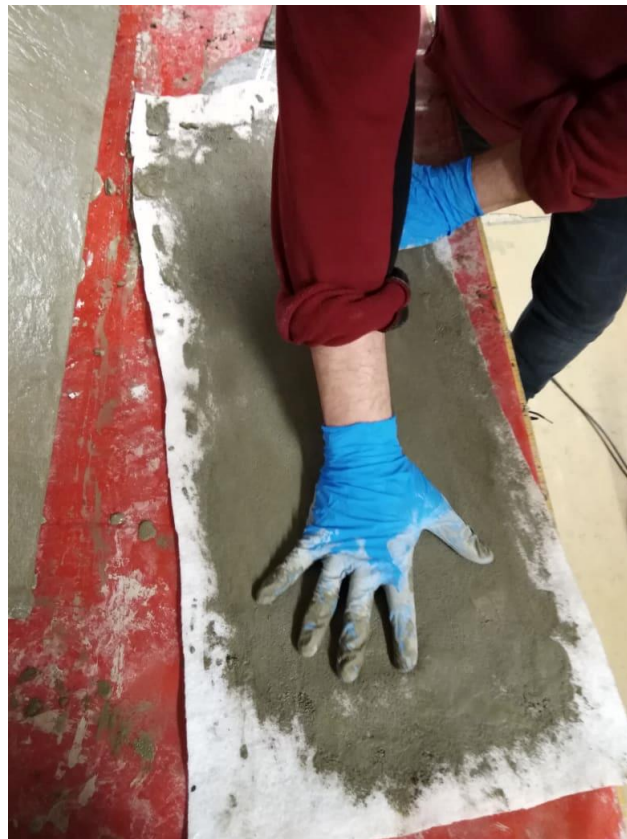
(Fig. 24: Manual rubbing of cement paste to PP Textile. Source: Author)

Secondly, the preparation of the first textile layer has begun. Canvas material was cut and in the meantime the cement paste was mixed. Before inserting the mixture, the PP textile was sprayed with water in small portions, because the PP canvas absorbs the water and as a result, it reduces dramatically water to cement ratio of the concrete substance. As the technology of penetration of the canvas was mentioned in section 3.2, it was applied during concreting, but it was made on a small scale of material to compare with a real one. For that reason, the decision was made to apply new technology, which requires manual inserting of the cement paste (shown in Fig. 24).

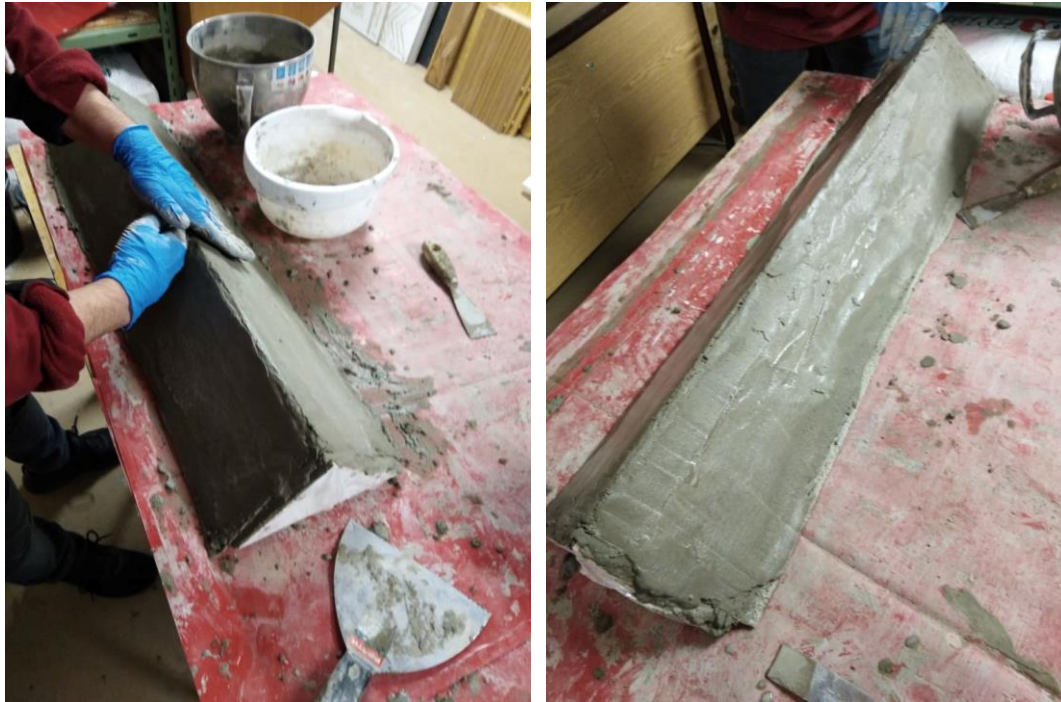
(Fig. 25: Concreting of interlayer. Source: Author)

Third step was to attach the penetrated canvas to fresh concrete, which was poured on the inclined formwork. There were no special conditions for laying the canvas. The approximate amount of cement paste, which was inserted to the textile was 1 kilogram that is why the material was prestressed to the concrete mixture by its own self-weight. The next step was to place interlayer of concrete between PP textile layers (Fig. 25). Only one complication was observed during the process and it was the oversaturation of already placed PP textile on the formwork with water. That specific condition made fresh concrete flow down the slope. The problem raised after spraying some extra water on the canvas, because concrete started to harden. That problem was solved by inclination of the formwork. In 30 minutes after new concreting, the old PP layer became marginally harder resulting in excess of water and concrete flowing out of the formwork.

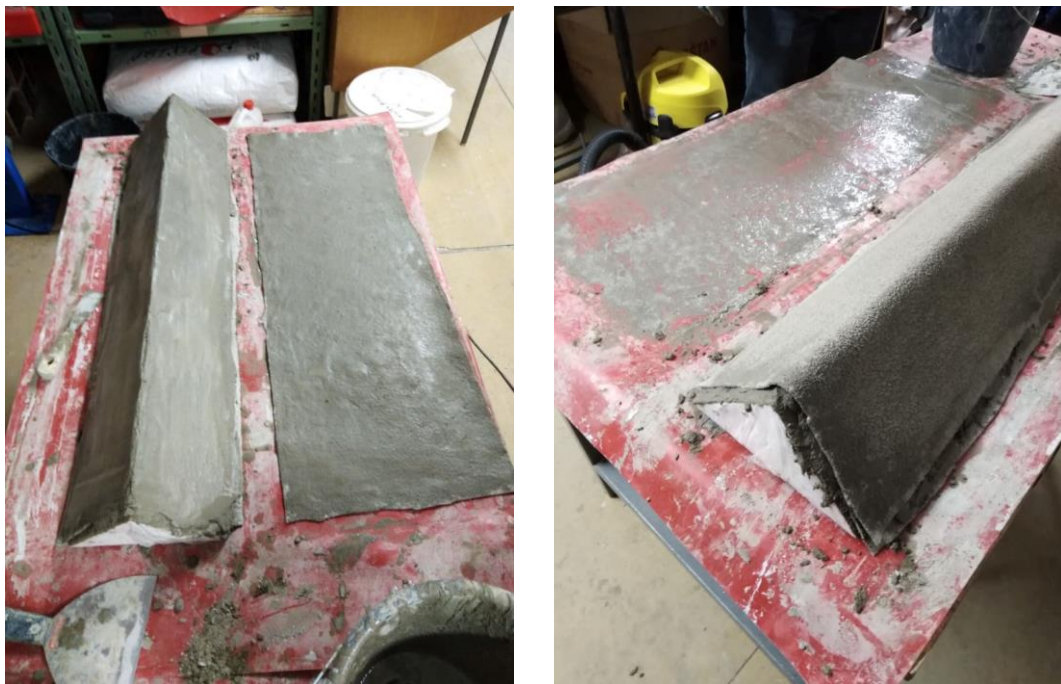
(Fig. 26: Layering of PP textile. Source: Author)

Further step was to repeat the process of textile penetration. The technology was exactly the same as it was during production of the first layer of PP textile, however concrete interlayer was not sprayed with water to prevent the PP textile from oversaturation. Subsequently it was laid on the concrete layer (shown in Fig. 26).

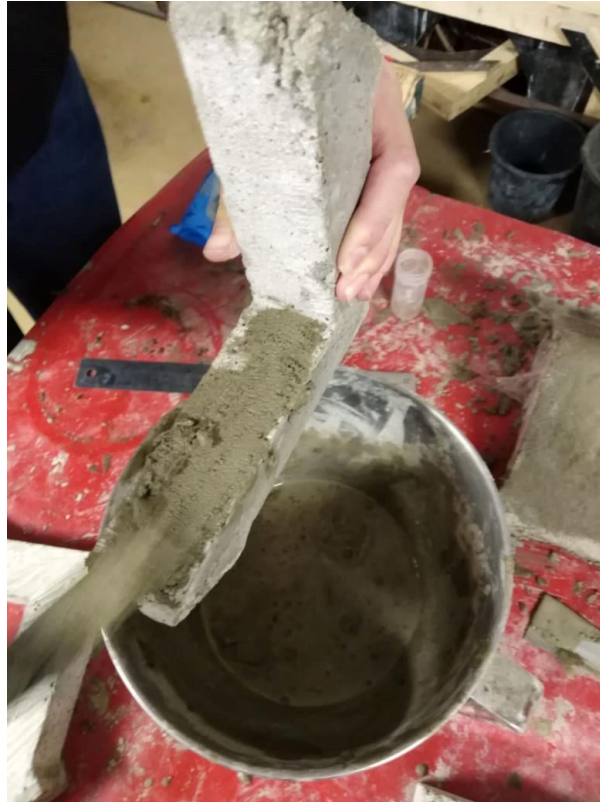
(Fig. 27: Placing extra concrete on RC samples. Source: Author)

The final step was placing concrete and RC samples on TRC coverage layer. After attaching second layer of PP textile the last concrete layer was poured. A few minutes later, when the concrete marginally hardened it was necessary to place the other portion of mixtures directly on concrete and RC samples (as shown in the Fig. 27). It was done to increase the bond between PP textile with outer concrete surface and RC sample, also to eliminate any chances for cavities between these layers.

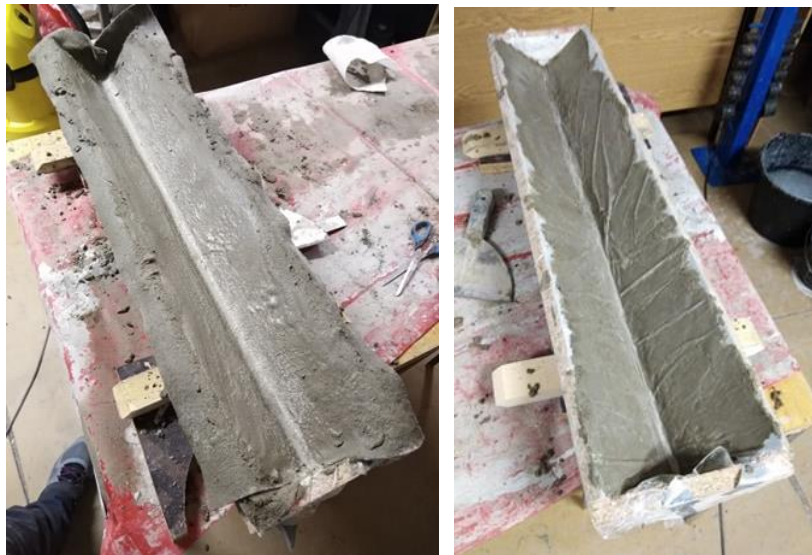
(Fig. 29: Creating TRC coverage layer. Source: Author)

Further manufacturing of TRC coverage layer was performed. The technology of application is identical. Firstly, TRC was placed on the formwork (shown in the Fig. 29)

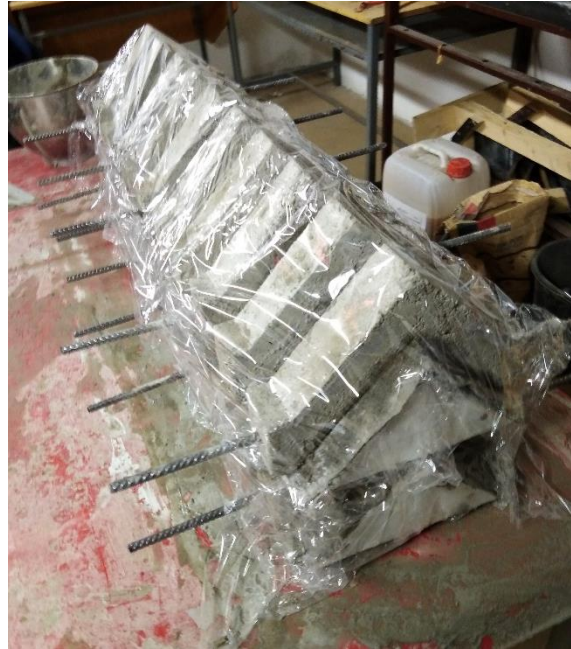
(Fig. 30: Inserting samples into the formwork. Source: Author)

Subsequently, the set of samples was placed directly into the formwork (see Fig.30). And prestressed by previous already concrete set of samples in order to achieve better bond between TRC and concrete/RC.

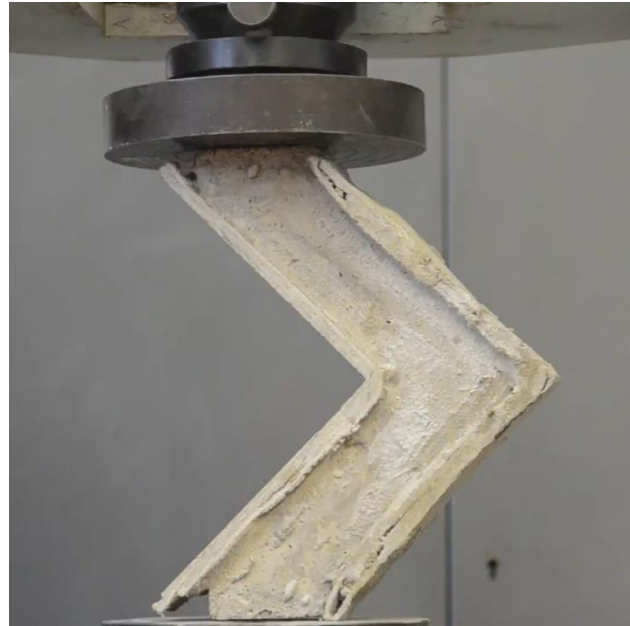
(Fig. 32: Compression test. Source: Author)

Firstly, the axial compression test (see Fig. 32) was conducted, where samples with rubbed and smooth surfaces between TRC and concrete/RC were tested until complete collapse. The reason for full destruction of the samples is to obtain the entire data for analysis of each individual element of composition, because both internal and external TRC layers have distinct roles.

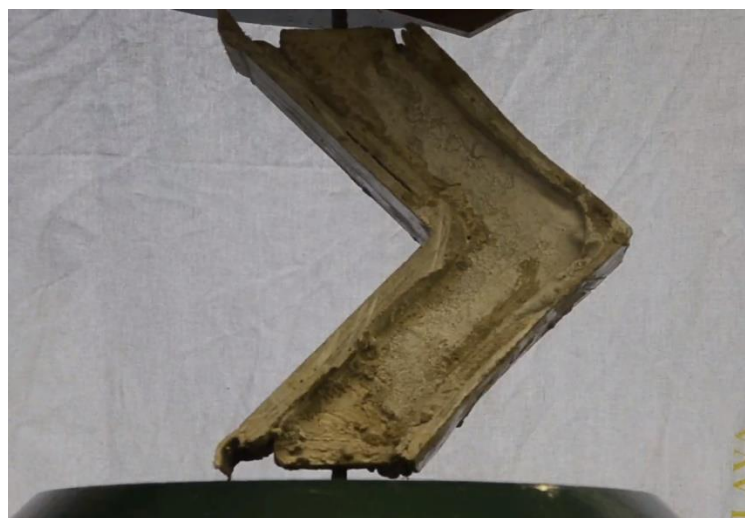
(Fig. 33: Tensile test. Source: Author)

The final measurement for tensile strength was carried out by axial tensile test (represented on Fig.33). Identically, samples with the rubbed and smooth surfaces were tested. The duration of this test was twice as long, because PP textile is a very ductile material and loading has to be done carefully with maximum precision. The machine applies some force and halts for a result of deformation, when the material starts to tear, the applied force stays at the same level or decreases to some extent. This is the result of linear sections of the graphs, where strain continues to enlarge, while the stress stays at the same level.

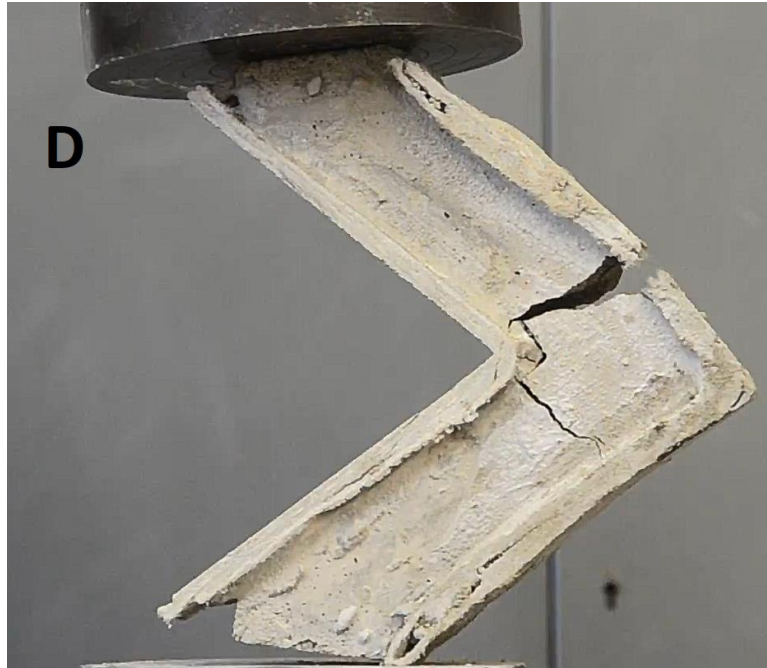
(Fig. 38: Failure of concrete specimen. Source: Author)

Point D shows failure point. In this specific case the failure caused by complete rupture of TRC layer above the first crack (Fig. 38). In the graph it is represented by a sudden drop to the lowest value on Stress Axis (point E). After complete opening of the sample the concrete stops to carry any load, only internal TRC layer continues to bear the external load (point F).

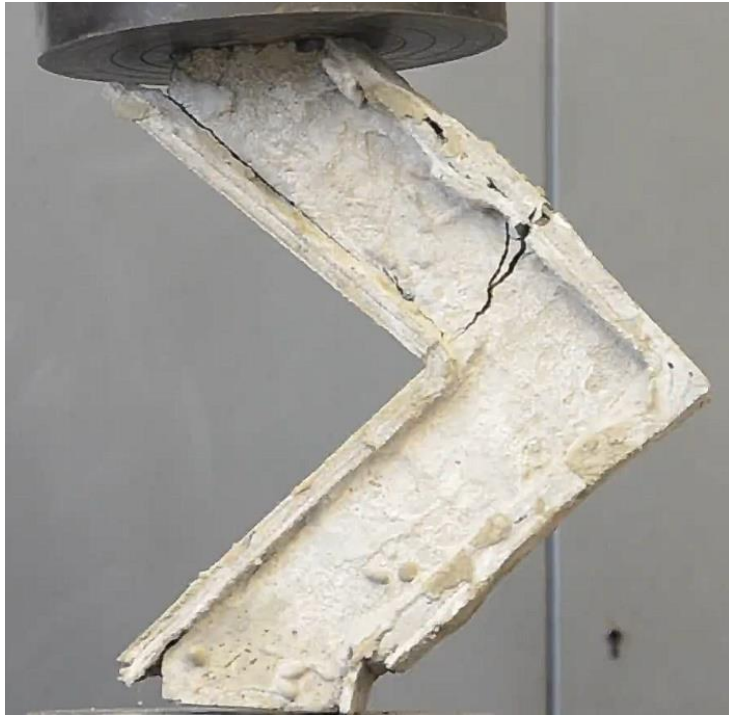
(Fig. 40: Poor bond between TRC and concrete sample. Source: Author)

Another set of samples was with a smooth surface. The final data from axial compression test is shown on the Fig. 39. According to the given graphs the main difference between rubbed and smooth specimens is the appearance of first and second cracks in concrete samples. The reason for this behaviour is less friction between attached TRC cover and an old concrete specimen (see Fig.40).

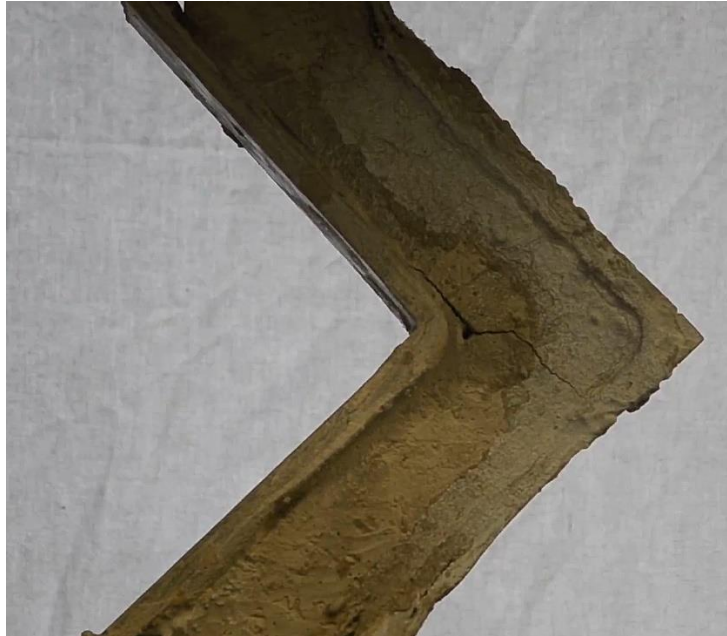
(Fig. 42: First crack during tension. Source: Author)

For the reason that in this work only average diagrams are presented, small errors are not visible on the graphs. Before the point A the first crack appeared in the cavity between TRC layer and load-bearing concrete in the corner (Fig.42).

The applied force was approximately 0.8 kN. The reason for this opening is non-unity of material at that cavity, where all internal forces are not able to distribute equally through the whole concrete and reduce the resistance of the entire composition. Moreover, the concrete itself is a weak material in tension, that is why the applied load is especially low with respect to compression test, but PP textile works as reinforcement and carries a greater amount of all internal forces, which appears on internal and external surfaces of samples.

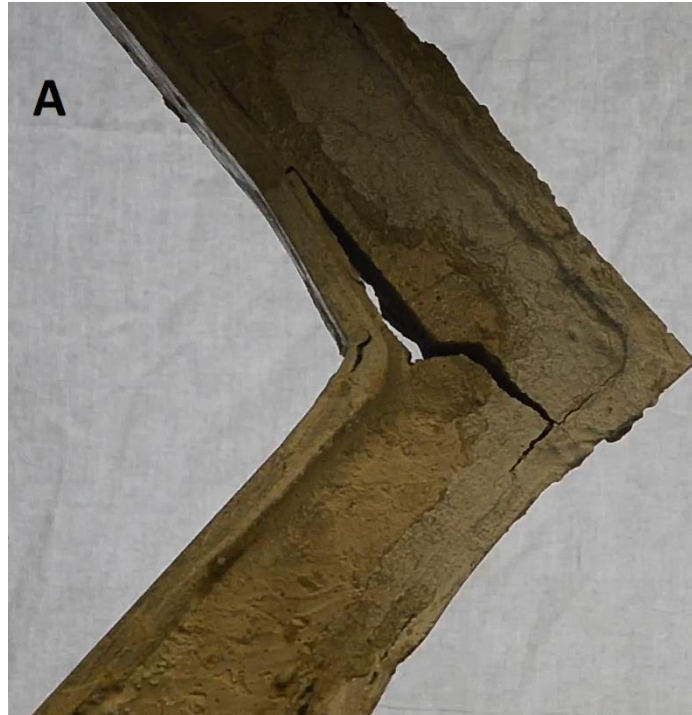
(Fig. 43: Delamination of TRC layer. Source: Author)

Point A represents the appearance of the first crack (see Fig. 43). At that time the concrete element stopped resisting to tensile force, because it was fragmented. In spite of that, bond between TRC and concrete prevent the sample from sudden failure, because it continues to bear internal forces, at the mean time the specimen progresses to open more the initial crack.

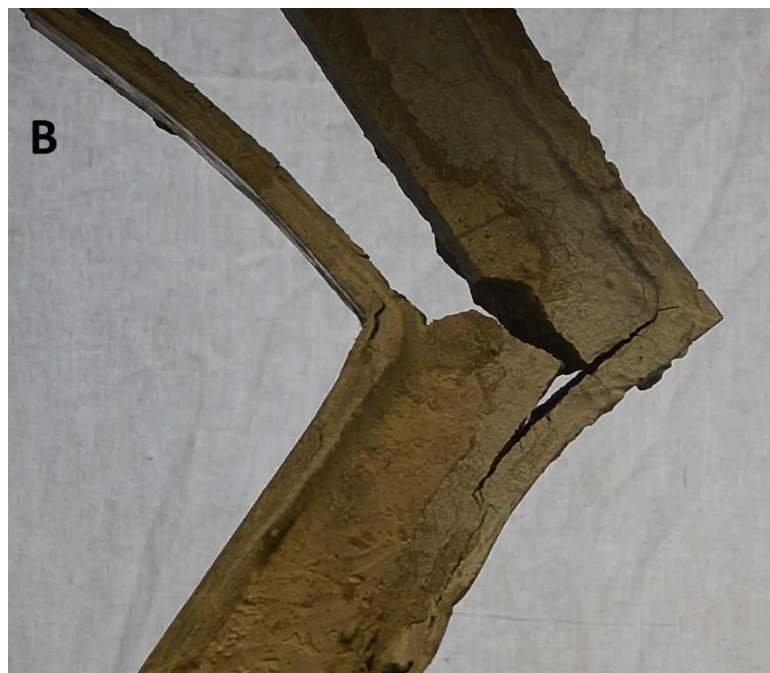
(Fig. 44: Failure of TRC specimen under tension. Source: Author)

When the bond reached its own tensile limit (point B) and completely delaminated from the concrete element (Fig. 44) the sharp drop in the graph was recorded as point C. Before that critical point the outer TRC layer engaged and another fragmentation can be visible there. For that reason, the specimens reach their second peak point.

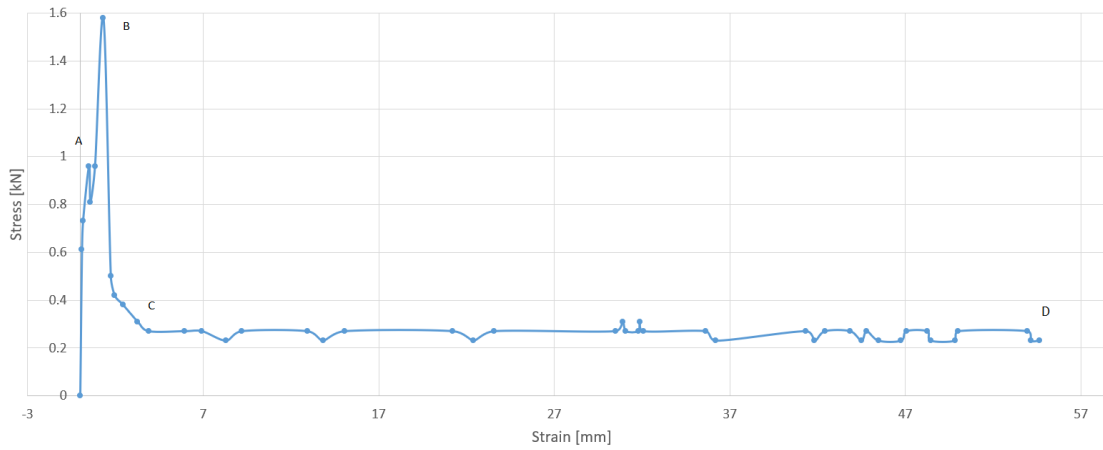
(Fig. 45: Tensile stress-strain diagram of rubbed sample. Source: Author)

From point C to D the concrete part of composite element was completely destroyed and did not play any role in the load-bearing function identically in the tensile stress-strain diagram of the rubbed samples (Fig.45). Only internal and external TRC layers were loaded. Point E represent the final rupture of outer TRC layer (as shown in the Fig. 46).
