ADVANCED MASTERS IN STRUCTURAL ANALYSIS OF MONUMENTS AND HISTORICAL CONSTRUCTIONS

**The assessment of the water transport in the soil-masonry complex of the 18th century churches.**

University: Czech Technical University in Prague

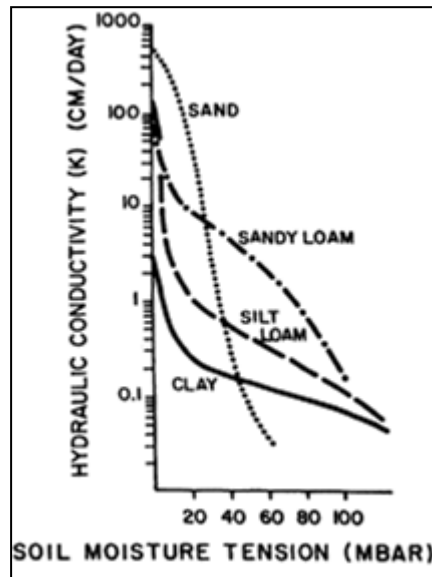
The value of unsaturated hydraulic conductivity marked  $K(\theta)$  depends on soil moisture shown in Figure 10.

**Figure 10 Example characteristic curves showing the relation between hydraulic conductivity and soil moisture tension [11]**

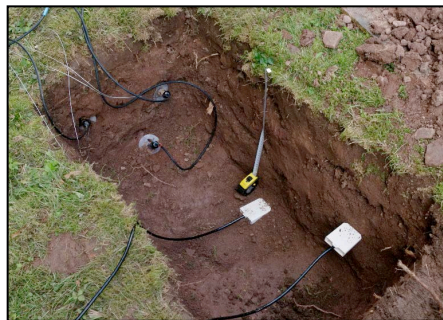
**Figure 23 Detail of the shaft after installation of sensors**

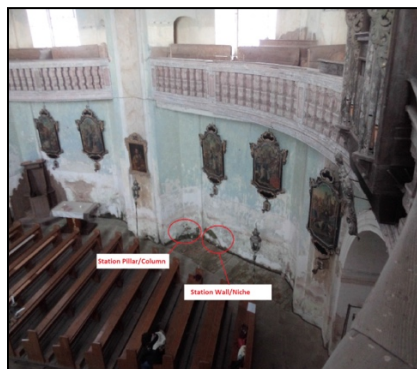
The indoor sensors are located in the north wall of the church, approximately in the extension of a straight line through outdoor measuring stations. They are arranged in two groups, in the parts of the structure that we refer to here as a pillar and wall/niche. The situation of the column and the niche is evident from Figure 24.

**Figure 24 Location of sensors in the interior**

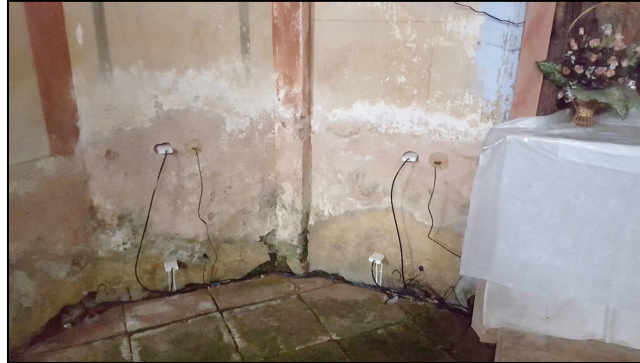
The long-term measurement system consists of a total of 3 stations. The first station is located inside the church, where the sensors are located in the wall and in the pillar Figure 25.

**Figure 25 Inside measurement station in St. Anna church**

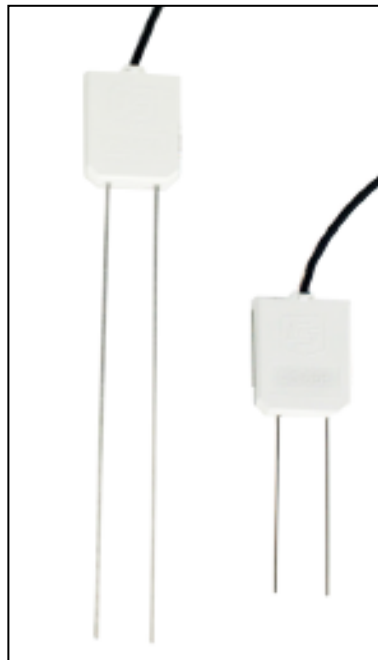
For the CS 650 and CS 655 sensors, the water content measuring range is 5% to 50% with an accuracy of  $\pm 3\%$ . Temperatures are measured in the range  $-50^{\circ}\text{C}$  to  $70^{\circ}\text{C}$ . With an accuracy of  $\pm 0.1^{\circ}\text{C}$  for the temperature range  $0^{\circ}\text{C}$  to  $40^{\circ}\text{C}$  and an accuracy of  $\pm 0.5^{\circ}\text{C}$  for temperatures above  $40^{\circ}\text{C}$  and below  $0^{\circ}\text{C}$ . [28]

**Figure 29 CS650 and CS655 sensors [28]**

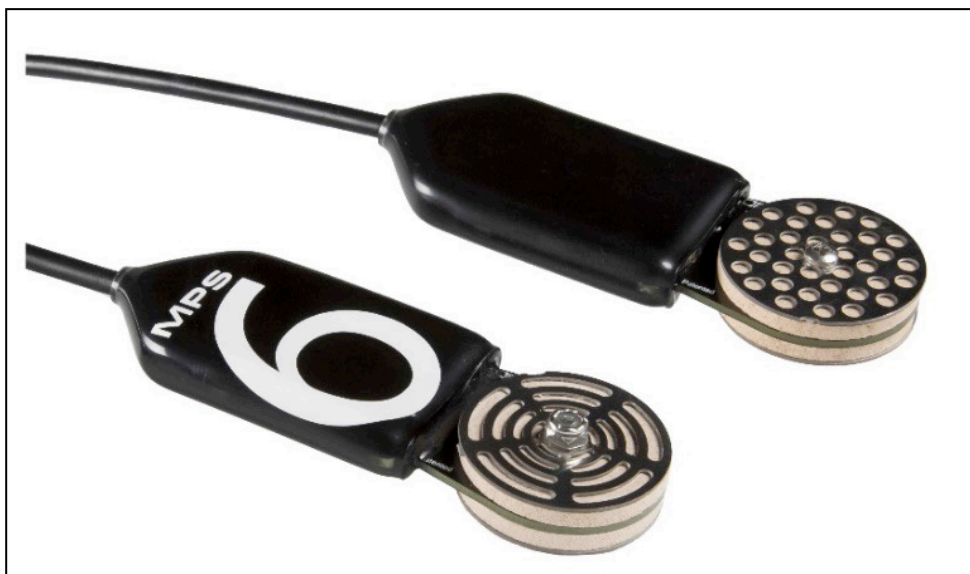
The MPS-6 pressure potential measuring instrument consists of two ceramic discs connected to a printed circuit board (Figure 30). The instrument also measures the temperature at the location of the ceramic disc. The pressure potential is measured on the same principle as that of the CS 650 and CS 655 sensors, i.e. by measuring the permittivity. In contrast to the sensors CS 650 and CS 655, the MPS-6 is measured on ceramic discs which are in equilibrium with the environment. The measuring range of the moisture potential is  $-9\text{ kPa}$  to  $-100,000\text{ kPa}$  with an accuracy of  $\pm (10\%$  of the read value  $+ 2\text{ kPa})$  in the range of values from  $-9\text{ kPa}$  to  $-100\text{ kPa}$ . The temperature measuring range is then from  $-40^{\circ}\text{C}$  to  $60^{\circ}\text{C}$  with an accuracy of  $\pm 1^{\circ}\text{C}$ . [29]

Figure 30 MPS-6 Sensor [29]

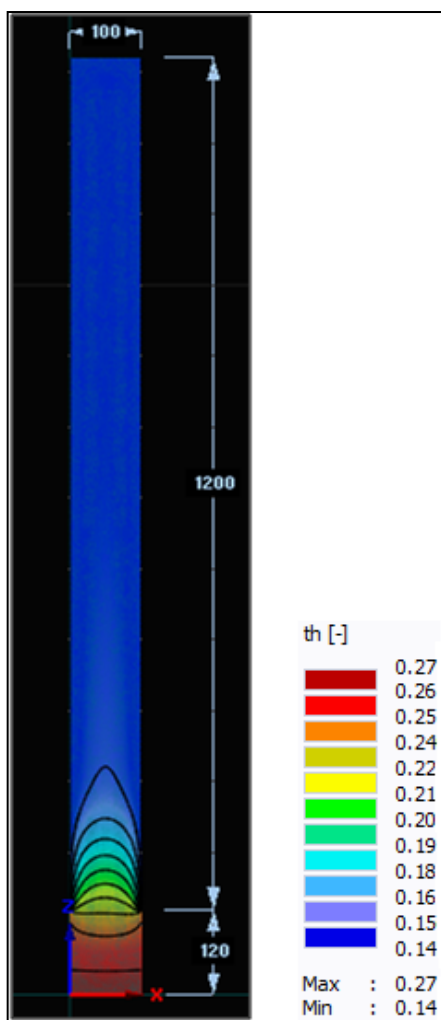
For the All Saints church, the steady state is achieved after an analysis of 8000 days long, where no difference in the results occur after this time duration. The water content values stay the same at this moment and thus represents the current state of the walls.

**Figure 33 Water content values for the wall of All Saints church**

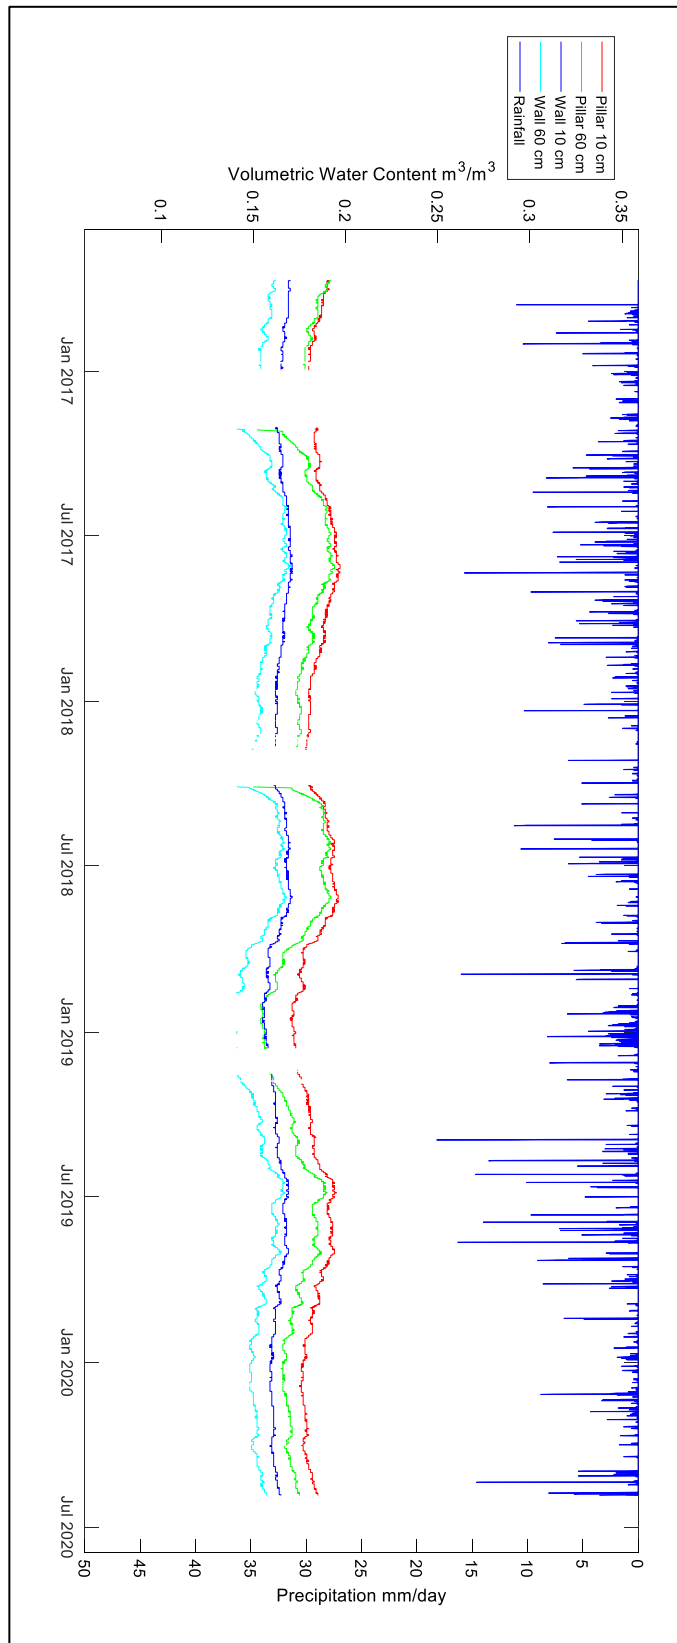
**Annex 4 Water content of CS650 in the church and rainfall plot, Hermankovice**

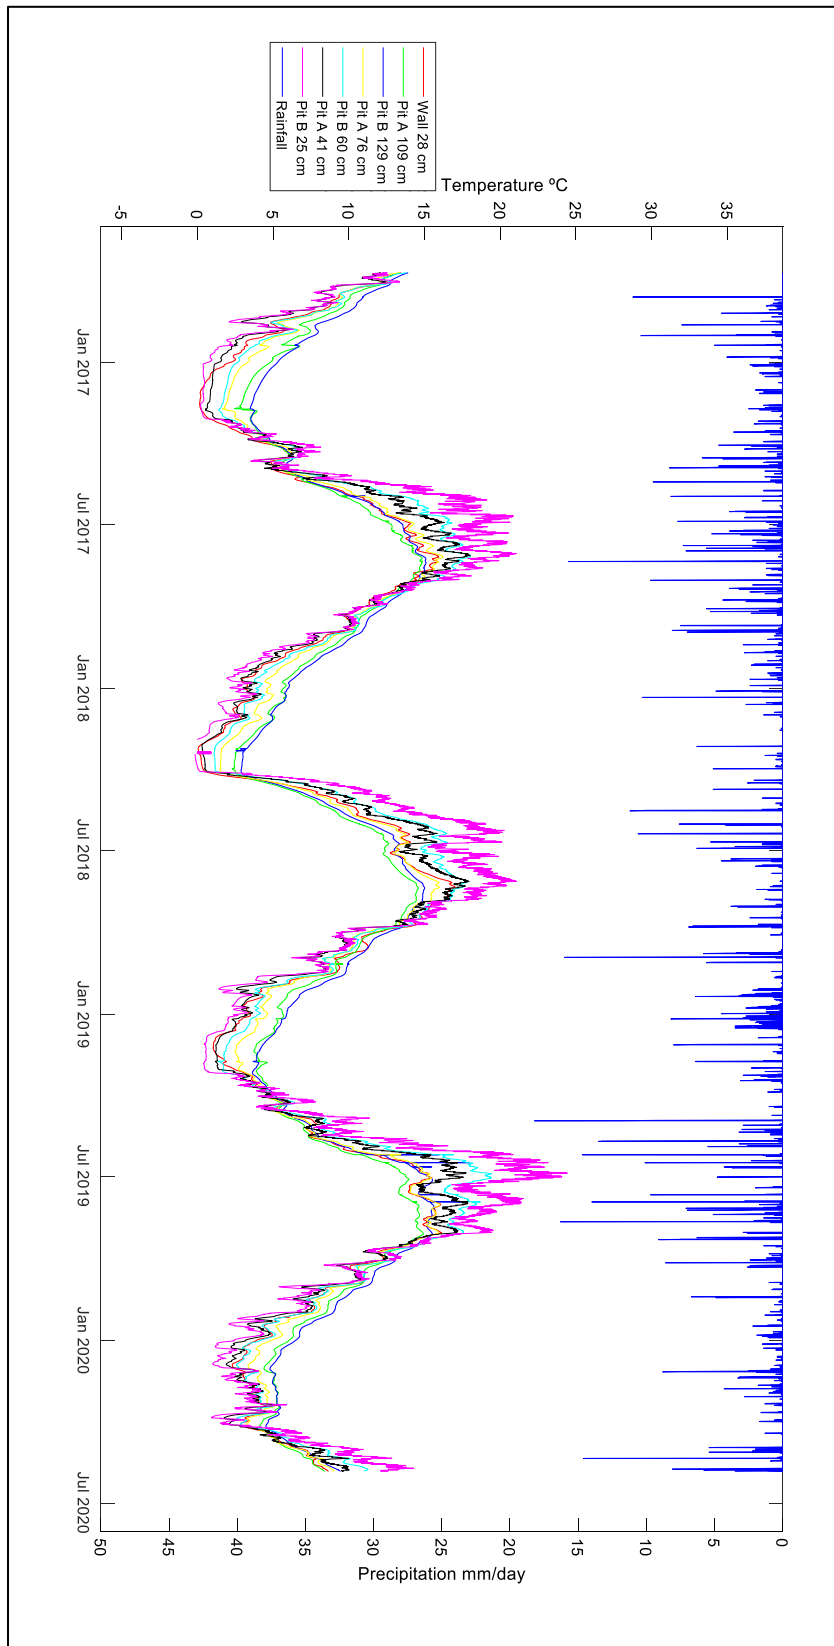
**Annex 7 Temperature from T8 tensiometer and rainfall plot, Hermankovice**

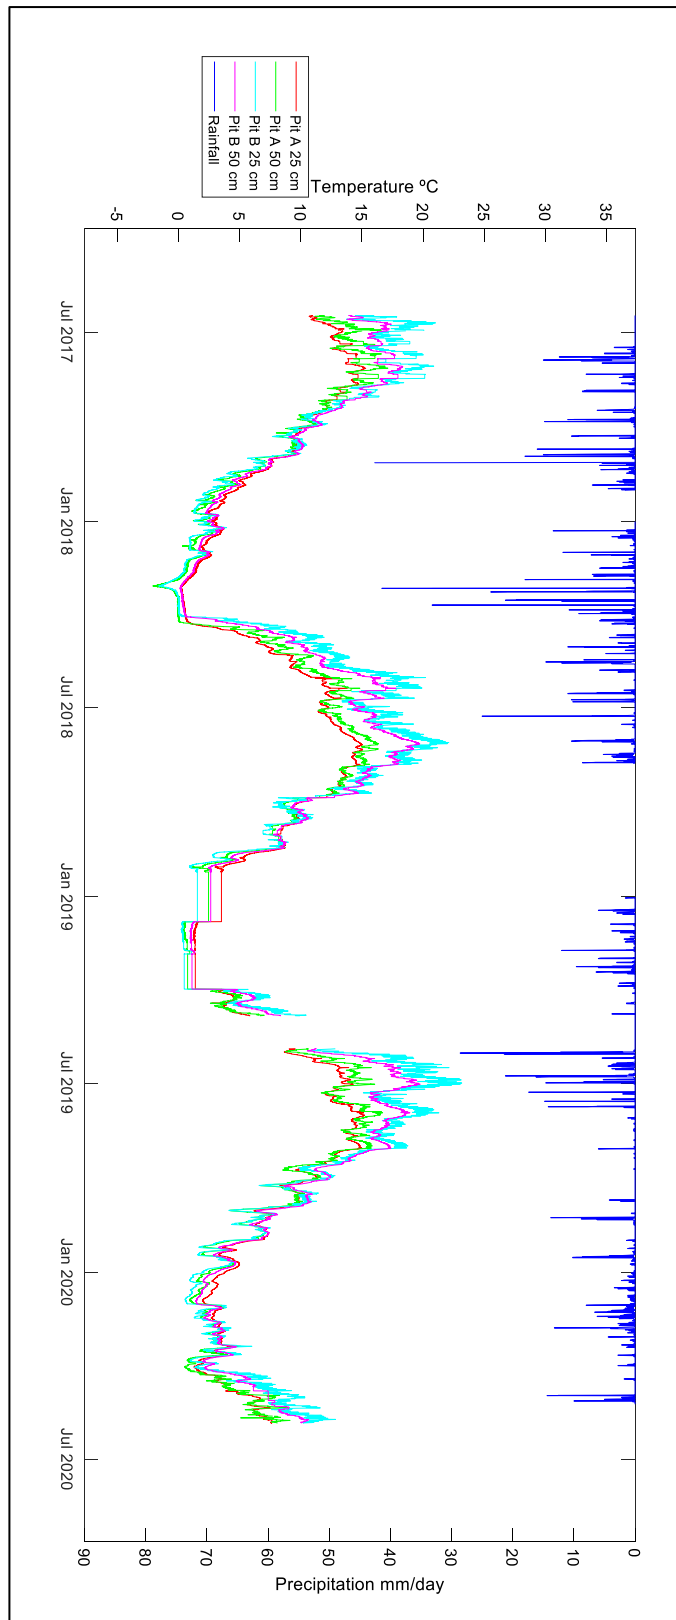
**Annex 9 Temperature of CS650 in the soil and rainfall plot, Viznov**
