## Appendix D: Specimens Overview Pictures

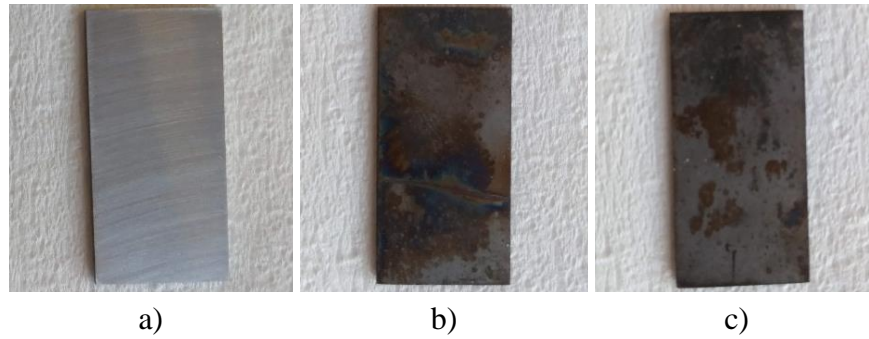
### Figure D1

*Pictures of stainless steel 316L specimens: a) before 720 h / 550 °C test, b) after 720 h / 550 °C test, and c) after 720 h / 700 °C test.*

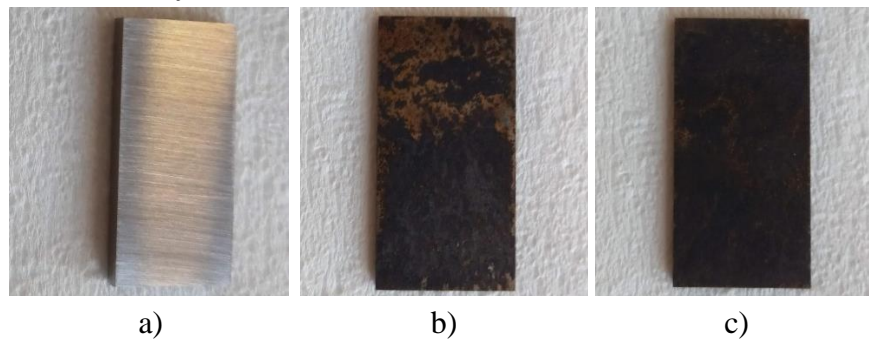
### Figure D2

*Pictures of stainless steel EUROFER 97 specimens: a) before 720 h / 550 °C test, b) after 720 h / 550 °C test, and c) after 720 h / 700 °C test.*

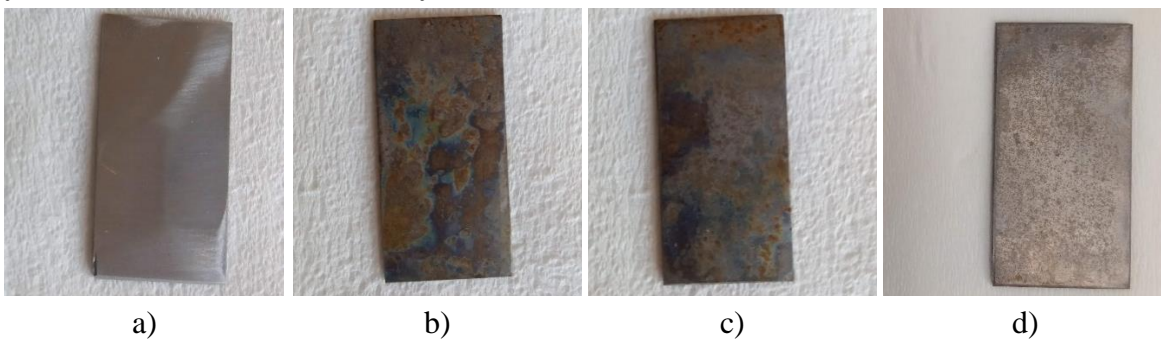
### Figure D3

*Pictures of Incoloy 800HT specimens: a) before 720 h / 550 °C test, b) after 720 h / 550 °C test, c) after 720 h / 700 °C test, and d) after 2160 h / 550 °C test.*

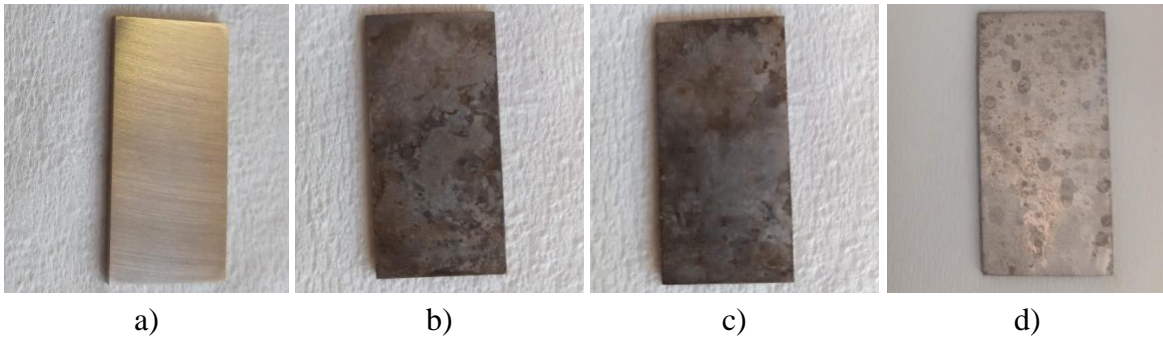
### Figure D4

*Pictures of Inconel 600 specimens: a) before 720 h / 550 °C test, b) after 720 h / 550 °C test, c) after 720 h / 700 °C test, and d) after 2160 h / 550 °C test.*

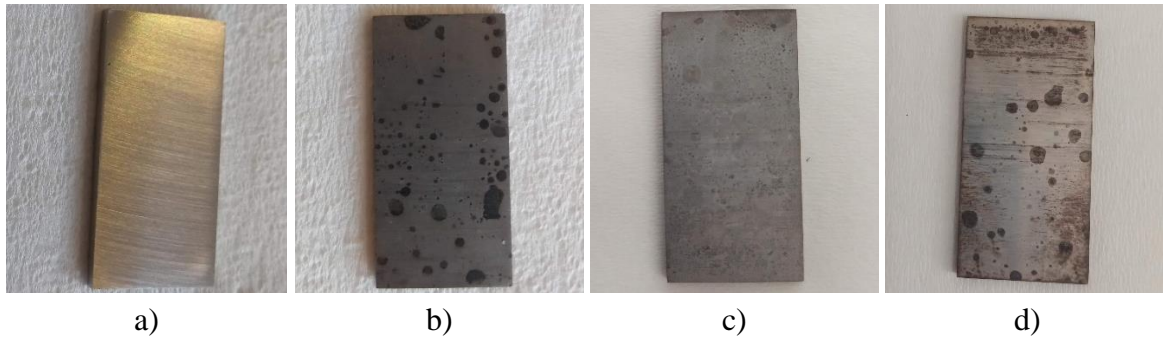
### Figure D5

*Pictures of Inconel 625 specimens: a) before 720 h / 550 °C test, b) after 720 h / 550 °C test, c) after 720 h / 700 °C test, and d) after 2160 h / 550 °C test.*

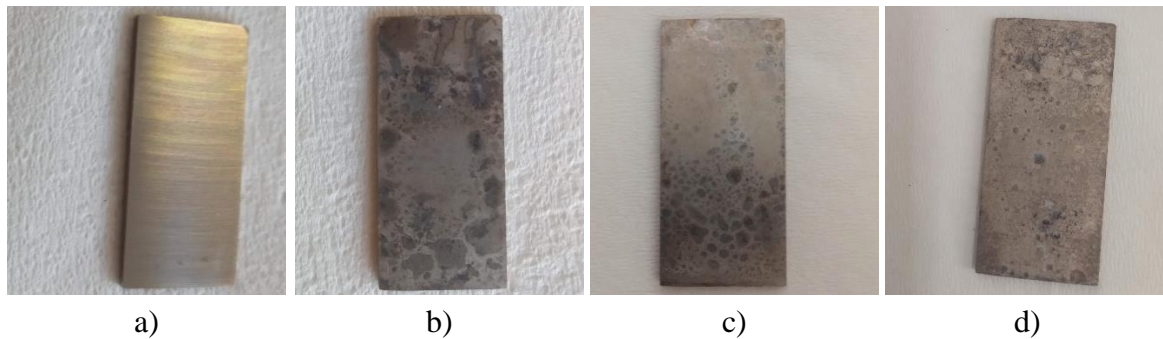
### Figure D6

*Pictures of MoNiCr specimens: a) before 720 h / 550 °C test, b) after 720 h / 550 °C test, c) after 720 h / 700 °C test, and d) after 2160 h / 550 °C test.*

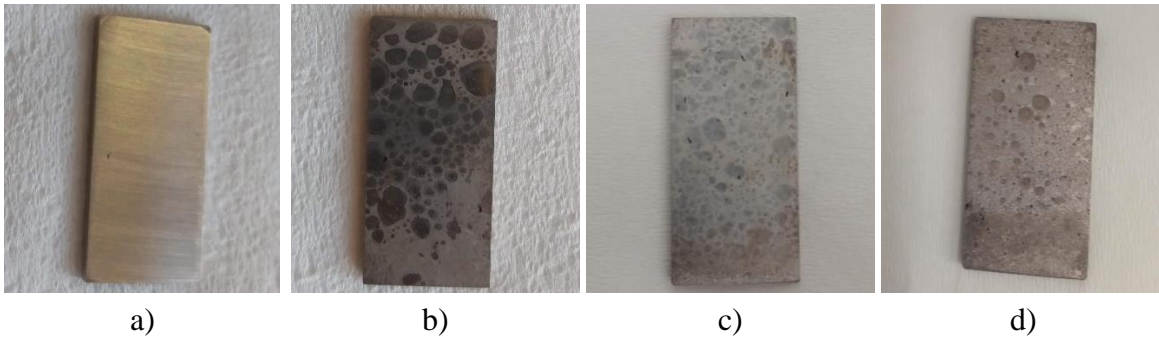
### Figure D7

*Pictures of MoNiCr sheet specimens: a) before 720 h / 550 °C test, b) after 720 h / 550 °C test, c) after 720 h / 700 °C test, and d) after 2160 h / 550 °C test.*

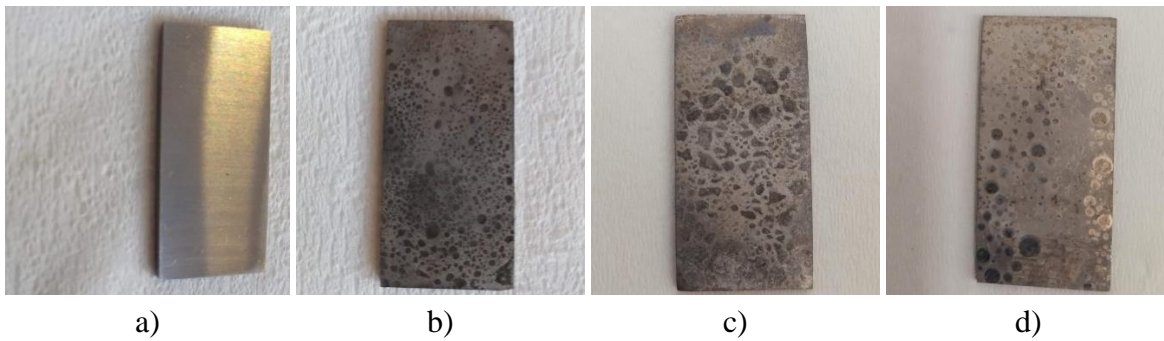
### Figure D8

*Pictures of HN80MTY specimens: a) before 720 h / 550 °C test, b) after 720 h / 550 °C test, c) after 720 h / 700 °C test, and d) after 2160 h / 550 °C test.*
