## APPLICATION OF ADDITIONAL INSULATION TO ETICS ON SURFACES WITH BIOCORROSION

**ABSTRACT.** The paper presents partial outputs from an experiment that demonstrated the impact of applying an additional insulation on an existing contact insulation system with a green-algae surface. The aim was mainly to detect the development of microorganisms in the gap between the original and the new insulation. The existing ETICS on the polystyrene-based contact thermal insulation system and EPS-based additional thermal insulation were used in the experiment. A theoretical modelling of temperature conditions showed that this type of doubling the insulation presented the highest risk of condensation of water in the gap between the insulation layers and that these conditions presented suitable humidity conditions for the growth of microorganisms. The reason for the experiment is to demonstrate the need to eliminate microorganisms before applying an additional thermal insulation to surfaces with biocorrosion. This is especially the case where EPS is used. The temperature and humidity parameters obtained during the experiment can be used to model the moisture regime in the gap of other types of ins

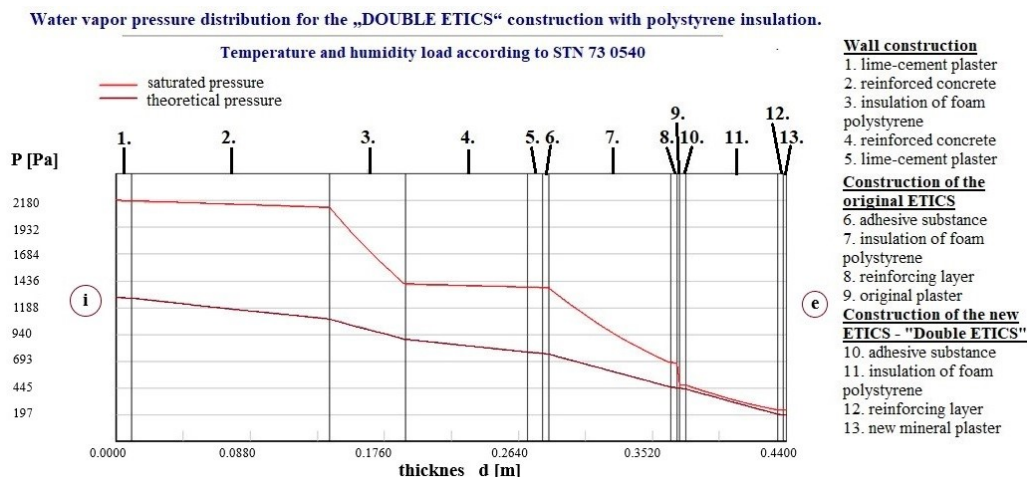
FIGURE 1. Theoretical analysis of steam pressure in DOUBLE ETICS.

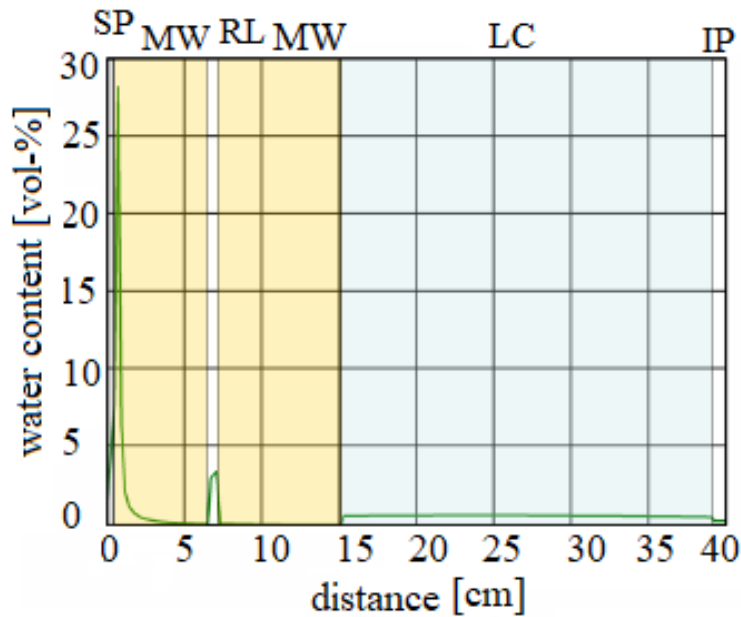
FIGURE 2. The content of humidity in layers of DOUBLE ETICS after 5 years from the construction – the German study [20].

water content in variant 3 [20] for DOUBLE ETICS with MW is in the 19 February in the terminsulation the point of the maximum water content. Composition in ETICS from left: synthetic resin plaster (SP) 0.6 cm, mineral wool (MW) 6 cm, the air gap between the original and the new insulation (RL), mineral plaster (MP) 0.6 cm, mineral wool (MW) 8 cm, expanded concrete (LC) 24 cm, interior plaster (IP) 1.5 cm

Similar conclusions were also reached by the authors when carrying out an analysis according to [20]. In this analysis, a long term condensation of steam in the layers of ETICS was observed, and places where humidity could accumulate were investigated. For comparison purposes, different types and widths of materials and thermal insulation were used. The results of the analysis show that a long term accumulation of humidity can occur in a DOUBLE ETICS system. The humidity conditions recorded in the layers create a suitable environment for the development of microorganisms on the original surface of ETICS. According to German study [20] Figure 2 expresses the content of humidity in layers of DOUBLE ETICS after 5 years from the construction. The profile of the

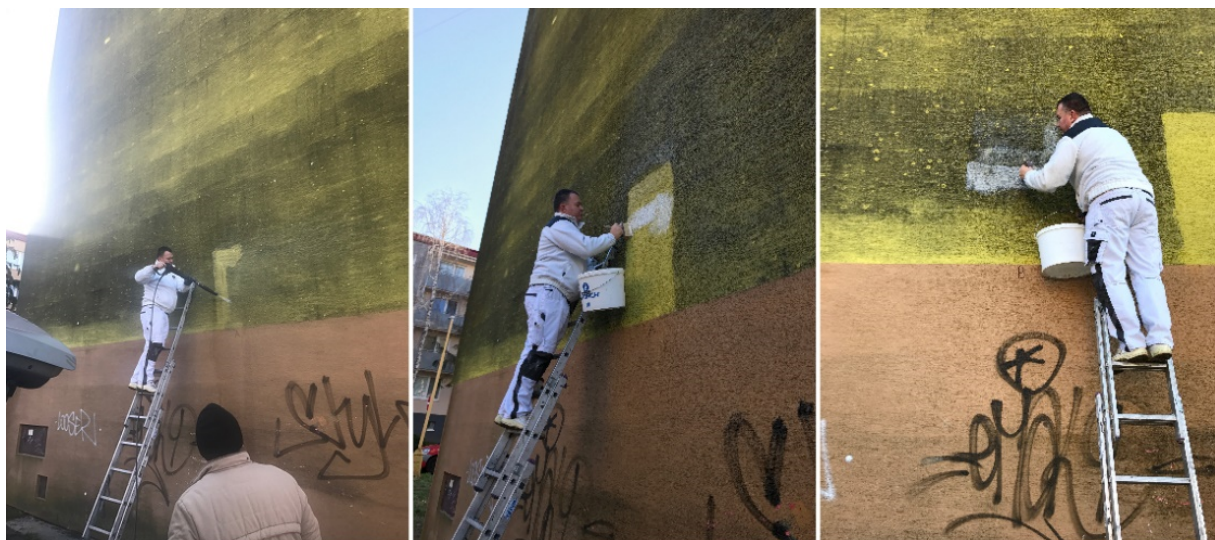
FIGURE 3. Preparation of bottom layer before applying additional insulation.

clared to have a high biocorrosion resistance) were placed on the existing insulation, which was already affected by biocorrosion. The samples were 30 × 30 cm each, see Figure 3, placed in three groups on different bottom layers.

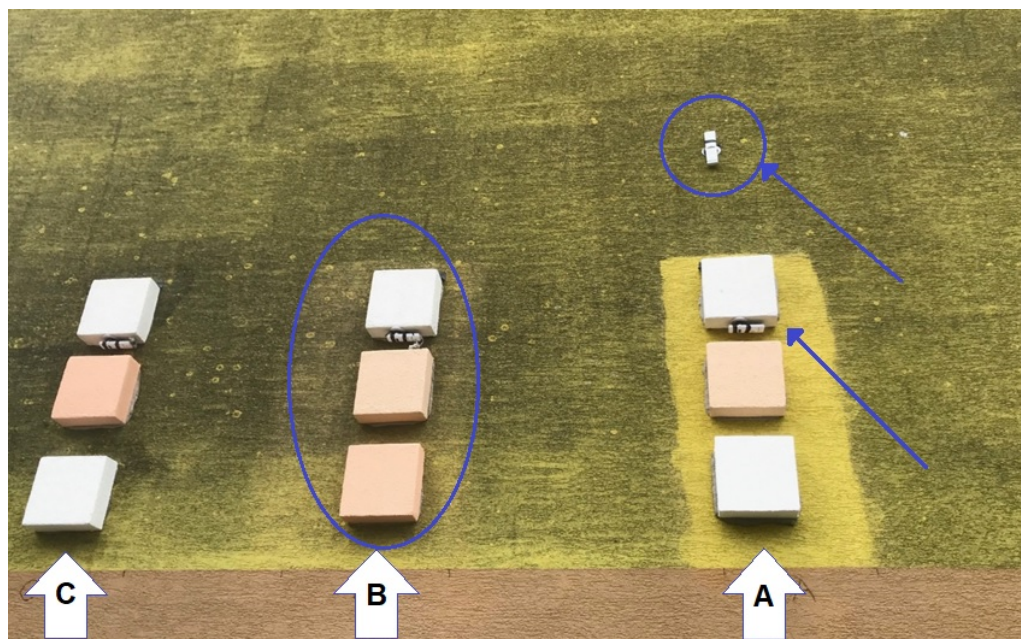
FIGURE 4. Placement of samples. Arrows denote the clusters of analysed samples – A, B and C used in experiment. C – reference sample without cleaning, B – sample with decontamination by biocide but not pressure washing, A – sample with decontamination by biocide and pressure washing after 24hrs.

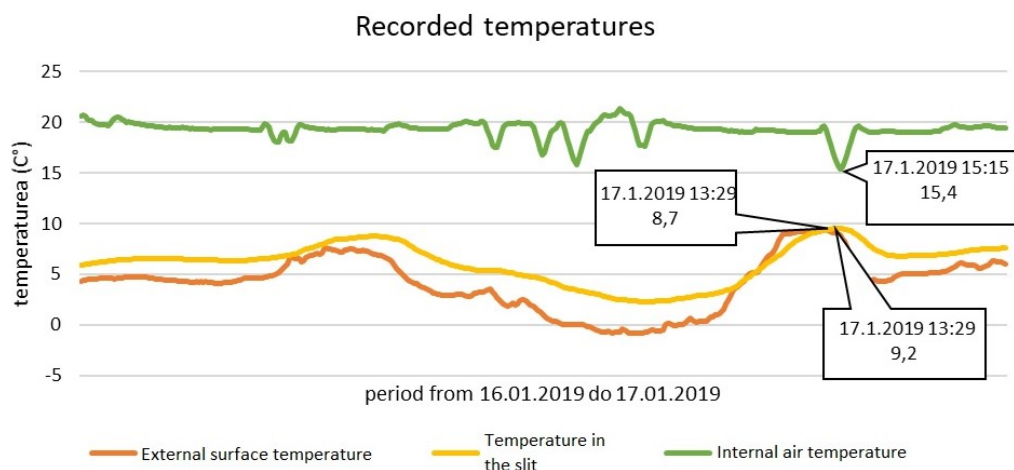
FIGURE 5. The anomalies of temperature in the gap of DOUBLE ETICS – sample.

occasions when anomalies in temperature (sudden drops in temperature in the gap and sudden rises in temperature on the surface) have been measured in the gap. In particular, on the days when such anomalies occurred, the risk of condensation increased (Figure 5). In the Figure 5 is internal air temperature represented of green colour, red colour represents the temperature on the external surface of the additional ETICS structure. Yellow colour represents the temperature in the gap between the original and the new structure of ETICS. The consequences of a significant reduction of the surface temperature of the structure related to the temperature of the immediate vicinity (e.g., gap temperature) are the same as for the moisture condensation in the summer months on a glass with a cold drink.

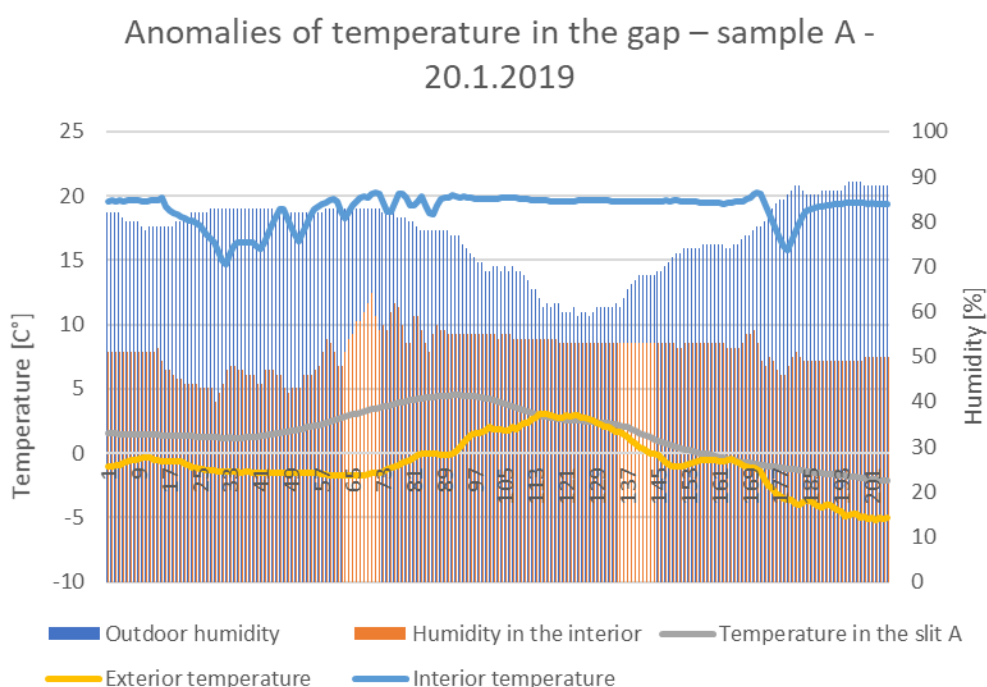
FIGURE 6. Repeated measurement of the decrease in temperature in the gap of DOUBLE ETICS compared to outside temperature – sample A.

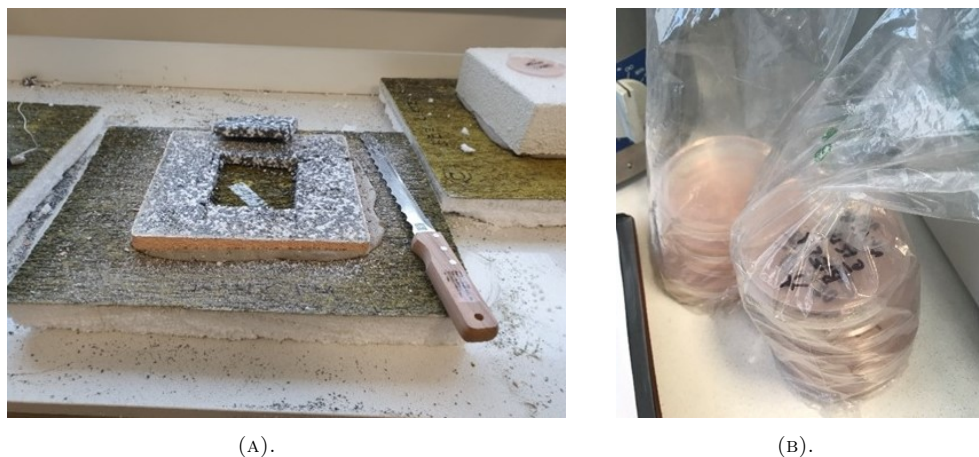
FIGURE 7. Removal of second layer of insulation. Sampling of biological material with sampling tape into petri dishes immediately after the opening of the gap.

After removing the second layer of insulation, further samples of biological material were taken in the laboratory. This was done for all groups, A, B and C.

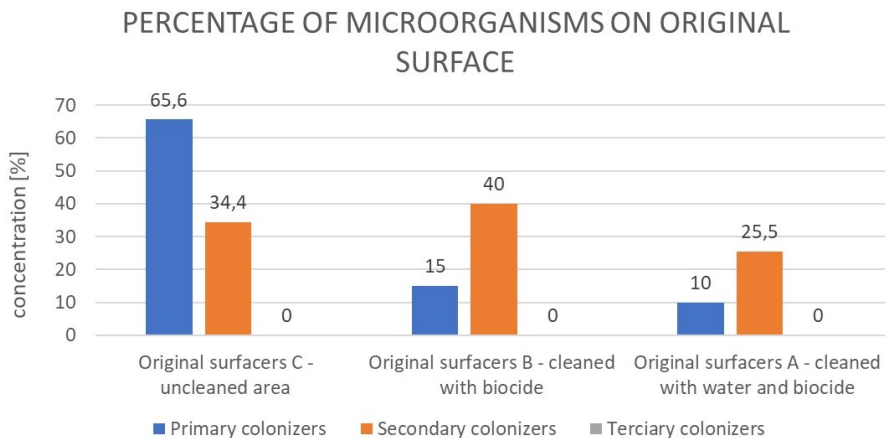
FIGURE 8. The comparison of microorganisms on samples taken before the application of DOUBLE ETICS – without any tertiary colonisers.

The results of the microbiological sample analysis indicate a long-term higher humidity, as shown by the tertiary microorganisms, that were found after the removal of the samples in the gap of the double insulation. Their quantity in each sample before the application of an additional insulation and after the removal of the samples is shown in the Figures 8 and 9.

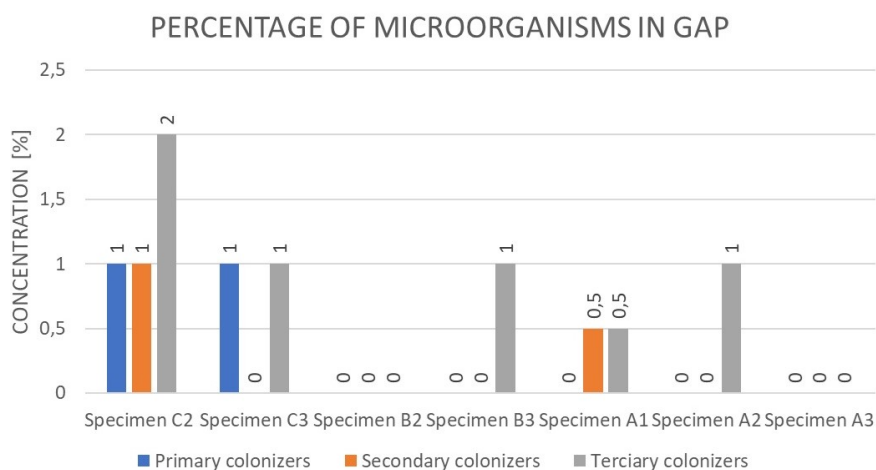
FIGURE 9. The comparison of microorganisms in samples taken from gap between original insulation and new insulation – tertiary colonisers present.

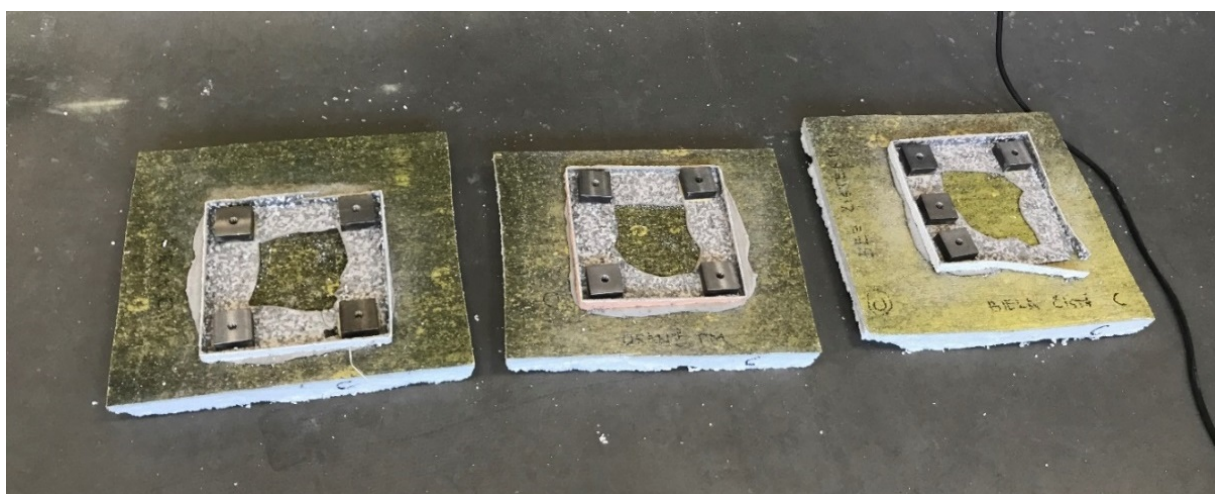
FIGURE 10. Removal of second layer of insulation. Preparation of samples in each group to test adhesiveness on the sample: from the right, C, B, A.

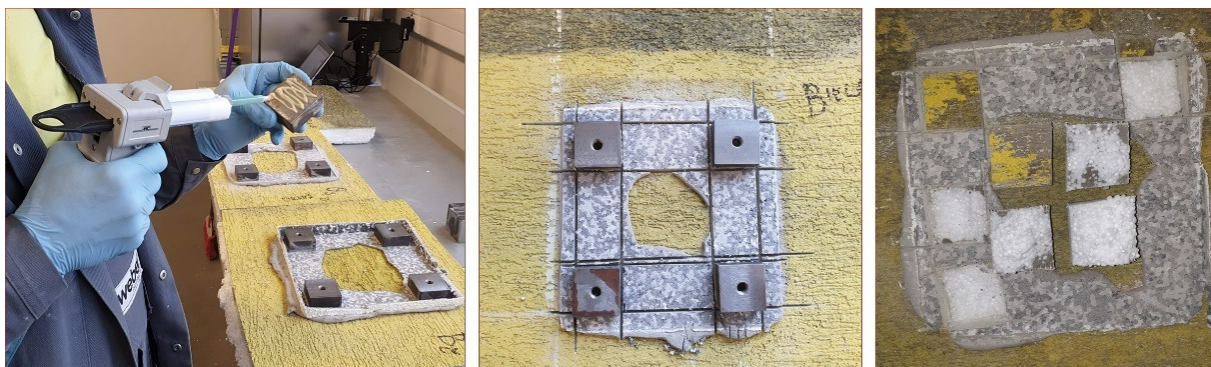
FIGURE 11. Preparation of samples in each group for adhesion tests with a certified device “ConsurTest 5, Serial No. 19763”.

individual and average values. The diagnosis was done with a certified “ConsurTest 5, Serial No. 19763” tester (Figure 11). The average adhesion value should have been at least  $0.08\text{N}/\text{mm}^2$ , in the case of an undamaged insulation layer. In Figure 12 we see a break in the adhesion between the layers of DOUBLE ETICS. Area 1 (red color) – failure of adhesion between the ETICS substrate and the adhesive mortar of the new ETICS. Area 2 (blue color) – breach of adhesion in the insulation of the original ETICS structure.

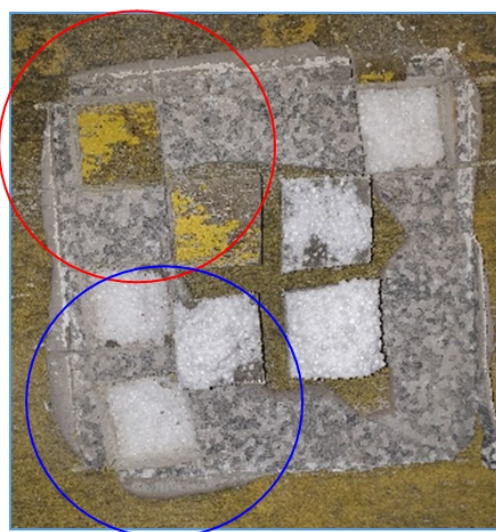
FIGURE 12. Example of visual condition after performing an adhesion test on sample C.

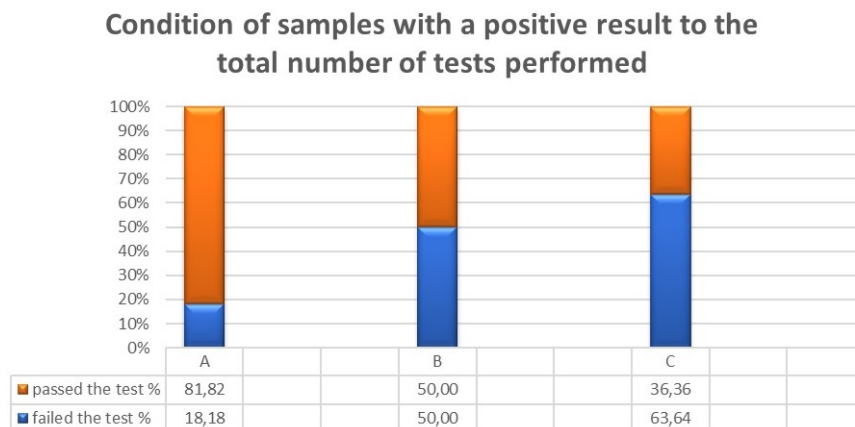
FIGURE 13. Evaluation of the results of the adhesion test of the new ETICS structure on samples A, B, C.

The experiment confirmed that, as compared with a clean and decontaminated surface, the adhesion to the original plaster with a biological material was significantly lower for many samples, almost outside the values expected by the standards. The differences in adhesion values are interesting, although not yet sufficiently analysed at this stage of the investigation. In order to confirm the results of the experiment, a higher number of samples is required to confirm the lower adhesion.
