Proposal of Measures for Preserving the Historical Fresco of the Assumption of the Virgin Mary by V.V.Reiner

Yasser Sidaoui

Czech Republic | 2 017

Master's Thesis

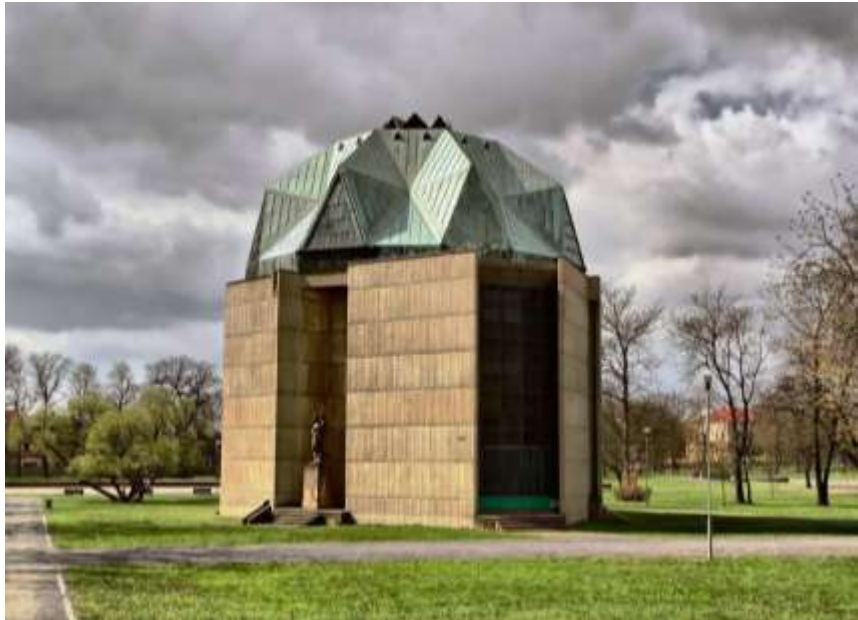
Figure 1 Duchcov Pavilion

In 1973, architect Jana Sokola started the construction of a new exhibition hall in the architectural style of Brutalist [3]. This newly constructed pavilion is located in the castle gardens in Duchcov. **Error! Reference source not found.** [5] shows the newly constructed pavilion.

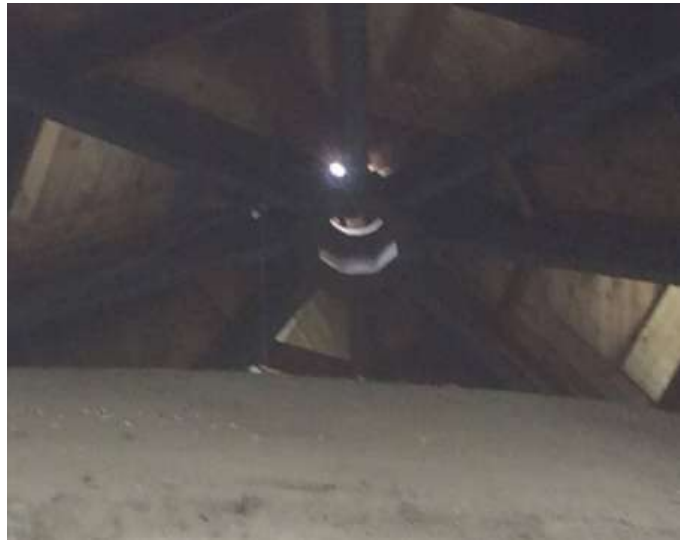
Figure 5 Roof ventilation hole

The fresco's condition is deteriorating due to excessive condensation [6]. As most historical buildings, the pavilion does not have any HVAC system which aggravates the problem further. Initially, the pavilion was designed with several ventilation vents to mitigate humidity issues. As mentioned previously, there are 5 openings in the small dome, and one opening in the roof. In addition, there are two large arch-shaped openings between the smaller dome and the roof. Figure 5 shows the ventilation hole in the middle of the roof.

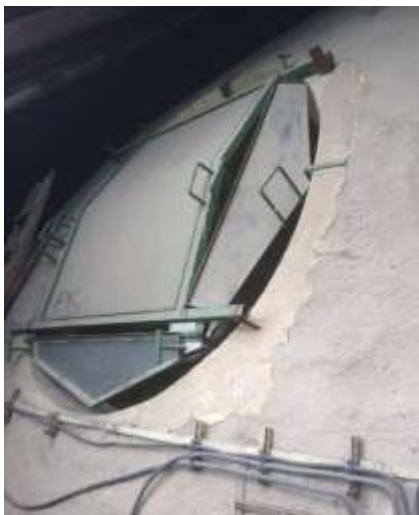
Figure 6 Fresco dome ventilation opening

Figure 6 shows the backside of one of the large ventilation openings in the fresco dome.

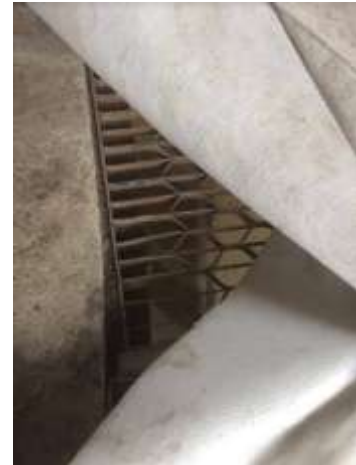
Figure 7 Side ventilation opening

Figure 7 shows the part of the two large side openings. Also shown in the picture is the piece of cloth that is used to cover the opening as it later was determined that said openings aggravate the conditions inside the building.

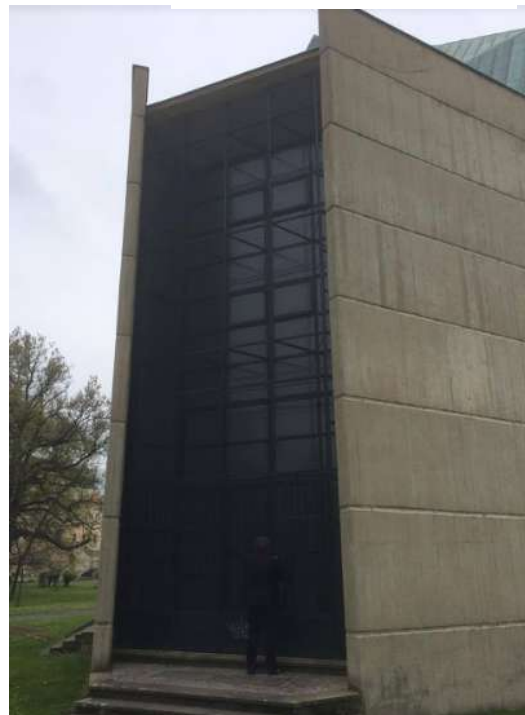
Figure 8 Double-glazed windows

Figure 8 shows the double-glazed windows.

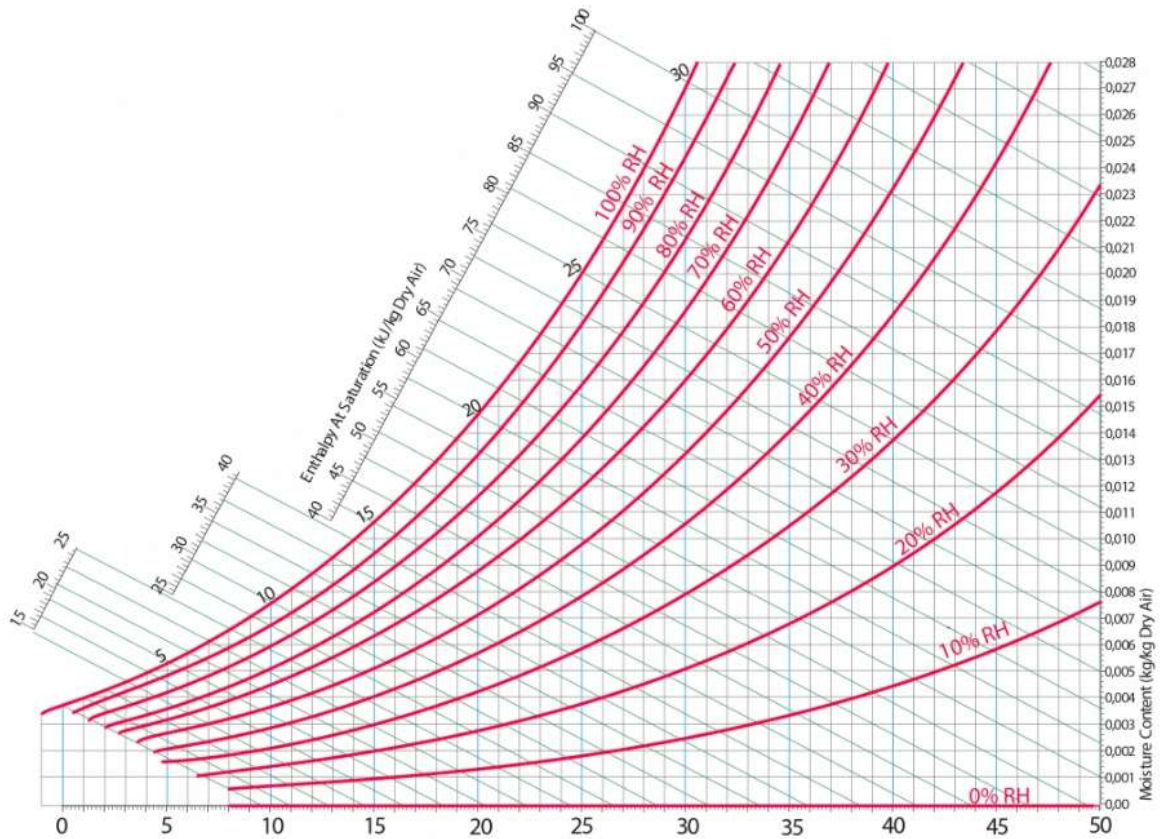
Figure 9 Psychrometric Chart

Condensation is the process where water vapor becomes liquid [8]. The condensation phenomenon is normally triggered by two reasons. Either the air is cooled to its dew point temperature, or it becomes fully saturated that it cannot hold any more water vapor [8]. The dew point temperature is the point at which the air can no longer hold the water vapor within it and some of the vapor must transform into liquid state [9]. This usually occurs at night when the air temperatures cools down and appears on cars, windows, etc. Condensation also appears when warm air passes a cooler surface; the surface then drops the temperature of the air below its dew point, thus creating condensation [8]. The dew point temperature is determined using the psychrometric chart (shown in Figure 9 [10]). A psychrometric chart is usually used to figure out the temperature (wet bulb & dry bulb), and humidity. The chart's main purpose is, hence, to interpret the occupants' comfort and effective passive design [10]. The horizontal axis represents the temperature (in °C), the vertical axis represents the moisture content (in kg/kg dry air), and the colored curves represent the different relative humidity levels [10]. Diagonal lines on the chart also represent Enthalpy (total heat content of the system) at saturation.

In order to determine the dew point temperature, both the air temperature, and relative humidity are needed first. Once those values are obtained, they are plotted on the above chart. A horizontal line is then drawn. The point at which the line crosses the 100% relative humidity curve is known as the dew point temperature. The chart provides a good approximation of the dew point temperature. For more precise calculations, the following formula [11] can be used:

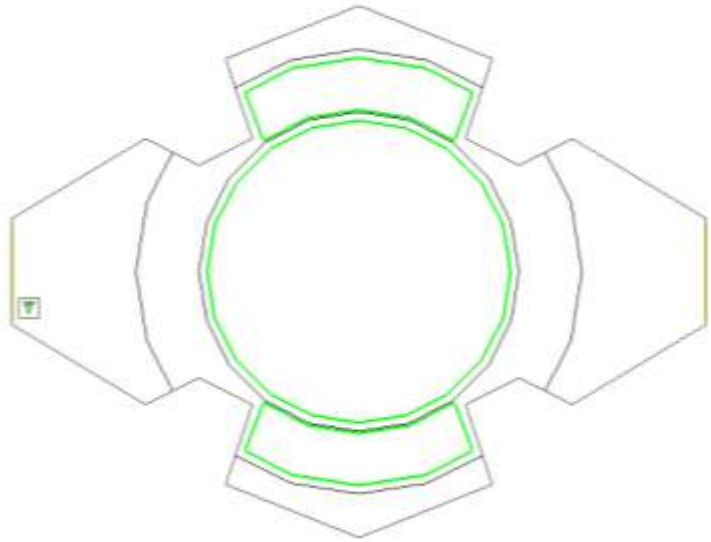
Figure 13 Zone 1

The different zones of the buildings are illustrated below. Figure 13 illustrates the plan layout of zone 1; this is the main zone of the pavilion. The large circle in the middle (highlighted in green), represent the border of the inner dome, where the fresco is placed. The two ventilation openings are also shown on the sides. Figure 14 shows the inner dome. There are four boxes, and small circle on top (all highlighted in green) that represent the openings inside and the inner dome for ventilation.

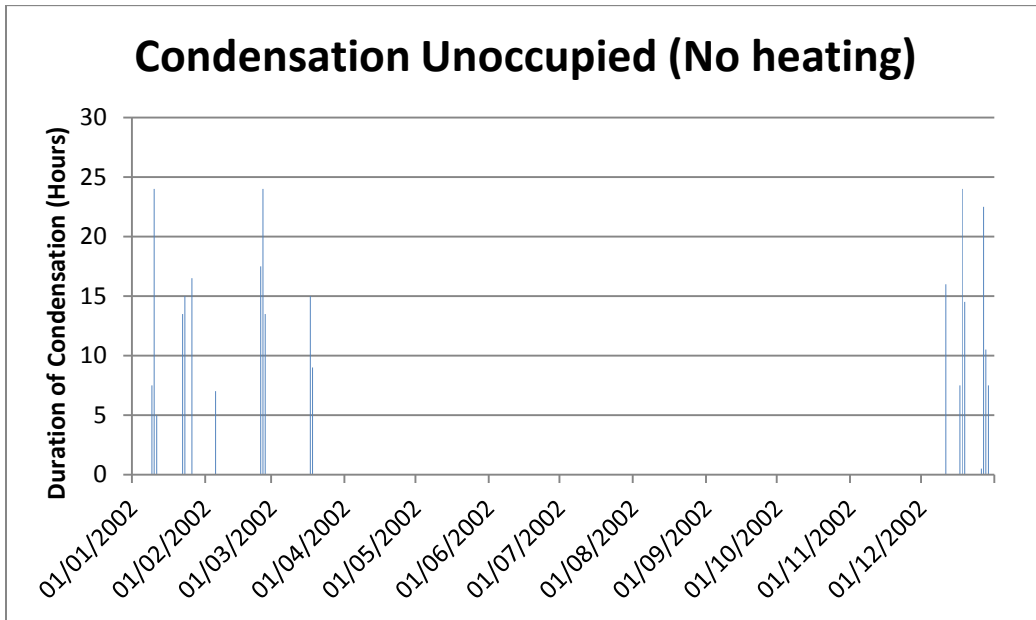
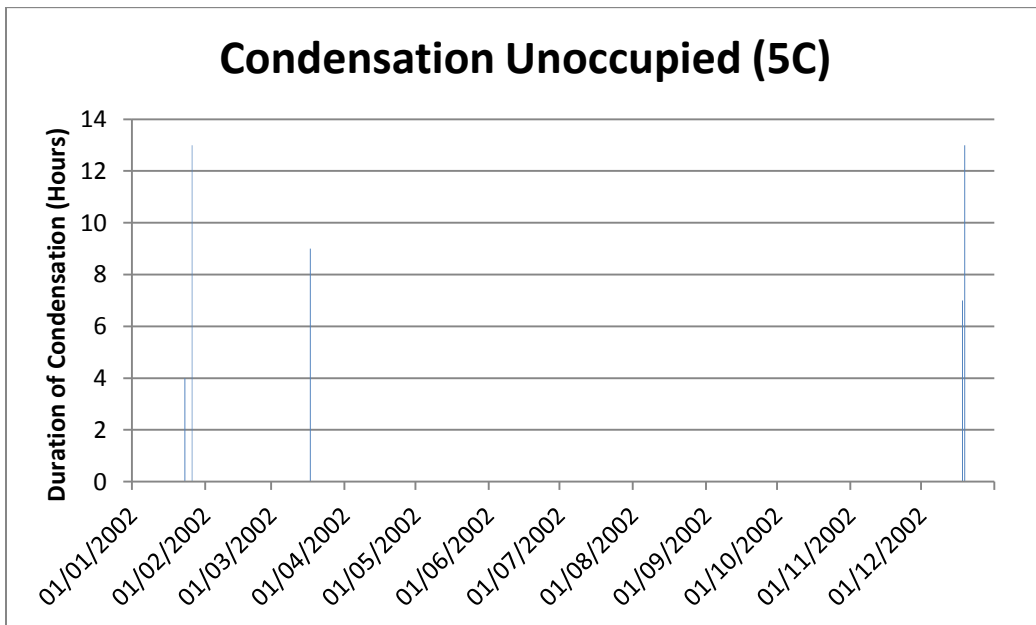
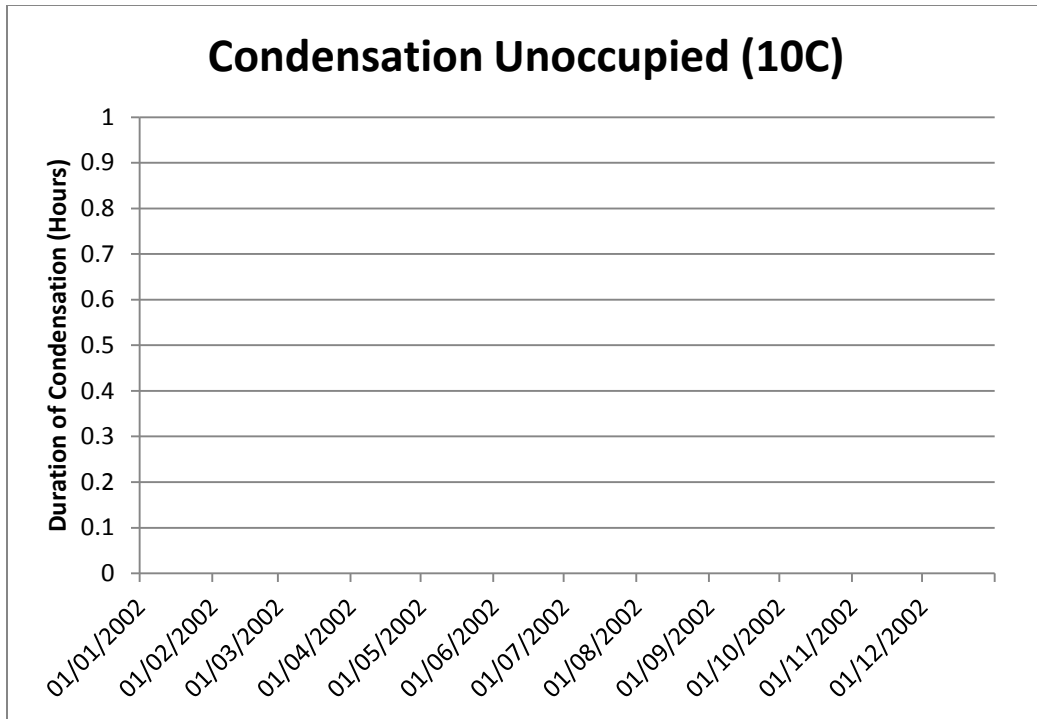
Figure 16, Figure 17, and Figure 18 show the cumulative number of condensation hours for the no heating, 5°C, and 10°C respectively.

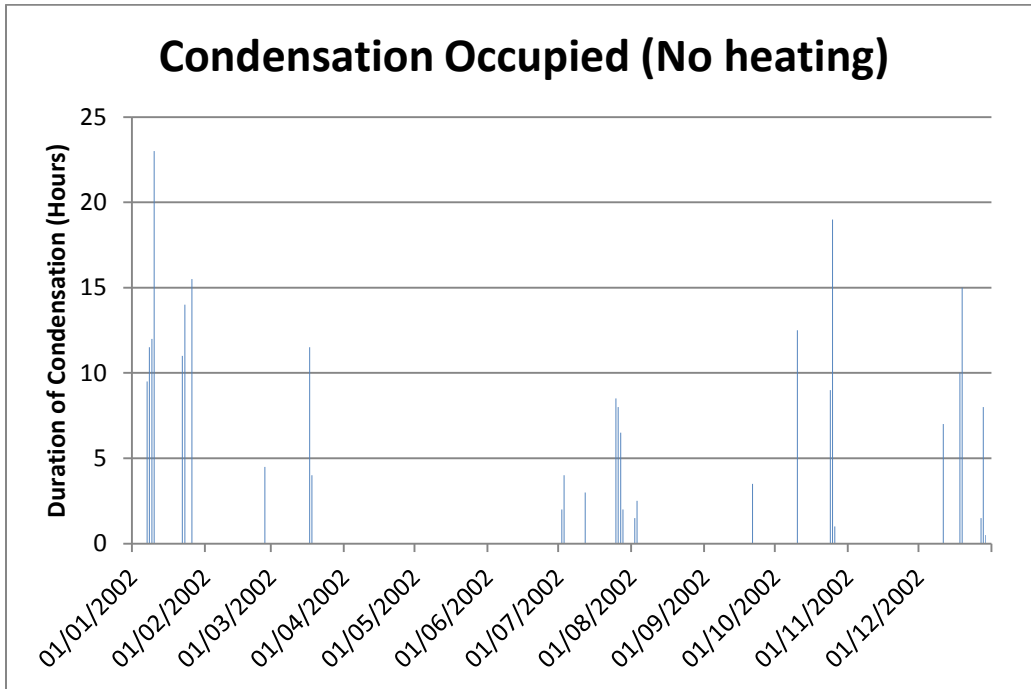
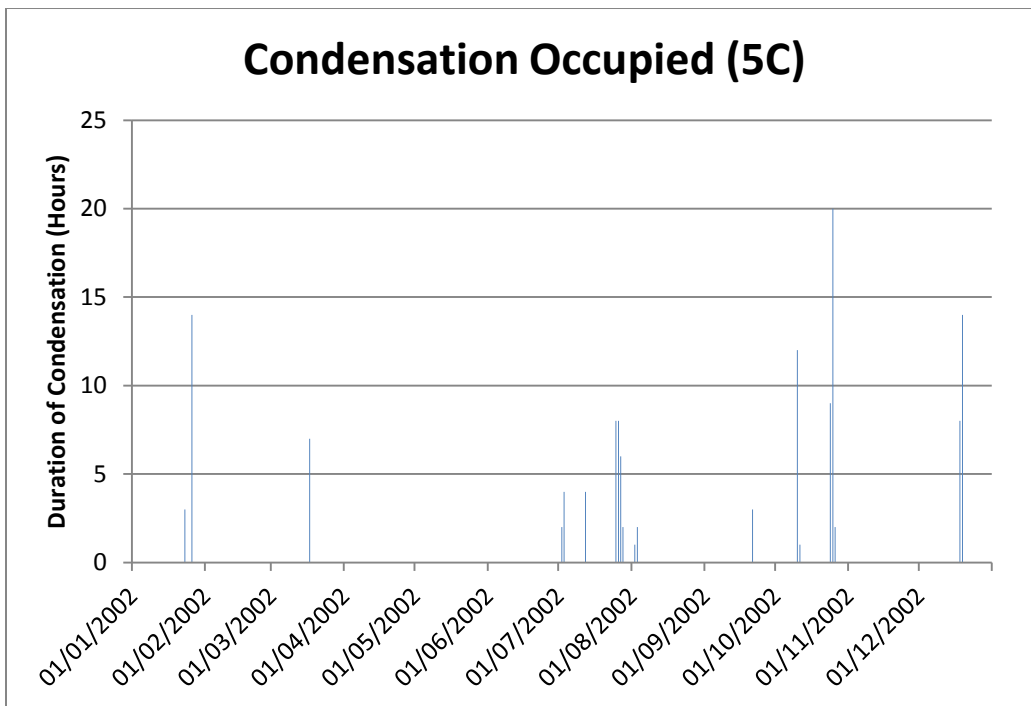
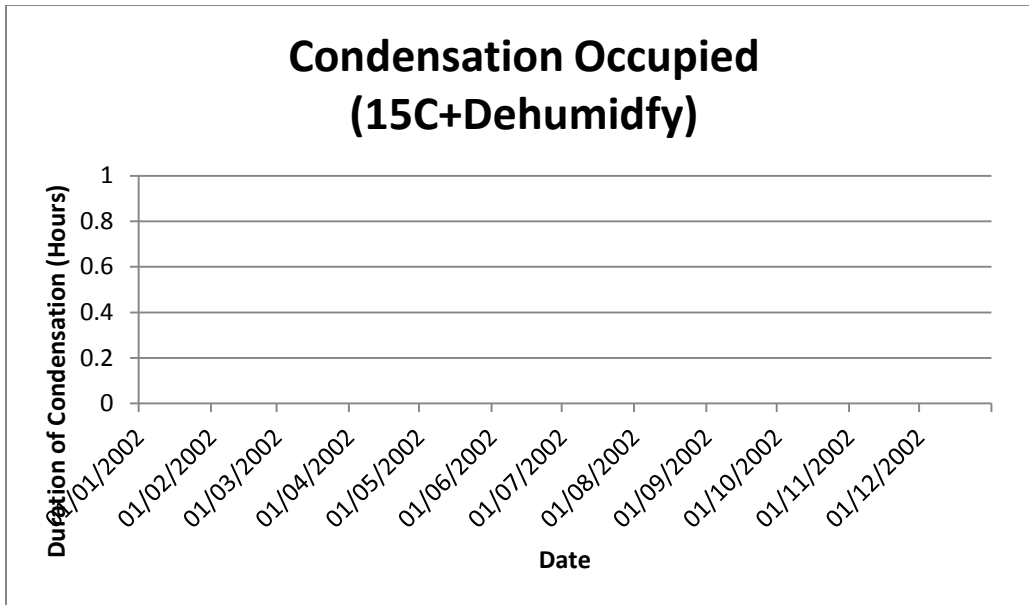
Figure 19, Figure 20, Figure 21, Figure 22, and Figure 23 show the cumulative number of condensation hours for the no heating, 5°C, 10°C, 15°C, and 15°C+dehumidify respectively.

On the other hand, for the occupied activity, condensation occurred throughout the full year with few exceptions. This is expected as more humidity is introduced to the building with the presence of people. And since the building has very few openings for ventilation, the humidity is trapped within, thus raising the amount of water vapor carried by the indoor air. Similar to the unoccupied occupancy, the maximum condensation also occurred during the winter months with January scoring 96.5 hours of condensation, followed by October, and December. One plausible explanation of why the winter months end up with the highest condensation rate is the fact that low air temperatures result in low dew point temperatures, which means that much less water vapor is carried by indoor air. And since the relative humidity during the winter months exceed 75%, the dew point temperature is close to the actual air temperature, thus easily condensing on the surfaces.

With still too much condensation occurring in five different months, the temperature was raised to 15°C. This raise eliminated all remaining condensation instances in all winter and spring months. It must be noted that with previous temperature raises, the condensation rate in the summer months remained untouched. This is due to the high humidity levels in both the indoor and outdoor climate as previously mentioned. To tackle this condensation, a dehumidification system was added to the model. It was determined that having a dehumidification set-point of 60% combined with maintaining a minimum temperature of 15°C eliminated the condensation completely in all months. It must be noted that the dehumidification system was set to work as per the exact schedule of the openings hours (i.e when occupancy is expected to rise). It is true that by doing so, the relative humidity will fluctuate and not be maintained at 60%. Yet, the average relative humidity values, as shown in section 5.3, dropped and the goal of eliminating condensation was achieved.

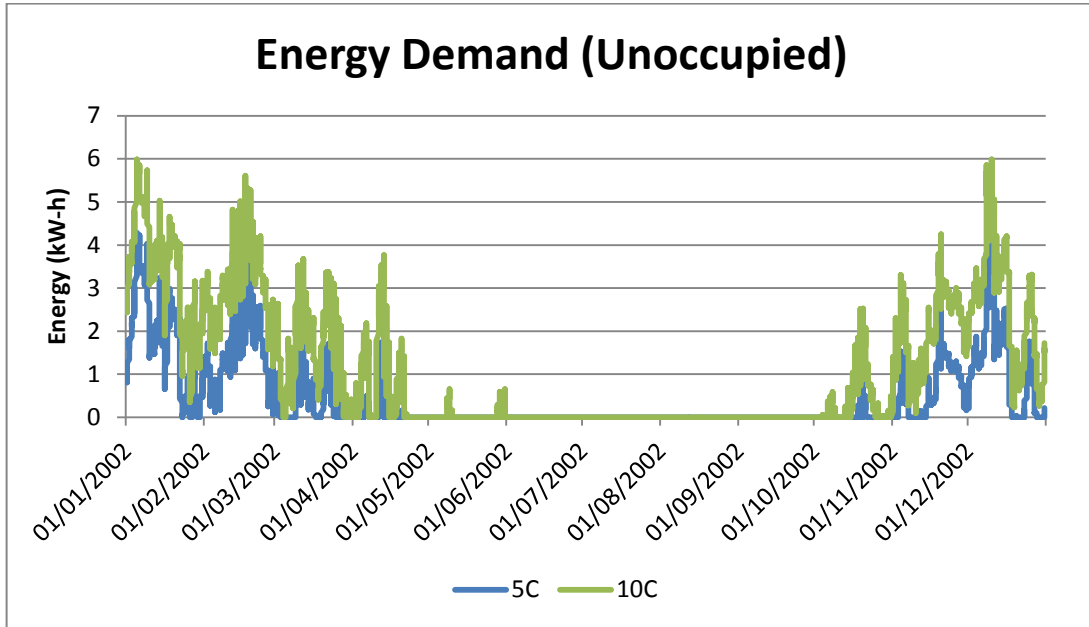
Figure 24 Energy demand (unoccupied)

Figure 24 illustrates the energy consumption for the unoccupied function.

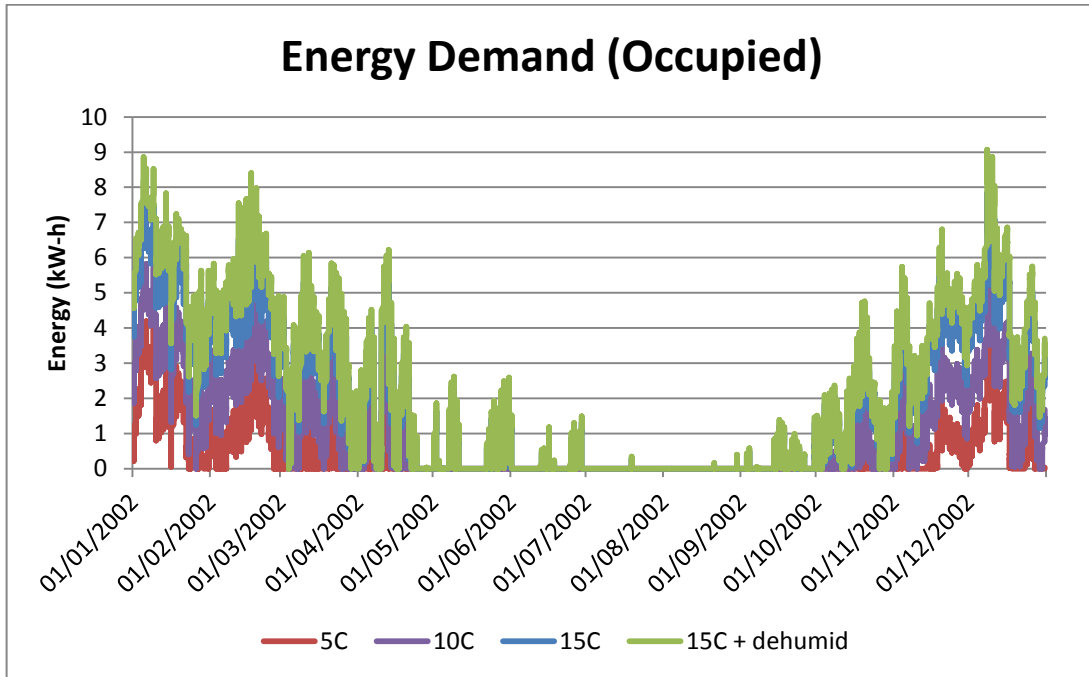
Figure 25 Energy demand (occupied)

Figure 25 illustrates the energy consumption for the occupied function.

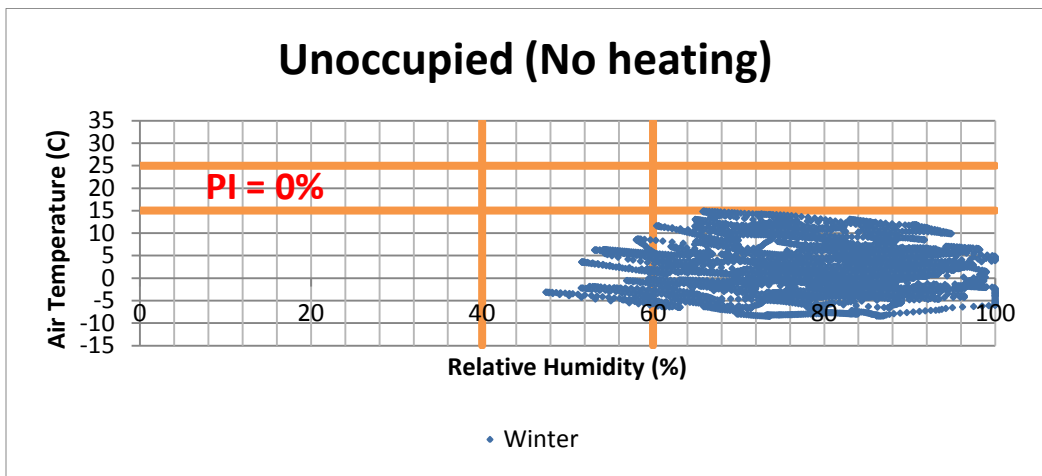
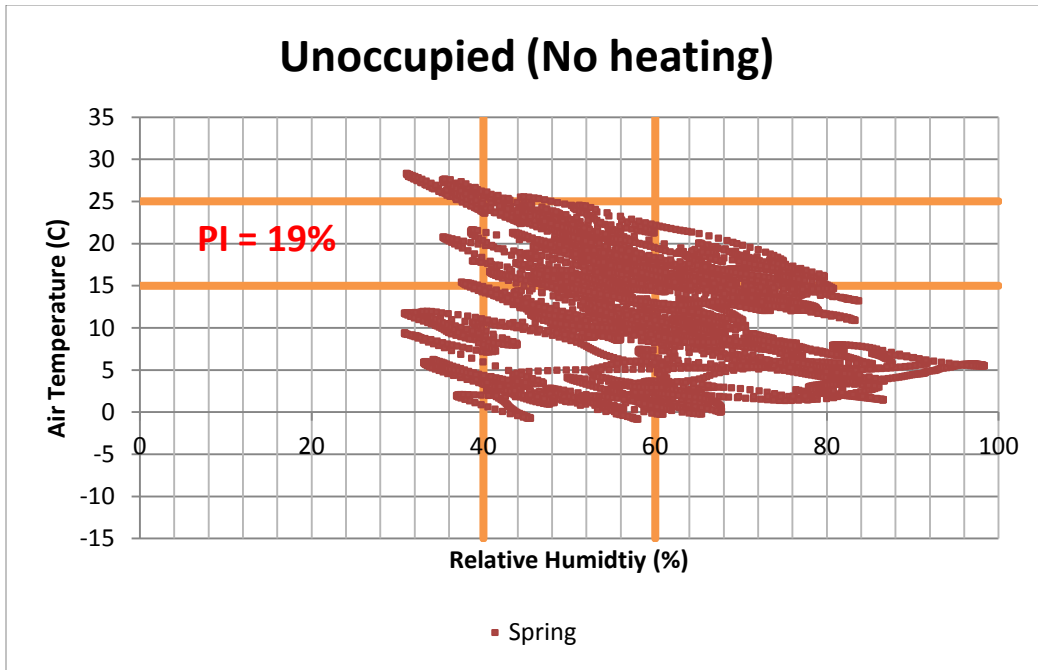
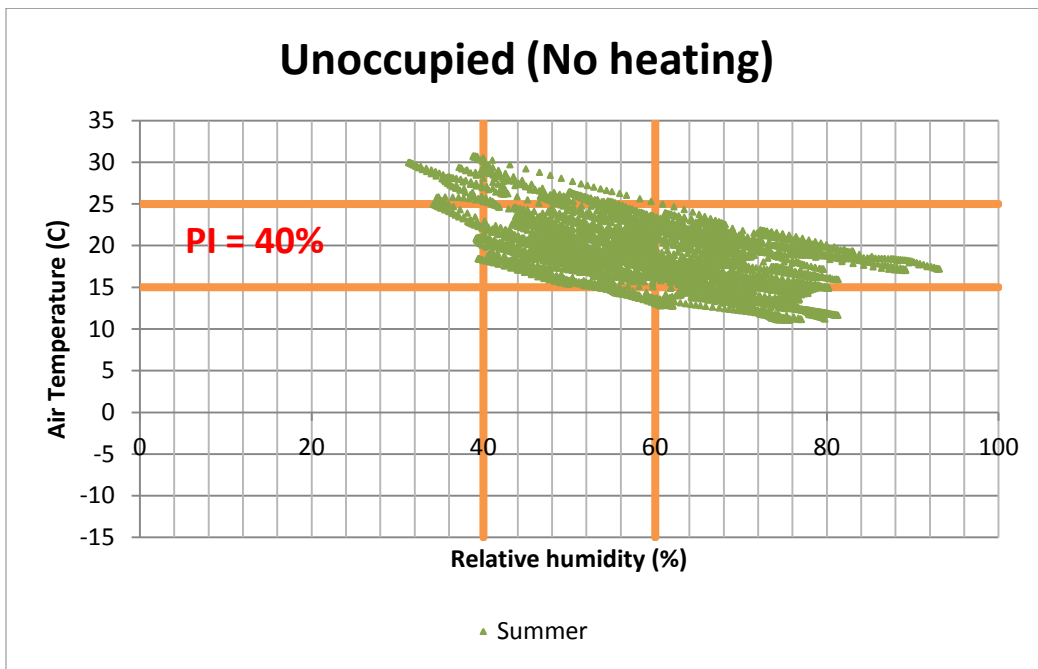
Figure 26, Figure 27, and Figure 28 illustrate the PI index for the unoccupied (no heating).

The PI index for all months combined for unoccupied with no heating is 19.6%. The PI is worse during the winter and spring months; an expected result since there's no condensation occurring in the late spring, and summer months. As shown in the previous figures, most of the data points lie in the high humidity zone (bottom-right corner).

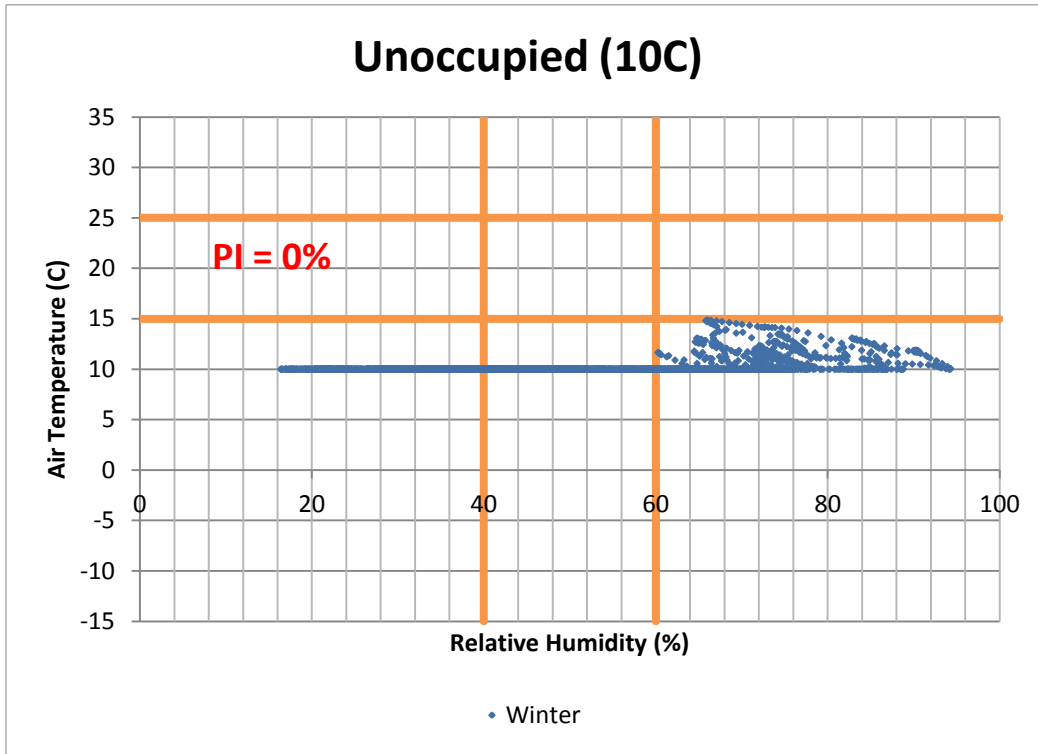
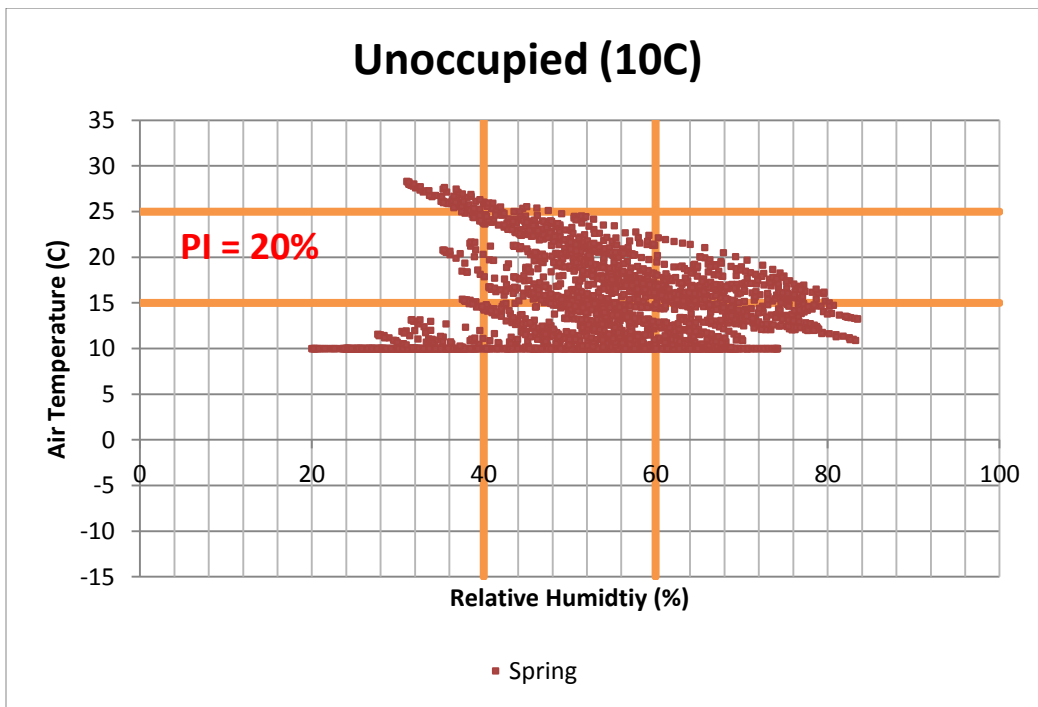
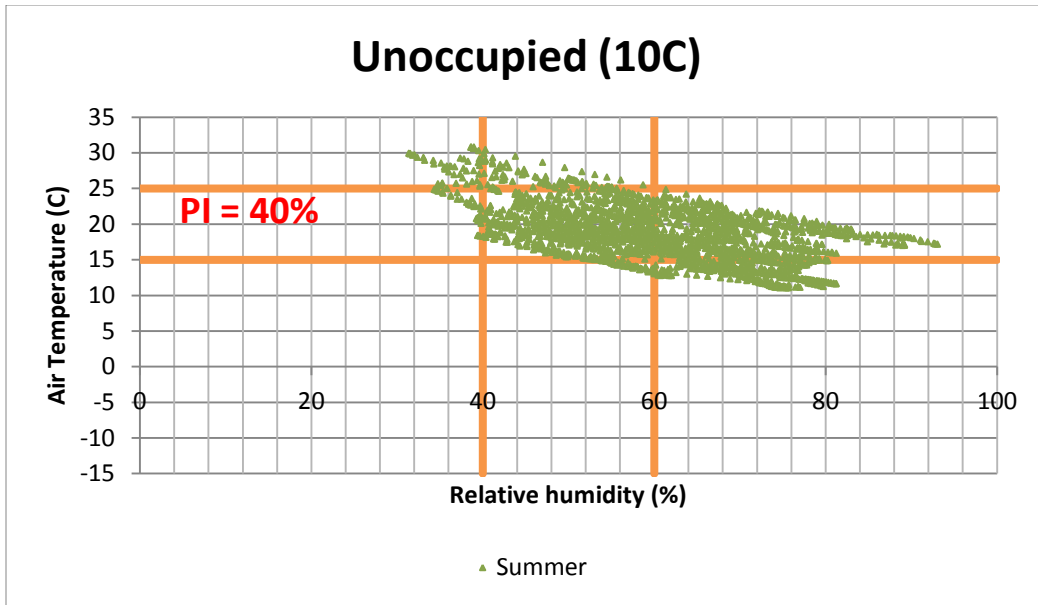
Figure 29, Figure 30, and Figure 31 illustrates the PI index for the unoccupied (10C) scenario.

Maintaining a minimum temperature of 10°C improved the PI index slightly. The new PI scored 20%. Although, this PI is not a significant improvement, the data points are no longer dominating the high-relative humidity, low-temperature zone (bottom-right corner). The points are now closer to the optimum PI zone.

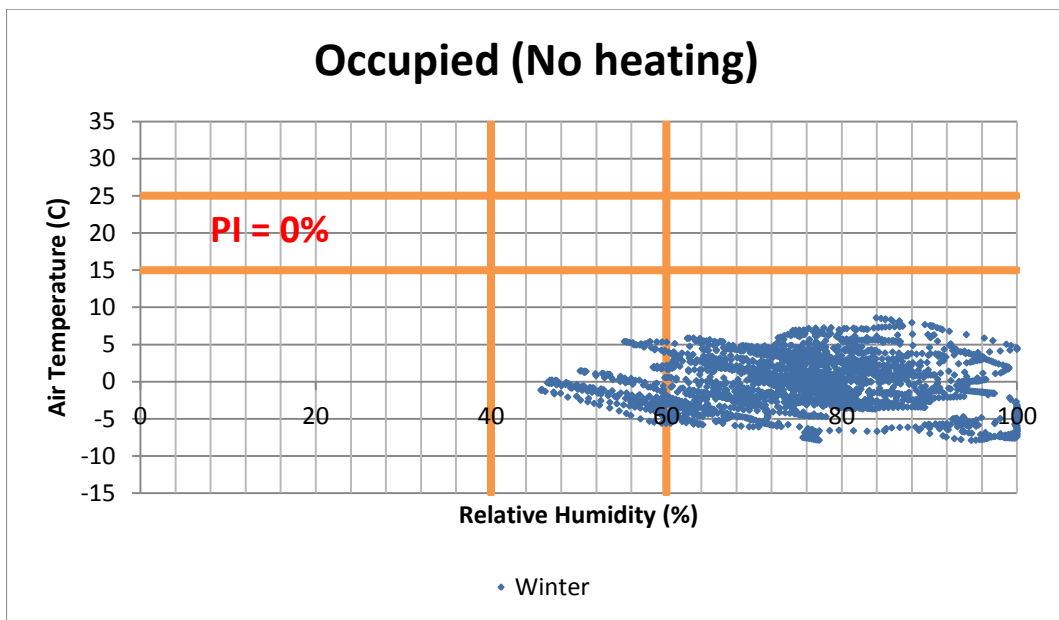
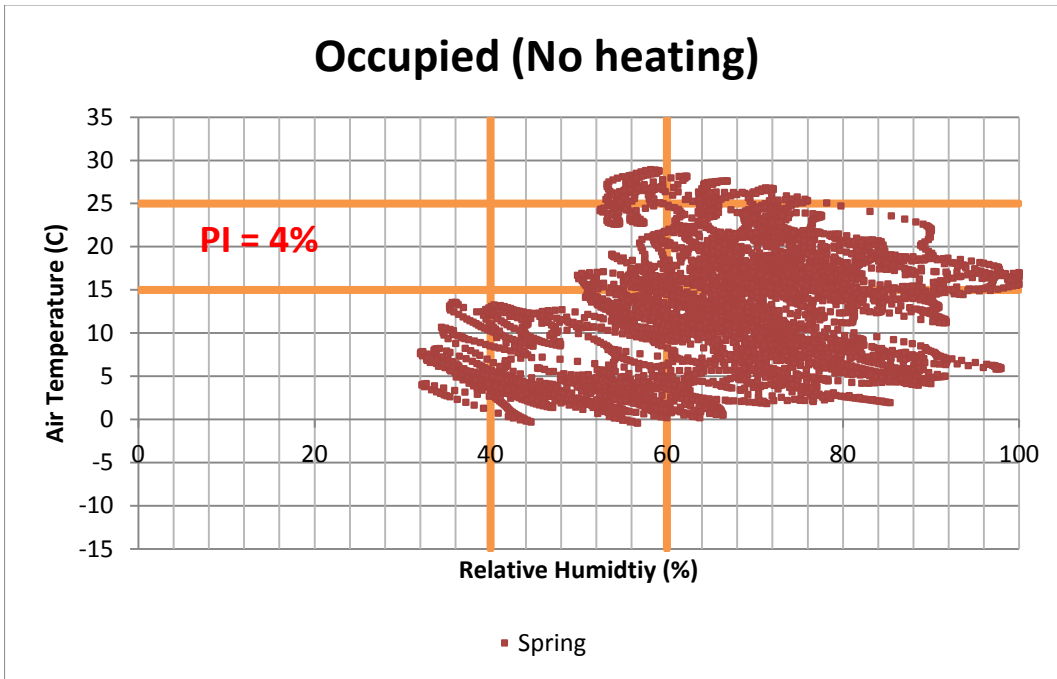
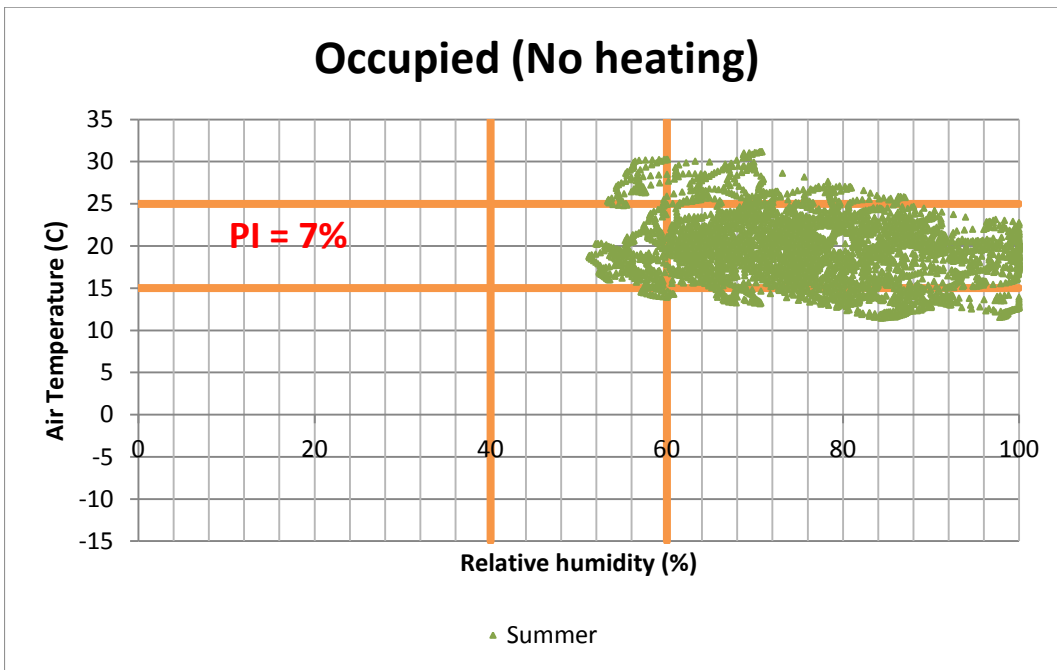
Figure 32, Figure 33, and Figure 34 illustrates the PI index for the occupied (no heating).

Unlike the unoccupied zone, the occupied zone's PI scored very poorly at 3% for the no heating case. This is also expected since condensation is occurring in all seasons as previously shown in the results' section. For the winter and spring, data points are, again, dominating the bottom-right corner.

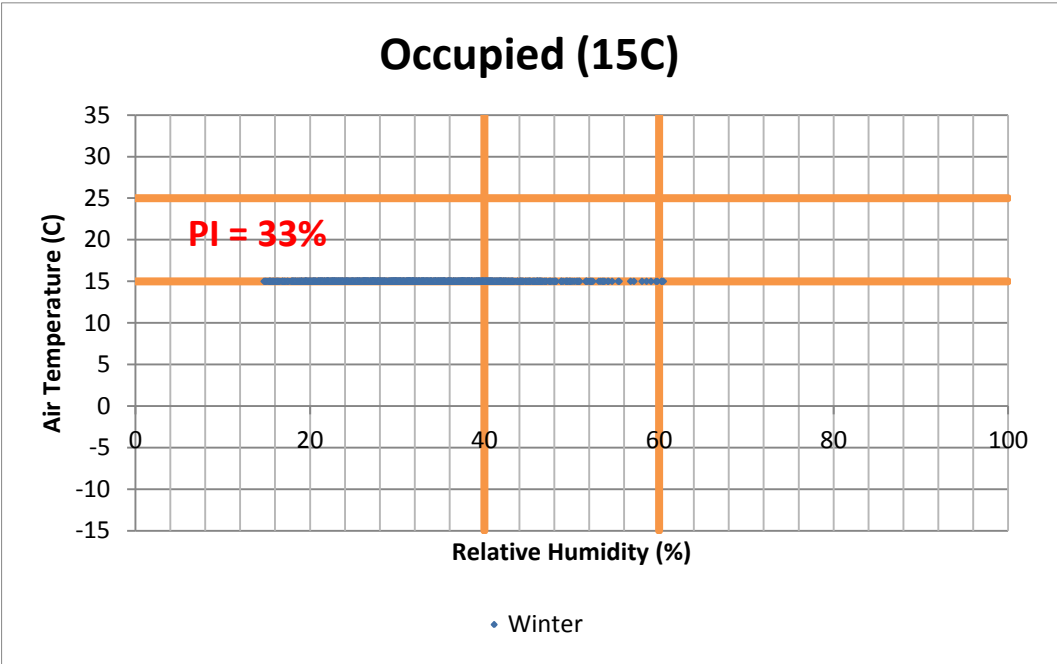
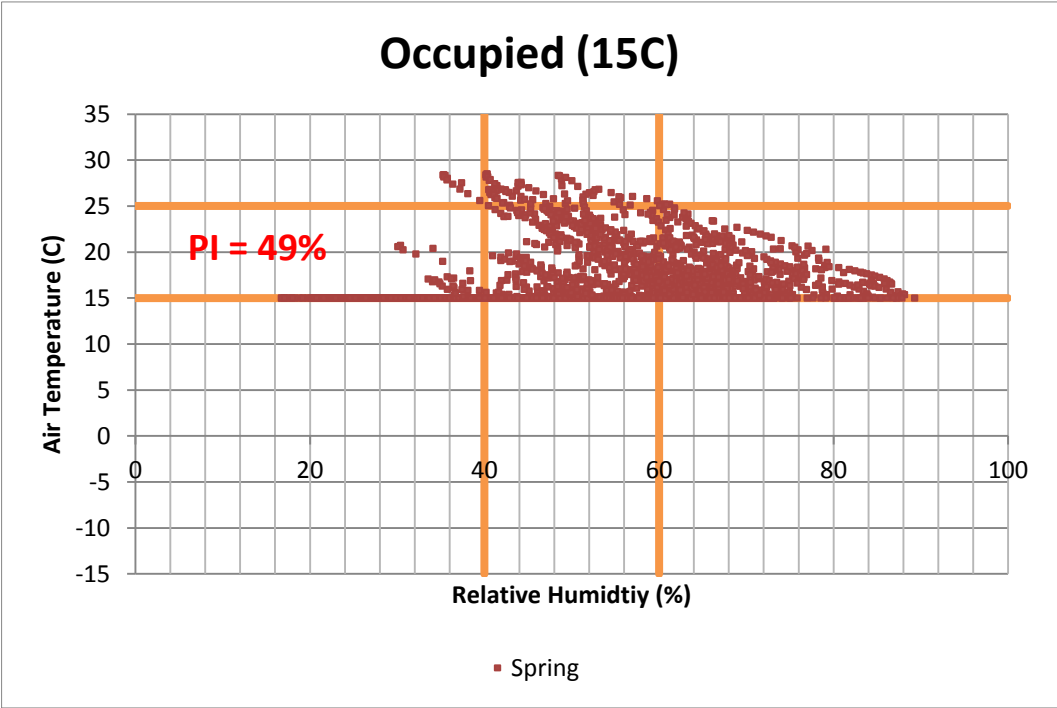
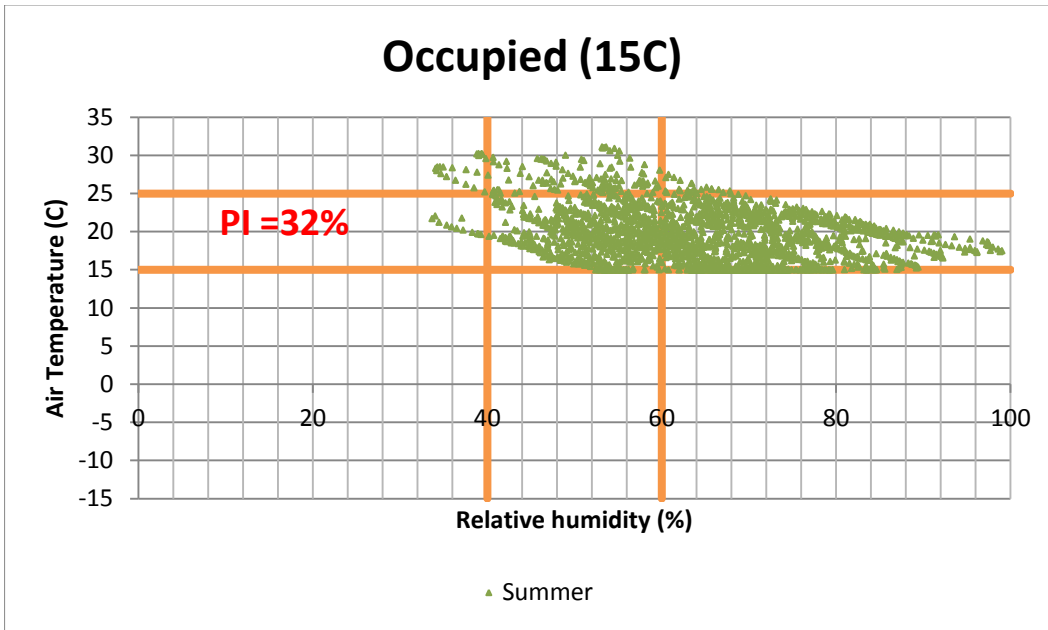
Figure 35, Figure 36, and Figure 37 illustrate the PI index for the occupied (15C).

Maintaining a minimum temperature of 15°C improved the PI index significantly. The new PI scored 38%, with the rest of data points within close proximity to the optimum PI zone.

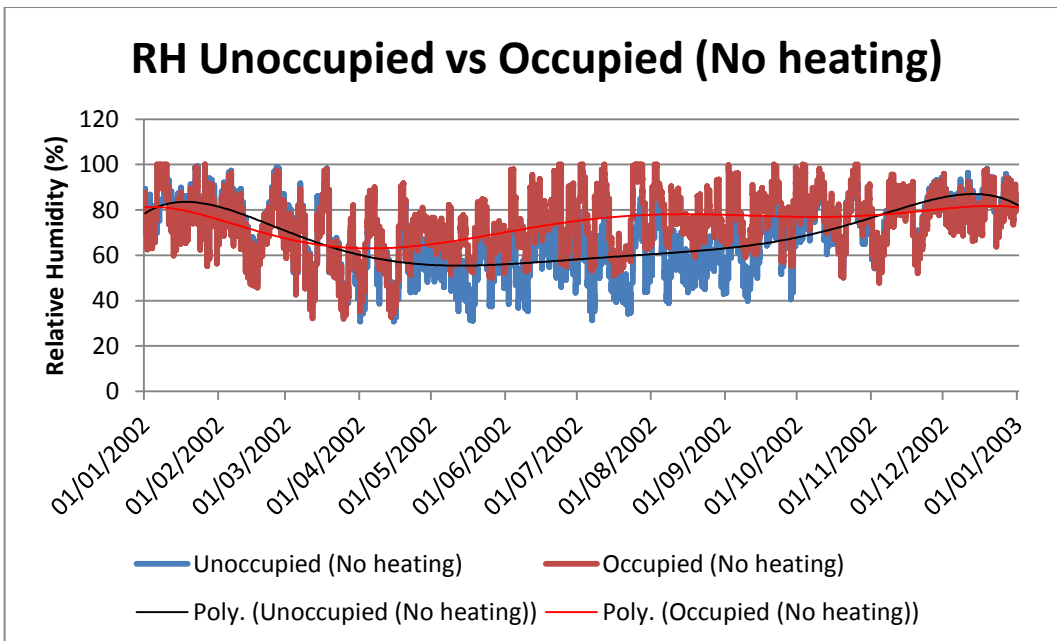
Figure 38 RH unoccupied vs. occupied (no heating)

Figure 38 illustrates the relative humidity values for the unoccupied & occupied functions (no heating).

As shown in the previous two figures, maintaining a 10°C for the unoccupied, and 15°C+Dehumidify for the occupied improved the relative humidity values significantly. In the no heating conditions, the average RH values ranged between 60%-100%. For the ideal condition, however, that range dropped in value to 35%-65%. Moreover, the number of instances of RH exceeding 60% dropped from 68% and 86% (no heating) for unoccupied and occupied to 35% and 30% (ideal conditions) respectively.

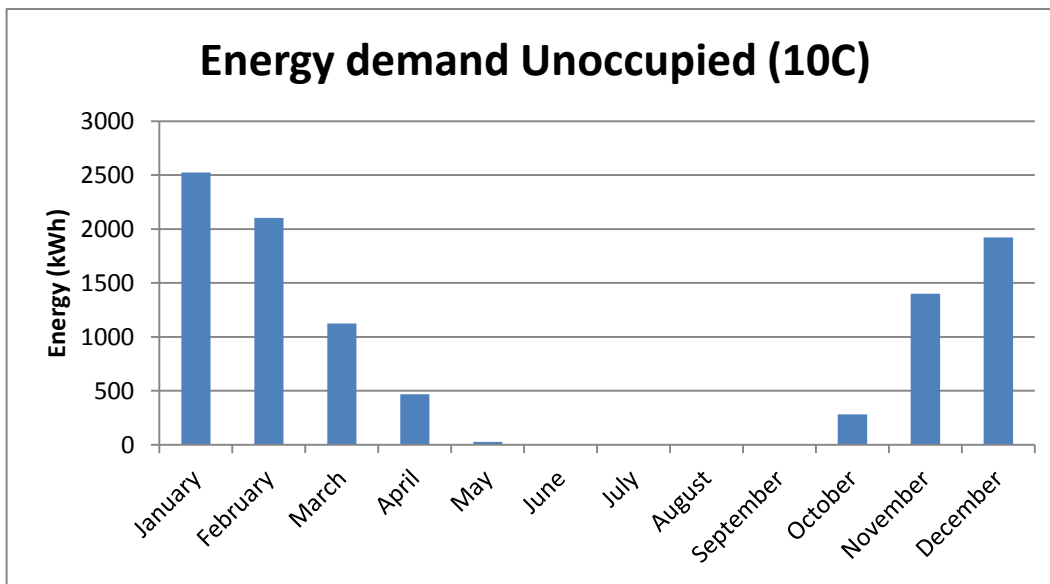
Figure 41, and Figure 42 illustrate the energy demand for the unoccupied, and occupied respectively.

For both functions, unoccupied & occupied, the energy demand peaks during the winter months, which is expected as weather is coldest. There is no energy demand in summer for the unoccupied function, and the demand for occupied function is at its minimum. The only energy required during the summer months is for dehumidification.

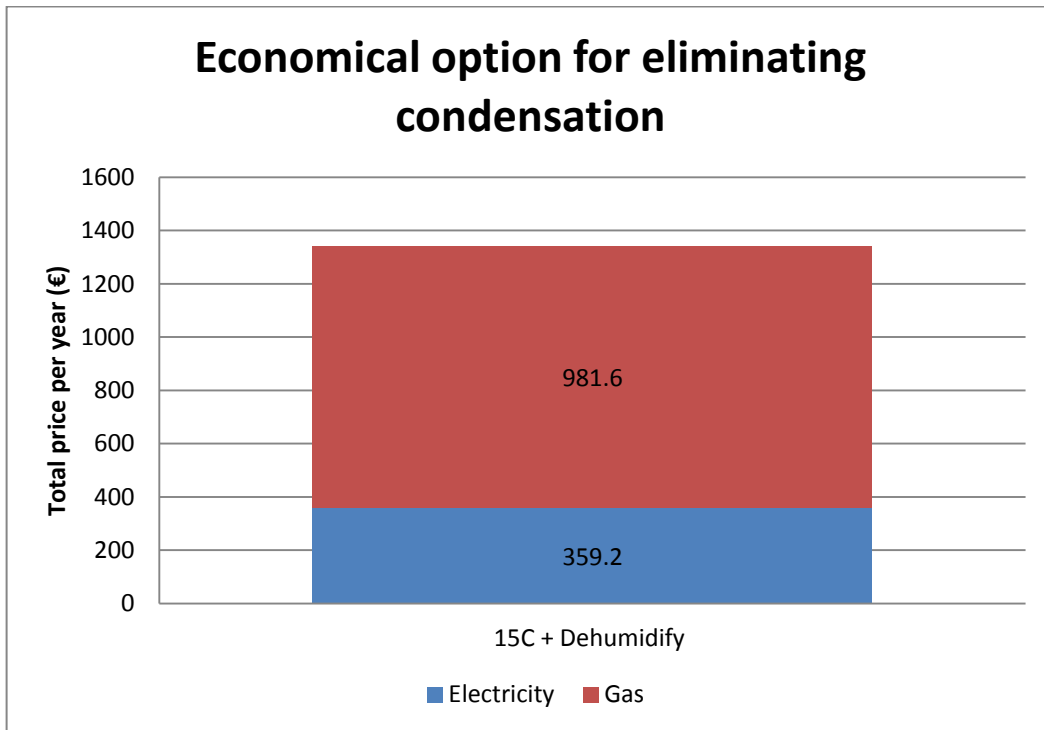
Figure 44 Economical option for eliminating condensation Occupied (15C+Dehumidify)

Since dehumidification can only be used with electric sources, the cheapest option would be to utilize a hybrid system that uses gas for heating, and electricity for dehumidification. The cost of such system is shown in graph Figure 44.
