ADVANCED MASTERS IN STRUCTURAL ANALYSIS  
OF MONUMENTS AND HISTORICAL CONSTRUCTIONS

# Master's Thesis

Krista MacWilliam

**Aging tests to assess the durability of building materials to salt crystallization - towards a more realistic and effective use of sodium sulfate**

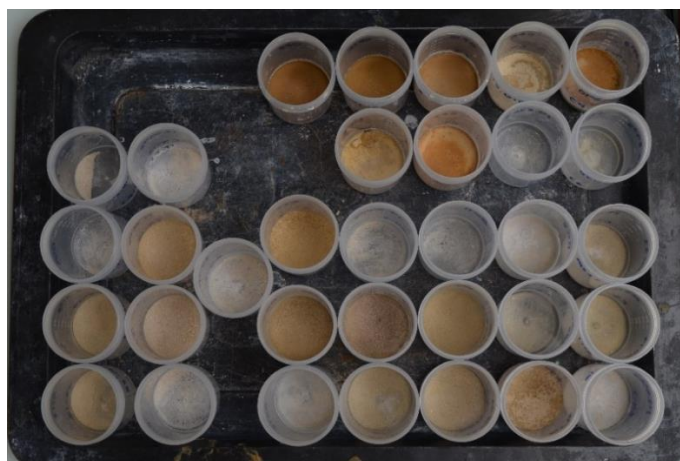
Figure 6: Example of collected and dried mass loss during wetting

During wetting, each specimen was placed in its own container allowing for easy collection of the mass lost in this phase. At intervals of four cycles, the lost material from each stone was decanted from the remaining salt solution, rinsed with distilled water to remove the salt, and then put in smaller containers to dry in the oven until constant mass. Figure 6 shows an example of the collected and dried material. For the samples that were used in the ultrasonic testing described in section 3.3.3, the mass loss during desalination was also collected, dried, and weighed.

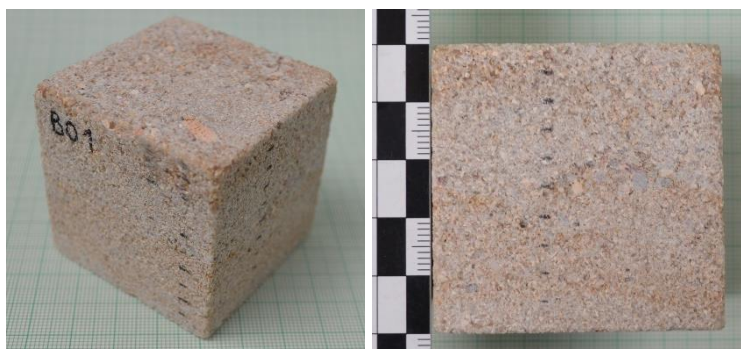
Figure 8 : Example of Božanov stone - visual characteristics

Božanov is a grey sandstone with beige-brownish spots (Figure 8). It is a locally quarried stone and commonly used historically in buildings and monuments in the Czech Republic [26]. It is a mid-grain, extremely hard silicate sandstone with a high level of diagenesis [27]. Similar to other sandstones it is composed of quartz clasts, tourmaline, epidote, muscovite, and zircon [26]. Figure 9 shows an image and the composition of Božanov's grains and binder from a SEM analysis. From the elemental analysis, it is known that silica and aluminum oxide are the two most prevalent components.

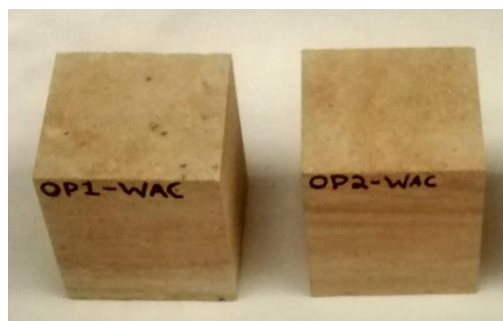
Figure 12: Example of Opuka stone – visual characteristics

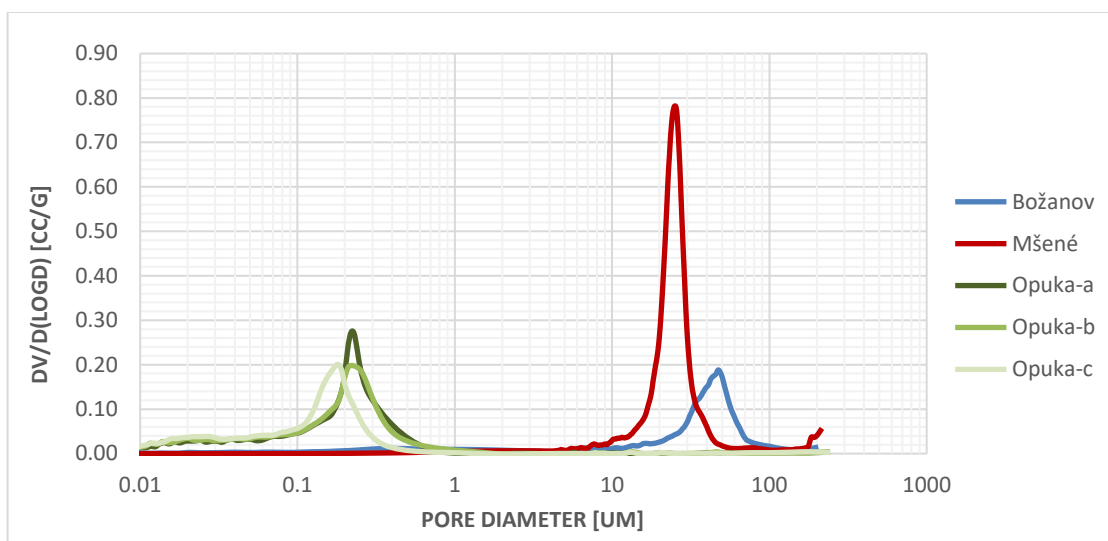
**Graph 1: Pore size distribution for Božanov, Mšeno, and Opuka stone (adapted from [25])**

The NAKI18 project conducted by ITAM investigated the pore structure of several stones types using the Mercury Intrusion Porosity (MIP) method [25]. From this study, the characteristic pore size distribution (PSD) curves for Božanov, Mšeno, and Opuka was determined and is shown in Graph 1.

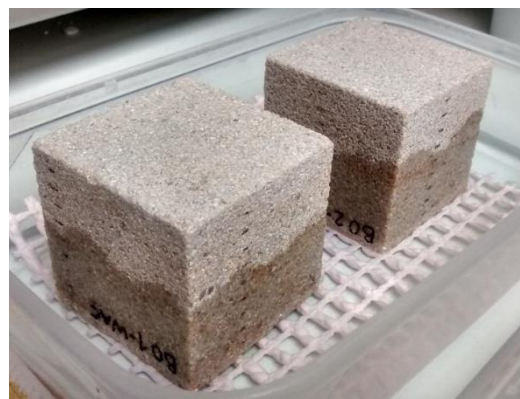
**Figure 14: Aspect of Božanov stone during the capillary test revealing the heterogeneity of the stone as seen from the tortuosity of the wet front.**

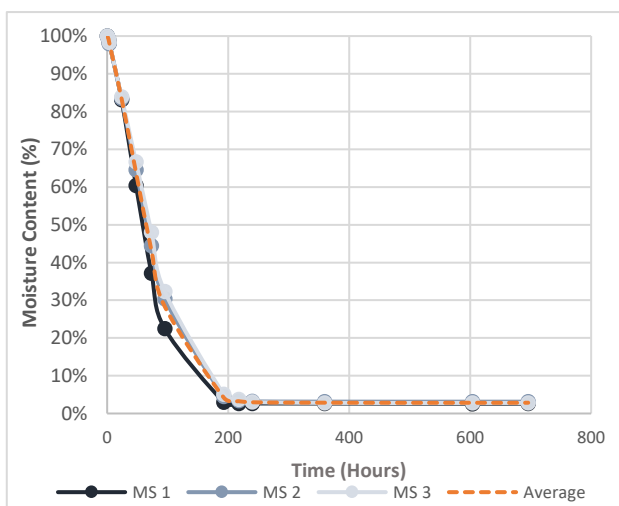
**Graph 6: Mšene drying curve (water)**

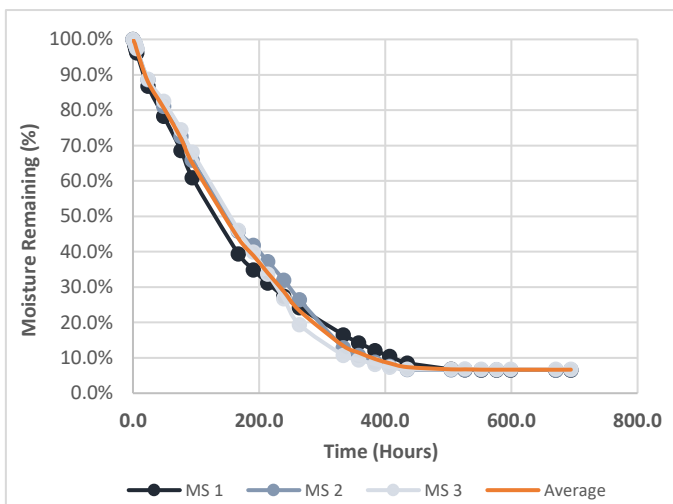
**Graph 10: Mšeno drying curve (salt laden)**

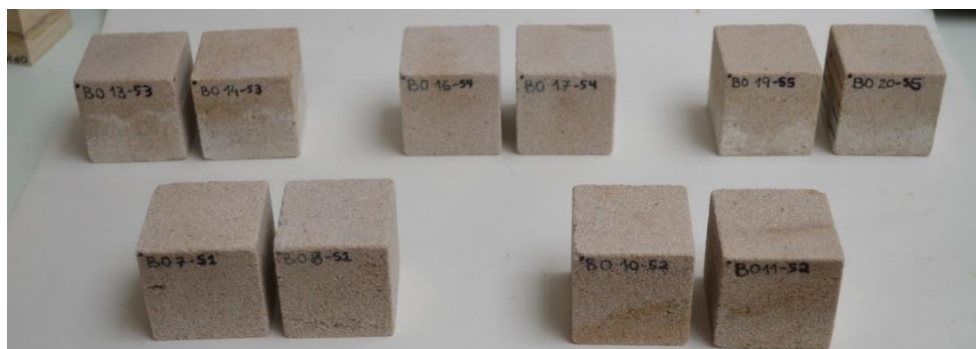
**Figure 15: Comparison of Božanov before and after salt aging cycles**

In general, Božanov showed little alterations to its initial visual aspect. A comparison of the stones from their sound state and after 12 wet/dry cycles is presented in Figure 16, which demonstrates that the overall size, shape, and colour was not significantly affected. Some erosion and rounding of the edges was noticed, however the most notable visual change was on specimens subjected to Test Procedures 3 and 5 in which the contamination was achieved through partial immersion. On these specimens, a film of white salt efflorescences was observed after drying. During the wetting phase, this 'film' of salt was observed as well. It was first noticed not by visual observation, but by touch; the texture of the surfaces felt 'slimy' when they were removed from the immersion dish. As more cycles were performed, the 'slimy' layer continued to build up until it was visible in both wet and dry states. This layer likely formed on the sides where the evaporation flux was strongest during the wetting phase. Comparing the samples from procedures 3 and 5, this crust was more significant on the specimens used in Test Procedure 3, in which 14% sodium sulfate solution was used. For both reference specimens, no visual alterations were observed.

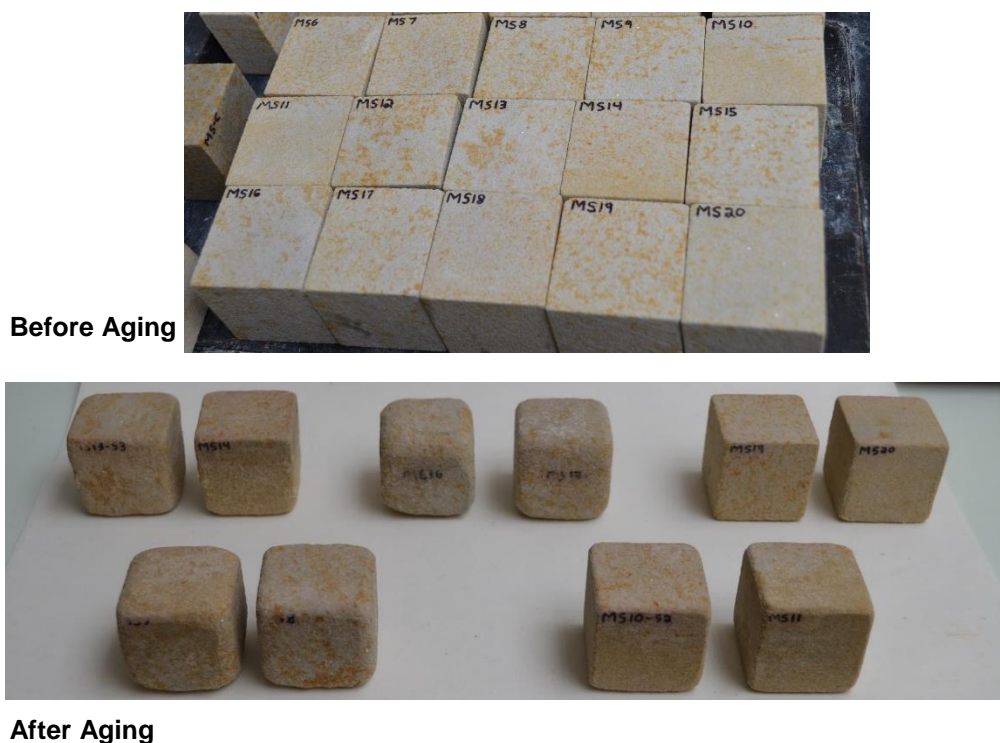
**Figure 16: Comparison of Mšene before and after salt aging cycles**

Of the three types of stone, the visual aspect of Mšene samples changed the most over the course of the salt aging cycles. In general, sand disintegration or sugaring was the main degradation pattern responsible for loss of material during ageing leading to the recession of the surfaces and to the rounding of the specimens' edges (Figure 17). Mšene samples also lost some material during handling. The samples that were subjected to salt contamination by immersion (i.e. Test Procedures 1, 2, and 4) showed the highest level of erosion of the edges. Samples contaminated with the highest salt solution concentration (i.e. Test Procedures 1 and 4) exhibited more severe deterioration. In general, a significant amount of material was lost during the wetting phase after the first ageing cycles. Between the two sets of specimens immersed in a 14 wt.% solution, those in Test Procedure 4, which were dried at a lower temperature, appeared to be slightly more damaged than those dried at high temperature. This aspect could be assigned to the fact that drying at a lower temperature facilitates the migration of salt towards the surface, thus increasing the level of damage within the superficial layers of the material.

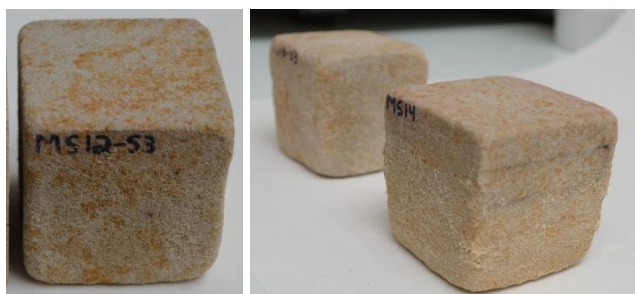
**Figure 17: Mšene Test 3 (partial immersion) - heterogeneous deterioration**

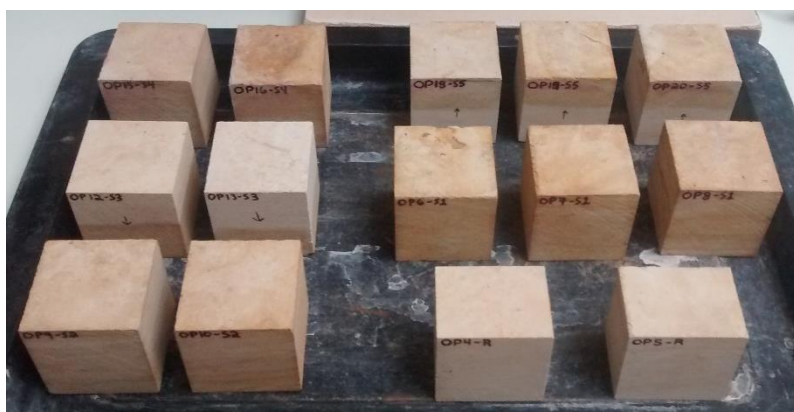
**Figure 18: Colour change after one cycle with all test procedures in Opuka stone.**

Opuka exhibited a different pattern of visual alteration in respect to Božanov and Mšene sandstones. In all the testing procedures, the material losses were more important than those observed in Božanov, but the shape/visual aspect of the stones was not altered to the same degree as in Mšene. One significant difference observed after the first cycle was a slight colour change (darkening effect), which affected the whole surfaces in the samples used in Tests 1, 2 and 4 (complete immersion) and part of the side faces of the samples used in Tests 3 and 5 (partial immersion), i.e. up to which the salt solution front was registered, as shown in Figure 19. Opuka was the only stone type in which the salt solution (during the 2h-contamination phase) did not reach the top of the specimen from capillary rise from the bottom.

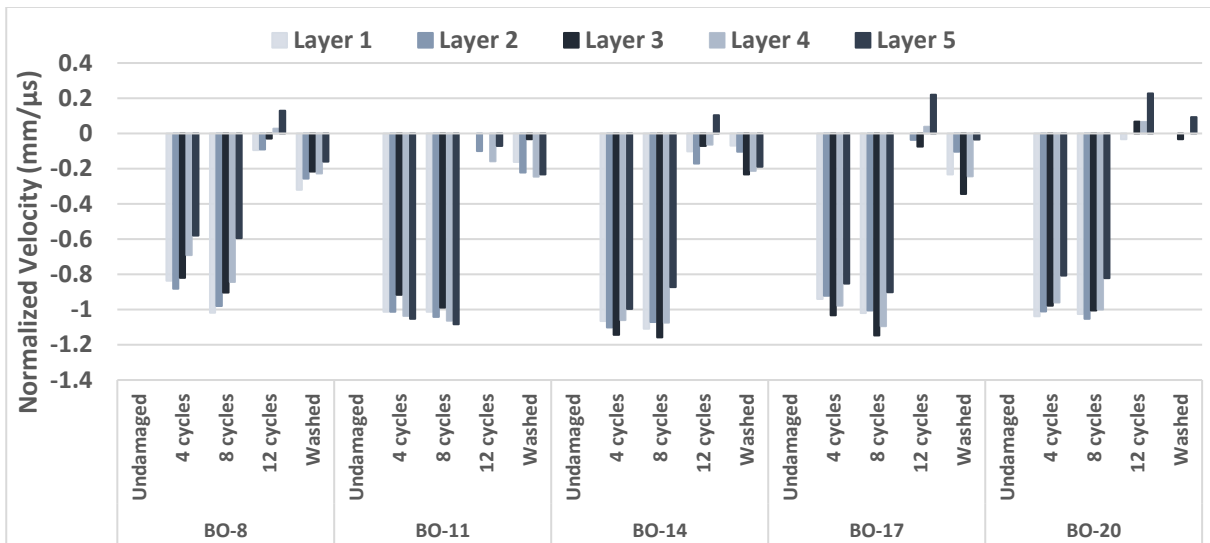
Graph 11: Normalized ultrasound velocity for Božanov samples

As previously discussed, the value of UPV is affected by physical and mechanical properties, most notable for this discussion are aspects such as porosity, pore size, and microcracks [5] [22]. The initial decrease in velocity seen across all the tests and samples could be from the start of damage and alteration to the porous network due to salt crystallization. The subsequent small increase or plateau between cycles 4 and 8 might be from the detrimental effect of damage from the salt crystallization competing with the positive effect of pores filling with salt. The authors Rossi-Manaresi and Tucci posit that salt can have a cementing or consolidating effect if the crystallization pressure is still below the materials mechanical strength and this can cause the UPV to increase [39]. Additionally, decay at this stage in the aging process was loss of mass from the edges, and faces of the samples, especially for Mšene. Perhaps, these vulnerable surfaces were suffering the damaging effect of the salt crystallization cycles. However, the overall porous network of the stones was not being further altered (i.e. increase in pore size, or development of microcrack). As salt continues to fill in the pores of the stones, this cementing behaviour has an increasing effect, to the point where the UPV measurement after 12 cycles is much closer to the sound state velocity. After desalination, the salt and its positive consolidating effect are removed so the ultrasonic velocities decrease again.

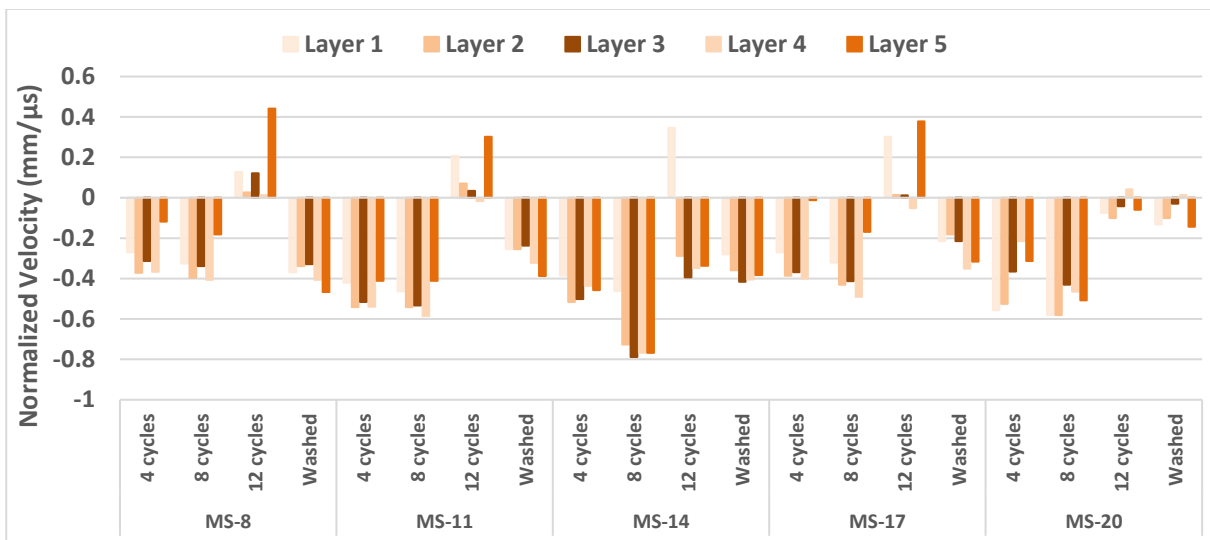
Graph 12: Normalized ultrasound velocity for Mšene samples

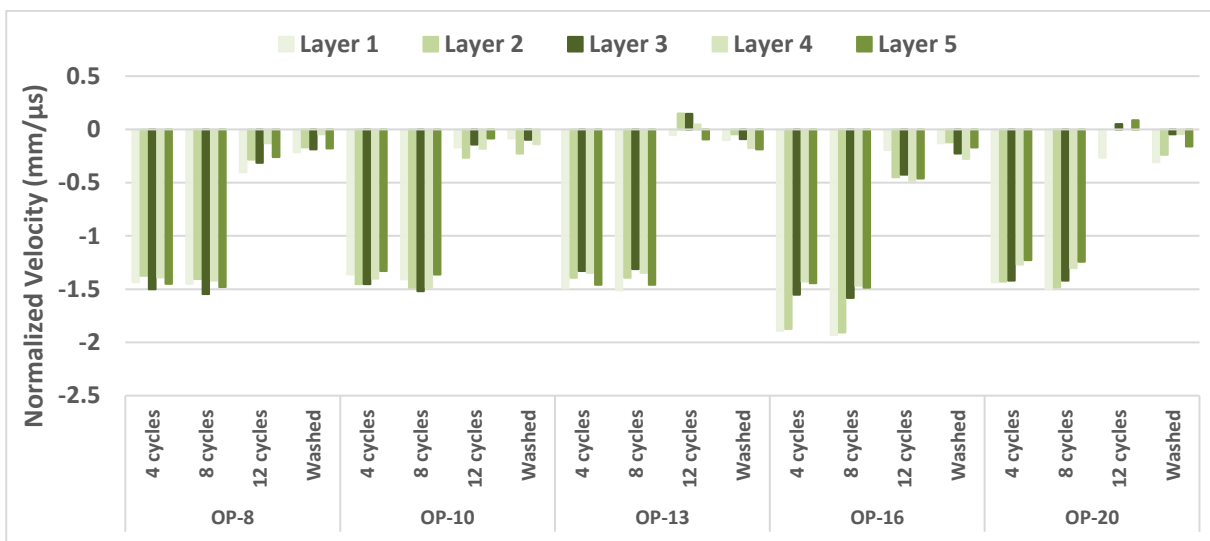
Graph 13: Normalized ultrasound velocity for Opuka samples

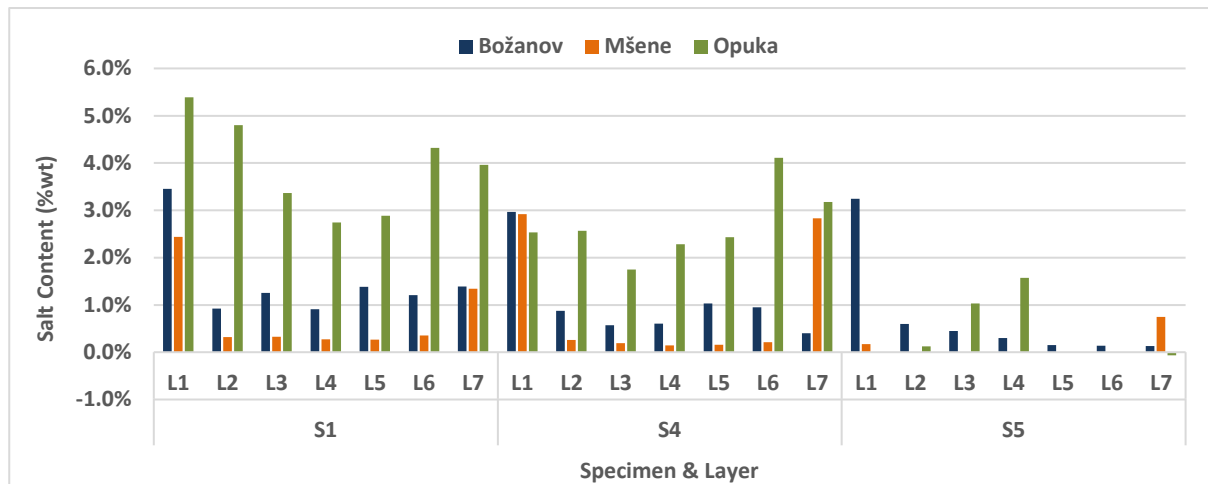
**Graph 14: Salt distribution comparison between three of the test procedures (L1-L7 denote the ‘layer’ the sample was extracted from, starting from the top of the specimen)**

exception of the drying temperatures. Bases on the conductivity curve that was developed (Appendix A), an approximate concentration of salt within each layer of the stone was calculated and is shown in Graph 14.
