Master's Thesis

**Reliability analysis of St.
Barbara's Church in Otovice**

University of Minho

Czech Republic | 2019

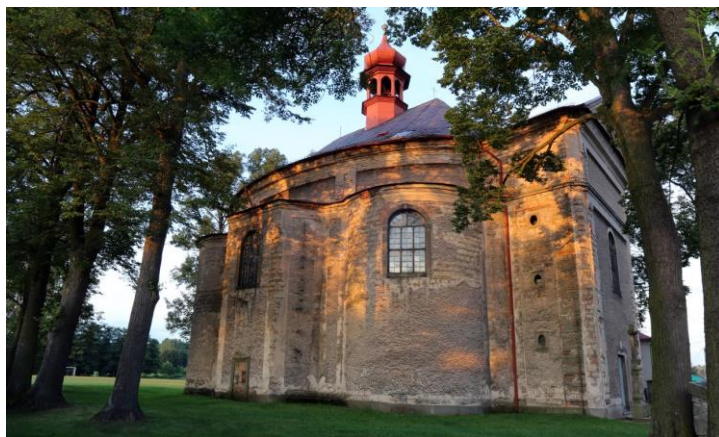
Figure 3.1: St Barbara's church, Otovice

Were founded some documents confirming the existence of an old church made of wood consecrated to St. George built in the same place as the Church of St. Barbara. According to the original sketch of Christoph Dientzenhofer, the construction of a new church began in 1725, but was modified by his son, Kilian Ignaz. The construction phase of the main part of the building took place in 1726. However, between 1748 and 1750, there were still works on interior design.

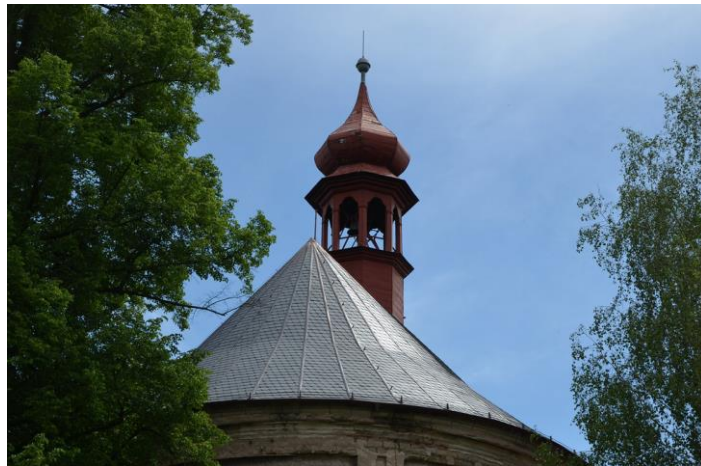
The region of Broumov is rich in sandstones. The stones used for the construction of the St Barbara's church is primarily built with claystone and sandstones that were obtained from the local quarries. The mortar of the structure is composed of lime. The roofs and the ceilings are made entirely with timber covered with slate/ shingles.

Figure 3.3: Building materials of St Barbara's church

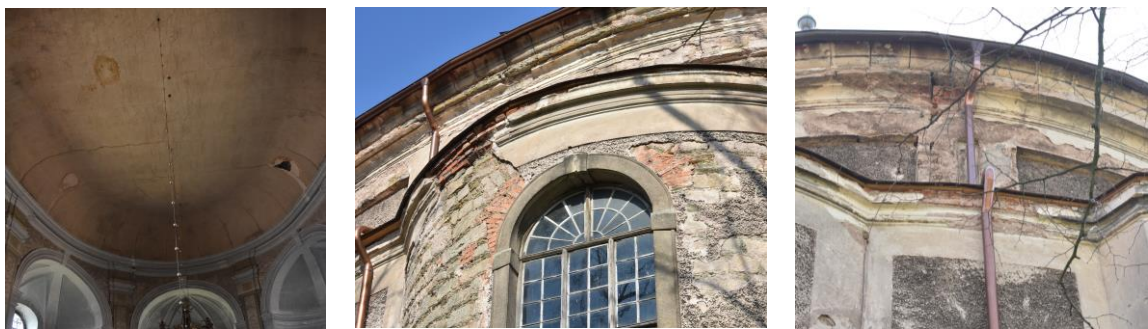
Figure 4.1 Cracks in the internal (a) and external (b) (c) walls of the church

In the case of St Barbara, it is very important to distinguish between an active and a dormant crack. While dormant cracks remain relatively unchanged in size, active cracks are related to a non-stabilized phenomenon that can increase, causing damage or failure of the element/structure. Most of the cracks in the church appear to be dormant. However, it should be noted that the appearance of cracks, is not necessarily an indication of risk of failure in a structure. This is because cracks may relieve stresses that are not essential for equilibrium.

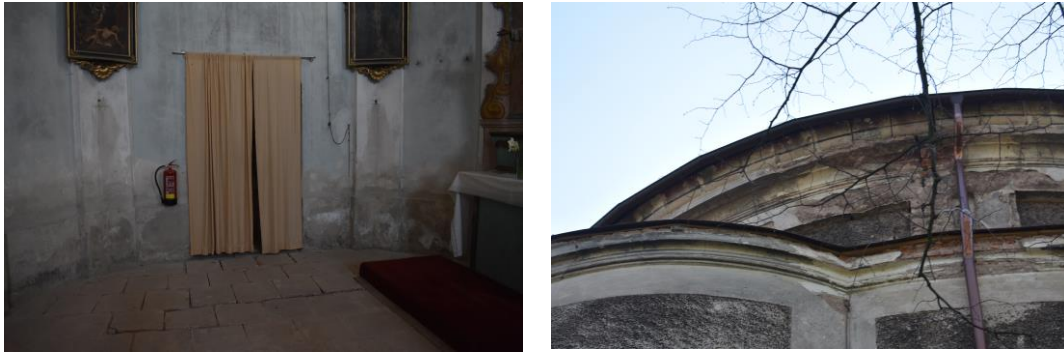
Deposits correspond to an accumulation of materials on the surface, such as salts and pollution. This accumulation could have a homogeneous or non-homogeneous and a regular or irregular. It could have a weakly or strongly bonded to the substrate. And when it detached from the substrate or are removed can include some material of the substrate.

Figure 4.2: Discolouration and deposition

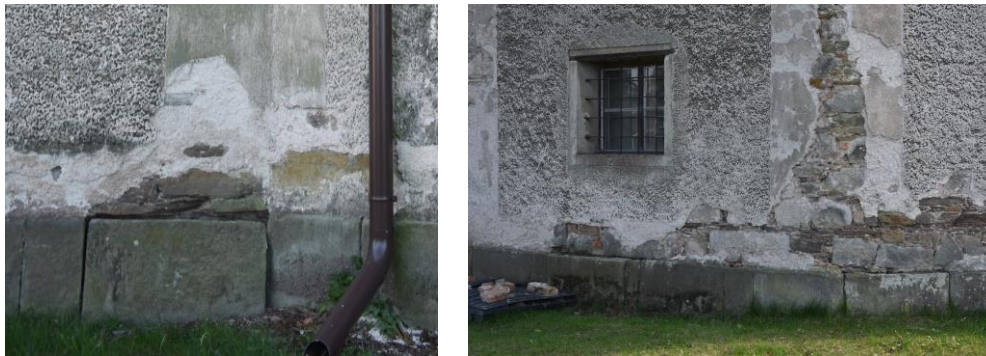
The structure shows signs of settlement in the exterior of the church. Some of the plinth stone close to the rainwater gutters has been detached or displaced from the wall.

Figure 4.3: Degradation of soil and settlement

To counter this problem, failure was defined for the structure in terms of crack width caused due to differential settlements. As mentioned earlier, the existing condition of the church shows that the foundation stones near some of the rainwater gutters have moved or detached from the structure. One of the probable causes of the damage could be due to the stagnation of water caused by non-functional gutters. Presence of water in the footing can cause an adverse effect on the structure.

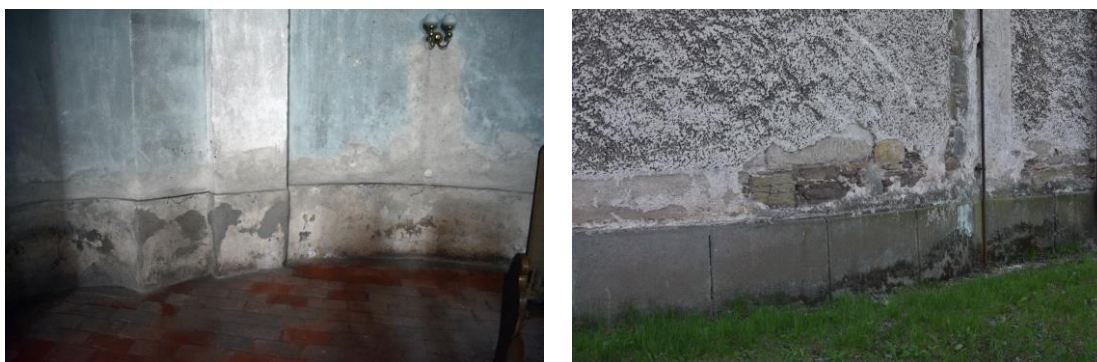
The excess of moisture can deteriorate the plaster and renders of a building. The presence of moisture in the surfaces allows the development of the organisms.

Figure 4.4: Effects of moisture and rising dampness in the church

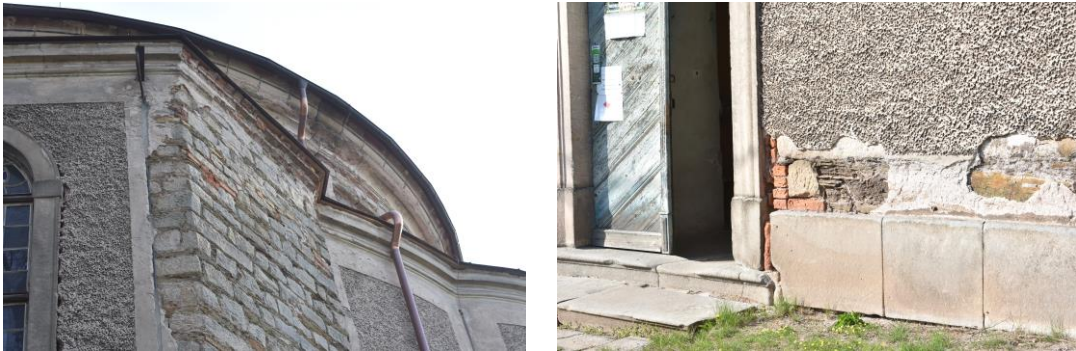
This damage in the church could have been caused by the combination of the action of rain, wind and water containing solid particles, volume variations with consequent internal pressures and chemical reactions.

Figure 4.5: Detachment and loss of material

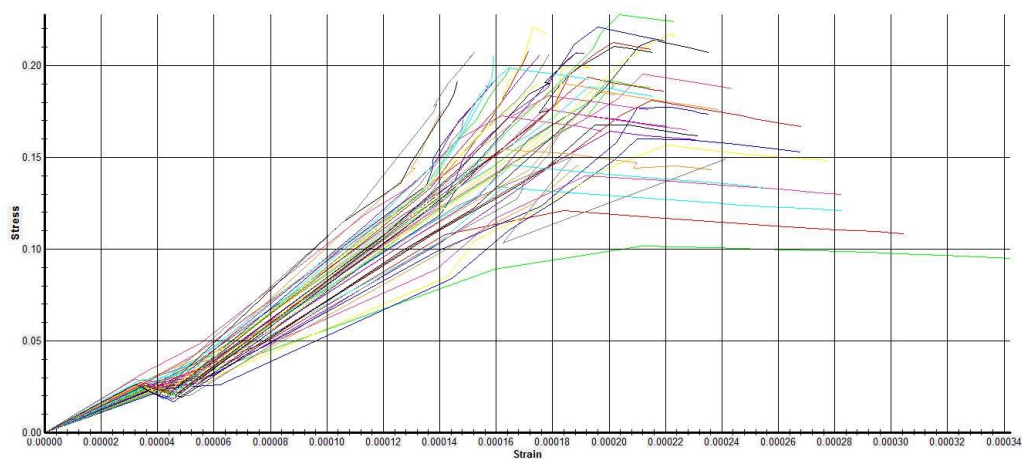
Figure 6.14: Stress vs strain graph of the structure obtained from randomization of material parameters

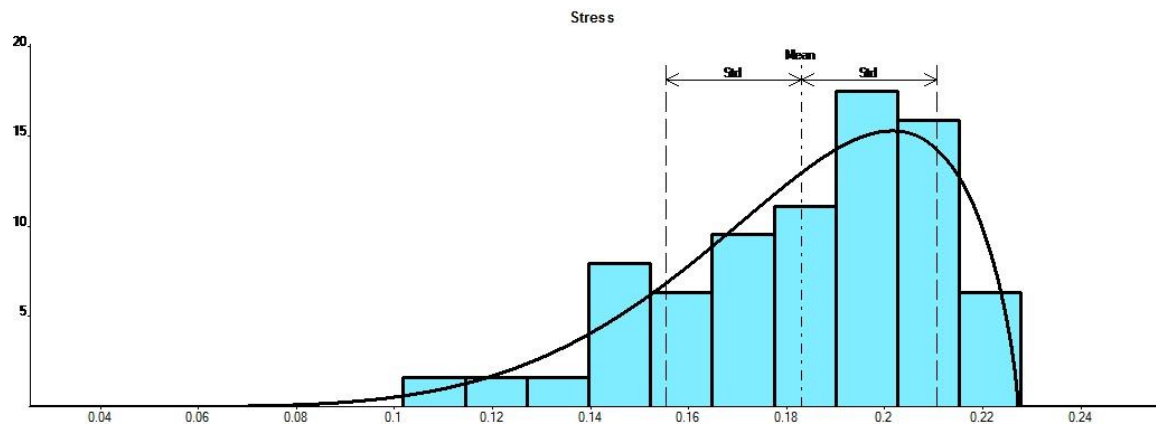
The probability of failure for St. Barbara church is calculated taking into account different scenarios as listed below. These results show that such probabilistic approach is desirable to assess seriously the reliability of historical structures. It should be noted that the term "failure" means here damage of a structural element (e.g. vertical crack in the enclosure wall, i.e. kind of serviceability limit state), and not the total collapse of the whole structure (ultimate limit state).

Figure 6.19: Histogram and the calculated probability distribution function of the structural resistance (uniform settlement)

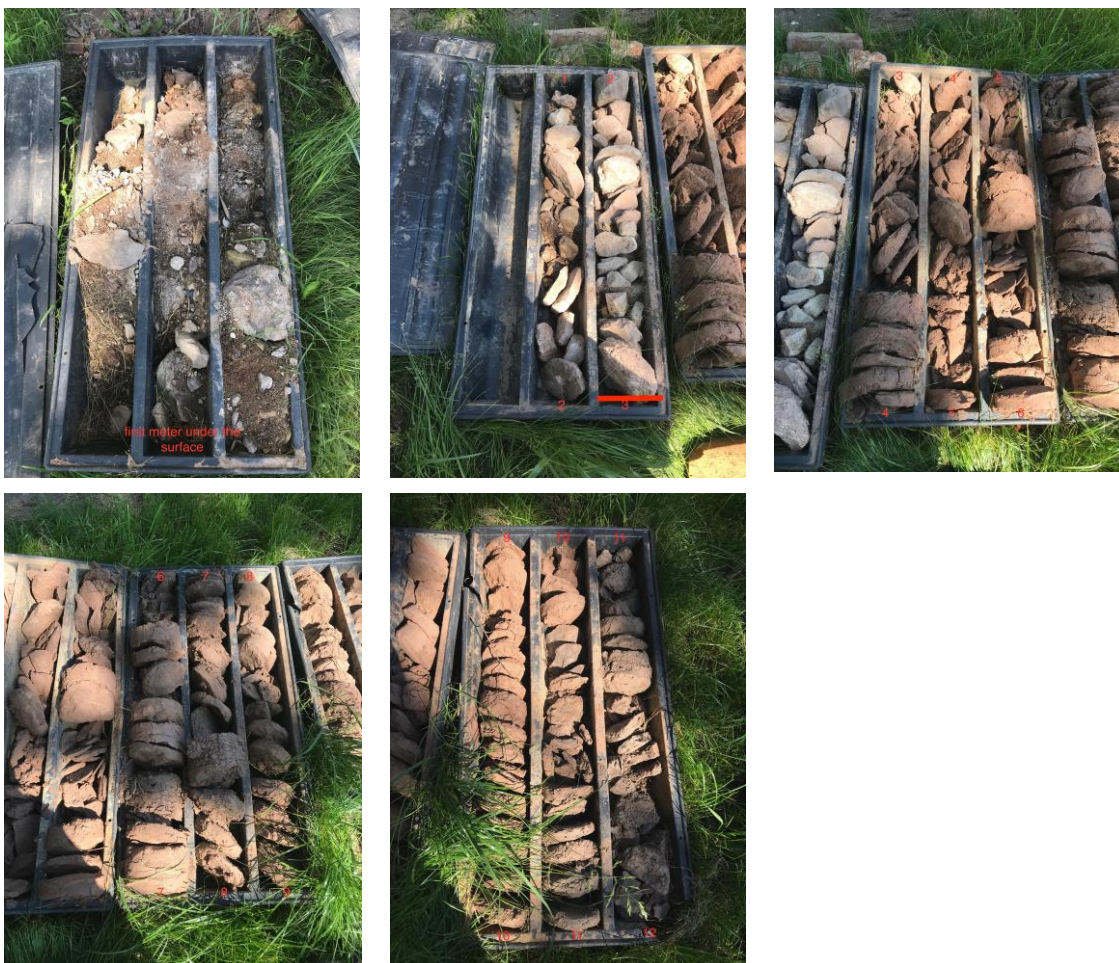
| 10,5 - 12,0 | Gray claystone, thin bedded, easy to break down by hand to thin layers | 6 | 16 |

Figure 0.1: Layers of extracted soil from boreholes at the front of the church

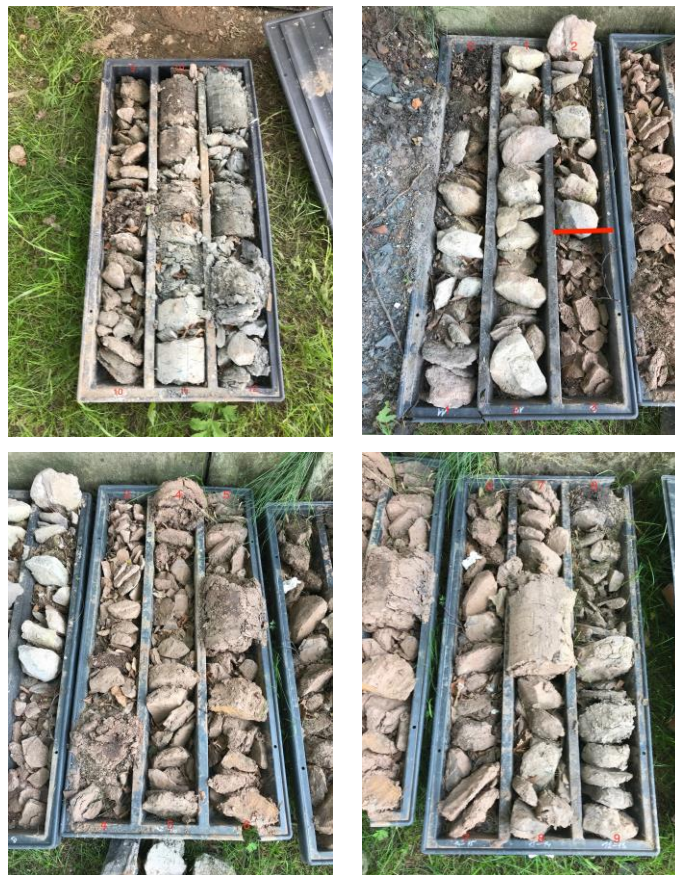
| 11,6 - 12,0 | Harder fragments of gray claystone | | |

Figure 0.2 Layers of extracted soil from boreholes at the back of the church
