Master's Thesis

Sandryne Lefebvre

**The Ultimate Load Capacity
of the Road Historic
Steel Bridge**

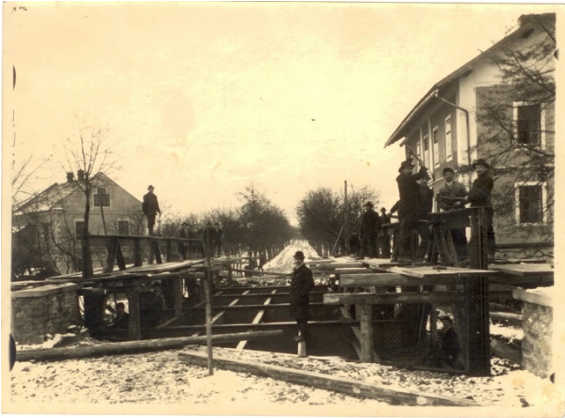
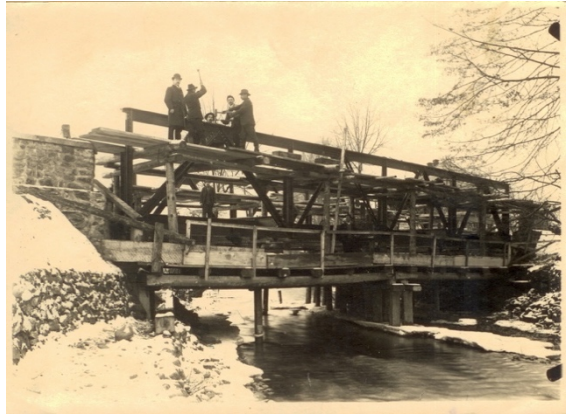
Figures 6 and 7. Historical Pictures During Construction Facing West (left); Facing North (right).
(Courtesy of the Czech Republic Highway Administration)

In total, only four historical pictures of the construction of the bridge still remain showing different stages of work and levels of completion. No original drawings were found or still exist. Figure 4 depicts the construction of the upper chord of the truss. Figures 5 to 7 showcase various views of the bridge will rivets appear to be put in place. It is interesting to note that these picture permit to provide a general idea of the construction techniques used at the beginning of the 20th century.

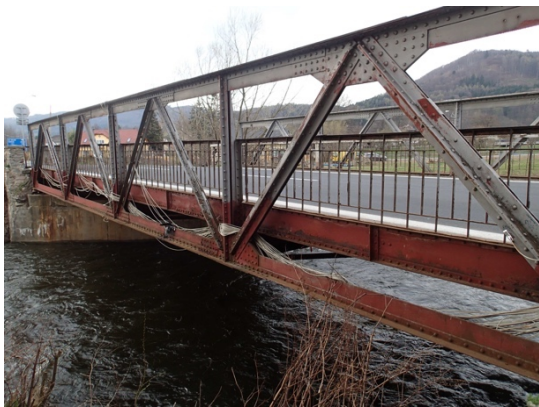
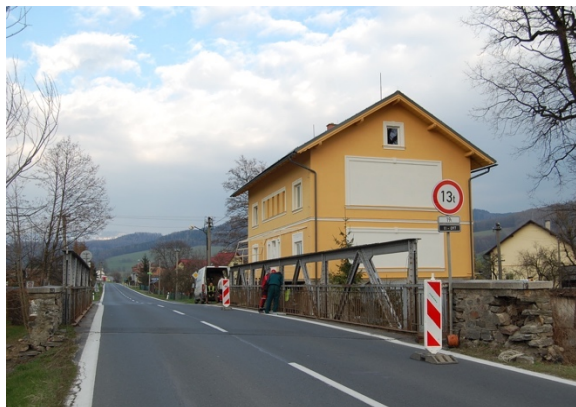
Figures 8 and 9. Overall Views from the Bridge: Side View (left); Front View (right).

The bridge is a skewed semi-through truss bridge of approximately 20 m long by 8 m wide by 3 m tall. It was built using a mild steel Warren truss with verticals spaced about every 5 m with its structural elements, including angles, built-up girders and I sections, connected using rivets and gusset plates. The bridge is symmetrical and supported by six bearings installed over concrete retaining walls and its railing is prolonged into masonry walls on both sides of the bridge. Figures 8 and 9 provide a general overview of the bridge.

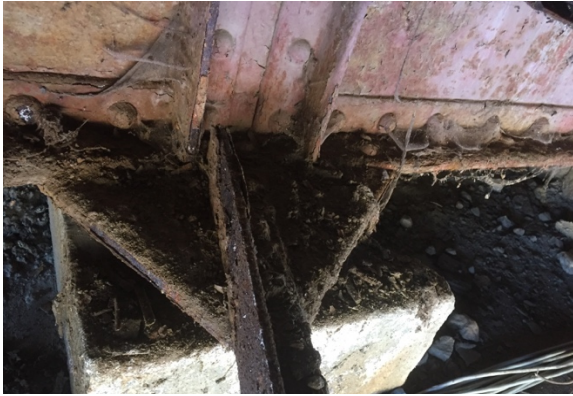
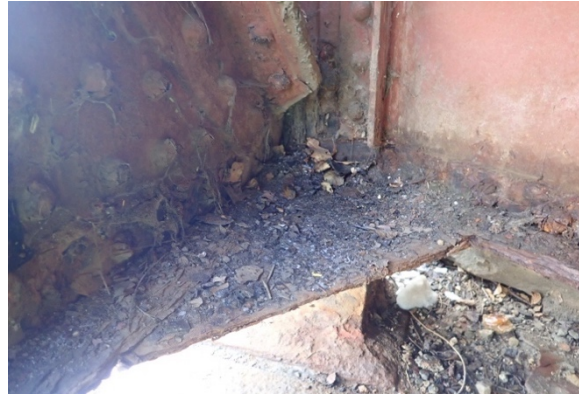
Figures 10 and 11. Bridge Condition: Accumulation of Debris (left); Gusset Plate Corrosion (right).

The bridge showcases signs of deterioration at various locations, mainly on the underside of the bridge. In general, an accumulation of dirt and corroded fragments on most of the horizontal members, i.e. gusset plates, bracing, and bottom flange of built-up sections can be observed across the bridge (Figure 10). No cleaning campaign appears to have ever occurred. Such a quantity of debris might increase the amount of dead weight on the structure since accumulations up to 10 cm in thickness could be observed along some of the members. In addition, some vandalism was observed where a cloth appeared to be set on fire and thrown on one of the bridge trusses. Furthermore, a reduction in the cross-section was also observed along some of the structural members. This appears to be caused by corrosion of the members. The deterioration is more advanced on horizontal surfaces at connections and near the supports. Such presence on horizontal members showcases the presence of an accumulation of water or of snow on the members leading to the expansion of the steel corroding, which was observed during the winter months by the team on the project. One of the typical corroded members includes the gusset plates, which have lost part of their thickness and are flaking. In some areas, the plates have lost almost half of their original shape. In addition, some segments of plates and angles of the bottom chord built-up sections are also corroded as well as part of the bracing angles. Few of the bracing angles have lost part of their cross-section mainly at connecting gusset plates and have also suffered an expansion in thickness due to their corrosion (Figure 11).

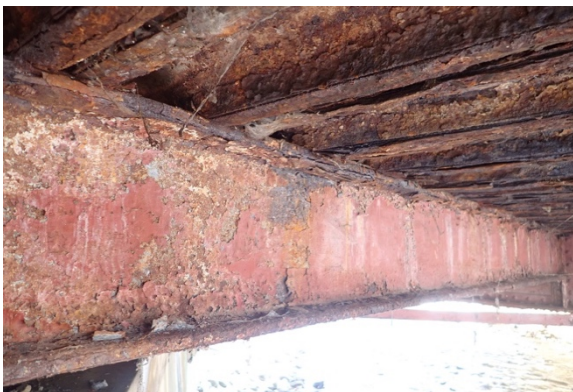
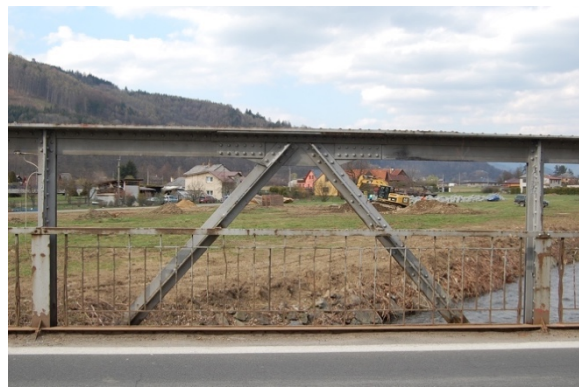
Figures 12 and 13. Bridge Condition: Corrosion of the Bottom of the Deck (left); Light Corrosion on the Section Over the Deck (right).

The bottom flange of the cross-beams in some areas also shows signs of expansion due to corrosion by-products. Signs of corrosion can be observed on the upper flange of the I sections in addition to the semi-circular steel members “ZORES” forming the deck of the bridge (Figure 12). Based on this observation, it can be assumed that there might be a loss of integrity of the structure due to corrosion weakening. Furthermore, near the supports, in the cross-beams, corrosion has weakened the beams to an extent to which the web has started to have an opening in it with the surrounding material being almost inexistent, i.e. thin sheets of corroded steel. This can be a critical location when assessing the ultimate capacity of the bridge due to the close proximity of the weakening to the support and due to the loads the member carries. In addition, light corrosion can be observed on the vertical and diagonal members above the deck where ferric staining can be seen emerging from below the paint and some flaking of the paint can be observed (Figure 13). For the top chord of the truss, a surface corrosion can be seen on top of the plates and angles with the presence of some biological growth. This really showcase the effects of the exposure to the elements that the bridge undergoes through where biological growth only grows with adequate growing conditions. It is to be noted that the bridge is located on an open field along a river and therefore, has no protection. The exposure to the elements might also be another accelerating factor for the corrosion of the members.

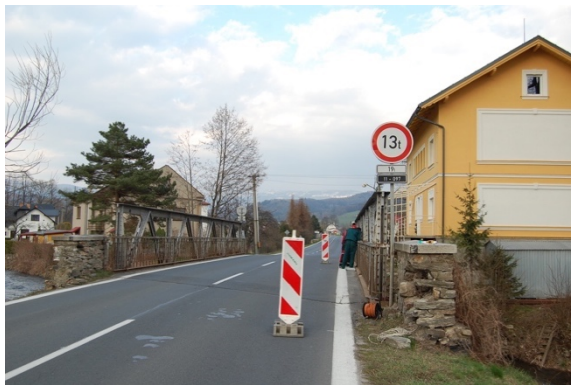
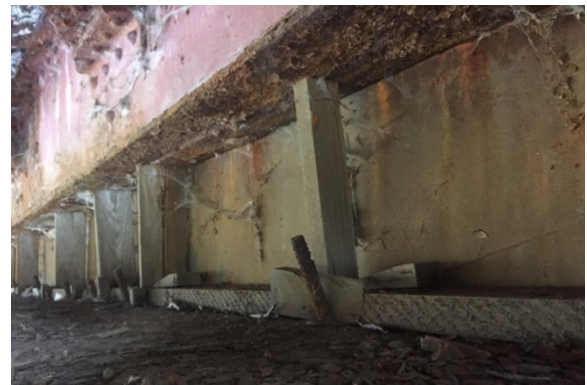
Figures 14 and 15. Previous Repairs: Asphalt Layer (left); Temporary Wooden Supports (right).

Between its erection and our current day and time, the bridge appears to have undergone through a few repair campaigns, however, all structural elements appear to be original. Such work could include repainting of the bridge upper part, i.e. the parts visible to its users which could have been associated with an anti-corrosion treatment, the repair of the asphalt route going over it (Figure 14) as well as the installation of temporary wooden supports along the diagonal cross-beams at the support (Figure 15). Such supports appear to prevent the bearing soil to further deteriorate. No documentation is available on any of these interventions, but they were possible to record through a visual inspection of the bridge. Further assessment could be conducted by, for example, doing a paint analysis of the various paint layers on the bridge or additionally by inspecting investigating the use of temporary supports.

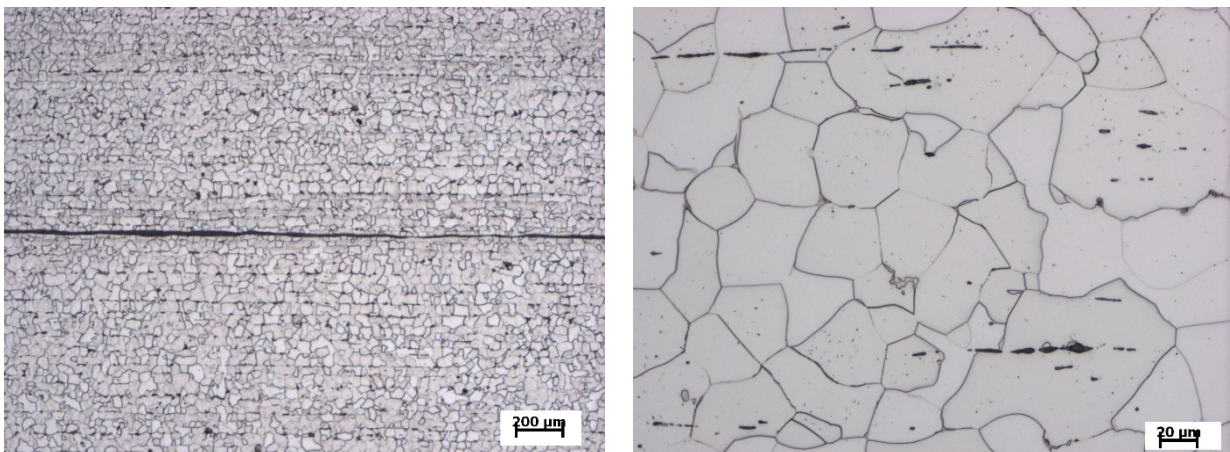
Figures 16 and 17. Metallography of P1: 25x (left); 200x (right). (ČVUT v Praze, 2019)

In terms of the metallography of the specimens, all specimens contain very similar microstructure and metallic components. For the plate sample, P1, it has a ferritic structure with cementite particles and small inclusion of sulfides or phosphides (Figures 16 and 17). For the two angle samples, U1 and U2, they also have a ferritic structure, but with a small quantity of perlite and some inclusions of sulfides or phosphides for U1 (Figures 18 and 19) and with a small quantity of perlite and cementite and other intermetallic phases some inclusions of sulfides or phosphides for U2 (Figures 20 and 21). (ČVUT v Praze, 2019)

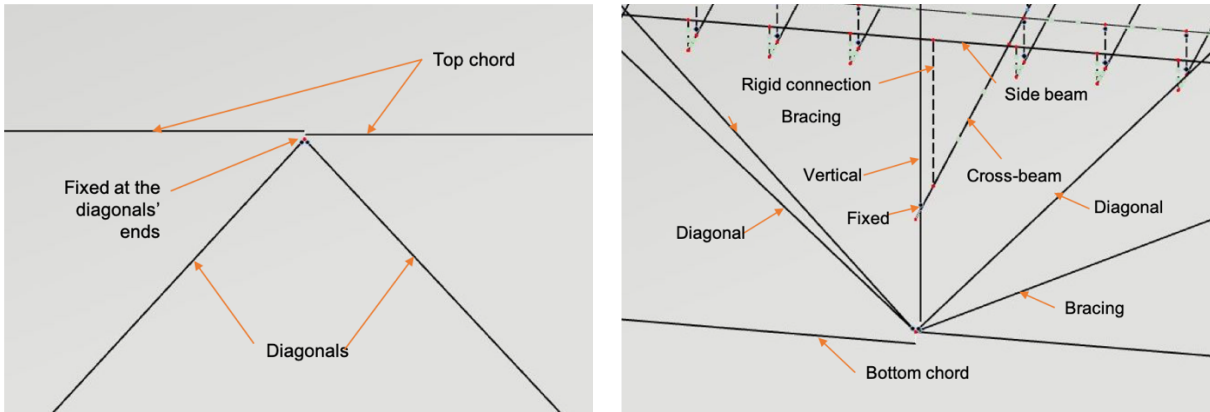
Figures 27 and 28. Rigid Connection: at the Top Chord (left); at the Bottom Chord (right).

modelled with shell elements and therefore exhibiting a semi-rigid behaviour. Therefore, the two ends of the diagonals and of the verticals were drawn as fixed. For the verticals, its end is fixed to the cross-beam (Figures 27 and 28). It is to be noted that throughout the model, member eccentricities were used in order to obtain the perfect match of the members at the connections.

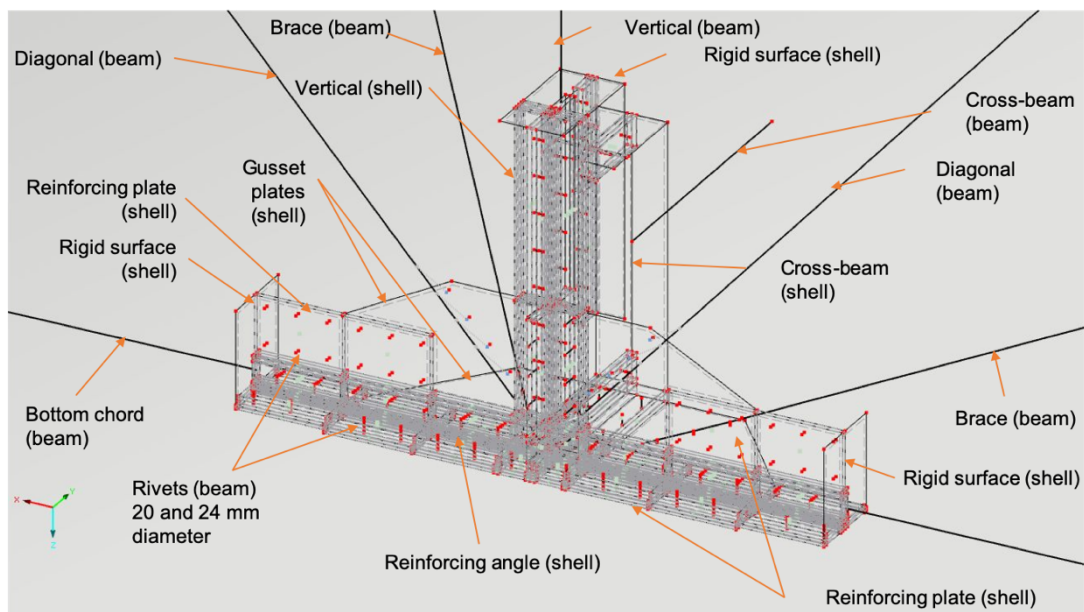
Figure 31. Modelled Connection with Gusset Plates.

31). For the creation of this detailed connection, the gusset plates and built up sections composed of angles and plates were modelled as shell elements instead of beam elements as per the rest of the model. The material properties of each shell elements were modelled as non-linear as per the material properties presented in the previous chapter. In order to recreate the friction between the angles and plates, solid contact elements were used. The solid elements were given a rigid friction coefficient of 0.35 and an assumed failure under tension. In order to connect the detailed connection to the rest of the original model, rigid surfaces at the end of the cross-beam, the vertical and the two sides of the lower chord were modelled. The node linking the beam element to the shell was then connected to the new surface.

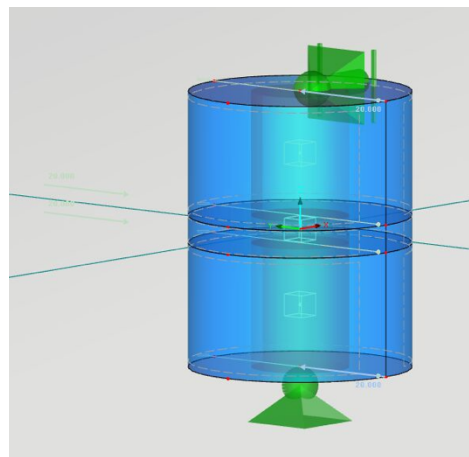
Figure 32. Modelled Behaviour of the Rivets as a Beam Element.

original detail should have one row of three rivets on the top angle and one row of 4 on the bottom angle. In order to account for this simplification, the rivet strength in the diagonal was modified with a ratio of 7/4 multiplied by 2 for the 24 mm diameter curve. This ratio takes into account the 7 rivets present in reality with the 4 rivets modelled and the factor of 2 represents the two existing shear planes modelled only as one due to the use of a simplified beam element. In terms of the small eccentricities for the existing rivets, they could not be modelled due to the simplification. Furthermore, in order to ensure the friction via contact elements between the shell elements for the plates and angles, a prestressing load based on a temperature of -400 degrees Celsius was imposed on the rivets. From this, the experiment conducted in the previous studies was reproduced via modelling and compared to the experimental data to confirm and to adjust the real behaviour of the rivets as modelled beam elements (Figure 33).

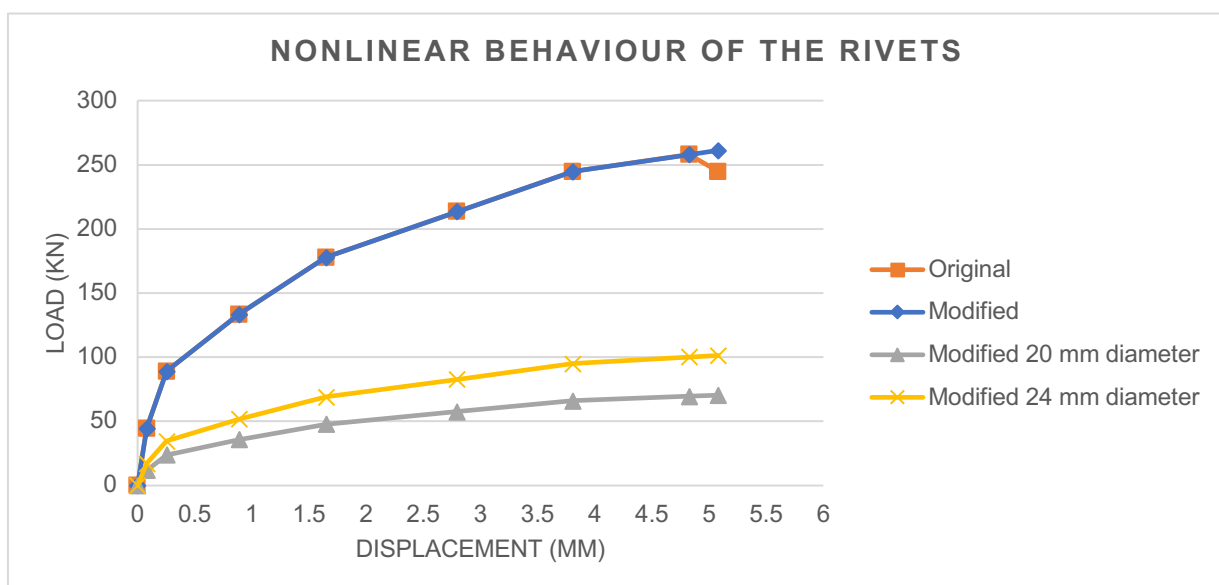
Figure 33. Behaviour at the Interface of the Rivets. (Kulak et al., 2001; Munse & Cox, 2007)

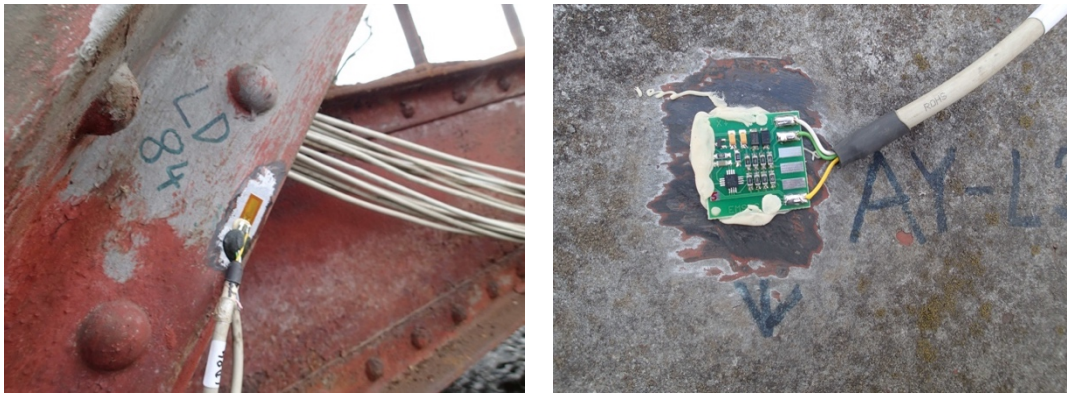
Figures 40 and 41. Monitoring Equipment: Strain Gauge (left); Accelerometer (right) (Ryjáček, 2019).

The monitoring helped to obtain real traffic and micro-seismicity data regarding the bridge which also helped for the calibration of the numerical model in addition to obtain additional information during the conducted tests. Figures 40 and 41 present some of the monitoring devices used for this project.

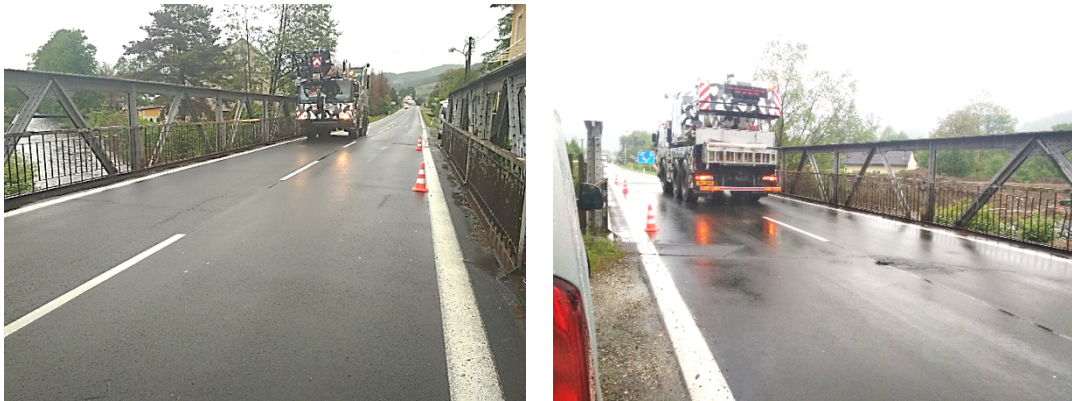
Figures 43 and 44. Load Test Being Performed: In the Lane (left); On the Axis (right) (Ryjáček, 2019).

In total, 9 passages across the bridge were completed, including one that failed and that was, then, repeated at last. The crane was positioned in the lanes of both directions and also along the axis of the bridge. The testing was performed at various speeds including 5 km/h, 20 km/h, 30 km/h and 40 km/h. The different set ups are presented in Table 14 below.

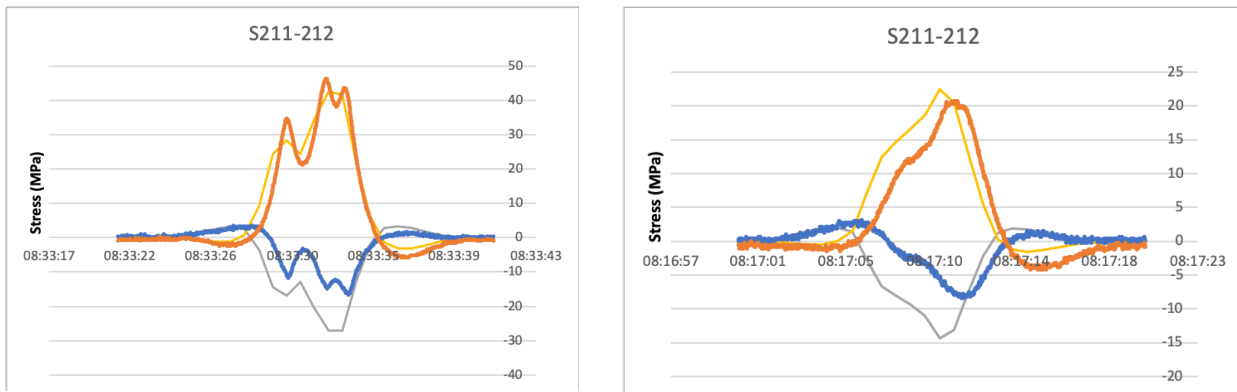
Figures 47 and 48. Calibration of the S211-S212 Stringer for the Unstrengthen Bridge: in the Lane (left); on the Axis (right).

In general, the stringers showcase a good response in terms of the calibration of the model. It can be observed on some of the stringers' response that in certain locations the stresses caused by the three axles are visible and that the central axle tends to lead to the highest stresses on this type of member. This response is also normally seen in the model. However, the stresses in the top chord tend to be less accurate than the lower chord stresses. The stringers showcase the same behaviour as per the cross-beams in this regard. This therefore also appears to be caused by the condition seen between the asphalt and gravel layers which was determined to be uncoupled. In addition, for most of the stringers model response, a lag of the shapes can be observed even if well-fitting and this can simply be caused by the change in speed of the driver (Figures 47 and 48).

In summary, for the stringers, a difference between the top flange experimental and modelled data at the maximums and minimums generally is of about 50%-60% and for the bottom flange is 5%-35%. It is to be noted that high percentage stresses in this case are often related to small stresses difference, i.e., the difference between -1.6 MPa and 2.8 MPa. In addition, the values for the top flange peaks around -2 to -17 MPa and for the bottom flange around 10 to 44 MPa.

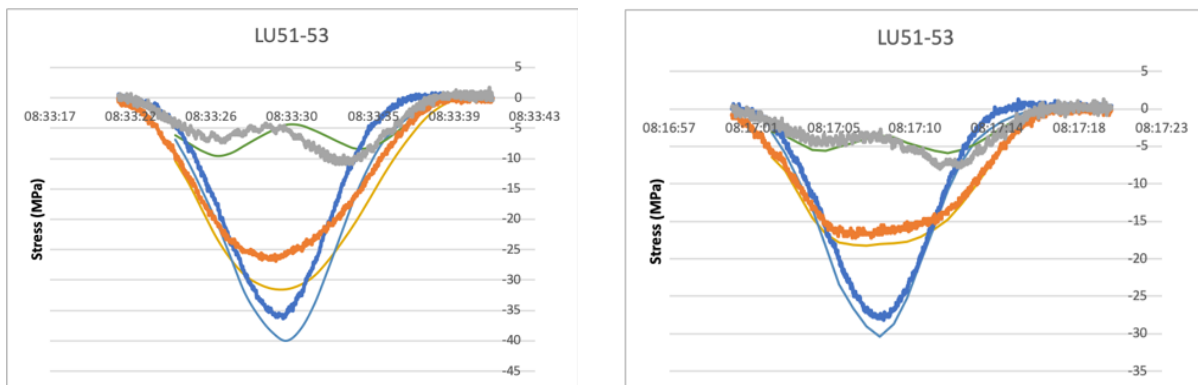
Figures 51 and 52. Calibration of the LU51-LU53 Upper Chord for the Unstrengthen Bridge: in the Lane (left); on the Axis (right).

Regarding the upper flange, a trend that was observed is that when the crane is located on the same side of the strain, the modelled stresses are greater than the experimental ones as when it is on the opposite side, the opposite phenomenon occurs. This might be due to the fact that the exact location of the crane in the lane is unknown and the chosen location for the calibration might be slightly offset to the true location of the crane. When looking at the behaviour of the modelled data according to the experimental data, it can be observed, in this case, that the position of the crane as an impact on the accuracy of the results. The percentage difference for when the truck is in the lane is at a maximum of 17% in this case and when on the axis, it is of maximum 7% (Figures 51 to 52). In terms of the shape of the stress curve, the results are quite satisfying. In general, a difference between the top flange experimental and modelled data at the maximums and minimums is 0%-20% and for the web is 0%-30%. In addition, the values from the experimental data for the top flange peaks around -17 to -36 MPa and for the web around 2 to 11 MPa.

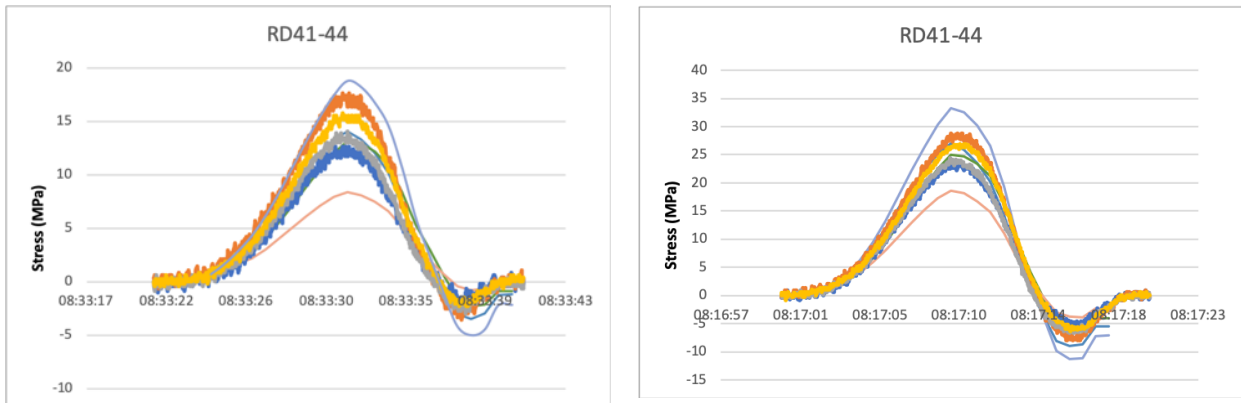
Figures 53 and 54. Calibration of the RD83-RD84 Diagonal for the Unstrengthen Bridge: in the Lane (left); on the Axis (right).

Looking at the diagonals, there is a wide range of behaviour and disparities depending on the type of diagonal and their location across the truss. Mostly, the stress curves for the diagonals are similar from the model to the experimental data and the main differences occur in the accuracy of the peak values in some instances. From the calibration, it can easily be observed that the members of the truss next to the lane being driven by are more stressed than the ones on the opposite side and that a passage on the axis permit a more equal distribution of the stresses between the two trusses. For example, Figures 53 and 54 present a mid-span diagonal which represents the typical behaviour of the diagonals. Stresses across the angles forming will slightly vary often being over or underestimated by a small percentage. Some other diagonals such as RD83-84 presents larger discrepancies as its mirrored diagonal LD83-84 behaves very closely to the true behaviour collected on site (Appendices 2.1 and 2.2). This different behaviour might be induced by the fact that the bridge is skewed providing therefore different results in this case. In general, a difference between the experimental and modelled data at the peaks is 0%-190%, therefore, highlighting the wide range of behaviour, and the peak values from the experimental data range from -19 to 27 MPa.

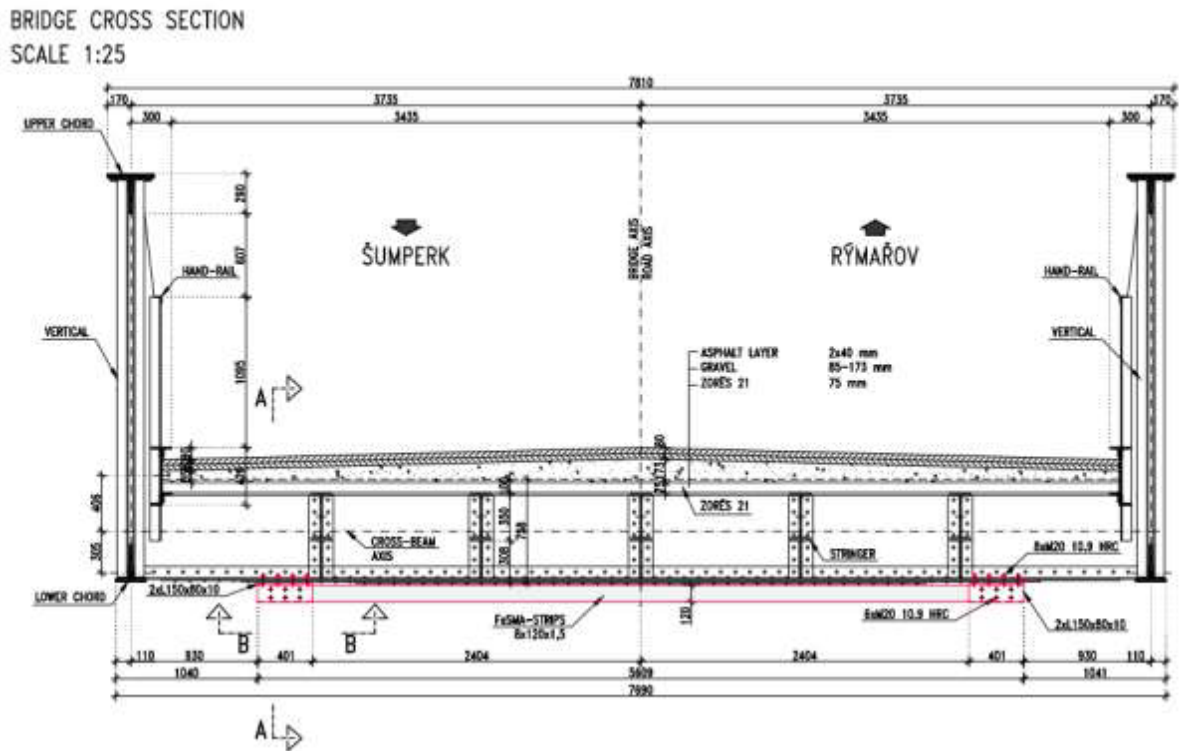
Figure 55. Location of the SMA Strengthening at the Cross-beam on the Bridge (Stančík, 2019).

use of prestressed screws. The procedure first started by exposing the SMA's to normal environmental temperatures and to then anchor it to the structure to be reinforced with the previously prescribed anchorage system. Then, the SMA was heated to an activation temperature of 260 degrees Celsius reaching 431 MPa followed by a cooling period. Once fully cooled, a new strain gauge, C224, was installed on the SMA strip for further monitoring. (Stančík, 2019)

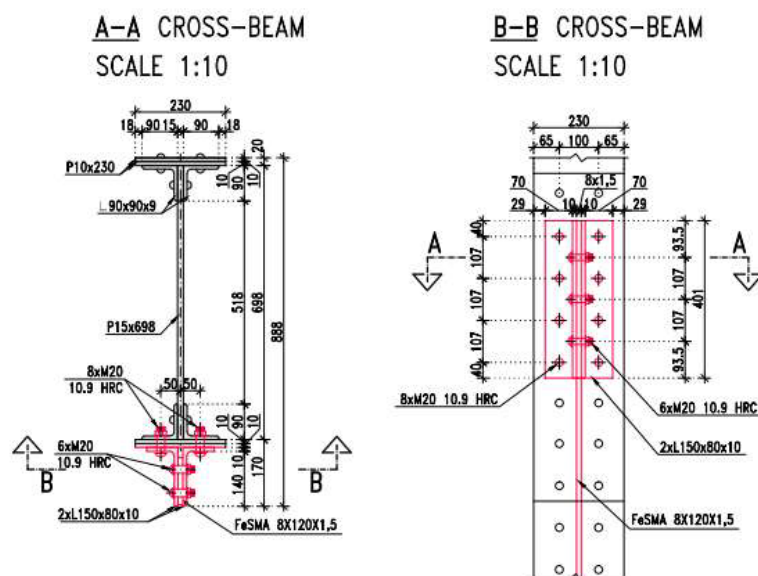
Figure 56. SMA Strengthening Anchorage System (Stančík, 2019).

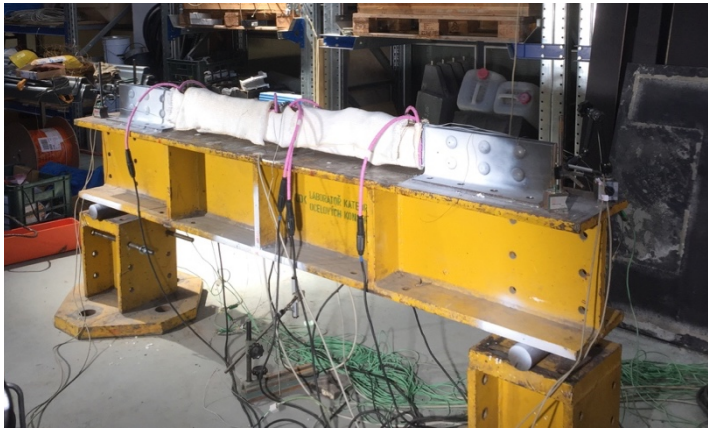
Figure 57. SMA Strengthening Laboratory Testing.

Prior to the on-site installation, a laboratory testing conducted on May 30-31, 2019 was performed to verify the SMA's applicability under real operating conditions. In addition, the testing permitted to establish the best activation technique for once on site. Figure 57 presents the test setup which consisted of a small scale representation of what would be performed on the bridge. A test I beam was used onto which the same anchoring system as for the bridge was anchored to the beam. In this case, the SMA was first activated at 140 degrees Celsius and then, finally, activated at 260 degrees Celsius. The time of heating was recorded in order to know better on what to expect on site. The system was heated with ceramic pads on both sides of the SMA covered by thermal insulation up to the desired temperature which was monitored by thermocouples. At the same time, strain gauges were also used to measure the strain in the test beam and track sensors were also used to measure the vertical deflections occurring in the beam. (Stančík, 2019)

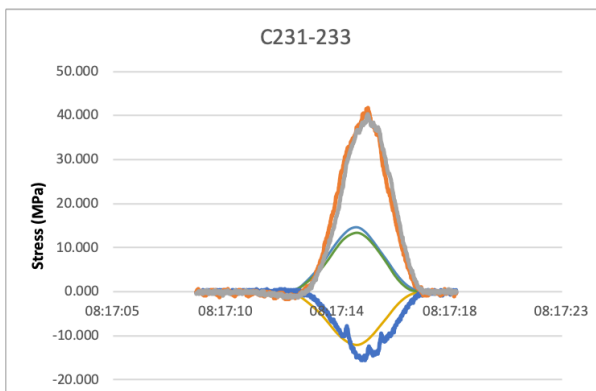
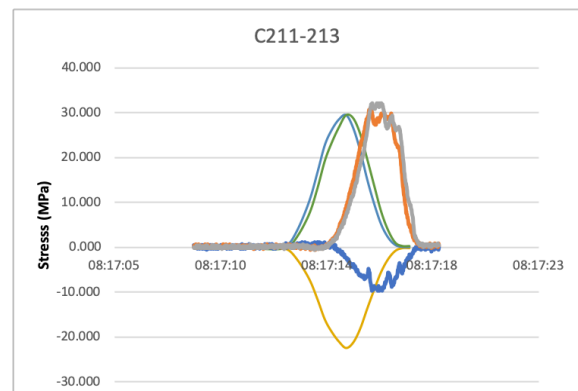
Figures 62 and 63. Calibration of the Reinforced Cross-beam for the Strengthened Bridge: C231-C233 in the Lane (left); C211-C213 in the Lane (right).

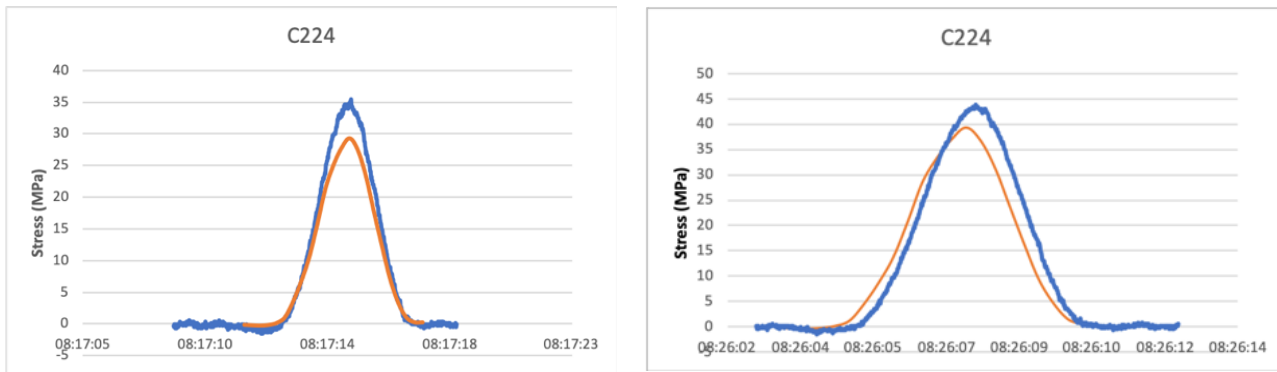
Figures 64 and 65. Calibration of the C224 SMA for the Strengthened Bridge: in the Lane (left); on the Axis (right).

In terms of the behaviour of the SMA, it can be observed that it is quite accurate and varies from 10 to 20%. This could be explained by the simplification of the anchorage system via the simple use of two rigid elements at the end of the SMA strip instead of the installed angles and prestressing bolts on-site. (Figures 64 and 65)

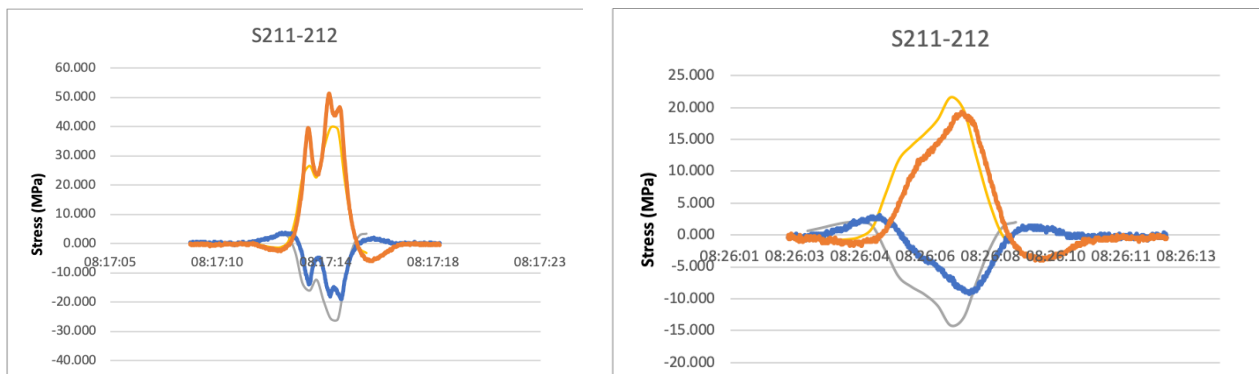
Figures 66 and 67. Calibration of the S211-S212 Stringer for the Strengthened Bridge: in the Lane (left); on the Axis (right).

In general, the stringer response from the strengthened model is quite adequate. The misalignment of the shape as for the Figure 67 can simply be caused by the inconstant speed of the moving crane during its passage. All the shapes of the stringer appear to be corresponding, but a difference in between the stresses for both the top flange and lower flange can still be observed as shown in Figures 66 and 67. In general, a difference between the bottom flange experimental and modelled data for the peak values is 0%-35% as previously mentioned and for the top flange is 20%-50%. In addition, the values for the bottom flange as per the experimental data peaks around to 17 to 46 MPa and for the top flange around -2.5 to -19 MPa.

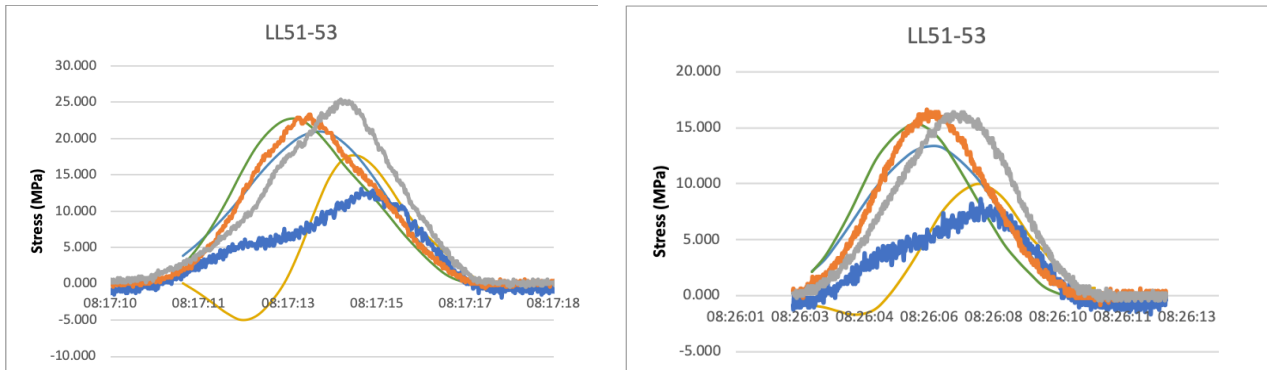
Figures 68 and 69. Calibration of the LL51-LL53 Lower Chord for the Strengthened Bridge: in the Lane (left); on the Axis (right).

In terms of the lower chord of the trusses, a similar behaviour can be observed with the reinforcement of the bridge. The correspondence between the shapes related to the experimental readings remains the same as shown in Figures 68 and 69. In general, a difference between the bottom flange experimental and modelled data at the peaks is of 12%-30% and for the web is 10-40%. Such difference is calculated by excluding the presented outlier in the figures below. In addition, the values for the bottom flange as per the experimental data peaks around 9 to 19 MPa and for the web around 5.5 to 11.5 MPa.

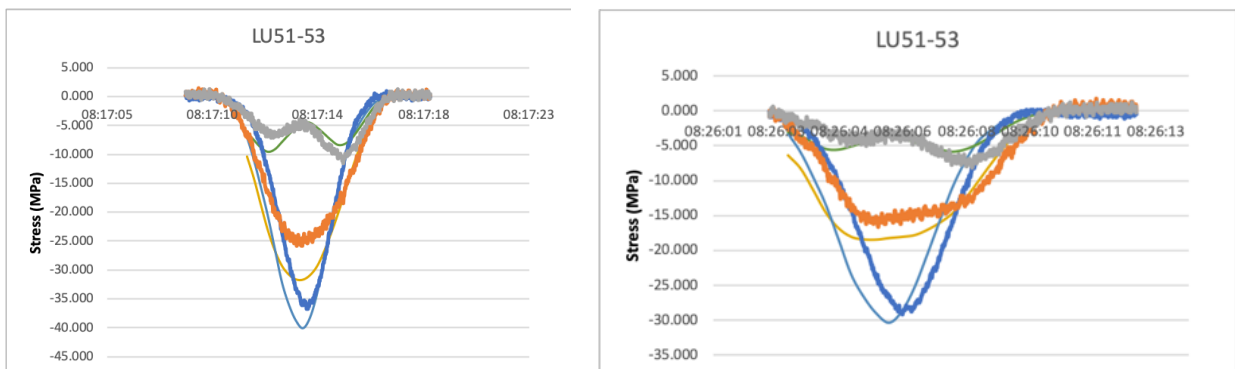
Figures 70 and 71. Calibration of the LU51-LU53 Upper Chord for the Strengthened Bridge: in the Lane (left); on the Axis (right).

Regarding the upper flange, the behaviour of the modelled data according to the experimental data is very comparable to the unstrengthen bridge. As per the lower chord graphs, the shape of the stress curve, the results are quite satisfying and no real discrepancies were observed (Figures 70 and 71). In general, a difference between the bottom flange experimental and modelled data at the peaks for the upper chords of is 10%-40% and for the web is 0%-20%. Such difference is calculated by excluding the presented outlier in the figures below. In addition, the values for the bottom flange as per the experimental data peaks around to -10.5 to -40 MPa and for the web around -3.4 to -10.5 MPa.

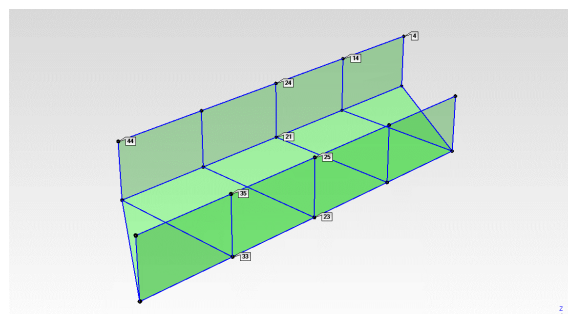
Figure 74. Accelerometers Positioning.

An operational modal analysis (OMA) was performed by Tomáš Plachy on May 20, 2019. From the results obtained from the dynamic testing of the bridge, six mode shapes were recorded based on the ambient vibrations, the traffic as well as from a few isolated impacts. For the purpose of this analysis, only the first five were selected for comparison. For the test, the accelerometers were positioned along the upper and lower chord of the truss only as per Figure 74.

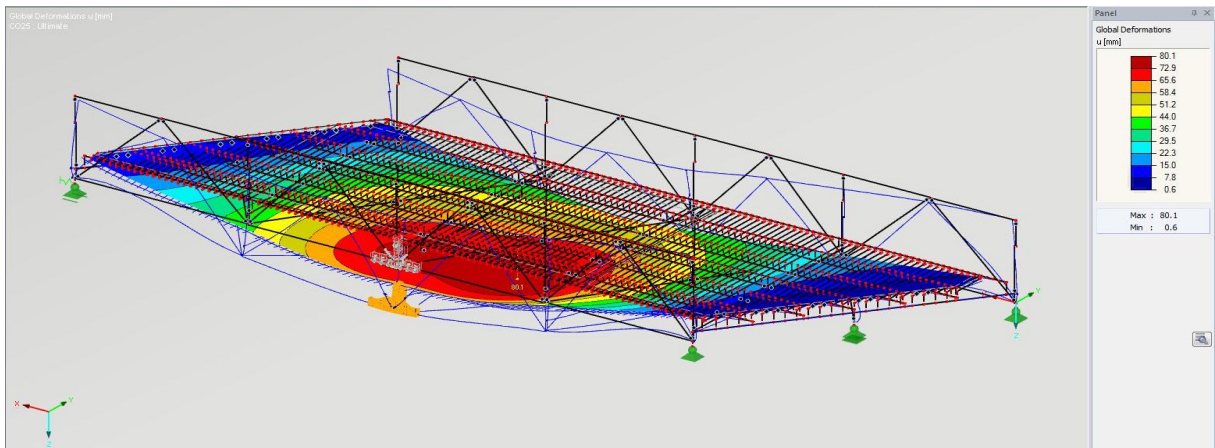
Figure 78. Deformed Shape: Ultimate Capacity Loading.
