Master's Thesis

Stability Analysis of St. Barbara Church in Otovice

University of Minho

Czech Republic | 2019

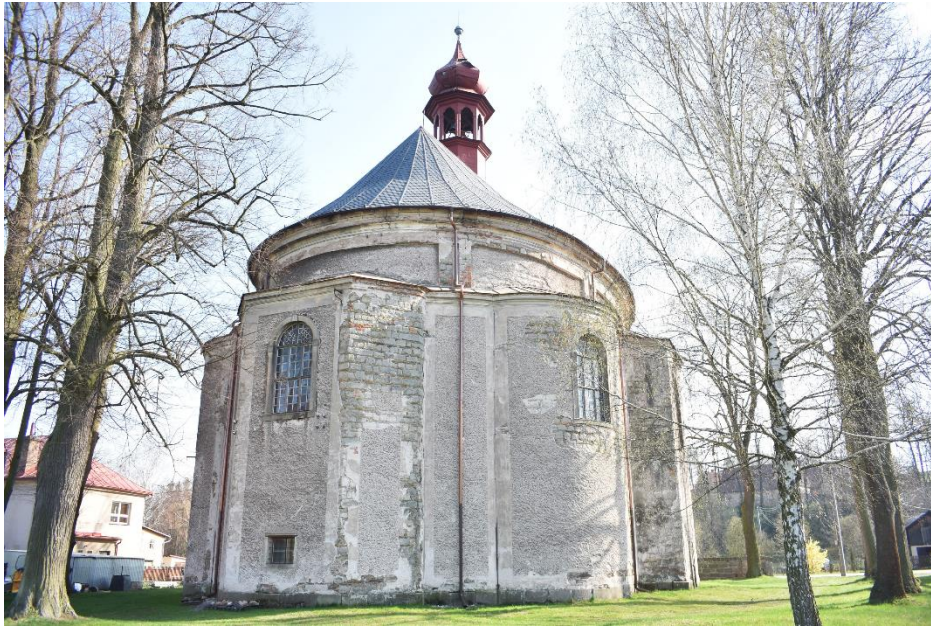
Figure 3.1. St Barbara Church

The single-aisle church has oval (longitudinal ellipse) shape with seven semicircular chapels including a chancel. It is 22m long and 15 m wide. The height of the church is 15.5m, measured from the floor to the ceiling. The interior is divided by eight pilasters without feet [8]. Robust walls are the main structural elements and they transfer roof loads to the foundations and further to the ground. The walls are made of three leaves. Coring was not performed, due to the importance of the building, but it is assumed that the infill layer is made of rubble and is of poorer quality than external leaves.

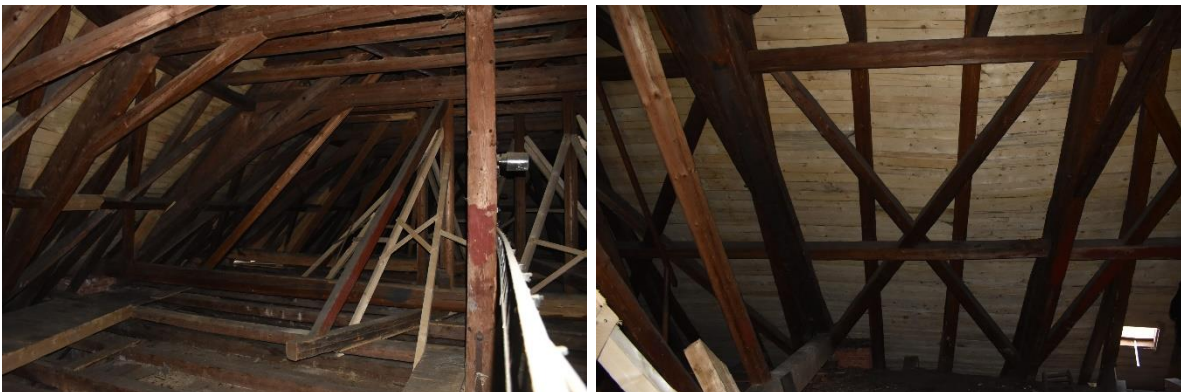
Figure 3.3. Roof truss in the Church

Externally, the church appears picturesque as a result of the curved contour due to the semicircular chapels. The structure is designed with a steep roof, which allows snow and rain to run off quickly. A roof truss is extremely complex, as it can be seen in Figure 3.3. The stability of the roof truss is improved by using St Andrew's cross. Originally, it was made of red-painted wood to finally be replaced by the more durable slate. The facades were covered by colored renderings due to weathering and economic costs.

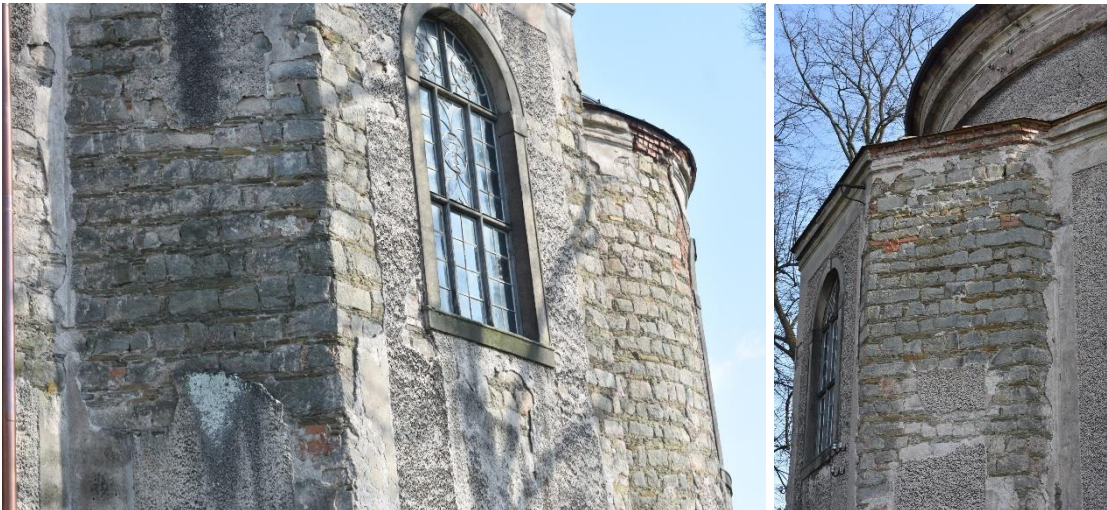
Figure 3.5. Uncovered wall facade

SM stands for Conservation state and mechanical properties of the units, **SD** depends on the units dimension properties, **SS** refers to the shape of units, **WC** to the wall leaf connections, **HJ** and **VJ** describe vertical and horizontal joints characteristics, and **MM** depends on the Mortar mechanical properties. Each parameter is graded as fulfilled, partially fulfilled or not fulfilled. Moreover, the assessment depends on the type of loading of the wall.

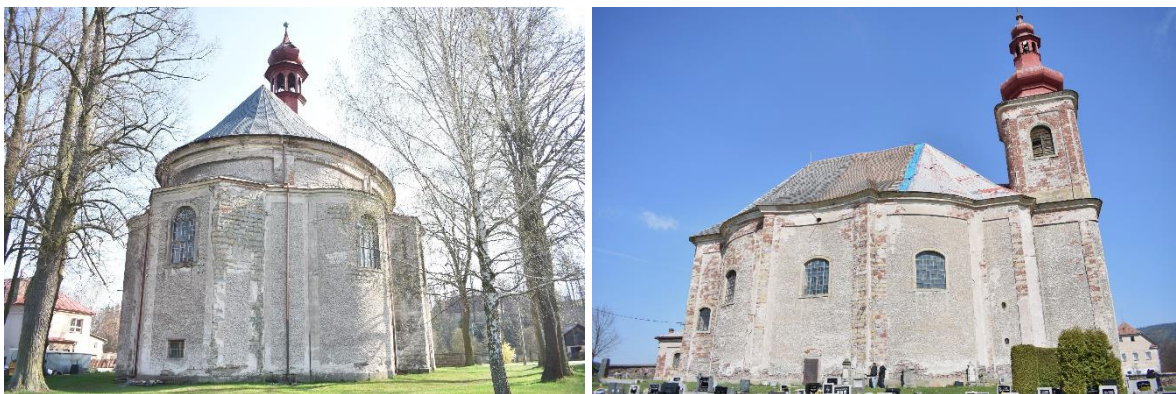
Figure 4.1. Facades of St Barbara Church (left) and St Anna Church (right)

The global condition of the exterior of the Church can be seen in Figure 4.1. In comparison with the other churches from the Broumov region, the Church of St Barbara shows a very well arranged course of stones, insignificant loss of material and good drainage system, resulting in a very good overall condition.

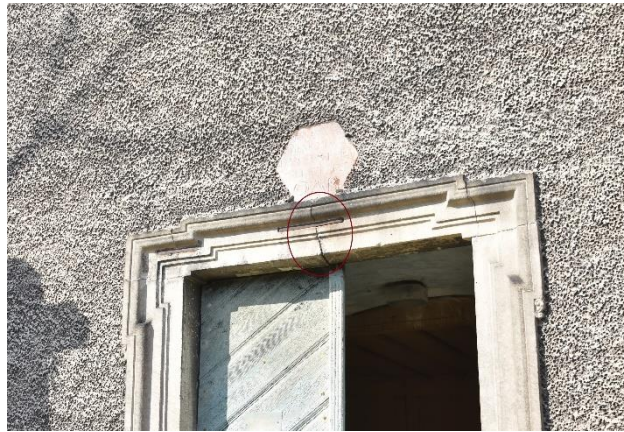
Figure 4.2. Crack in the lintel

In the facade of the church, no significant cracks were observed. However, in the front door, a typical crack in the middle of the lintel can be noticed. Further damage was stopped by using a clamp.

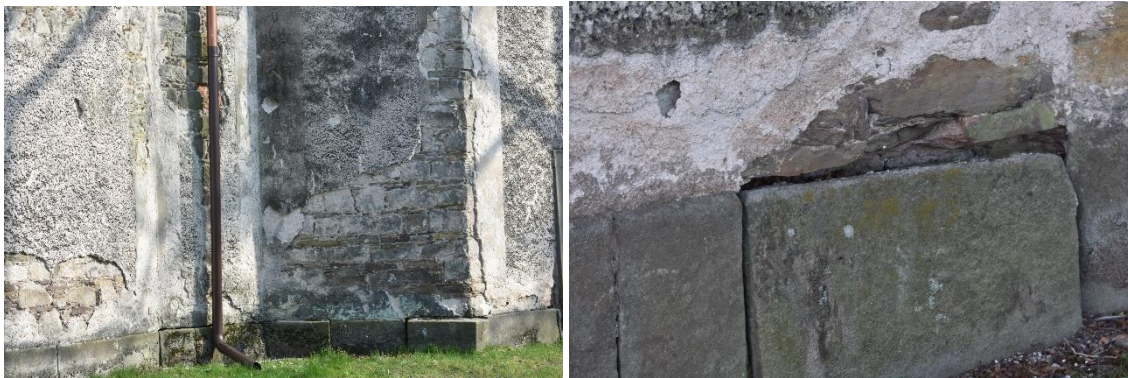
Figure 4.3. Cracks due to soil settlements

Cracks due to the soil settlements can be observed in few places, where foundation stones seem to be moved horizontally or diagonally.

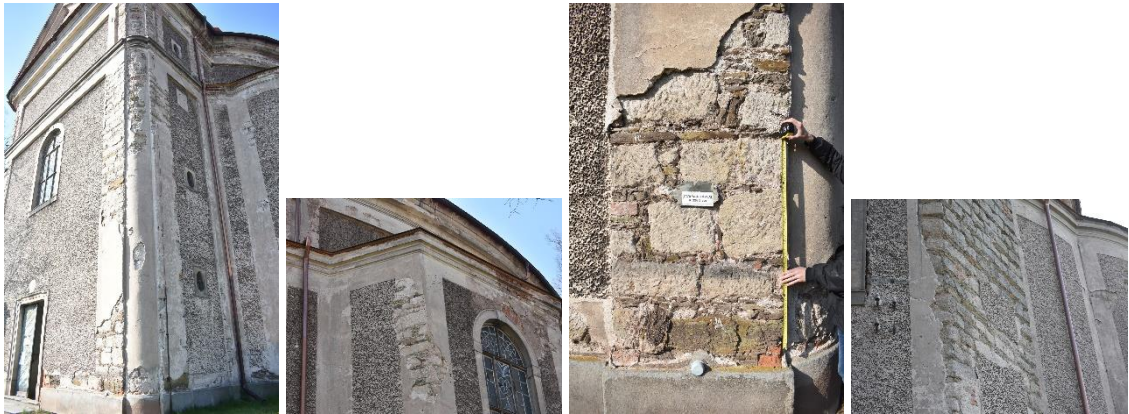
Figure 4.4. Detachment of render

The detachment of the plaster can be seen in multiple parts of the facade. Spalled render leaves the surface of stones unprotected, which can lead to further damage due to the weathering. The reason for this common phenomenon can be related to the presence of water, and its influence was reduced by the newly placed drainage system in the church.

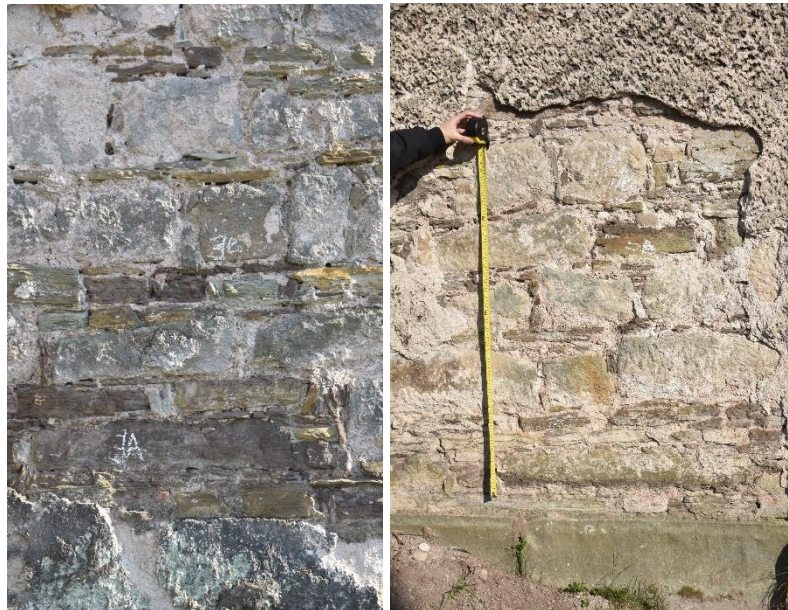
Figure 4.5. Material Loss

Due to weathering, the condition of the facade is not uniform, and the damage due to erosion can be seen. As a result of erosion, different stones deteriorate irregularly. Usually, only the stone surface is deteriorated, but the substrate is still sound. This phenomenon can be easily seen wherever the plaster is detached.

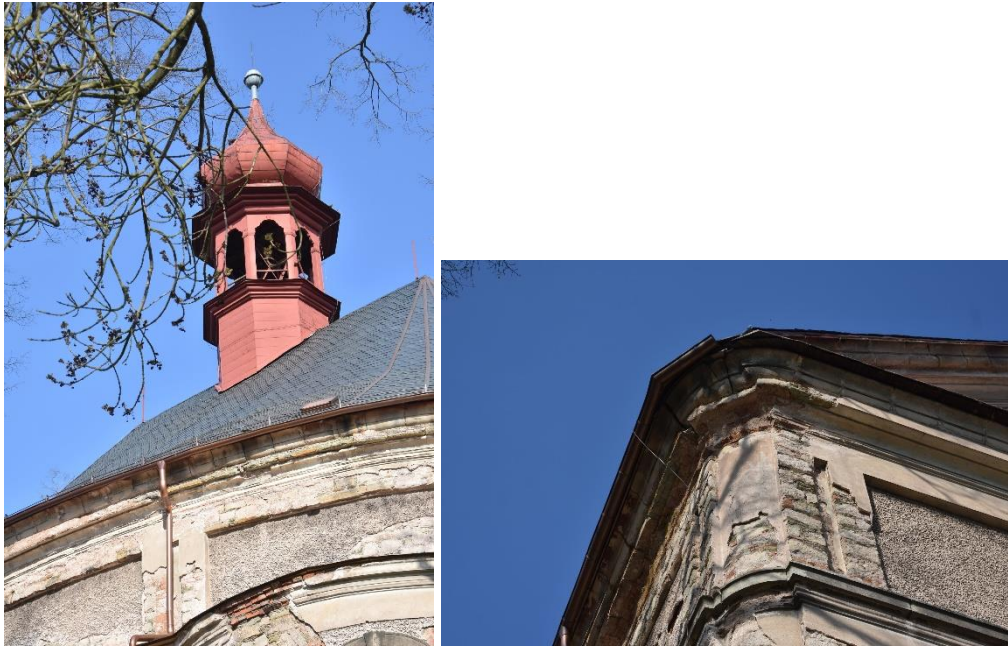
Figure 4.6. Black crust

The dark coloured crust can be observed mostly at the top of the church, in the areas that are protected against direct rainfall or water runoff. Black crust adheres firmly to the stone. It is mainly composed of atmospheric particles and its thickness is not constant.

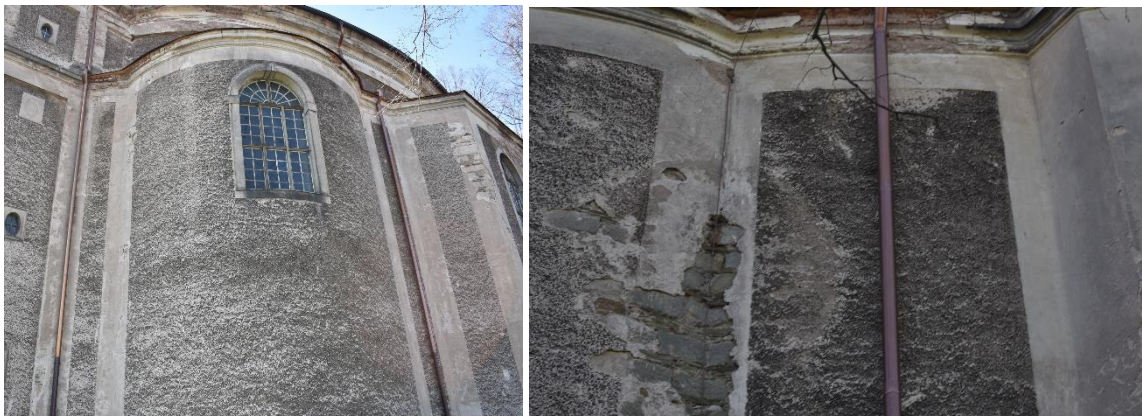
Figure 4.7. Soiling

Furthermore, soiling, which is defined as a thin layer of atmospheric particles, giving a dirty appearance to the surface, is noticed in multiple spots on the facade. The substrate structure does not seem to be affected.

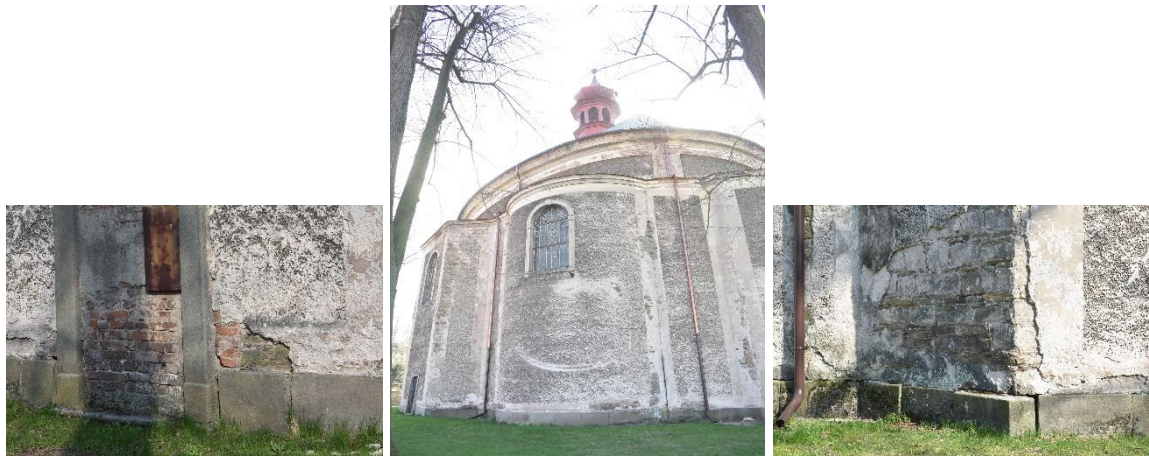
Figure 4.8. Efflorescence

Efflorescence is observed mostly at the bottom part of the structure, in the area of rising damp, where the humidity level is higher compared to the other parts of structures. Soluble salt crystals can be seen on the surface of the stone, and they are poorly bonded to it.

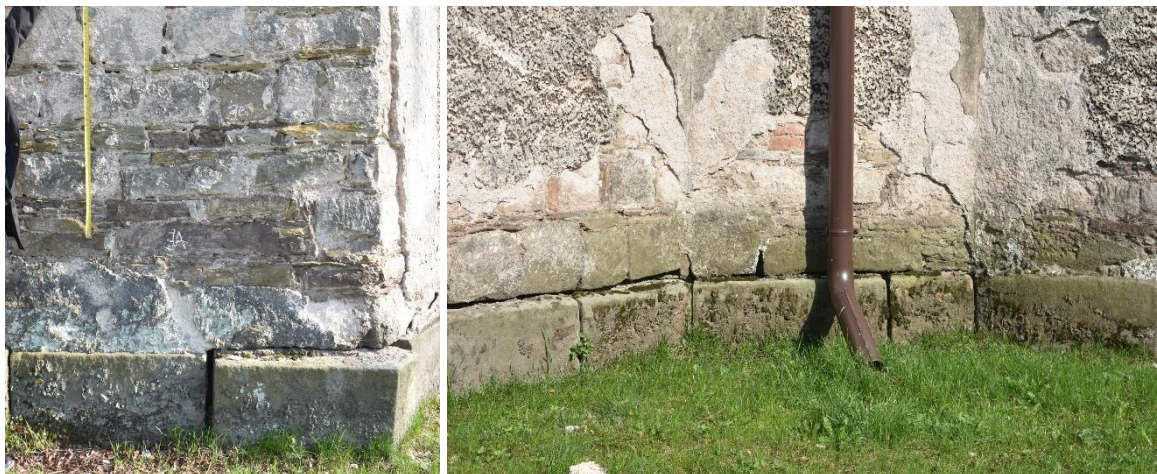
Figure 4.9. Biological growth

Biological colonization was found on the stones which are in contact with the ground, meaning the higher level of humidity allows creation of algae, lichens, and plants.

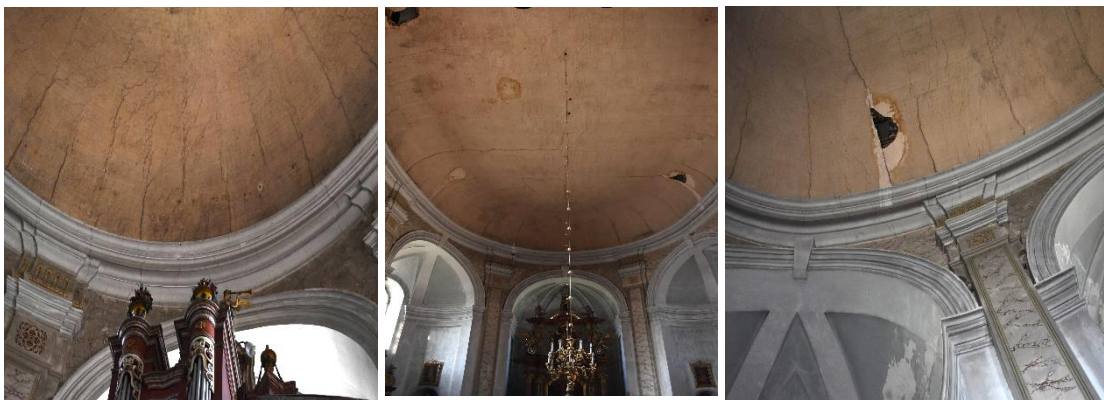
Figure 4.10. Cracks in the ceiling

On the ceiling, cracks with the regular patterns were observed. Their origin is probably related to the false vault system used in the Broumov group of churches since the same cracks were also detected in St. Jacob Church. Development of cracks occurred probably due to the long term actions and deformation of timber elements in roof trusses.

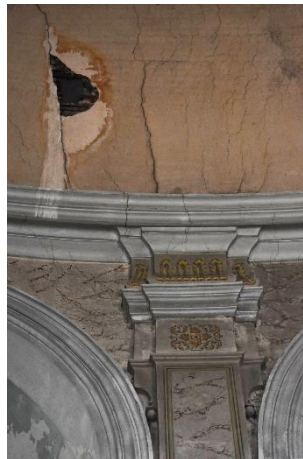
Figure 4.13. Cracks above pillar due to the concentration of stress

Moreover, some of the cracks can be related to the local concentrations of stresses.

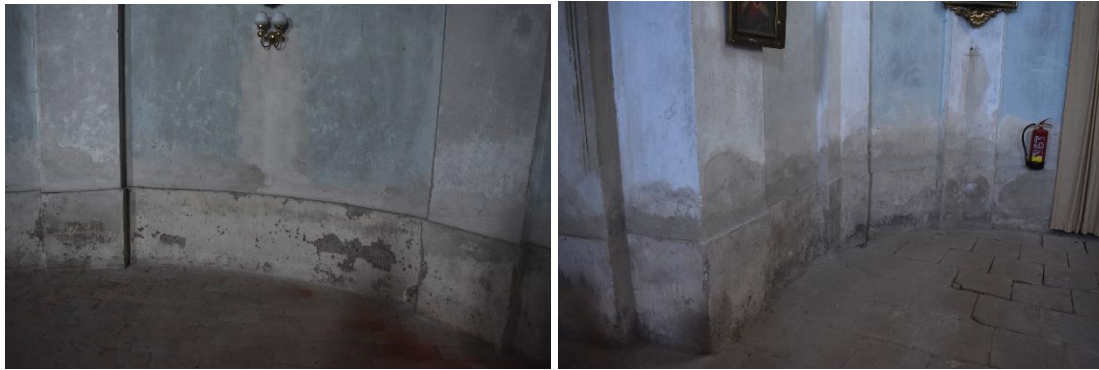
Figure 4.14. Discoloration due to previous interventions and humidity level

Locally, parts of plaster are detached and it can be seen that previous similar damages were treated during past interventions. During these repairs, applied plaster was based on cement, which is not the best solution for masonry walls, due to the low compatibility of properties.

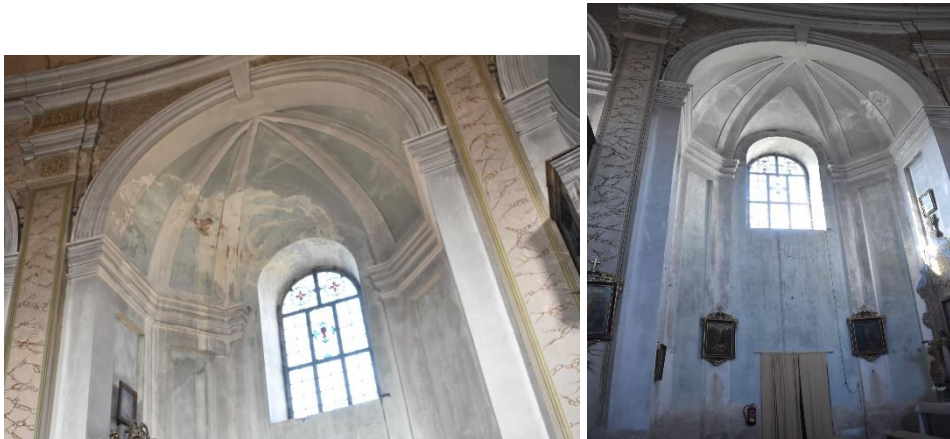
Figure 4.15. Humidity stains on the plaster

Stains on the plaster on the ceiling were noticed, most likely due to the water infiltration. Different levels of this damage were noticed. The ultimate stage of this damage is a hole in the ceiling, which could lead to even worse deterioration.

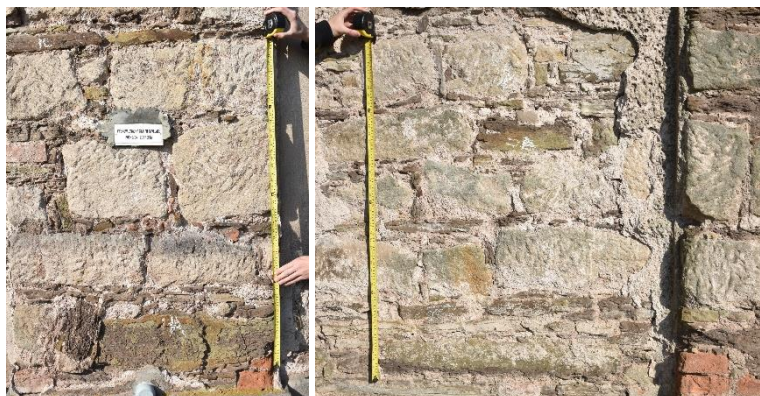
Figure 5.1. Two different parts of the enclosure walls that were tested

External parts of the walls with detached render served as testing locations. In order to have more accurate results, testing was performed on two different parts of the enclosure walls, the first one located in the facade wall, and the other in the longitudinal wall. Data from these spots were used in further analysis, as it can be seen in Figure 5.1. In order to obtain the surface hardness, which can yield the useful value of the superficial strength of different stones, the non-destructive Schmidt Hammer test was performed. In Figure 5.1 and Table 5.1 detailed drawings of the testing spots in the external leaf of the wall, as well as results obtained by Schmidt Hammer campaign, can be observed. The main disadvantage of this method is that it represents only a 5cm deep layer and does not provide the information on the characteristics of a whole volume of element. Moreover, the obtained data is very sensitive to the presence of moisture and it is important to be careful with the application of these results. In each sample, three different types of stone were noticed, as well as the deteriorated units on which the test could not have been carried out. The rebound test was performed 15 times on each stone, and then Schmidt Hammer provided results of the average value of the rebound number and Standard Deviation.

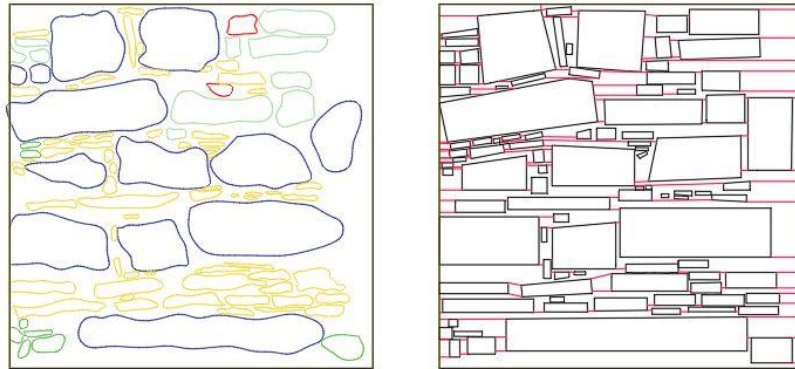
Figure 5.6. Longitudinal Wall

The valuable information about the structural behaviour can be obtained from the data collected during the analysis at the monitoring points. The first monitoring point was chosen near the line where the prescribed displacements were applied. The second monitoring point was chosen at the support, in order to obtain the value of reaction. The disadvantage of ATENA 2D is that it can not provide a summation of reactions, so they were obtained from output reports and summed manually in Excel. The strain of the model was calculated as the total displacement divided by the length of the model, while the stress in the wall was obtained as the sum of all reactions divided by the width of the wall. Load-displacement curves can be seen in Figures 5.7 and 5.8.

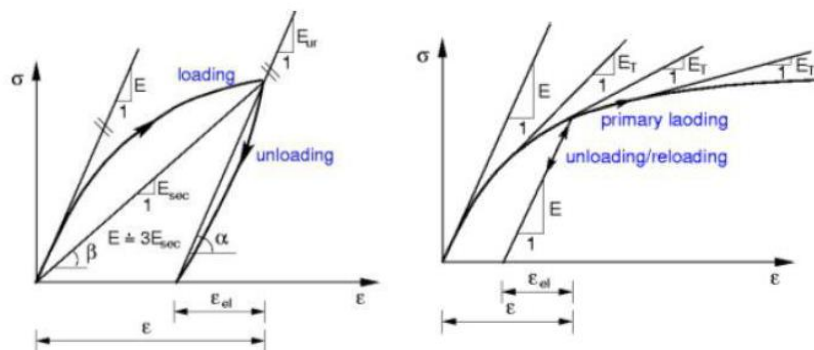
Figure 6.4. Real behaviour of soil (left) and Mohr-Coulomb model (right)

Regarding the constitutive model of soil, in software, it is possible to analyze a purely isotropic material, which is not very accurate. The more realistic assumption would be modified elastic law, which assumes different material response in loading and unloading. For this model, it is necessary to know E_{ur} , which is unloading-reloading Young's modulus.

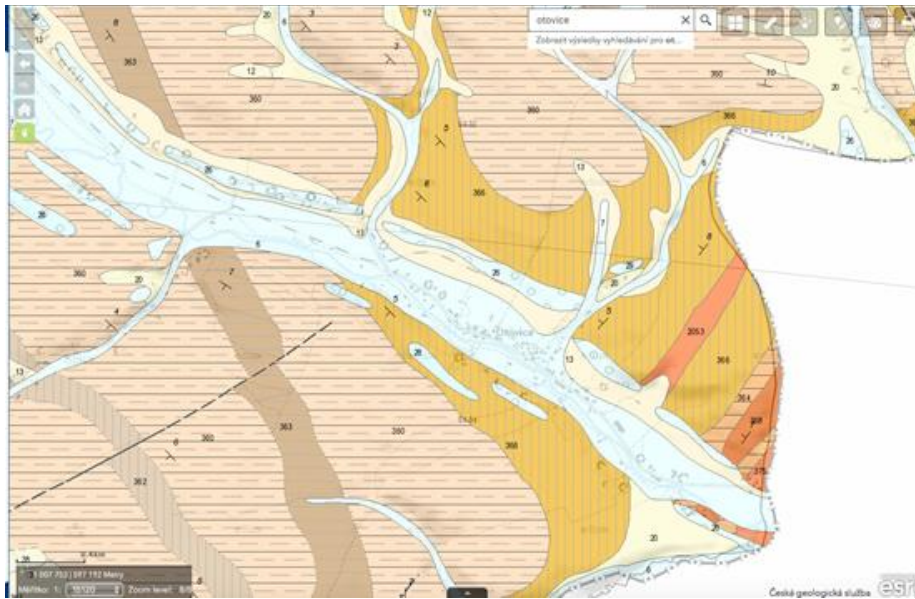
Figure 6.5. Geological Map of Otovice (366- gray sandstone, 360- siltstone, 2053 - limestone.) (Geology.cz)

In Otovice, where St Barbara church is located, the bedrock consists mostly of siltstones, sandstones, and claystones. These stones are classified as sedimentary, as they were formed in the process of sedimentation, which is accumulation or deposition of small mineral or organic particles on the seabed. The surface layer is composed of sandy soil with a small amount of claystone. The colour of layers changes from red-brown to gray claystone in the bottom. Compaction and degradation due to the weathering are different for each layer. The geological map of Otovice can be seen in Figure 6.5.

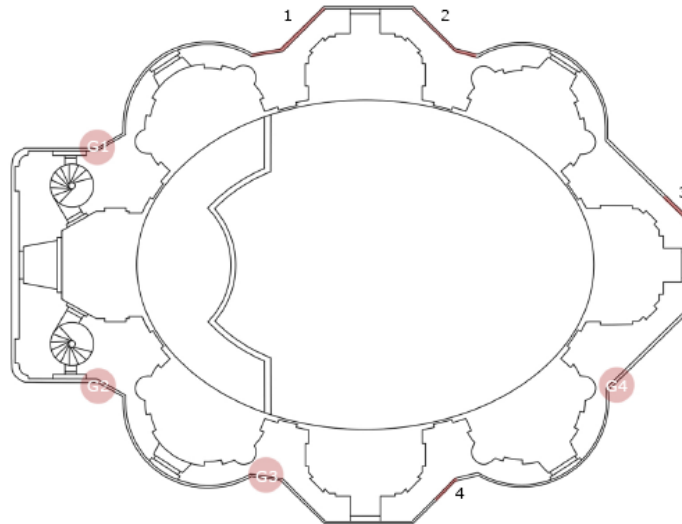
Figure 7.4. Location of gutters and settlements

As it was already mentioned, the soil around and under the Church seems to be in a very good condition, showing only slight deterioration in the areas close to the gutters. Due to the water flow, the soil is eroded, and this could be a possible reason for settlement and cracks in the walls. Few hypotheses will be verified, depending on the location of the gutter and the level of decay of soil.
