## TUNNEL PORTAL INSTABILITY IN LANDSLIDE AREA AND REMEDIAL SOLUTION: A CASE STUDY

**KEYWORDS:** Slope instability, collapse, landslide, Sabzkuh Tunnel, remedial solution.

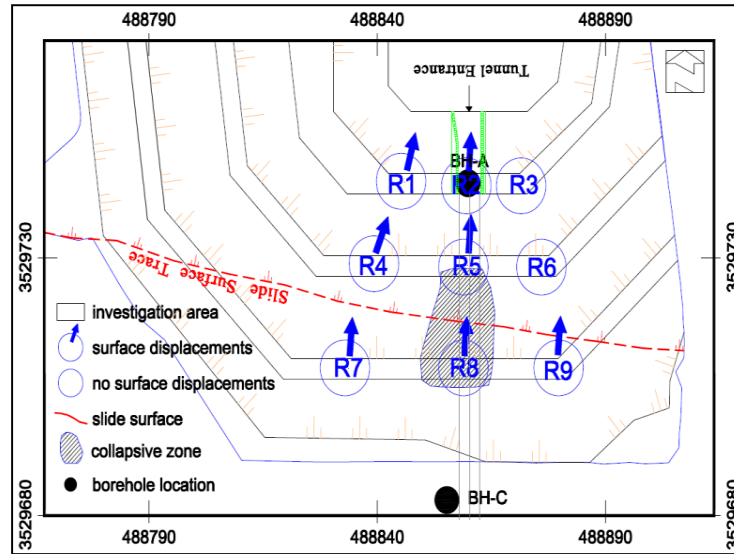
FIGURE 3. The location of monitoring points in the tunnel portal.

This caused the alarm for geotechnical engineers to design a monitoring system using mapping points for monitoring slopes. For this purpose, nine settlement markers were installed on the surface along the tunnel and the berms and the monitoring of them was carried out by surveying (Figure 3). Readings of those markers were taken at regular intervals to check for any signs of settlement or heave. The results of the monitoring showed some displacements in both Z and Y directions.

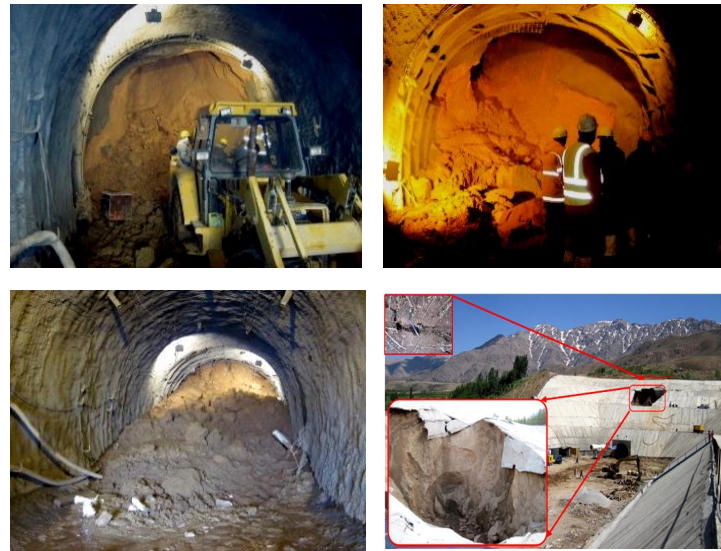
The excavation operation of the T1 part of Sabzkuh tunnel was generally performed below the groundwater levels. Because of the excavation operation in the saturated ground, the pore water seeped into the created cavity. On the one hand, the flow of the groundwater reduced the quality of geotechnical parameters of the soil mass around the tunnel, but, on the other hand, reduced the effective stress around the tunnel. This problem along with facing the old landslide surface with complex geological stratification, and inappropriate excavation pace, led to the instability on the tunnel crown. Encountering these areas at a distance of 35 m along the tunnel simultaneously led to local collapses in the forefront of the excavation operation and the rapid development of collapses in less than 8 hours towards the tunnel crown, creating a chimney-like cavity at the top of the tunnel and

eventually leading to the slope failure. In addition, the activation of the old landslide surface caused the mass smoothening of about 1000 cubic meters of soil from the collapsing area into the tunnel exterior and the development of the cavity into the entrance slope (Figure 4).

FIGURE 4. The development of the collapse and slope failure.

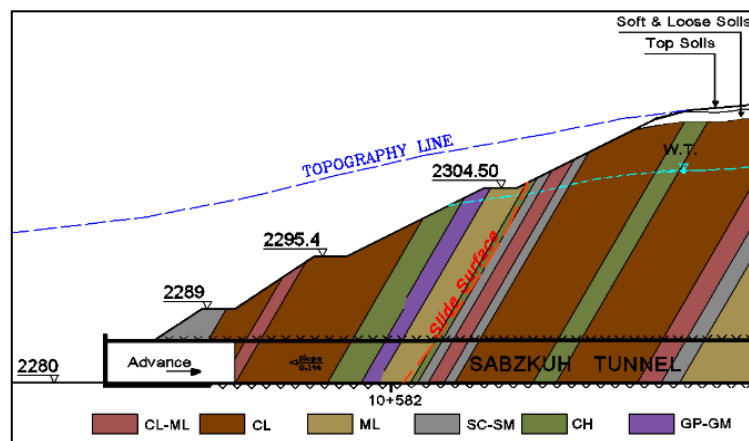
FIGURE 5. The geological characteristics of the soil layers of tunnel portal.

weak layers. Thus, special attention must be paid to the geological aspects when performing the slope stability assessment. In Figure 5, the geological characteristics of the soil layers, the slope of the layers, the groundwater level, and the different levels of overburden of the tunnel are displayed at a distance of 350 meters from the tunnel entrance (Figure 5).

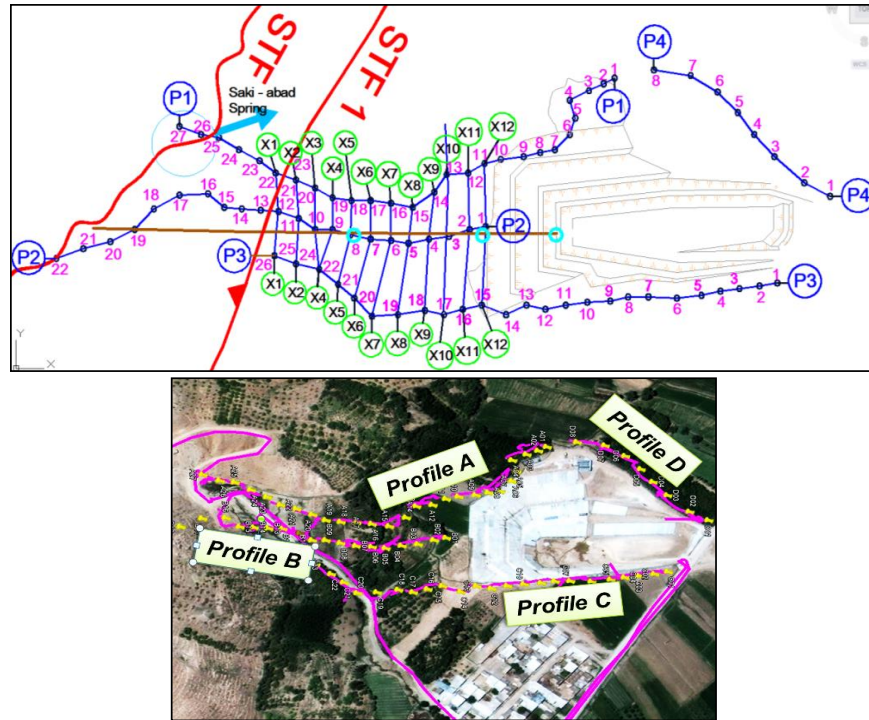
Geoelectrical explorations that were performed in this study used combined resistivity profiling (CRP). This technique is able to detect heterogeneities and discontinuities, such as fault zones and intersections, in the studied area. In order to evaluate the variation in the resistance of alluvial layers and detecting them based on their resistivity and their possible rupture to a distance of 350 meters from the entrance of the tunnel, a total number of 82 CRP stations were used on four main exploration lines called lines 1 to 4 with a north-south orientation. In addition, a total of 12 offset lines, termed as X1 to X12, were marked on the location map (Figure 6).

FIGURE 6. Profile plan of geoelectrical explorations.

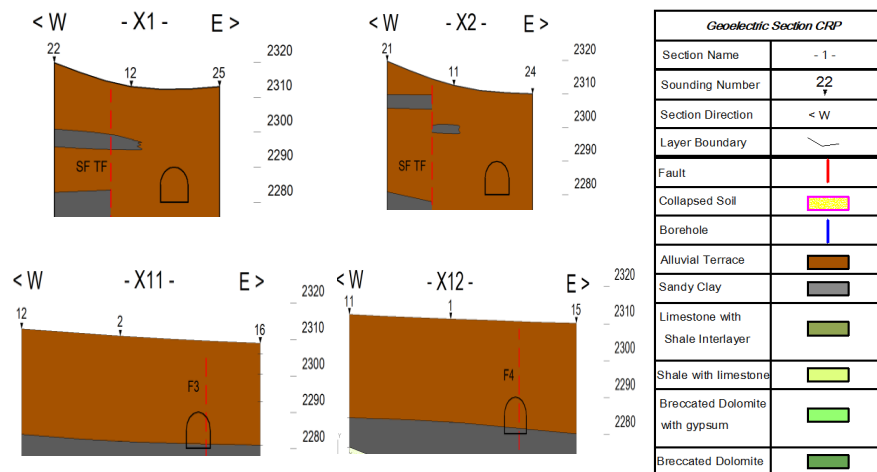
FIGURE 7. The cross-section of geoelectrical explorations.

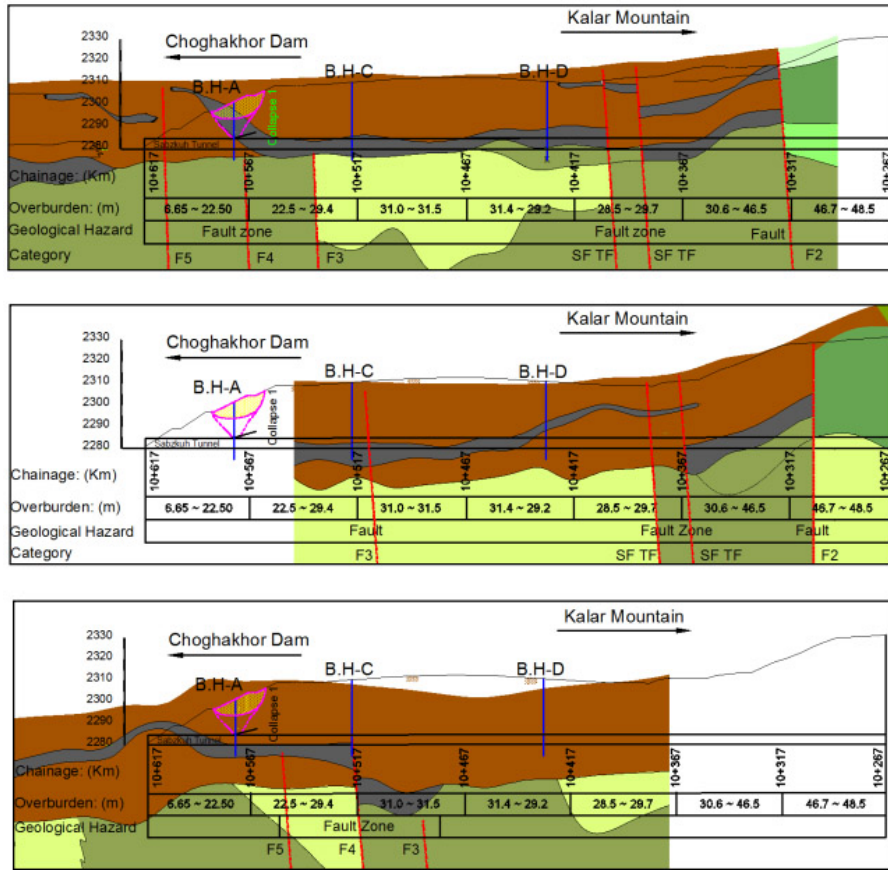
FIGURE 8. Profile plan of geoelectrical cross-sections.

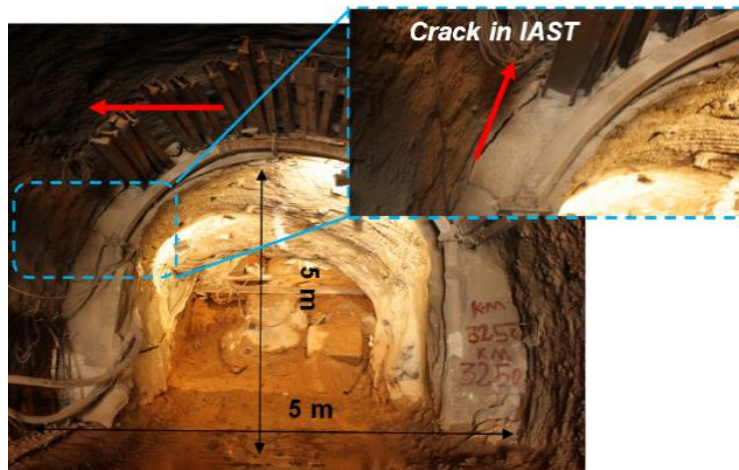
In April 2013, coinciding with the implementation of the drainage system in the slopes and before the start of the tunnel excavation, after heavy rainfall and rapid melting of snow because of a spike in temperature in the surrounding mountains, signs of the increased stress imposed on the pre-support systems and the arch support technique were observed (Figure 10).

FIGURE 10. Cracking in the pre-support system.

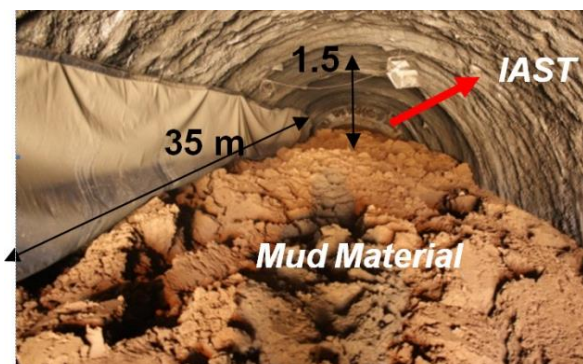
Following this, just one day after the heavy rainfall, the second event occurred. Within 35 meters of the tunnel entrance, about 500 cubic meters of soil in the form of debris flows started to move from the tunnel crown toward the entrance of the tunnel in 8 hours (Figure 11). The samples taken for the materials showed that more than 50 percent of the materials included gravels, sand, and silt and only a small percentage of clay. These materials started to flow down under the influence of the steep slope of layers, the gravity, and gravitational forces accompanied by the increased leakage force. In addition, another reason for the occurrence of debris flow was the presence of an old landslide in this area, which placed unstable soil masses on steep slopes. The infiltration of water flow over the old landslide lubricated and smoothed the sliding materials. Besides, the impacts and shocks from the arch support system stimulated sliding masses in the slope followed by decreased resistance forces, which resulted in debris flows inside the tunnel.

FIGURE 11. The mud flow running into the tunnel.

to its high rigidity. After the discharge of sliding materials inside the tunnel, so as to prevent re-occurrence of the problem and reduce the pressure from the excavation, the forefront was plugged with plastic concrete with a thickness of 10 m before resuming the excavation.

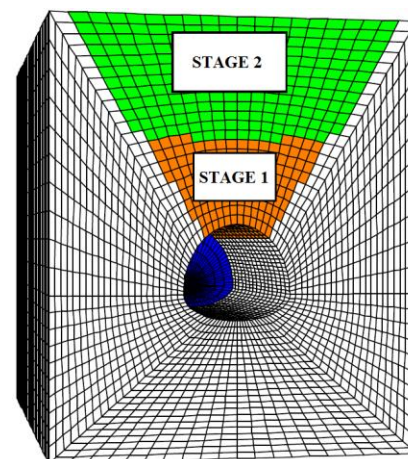
In order to model the filling conditions of the collapsing cavity, it was divided into two parts: The first part started from the tunnel crown to a height of 5 meters and the second parts included areas from a height of 5 meters to a height of 11.8 meters (Figure 12).

FIGURE 12. Two stages of filling the collapsing cavity above the tunnel crown.

To fill the cavity developed in the slope by meeting the slope stability requirements and minimizing stresses applied to the pre-support system, three options were proposed, (Table 3) and the three-dimensional modelling was performed using FLAC-3D Software [10]. The input parameters of the soil for the modelling are shown in Table 1.

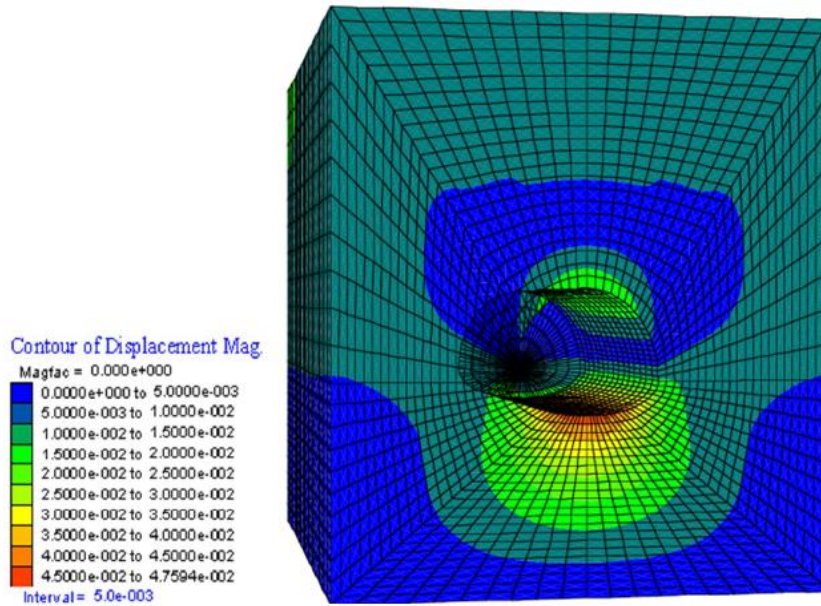
In the next stage, the properties of filling materials were studied and the displacement and maximum stress on the crown were calculated. The technical and economic results indicated that the first option is not favourable because of the displacement and high stress imposed on the support system. From the second and third options, the second option was selected due to lower displacement and stresses applied to the tunnel crown and its economic advantages. As shown in Fig. 13, the maximum calculated displacement in the tunnel crown after filling the collapsing cavity with soil and lightweight aggregate concrete (LWAC) is about 20 mm.

FIGURE 13. The displacement changes around the tunnel after filling the collapsing cavity with the second option.

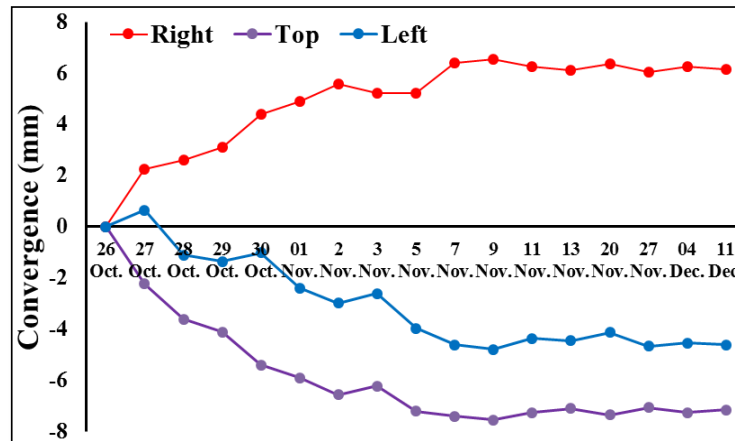
In order to validate and verify the results of the numerical analysis, a convergence station was installed in the centre of the tunnel crown in the collapsing area and the displacement of the support system during the filling process was monitored and recorded. The maximum displacement recorded in the tunnel crown was 8 mm. The results of the monitoring are shown in Figure 14.

FIGURE 14. The displacement curve of the convergence station in the centre of the tunnel crown in collapsing area.

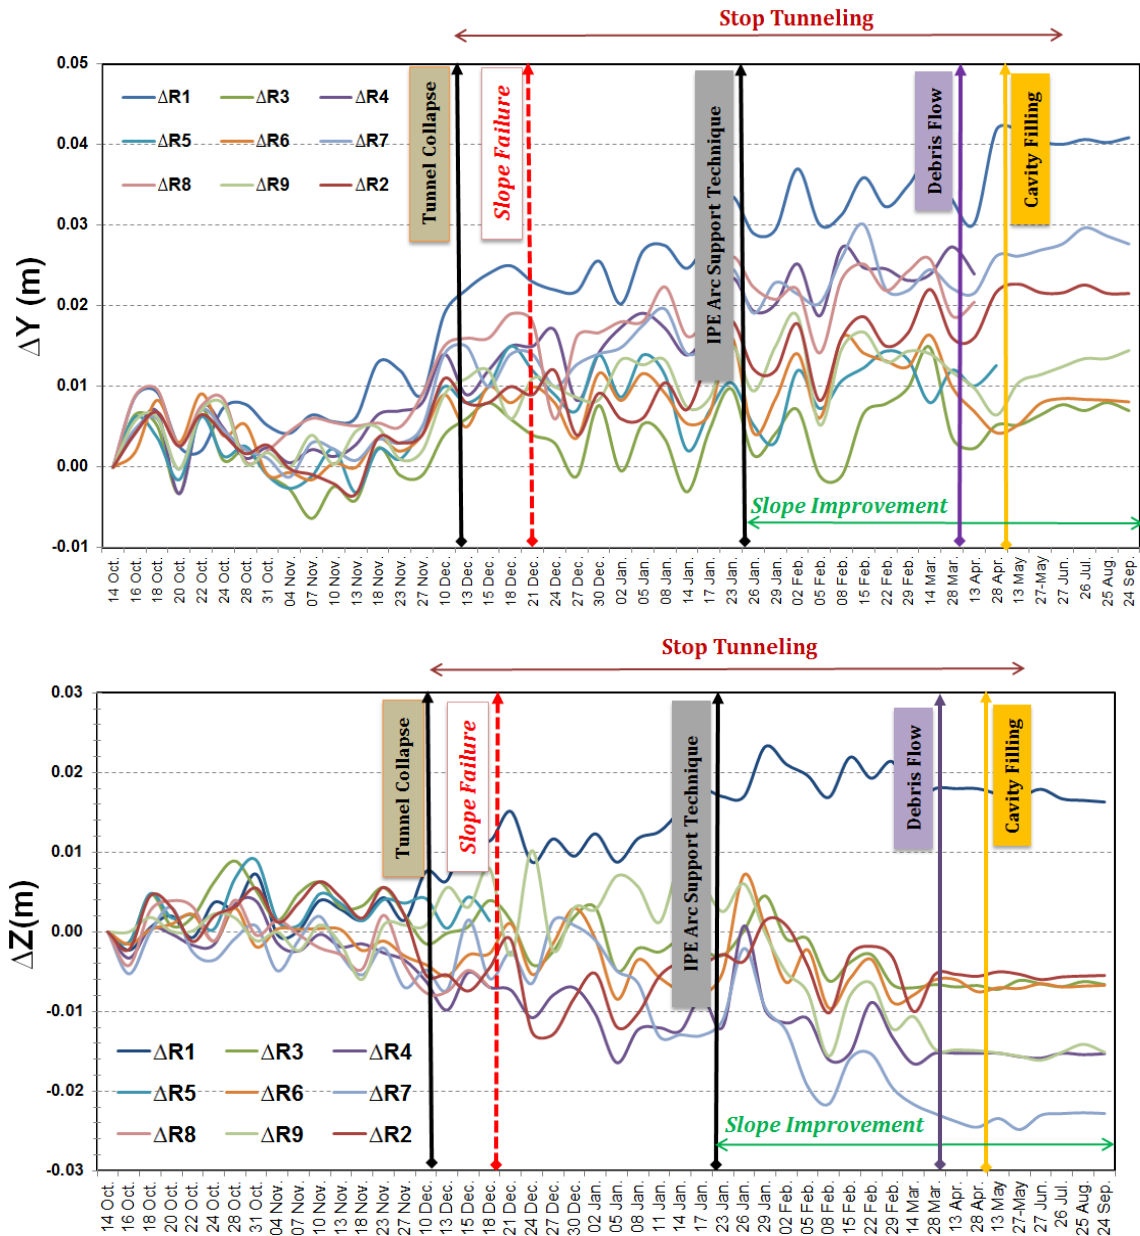
forcement procedure, the slope monitoring continued through visual visits and geodetic surveying to make sure that the instability would not be further developed in the long run. As it is shown in figure 14, before the start of the reinforcement operations, the displacement rate was on the rise. The displacement along the Y axis was greater than along other axes due to a higher sliding potential. The maximum displacement was observed in Pin No.1, which was caused by a high pore-water pressure in this area of aquifers that were observed during the slope excavation. After performing each step of the improvement in the tunnels and the slope, displacements slowed down. After the completion of the improvements and with the start

of the stage excavation, displacement rates became almost stagnant (Figure 15).

FIGURE 15. The slope monitoring stages.
