**THE CURRENT STATE OF SELECTED CHURCHES  
OF THE BROUMOV GROUP  
NUMERICAL ANALYSIS OF WALL FAILURES**

**Master's Thesis**

**Prague, 2020**

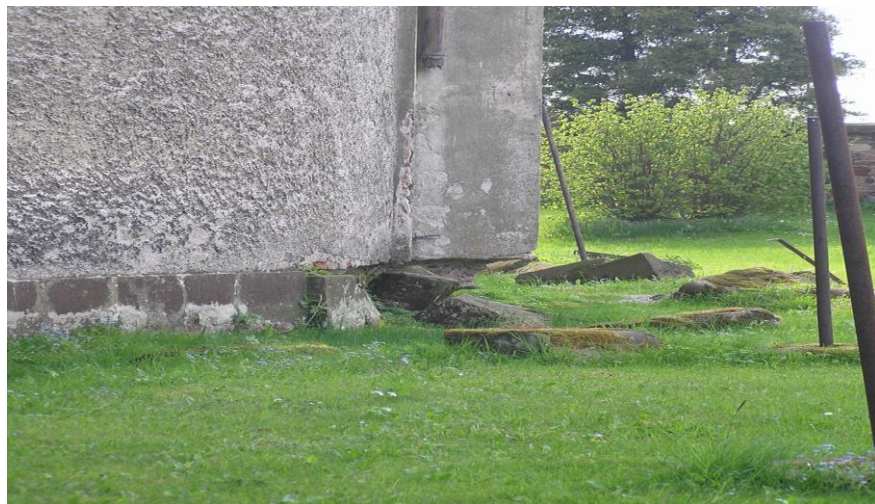
**Picture 23: Deterioration of the external wall**

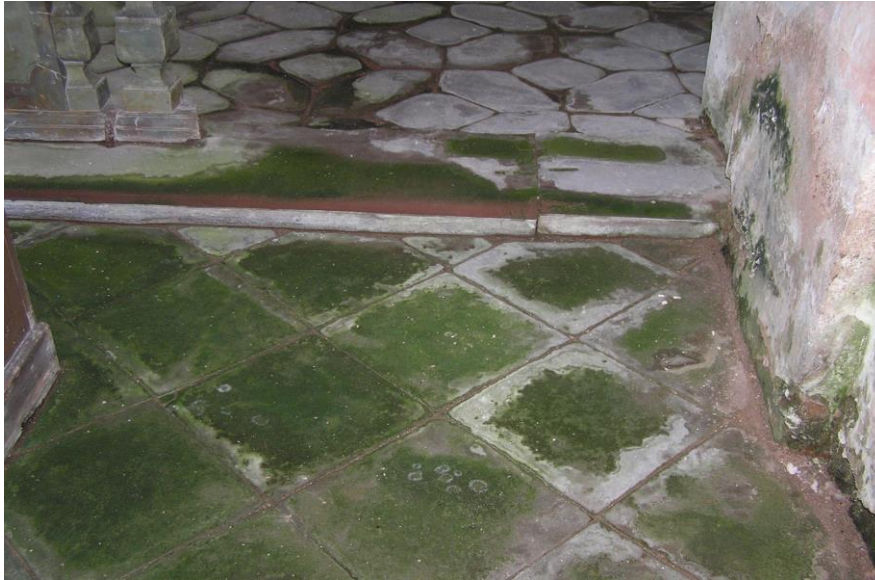
**Picture 24: Moss on the floor of St. Anna's Church in Vižňov**

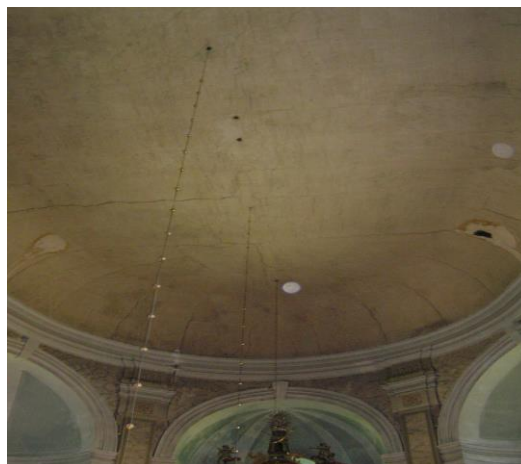
**Picutre 28: Cracks of the Ceiling ( St. Barbara's Church)**

The walls and the ceiling are cracked on several places. The crack of the ceiling is originated in the vault-system, used in the Broumov Group of Churches. Deformed timber elements are also a reason, why cracks are located around main trusses.

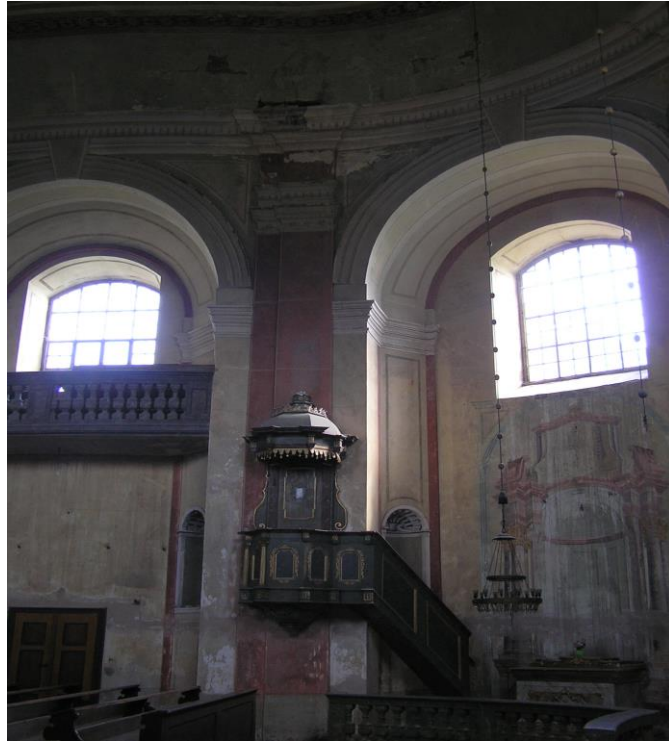
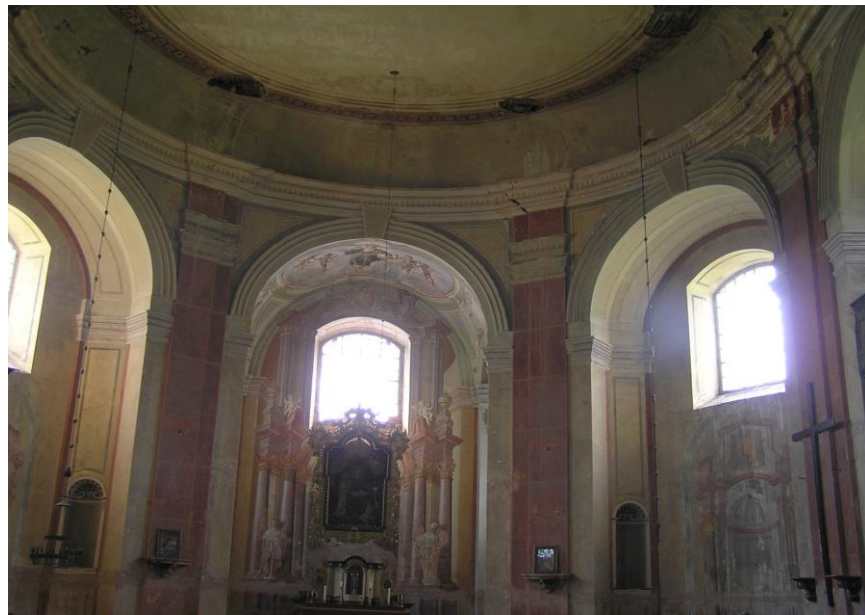
**Picture 29, 30: Cracks of the internal wall and ceiling (St. Anna's Church)**

Both churches have interior and exterior cracks. Crack is a complete or incomplete separation of the concrete into two or more parts (19) (Pictures 28-32). Burland and Day (20) provides classification of cracks based on visual damage to the walls:

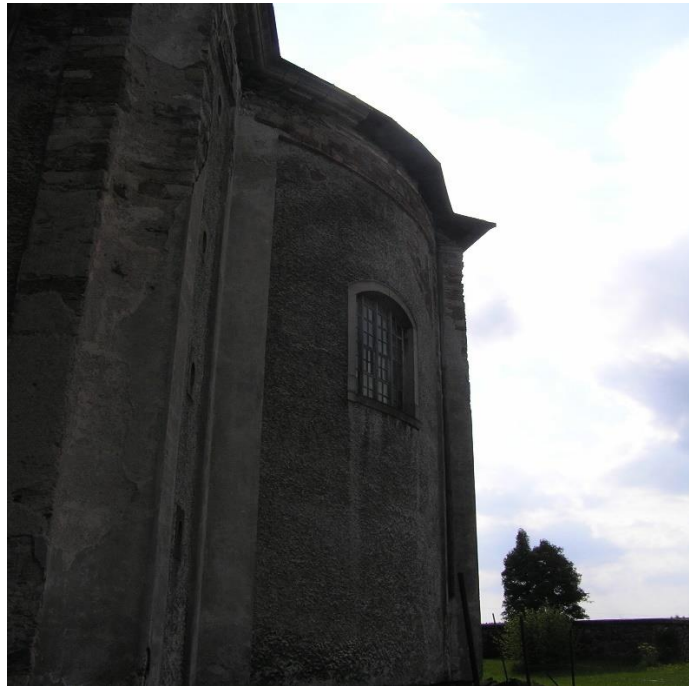
**Picture 31: Cracks, render loss and erosion of the stones (St. Anna's Church)**

Rising capillarity caused on both churches severe damage (more on St. Anna's Church), which led to loss of plaster and biodegradation due to moss and fungi. The loss of the render causes, that the stones are not protected and they are exposed to weathering and other external influences directly. Because of the roof damage and insufficient drainage system, St. Anna's Church is in even worst condition due to rainwater flow, causing severe problems of soil settlement too.

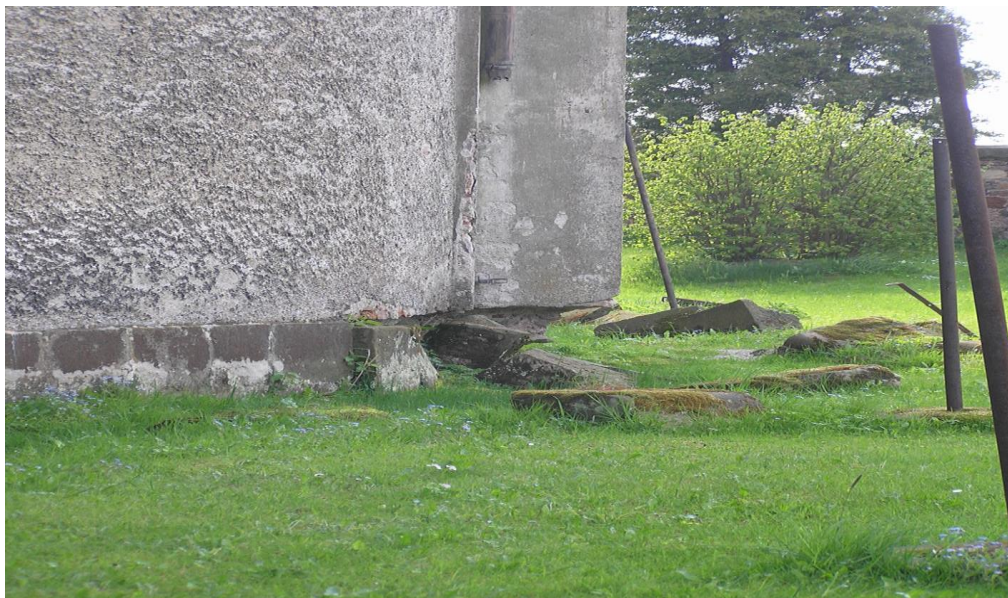
**Picture 32: Deformation of the external wall (St. Anna's Church)**

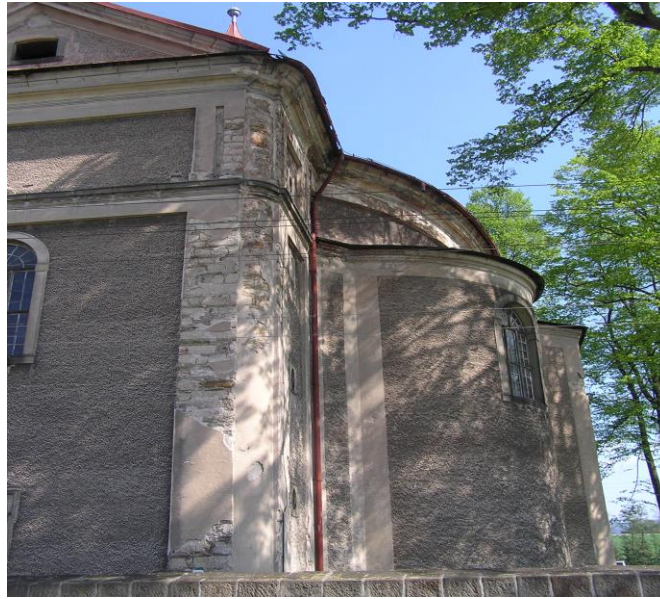
**Picture 33: Missing render of the external wall (St. Barbara's Church)**

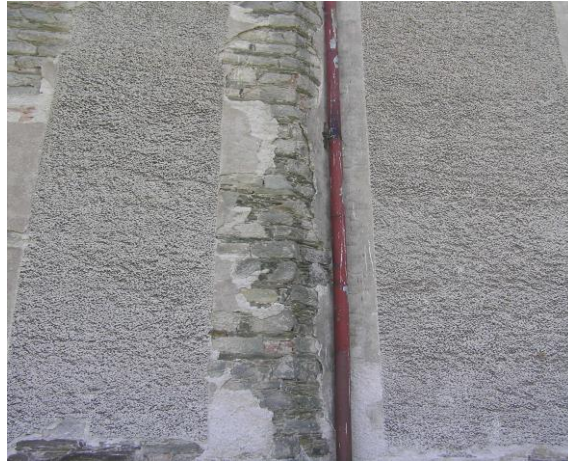
**Picture 34: Discoloration of the external wall and missing render  
(St. Barbara's Church)**

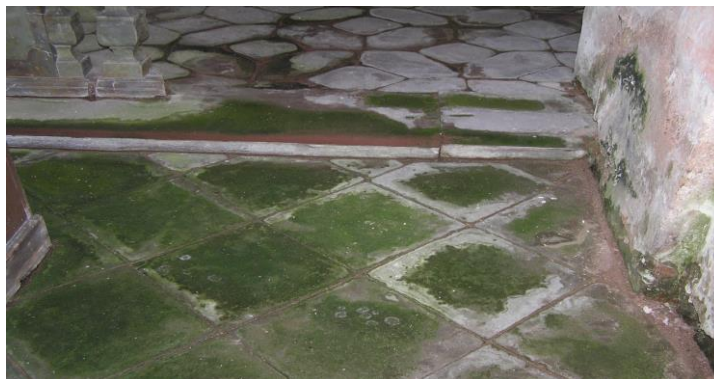
**Picture 35: Moisture, biological degradation - internal wall and floor  
(St. Anna's Church)**

Moisture can lead to damage of the plaster and renders of a building. The presence of moisture in the surfaces allows growth of moss and fungi, which causes biological degradation of the material.

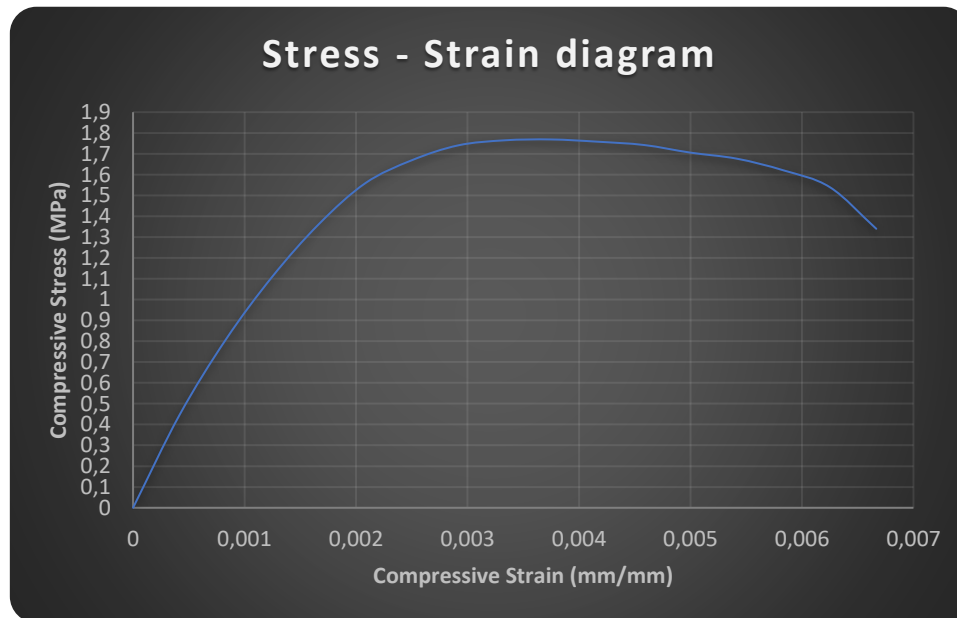
Load step	1	2	3	4	5	6	7	8
compressive stress [Mpa]	0,446	0,809	1,111	1,363	1,559	1,669	1,741	1,765
Vertical strain [mm/mm]	0,00042	0,00083	0,00125	0,00167	0,00208	0,0025	0,00292	0,00333
Load step	9	10	11	12	13	14	15	16
compressive stress [Mpa]	1,769	1,758	1,743	1,706	1,677	1,621	1,540	1,340
Vertical strain [mm/mm]	0,00375	0,00417	0,00458	0,005	0,00542	0,00583	0,00625	0,00667

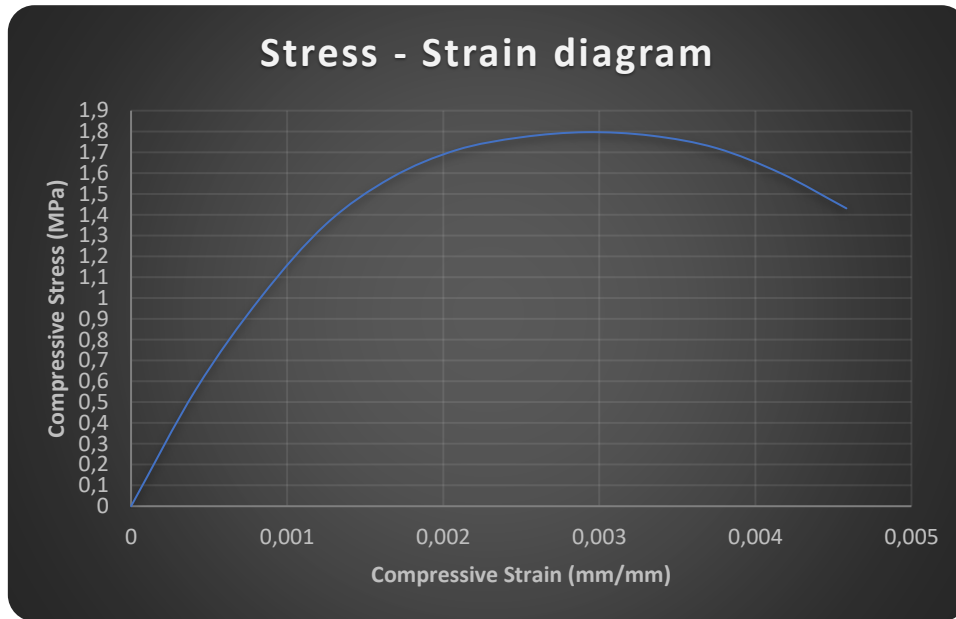
Load step	1	2	3	4	5	6
Compressive stress [Mpa]	0,5623	1,0049	1,3556	1,5778	1,7104	1,7722
Compressive strain [mm/mm]	0,00042	0,00083	0,00125	0,00167	0,00208	0,00250
Load step	7	8	9	10	11	
Compressive stress [Mpa]	1,7965	1,7799	1,7201	1,5979	1,4306	
Compressive strain [mm/mm]	0,00292	0,00333	0,00375	0,00417	0,00458

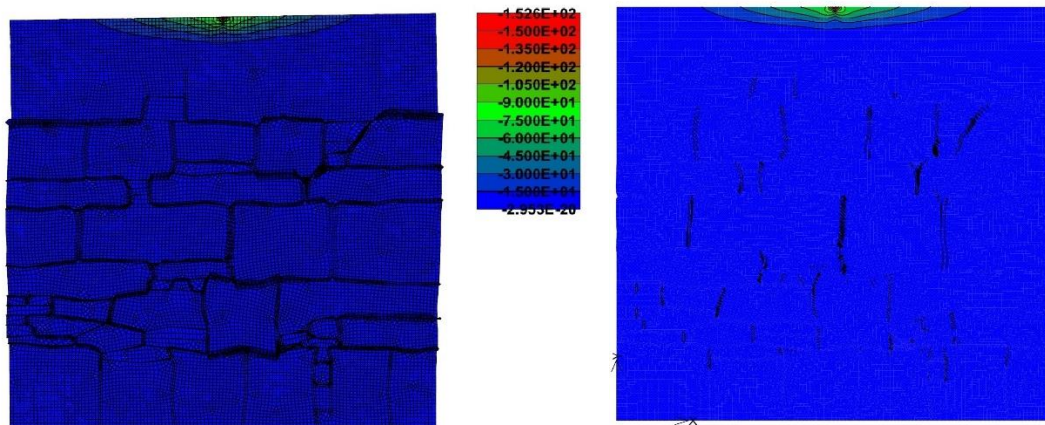
Figure 9: Minimum Principal stress in MPa and crack propagation at step of max. compression stress  
(Right: without mesh, undeformed shape / Left: with mesh, deformed shape)

Compressive stress [MPa]	Max crack width [mm]
1.7965	0.558
1.3556	0.1653

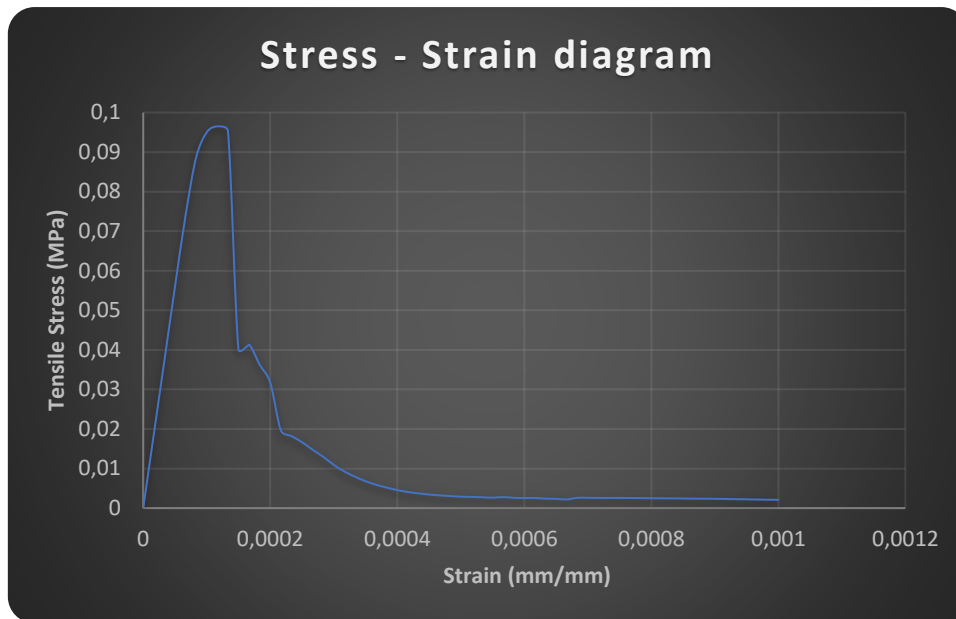
Load step	1	2	3	4	5	6	7	8	9	10
Tensile stress [Mpa]	0,01866	0,03732	0,05596	0,07399	0,08867	0,09500	0,09650	0,09533	0,04008	0,04131
strain [mm/mm]	1,67E-05	3,33E-05	5,00E-05	6,67E-05	8,33E-05	1,00E-04	1,17E-04	1,33E-04	1,50E-04	1,67E-04
Load step	11	12	13	14	15	16	17	18	19	20
Tensile stress [Mpa]	0,03625	0,03173	0,01968	0,01823	0,01667	0,01476	0,01298	0,01095	0,00928	0,00796
strain [mm/mm]	1,83E-04	2,00E-04	2,17E-04	2,33E-04	2,50E-04	2,67E-04	2,83E-04	3,00E-04	3,17E-04	3,33E-04
Load step	21	22	23	24	25	26	27	28	29	30
Tensile stress [Mpa]	0,00682	0,00592	0,00519	0,00457	0,00407	0,00373	0,00344	0,00323	0,00305	0,00291
strain [mm/mm]	3,50E-04	3,67E-04	3,83E-04	4,00E-04	4,17E-04	4,33E-04	4,50E-04	4,67E-04	4,83E-04	5,00E-04
Load step	31	32	33	34	35	36	37	38	39	40
Tensile stress [Mpa]	0,00284	0,00275	0,00264	0,00279	0,00261	0,00255	0,00257	0,00240	0,00234	0,00219
strain [mm/mm]	5,17E-04	5,33E-04	5,50E-04	5,67E-04	5,83E-04	6,00E-04	6,17E-04	6,33E-04	6,50E-04	6,67E-04

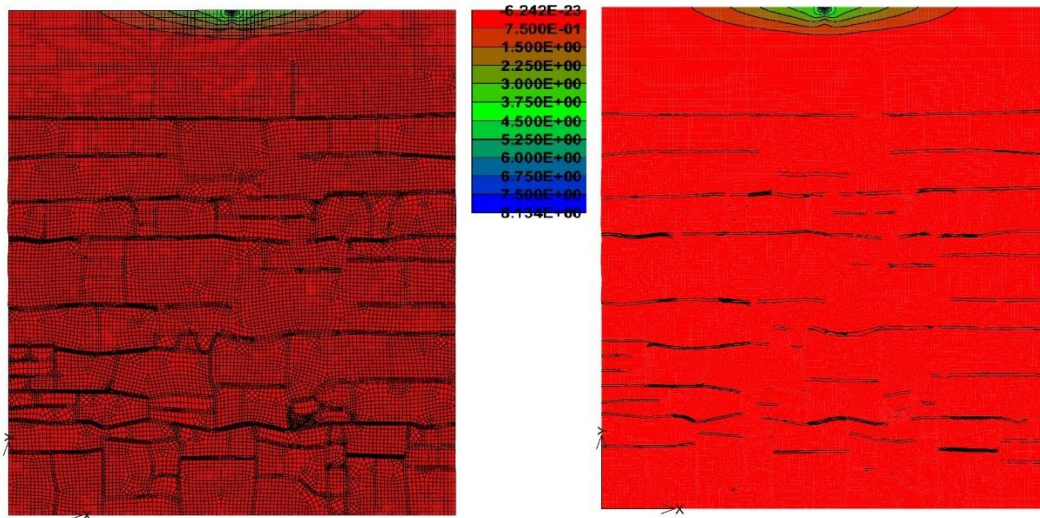
Figure 14: Maximum Principal stress in MPa and crack propagation at step of max. tensile stress  
(Right: without mesh, undeformed shape / Left: with mesh. deformed shape)

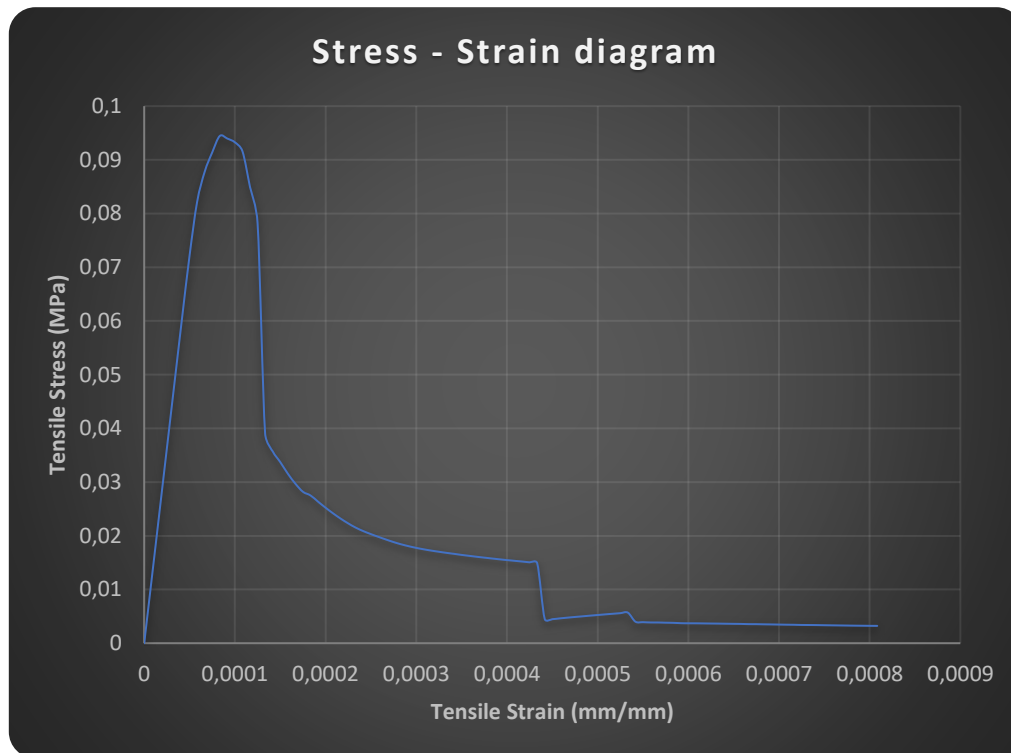
Load step	1	2	3	4	5	6	7	8	9	10
Tensile stress [Mpa]	0,0121	0,0242	0,0363	0,0484	0,0605	0,0722	0,0822	0,0878	0,0914	0,0944
Tensile strain [mm/mm]	8,33E-06	1,67E-05	2,50E-05	3,33E-05	4,17E-05	5,00E-05	5,83E-05	6,67E-05	7,50E-05	8,33E-05
Load step	11	12	13	14	15	16	17	18	19	20
Tensile stress [Mpa]	0,0940	0,0933	0,0916	0,0849	0,0782	0,0390	0,0357	0,0337	0,0316	0,0297
Tensile strain [mm/mm]	9,17E-05	1,00E-04	1,08E-04	1,17E-04	1,25E-04	1,33E-04	1,42E-04	1,50E-04	1,58E-04	1,67E-04
Load step	21	22	23	24	25	26	27	28	29	30
Tensile stress [Mpa]	0,0282	0,0275	0,0264	0,0252	0,0242	0,0232	0,0223	0,0215	0,0209	0,0203
Tensile strain [mm/mm]	1,75E-04	1,83E-04	1,92E-04	2,00E-04	2,08E-04	2,17E-04	2,25E-04	2,33E-04	2,42E-04	2,50E-04
Load step	31	32	33	34	35	36	37	38	39	40
Tensile stress [Mpa]	0,0198	0,0193	0,0188	0,0184	0,0181	0,0178	0,0175	0,0172	0,0170	0,0168
Tensile strain [mm/mm]	2,58E-04	2,67E-04	2,75E-04	2,83E-04	2,92E-04	3,00E-04	3,08E-04	3,17E-04	3,25E-04	3,33E-04

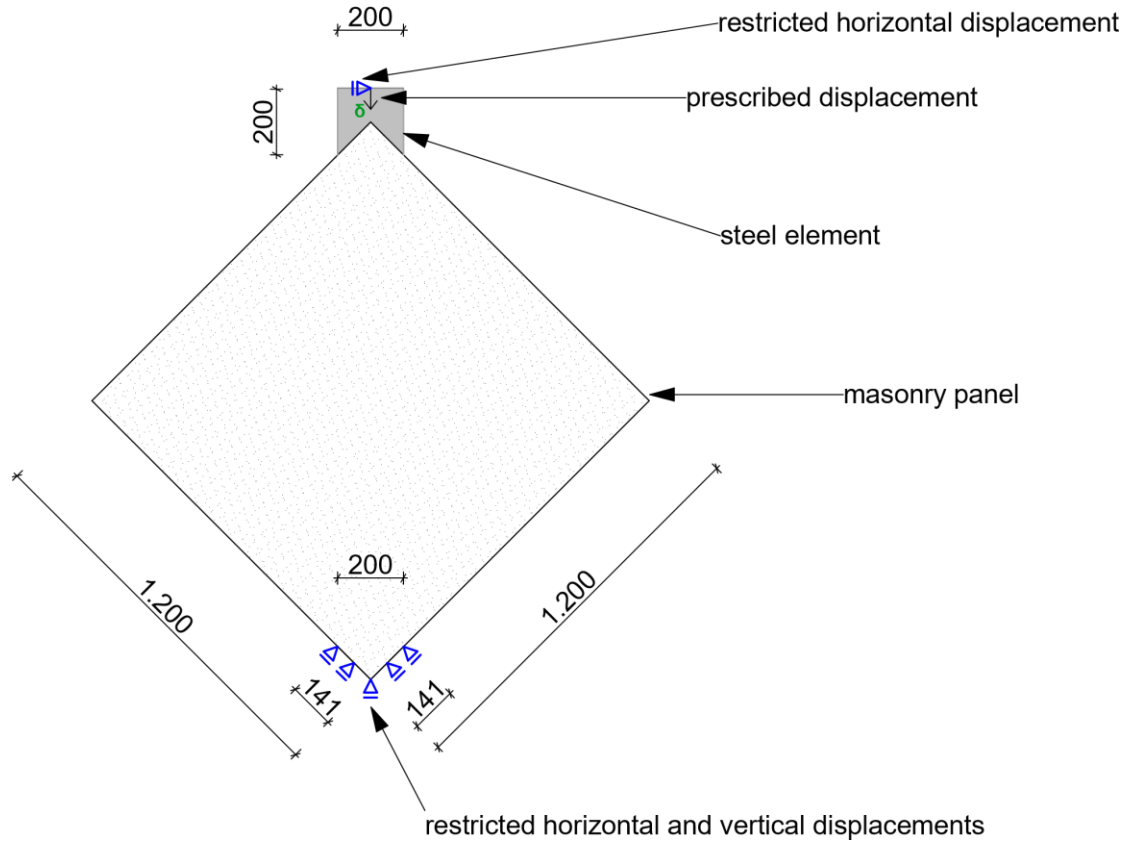
Figure 17: Numerical model arrangement for the simulation of a diagonal compression test

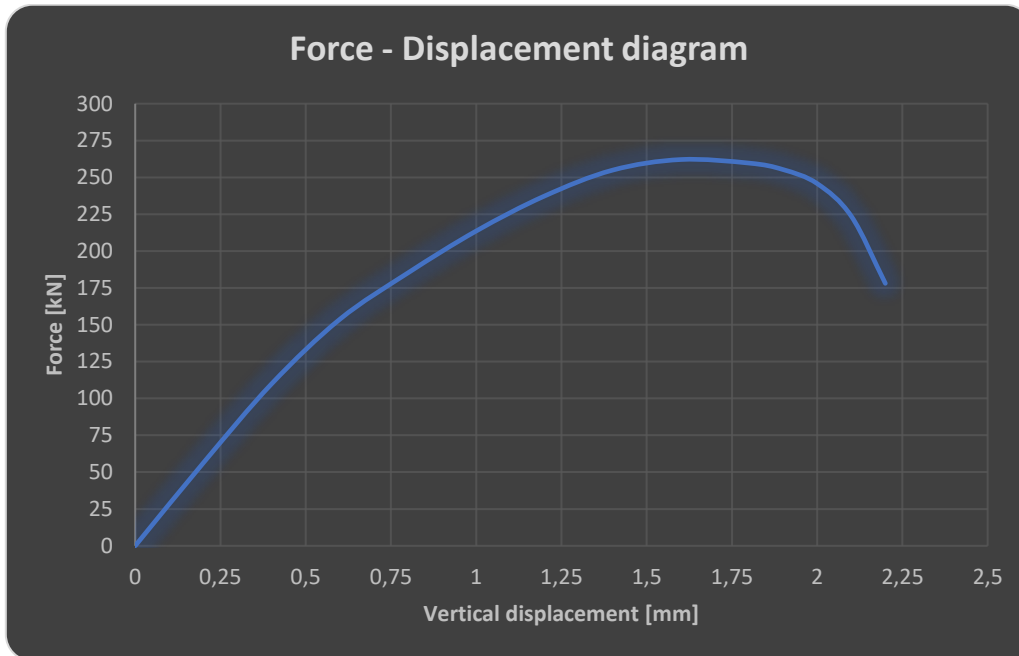
Load step	1	2	3	4	5
Force [kN]	56,34	109,9	153,7	185,2	213,6
Vertical displacement [mm]	0,2	0,4	0,6	0,8	1
Load step	6	7	8	9	10
Force [kN]	237,3	254,9	262,1	259,7	255,3
Vertical displacement [mm]	1,2	1,4	1,6	1,8	1,9
Load step	11	12	13		
Force [kN]	245,8	223,7	178,1		
Vertical displacement [mm]	2	2,1	2,2

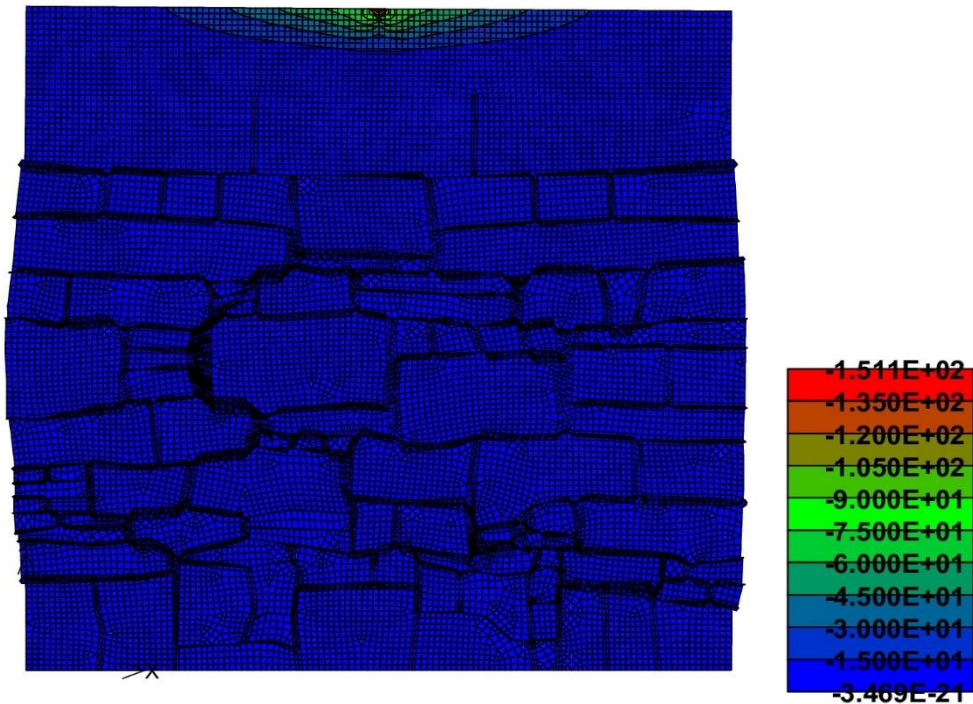
Figure 32: Minimum Principal stress and crack propagation (step of max. compressive stress)
