ADVANCED MASTERS IN STRUCTURAL ANALYSIS OF MONUMENTS AND HISTORICAL CONSTRUCTIONS

Master's Thesis

Structural Analysis of Historic Reinforced Concrete Building - Fuchs' Cafe in Prague.

Czech Republic | 2020

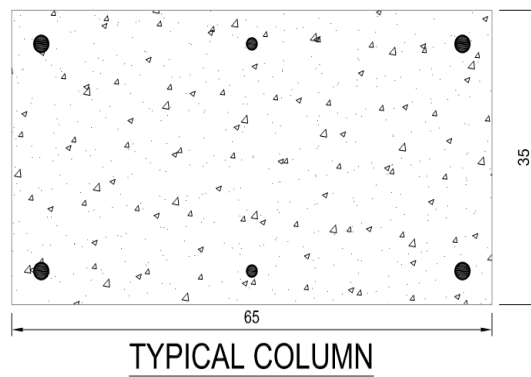
Figure 3.6: Typical column cross-section dimensions in centimeters [16]

The columns are monolithically cast-in-place with continuous vertical reinforcement and stirrups (figure 3.6). The full height columns are 35 cm by 65 cm, while the single-story columns are 35 cm by 55 cm. All columns have the strong axis in the transverse direction of the building. Many of the columns have coverings, making it difficult to inspect the current condition. Where the structure is exposed, the concrete is in adequate shape with minor cracking and minimal spalling. In the locations of the previous probe testing, the outer layers of concrete were removed and never repaired, leaving the steel reinforcing exposed (figure 3.7).

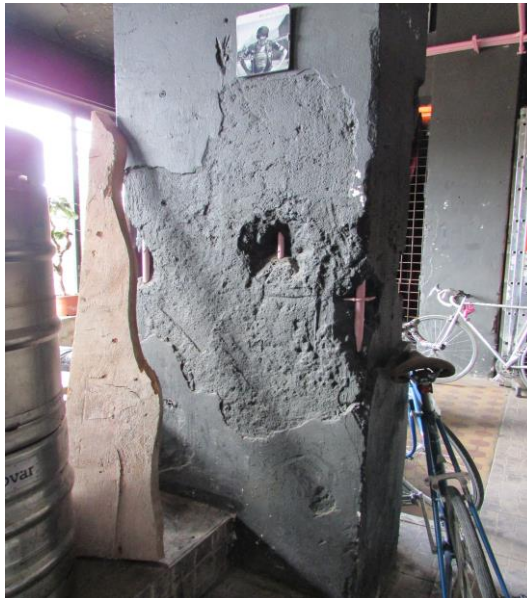
Figure 3.7: Column damage from 2015 above Level 1PP at column lines A-4

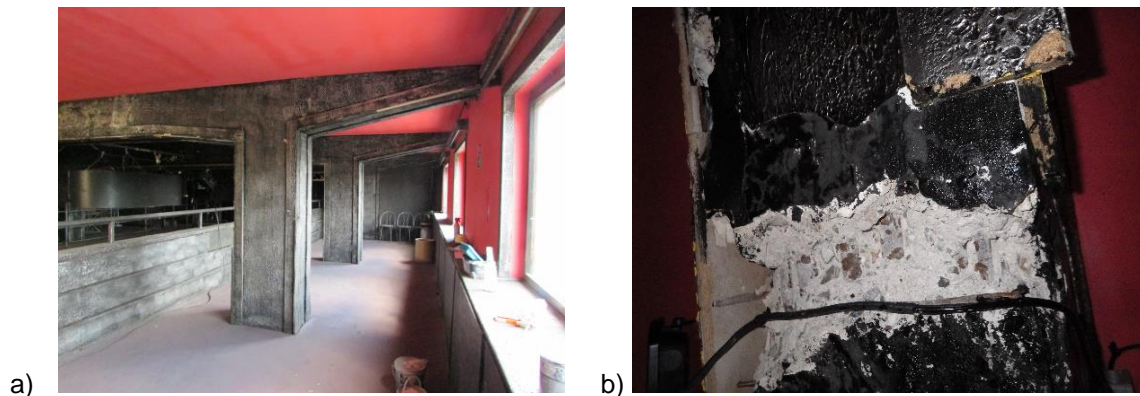
Figure 3.9: a) 3NP transverse beams at column line A looking south
 b) Damage at 2015 probe location (Beam at Level 3NP, Column Line 5)

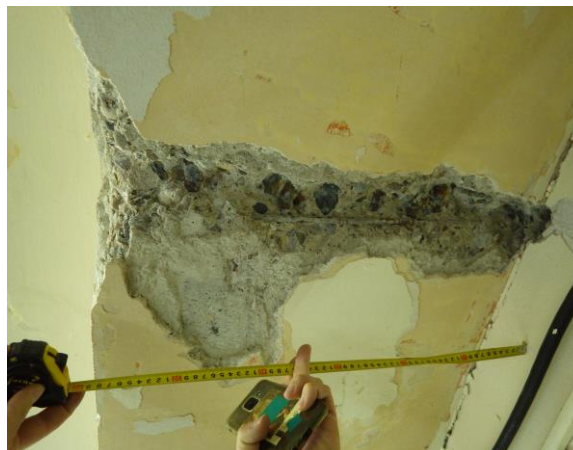
Figure 3.11: Longitudinal Beam Damage from 2015 at Level 2NP, Column Line A, Between 8 and 9

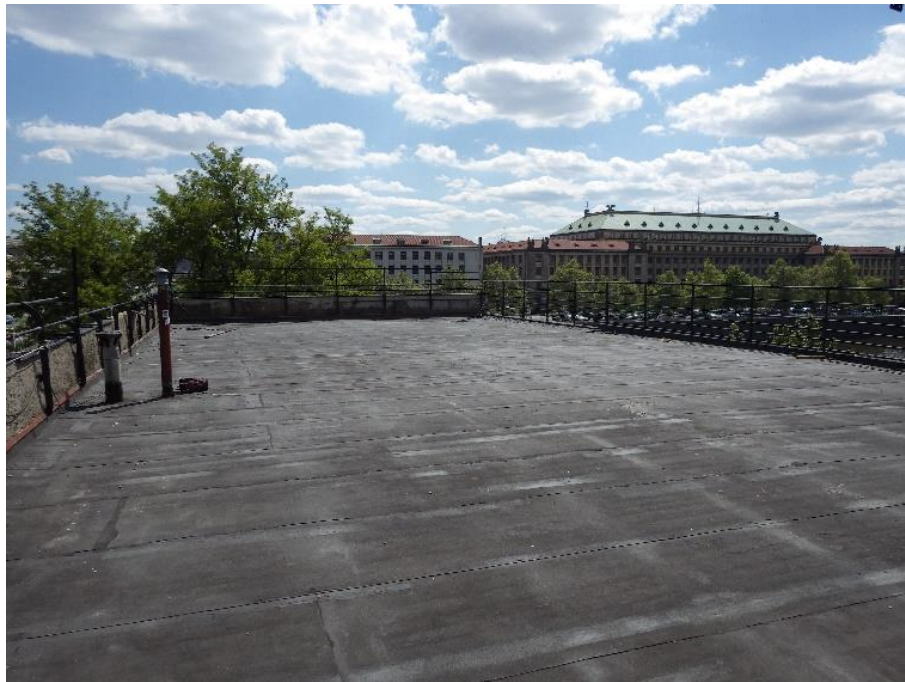
Figure 3.14: Roofing above the level 3NP slab looking south

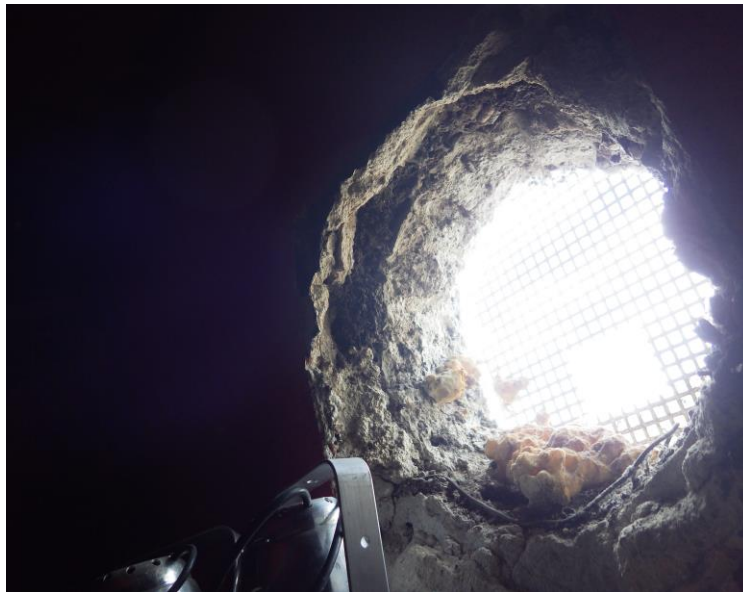
Figure 3.17: Exterior wall penetration at northeast corner of level 2NP

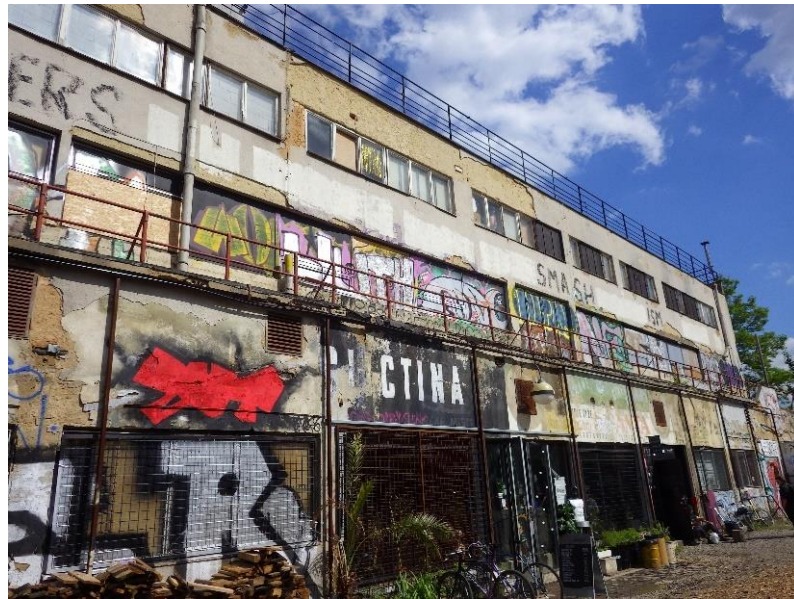
Figure 3.17: Exterior wall surface condition on western side of building

The exterior walls have been altered significantly throughout the history of the building. Some window and door penetrations in the wall have been infilled. Various materials have been used to achieve this purpose, including masonry and timber. New coverings and cladding have been installed as well. There are many areas where the exterior cladding surfaces are cracking and detaching, exposing the substructure (figure 3.18). This damage occurs on all the exterior walls, the extent of which is difficult to quantify. With all these alterations, the condition of the walls is poor, however, the extent of the damage is unknown until more extensive testing and inspections are performed.

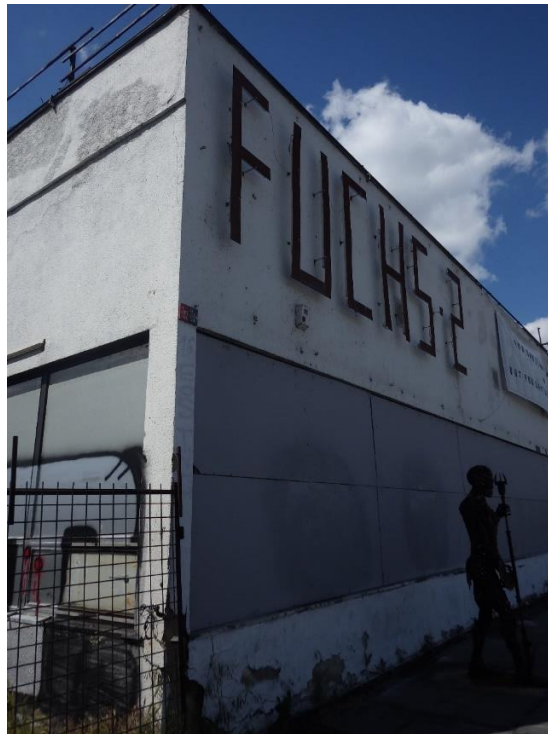
Figure 3.18: South east corner of the building with corner post

The load path of the walls is unknown. The two possibilities are that the walls are supported or hung from the slabs at each level, acting like a curtain wall. The alternative is that the walls act in a load bearing manner with the total self-weight of the wall bearing at the base of the wall. Many of the windows on the east, west and south are very large and apparently lack any interior support. The window above level 2NP on the west exterior wall is over 34 meters long. This condition makes the bearing wall load path unlikely. However, if the exterior walls are supported by the slab on each level, this means that the ceramic composite slabs are supporting the wall self-weight, which also seems like a flawed method, but the lesser of two evils. Additionally, with the intention to reopen all the original windows that have been infilled, it is possible that the original load path has changed through all the alterations. Additionally, at the intersection of the south wall and east wall, the windows extend to almost all the way to the corner leaving a 24 cm by 32 cm post (figure 3.18). The function of the post is unknown, whether is it loaded and behaves like a post or whether it acts as a mullion for which the windows attach.

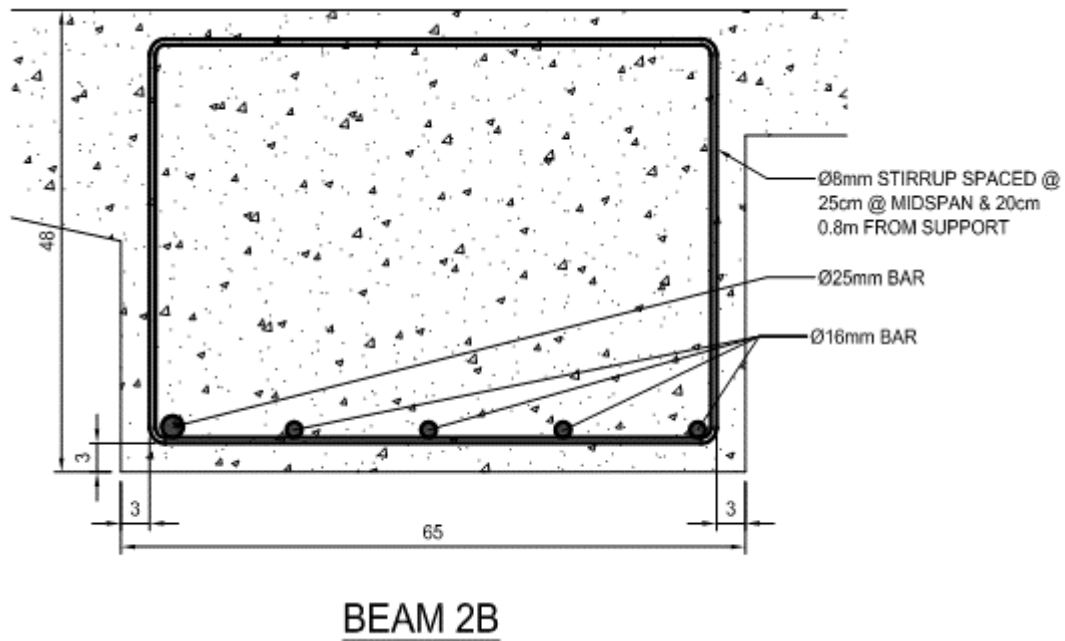
Figure 8.12: Beam 2B Cross Section with dimensions in centimeters [16]

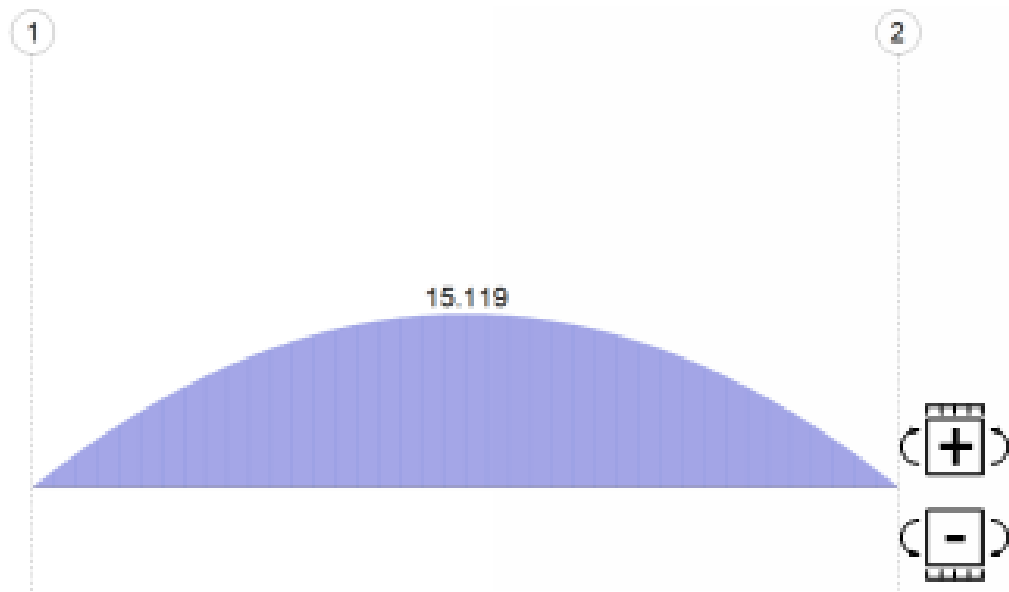
Figure 8.24: Level 1NP Moment Diagram from Simple Span Condition (kN-m/m)

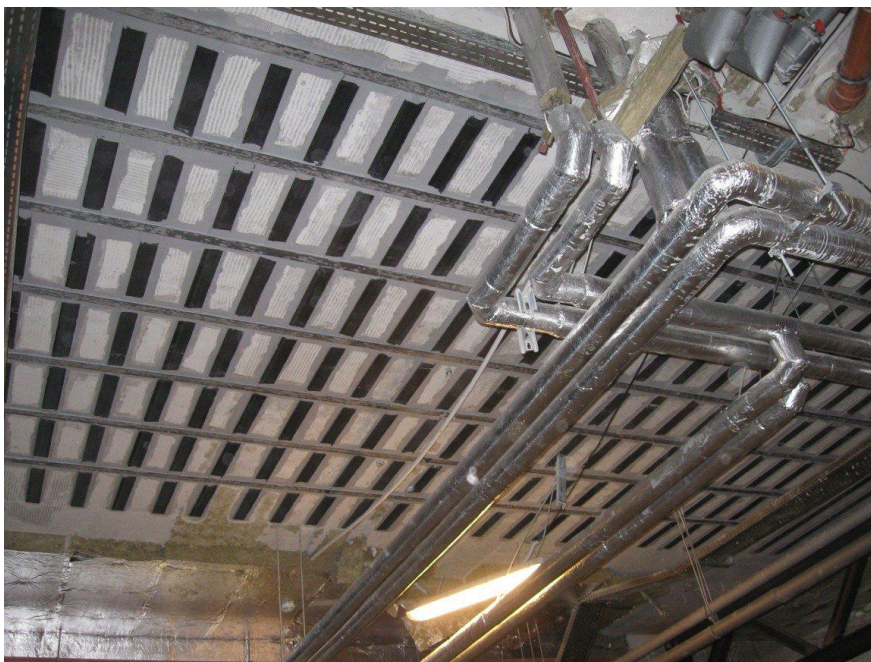
Figure 9.1: Example of CFRP slab reinforcement [25]

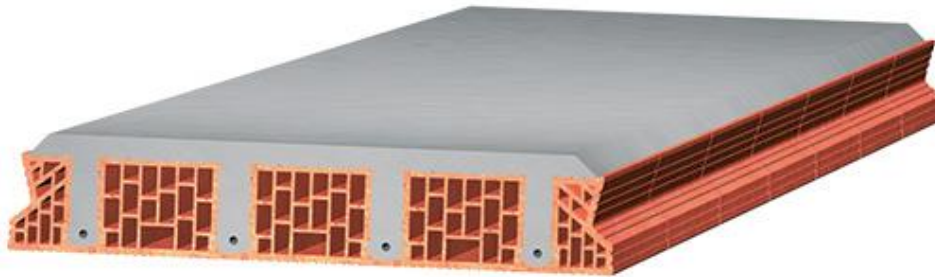
Figure 9.2: Heluz Miako composite ceramic concrete slab schematic [26]

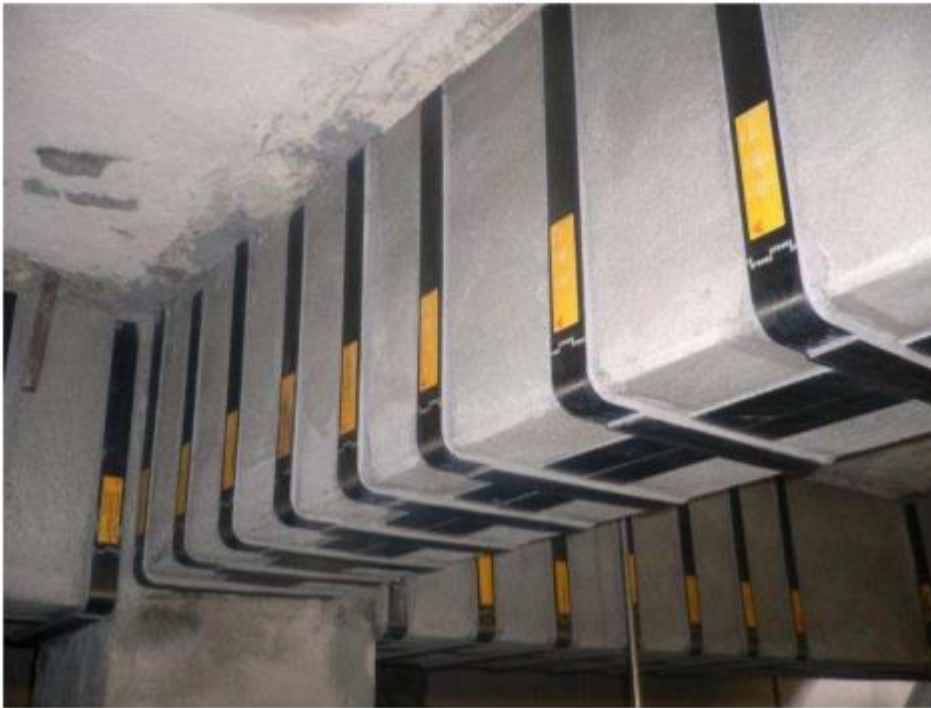
Figure 9.3: GFRP shear beam reinforcing [26]

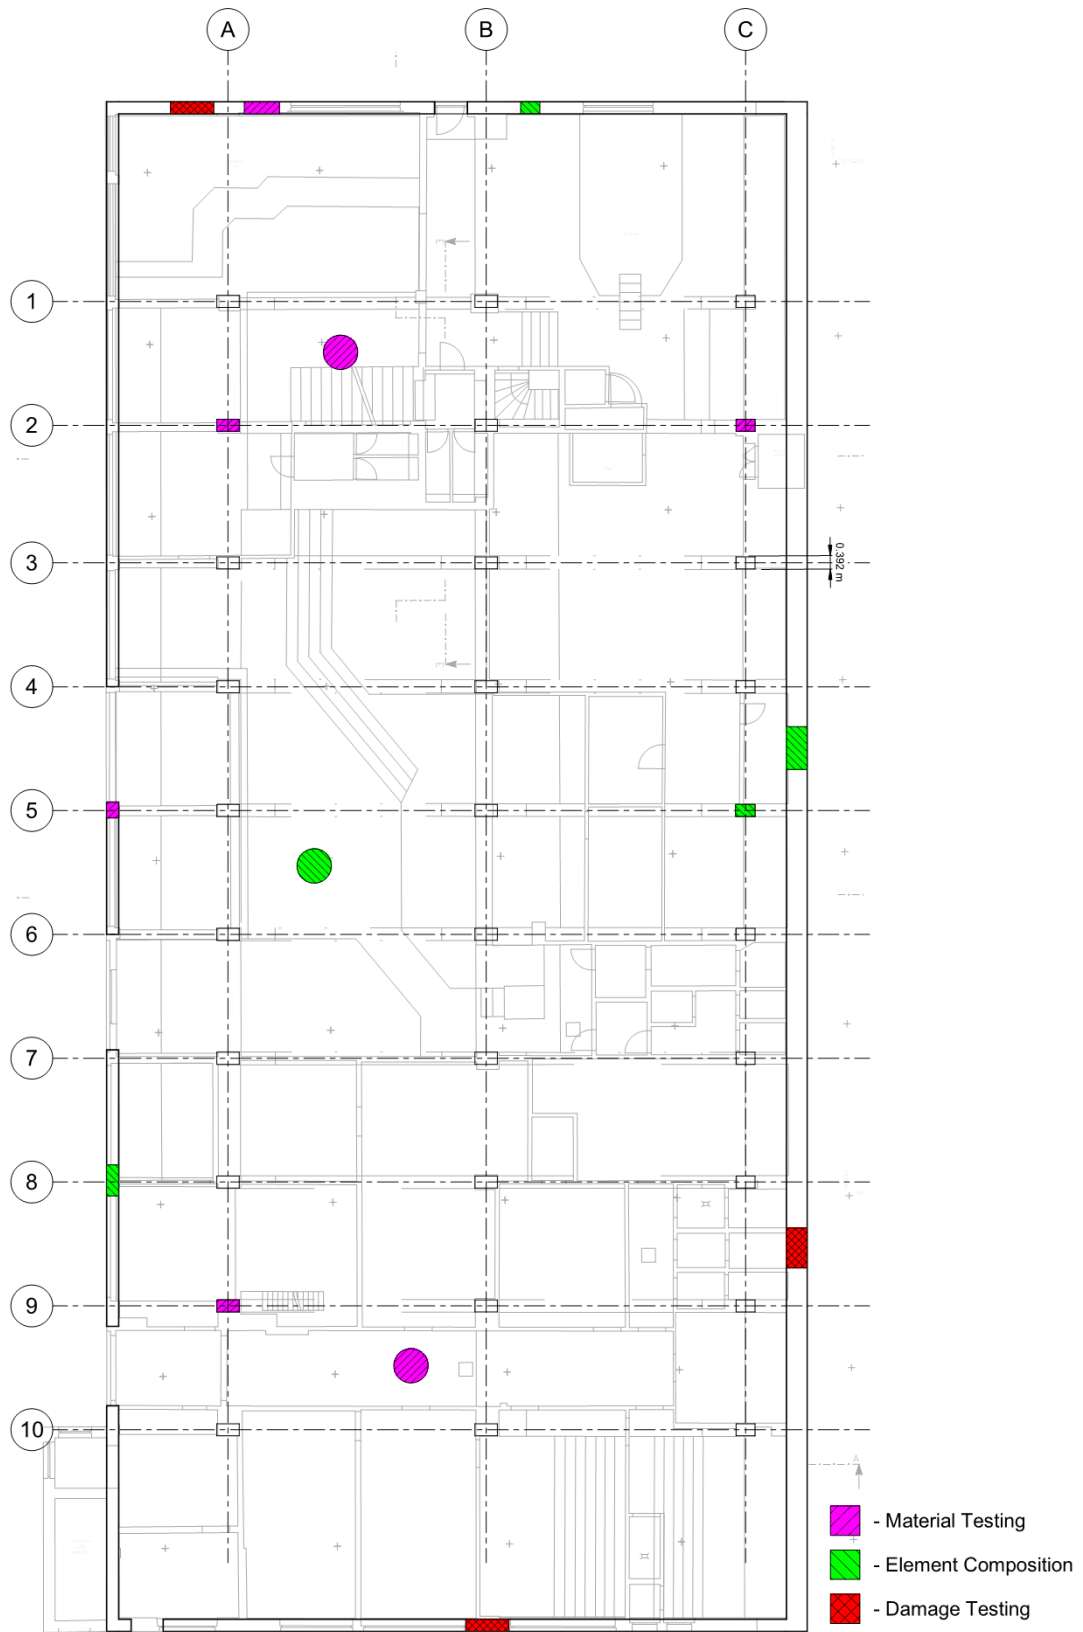
Figure 9.4: Level 1PP Testing Locations

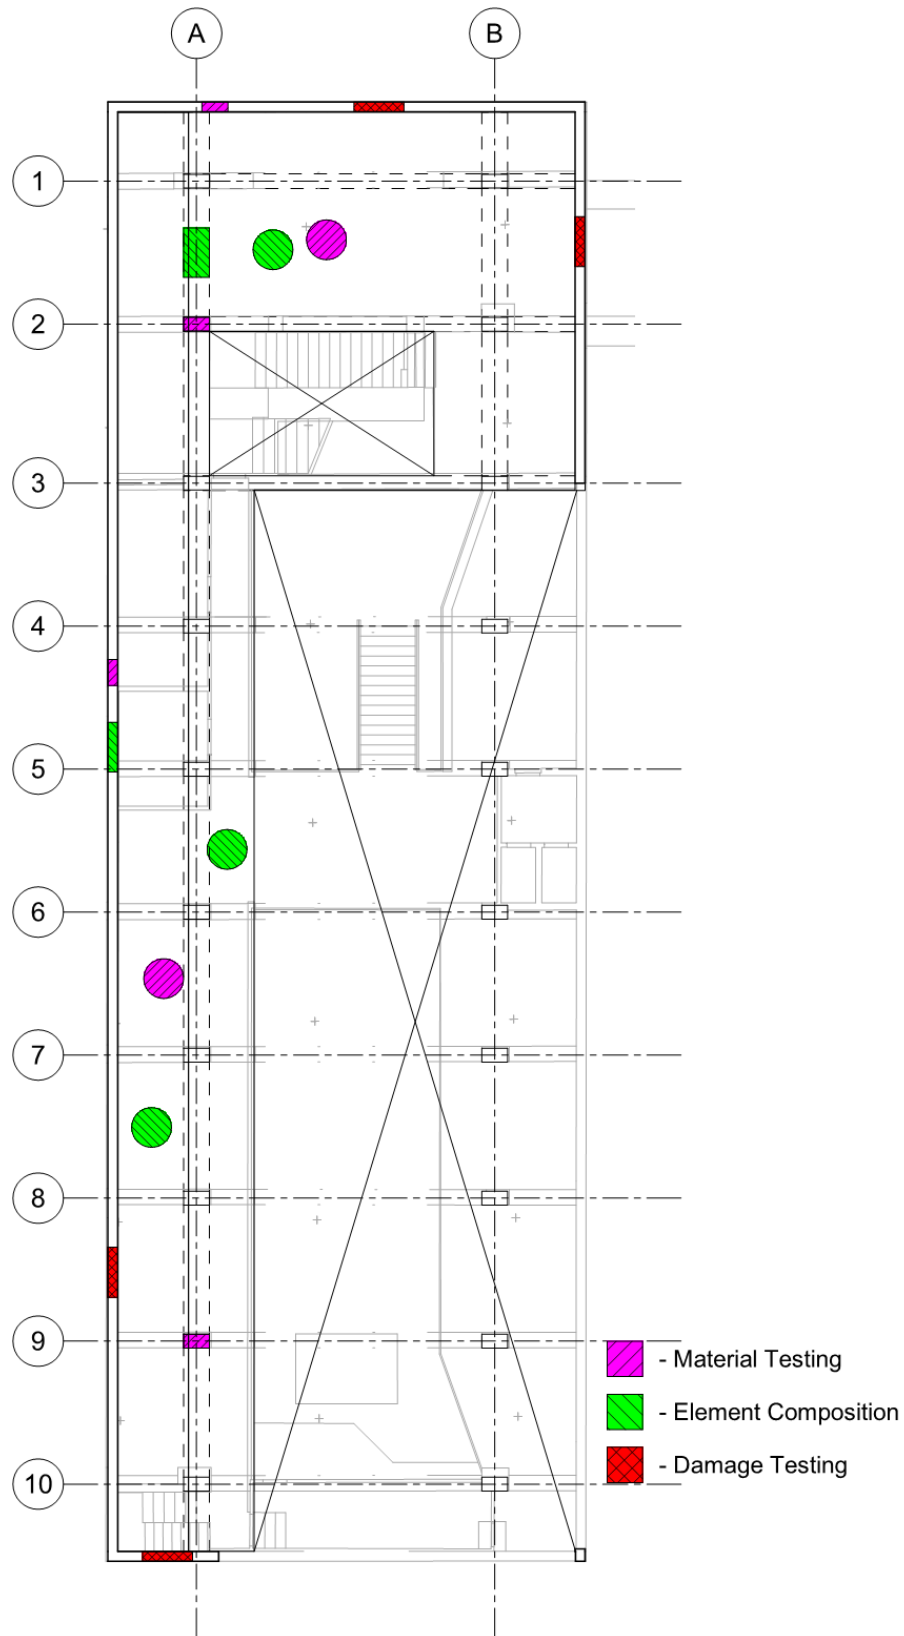
Figure 9.6: Level 2NP Testing Locations
