Diploma Thesis (DT) title: <u>Evaluation of the Broumov parish house failure, its causality, and some ideas of remediation</u>	
Diploma Thesis title in English: <u>Evaluation of the Broumov parish house failure, its causality, and some ideas of remediation</u>	
Instructions for writing the thesis: <p>The main goal of the dissertation will be to assess and evaluate the cause of the failure of the parish house, deanery Broumov. The analysis requires not only technical knowledge but also historical, cultural, and investigative knowledge as well.</p> <p>The work will consist of the following parts:</p> <ol style="list-style-type: none"><li>1. It should start with an overview of the historical development of the area.</li><li>2. Followed by inspection of the Broumov deanery real estate. With a focus on failures and their possible causes and determining the material properties of masonry.</li><li>3. The obtained knowledge will lead to the creation of the FEM models, and selection of the loading cases.</li><li>4. By comparing the results of the FEM model and the current state of the structure, the probable causes of the failure are determined.</li><li>5. Recommendation of the next procedu

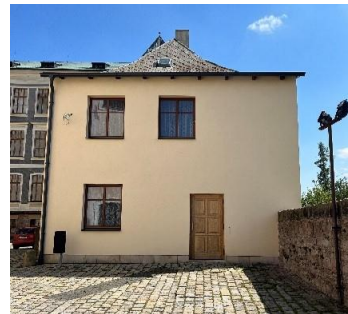
Northwest Façade

Upon the examination that was done, it has been determined that the exterior of the building exhibits no significant damage or deterioration. All the four façades can be seen in Figure 4.1 and their damage mapping is provided in Annex 1. The findings reveal that the majority of the exterior elements remain structurally intact. In contrast, the plaster on the exterior surfaces shows signs of decay. This observation suggests that the deterioration is primarily limited to the superficial layer of plaster rather than affecting the underlying structural elements.

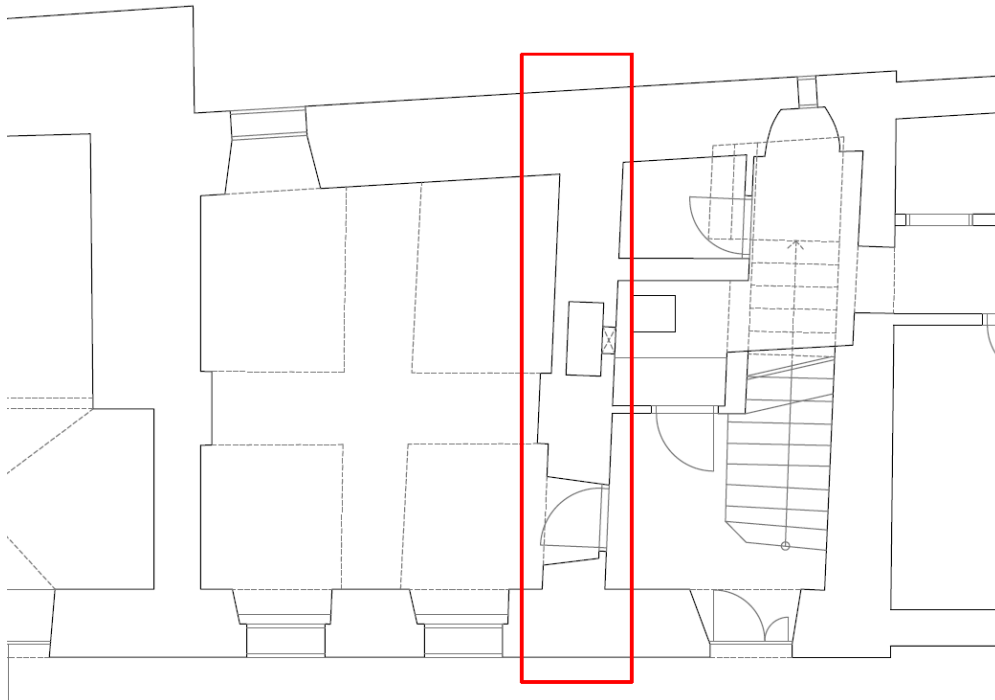
Figure 4.6 - Middle wall

Within the interior of the building, two primary types of decay are observed. The first type is fractures that as it is depicted in Figure 4.7 are concentrated along the middle wall of the main section of the building (Figure 4.6). A particular concern is the basement, where part of a wall has become detached, and the staircase within the basement area has become inclined. The reason is assumed to be potential ground deformations.

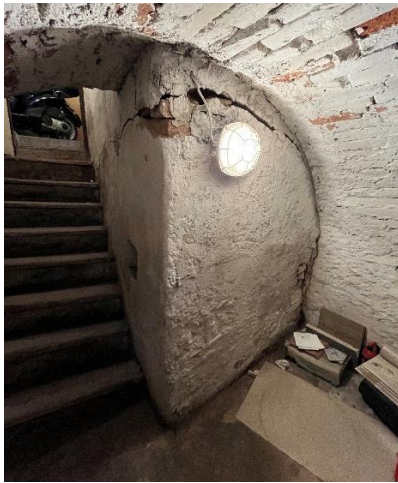
Figure 4.8 - Basement a) Detached wall, b) Inclined staircase

Upon assessing the various decay patterns that appear on the building, it has been determined that those present on the exterior are not deemed severe since they appear only on the plaster and the surface of the walls. In contrast, the interior is where the most significant deterioration is observed. The most significant structural damage that affects the building is the formation of a network of cracks along the central wall. According to the information provided by P. ThLic. Martin Lanži during the visit some cracks have also appeared in the church and the school that is located on the same cliff as the Parish House. Based on the factors listed above, it can be assumed that the settlement of the ground is the most probable cause.

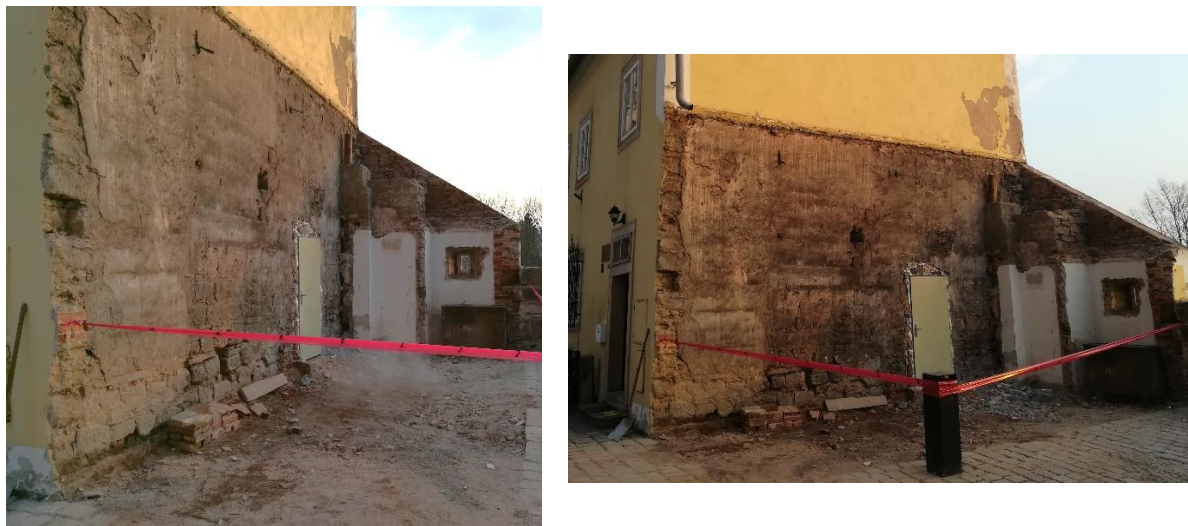
Due to the complete plaster coverage of the walls throughout the building, conducting the MQI was challenging. However, P. ThLic. Martin Lanži was able to provide some photographs of the building during the demolition of the newest section, revealing the exposed masonry that was used for the evaluation of the wall.

Figure 6.3 - Uncovered wall

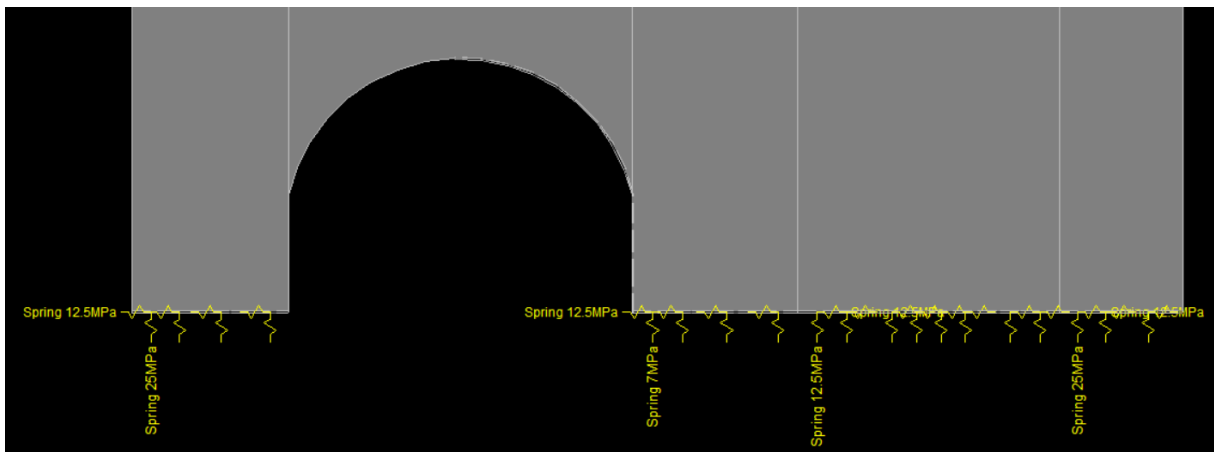
Figure 6.13 - The springs and their assigned values

Considering the current condition of the building, varying stiffness values were assigned to the springs at the base of its macro-element (Figure 6.13). The exterior wall on the left side, which relies on the city wall, is assumed to have a better foundation condition compared to the other walls. Hence, the springs at the base of this wall were given the highest stiffness value of 25 MPa. The remaining walls were assigned lower stiffness values to account for the assumption of poorer ground conditions, with the value being 12.5 MPa. Furthermore, given the observed settlement in the basement (Figure 6.12), the springs of the wall beside the basement were assigned the lowest stiffness value of 7 MPa. These chosen stiffness values aim to accurately reproduce the existing crack pattern evident in the building, as discussed in paragraph 4.2 of the thesis.

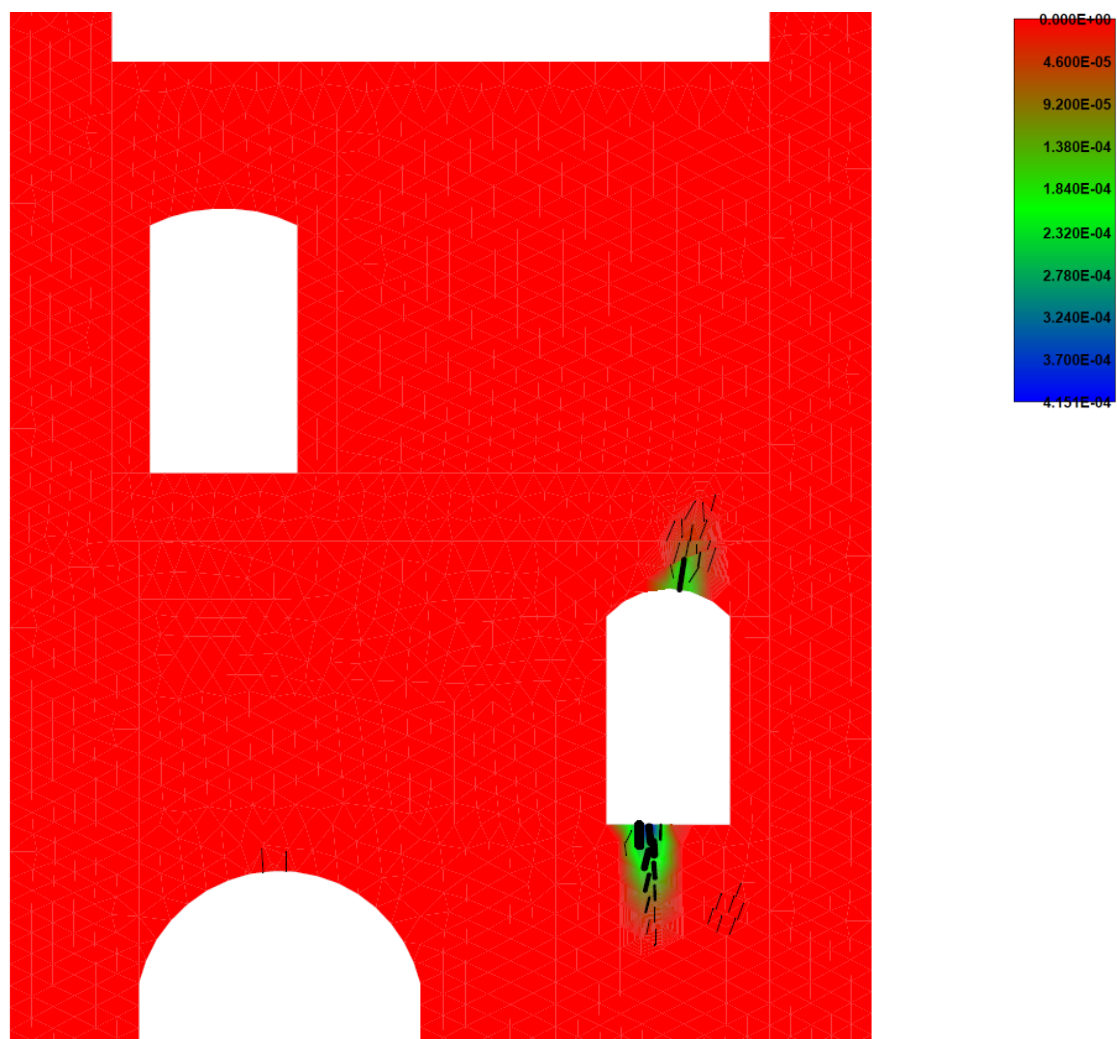
Figure 6.14 - Results of the preliminary analysis (m)

The crack pattern as a result of this analysis is presented in Figure 6.14.

The analysis of the model did not reveal the exact crack pattern observed in the building. Moreover, the cracks that appeared were found to be minor. These findings indicate that the crack pattern observed on the walls of the building today cannot be attributed to a lack of bearing capacity, as the structure demonstrated sufficient strength to withstand the existing loads without any significant issues.

To ensure that the observed crack pattern is not created under the chosen circumstances, additional combinations of stiffnesses along the springs were tested. Approximately 30 different models were examined, considering variations in stiffness values, analysis methods (Newton-Raphson and Arc-length), and the number of analysis steps. However, these alterations did not result in any substantial differences compared to the results depicted in Figure 6.14.

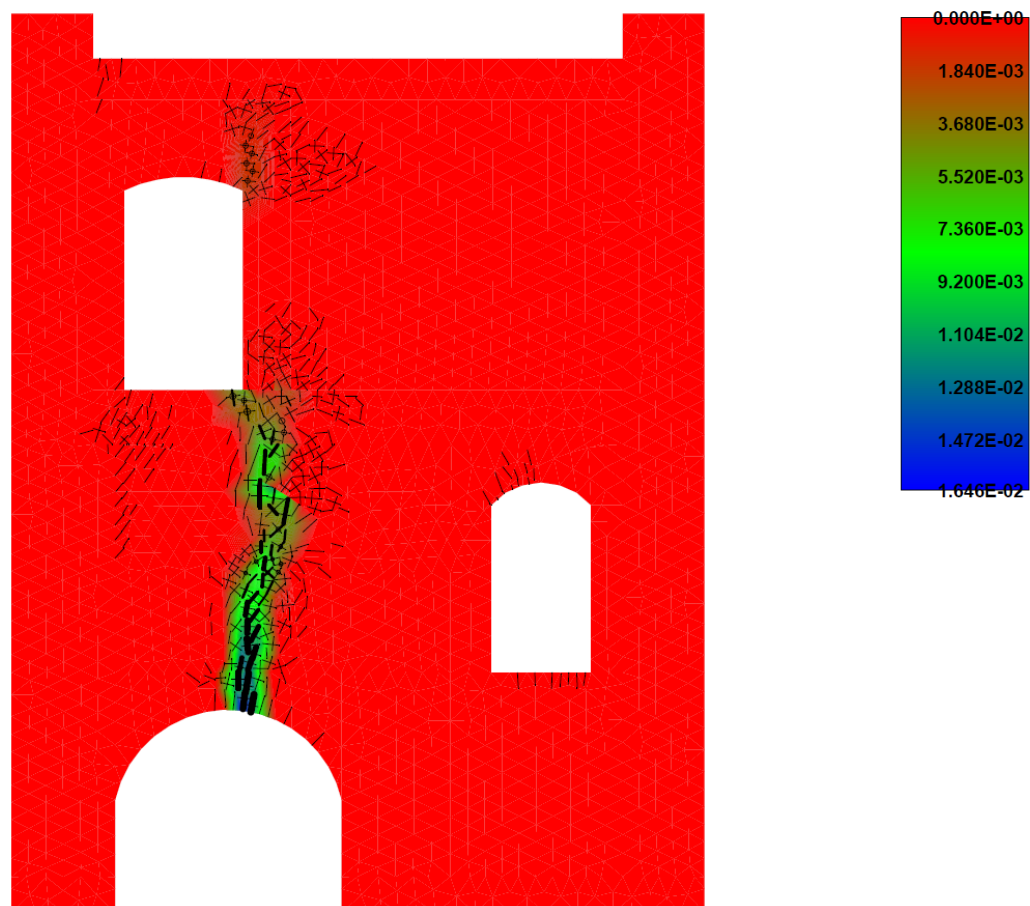
Figure 6.19 - Results of the settlement analysis (m)

The second part of the analysis is a combination of the Newton-Raphson and arc length methods, for 20 additional steps. The results of the analysis are presented in Figure 6.19

Comparing the results of the analysis with the reality (Figure 6.20), some similarities can be observed. However, when taking into account the width of the cracks rather than solely focusing on their pattern, only the vertical crack above the basement vault exceeds a width of 1 cm. In contrast, the cracks around the door of the upper floor have widths of less than 1 mm. This indicates that if the situation were as depicted in the analysis, these cracks would likely not be visibly noticeable, which contradicts reality.

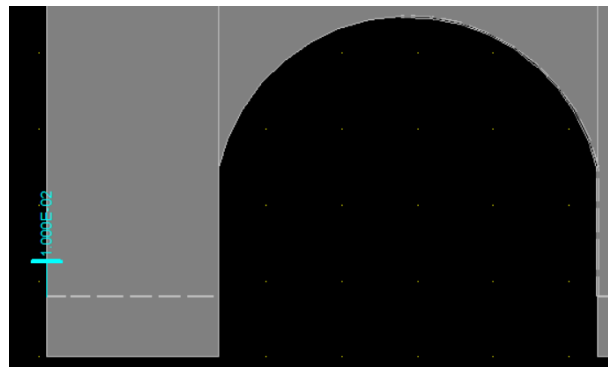
Figure 6.25 - The upward displacement of the left exterior wall

The chosen displacement to represent the expansion caused by water freezing is 1 cm (Figure 6.25). Considering that water expands by approximately 9% when frozen, it implies that for the city wall and its underlying foundation, if they exist, to experience such a displacement, they will need to have a significant degree of porosity and be fully saturated with water [33]. This would allow the frozen water to create high pressure on the elements of the masonry, resulting in the expansion of the wall, which creates upward movement of the building.

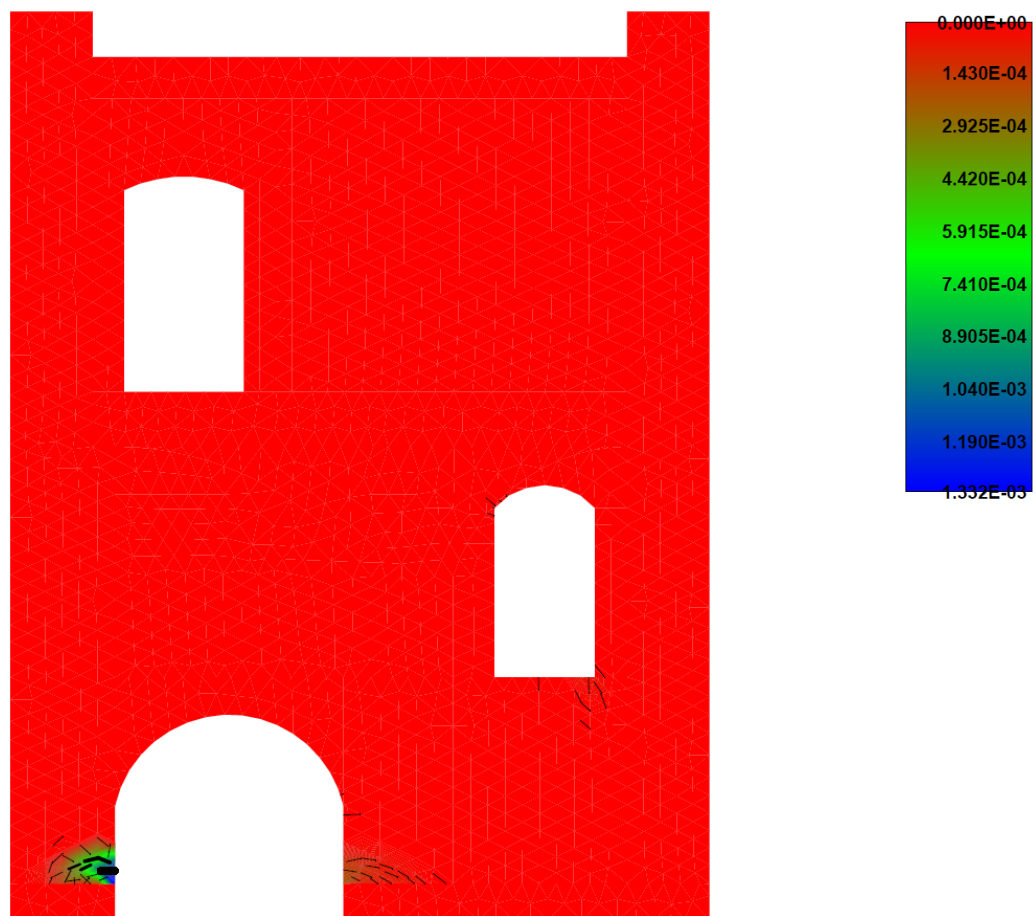
Figure 6.26 - Results of the settlement analysis (m)

The results of the analysis are presented in Figure 6.26

Comparing the results of the analysis as before (Figure 6.27), it becomes evident that the crack pattern observed does not align with reality. However, it is important to consider that the assumptions made during the modeling process may have influenced these outcomes. The results could be significantly different if the actual process and real data were utilized in the analysis.

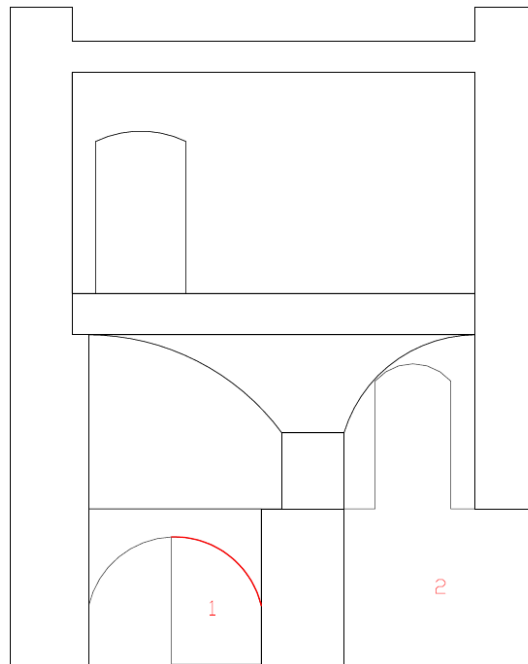
Figure 6.30 - The first model

The key differences in the final chosen model are as follows: Firstly, the wall that became detached at the basement is modeled with an interface separating it from the arch above (referred to as no. 1 in Figure 6.30). Secondly, the macroelements below the right part of the wall are not included in this model due to a lack of information regarding that specific area (referred to as no. 2 in Figure 6.30). Finally all of the macro-elements in this model have the same thickness and the same material properties.

All of the various scenarios discussed previously (spring boundary conditions, settlement, freezing-thaw cycle) were also tested for this model. However, several challenges were encountered during each analysis. Primarily, many of the analyses could not be completed due to convergence issues. Moreover, in order to achieve the desired cracking pattern or make the model run, certain assumptions had to be made that may not reflect in reality conditions. After multiple attempts, it was concluded that the detached basement wall should be removed from the model. Additionally, considering the right part's exterior wall acts as a bearing wall, it was determined that it should extend to a greater depth than just the surface of the ground. Consequently, the model was modified to the version discussed in paragraph 6.1.

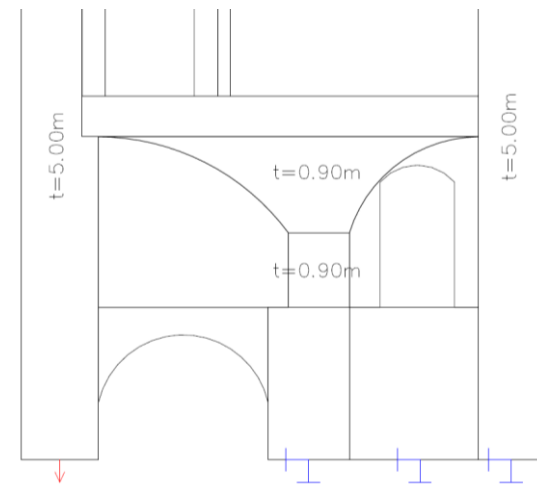
Figure 6.31 - Settlement analysis with fixed boundary conditions

The problem with this models was that its displacement had to be modelled evenly in the whole length of the element. However, by neglecting the ground's solid representation, the models failed to account for differential settlements. This oversight leads to an uneven distribution of stresses, which, in turn, caused convergence issues.
