ADVANCED MASTERS IN STRUCTURAL ANALYSIS
OF MONUMENTS AND HISTORICAL CONSTRUCTIONS

Master's Thesis

Winery Wilomenna Chlumčany
u Loun: Revitalization of the
winery grounds

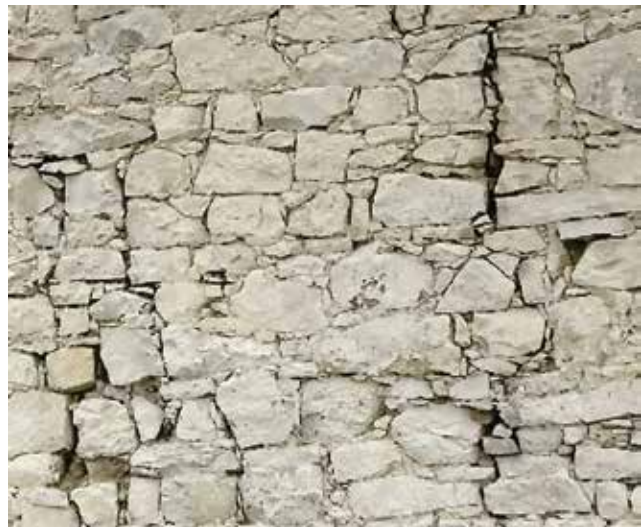
$$f_{md \text{ med}} = 2.55 \text{ Mpa}$$

Fig 25: 1x1 square of opuka masonry wall

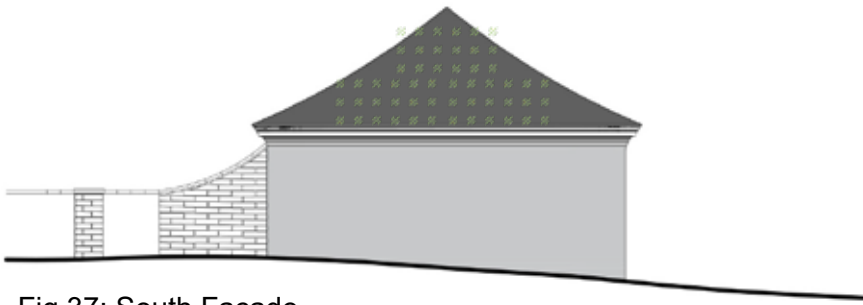
Fig 37: South Facade

Damages observed in the exterior transversal facades of the masonry walls include deterioration of opuka stone occasioned by different reasons like raising damp and freeze & thaw cycles. These are observed at the base of the north facade on the adjoining part with the grass slope. Another visible characteristic are the previous interventions made with different materials. For instance the brick filling that was used to cover the original openings of circular windows and others. Low quality concrete mortars and grouts were used to fill cracks and gaps. Also used to hide electrical installations that are visible from the street level. There are few remains of the original plaster renders, which are only visible in the South facade. The most serious damage in this two facades is the weathering and decay of the opuka stone as well as its original mortar joints, that had been washed out by natural agents due to lack of any waterproof treatment or maintenance.

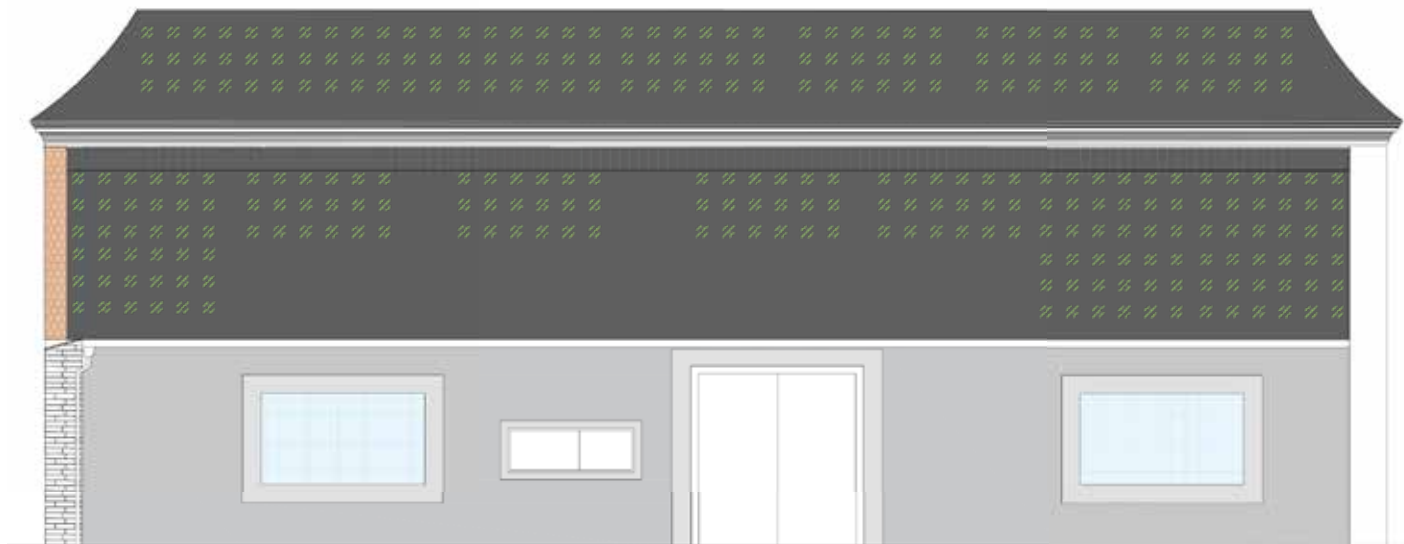
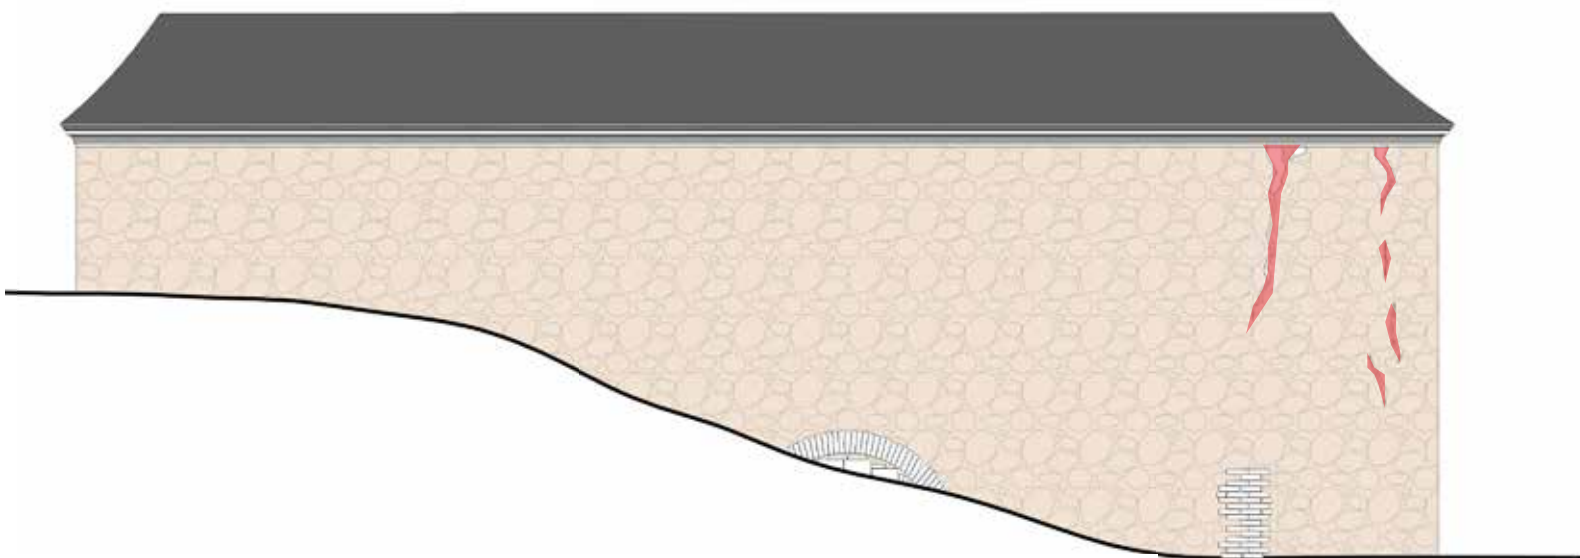
Fig 40: West Facade

On the west facade , the opuka stone wall has experienced recent crack openings, that according to the owners ,they appeared recently during the construction of a viaduct in the proximities of the site. This facade also has some deterioration of the opuka stone due to raising damp of the soil next to it therefore it is necessary to consolidate and strenght this wall.

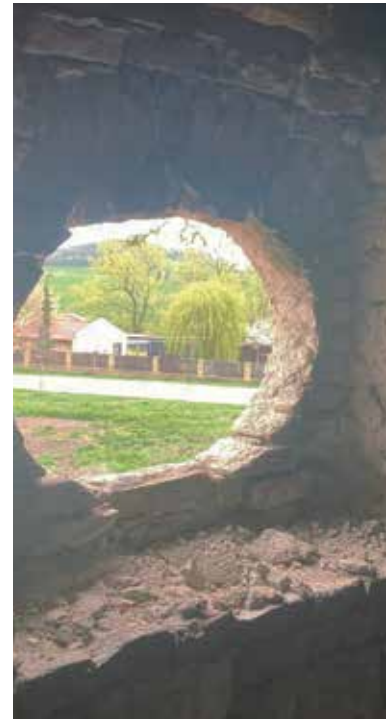
The interior inspection and diagnosis of the north facade shows at ground level the original plaster renderings with some good level of preservation. At the upper level in the attic, the former window leaves open space to environmental agents to enter the structure and weather the stone. For this reason all of the plaster renderings in this level are now gone, leaving the masonry walls exposed. This inside face shows crumbling and weathering of stone due to humidity saturation of the rock. The cornice detail of the timber roof is splitted due to moisture saturation, swelling and shrinkage of the wood exposed to the sunlight.

Fig 41: Circular opening from interior

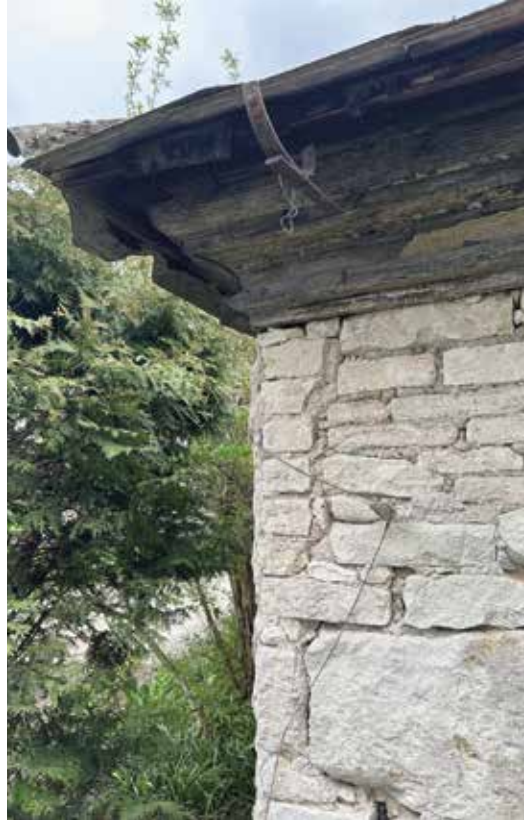
Another interesting feature appreciated in the North Facade is the Bubrobka tiles placed along the right upper edge. Used in order to avoid water penetration in the thickness of the opuka wall. This traditional roof system is made of fire based clay units that resemble the shape of a beaver's tail, hence the name of it. There are also minor cracks and fractures that appear at the base of the facade.

Fig 43: Cornice detail

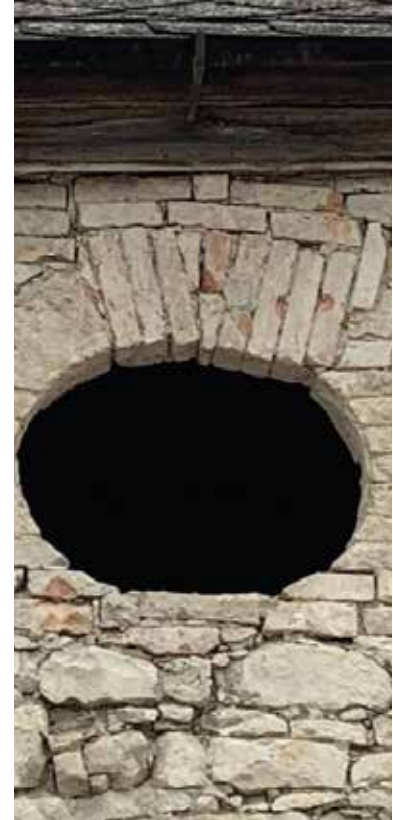
Fig 44: Former circular window

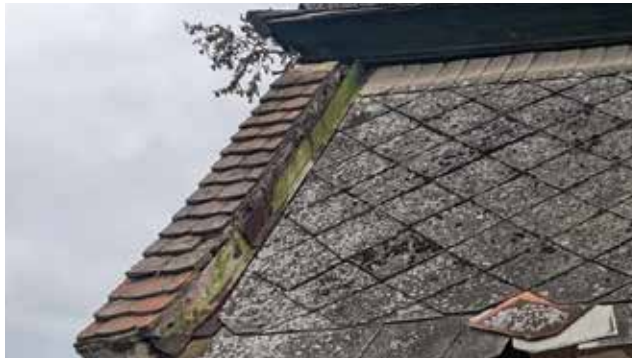
Another disadvantage of eternite roofing is its relative brittleness and porous surface. This results in a greater amount of moss, lichens or salt blooms that are visible in all of its outer surfaces. There is also moss growth in the edge of the masonry walls that are in contact with the exterior eternite sheets.

Fig 45: Moss growth in joints between masonry walls & eternite sheets

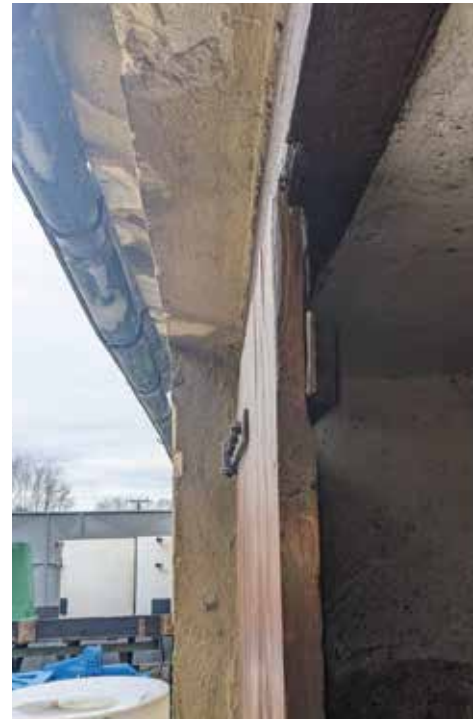
Fig 46: Different color & texture interior and exterior plaster renders

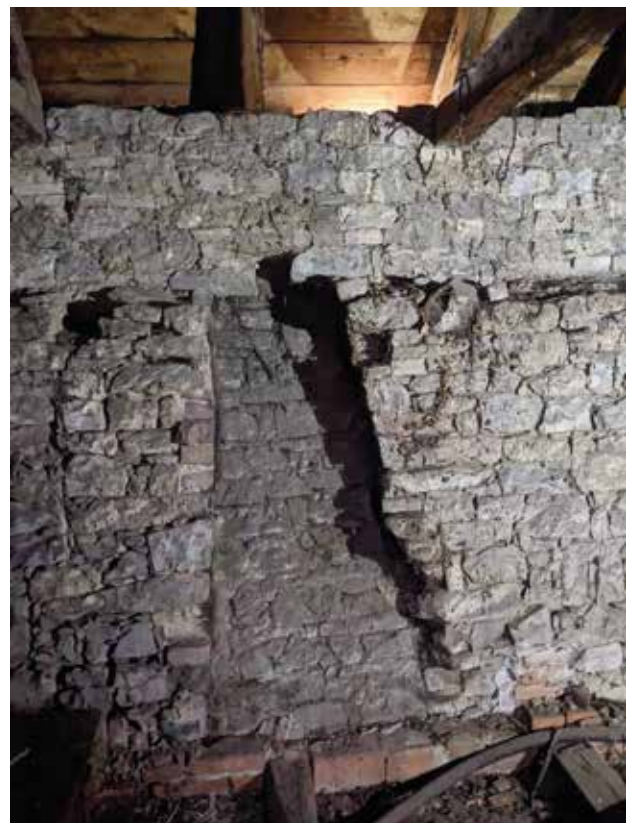
Fig 48: Former chimney shaft

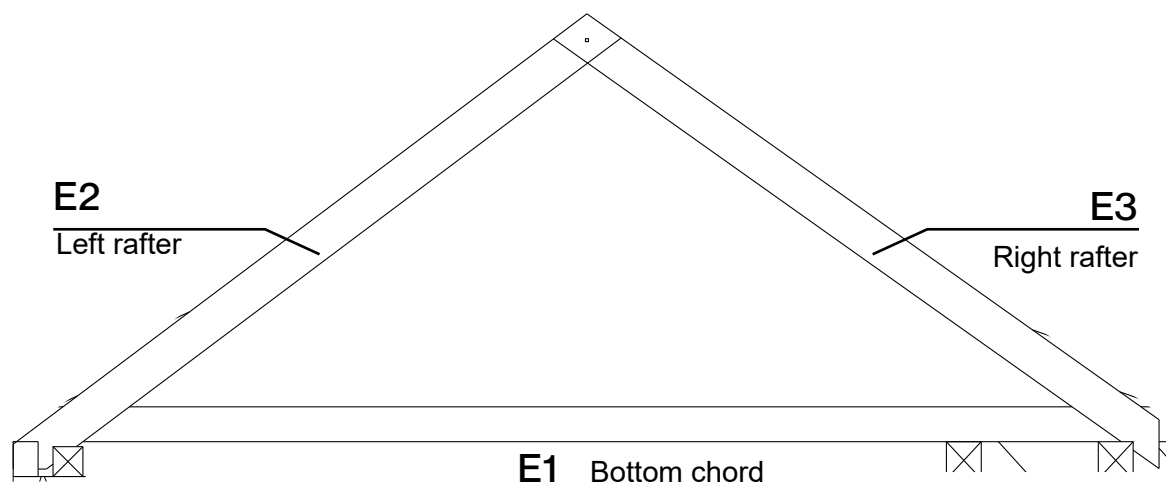
TPA: Elevation : Truss type A

Most of the trusses type are in a considerable salvage state of conservation. It present from moderate to sever damages in their members such as cracks, biological attack ,interventions with new timber members and repairs made with sealings and polyurethane.The trusses were coded by its diferent members in order to have a better understanding of the localized damage.

The wood struts , vertical posts and partition walls were found in a completely degraded state by humidity and insect attacks. The posts are not longer complying with any function and so for this reasons they will be removed completely.

Truss A2 & 4, where the most severe damage is found on the corner points of the rafters. This points should be intervened with metalic conectors embeded in the joints. Further studies of the mechanical behaviour of the joint should be performed to dictaminare the specifications of the elements.

Truss A2 presents a long crack in the upper section of the element. This represents a posible future expansion or splitting in this section of the member. Reinforcing with U steel profiles can be incorporated along its lenght as a posible solution to stich this crack. An adecuate resistance test with a screwdriver or a rod penetration test should be performed in order to know the depth of this soft section and derive its actual resistance.

Truss A1 shows some minor damage on its front face caused by acidity provoked by organic fecal mater of peagons and xilophagus attack that are penetrating inside the wood. Insecticide should be sprayed and/or injected in this areas depending on the exact insect species that is eliminated.

Rehabilitation of wooden structures can be carried out by direct strengthening of individual elements (by means of prosthesis, extension, height extension, application of carbon fibres, anchoring into a steel bracket, etc.), by their indirect strengthening (by supporting, lightening, etc.) or by strengthening of structural units (by coupling in the form of wood - wood, wood - concrete and other load-bearing systems, by tightening with steel rods, etc.). This chapter focuses on the methods of prosthesis, attachment and anchoring to steel brackets, which are recommended in the rehabilitation of the ceiling and timber trusses.

The restoration methods recommended for the wooden elements and the whole structure are prosthesis, bolting and anchoring to steel brackets.

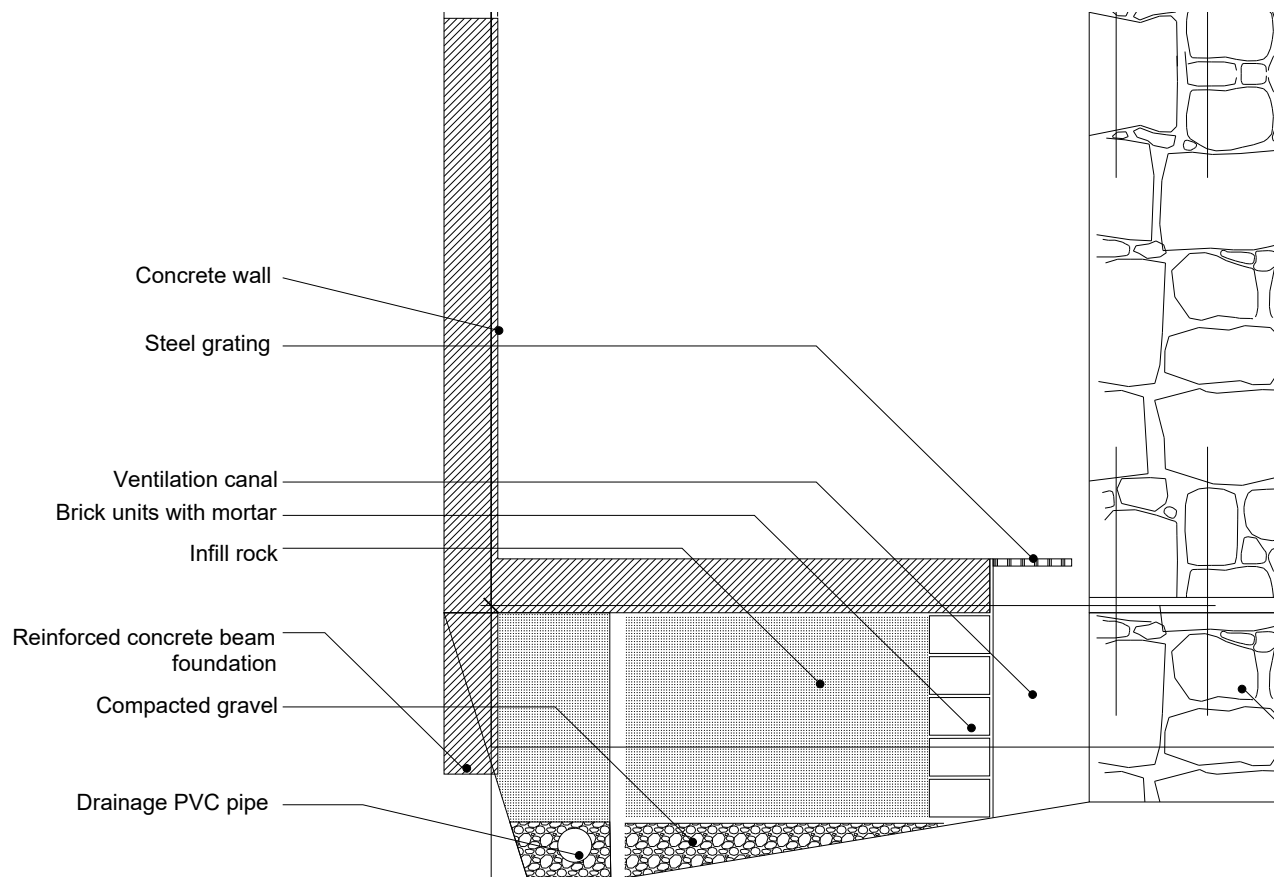
DA-01

The perimetral opuka walls have masonry foundations from 30 to 40 cms below ground level. This buried stone is now damaged due to rising damp of underground water table. Therefore it is necessary to implement a passive ventilation technique which consists in making air ventilation canals along the perimetral walls. This air ducts will avoid the direct contact between the masonry stone foundation and the water from the soil in its surrounding. The channel is based over a small concrete template and built with brick units binded with mortar and a waterproof layer of hydraulic lime.

It is also important to consider the pre existing adjoining ditch which will be reinforced with a concrete beam as a base, that will help settle the pre existent wall over diferent types of infill, gravel and soil that will be poured underneath this concrete wall in order to drain the accumulated water around the masonry walls and foundation. On the inside of the building the ventilation allows the pass of the air through open steel gratings and a dilataion gap that is left so the materials can contract and dilate without creating any tensions or streesses in the walls.

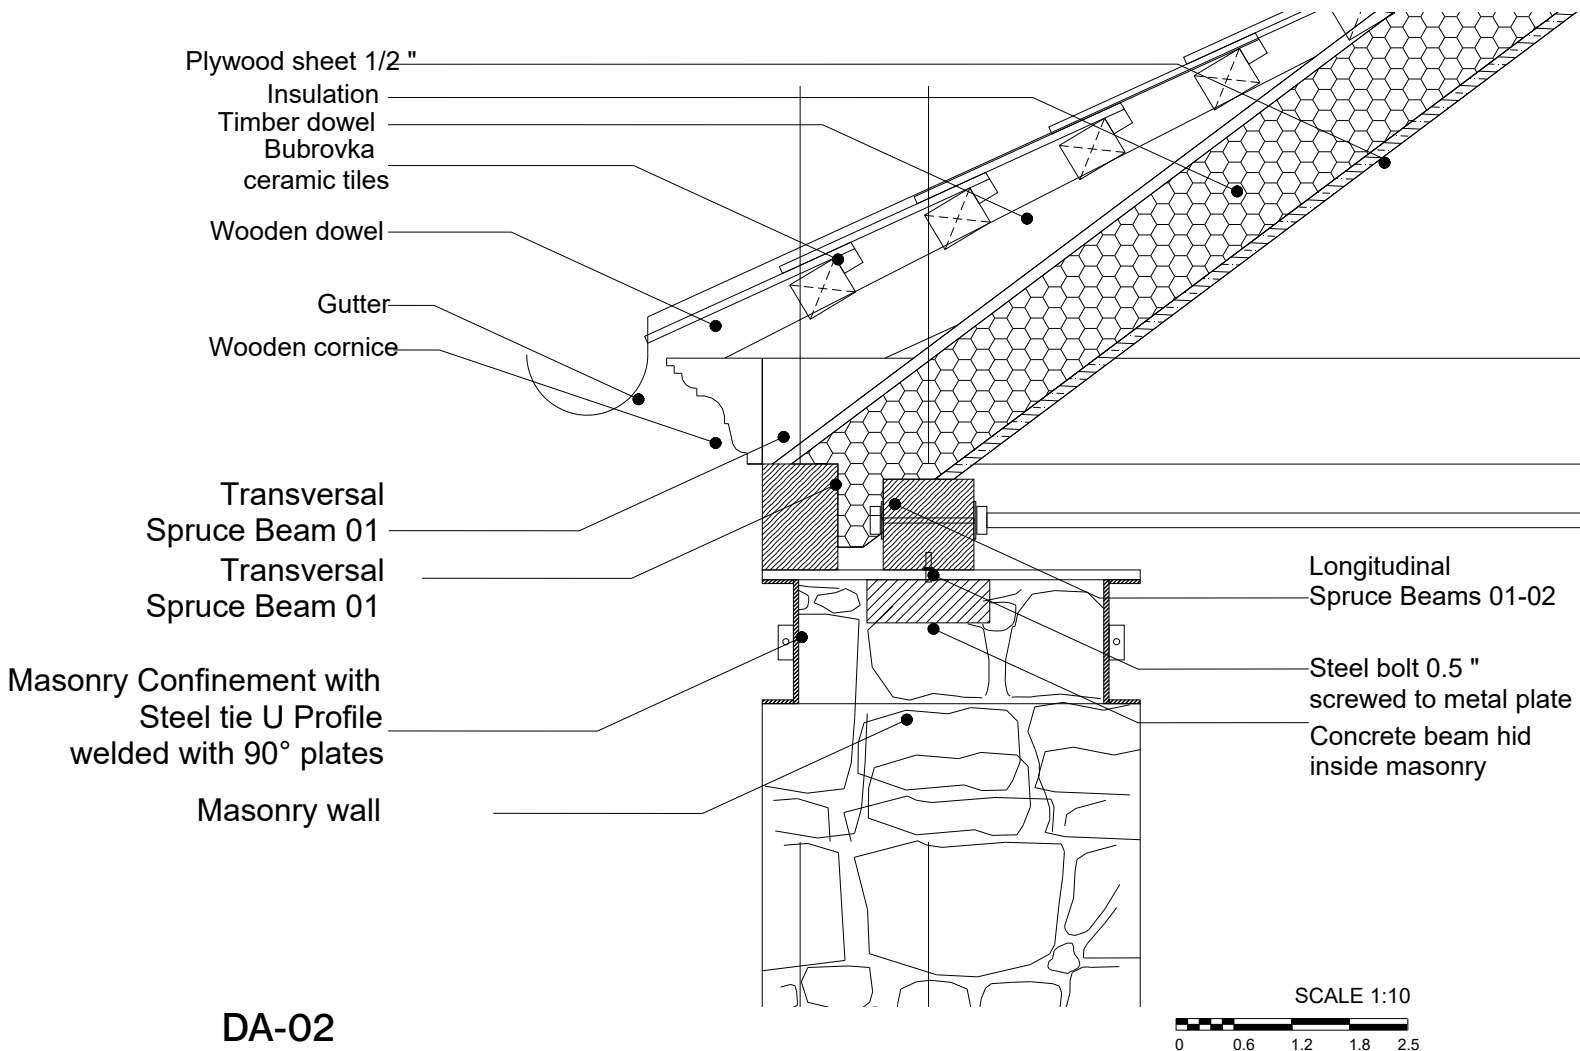
DA-02

The top part of the masonry walls needs to be stabilized due to material loss and degradation of the opuka stone, which throughout the years without any maintenance, has left an uneven degraded surface of stone and rubble.

This masonry confinement belt of 17 cm of height, is made by a U Steel profile on both faces of the wall anchored in the corners with steel plates. Along with repointing and grouting techniques within the masonry structure. This ties compact the opuka masonry walls from both sides, creating a stable and leveled element that acts as a beam where the timber trusses of the roof will be resting.
