Master's Thesis

Static Assessment of Judit
Tower in Prague.

University of Minho

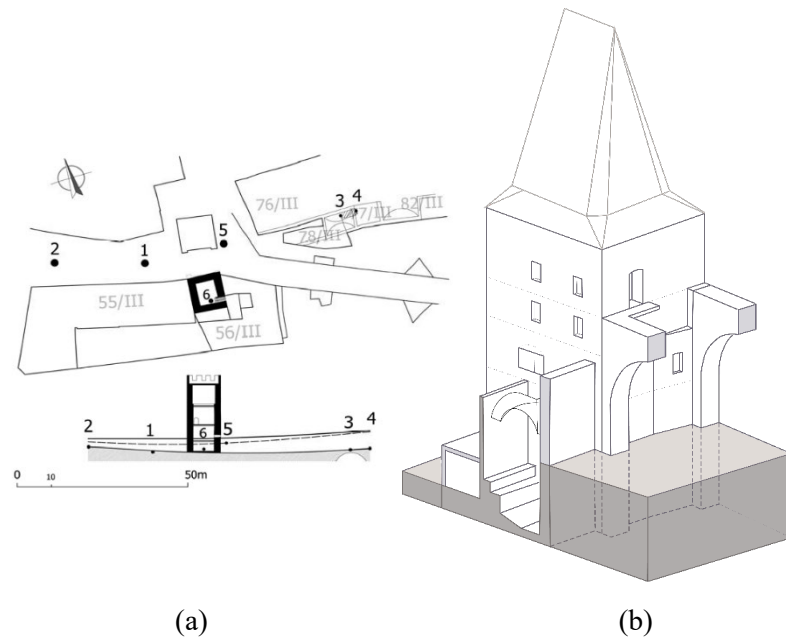
Figure 4.4 North Façade – (a) Topographic diagram by J. Veselý, (b) 3D diagram showing the street level of the north and level of the courtyard on the south.

Most of the north and south facades of the ground floor, along with the basement's walls, are hidden under the street's current level. (Figure 4.4, a) is a topographical diagram illustrating a vertical section of the tower and terrain below. (1) and (2) levels captured by J. Čiháková on Mostecká Street in 1997; (3) and (4) levels exposed of diabase paving of Judita Bridge on the ground floor of house No. 77/III; (5) level of older paving of Charles Bridge captured by Z. Dragoun in 2007; (6) assumed level of the floor of the Romanesque ground floor of Judita Tower; the current ground level is shown by a solid thick line (Survey and drawing by J. Veselý, topography of remnants of Judita Bridge taken from the book by V. Hlavsa and J. Vančura, Lesser Town, Prague 1983).

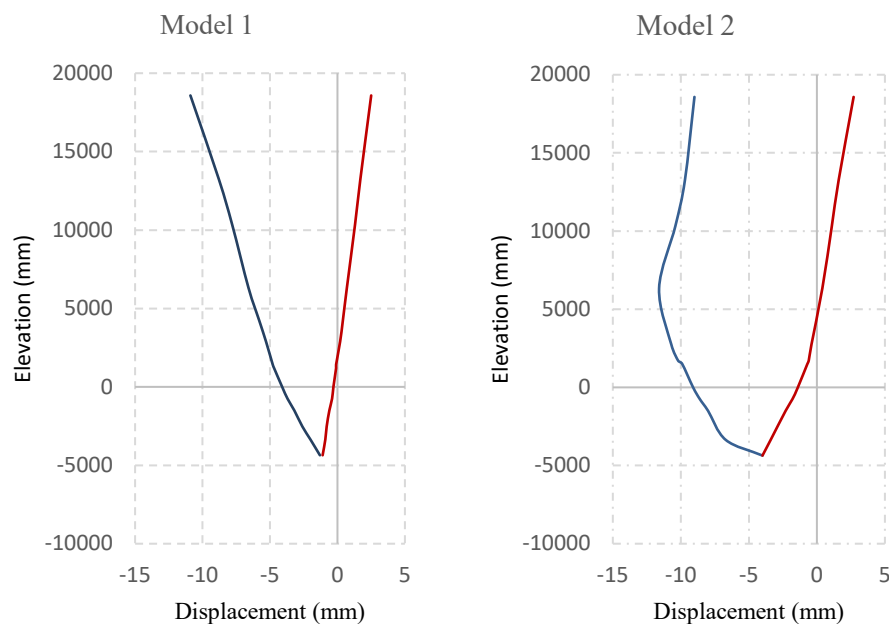
Figure 6.1 Displacement – Southeastern Corner of the Tower

In both models, the tower shows greater deformation in the (-x) direction than in the (+y) direction (Figure 6.1). The first model shows that the highest displacement of 10.9 mm is at the top of the southeast corner, whereas the second model shows that the highest displacement of 11.6 mm at the ground floor level (6.33 meters height). The accurate distribution of the mass of the walls and the relationship between the walls and vaults in the second model might have contributed to shaping the deformation in M2. The presence of the gate to the north of the tower and the decrease in the thickness of the third floor's walls contributed to the deformation shape observed in the top north corner in both models (Figure 6.2).

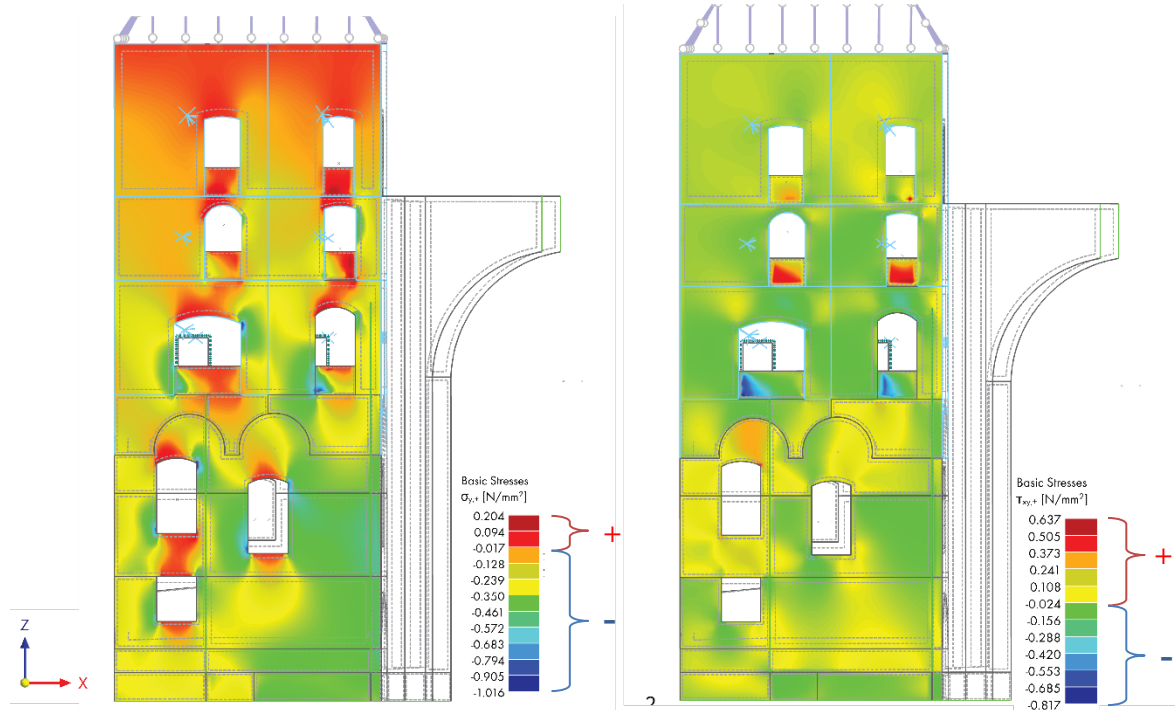
Figure 6.3 Eastern Façade – M1, (a) compressive [basic] stress σ_x , (b) Tension stress τ_{xy}

The stresses were investigated in the eastern façade, which shows the most damage. Figures 6.3 and 6.4 show the distribution of stresses in both models, including the compressive stresses σ_x and shear stresses τ_{xz} along with the principal shear stresses τ_{max} . It should be noted that the tension stress experienced is relatively low compared to the compression stress. As a conservative assumption, masonry should not have any tensile stresses. However, in the numerical model, tensile stresses are observed. They are approximately below 1.5 MPa, and it is possible that the masonry may actually resist these stresses.

The concentration of the stresses is shown in Figures 6.3 and 6.4, appeared mainly in the weakest elements, above and under the opening, and in the intersection between the tower and the adjacent structures. The latter have contributed greatly distribution of to the shear stresses along the structure. Moreover, the compression and shear stresses distribution's angle are results of the soil settlement. Figures 6.6 and 6.7 illustrate and compare between the result from numerical model and the visual inspection (crack maps).

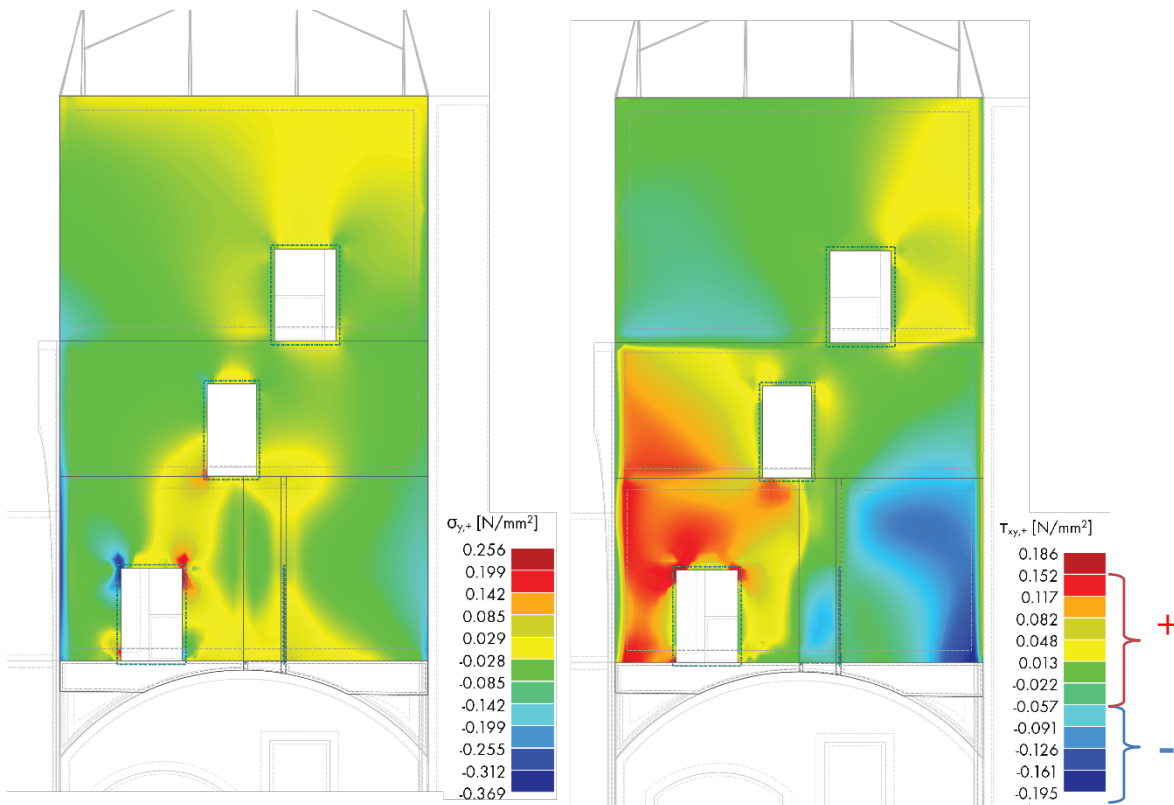
Figure 6.8 Interior wall partition, (a) Compressive stress σ_y , (b) Shear stress τ_{xy} .

Furthermore, linear analysis was performed on interior wall partitions (Figure 6.8). It shows cracks long and wide. These are inclined symmetrically, interpreted as shear cracks resulting from the settlement of the fill or the threshold beam beneath the load-bearing wall. The numerical models showed compressive and shear stresses concentration, which matches the previously described deficiencies (Figure 6.9).

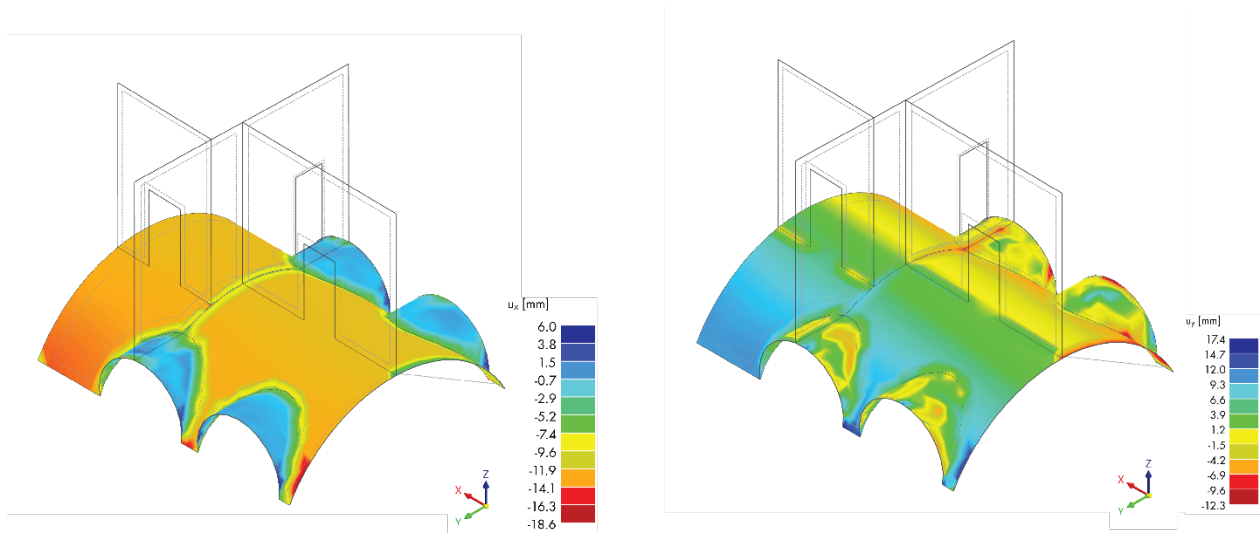
Figure 6.10 Local deformation of the cross vaults; (a) Displacement on the x-direction, (b) Displacement on the y-direction

By examining the local deformation of the vault in the numerical model, the analysis shows that the vault exhibits displacement of 18.6 mm in the (-x) direction and 17.4 mm in the (+y) direction, influenced by the global deformation of the tower (Figure 6.10). However, the vault also suffers from compressive stress from the weight of wall partitions, and shear stress caused probably from global behavior of the structure (Figure 6.11).
