ADAPTIVE REUSE OF AN OLD STEEL HALL

Thesis submitted in partial fulfillment of the requirements for the degree of
MASTER OF SCIENCE

The frames damaged by the storm are the frames in axis 4 (significant plastic deformation of the girder) and the frame in axis 5 (the girder is only slightly deformed). The state of the structure following the storm is presented below.

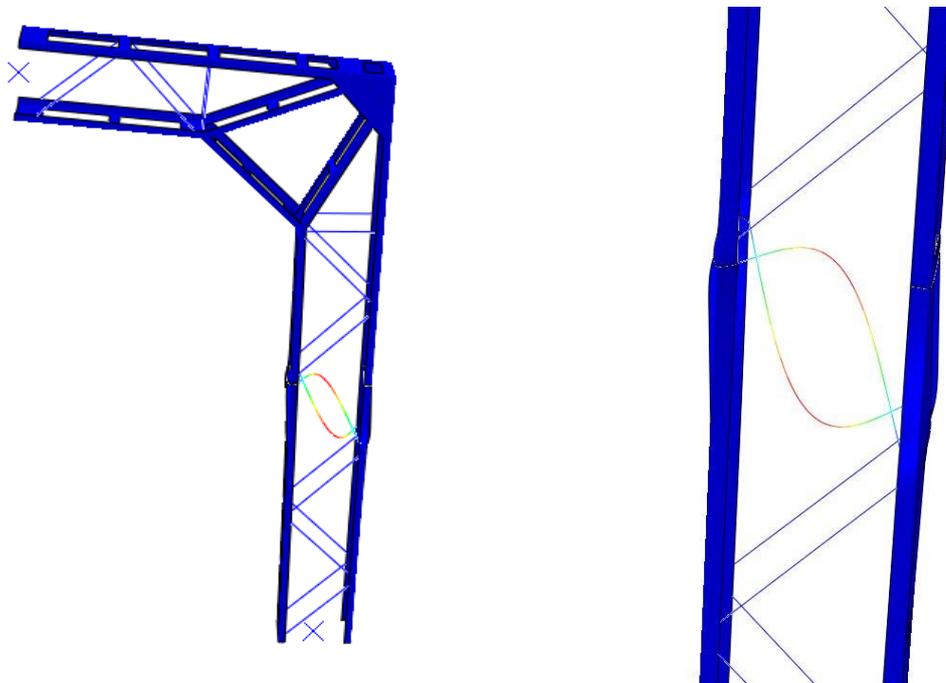
Figure 3.18 The fifth buckling mode of the node in the initial state

(a) General view of the node

(b) Close-up of the region where the buckling occurs

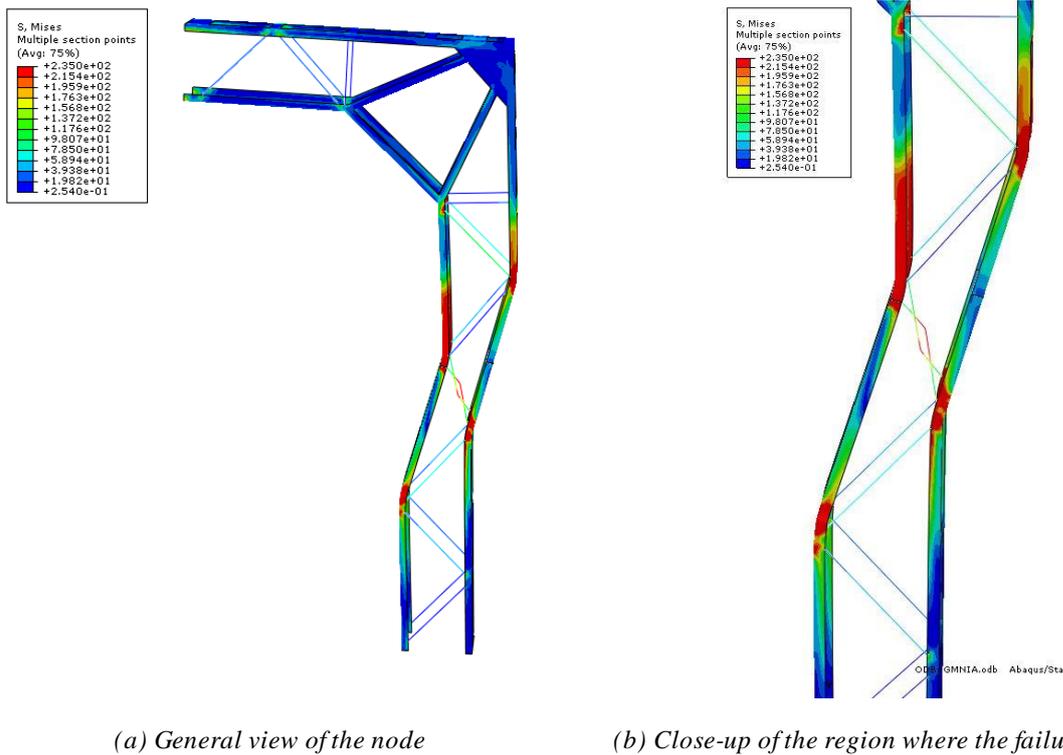
Figure 3.19 The distribution of von Mises stresses and the deformed shape of the node in the initial state

The failure of the node occurs due to the out-of-plane flexural buckling of the column diagonals, which leads to the formation of a mechanism. The same failure mechanism was observed in case of the damaged girders after the September 2017 storm (See Paragraph 2.3).

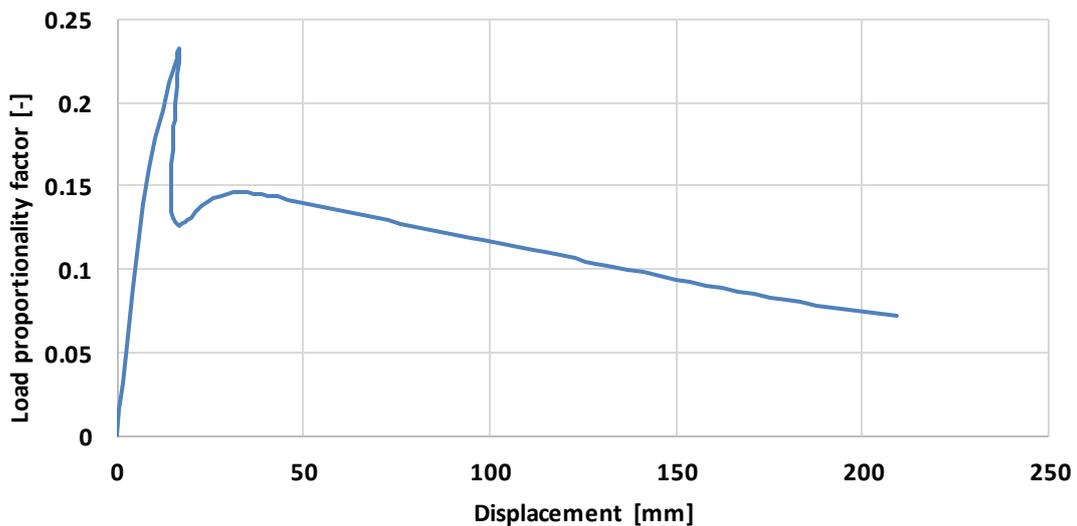
Figure 3.20 Load proportionality factor of the node in the initial state

As the value of the Load Proportionality Factor is 0.23, the bearing capacity of the node is exceeded.

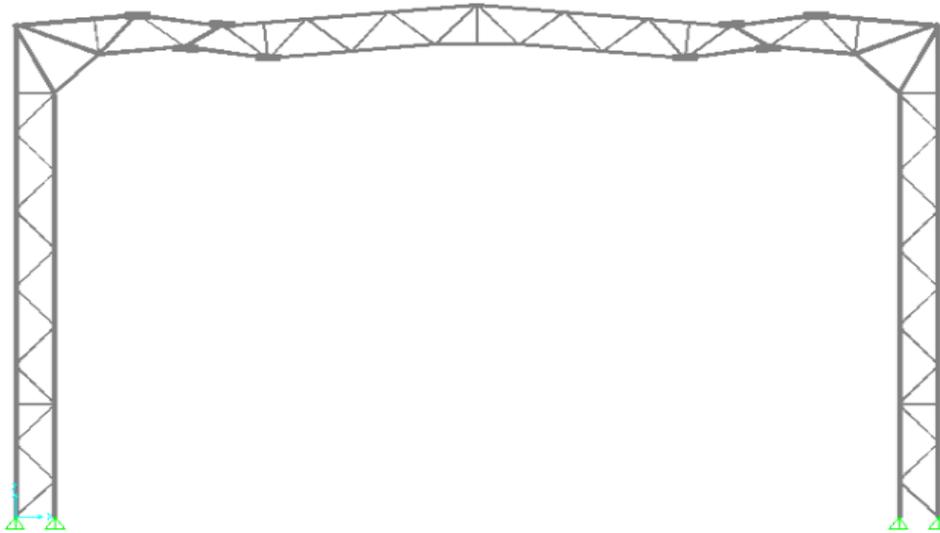
Figure 4.3 2D model of the transversal frame in axis 4, after the storm, with the partial rehabilitation solution

The 2D model of the deformed transversal frame in axis 4 is presented in Figure 4.3 (buckled diagonals are replaced with new ones and the steel plates are provided in the regions where deformations occurred). The crack in the weld is modeled by a discontinuity in the angles. A similar model was used for the analysis of the frame in axis 5.

The partial rehabilitation of the frames from axes 4 and 5 consists of welding steel plates in the regions where deformations occurred (the nodes in which cracks occurred in the welds, as well as the adjacent nodes in which the weld did not fail) in order to ensure the continuity of the angles. Also, the buckled diagonals will be replaced with new ones. The steel plates have a thickness of 10mm and the new diagonals are angles with the cross-section of L45x45x5. Both the steel plates and the angles are made from S235 steel.

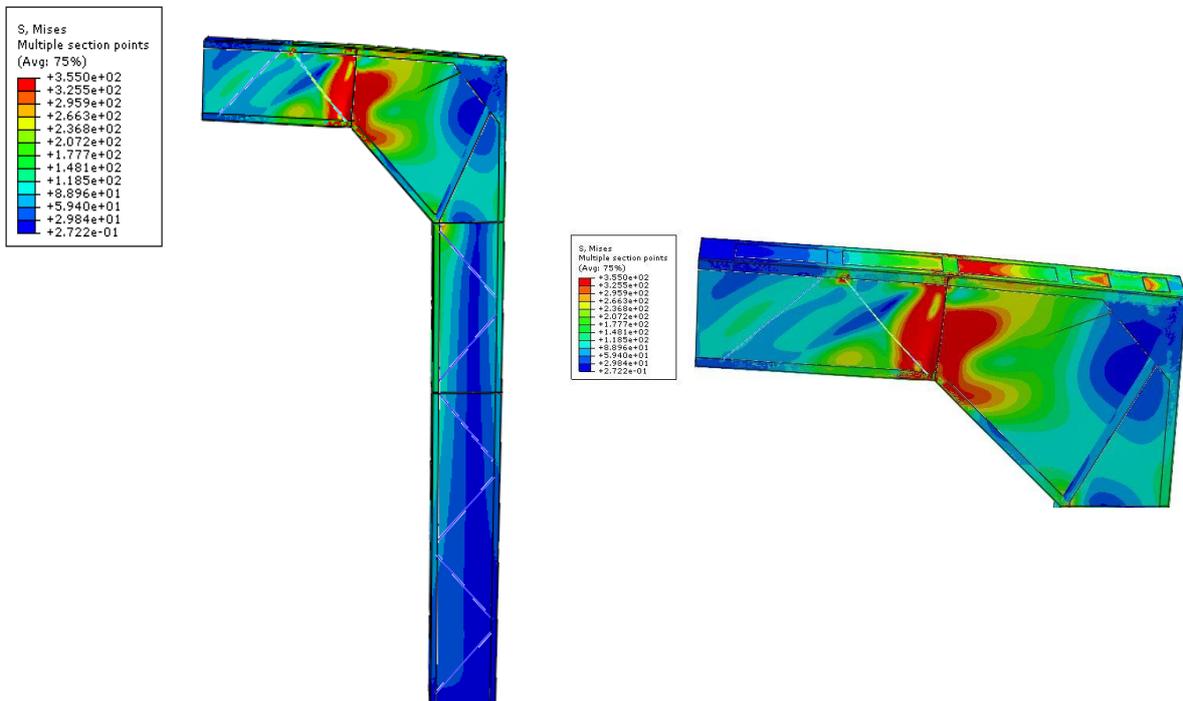
Figure 5.20 The distribution of von Mises stresses and the deformed shape of the node after the final rehabilitation

The failure of the node occurs due to the failure in shear buckling of the girder and node web steel plates. This failure mechanism can be explained by considering that the web steel plates are slender, making them susceptible to the phenomenon of shear buckling. Moreover, the failure occurs close to the end of the node, where the value of the shear force is maximum. Even in the analytical check of the girder, the check to shear buckling proved to be significant (See Paragraph 5.3.4).

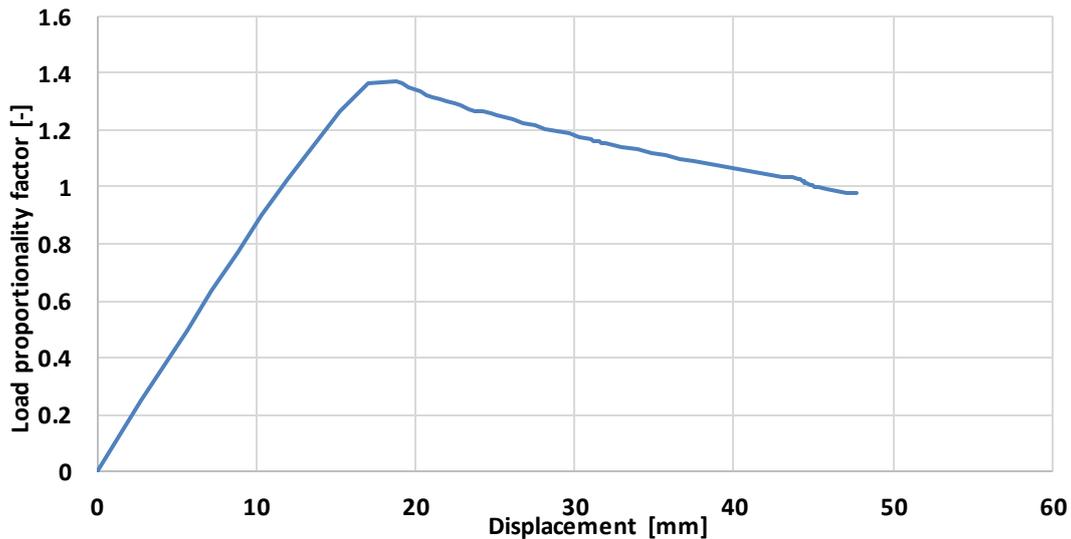
Figure 5.21 Load proportionality factor of the node after the final rehabilitation

As the value of the Load Proportionality Factor is 1.37, the bearing capacity of the node is sufficient.

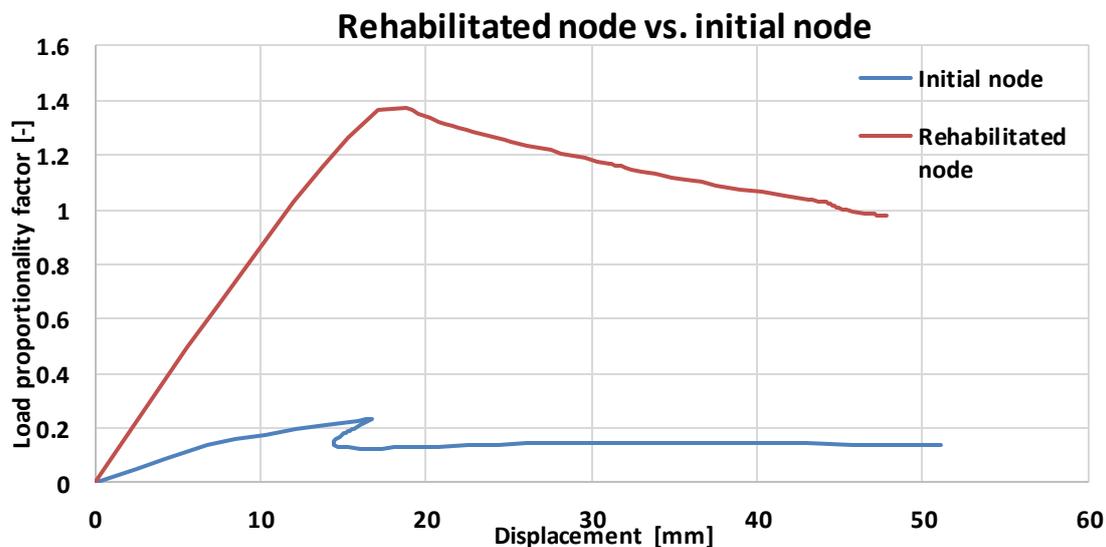
Figure 5.22 Comparison between the initial node and the rehabilitated node

The comparison between the rehabilitated node and the initial node is presented in Figure 5.22. The bearing capacity of the node is increased almost 6 times following the structural upgrade.
