## MASTER'S THESIS PROPOSAL

Thesis title: Nonlinear numerical evaluation of the wall bearing capacity and the structure stability of the St. Ann Church from the Broumov Group of Churches

This report summarizes the visual investigation, structural investigation using ATENA 2D software, Geo 5 geotechnical FEM software and DIANA FEM software, to assess and verify the safety of the church walls regarding the damages it currently suffers. With regards to the material and sub-soil data available, micro modelling of different wall configuration in longitudinal and transversal direction was done with ATENA 2D software to evaluate the safe bearing capacity of the walls, from the analysis it was found that the current bearing capacity of the walls are higher than the values recommended by the Eurocodes. From this 2D FEM analysis, a set of homogeneous properties were also computed, which were later used in the geotechnical and 3D macro FEM analysis. In Geo5 software, the effect of sub-soil conditions was analyzed, and it was observed that, for the present condition of the soil, the church suffers from the differential settlements between the area where drainage water is accumulated and have

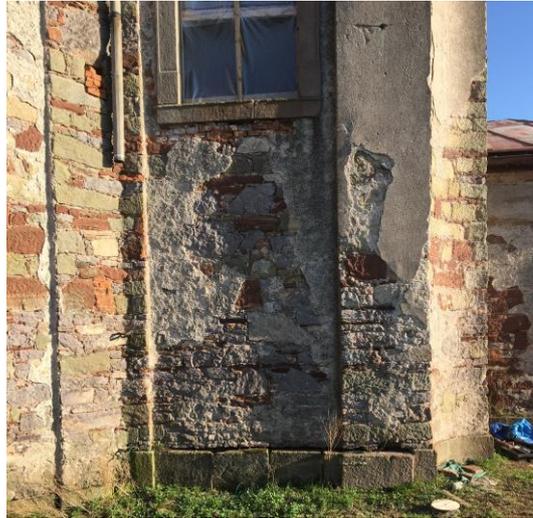
Detachment includes: blistering, bursting, delamination, disintegration, fragmentation, peeling, and scaling. The exterior of the Church shows some disintegration of the granite stone. Disintegration, as defined by ICOMOS, is the detachment of single grains or aggregates of grains (**Figure 3.7**).

Figure 3.7 - Detachment as scaling on plasters

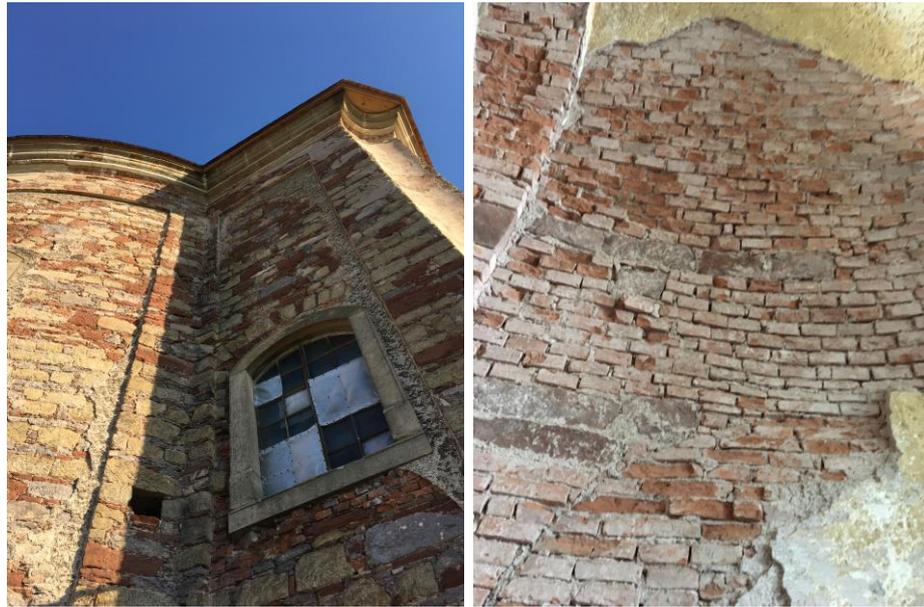
The material loss includes alveolization, erosion, mechanical damage, microskarst, missing part, perforation, and pitting. The exterior of the Church presents erosion including loss of matrix and rounding of the edges close to the joints, these are due to the erosion of the stones at the exterior part mainly due to freeze and thaw cycles **Figure 3.8**. There are also some missing parts, as shown in **Figure 3.9**.

Figure 3.9 - Plaster loss at the exterior (Left) and Interior (Right)

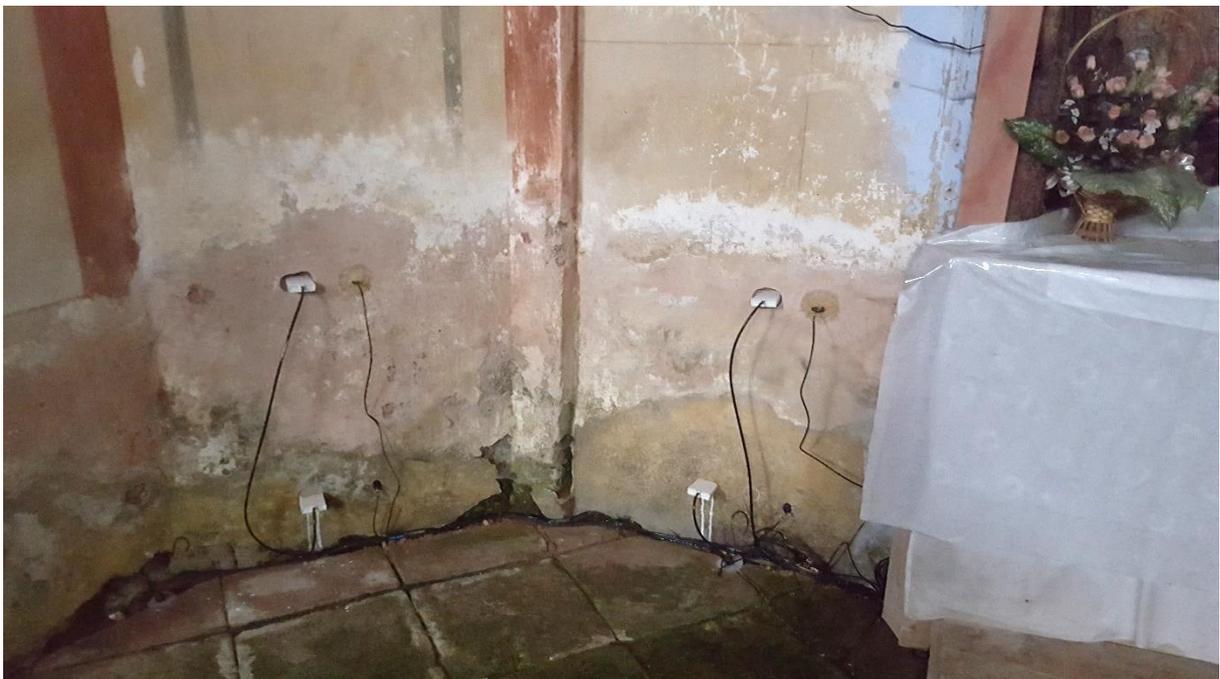
For the investigation work, a network of monitoring systems is installed on site, which consists of humidity sensors, strain gauges, and MPS-6 sensors. These sensors are located inside the church on the wall and outside in the soil as shown in **Figure 3.16** and **Figure 3.17**. From this research work, it was possible to observe the presence of the pressure water at the shallow depth in the soil and the capillary rise of the water in the masonry walls of the church. From the work, it was also concluded that the groundwater at the area is more affected by the water coming from the uphill than the water infiltrated from the precipitation directly on the site (Peleška, 2108).

Figure 3.16 - Sensors installed inside the church at north side (**Peleška, 2108**)

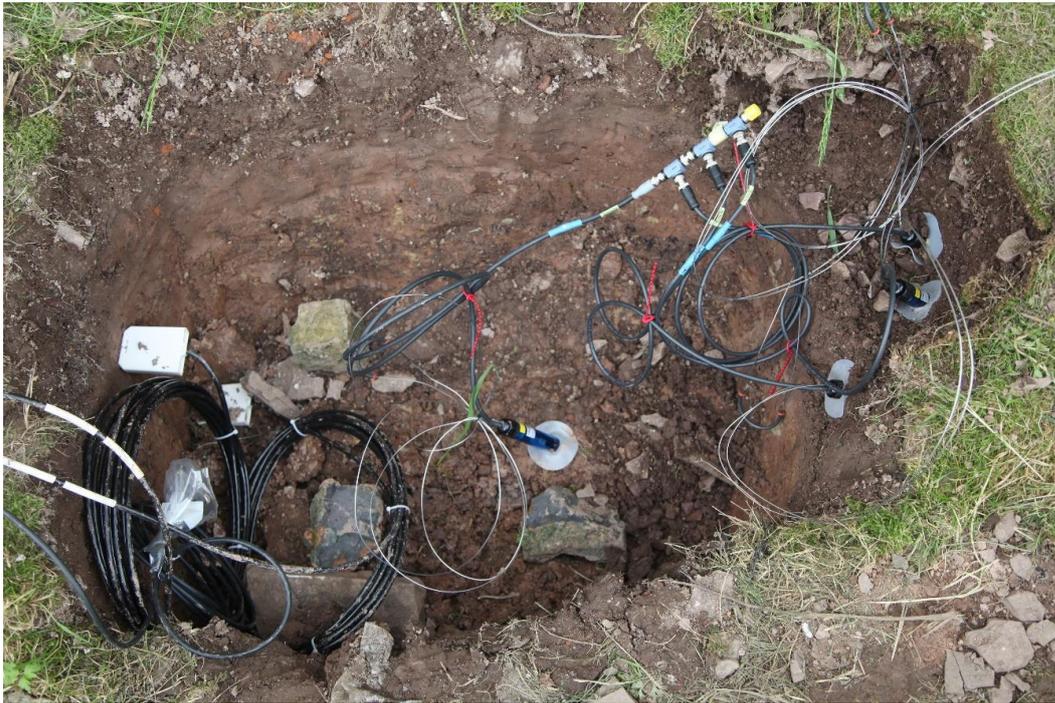
Figure 3.17 - Sensors installed in the surrounding soil at north side (**Peleška, 2108**)

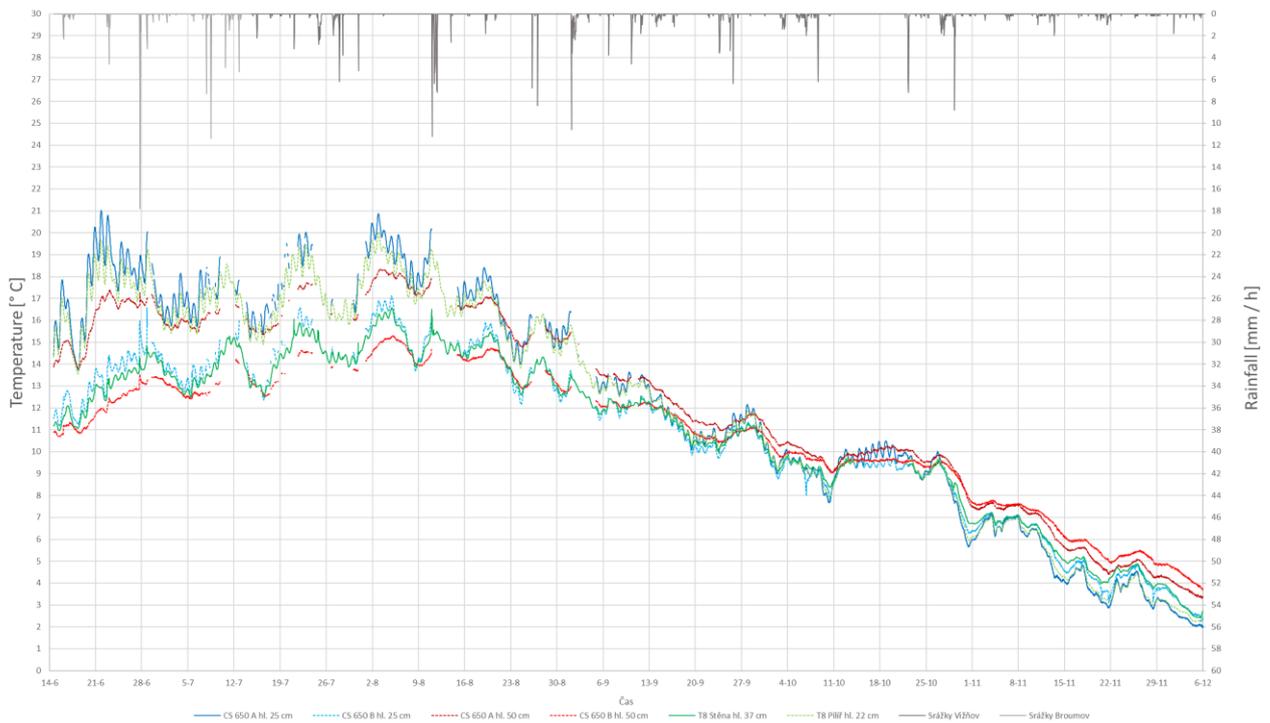
This research work is found to be very informative regarding the subsoil condition with respect to the groundwater movement and the capillary rise of water in walls and its relations with the rainfall in the area (**Figure 3.18**).

Figure 3.18 - Comparison of temperatures measured by the humidity sensors and the strain gauges in the church (**Peleška, 2108**).

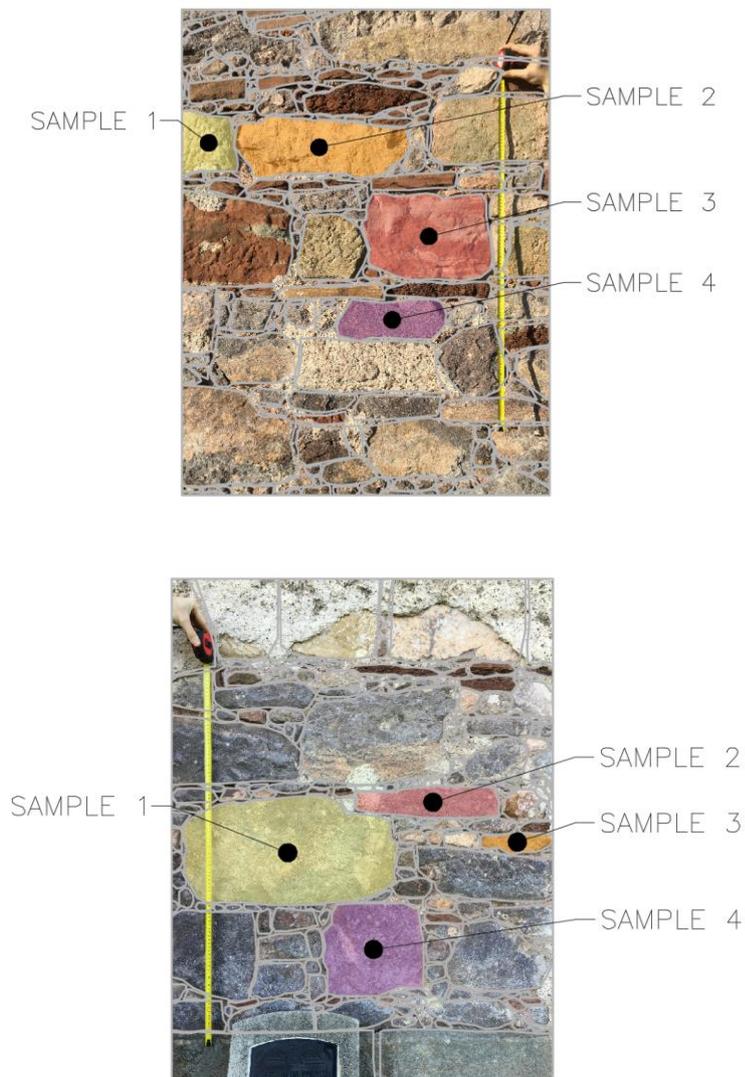
For the same reason, two different spots were chosen to perform the Schmidt hammer test on different types of stones. The wall samples which were chosen are of size 1 meter by 1 meter at two different locations in the church and these two locations of the sample represent the different combinations of the stones to build the masonry as shown in **Figure 4.2**

Figure 4.2 - Wall samples considered in the analysis. Wall sample 1 (top) wall sample 2 (bottom)

As it can be observed from the above figure, on each wall samples, four different types of stones were chosen to perform the superficial strength test. On each stone sample the rebound hammer was performed for 10 times and then the average value of the rebound number was chosen, this average number of rebound number was transformed into the equivalent strength values from the formula provided by the manufacturer of the equipment (Proceq, 2017). Following are the tables showing the strength of these sample stones.

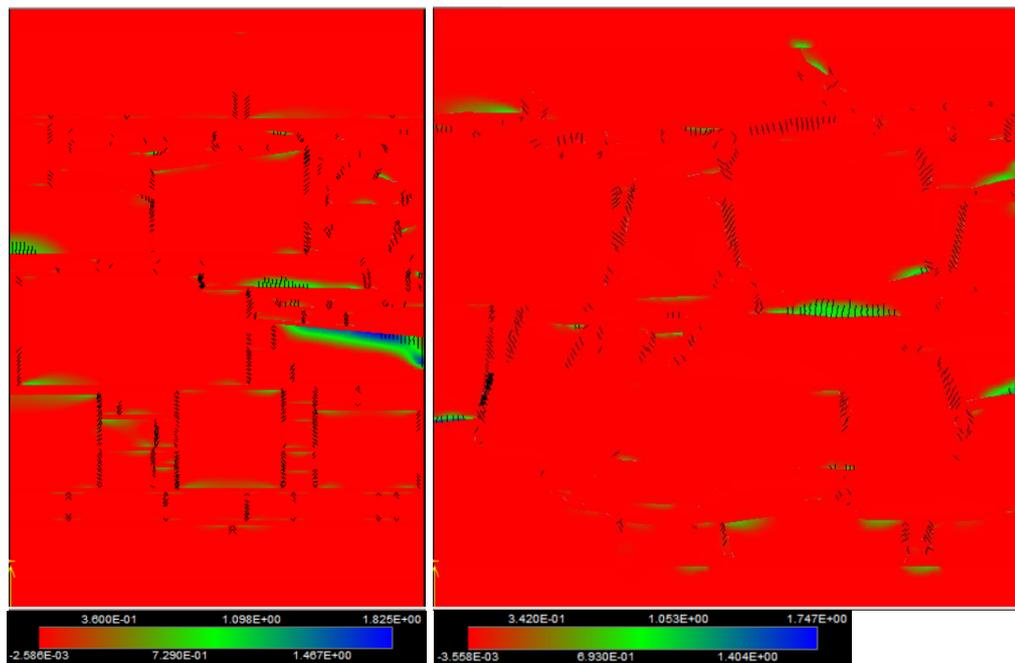
After performing the analysis, to observe the damage and performance of the wall under the compressive stress applied as the deformation, cracks and the maximum principal stress was observed on the section as shown in **Figure 4.7** and **Figure 4.8**.

Figure 4.8 - Maximum Principal stress in the wall configuration 1 (Left) configuration 2 (Right)

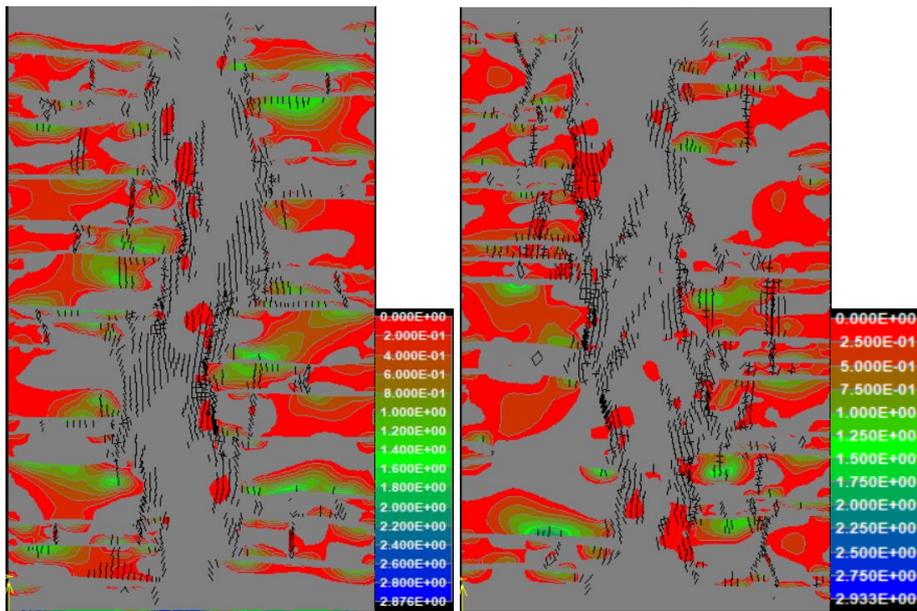
From this analysis, it is possible to observe the damages occurred in the transversal walls. Here with an increase in the compressive stress, it can be observed that the wall undergoes the damage, which starts to occur near the infill rubble and outer leaf from both sides, these cracks separate the infill from the external masonry and relatively high transversal deformations can be observed in the wall. With further increase in the load, cracks in the lime mortar and crushing of stones can be observed at some locations. From this analysis, a stress vs strain graph can be plotted which is shown in Graph 2.

Figure 4.11 - Horizontal tensile stress in transversal wall configuration 1 (Left) configuration 2 (Right)

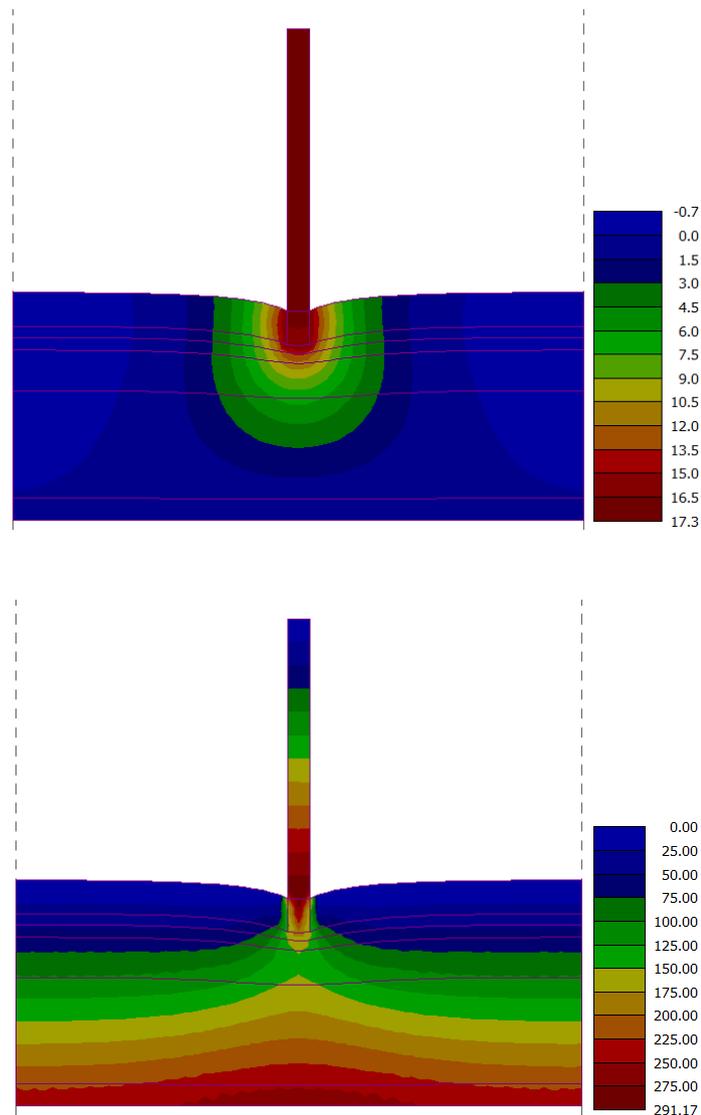
**Figure 5.8 - Settlement at the westside wall for the present soil condition [mm] at top and distribution of vertical compressive stress in soil layer [kPa] at bottom**

From the analysis results of the settlement using Geo 5, it is possible to observe that the differential settlement from westside to the east side of the church for the present state of soil is negligible [0.6 mm] but in the change of sections such as near the tower and sacristy where the applied load on soil is different than the man nave higher differences between the settlements can be observed for the present state of soil. While from the site observation it was observed that at many locations of the church foundation is degraded, and to evaluate the condition of foundation at those level, analysis was carried out considering the degraded condition of the soil at those locations, the amount of settlement observed at that location was much higher compared to the settlement in the present soil, which strongly suggest that the damages observed on the site can be related to the problems of differential soil settlement and a study is required to be carried out to analyse such effect by using 3D model.

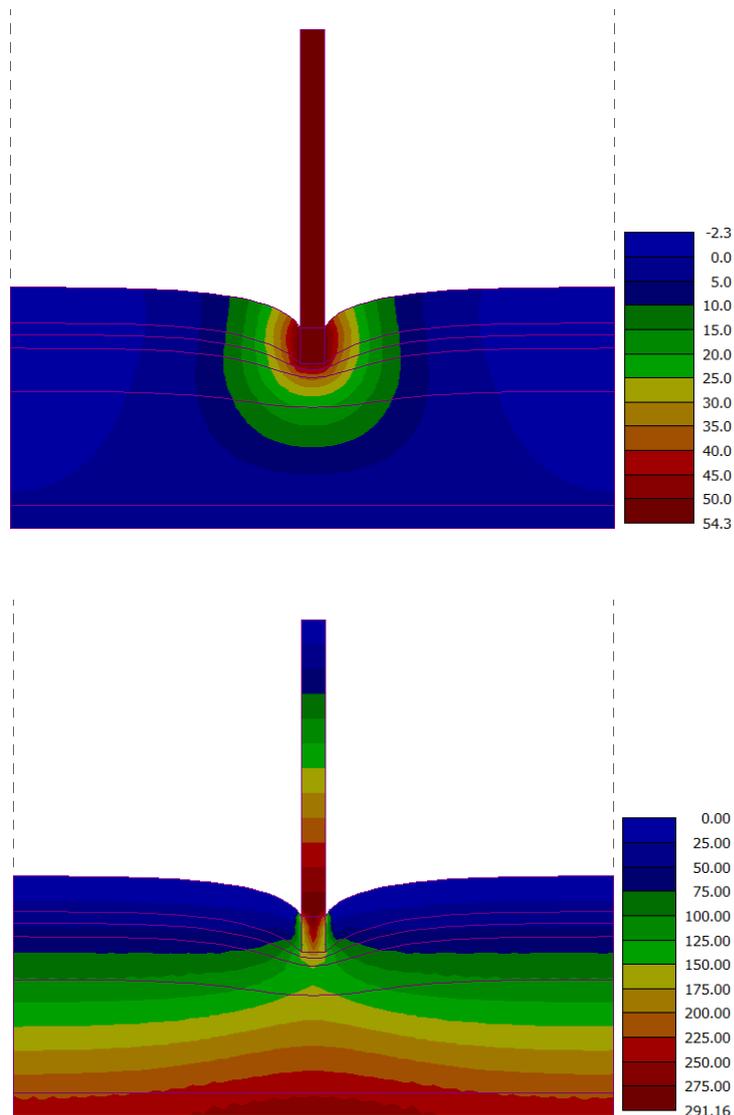
**Figure 5.9 - Settlement at the westside wall for the degraded soil condition [mm] at top and distribution of vertical compressive stress in soil layer [kPa] at bottom**

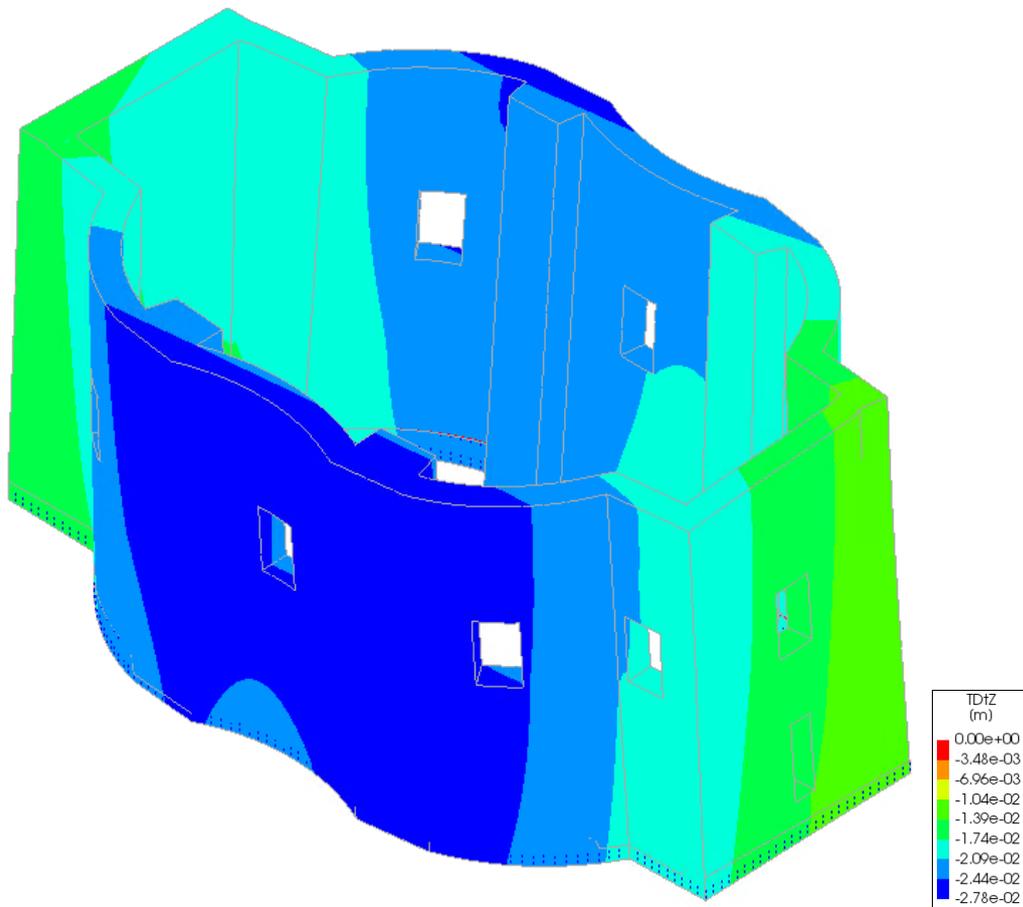
**Figure 5.14 - Deformation in the structure after implication of settlements in the structure**

From the above figure it is possible to observe the settlement of the structure at the final stage of analysis. The load-step vs settlement plot can be observed in the Graph 3, at the different location in the structure. From the plot it is possible to observe that until step 10, all the locations went through the same settlements approximately, which was the case where the springs were applied for the good soils conditions throughout, but when the effect of differential settlements was mimicked, it is possible to observe the evolution of settlements at different locations.

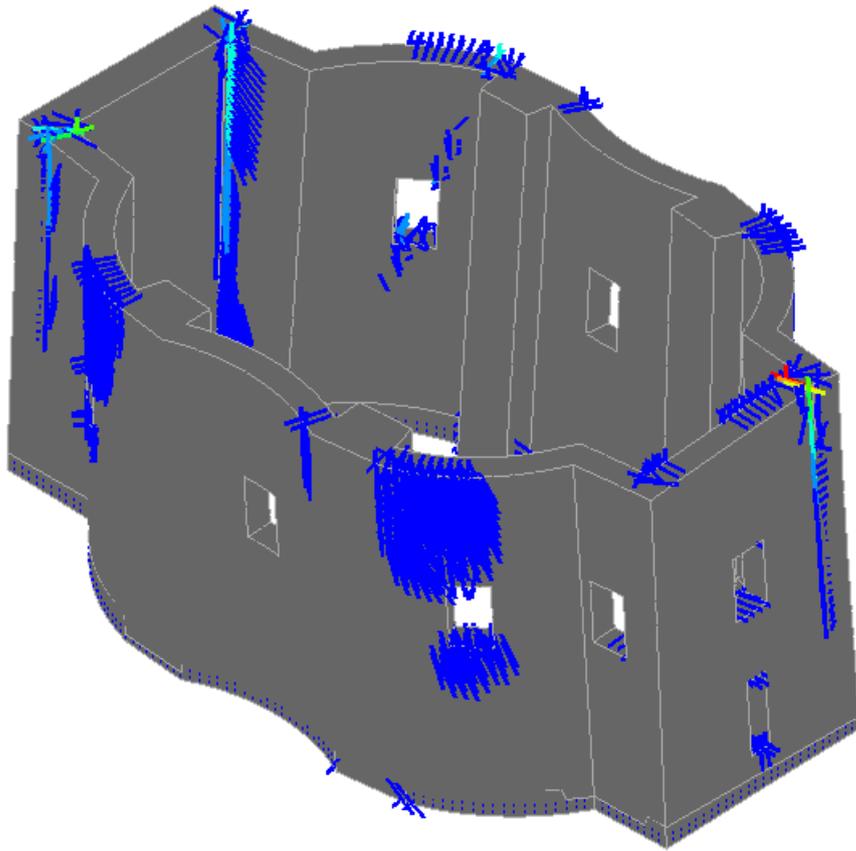
**Figure 5.15 - Crack strains in the 3D view**

From the above figures, the crack strain obtained in the structures can be found which occurred due to the increased differential settlements. Here it is interesting to notice the that most of the crack strains that can be observed here were found to be in accordance with the damage observed on the site. From this, it supports the considered hypothesis behind the occurrence of damages (i.e. differential settlements).

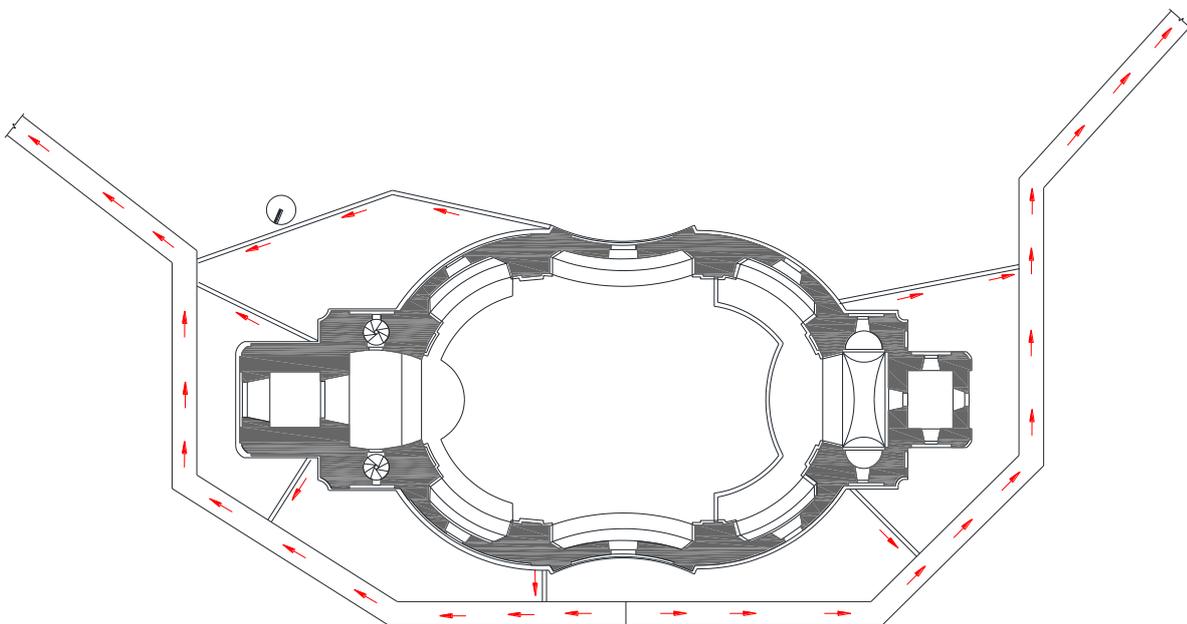
Major contributing factor regarding the current decayed state of the structure was observed to be due to the non-performing roof and ground drainage system, which allows rain and groundwater to accumulate near the walls and increases the decay process in both, the walls and sub-soil. This phenomenon is found to be the prime cause of the differential settlement which the structure is currently suffering from. As shown in Figure 7.2, it can be observed that the downspout to drain away the rainwater is not adequate and also the damages it can cause in walls due to capillary rise of water from the ground on walls.

**Figure 7.3 - Schematic drawing showing proposed layout of the ground drainage system**

The idea behind this proposed groundwater drainage system is to drive away the drainage water as far as possible from the walls of the church. As it was observed from the previous studies and present study on this structure, the main problem of groundwater accumulation is at the north side where the groundwater comes from the uphill side as well as due to rainwater downspouts, the proposed system is designed to drive away the water from the walls, the detailed sections of the proposed drainage system can be observed in Figure 7.4.

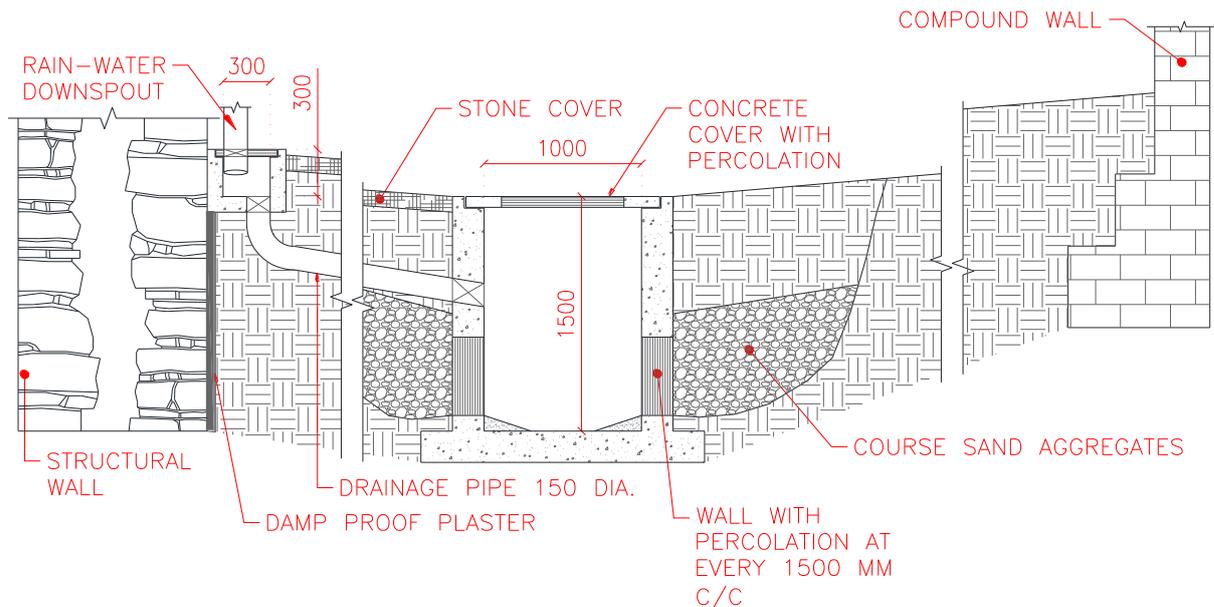
**Figure 7.4 - Section of Proposed rain and groundwater drainage system**

The philosophy behind this design was the drainage of not only the rainwater coming from the roof or the direct precipitation around the church wall but also to collect and drive away the groundwater coming from the uphill places. There are two elements of the design, one is the rainwater collection and drainage pit at every downspout and plinth protection along the outer side of wall in terms of damp proof plaster and stone cover to drive away the precipitated water, to collect the groundwater and maintain the level of groundwater, so that further decay of sub-soil can be stopped, a series of course sand aggregates is proposed on both side of the drainage line so that the groundwater could be filtered out and collected into the pit and any unwanted variation in the groundwater level can be stopped.

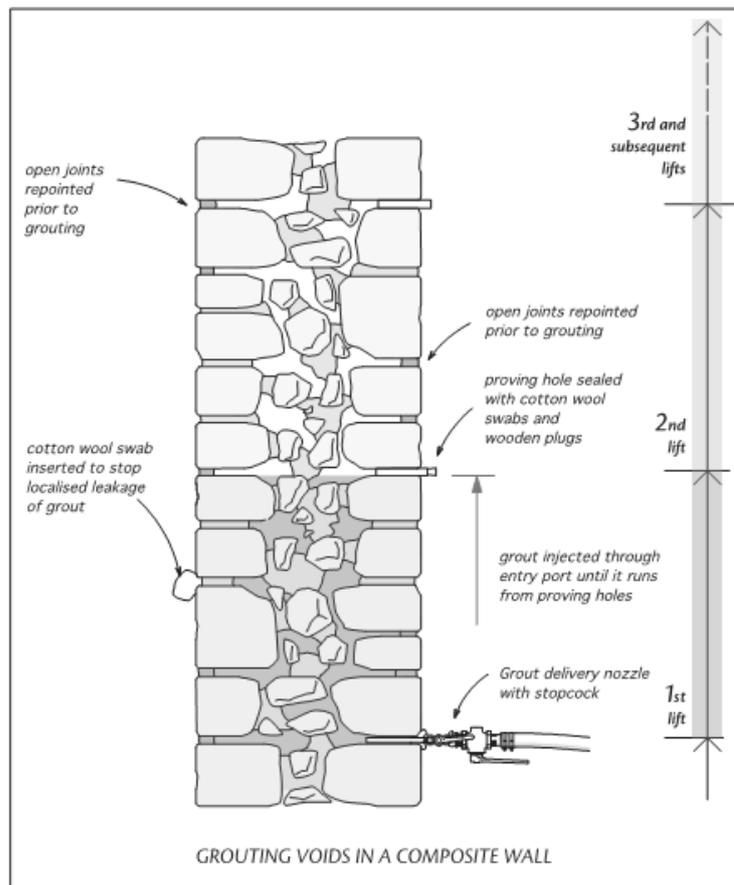
From the site inspection and 3D analysis of the structure, it is evident that the structure has some cracks that are the results of the differential settlement, it is also assumed here that in the effect of differential settlement and because the wall is made of the three leafs, there will be some separation between the leaf as well. To homogenize the wall once again it is recommended to use the ground injection and crack sealing after it is assured that the further problems of settlements are stopped.

Figure 7.6 - Grout injection procedure (building conservation, 2018)

The schematic and procedure of grout injection are illustrated in below figure. Here it is recommended to use the lime-based grout with low shrinkage and low water content.
