## MASTER'S THESIS PROPOSAL

Student's name and surname: Bledian Nela  
Department: Department of Mechanics  
Thesis supervisor: Jiří Bláha  
Thesis title: The analysis of the timber roofs of the Loreta in Prague  
Thesis title in English: see above

Title of the Msc Dissertation: The analysis of the timber roofs of the Loreta in Prague

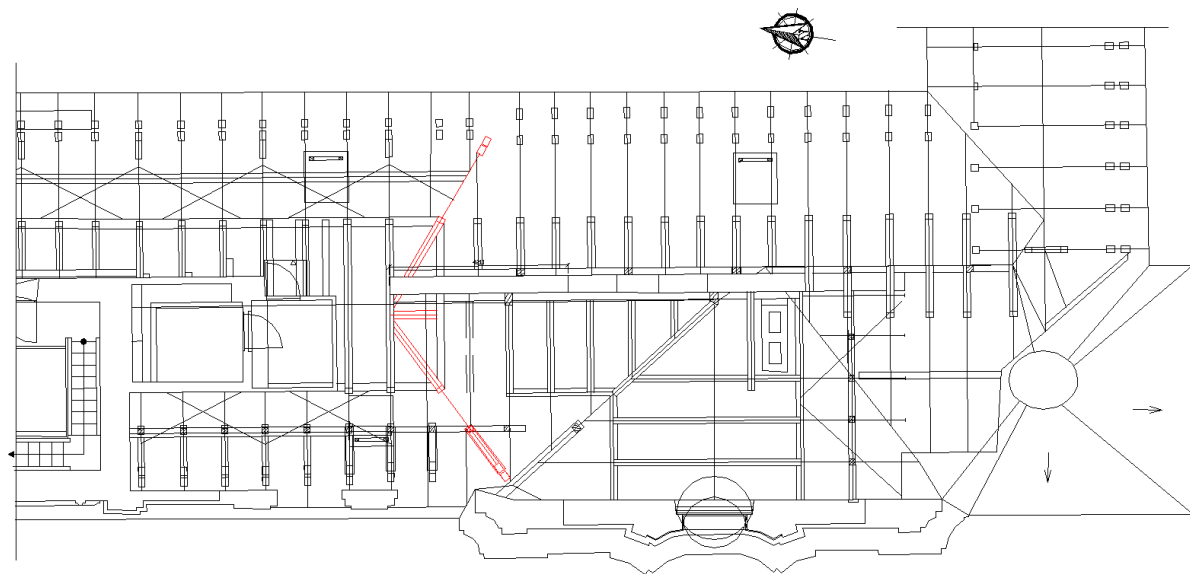
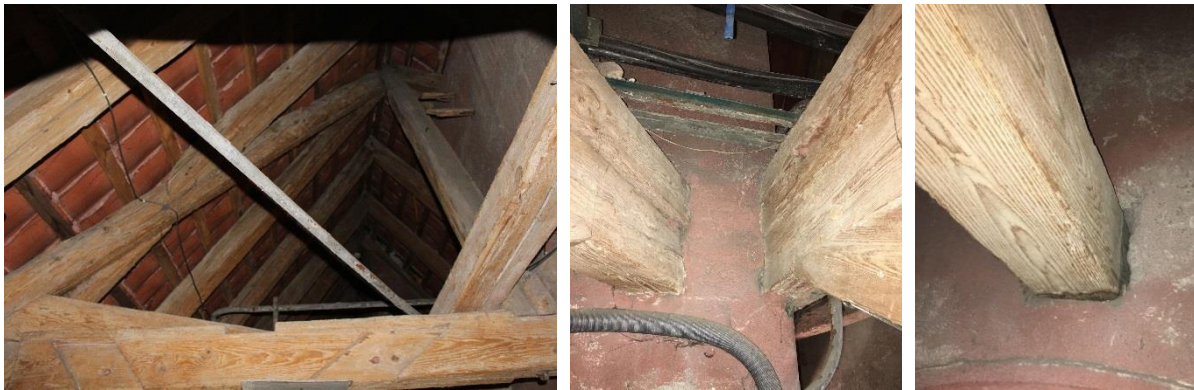
**Figure 3.14 – The base plan of the southern part of the west wing roof (top), the traces of the original roof (left), the original tie beam (center) and the new tie beam (right)**

From the Figure 3.14 (top) are visible the frames of the hipped roof and the cut rafter in the middle from later developments. The ridge of the previous hipped roof is seen in Figure 3.14 (left), while in Figure 3.14 (center) is shown the tie beam which connects the two rafters. From the figure it is visible that the attic wall added later was built around the frame. However, with the unification of the front façade the cloisters as mentioned before were elevated to a second level and the roof was attached to the wall. It

is also visible in the Figure 3.14 (right) the chipping of the wall to insert the new members to support the new roof. Bláha (2017) presents the felling dates of the members of the eastern side of the West wing roof which correspond to the elevation of that part by Kilian Dientzenhofer. The felling date of those members is 1744-48, whereas the members in the western side have a felling date of 1720/21. On the northern side of the West wing during 1717 was built the treasury and from the dendrochronological dating the members in that area show a felling date of 1697/98 and 1698/99.

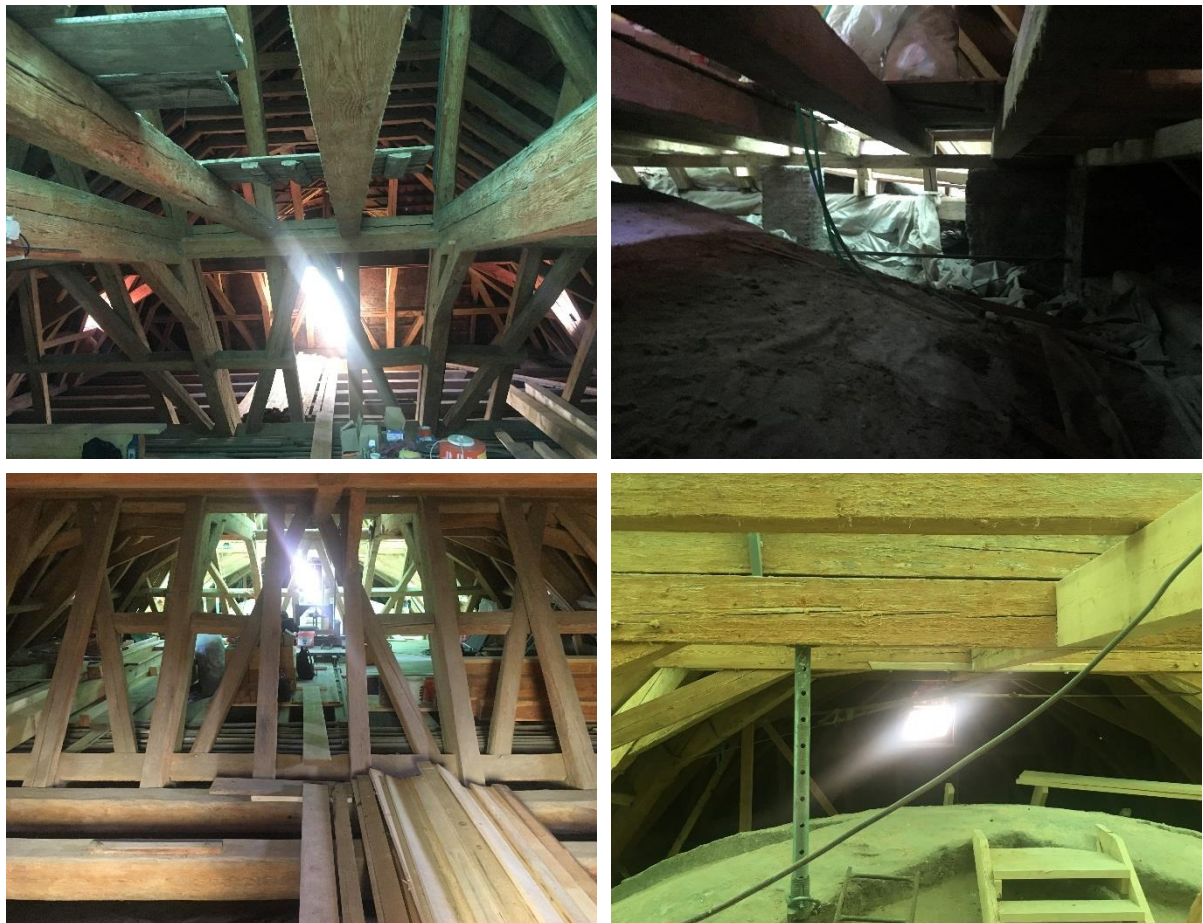
**Figure 3.15 – The western part of the church’s roof (top-left), the wall openings of the older church (top-right), the central roof of the church (bottom-left) and the eastern part of the roof (bottom-right)**

From the Figure 3.15 (top-left) can be seen the hipped roof rafters that used to be in the central section where now continues to the West the choir's roof. Furthermore, in the Figure 3.15 (top-right) can be seen the openings which used to be before the extensions. In the Figure 3.15 (bottom-left) from the western extension is shown the central section of the church's roof. The two slopes of the previous roof are visible and also in the further back can be seen the roof of the eastern extension, also shown in Figure 3.15 (lower-right). The dendrochronological dating of the roofs of Loreta can be seen in Figure 3.16 below.

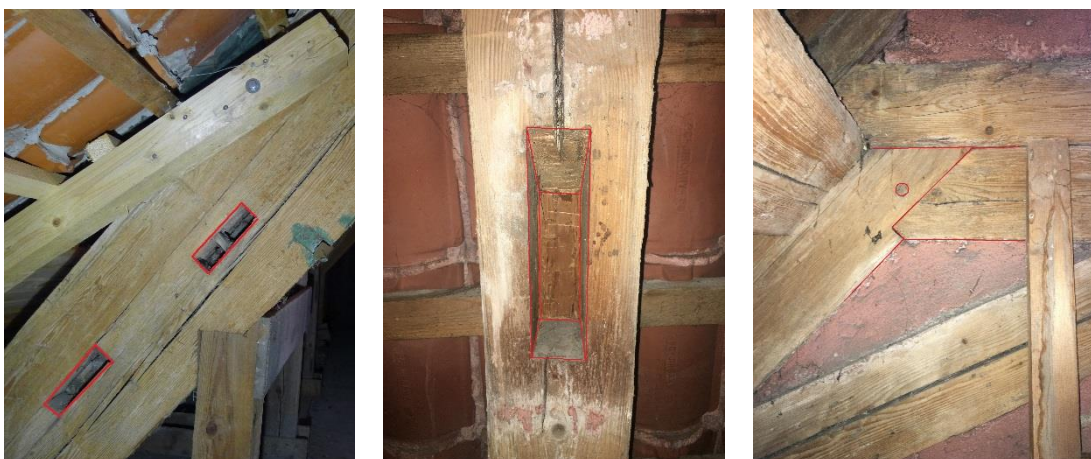
Although there are seen some metallic elements in the joints, the original connections of the elements are timber carpentry joints. From alterations through time some of the members are removed and used in other areas and thereupon some gaps from previous connections are visible where the type of connections can be observed. Some of these examples can be seen in the Figure 3.18 below.

**Figure 3.18 – Examples of the carpentry joint connections in the southern part of the west wing roof**

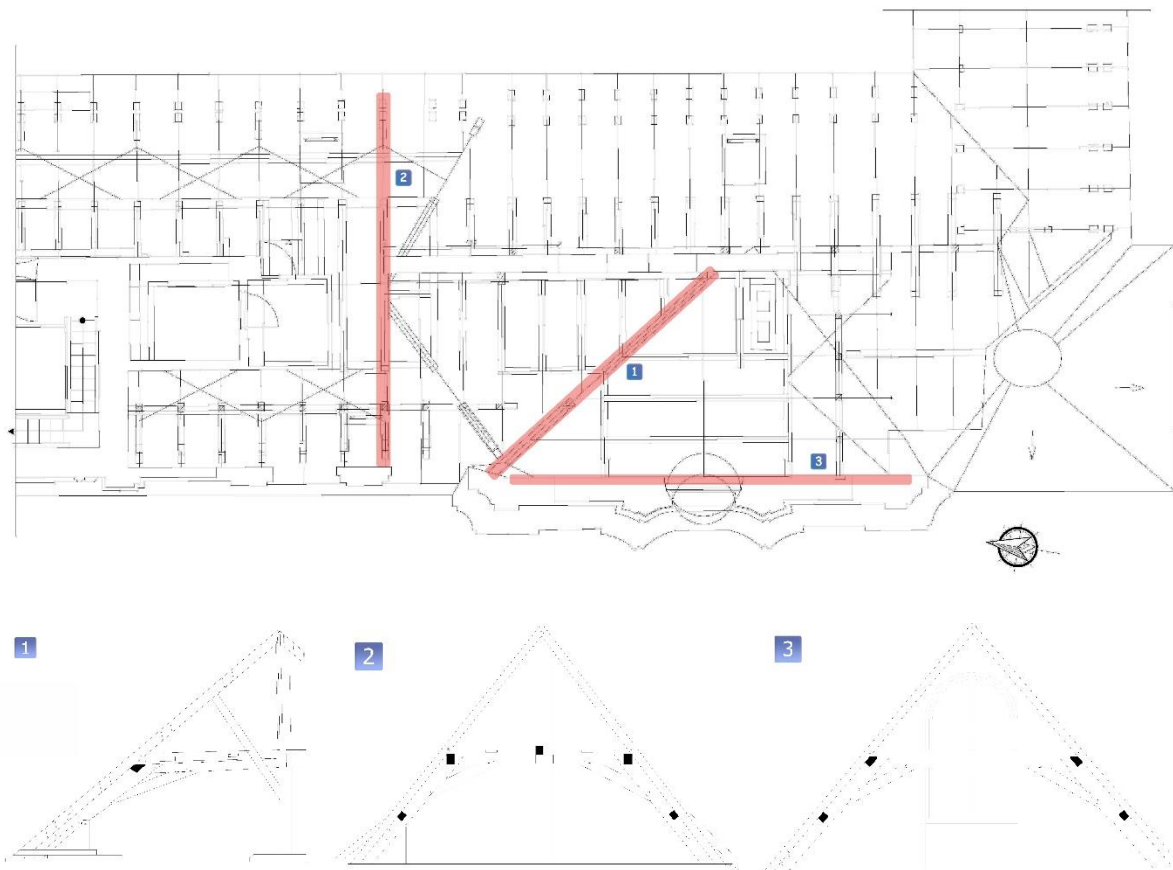
**Figure 4.1 – Base plan drawing of the southern part of the west wing roof (top), Frame 1 (left), Frame 2 (center) and Frame 3 (right)**

On frame number 1 is performed the resistance microdrilling test, the loading jack test and the moisture content. On the other frame, frame number 2, was performed the loading jack and the moisture content in order to compare it with frame number 1. Whereas, in frame number 3 only the moisture content was measured since it is embedded inside the masonry wall and presents valuable information about the degradation state of timber.

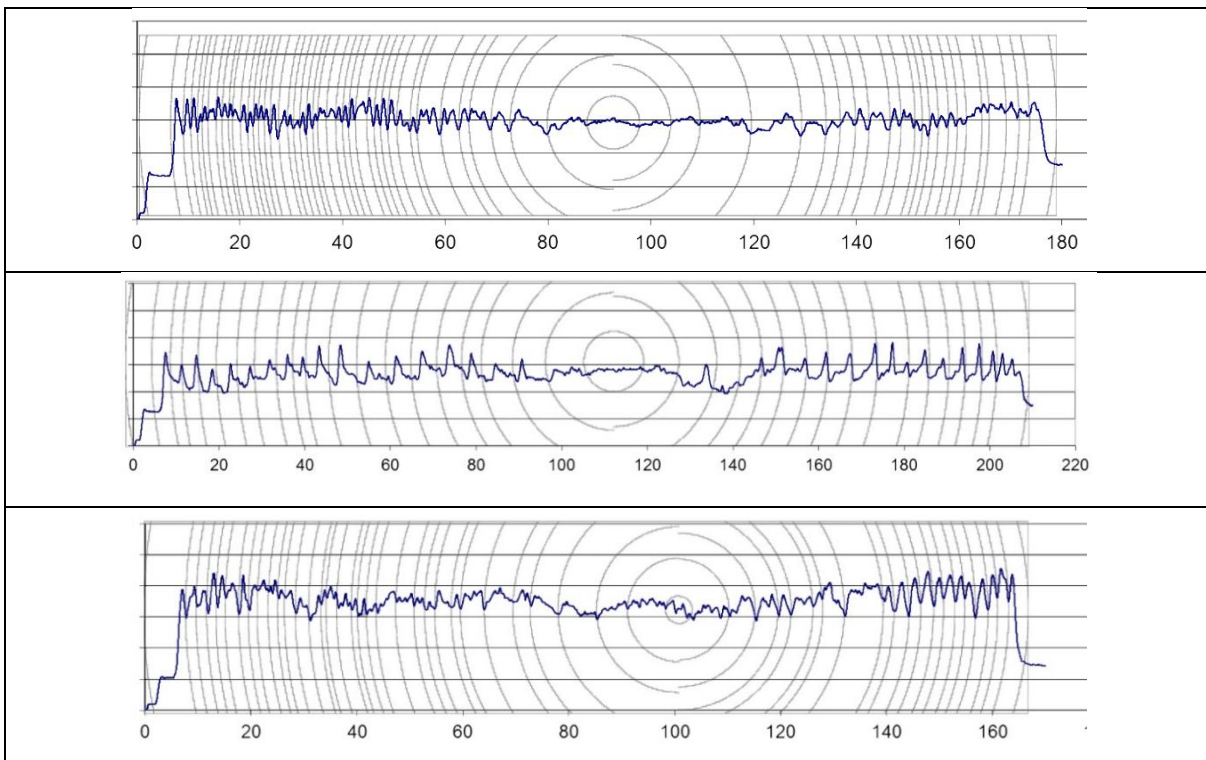
**Figure 4.2 – Tree rings drawn according to the microdrilling measurements; R5 (top), R7 (center) and R15 (bottom)**

As can be concluded from the Figure 4.2 above, the tree rings vary between the mature wood and the juvenile wood. Nevertheless, the number of rings in a distance of 75 mm varies between 12 to 35. The width of the rings varies from 2 to 4 mm for the mature wood rings and from 5 to 7 mm for the juvenile wood rings. According to UNI 11035:2003 table for Coniferous 1, for the parameter of distance between rings the frame is classified as S1, since the majority of the rings is from mature wood.

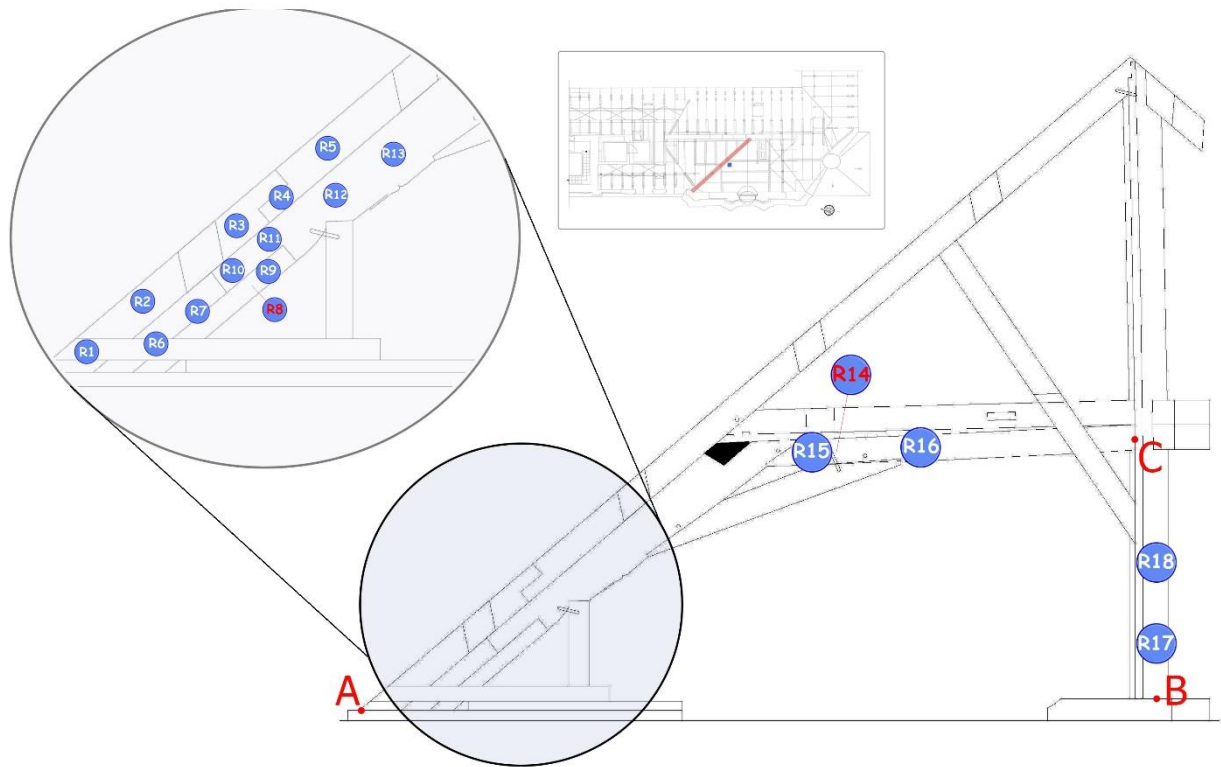
**Figure 4.7 – Location of the microdrilling tests performed on Frame 1**

As can be observed in the Figure 4.7, 18 tests are performed on the frame. During the test R8, which was performed near R9, the needle broke because it ended in a metal element and it can be clearly seen in the graph in Figure 4.8 (top). From the graph can be observed how the resistance experiences an immediate jump and then stops. This was peculiar since the connections in the roof are mainly timber connections and from this can be stated that there are some strengthening works which are not visible. Furthermore, during the drilling of R14 the needle ended in a crack and the test was carried on with R15 on the other side of the element. It can be observed from the graph in Figure 4.8 (bottom), that the resistance amplitude decreases drastically until the test was stopped.

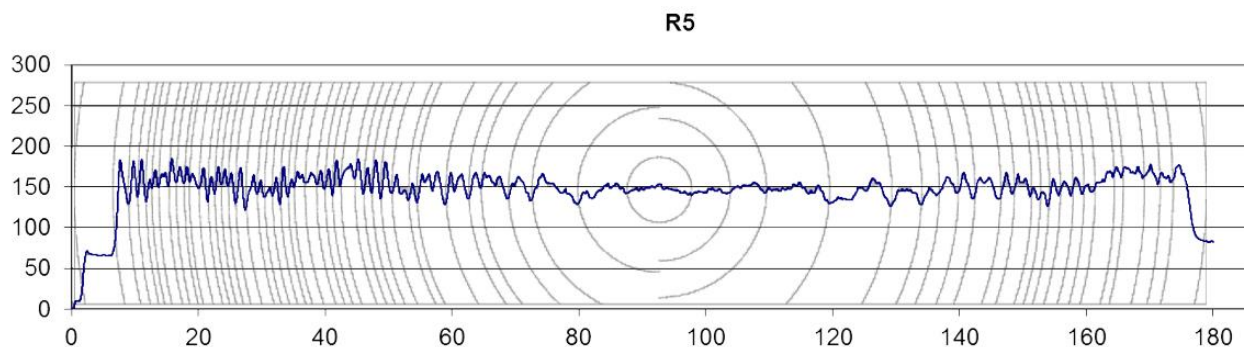
**Figure 4.11 - Tree rings drawn according to the R5 microdrilling measurement**

From the Resistograph® it also possible to assess the rings of the cross section. The latewood is much denser than the earlywood and that is expressed also in the resistance measure as the beginning of a ring. Usually if the middle of the section experiences a reduction of resistance with a smaller variation of amplitude, indicates the presence of the juvenile wood rings. Whereas, in the parts of the graph with bigger variation of amplitude and higher resistance indicates the presence of mature wood rings. To obtain the exact profile of the tree rings, a cross section is required. However, observing the measures from the test a hypothesis of the rings is possible to be made. The test R5 presents a clearer resistance profile where the mature wood can be distinguished from the juvenile wood. The tree rings of the rafter according to R5 resistance measures are shown in the Figure 4.11. On the both sides of the graph are similar high variations in amplitude and small variations in the middle. Therefore, the juvenile wood rings can be seen in the middle of the section, while the mature wood ones are on the sides.

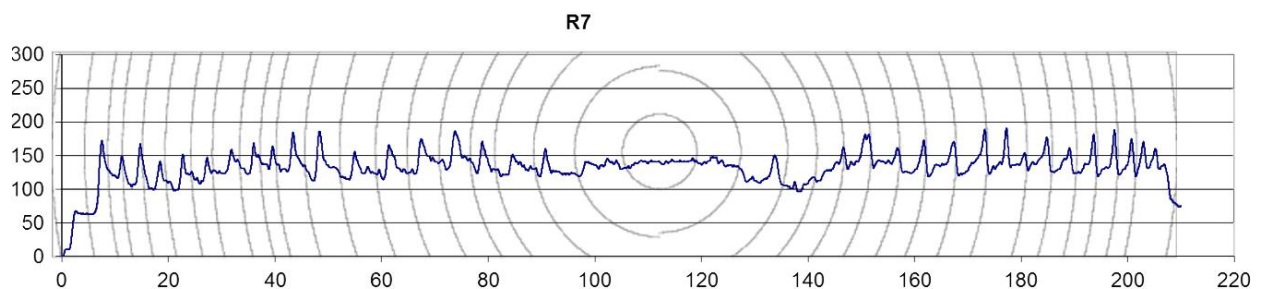
**Figure 4.12 - Tree rings drawn according to the R7 microdrilling measurement**

From the R7 test, the tree rings of the strengthening prosthesis can be observed. It can be clearly seen in the Figure 4.12 the distribution of the juvenile wood and mature wood rings. Again, the mature wood rings are on the sides, while the juvenile wood is on the middle.

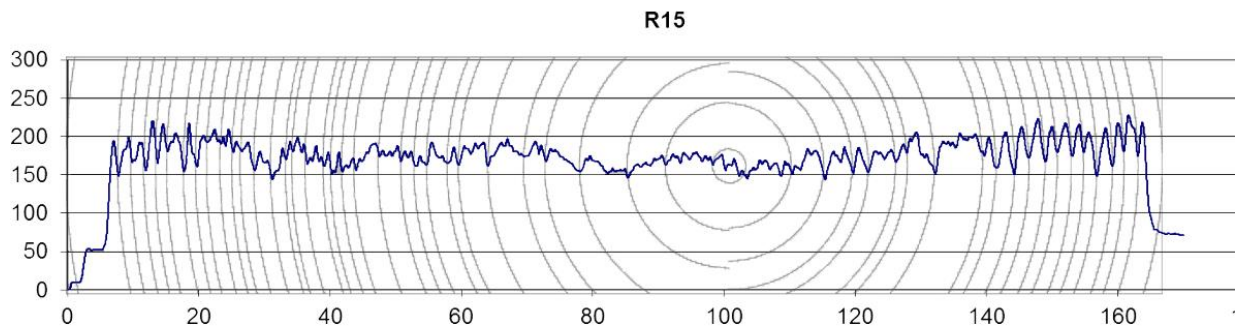
**Figure 4.13 - Tree rings drawn according to the R15 microdrilling measurement**

The R15 presents the tree rings of the beam in the frame as seen in Figure 4.13. In contrast to the other tests, the juvenile wood rings in R15 are a bit shifted to the right side of the section. Nevertheless, the mature wood rings are again on the sides of the section.

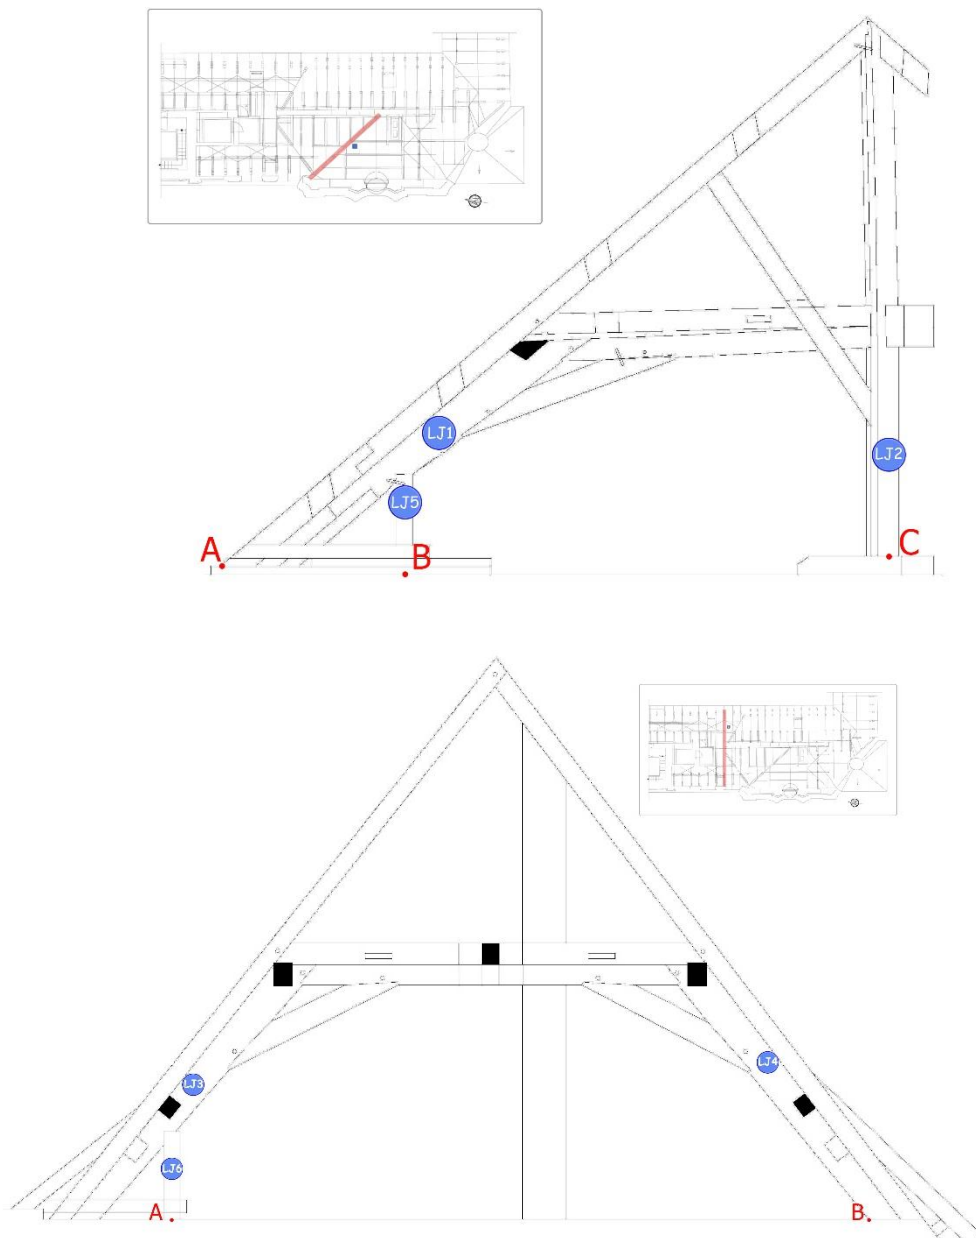
**Figure 4.16 - Loading jack locations performed on Frame 1 (top) and Frame 2 (bottom)**

The  $CS_c$  and the MOD of the first test which represent the original rafter of Frame 1 show higher values than the newly added column (LJ5) and the original column (LJ2). The mechanical condition of the rafter is in good compared to the above mentioned. Nevertheless, the mechanical property of the added column and the rafter are similar and therefore the mechanical compatibility is roughly achieved. The modulus of deformability of the column of the frame is considerably low. Regardless, the column works mostly in axial forces and the axial deformations are usually lower. Correspondingly, the deformability is measured in the axial direction and will not highly influence the column. In contrast the values from Frame 2 of  $CS_c$  and MOD are similar with small variation in-between. Compared to Frame 1 the values are similar overall. The average values are shown in the Figure 4.19.

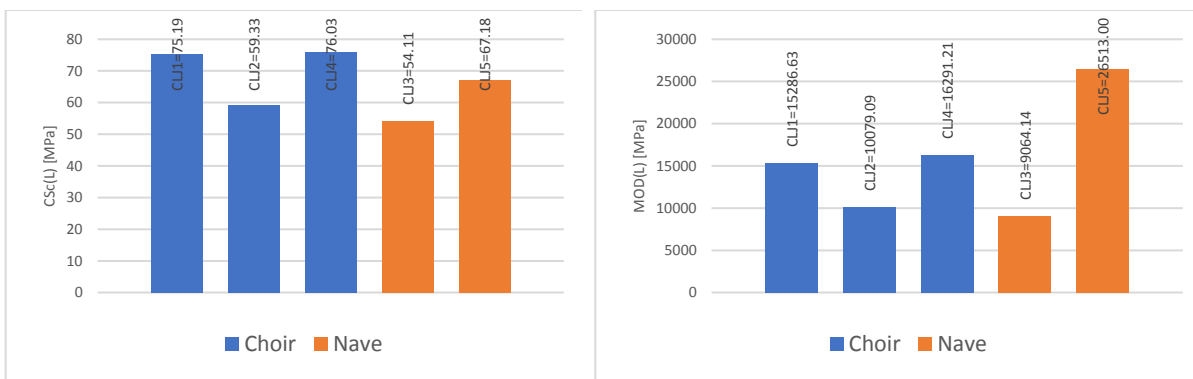
**Figure 4.20 – Comparison of results between Choir roof and Nave roof for conventional strength (left) and modulus of deformability (right)**

CLJ-1, CLJ-2 and CLJ-3 represent the tests performed in the Choir and the average values for it are  $CSc=70.2$  [MPa] and  $MOD=13885$  [MPa]. On the other hand, CLJ-4 and CLJ-5 represent the tests from the Nave and the average values are  $CSc=60.6$  [MPa] and  $MOD=17788$  [MPa]. The average values of each test are shown in the Figure 4.20.

As mentioned before the roof of the nave is older than the choir, but with the felling date not so much different from each other. Nevertheless, the roof of the choir shows a better mechanical state than the roof in the nave. Possibly that also justifies the restoration works being carried out in the roof of the nave.

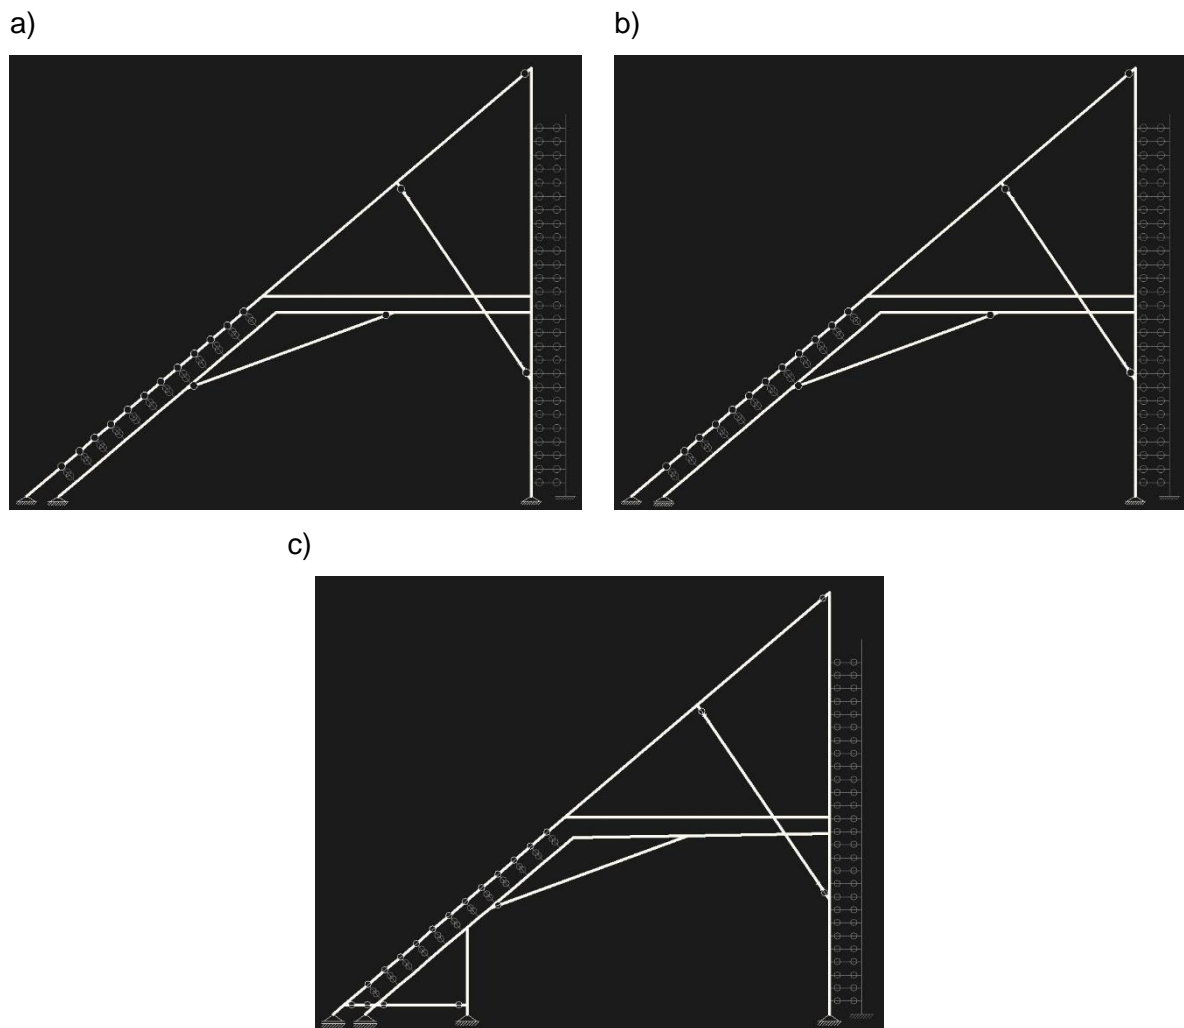
**Figure 5.12 – Modelling of Frame 1; a) first scenario with the tie beam; b) second scenario without the tie beam; c) third scenario representing the actual state;**

stiffness in the direction of the beam. Assuming that the beam has a cross-section of (30x30) cm, the axial stiffness is calculated to be 150000 [kN/m]. The model can be seen in the Figure 5.12 (a). In the second scenario is assumed that during the process of strengthening the tie beam was removed or at least its effect on the truss. The model in Figure 5.12 (b) represents this scenario where the support on the truncated rafter has no reaction on the horizontal direction. The support on the main rafter is assumed to have two reactions in the vertical and horizontal due to the external wall. The third scenario, shown in Figure 5.12 (c), represents the current state with the column placed as a strengthening manner. The lower horizontal tie beam is displaced vertically for 5 cm to represent the actual state.

As can be seen from the illustrations above, between the main rafter and the truncated rafter are set the weightless rigid links which work only under compression. Similarly, on the right side are set the same rigid links connected to a member with rigid stiffness, which represents the attic wall. The diagonal strut is set to work only under compression for the first and second model (Figure 5.12-a and -b). In the third

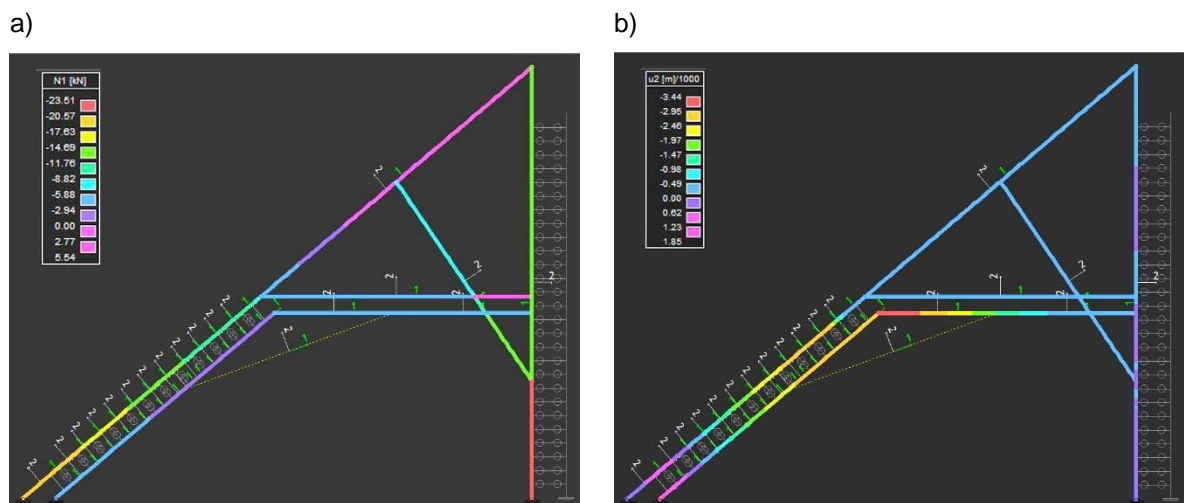
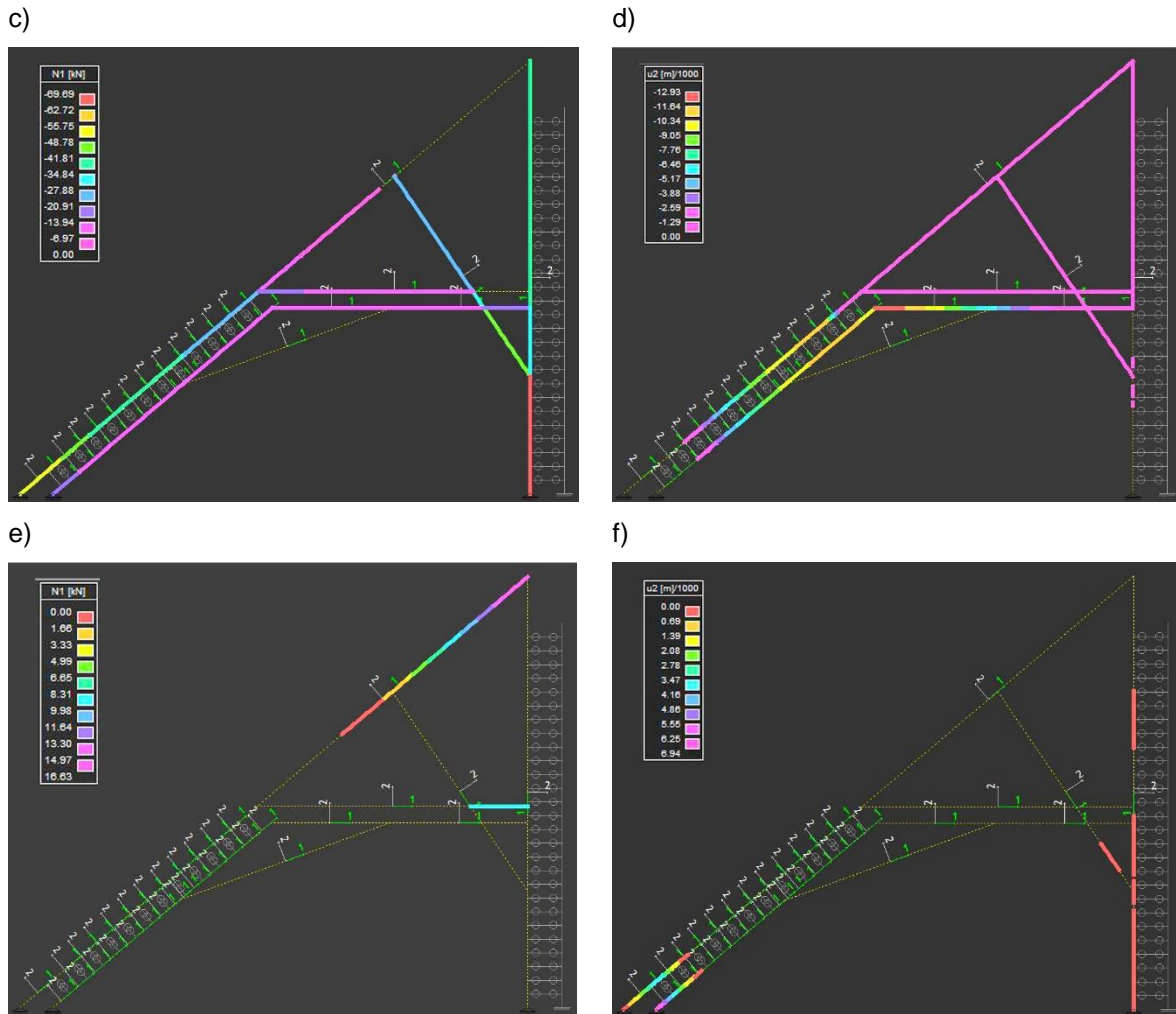
The second scenario results are presented in the Figure 5.14 below. With the sliding of the truncated rafter on the bottom part, the diagonal strut starts to work under tension. This behavior can be explained as a common rafter roof with a collar tie. The rafter of this hypothetic truss are the truncated rafter and the lower horizontal beam, whereas the diagonal strut works as a collar tie under tension. This can be seen also from the results where the diagonal does not take tension.

In the Figure 5.14 (b) the deflections from the dead load are excessively higher. The left end of the lower horizontal beam, which suffers from the deformation in the actual state, shows the highest deflection. This can be seen both from the dead load and the envelope, where the deflections for both load cases are around fifteen times higher than in the first scenario. This proves one of the hypothesis of the current deformation seen on site.

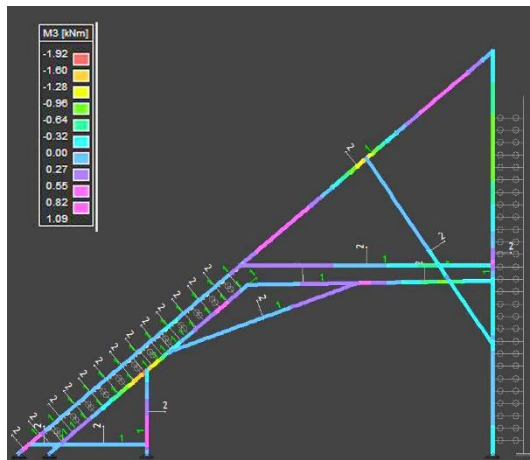
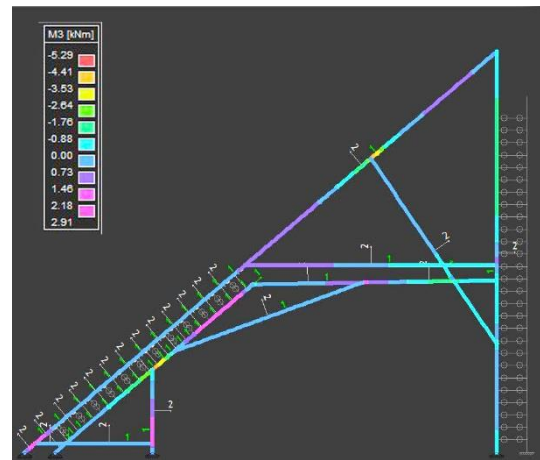
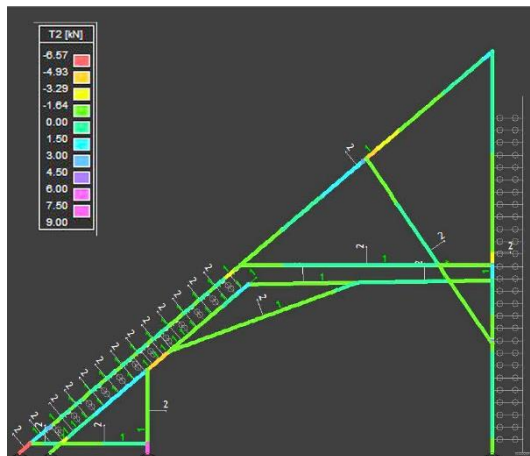
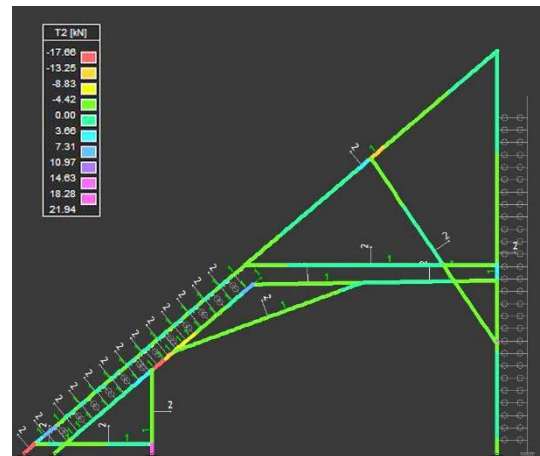
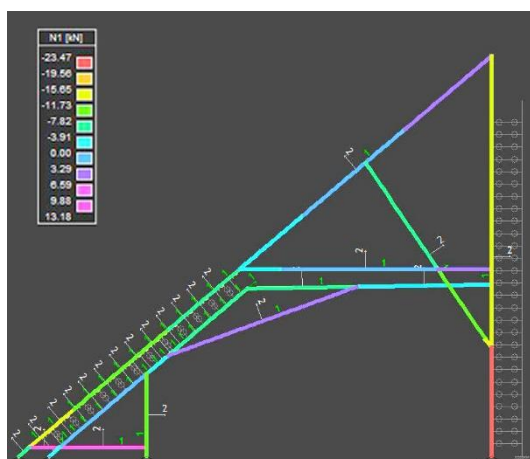
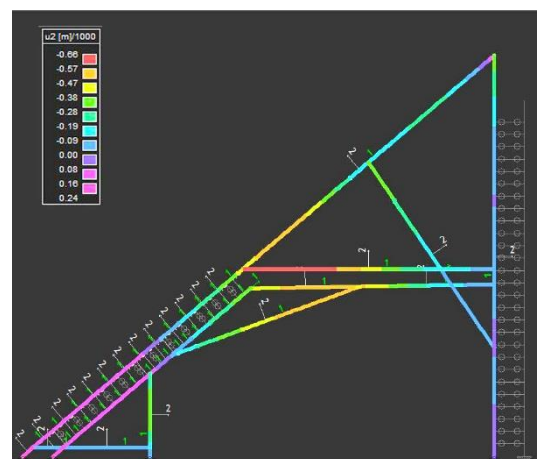
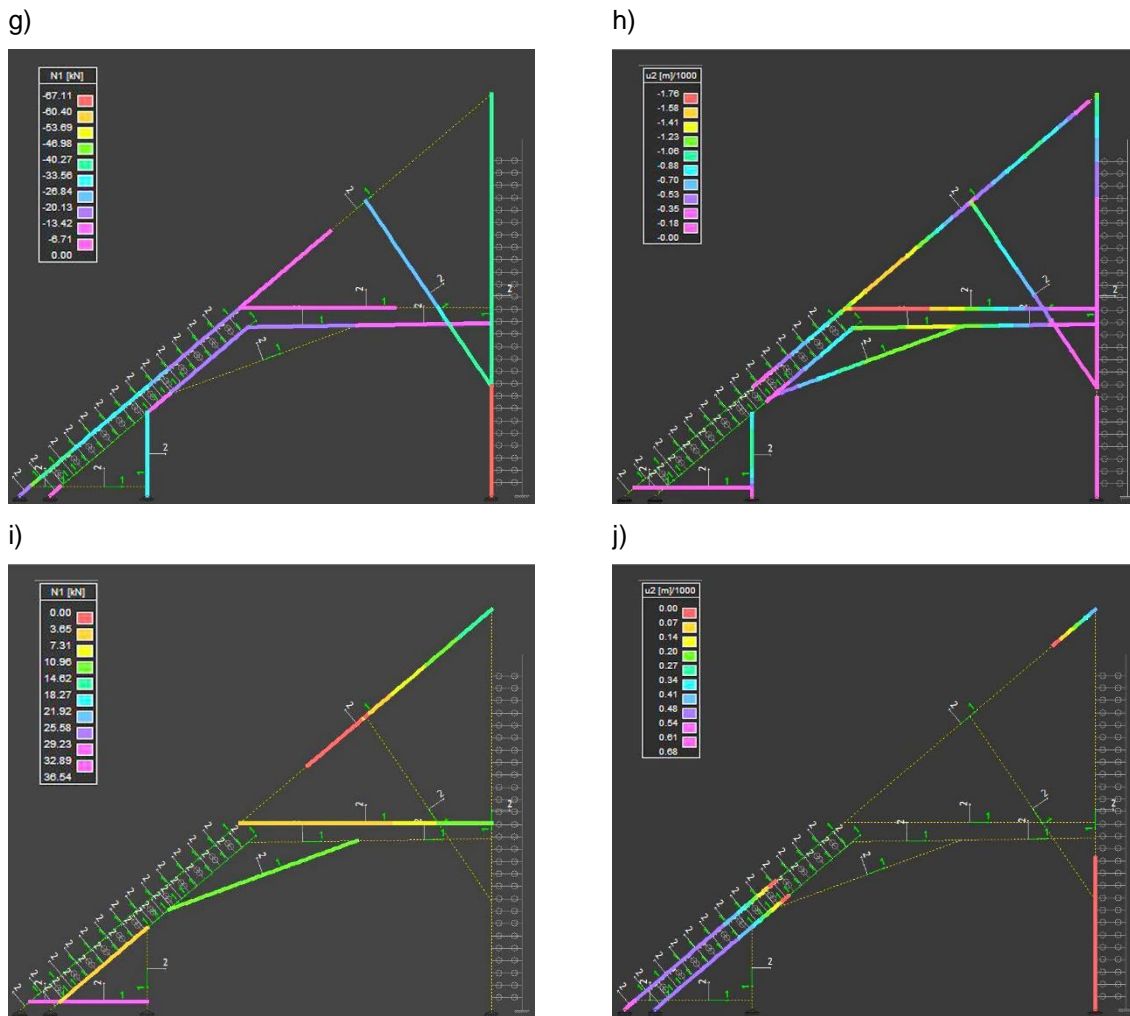
For the last scenario which represents the actual deformed shape the results are shown in Figure 5.15. The diagonal strut in this model was set to work in tension and in compression and from the axial forces, both the dead load and the envelope (Figure 5.15-e and -i), the strut works under tension. The assumption explained previously, where the strut works as a collar tie, still stands for the actual state.

As can be observed from the results, the bending moments and the shear forces are low on the overall structure. The big deflections seen in the first scenario in the middle of the truncated rafter, are reduced drastically with the addition of the column. The deflections for the dead load from the actual state are three times smaller than those from the first scenario. For the envelope the deflections in the current state are six times smaller than the first scenario. Furthermore, concerning the overall deflections the addition of the column reduces the deflection for around 10% for the dead load and around 50% for the envelope. This certifies the addition of the column in the reduction of deflections for the structure.

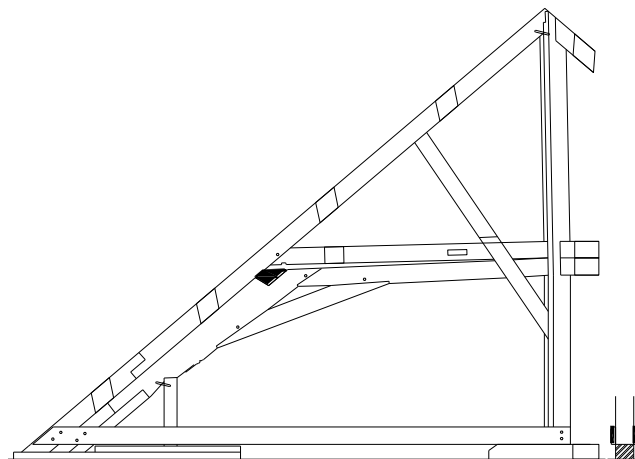
**Figure 5.17 – Tie beam strengthening of Frame 1**

As it was seen from the first scenario, the diagonal strut works under compression if there is a tie beam on the bottom of the frame. That is why one of the possible solutions for the strut is to put a tie beam on top of the concrete slab and connect the bottom part of the rafters to the bottom part of the column. Since the short column which was added later consists of two timber planks, a good solution would be to put bigger dimensions of the planks and extend them to reach the column. The illustrated solution is presented in Figure 5.17.

The first strengthening solution (Figure 5.17), provides minimum intrusiveness, compatibility and removability. The second solution (Figure 5.18), provides strengthening with more intrusive measures but still compatibility and removability are accomplished.

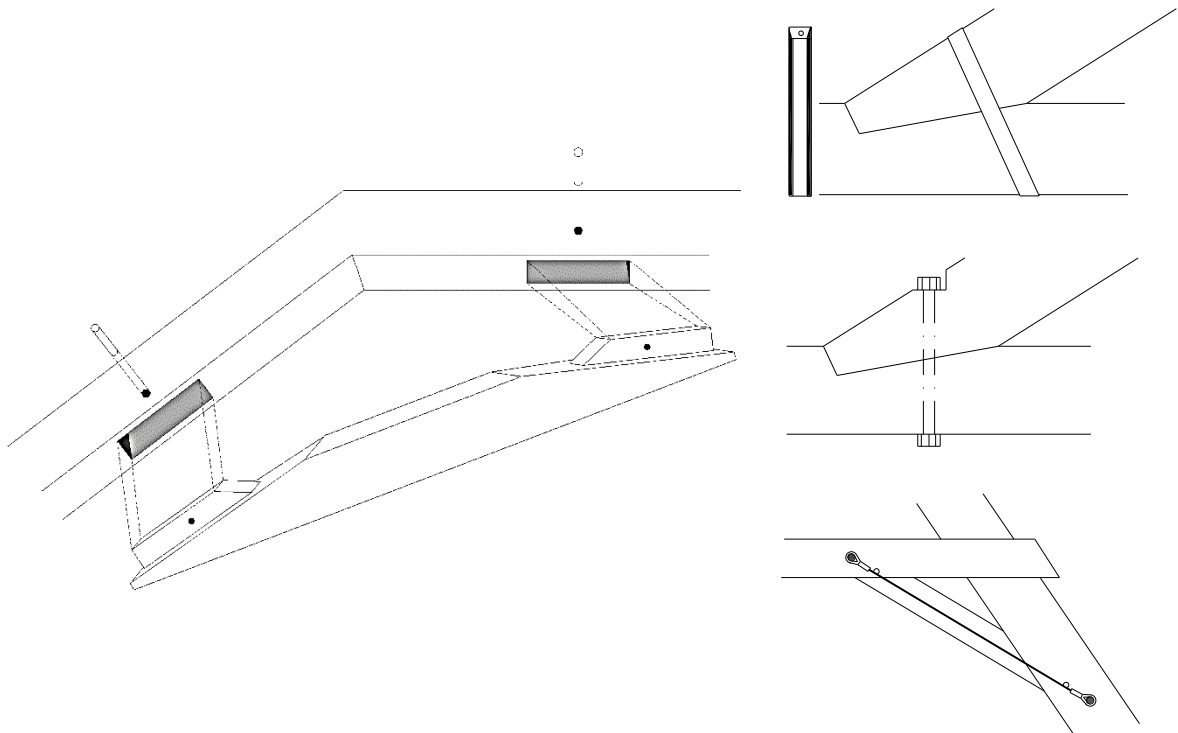
**Figure 5.18 – The diagonal strut (left); binding strip (top) (Branco & Descamps, 2015); internal bolt (center) (Branco & Descamps, 2015); steel wire (bottom) (Branco & Descamps, 2015)**

The other possible solution can be the strengthening of the diagonal strut. The strengthening of the diagonal strut can help the strut receive the axial force and keep the frame stable. Some of the strengthening methods can be by using the metal elements to tie the notched joints of the strut presented

in Figure 5.18 (top and center). Another strengthening method proposed by Branco & Descamps (2015), is to use a steel wire to help the strut work under tension (Figure 5.18-bottom).
