CZECH TECHNICAL UNIVERSITY IN PRAGUE

MASTER'S THESIS

**THE INFLUENCE OF DAMAGED ZONES IN WOOD COLUMN
ON ITS LOAD BEARING CAPACITY**

JANUARY 2017

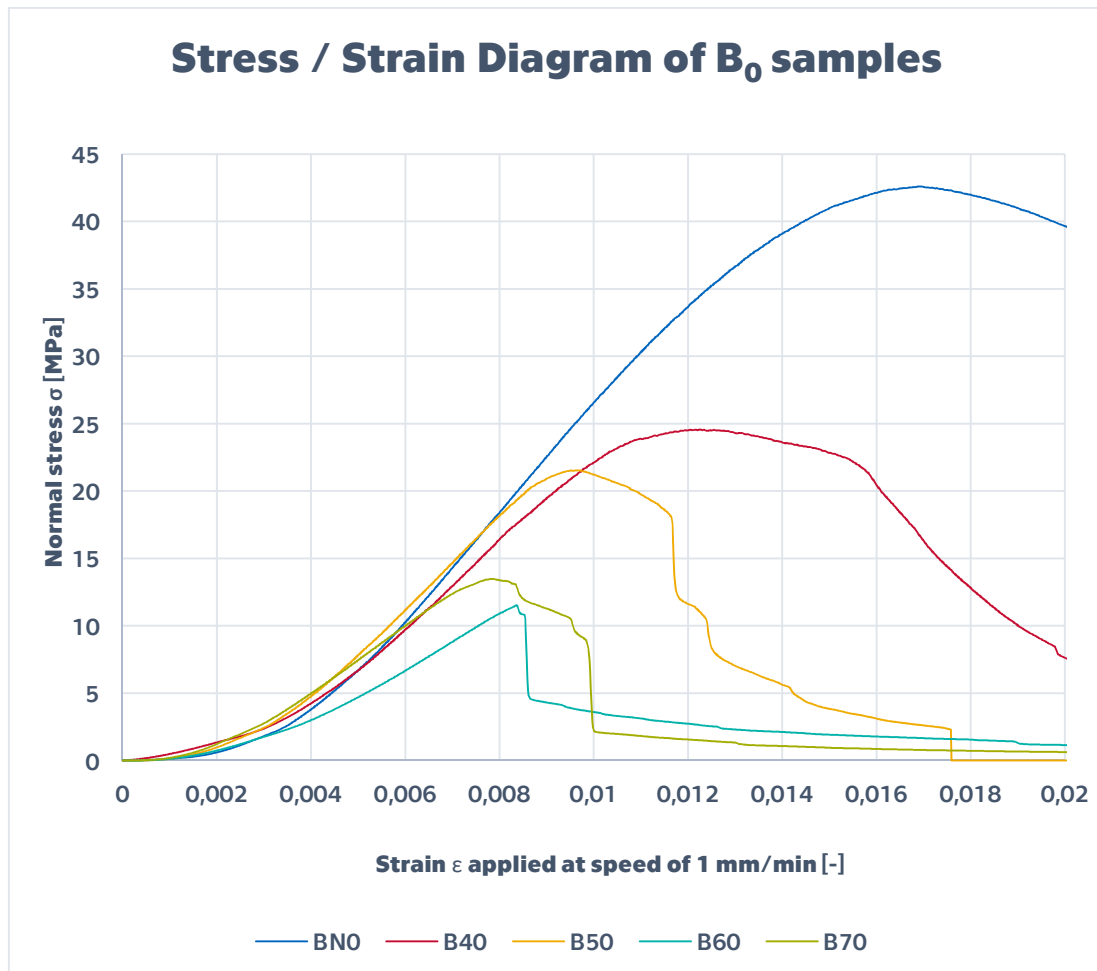
Chart 3-3 Stress / Strain diagram of B₀ samples

A trend of decreasing compressive strength with increasing degree of damage is recognisable in the Chart 3-3. There is one exception in the trend. Specimen B7₀ performed higher in compressive strength test than less perforated specimen B6₀. The surface part of the specimen B6₀ suddenly buckled at one point (Annex 1 Photo 5-13). Probably because of relatively fast loading of specimens, decrease of stiffness is not very clear in the Chart 3-3:

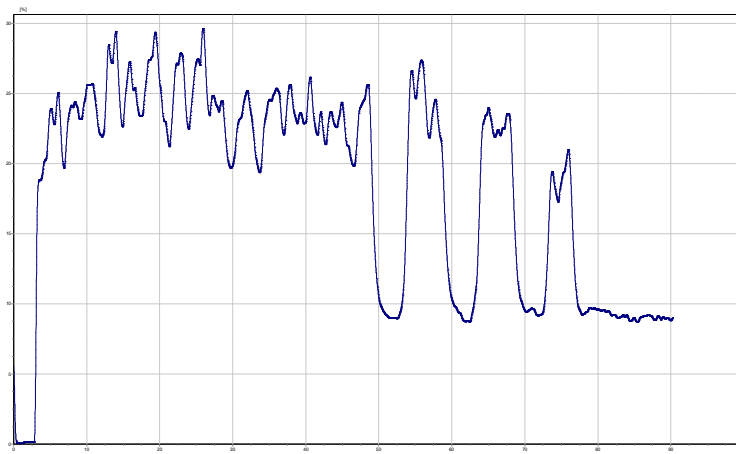
Chart 3-16 Example of a diagram from Resistograph® (drilling B5.2)

This example diagram is from drilling in the middle part of the column B5 started in the undamaged side going perpendicular to the member surface:

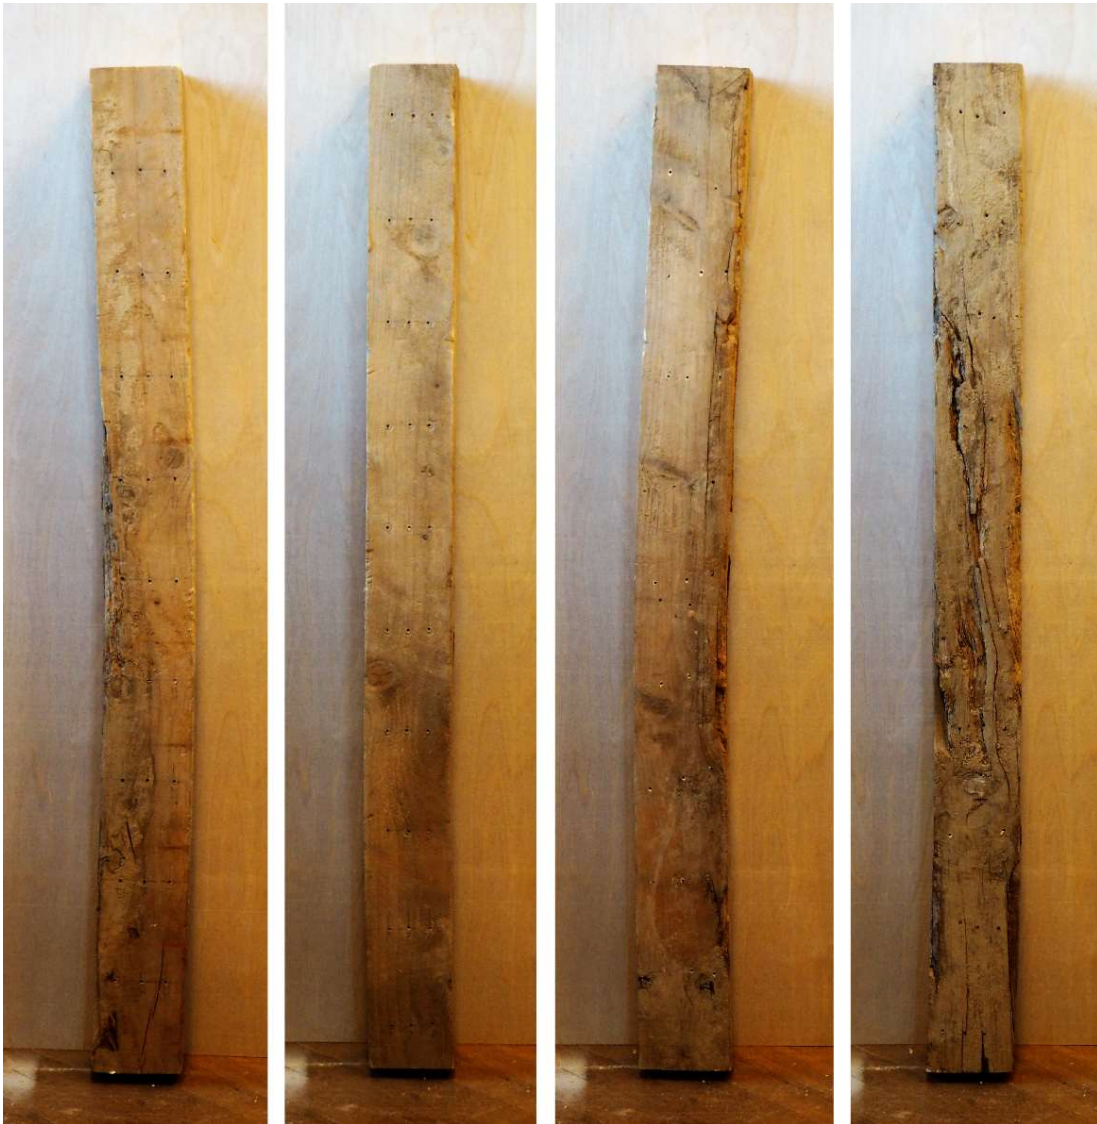
Photo 3–9 The Column S after the static load test

Measured load bearing capacity of the column S is $F_{MAX} = 84,4$ [kN].

If the column S had had no damaged zones, it would have collapsed in the compressive failure mode under the force of about 120 [kN]. It means that its damage (displayed in the Annex 1 chapter 5.3) made a difference in the load bearing capacity of about 36 [kN].

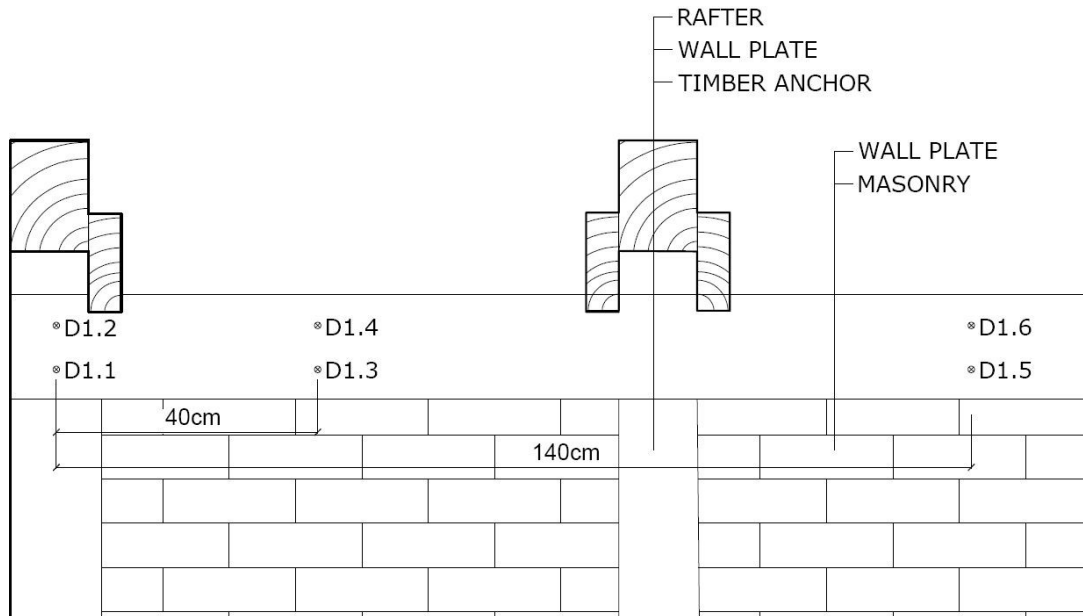
Figure 4-3 Detail D1 – Section longitudinal to the wall plate

At the southwest corner of the roof a wet wall plate was found, which responded by a hollow sound after knocking on its surface. Furthermore, discolorations and fungi were spotted.

In the course of possible refurbishments of the roof, the roof cladding has to be fixed and the wall plate must be replaced in this area to keep the roof serviceable. In addition, there is no structural separation between the wooden components and the masonry throughout the roof area. Further design of remediation should focus on this fact.

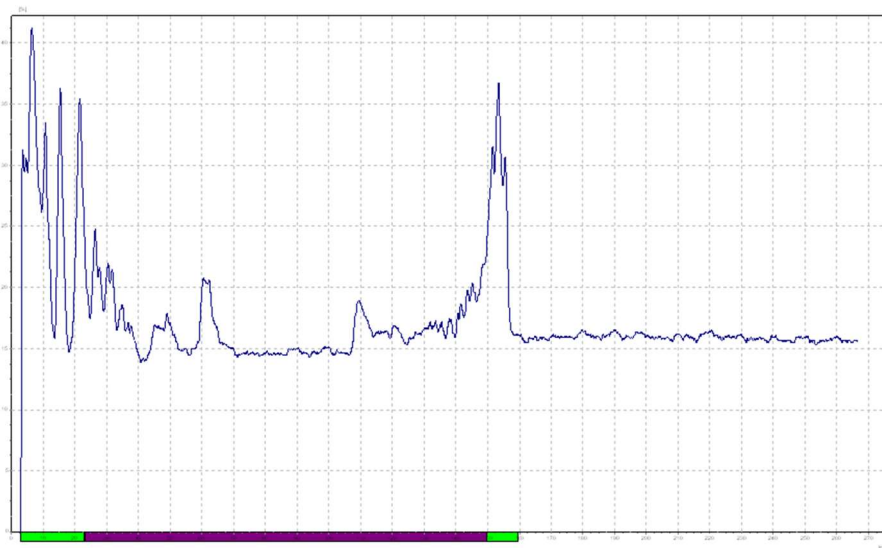
Chart 4-1 Drilling D1.1

According to the assumption, there is almost no resistance about 3 cm under the surface. The reason could be a leak in the roof, which has destroyed the wall plate over the years.

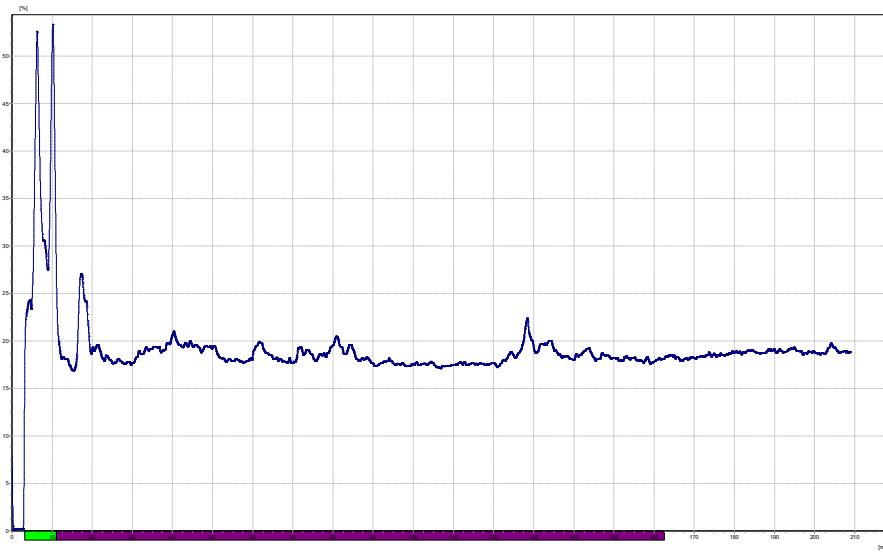
Chart 4-2 Drilling D1.2

Similar to the previous drilling D1.1, there is no resistance after 1-2 cm. Almost whole cross-section is destroyed.

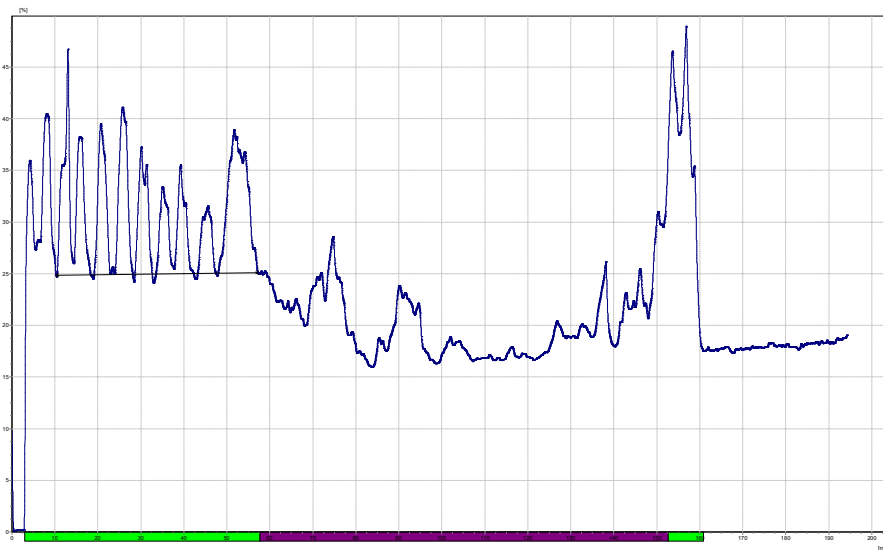
Chart 4-3 Drilling D1.3

The drilling D1.3 shows a slight increase of the resistance. However, 60% of the cross-section is damaged.

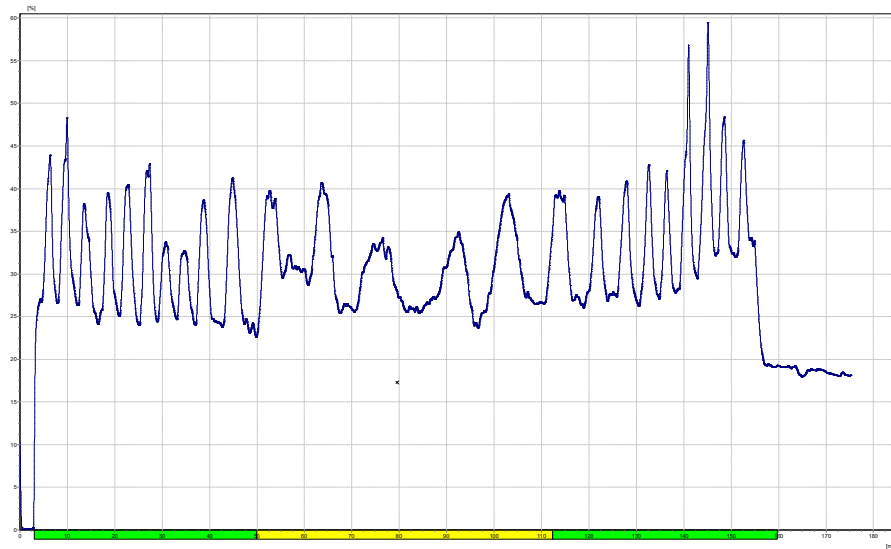
Chart 4-4 Drilling D1.4

Despite the fact that the bore D1.4 has been carried out only 10 cm above the point D1.3, a clear increase of the resistance can be seen.

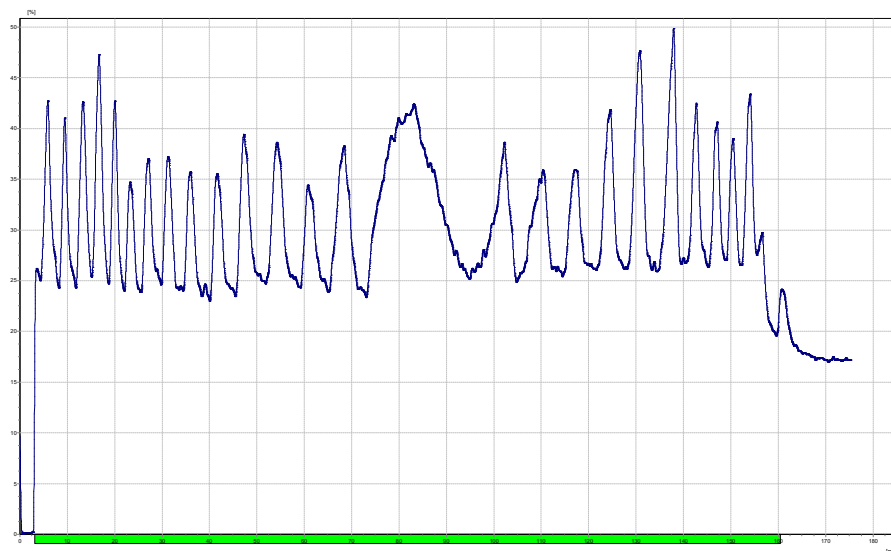
Chart 4-5 Drilling D1.5

This resistance measurement is located 1,40 m away from the D1.1 and D1.2. The diagram provides the prove that at this point the wood is not damaged.

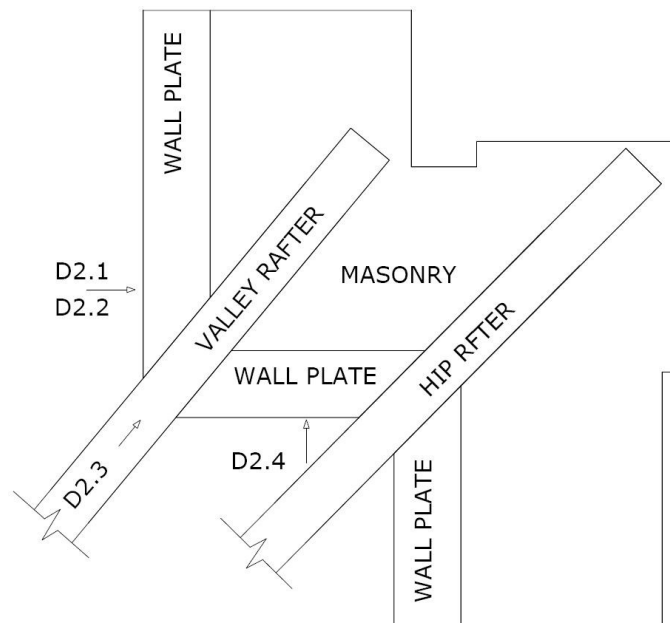
Figure 4-4 Detail D2 – Top view of the corner

As can be seen in the Photo 4–4 Detail D2, a reduction in the wood substance can be determined on the basis of the visual survey in detail D2. The Figure 4-4 shows the locations of the drillings.

The investigation in the detail D2 showed that the damage is located directly in the corner of the wall plate under the valley-rafter. The wall plate should be replaced in this area.

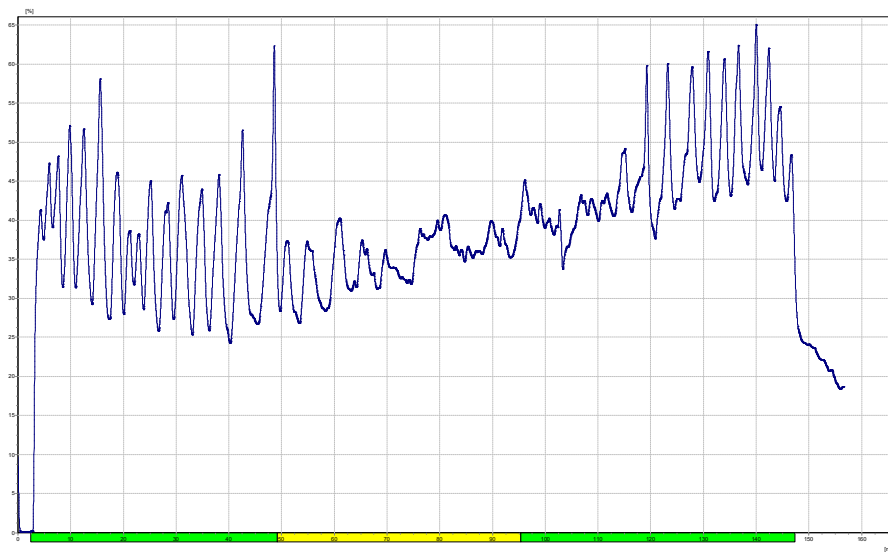
Chart 4-6 Drilling D2.1

The diagram in detail D2.1 shows disturbed structure of the material in the middle area of the wall plate. Towards the end, the annual ring density looks good again.

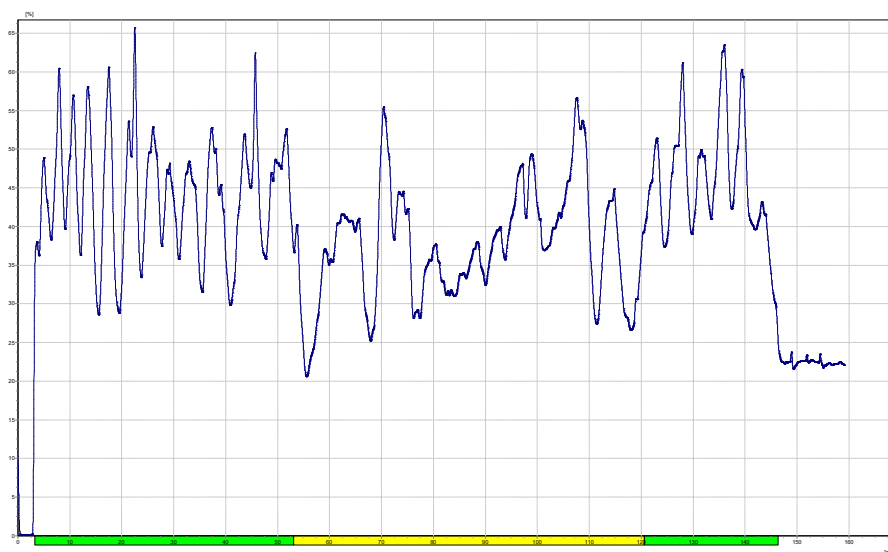
Chart 4-7 Drilling D2.2

The resistance measurement in detail D2.2 shows even clearer differences in strength and indicates a problem in the central part of the member.

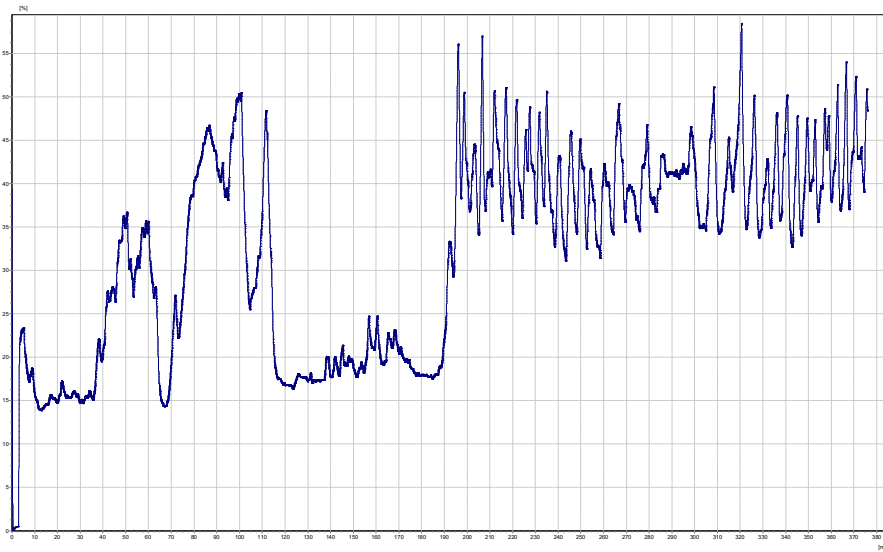
Chart 4-8 Drilling D2.3

This diagram is a product of the drilling made in the direction displayed on the Photo 4-4. It shows the differences in the strength of the wall plate and the rafter. Decrease in the drilling resistance is evident in the wall plate and the rafter seems to be intact.

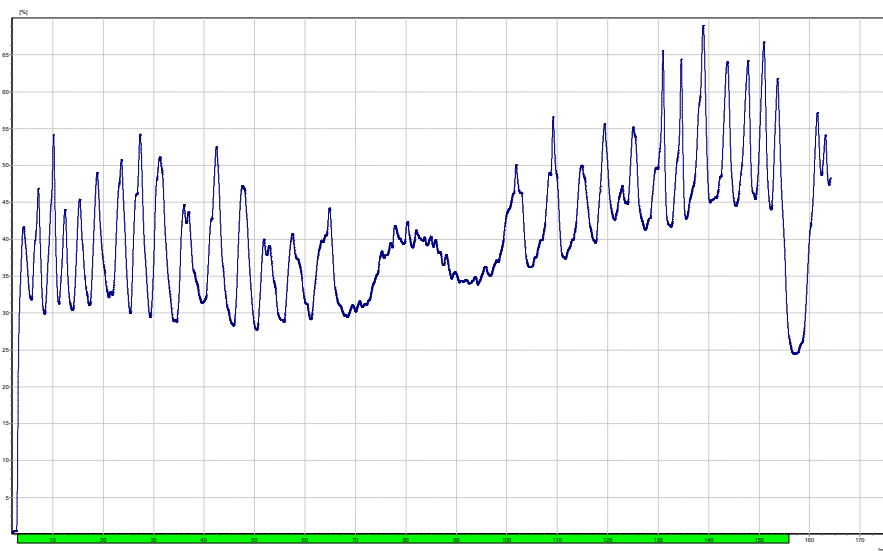
Chart 4-9 Drilling D2.4

The D2.4 is located about 40 cm away from the damaged spot (corner). The diagram shows an intact material.

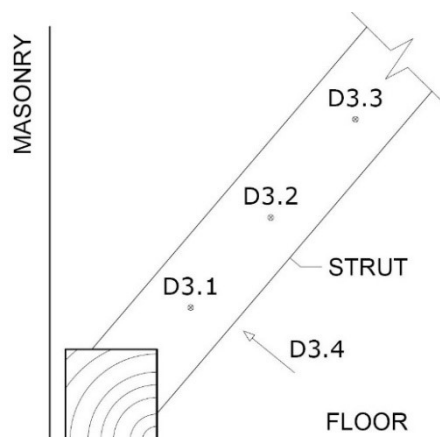
Figure 4-5 Detail D3 – Part of the cross section

Damage caused by insects was found in a strut in the middle part of the roof. This member supports the top purlin in the spot, where it is interrupted. Damaged zone was found close to the floor.

No beetles were spotted in the time of the brief inspection, but this region of the roof should be examined by an expert in the field of wood decaying insect. Assuming a good treatment of the wood, the strut could probably stay in the service.

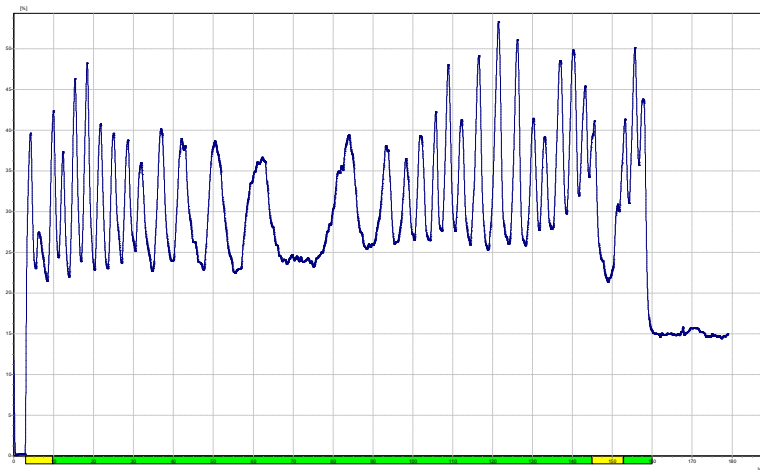
Chart 4-10 Drilling D3.1

The bore D3.1 is located directly in the area, where burrows of insects were found. The damage can be seen in the first external centimeters of the cross-section only. According to the chapter 2.1.2 the damage can be classified as shallow. Damage is affecting the mechanical properties of wood but the degree of damage is very low in this case.

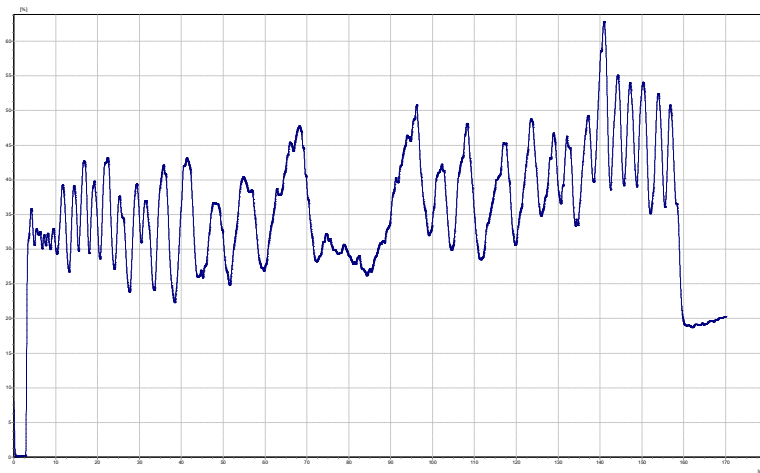
Chart 4-11 Drilling D3.2

Again the front surface is decayed but just in the depth of 1 cm. In the central part of the cross section the drill probably penetrated the member close to the original center of the tree in the tangential direction. Extending distance of hitting the annual rings to both sides from the center is in correspondence with this explanation.

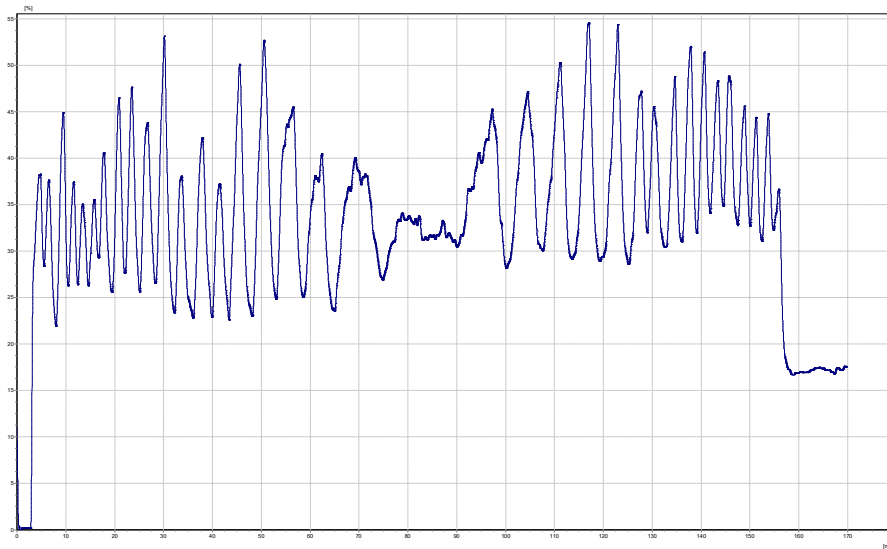
Chart 4-12 Drilling D3.3

This drilling was done 1m away from D3.1 where the wood seemed to be intact. Diagram confirmed the assumption as well as the explanation of the diagram D3.2.

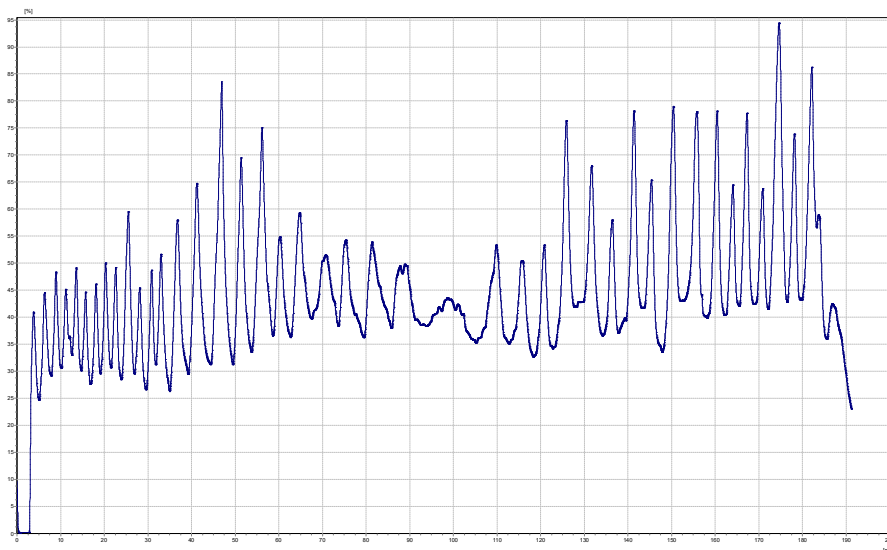
Chart 4-13 Drilling D3.4

Drilling D3.4 was made in the same cross section as D3.1, but in the perpendicular direction. Both front and posterior surfaces were not damaged. Resistance curve shows the intact intra-annual density of the timber and confirms the location of the tree center in the middle of the cross section.

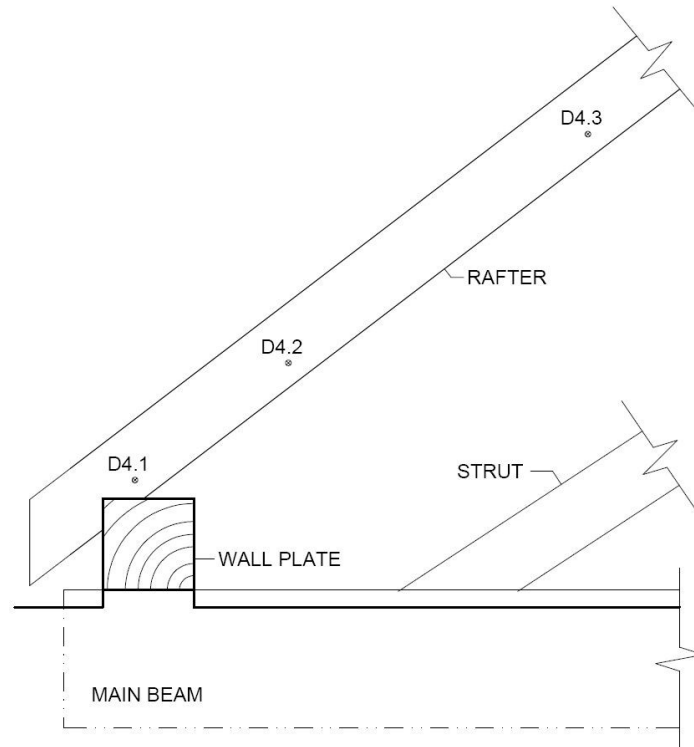
Figure 4-7 Detail D4 – Part of the cross section

Wet and moldy surface was found on the rafter which is a part of the main bond. The rafter is situated next to a roof window. Several drillings were made to determinate the internal condition of the rafter. The wall palate is affected by a mold as well.

The cause of moisture has to be found and solved in any case. The rafter should be subjected to further examination.

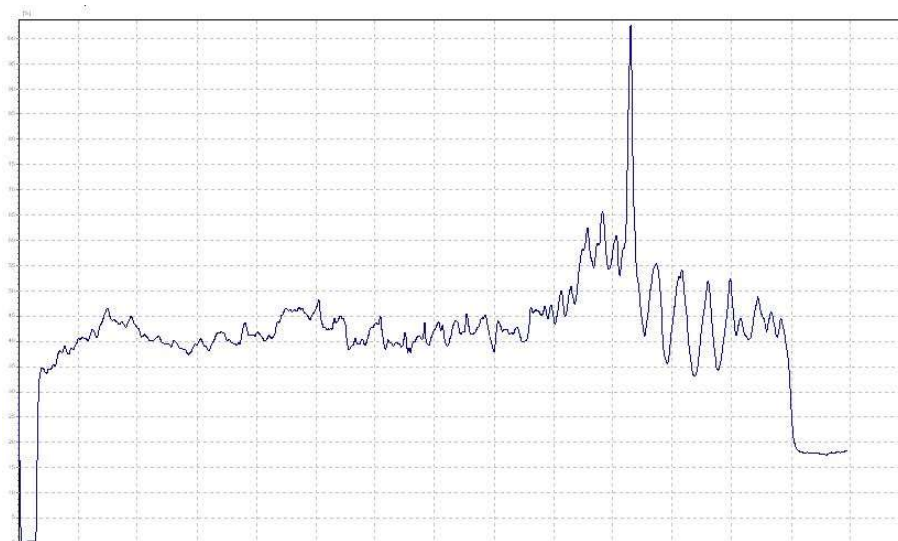
Chart 4-14 Drilling D4.1

Interpretation of the diagram D4.1 is not conclusive. The material still had some strength, but the difference of the resistance is not significant through the annual rings. It can mean two things, a problem of material or a tangential direction of drilling. In this case acc. to Figure 4-6 it could be combination

of both. First few centimeters were damaged, then the borer entered the spring wood.

The product of drilling D4.2 in the distance of 50 cm away from the wall palate is very similar to the diagram D4.1.

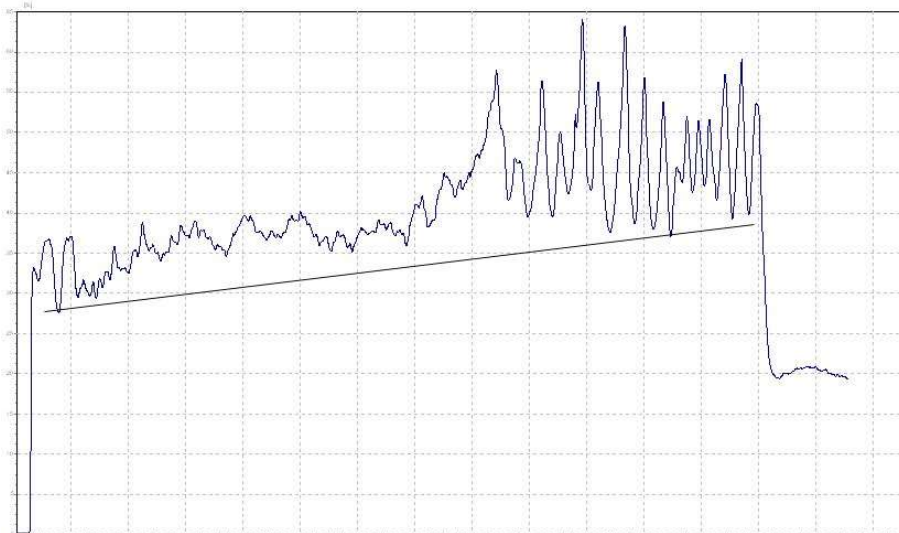
Chart 4-15 Drilling D4.3

This drilling was done about 1,5m away from the wall plate where the rafter seemed to be undamaged. At the beginning two annual rings were hit and then the fluctuations of resistance are not significant again. It further contributes to the possibility of tangential direction of drilling, so the material of the rafter could be in a good condition at this point.

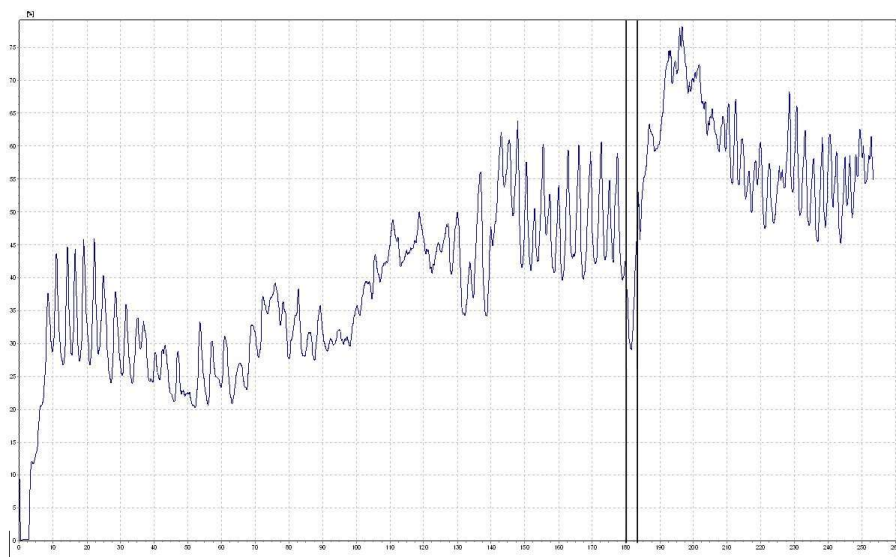
Chart 4-16 Drilling D5.1

The resistance of the historical wood is comparable to and even higher then the resistance of the wood from 1984.

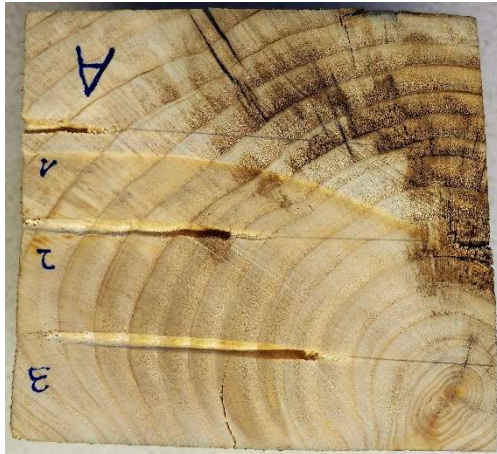
Photo 5-43 Cross section A; Figure 5-2 Cross section A

1	2	3	4	5	6	7	8	9
1	0,0	0,0	0,0	0,1	0,1	0,1	0,0	0,0	0,0
A 2	0,0	0,0	0,0	0,0	0,0	0,0	0,2	0,2	0,2
3	0,0	0,0	0,0	0,0	0,0	0,0	0,0	0,0	0,0

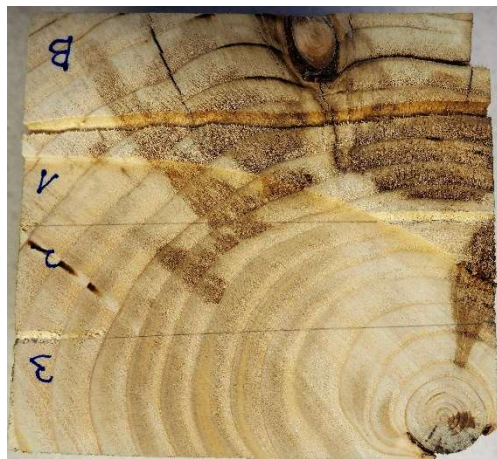
Photo 5-44 Cross section B; Figure 5-3 Cross section B

1	2	3	4	5	6	7	8	9
1	0,0	0,0	0,0	0,0	0,0	0,0	0,0	0,0	0,0
B 2	0,0	0,0	0,0	0,0	0,0	0,0	0,0	0,2	0,2
3	0,0	0,0	0,0	0,0	0,0	0,0	0,0	0,0	0,0

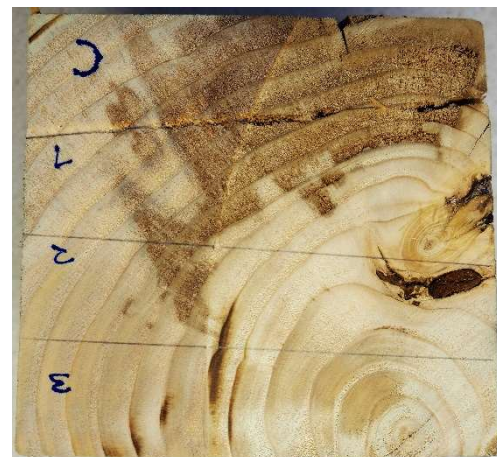
Photo 5-45 Cross section C; Figure 5-4 Cross section C

1	2	3	4	5	6	7	8	9
1	0,0	0,0	0,0	0,0	0,0	0,0	0,0	0,0	0,0
C 2	0,0	0,0	0,0	0,0	0,0	0,0	0,0	0,0	0,0
3	0,0	0,0	0,0	0,2	0,2	0,0	0,0	0,0	0,0

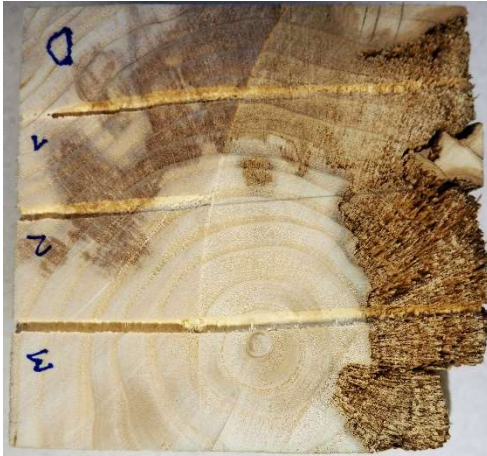
Photo 5-46 Cross section D; Figure 5-5 Cross section D

1	2	3	4	5	6	7	8	9
D 1	0,0	0,0	0,0	0,0	0,0	0,0	0,4	0,4	0,4
D 2	0,0	0,0	0,0	0,0	0,0	0,0	0,5	0,5	0,5
D 3	0,0	0,0	0,0	0,0	0,0	0,0	0,5	0,5	0,5

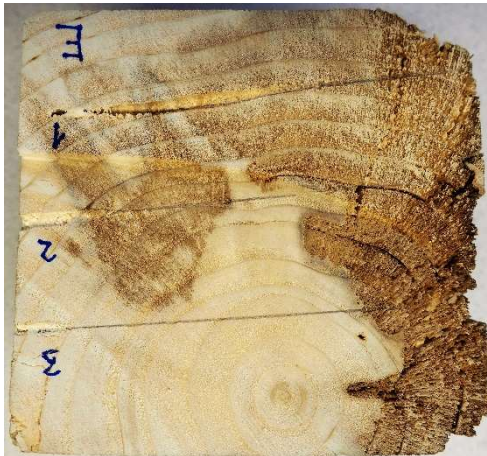
Photo 5-47 Cross section E; Figure 5-6 Cross section E

1	2	3	4	5	6	7	8	9
E 1	0,0	0,0	0,3	0,3	0,3	0,3	0,3	0,6	0,6
E 2	0,0	0,0	0,1	0,1	0,1	0,1	0,5	0,5	0,5
E 3	0,0	0,0	0,0	0,0	0,0	0,0	0,5	0,5	0,5

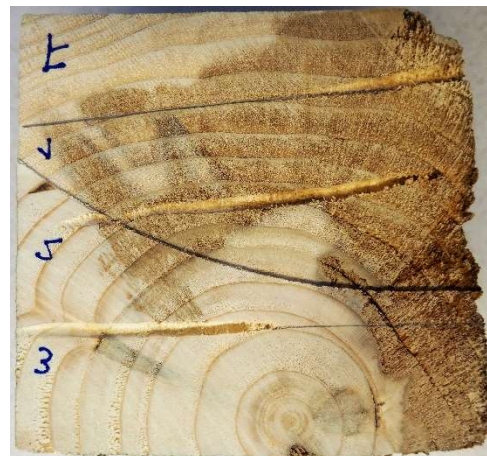
Photo 5-48 Cross section F; Figure 5-7 Cross section F

1	2	3	4	5	6	7	8	9
F 1	0,0	0,2	0,2	0,2	0,2	0,0	0,0	0,4	0,4
F 2	0,0	0,0	0,0	0,0	0,0	0,2	0,2	0,4	0,4
F 3	0,0	0,0	0,3	0,3	0,3	0,0	0,0	0,7	0,7

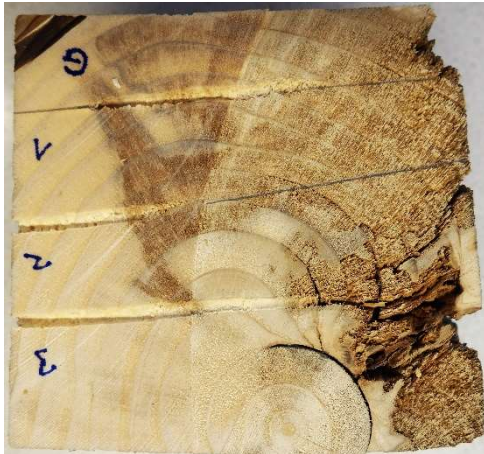
Photo 5-49 Cross section G; Figure 5-8 Cross section G

1	2	3	4	5	6	7	8	9
G 1	0,0	0,0	0,0	0,3	0,3	0,0	0,0	0,5	0,5
G 2	0,0	0,0	0,0	0,0	0,3	0,3	0,3	0,5	0,5
G 3	0,0	0,0	0,0	0,0	0,0	0,0	0,8	0,8	0,8

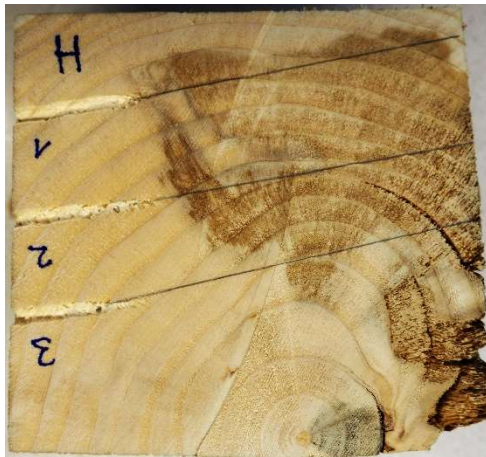
Photo 5-50 Cross section H; Figure 5-9 Cross section H

1	2	3	4	5	6	7	8	9
H 1	0,0	0,0	0,1	0,1	0,1	0,0	0,0	0,0	0,0
H 2	0,0	0,0	0,0	0,0	0,2	0,2	0,2	0,2	0,2
H 3	0,0	0,0	0,0	0,0	0,0	0,0	0,4	0,4	0,4

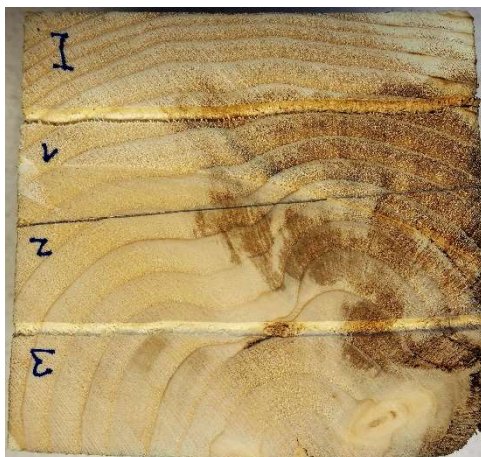
Photo 5-51 Cross section I; Figure 5-10 Cross section I

1	2	3	4	5	6	7	8	9
I 1	0,0	0,0	0,0	0,0	0,0	0,0	0,0	0,0	0,2
I 2	0,0	0,0	0,0	0,0	0,0	0,0	0,0	0,2	0,2
I 3	0,0	0,0	0,0	0,0	0,0	0,0	0,0	0,0	0,0

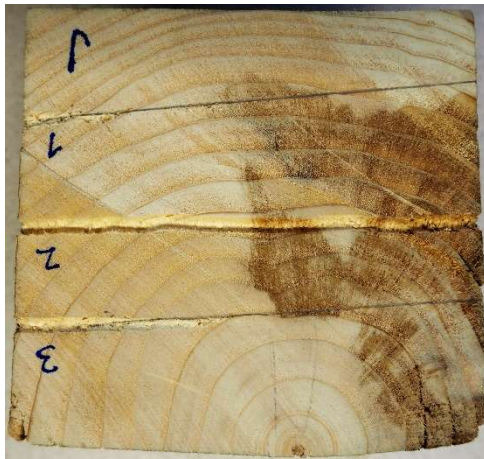
Photo 5-52 Cross section J; Figure 5-11 Cross section J

1	2	3	4	5	6	7	8	9
1	0,0	0,0	0,0	0,2	0,2	0,2	0,0	0,0	0,0
2	0,0	0,0	0,0	0,0	0,0	0,0	0,0	0,0	0,2
3	0,0	0,0	0,0	0,0	0,0	0,0	0,0	0,2	0,2
