ADVANCED MASTERS IN STRUCTURAL ANALYSIS
OF MONUMENTS AND HISTORICAL CONSTRUCTIONS

Master's Thesis

Structural Survey of Historical Building Strahovská FARA in Pohořelec

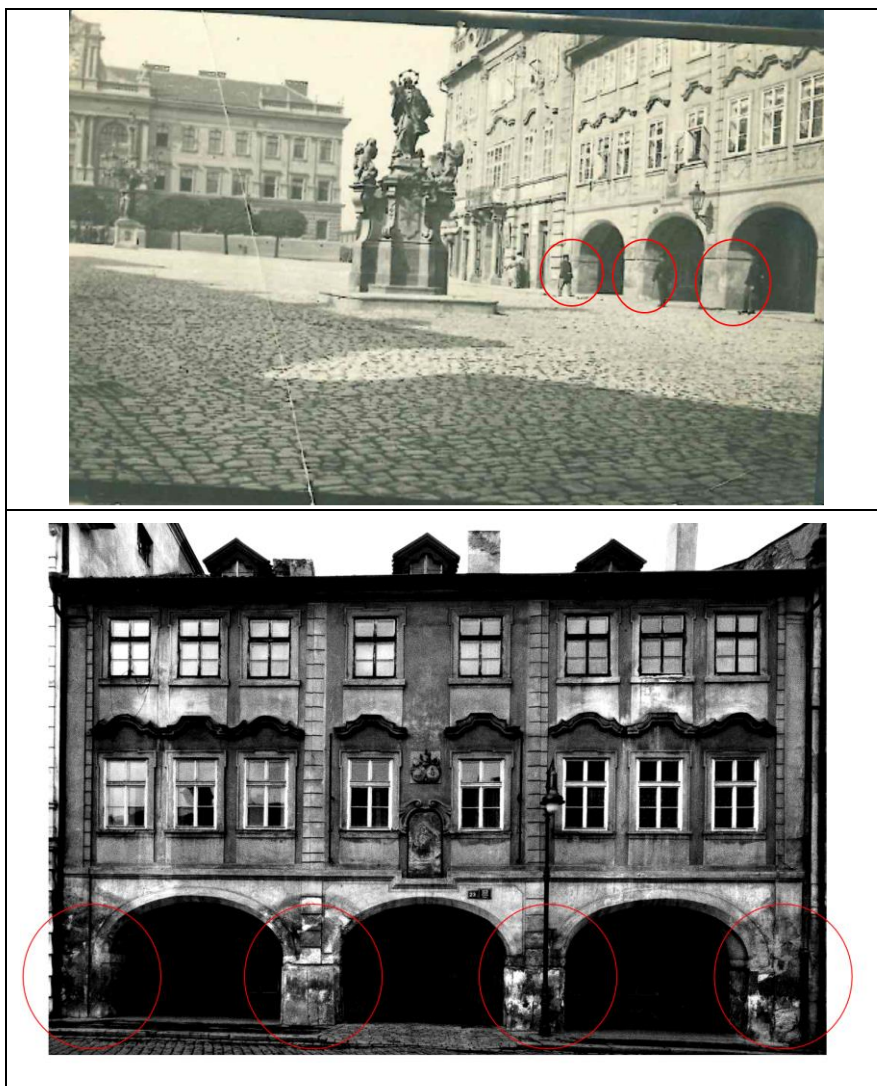
Figure 3: Building Strahovská FARA in 20th Century (Strahov Monastery Provided)

Based on historical documentations, the historical photo was taken in 20th century, and it showed that supporting columns had effect of moisture (See Figure 3). The recent

restoration occurred in 2011, all columns have been strengthened by iron frame and concrete material as layer.

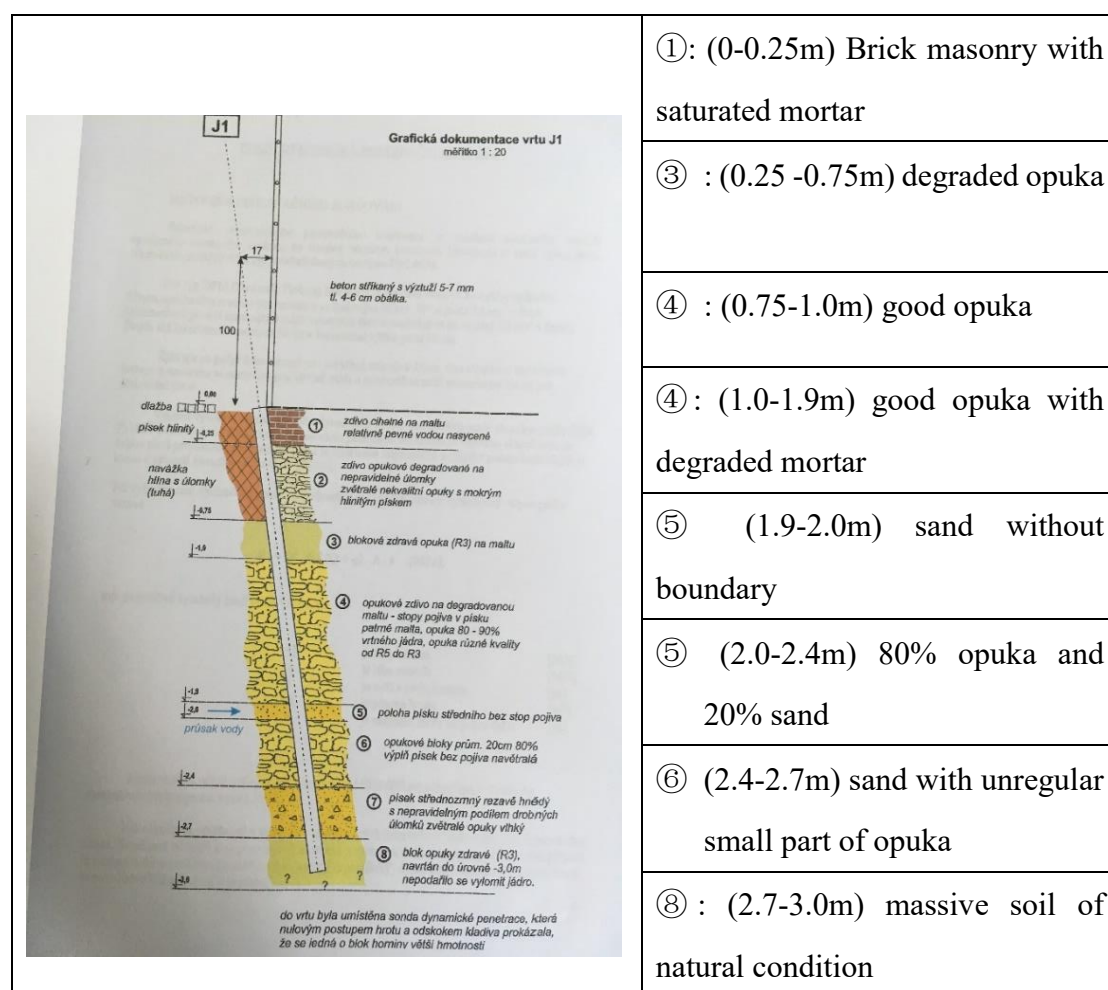
Figure 13: J1 Drilling test of Foundation (Geotechnical Report; Ing. Lumir Caithaml, 2016 [10])

The rock base of the Pohořelec area is black gray claystone with coal. A drilling test has been taken next to the column of main façade with drilling bore J1 (see Figure 13) (Geotechnical Report; Ing. Lumir Caithaml, 2016 [10]). The total depth of drilling is 3-meter-deep from the terrain. The underground material below the column of main façade can be shown in Figure 14. Based on the data in geotechnical report, the major problem of foundation and columns is the degraded opuka stone between the depth of 0.25 meter to 0,75 meters, due to the moisture (Ing. Vaclav Jandacek [11]).

<ol style="list-style-type: none"> 1. (0-0.35m) bricks 2. (0.35-0.75m) bad quality masonry 3. (0.75-1m) good quality opuka block 4. (1.0-1.9m) opuka masonry 5. (1.9-2.0m) sand layer 6. (2.0-2,4m) opuka 7. (2.4-2.7m) sand and sandstone
--	---

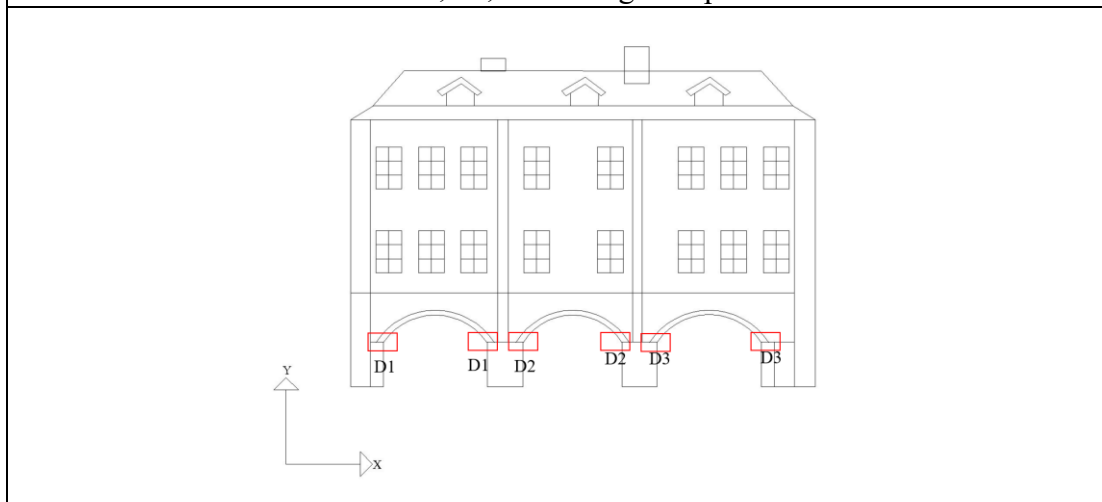
D1;D2;D3: Rising Damp

Location: D1,2,3 locate at connection part between columns and arches on the main facade

Description: from east side to west side of main facade, 4 load bearing columns have problem of material detachment.

Diagnosis: the rising damp of D1,2,3 is due to the previous restoration of main facade. The surface layer of each column has 5 to 7 centimeter thickness of concrete layer, which do not allow the evaporation of water, due to the impermeability of concrete material. As the ascension of groundwater from the terrian to arches' rib, rising damp evaporate slowly in the moisture zone above concrete layer.

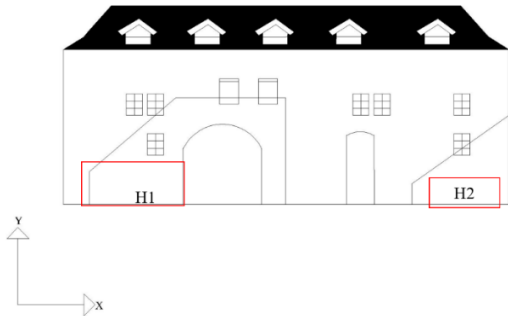
<p>H1; H2: Water Splashing and Rising Damp</p>

<p>Location: H1 and H2 are located at left and right side of the Building 2. H1 is on the left exterior staircase, and H2 is on the right exterior staircase.</p>	
<p>Description: H1,2 appear problem of material detachment. For H1, material detachment is along with the left exterior staircase. The rising damp area of H1 is rising to a level of 1.5 meter up to 2 meter.</p>	
<p>Diagnosis: H1 is related with material problem of poor details. H1,2 are affected by splashing water since heavy rainy period. On the other hand, due to the slop of terrain, water flow through underground drainage system at front of staircase from left to right. Water in the damaged drainage system could penetrate inside masonry and rise up. Additionally, soil at front of H2 contain high amount of moisture during rainy period. Moisture in the soil can rise and cause damage.</p>

Figure 24: Water Splashing and Rising Damp on Building 2

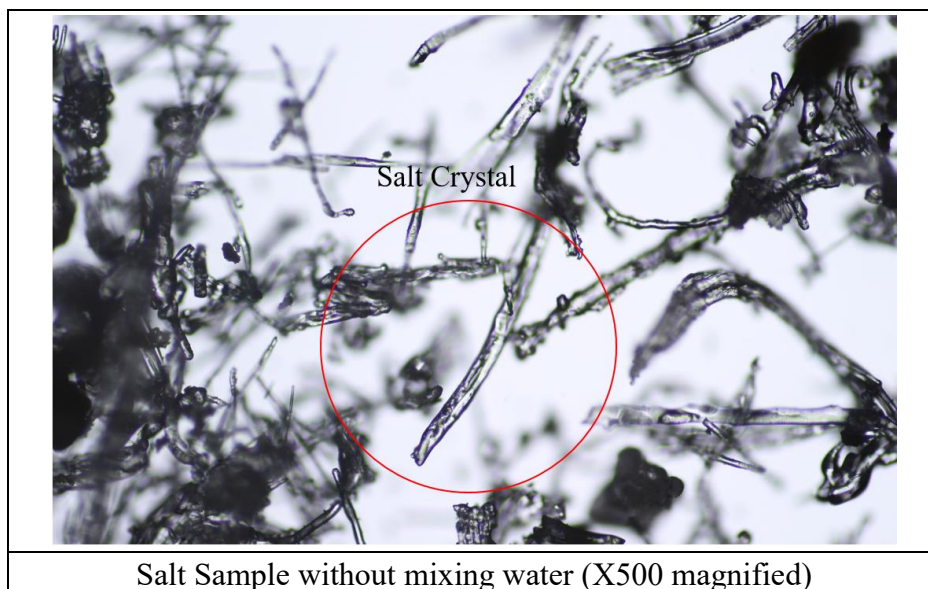
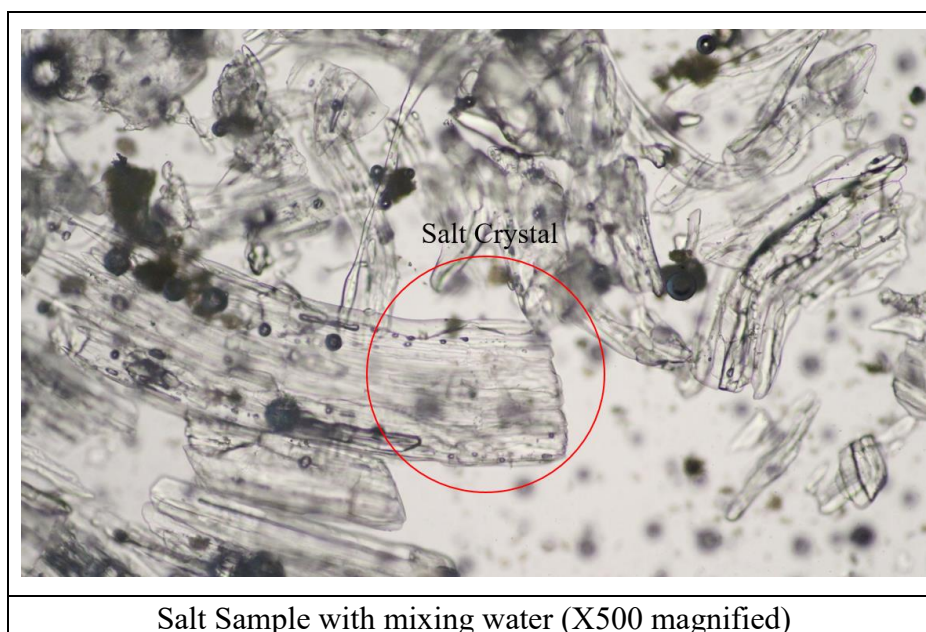
Figure 40: Result from Chemical Analysis

Based on the result of chemical analysis, the presence of salt in the masonry is the result of long time process (See Figure 40). These soluble salts can last in the masonry even for hundreds of years.

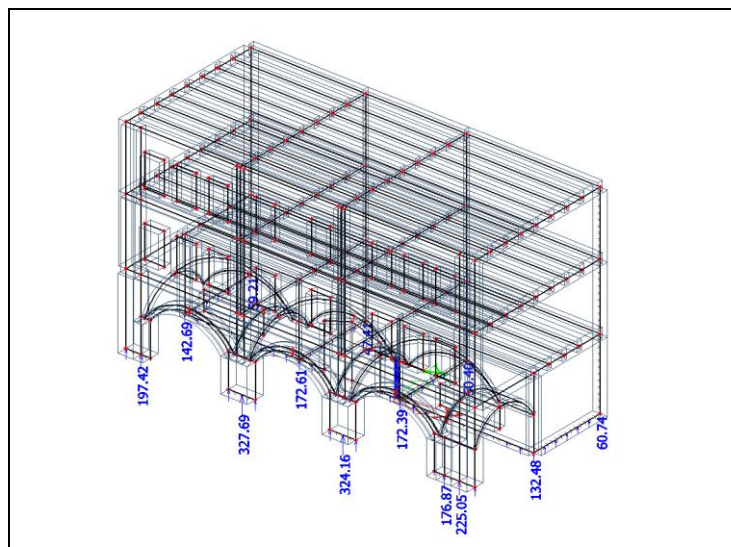
Figure 49: Reaction of Supports

The reaction of supports can be shown in Figure 49. In the static view, the load of columns is in a reasonable level which would not bring damage-able effect to the building 1.

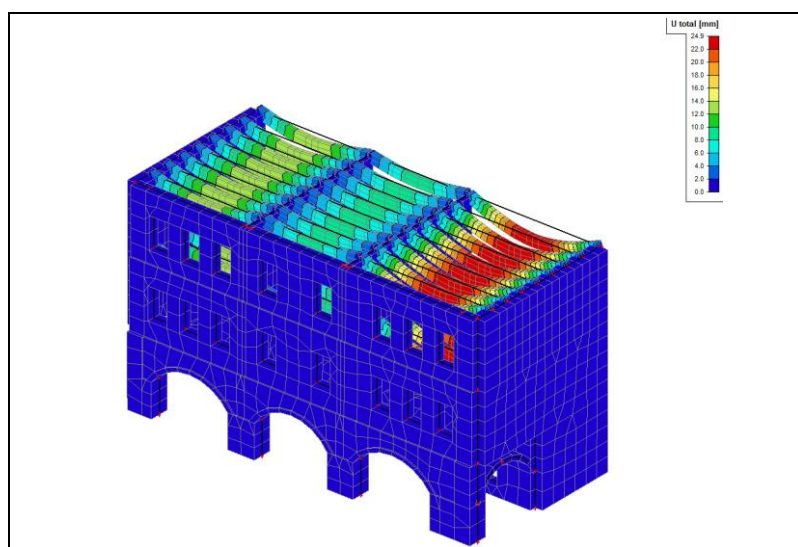
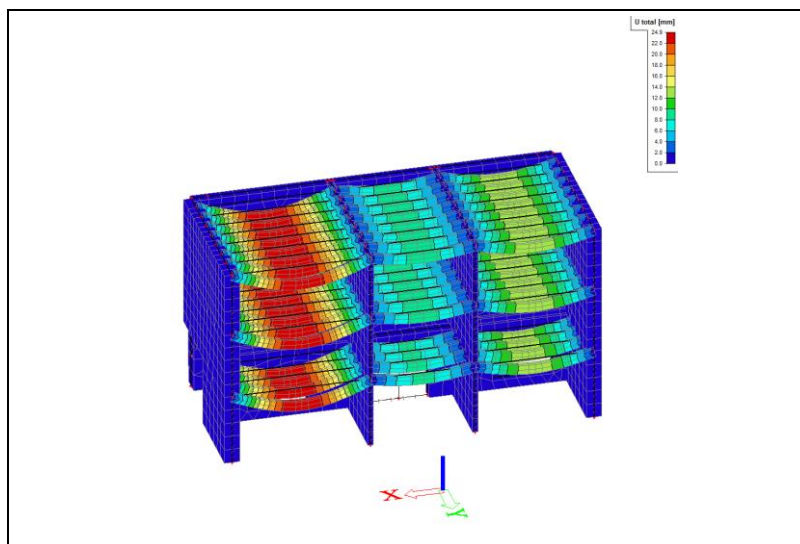
Figure 50: 3D Displacement

The 3D displacement was shown in Figure 50. Based on the Figure #, Columns of main facade have not huge displacement, but right side beams from 1st floor to 3rd floor have maximum displacement of 24.9mm.

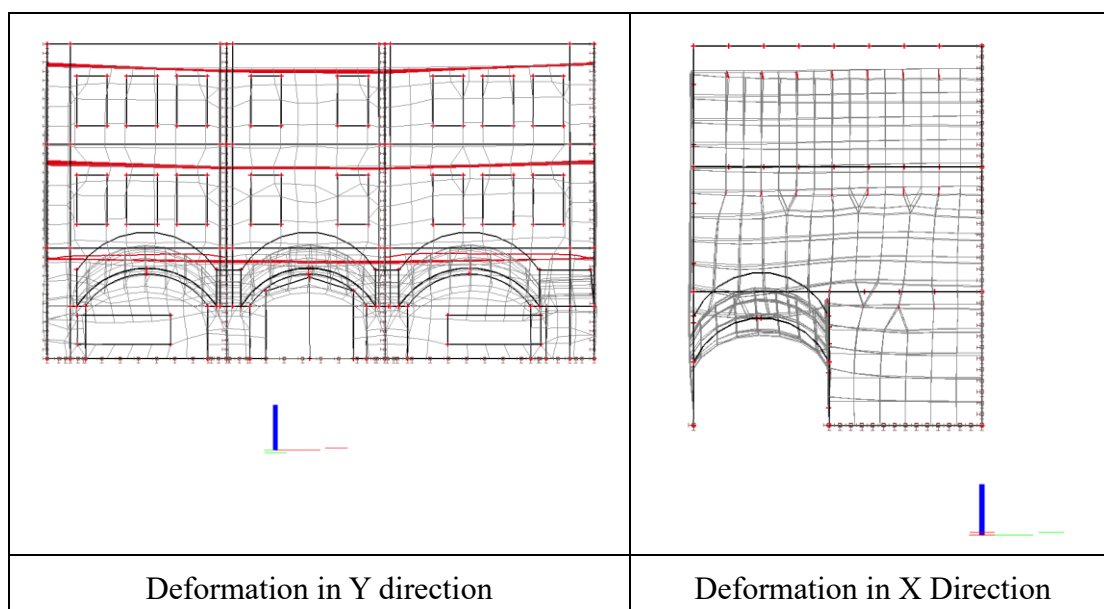
Figure 51: Structural Deformation in X and Y Direction

The structural deformation in x and y direction can be shown in Figure 51. Based on the result from Figure 51, the structure would not suffer huge deformation on y direction, but it would have huge deformation in x direction. Due to the original design of building, the deformation in x direction shows tendency of large deformation on arcade of main facade and second floor.

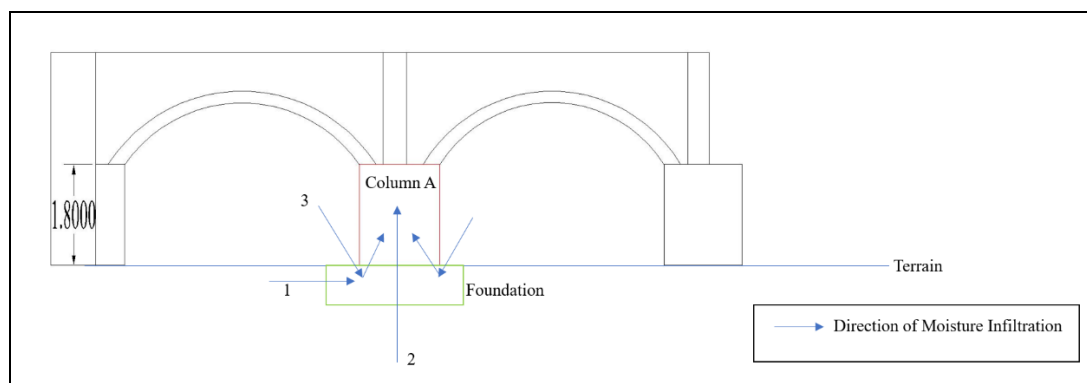
Figure 55: Moisture Infiltration Directions

According to the section 6 (Inspection and Diagnosis of damage and decay), the analysis of load-bearing columns on the main façade of Strahovská FARA have pointed out that the present damage was produced by moisture problems. Based on numerical model analysis in section 7.2 and the information collected above, columns do not compromise the stability and global behavior of structure immediately, but it may cause future static problems. Taking the Column A as an example, moisture can mainly infiltrate column in 3 directions (See Figure 55). In order to reduce the effect of moisture problem on columns, an immediate treatment of column replacement is proposed in this section. This treatment of column replacement has been considered intervention procedures and experience from neighbor building (Pohorelec 112, Praha) [19].

The main risk factor of column replacement in this case is pre-stressing. When the old column is taken out, the distribution of forces on main façade is changed. Since the new column is put back, it cannot usually be prestressed. Thus, the column replacement should have local readjustment of the stressing before new column carrying its load.
