Evaluation of Blast Resistance of Fiber Reinforced Composite Specimens under Contact Blast Load

Ondřej Janota¹ and Marek Foglar²

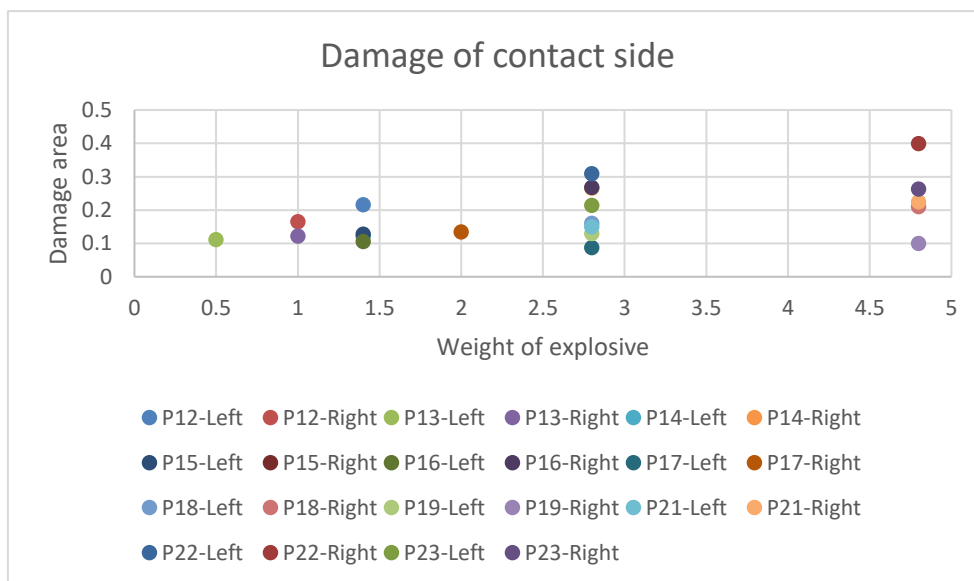
Figure 13. Dependency of the damaged area and the weight of the explosion – contact side

Table 1 presents summary of the experiment in the terms of the damaged area on the different specimens. It is apparent that there is a dependency of the final damage on the value of the concrete strength and also amount of fibres in the specimen. Specimen No. 16 with strength 129.5 MPa, but much shorter fibres, was damaged little more than specimens with lower concrete strength on the soffit but the damage on the contact side was lower. Figure 13 and 14 presents dependency of damaged area to the weight of the explosive. Adding elements for increasing the heterogeneity in specimens No. 18 and No. 19 rapidly decreased the final damage of the specimens. This phenomenon can be caused by the change of the mass density within the specimen on the boundary between concrete and the added elements. On this boundary, the overpressure wave from the explosive is partially rebounded back and partially goes through. Using this system, the wave can be distributed to a wider area and the overpressure decreases. Specimens No.18, No. 19, No. 22 and No. N23 has also showed different type of the failure on the contact side than the other specimens.
