**FAKULTA DOPRAVNÍ
ÚSTAV LETECKÉ DOPRAVY**

Rizika námrazy v letovém provozu
Safety risks arising from icing in flight operations
(diplomová práce)

Slavomír Filo

Praha 2015

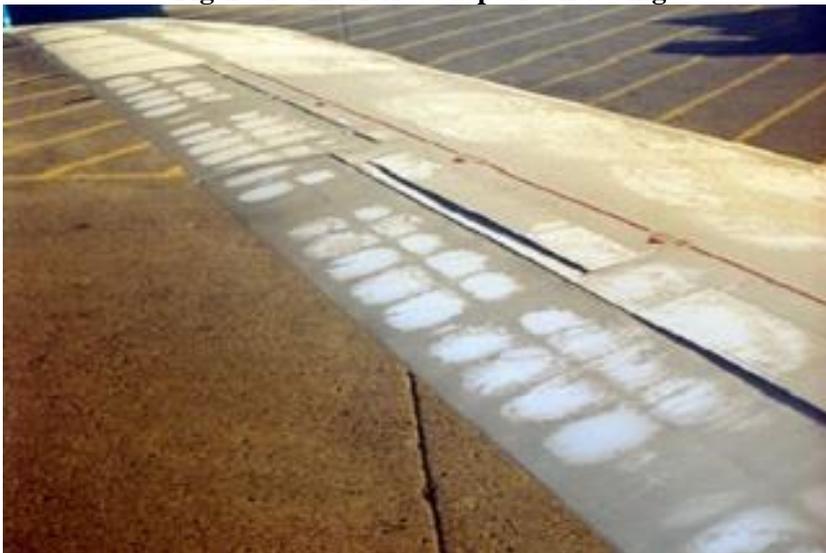
Hoar frost appears in the conditions when the air temperature reaches the saturation point and a surface of the aircraft is cooled to the freezing temperature. It is the only type of icing that can occur in clear air if we don't speak about the ice crystals icing (described in the chapter 1.2.3). The water vapor that touches the airframe is directly transformed to ice crystals. This phenomena is known as desublimation or more precisely gas-to-solid condensation. It requires the presence of the desublimation nucleus that has often an inorganic composition (volcanic dust, clay, soil particles). Hoar frost appears both on the ground and in flight. On the ground it usually builds up on the airframe of the aircraft parked outside overnight. It is very similar to the frost that forms on a car windscreen.

Figure 1 – Hoar frost deposit on a wing

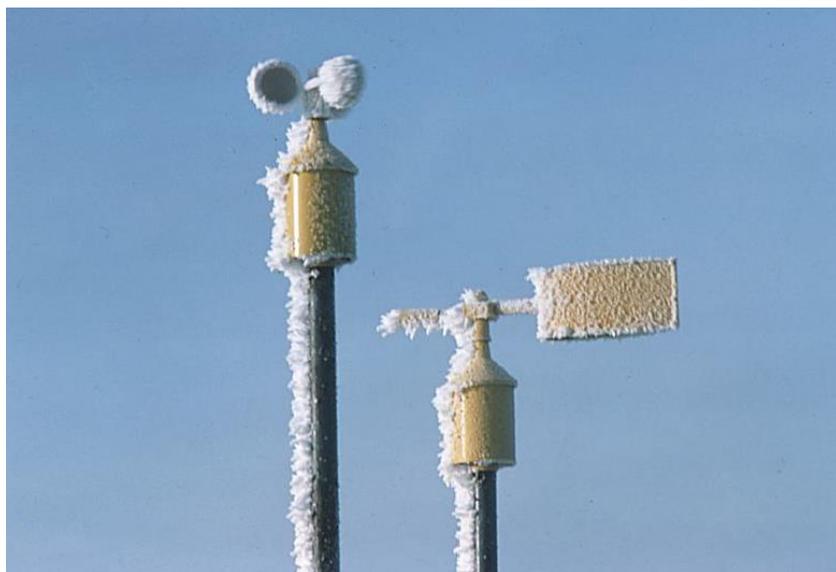
The rime ice has an opaque, white appearance that is making it fragile and brittle due to trapped air bubbles.

Figure 2 – Rime ice accretion on the meteorological measuring equipment

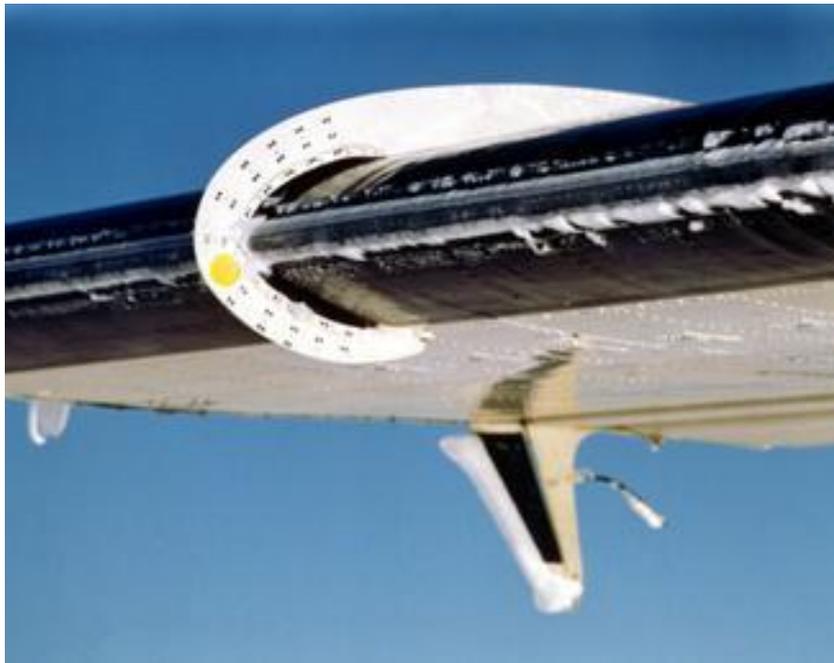
Clear ice forms a transparent layer of ice without air inclusion. It can be characterized as homogeneous, smooth, clear, compact and very solid. (Labyt, 2008) It can spread over big airframe surface.

Figure 3 – Clear ice on a leading edge

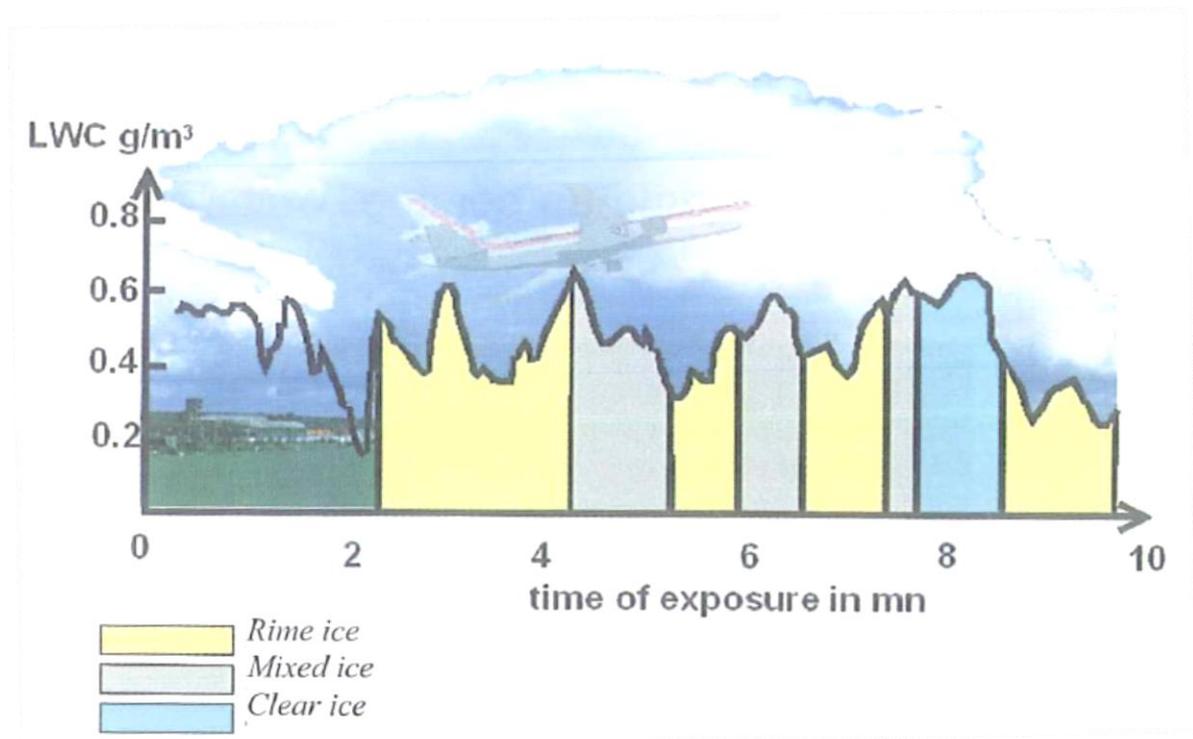
We speak about the mixed ice when clear ice and rime ice are formed simultaneously or in rapid alternations. This occurs in a cloudy atmosphere with a great variety of droplet sizes. The mixed ice formation depends on the variability of phenomena leading to the water freezing.

Figure 4 – Type of icing accreted according to LWC and time exposure

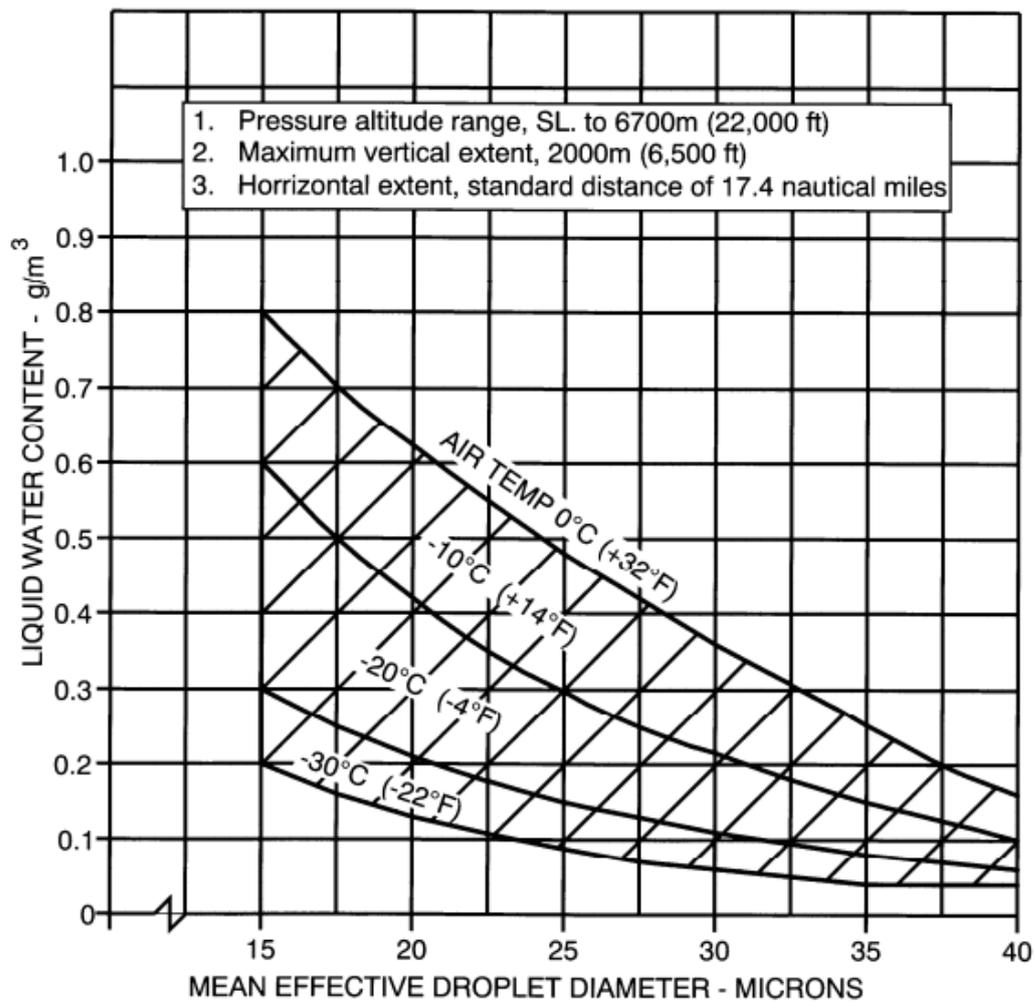
**Figure 5 – Continuous maximum (stratiform clouds) atmospheric icing conditions
Liquid water content VS mean effective drop diameter (CS-25, 2012)**

Each type of icing conditions is defined by multiple figures or values as variables of the cloud liquid water content, the mean effective diameter of the cloud droplets, the ambient air temperature. The interrelationship of these three variables is given as it's shown in the figure below. The limiting icing envelope is defined in terms of altitude and temperature. Continuous maximum icing differs from Intermittent maximum icing mainly by the horizontal extent that is defined in the regulation.

For example the takeoff maximum icing is defined by the cloud liquid water content of 0.35 g/m³, the mean effective diameter of the cloud droplets of 20µm, and the ambient air temperature at ground level of minus 9 °C. CS 25 defines that the takeoff maximum icing conditions can extend from ground level to a height of 457 m (1500 ft) above the level of the takeoff surface.

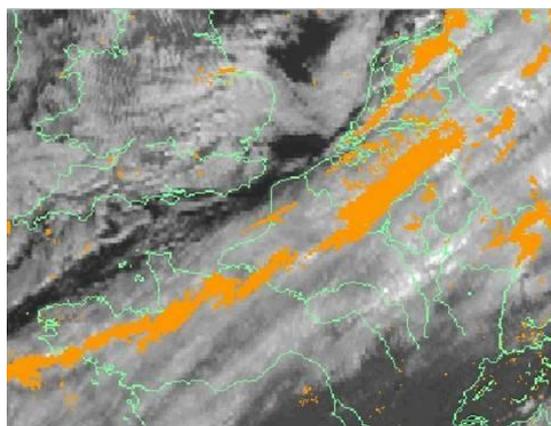
Figure 6 – Superposition of radar echoes with the satellite image

Icing can be sometimes identified thanks to the rain bands that are displayed on the rainfall radar screens. We can see the superposition of radar echoes with the satellite image taken when the front was passing over the Northwest part of France in the Figure 6. It shows the areas of icing in long bands.

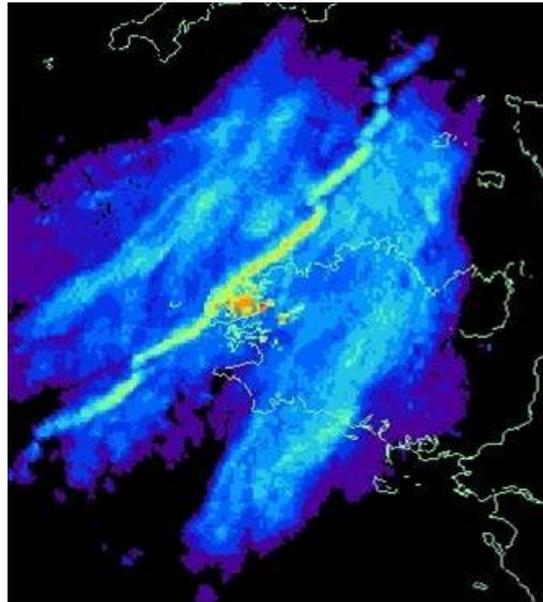
Figure 7 – "Scaled structures" in the radar picture

In the other radar picture (Figure 7), it's possible to identify the structures known as "scaled structures". In these areas it's very probable to find a maximum icing intensity.

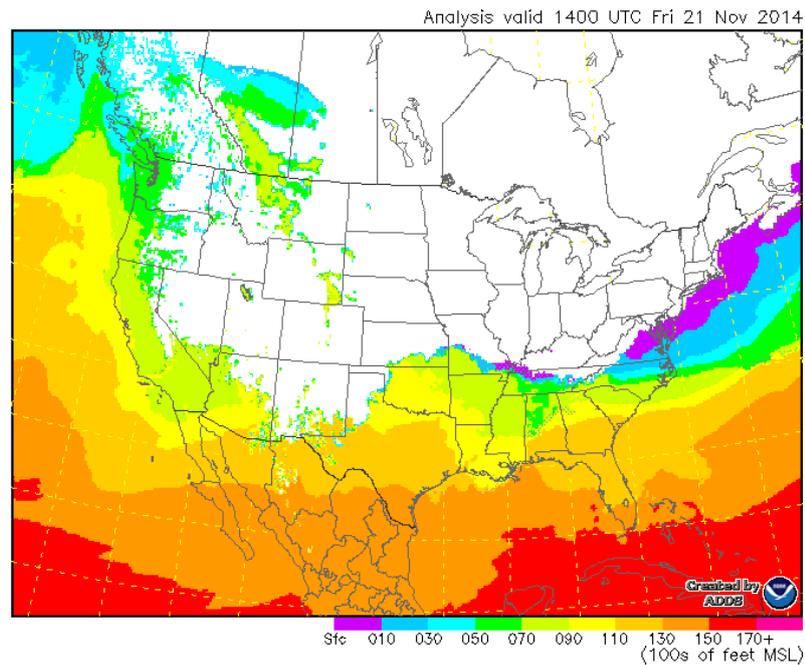
The observed freezing level charts are provided to determine the altitude of 0 °C isotherm. The traditional way of measuring air data needed to publish these types of chart was a radiosonde. Nowadays an additional instruments such as measuring devices attached to the aircraft, satellites and weather radars are used to determine the actual freezing level.

Figure 10 - Freezing level chart

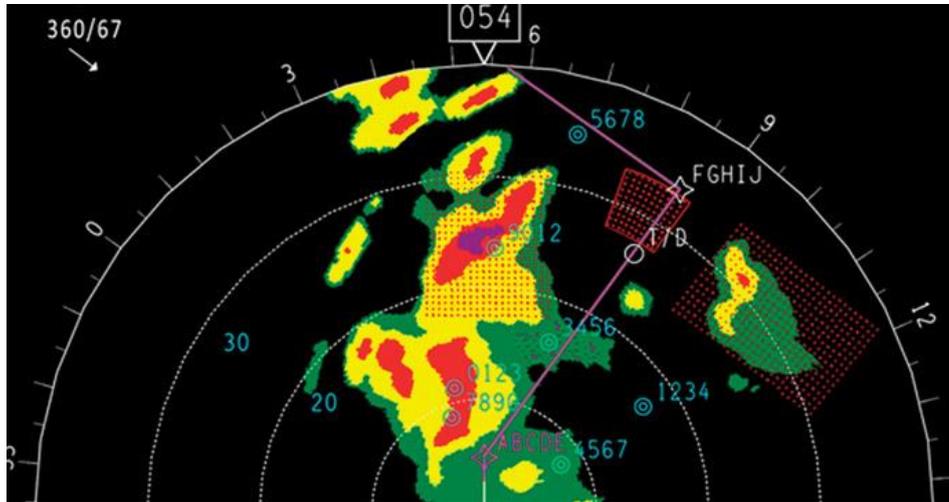
radar antenna beam down to look for the more reflective parts of the storm that may cause problem at their altitude. (PALMER, 2013)

Figure 11 – On-board weather radar screen

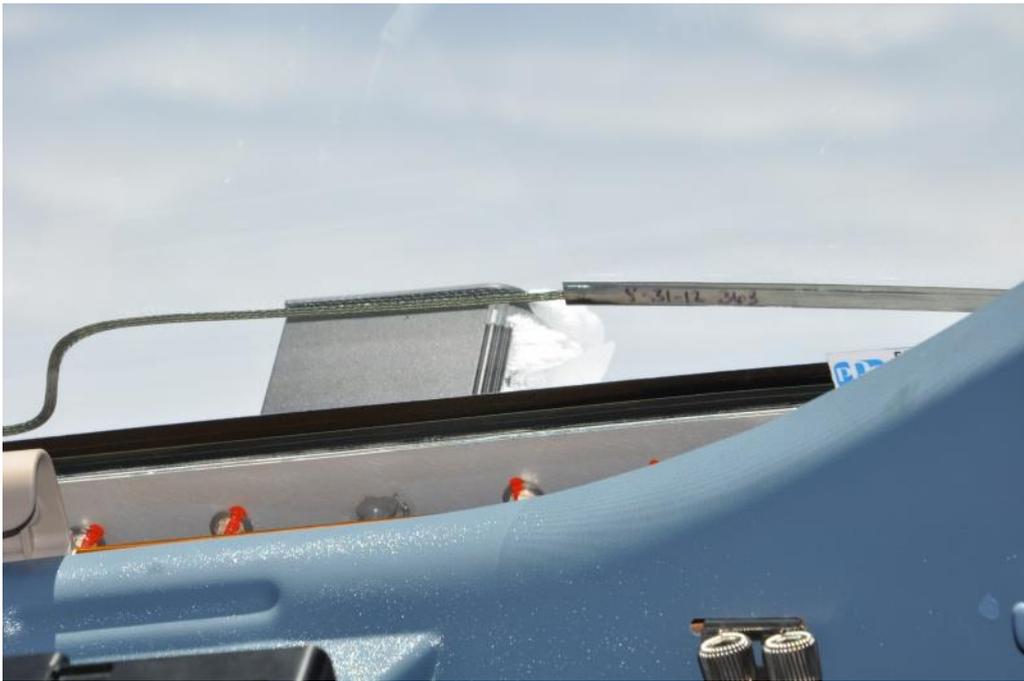
Figure 12 – Ice detector used on the ATR aircraft

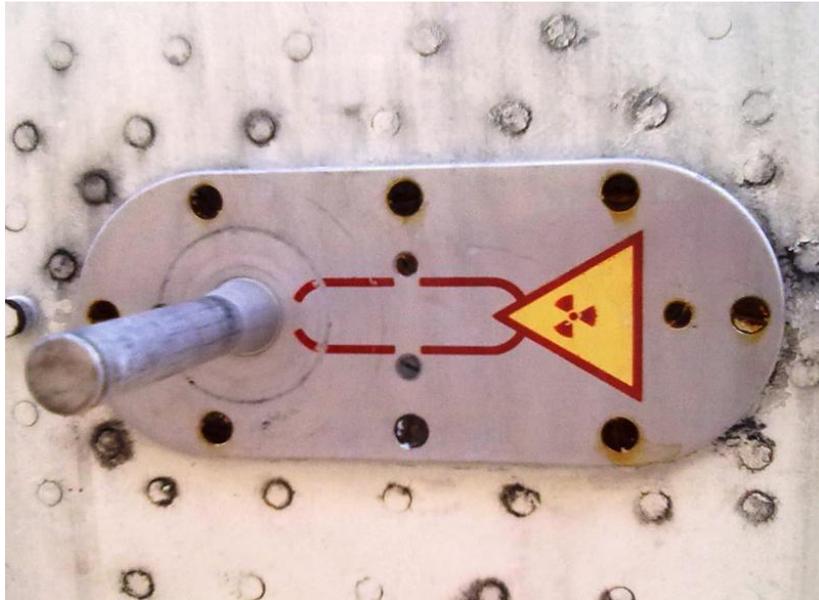
Other types of detectors use an emission of small quantity of radioactive beta particles. If ice builds up on the detector, beta particles are absorbed by ice. A known difference between the amount of emitted and detected particles is proportional to the level of icing. (Oxford: Oxford Aviation Academy, 2001)

Figure 14 – Ice detection probes emitting beta particles

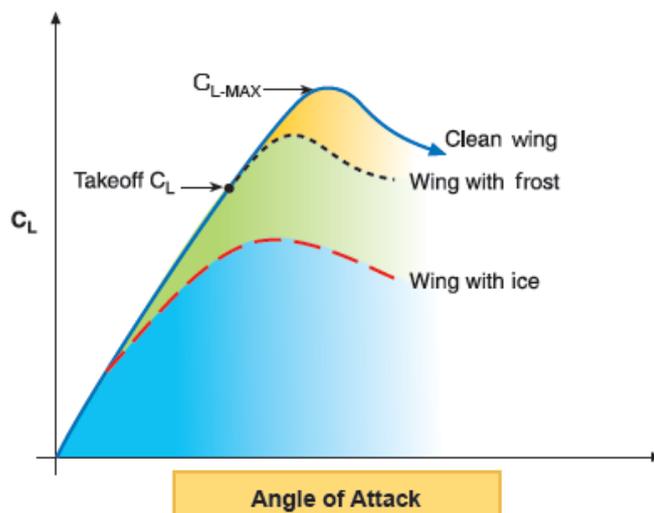
**Figure 15 – Lift curve showing the effect of the icing
(U.S.Federal Aviation Administration, 2008)**

1mm thick layer of the ice on the wing is sufficient to change the wing lift-angle of attack curve. This leads to a smaller value of maximum lift coefficient and to a smaller stall angle value. The maximum value of the lift (on the lift coefficient/angle of attack curve) can be reduced by a half because of the ice accretion depending on the airfoil type. The controllability of the aircraft becomes worst at low speeds, close to the stall speed, when plane flies at high angle of attack.

Ice deposit on a wing affects the lift negatively. It decreases the critical angle of attack while drag and weight increase.

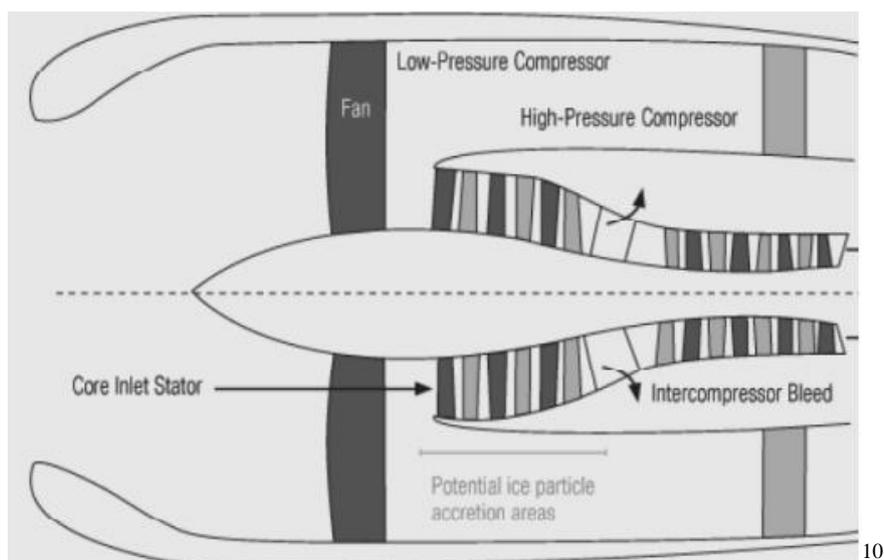
Ice crystals often present a high risk for a safe run of the jet engine. The principle of the ice crystals accretion in the engine is not completely understood. It seems that the ice crystals which enter the engine start to melt on the surfaces of the compressor. The melted ice creates a liquid film that captures other ice crystals. Heat is removed from the compressor until the liquid film starts to freeze inside the engine. The ice layer can easily shed from the compressor parts. It results in the engine instability such as a surge, a flameout, or an engine damage. (Duvivier, 2010)

Figure 16 – Cross-section of the turbo-fan jet engine and the potential icing accretion area

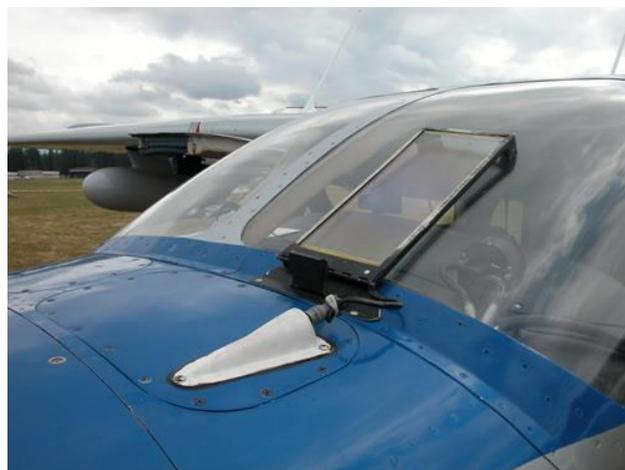
In case of an IFR flight in a cruising level, you don't need to watch out through the window frequently. When landing, it can be necessary to have a visual reference with the ground and the obstacles. The ice formation on the windscreen is nothing uncommon during the winter operations in Europe. The airliners are prepared for it. Their windscreen are composed from the multiple layers. One of the layers contains electrically heated metal, used to de-ice the windows. The advantage of this type of anti-ice equipment is that it keeps all the windscreen without the ice. The pilots of smaller planes that are not equipped with this type of windscreens, must watch out from the cockpit through a small rectangle that is de-iced by electricity, hot air or by other means.

Figure 17 – Anti-icing plate on the Cessna's windshield

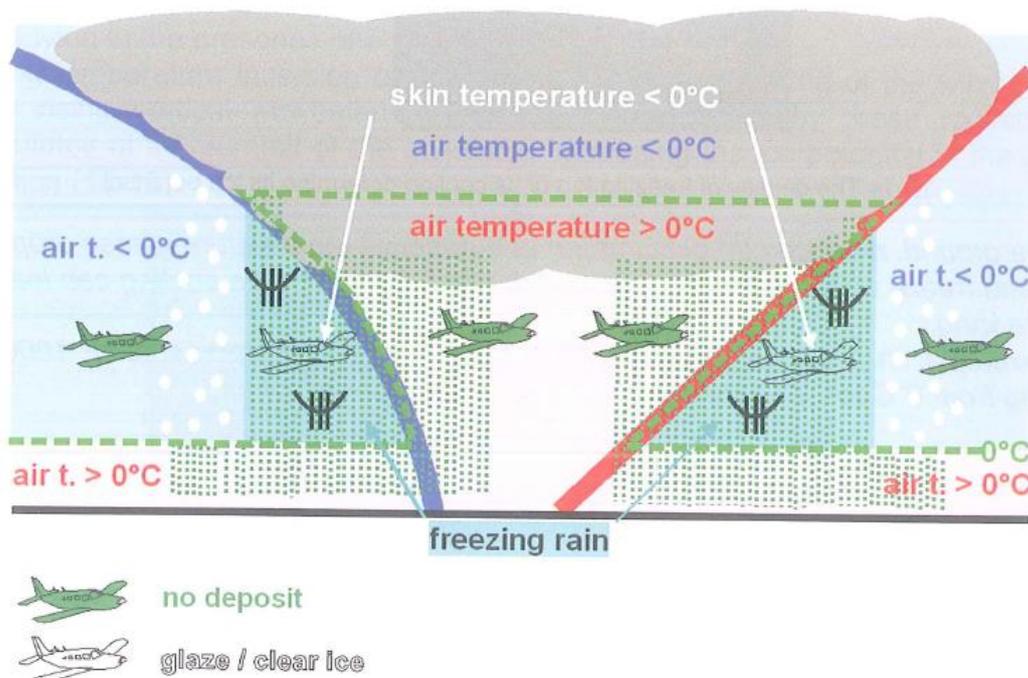
Cold front is a barrier that separates two different air masses. The warmer air is being replaced by the colder air. The colder air has bigger density than the warmer air and it pushes up the warmer air to the higher altitudes. Two different air masses exist one over the other, separated by the front line. This state is perfect for the icing formation. Precipitations that are formed in the warmer air, in form of the rain, fall to the colder air. If the colder air has a temperature below 0 °C, freezing rain occurs. Rain drop that condenses in the warm sector, falls to the cold air. Freezing air cools the water droplet. When it falls on the ground or on an aircraft in flight, it breaks, spreads out and forms clear ice. In these conditions severe icing is very probable. Ice accumulates so quickly that almost every aviation industry manufacturer advises that none of its products, even those certified for known icing, are design to fly in the freezing rain.

Figure 18 – Icing conditions near fronts

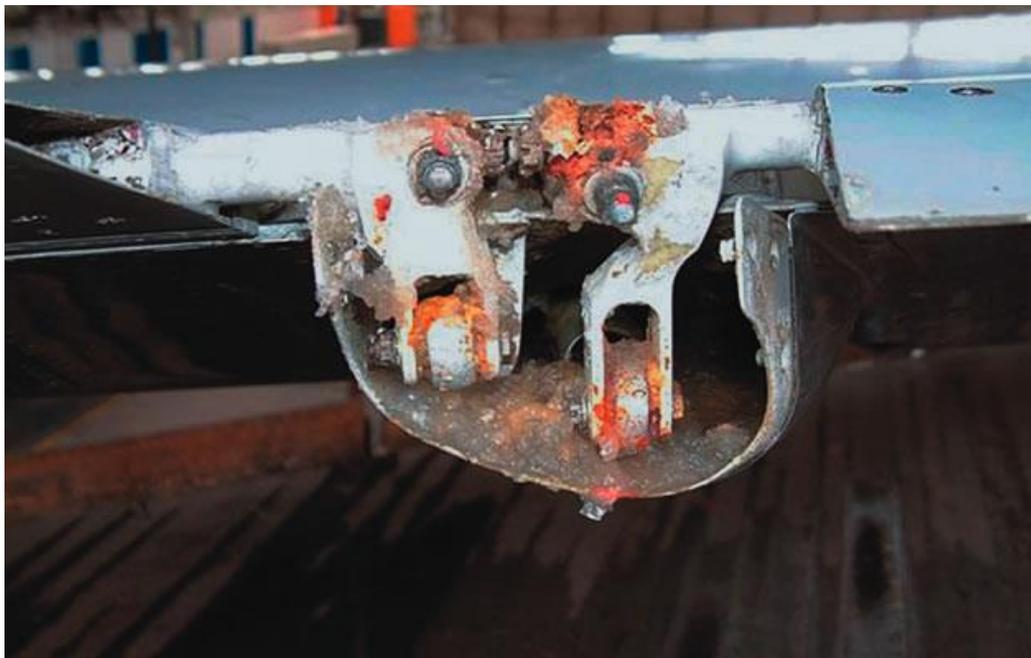
Figure 19 – Anti-icing fluid residues development

The flight nearly resulted in catastrophe, because of the development of residues from de-icing and anti-icing liquids. Several types of de-icing and anti-icing fluids are used to treat an aircraft before a flight. Some of the liquids are thickened, for example SAE^{xi} Type II (used on the BAe 146-300), Type III or Type IV. These types of anti-icing fluids contain small amount of polymers, which create a thick layer on the anti-iced surfaces. The polymers are used in anti-icing fluids to prolong hold-over time. When the fluid dries or it shears off the airframe, the polymers persist on the airframe. An excessive quantity of rehydrated polymers can influence aerodynamic performance of the aircraft or it can mechanically block the controls. The problem of the polymers is that it easily absorbs the humidity from the air. The polymers that accumulate high water content are very dangerous in the freezing temperatures. Even a small amount of them, which freezes in a small gap on the airframe, can block the controls as it had happened on the flight from Frankfurt to Stuttgart. (Figure 19)
