Effects of high-pressure cooling in the flank and rake faces of WC tool on the tool wear mechanism and process conditions in turning of alloy 718

Nageswaran Tamil Alagan^{a,*}, Philipp Hoier^b, Pavel Zeman^c, Uta Klement^b, Tomas Beno^a, Anders Wretland^d

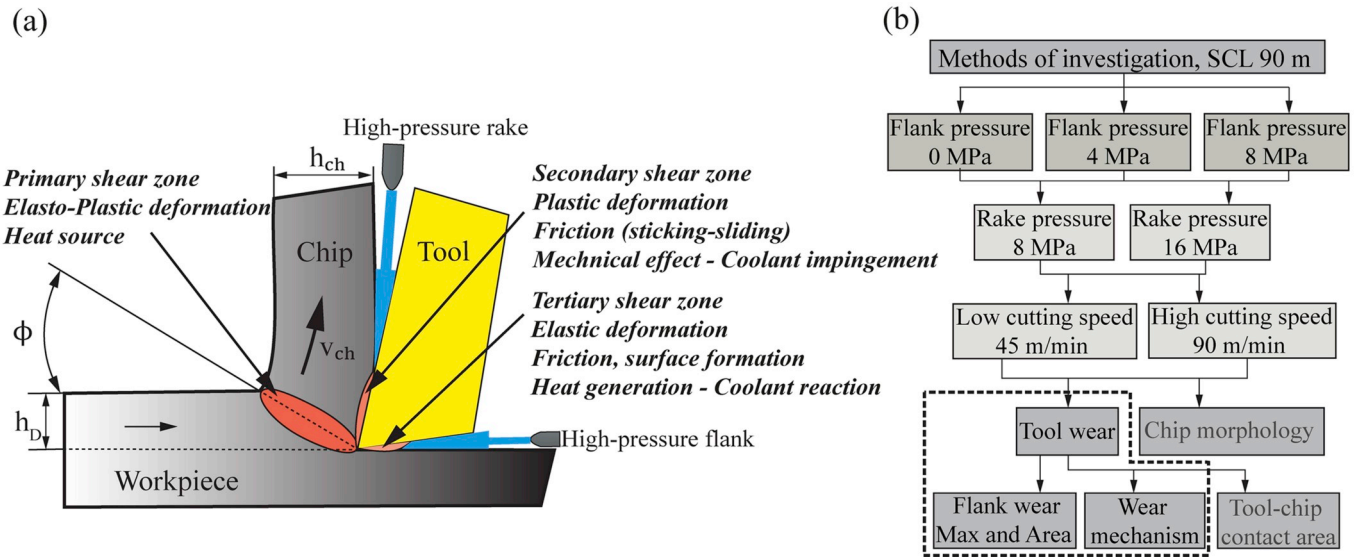
Fig. 1. (a) Illustrates three shear zones with focus of high-pressure coolant and (b) Overview of the research methodology incorporating investigation methods and process conditions focussed on tool wear.

The investigations were focussed on the maximum flank wear (VB_{max}), flank wear area (VB_{area}) and wear mechanism observed on the WC cutting tools, by varying flank pressures conditions (0, 4 and 8 MPa) for rake pressure 8 and 16 MPa at cutting speeds 45 and 90 m/min (Fig. 1(b)). The findings are explained in the corresponding subsections.

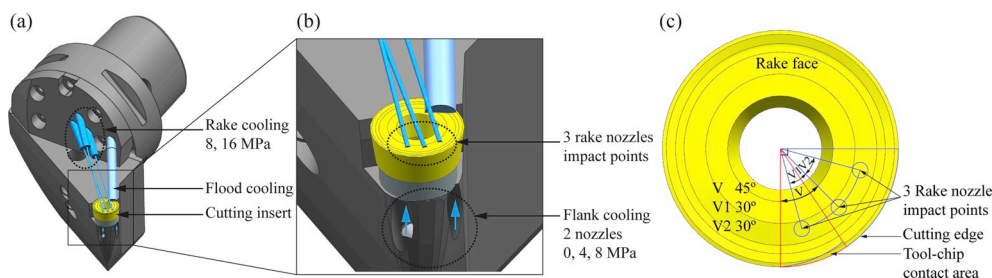
Fig. 2. (a) CAD model of special tool holder with internal delivering of high-pressure coolant to rake and flank extracted from Ref. [9]; (b) Magnified close to the cutting tool and impact directions; and (c) Illustration of the impact points of the coolant on the rake face as extracted from Ref. [9].

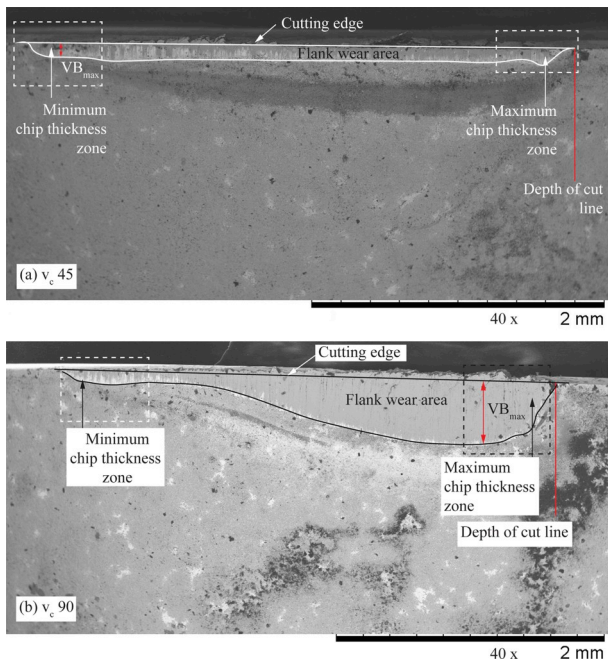
Fig. 3. Flank face of the WC cutting tool for rake pressure 16 MPa and flank pressure 8 MPa and a cutting speed v_c of (a) 45 m/min and (b) 90 m/min.

uniformly distributed and VB_{max} was measured in the region the maximum chip thickness zone and as shown in Fig. 3 (b). In addition, VB_{area} was measured to increase the understanding and avoid just one single number (VB_{max}) value to describe the flank wear. Values of the reached wear levels, extracted from a 3-D scanning microscope, can be found in Table 2.

Various researchers like Ezugwu et al. [20, 21], Machado and Wallbank [22], and Suárez et al. [23] have investigated machining with the use of high-pressure coolant and reported increases in tool life by lowering flank wear compared to flood cooling or even dry cutting conditions. However, the dominant depth of cut notch wear was observed in their research work for both carbide and ceramic tools. This failure mode was reported to be the most prominent cause for tool failure while machining Alloy 718. Shalaby and Veldhuis [24] mentioned that the probable cause of notch wear can be caused by one effect or a combination of the following: adhesion effects, work-hardened surfaces, stresses, adverse chip flow conditions with chip curling, and temperature gradients. Further, notch wear is the dominant tool failure criterion when machining at higher cutting speeds. However, in some cases notch wear was identified even at lower cutting speeds [23]. In this experiment, no such observation of groove shape or notch wear were found for any of the cutting tools at the depth of cut line (at approx. 3.6 mm as shown in Figs. 3 and 12).

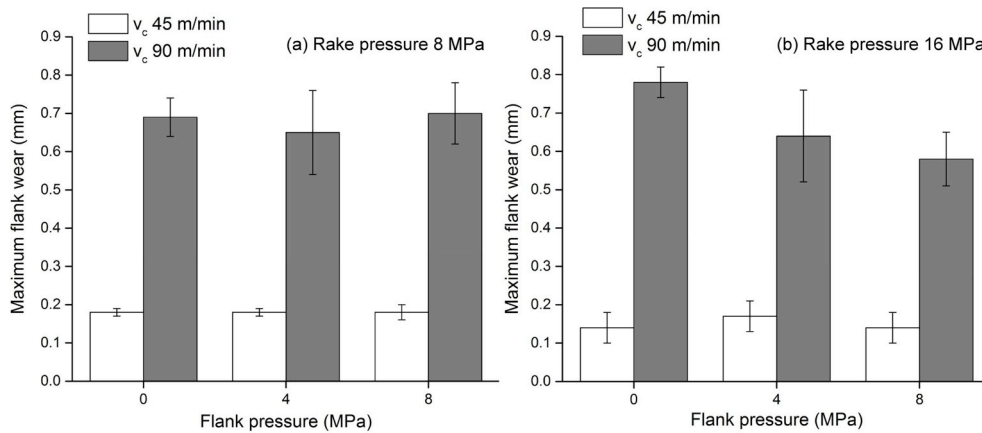
Fig. 4. Comparison of measured maximum flank wear for different cutting speeds and flank pressures; (a) Rake pressure 8 MPa (b) Rake pressure 16 MPa.

The maximum flank wear was measured for all the cutting trials (including the replicates, which is shown by the error bar), see Fig. 4. In addition, the flank wear area of the worn zone was measured and values are plotted as shown in Fig. 5. While comparing the effects of varying v_c , the difference in mean value of VB_{max} and VB_{area} can be readily seen. The numbers have increased significantly (by approx. 3 to 4 times) for all the cutting conditions. Despite using a high-pressure coolant, the increase in cutting speed reduced the tool life significantly. This is in line with the theory that increased cutting speed leads to rises in the temperature at the cutting edge due to the heat generated in tool-chip and tool-workpiece shear zones, which consequently accelerates tool wear and lowers tool life [6,14].

For v_c 45 m/min, an increase in rake pressure from 8 to 16 MPa for constant flank pressure of 8 MPa led to a reduction of the mean values for VB_{max} and VB_{area} by approx. 20 and 17%, respectively. The corresponding wear levels were not significantly influenced by similar cutting conditions by flank pressures of 0 and 4 MPa. For a v_c of 90 m/min and a rake pressure of 8 MPa, an increased flank pressure did not lead to a reduction of the maximum flank wear and flank wear area (Fig. 4 (a) Fig. 5 (b)). However, if the rake pressure is increased to 16 MPa (Figs. 4 (b) and Fig. 5 (b)) the mean VB_{max} and VB_{area} are reduced by approx. of 25 and 20%. The wear levels were not influenced when no flank coolant was used and when the flank pressure was 4 MPa. Finally, at a flank pressure of 8 MPa, the downward wear rate trend was regained.

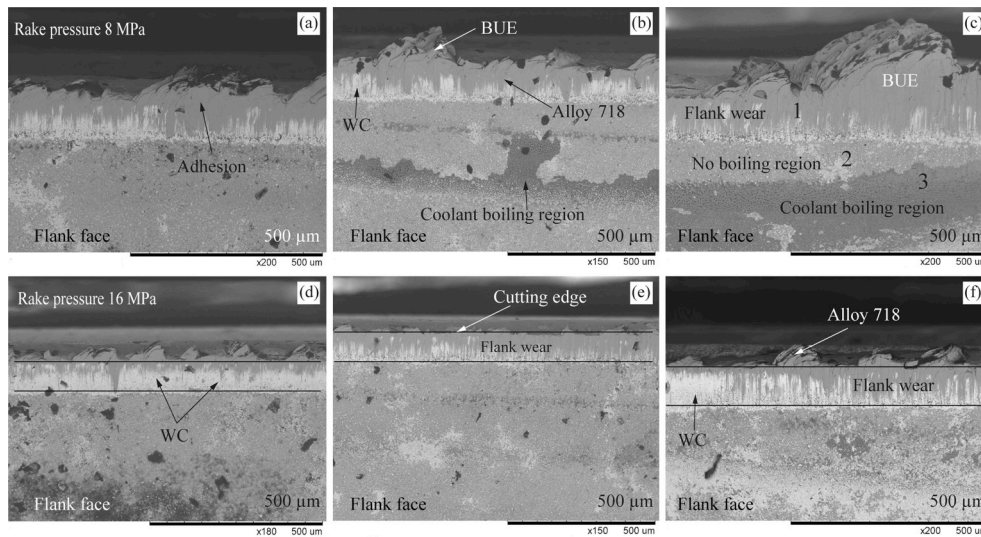
Fig. 6. Wear observation on the selected tool at v_c 45 m/min for rake pressure of 8 MPa and flank pressure of (a) 0 MPa, (b) 4 MPa, and (c) 8 MPa and for rake pressure of 16 MPa and flank pressure of (d) 0 MPa, (e) 4 MPa, and (f) 8 MPa.

Further analysis by SEM and EDX revealed the adherence of the workpiece material, Alloy 718 as a uniform grey region on the flank wear land as shown in Fig. 6 (a, b and e), while the white regions (varying spikes) were identified as the WC tool material.

The coolant-boiling region formed as a continuous layer below the flank wear region for flank pressure conditions between 4 and 8 MPa, Fig. 6 (b and c). However, continuous formation of the coolant-boiling

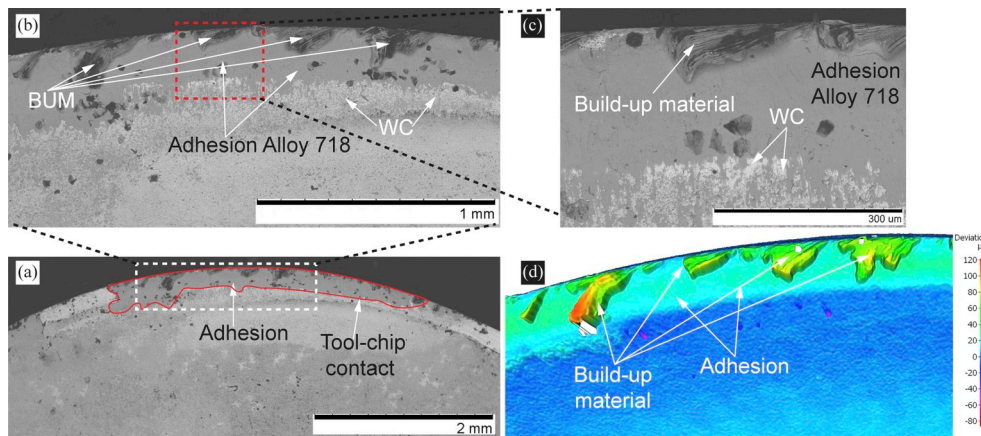
Fig. 7. Wear mechanism observed on rake face of the tool for v_c 45 m/min with rake pressure of 8 MPa and no flank cooling.

The rake face of all the cutting tools had the build-up layer (BUL) on the tool-chip contact area; one of the tools is shown in Fig. 7 (a). In addition, build-up material (BUM) formation was observed in different areas along the contact zone, as seen Fig. 7 (b) is not the build-up edge (BUE). Normally the BUE is non-stable, breaks periodically and takes away a small amount of tool material, which in turn leads to deterioration of the cutting edge [18]. In this case, the BUM can be from the chips adhered to the tool during the cutting tool disengagement from the workpiece. BUM is scattered along the tool-chip contact area, it

does not represent traditional BUE formation. However, intense formation of BUL could lead to negative effects of the tool life by acting as barrier for the heat to dissipate through the tool. Fig. 7 (c) shows the region of BUM, adhesion of alloy 718 and WC at higher magnification. By use of a 3-D microscope, volume difference analysis was conducted and the resultant micrograph clearly shows the volume adhered to the tool-chip contact area along the cutting edge (Fig. 7 (d)). The colour variation orange and red being the highest level of material adhered and cyan colour showing the build-up layer on the tool.

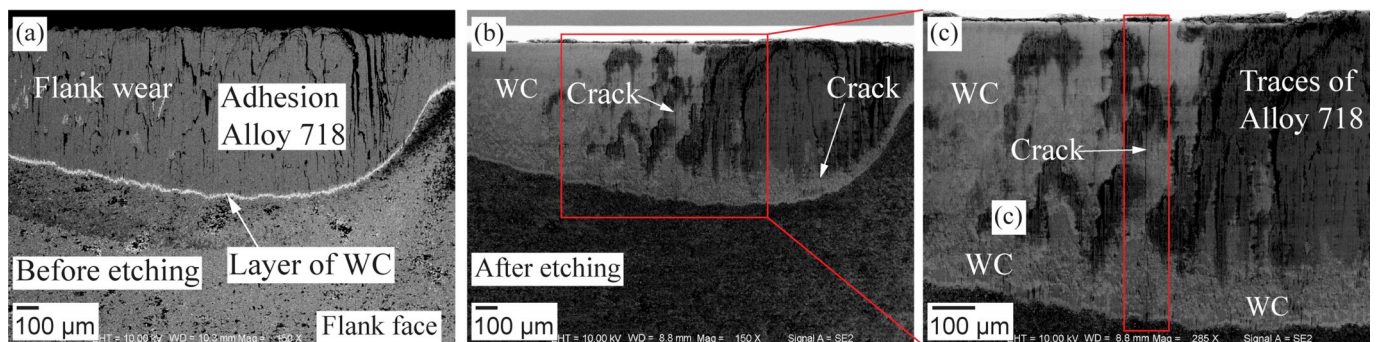
Fig. 9. SEM micrographs of the flank face of selected tool machined with a rake pressure of 16 MPa and no flank cooling (a) before etching, (b) after etching, and (c) higher magnification showing the crack.

When investigating the cutting tool in SEM, it was not possible to see a crack before etching the sample (Fig. 9(a)). Since the adhered workpiece material obscured the actual flank wear land, the tools were investigated after etching (Fig. 9(b)). After removing the adhered workpiece material from the flank face, the presence of the cracks was revealed see Fig. 9 (b & c). This could be seen as a kind of confirmation that the cracks are actually present in the tool and are not just part of the adhered layer.

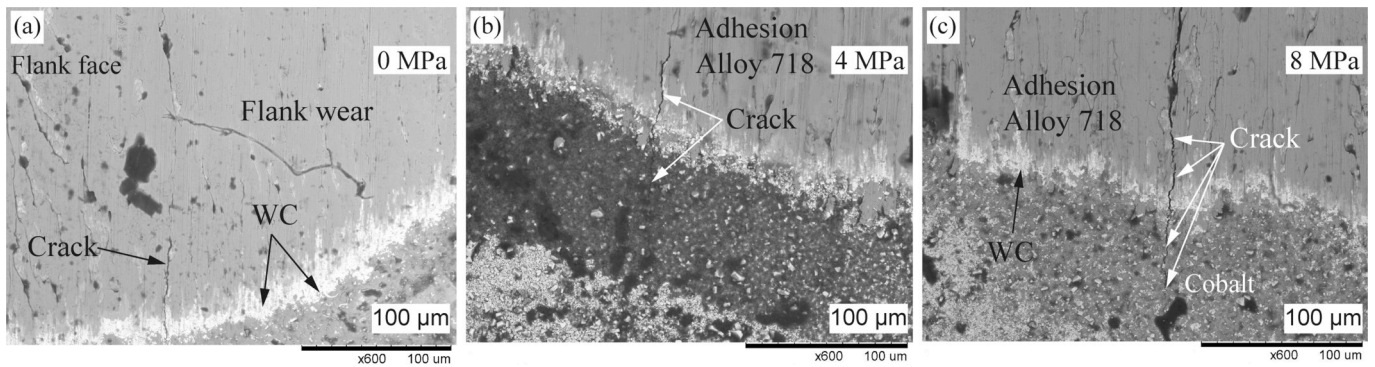
Fig. 10. For a rake pressure of 16 MPa selected tools SEM micrograph of flank face at higher magnification on the crack for different flank pressures condition (a) 0 MPa (b) 4 MPa (c) 8 MPa.

Selected cutting tools from different flank pressure conditions were investigated for cracks in flank wear zone using SEM, micrograph showing the crack propagation for all three conditions can be seen in Fig. 10. For 4 and 8 MPa of flank pressure, the maximum flank wear and area were measured to be lowered compared to no cooling conditions. However, cracks exist in the tools as can be seen in Fig. 10. In addition to adhesion of Alloy 718 and cracks, abrasion in form of sliding led to

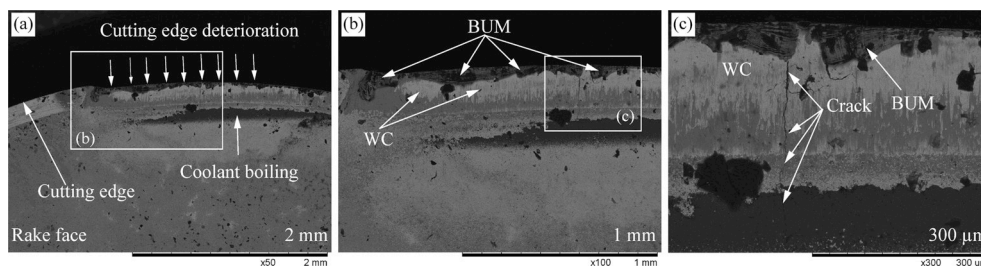
Fig. 11. Rake face of the cutting tool machined with rake pressure of 16 MPa and flank pressure 4 MPa (a) cutting edge deterioration (b) BUM on the cutting edge, and (c) crack initiation from the cutting edge crossing the tool-chip contact area.

The cutting edge deformation was identified as a common problem in machining HRSA [19]. On the rake face, tool-chip contact area was filled with Alloy 718 material. The cutting edge deterioration due to extensive abrasion and fracture were observed, Fig. 11. Increase in wear occurs as the cutting tool exceeds the deformation resistance due to the thermomechanical stress and at elevated cutting temperature. At this condition, the cutting edge cannot withstand the compressive stress. In case of carbide tools, plastic deformation mechanism occurs due to the increase in the cutting temperature (increase in cutting speed), under high cutting forces.

intense tool wear rate and cause tool breakage in form of cracks, as seen in Fig. 11 (c).

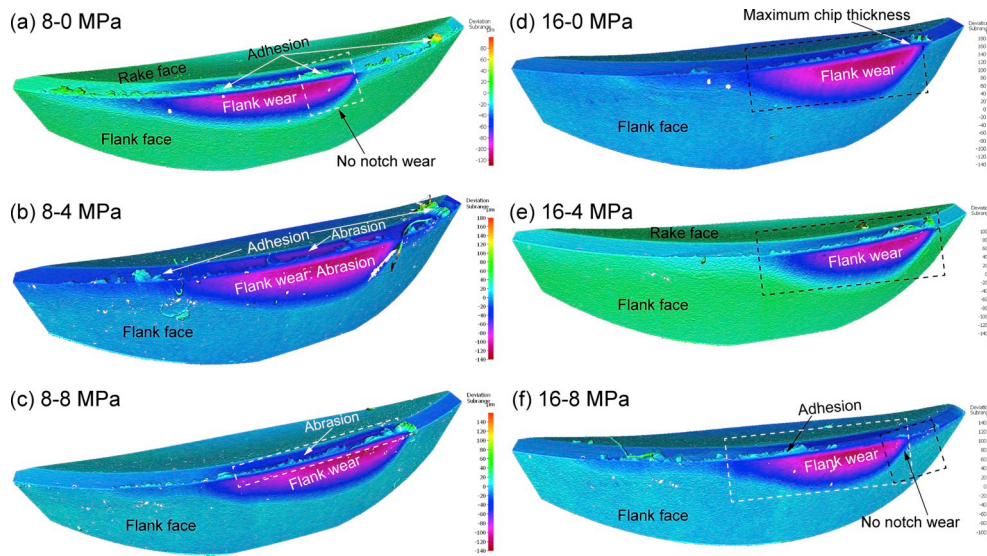
Fig. 12. Volume difference measurement of the cutting tools at different pressure conditions for v_c 90 m/min.

At higher cutting speed of 90 m/min and disregarding the strength of insert geometry and flank pressure conditions, the tool wear mechanism changed between 8 and 16 MPa. Instead of crater wear, which is one of the common wear mechanism in machining Alloy 718, loss of material was observed on the cutting edge (see Fig. 12 a, b and c), in form of abrasion. However, the shape looks like a “crater valley” than a localized crater wear. For the cutting tools machined with a rake pressure of 16 MPa, abrasion rate and flank wear area were less. In addition, the tool-chip contact area was more constrained and showed less abrasion compared to the tools with a rake pressure of 8 MPa (see Fig. 12).

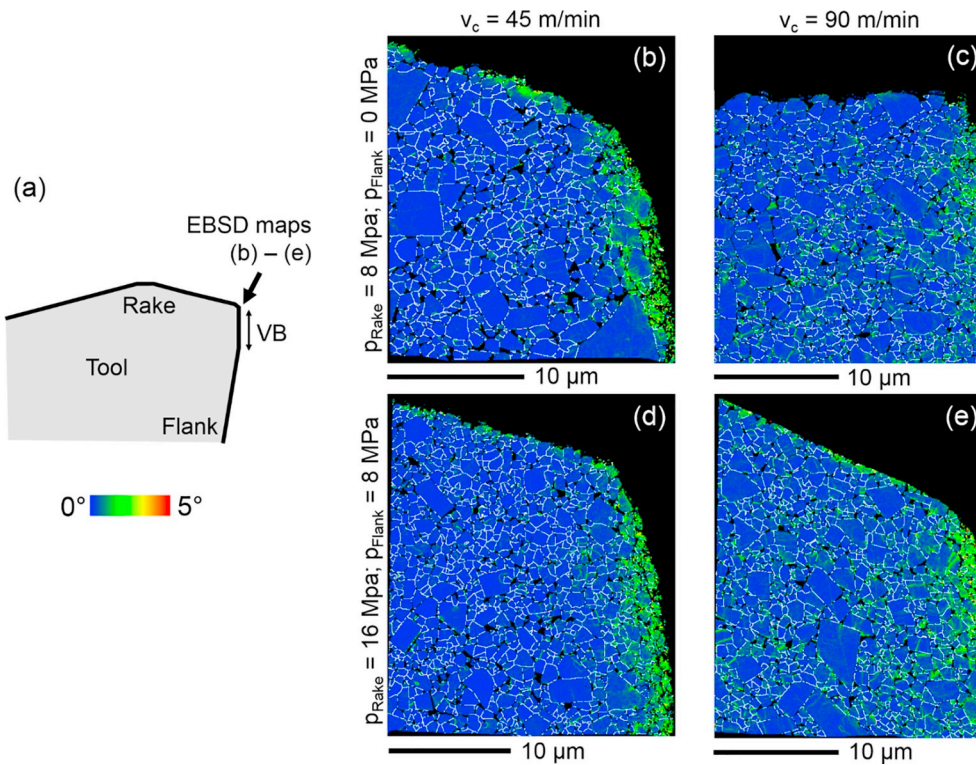
Fig. 13. EBSD results of worn cutting tools: (a) schematic representation of cross section through worn tools with location of EBSD maps indicated; (b)–(e) EBSD local misorientation maps of WC grains for low cutting speed (left column) and high cutting speed (right column) with low and high coolant supply pressures to rake (p_{Rake}) and flank (p_{Flank}) in the upper and lower row respectively. The local misorientation maps were generated using 3×3 pixel filter size, 5° subgrain exclusion angle. Grain boundaries ($> 10^\circ$) are shown in white.

dependence of the machining and coolant conditions, cross sections of four worn inserts were prepared and examined with EBSD regarding the plastic deformation of WC grains. Local misorientation maps of EBSD datasets acquired at the cutting edge can be seen in Fig. 13. The colour of every pixel represents its average orientation difference with a set of surrounding pixels [13]. According to the colour code in Fig. 13 (a), undeformed regions with low/no local misorientation are therefore shown in blue while higher misorientations due to deformation of the WC grains are shown by green, yellow, and red. As can be seen, the majority of all four maps are coloured blue indicating that these areas are free of deformation. However, close to the worn surfaces on the rake and flank faces, green and yellow coloured pixels show significant local misorientation (deformation) within WC grains. The affected zones extend a few rows of WC grains into the tools (below 5 μm). The examined part of the rake face in Fig. 13 (c) shows an exception where no local misorientations can be seen in close vicinity to the worn tool surface. As indicated by the significantly different geometry of the cutting edge (compare with e.g. Fig. 13 a), it is believed that this tool exhibited local chipping of the cutting edge in the region where the tool was sectioned. Brittle fracture of the tool material due to chipping instead of gradual wear might explain the absence of deformation in Fig. 13 (c).

Interestingly, no significant differences between the low and high coolant supply pressures can be observed for the two cutting speeds: The majority of deformation reaches to about the same depth beneath the worn rake and flank face when comparing Fig. 13 (b with d) and when comparing the flank face in Fig. 13 (c with e). The observed reduction in tool flank wear for constant cutting speed when using higher coolant supply pressures (see Figs. 4 and 5) are therefore not likely due to a significant reduction of plastic deformation of WC grains. Instead, the increased cooling is expected to affect other wear mechanisms such as diffusion/dissolution or abrasion, which lead to the reduced overall flank wear.

the tools used with the higher cutting speed of 90 m/min as compared with the tools used for 45 m/min cutting speed (compare Fig. 13 (c and e) with Fig. 13 (b and d)). This is likely to be the result of higher thermal and mechanical loads, which are expected to act on the cutting edge when for the higher cutting speed, resulting in a larger zone of the network of WC grains to be deformed during cutting.
